LUNESIDE WEST LANCASTER

Archaeological Building Assessment

November 2005

Countryside Properties

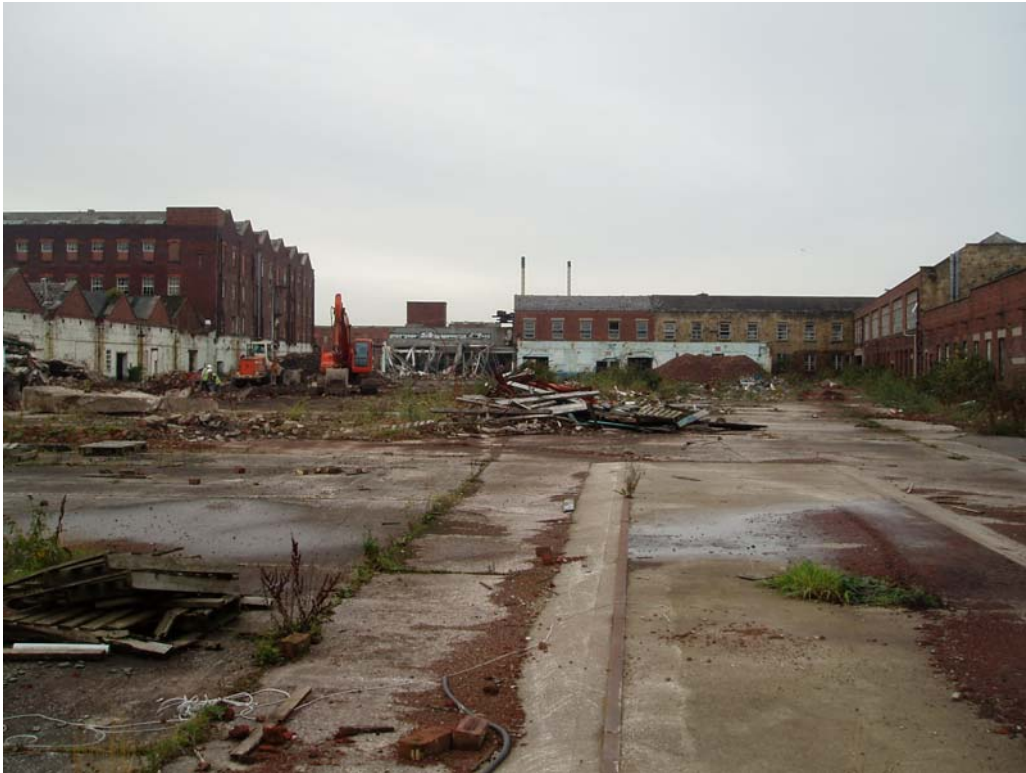
Single-storey brick shed with east/west aligned roof with timber queen-post roof trusses. Butts the eastern side of stone Structure 12. Remains of the metal railway platform edge were observed within the floor surface. This originally formed part of the nineteenth century sawmill. Now demolished (Plate 1).

Plate 1: The site of Structures 3, 5-8 and 12-13 following demolition, looking west

The shed appeared to relate to the expansion of the site and the loading/unloading of materials for transport to/from the site by rail after World War 2. It was originally constructed as part of a sawmill. As the structure is now demolished there are no recommendations for further work.

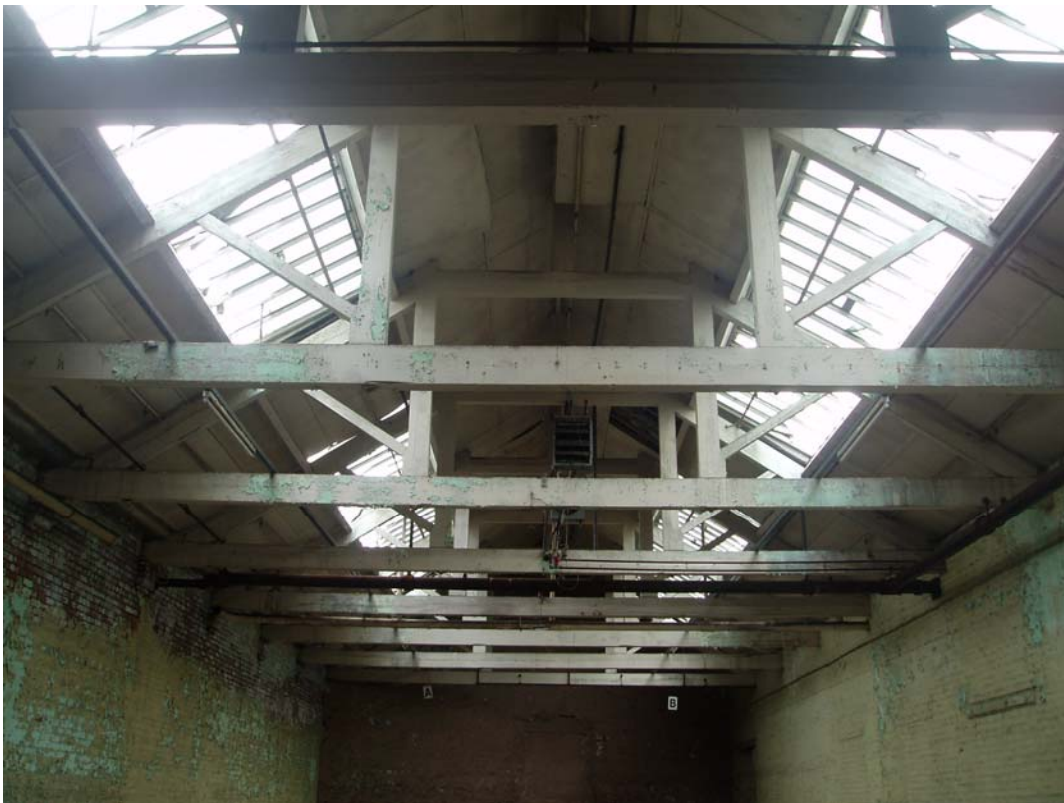
Plate 2: Trusses in Structure 4, looking south

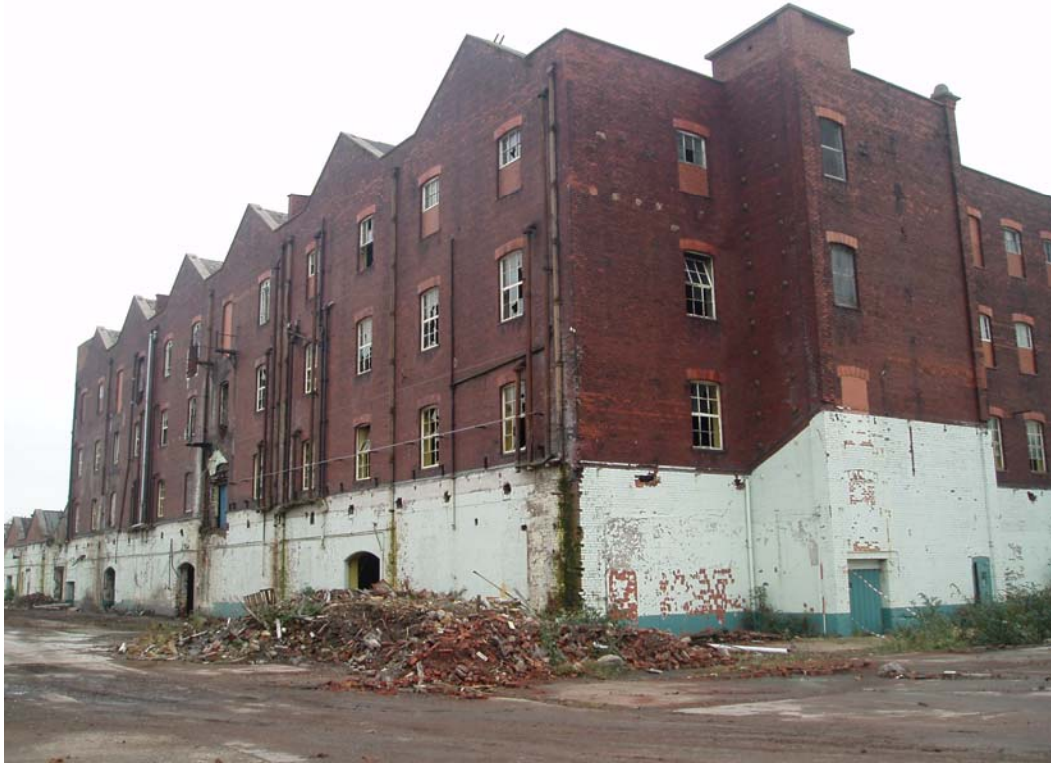
Four-storey brick warehouse with multiple-span roof (Plate 3, 16 and 17). It has three lift-shafts, all apparently intact, and a walkway at first floor level over Structure **9** into Structure **17**. Original timber flooring and much of the metal sheeting on the ceilings survives internally, as do the large round-section columns supporting each floor. Metal-lined apertures observed on the upper floor may possibly relate to power or

Plate 3: General view of Structure **11**, looking southeast

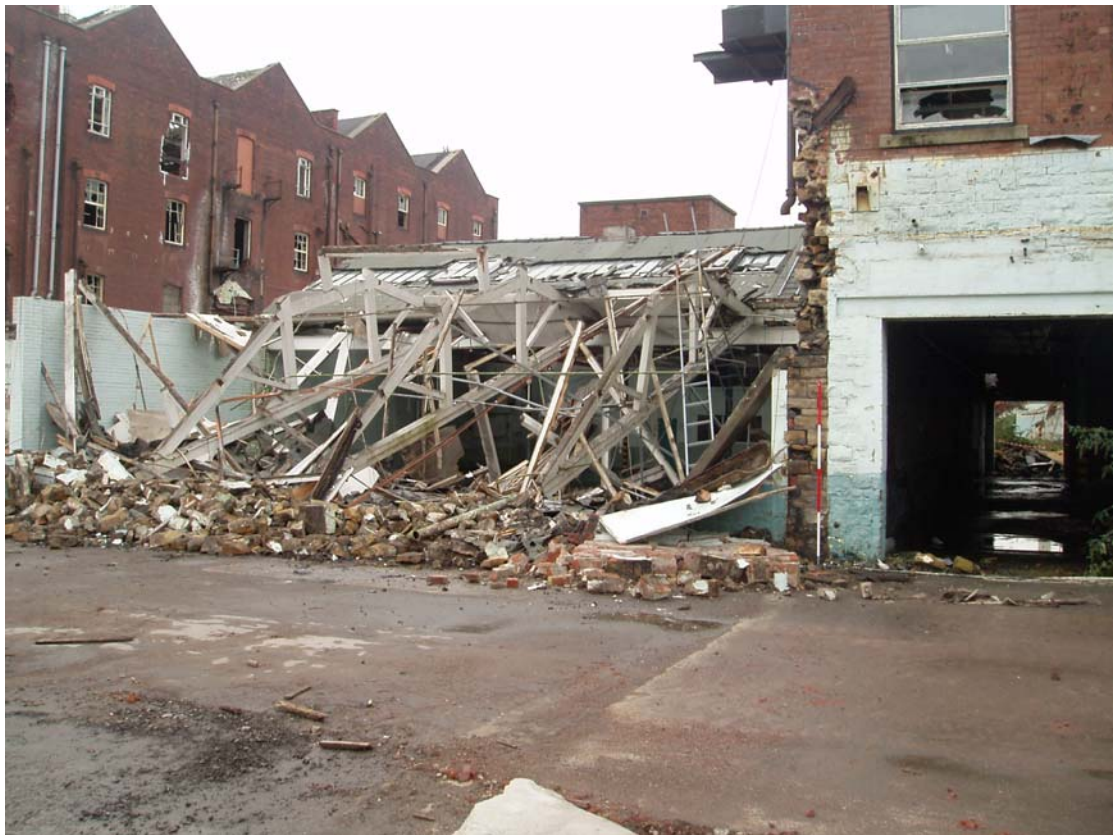
Plate 4: The remains of Structure **12**, looking west

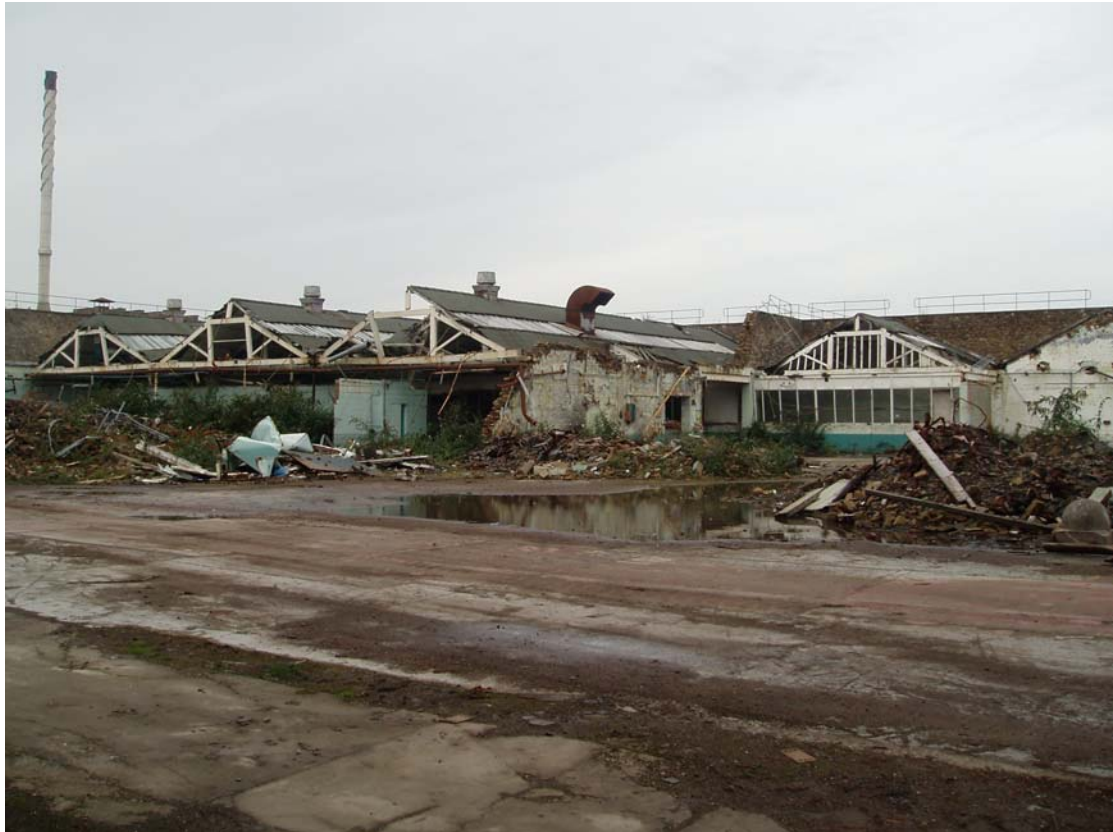
Large single-storey sandstone rubble constructed structure (Plate 5). It is divided internally into six roughly equally-sized cells by similar stone walls and has north/south aligned roofs with timber queen-post trusses, and retains many of the better preserved features observed within the structures of this date. A large part of the south end has been demolished, exposing later internal walls constructed of brick and concrete blocks.

Plate 5: The damaged remains of Structure **17**, looking northwest

This warehouse is the largest surviving stone-built structure and retains many original features typical of the style of construction during this phase of expansion of the mill complex. It is recommended that this is recorded to RCHME Level II-type standard prior to redevelopment. However, this structure would appear to be inaccessible due to health and safety reasons

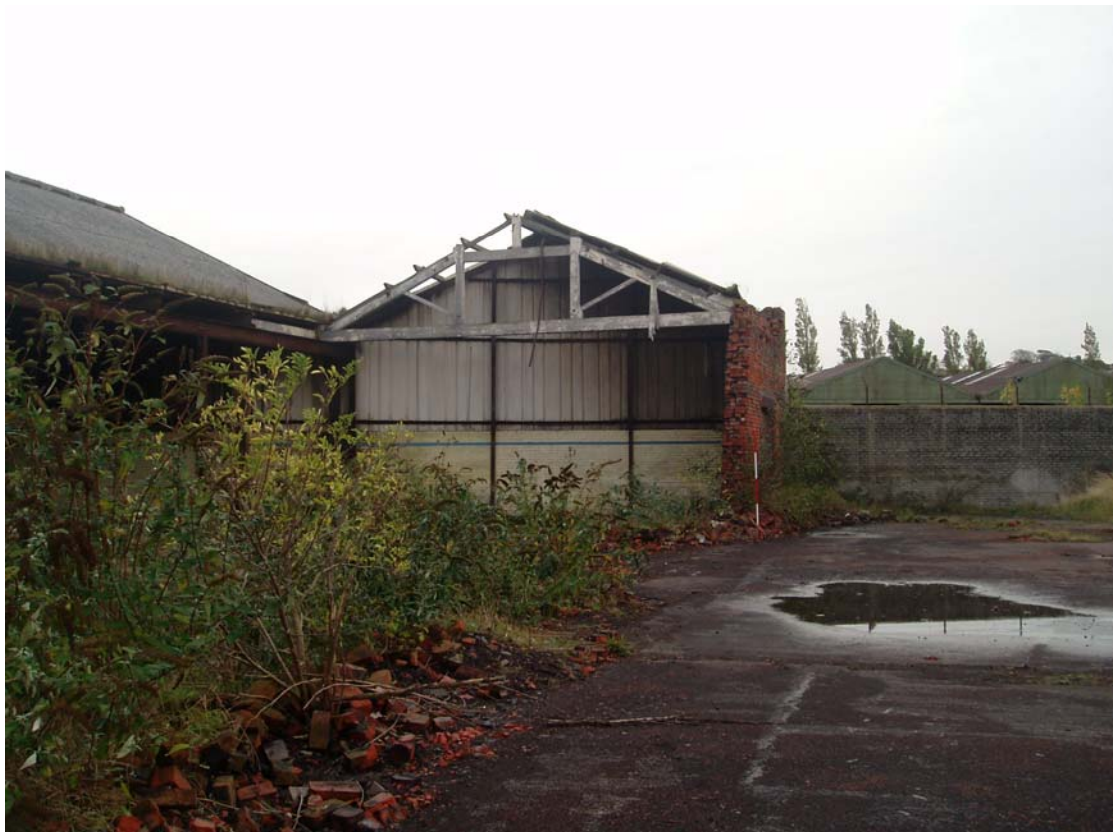
Plate 6: The damaged remains of Structure **20**, looking south

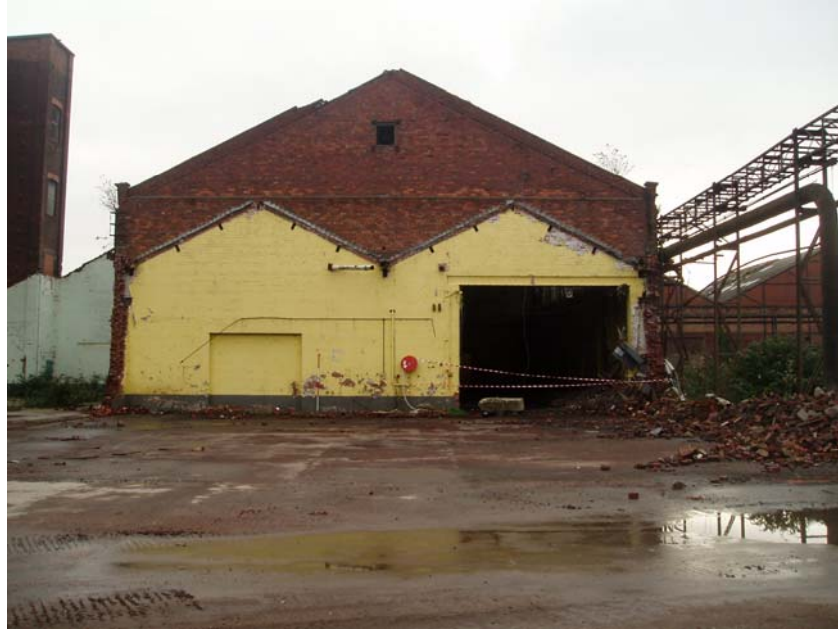
Plate 7: The damaged remains of Structure **21**, looking south

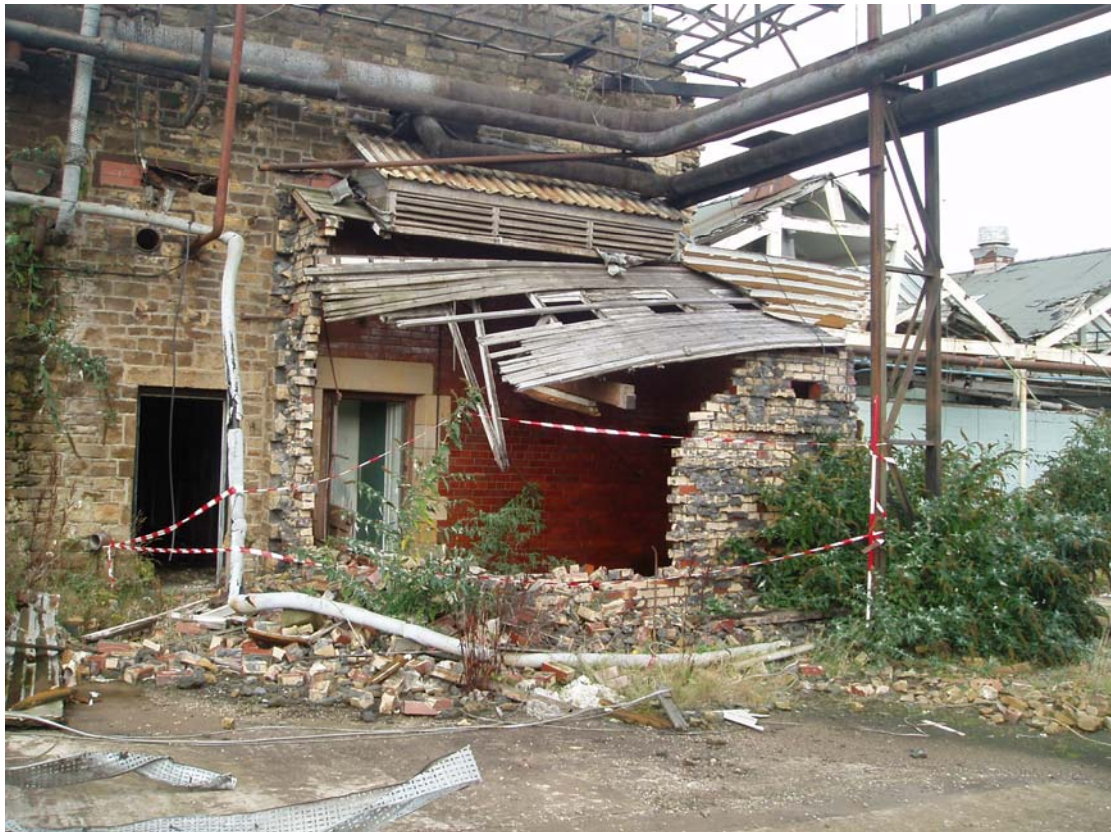
Narrow single-storey sandstone rubble structure. It has a north/south-aligned roof with queen-post timber trusses (Plate 8). The south end has been partially demolished revealing the structure, which comprises an outer skin of sandstone blocks and an inner face of brown and white glazed brick marked 'Leeds Fireclay Co Ltd' and 'LFC England' (founded 1889 (Burnmantofts Pottery History n.d.)). The relationship of its walls to Structure **24** suggests that it is earlier.

Plate 8: The damaged south end of Structure **22**, looking northeast

This is one of the few stone built structures within the complex of surviving buildings. It relates to the earlier phases of the expansion of the mill, and forms the northern end of the parcel of land bought in 1888. Despite the damage, it should be recorded to RCHME Level II-type standard prior to redevelopment.

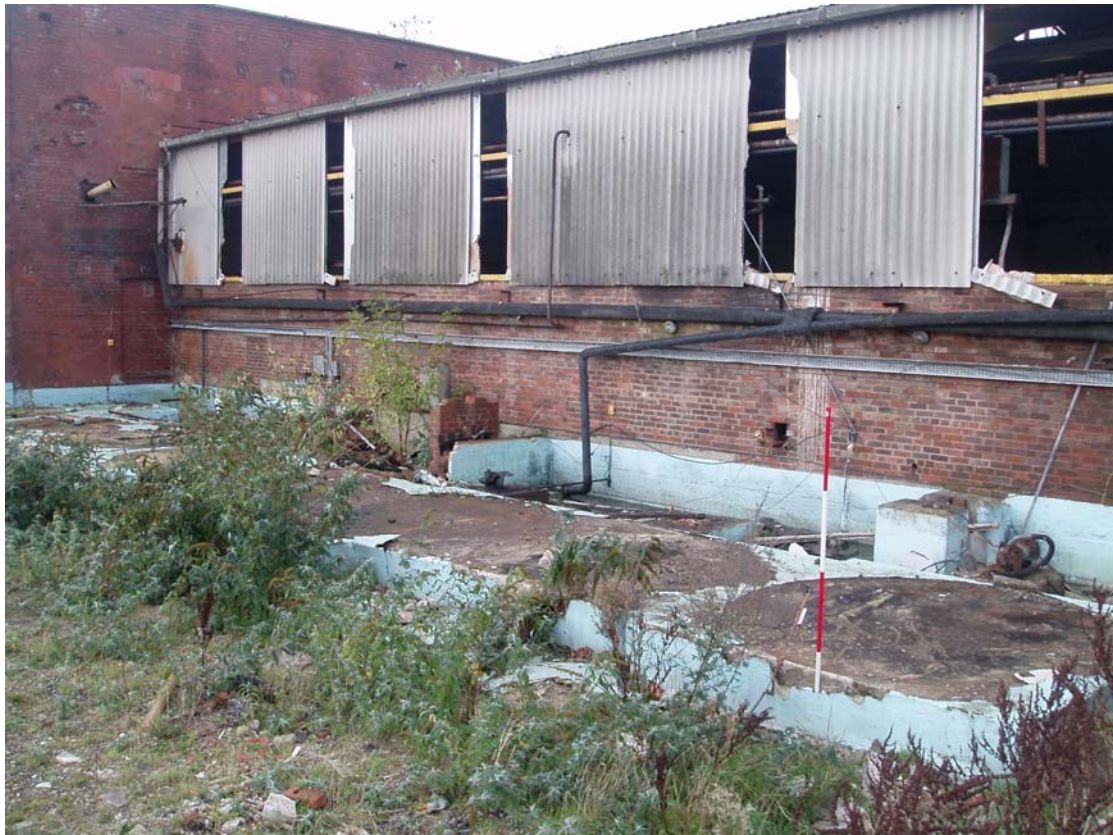
Plate 15: Engine bases at the south end of Structure **25**, looking north-west

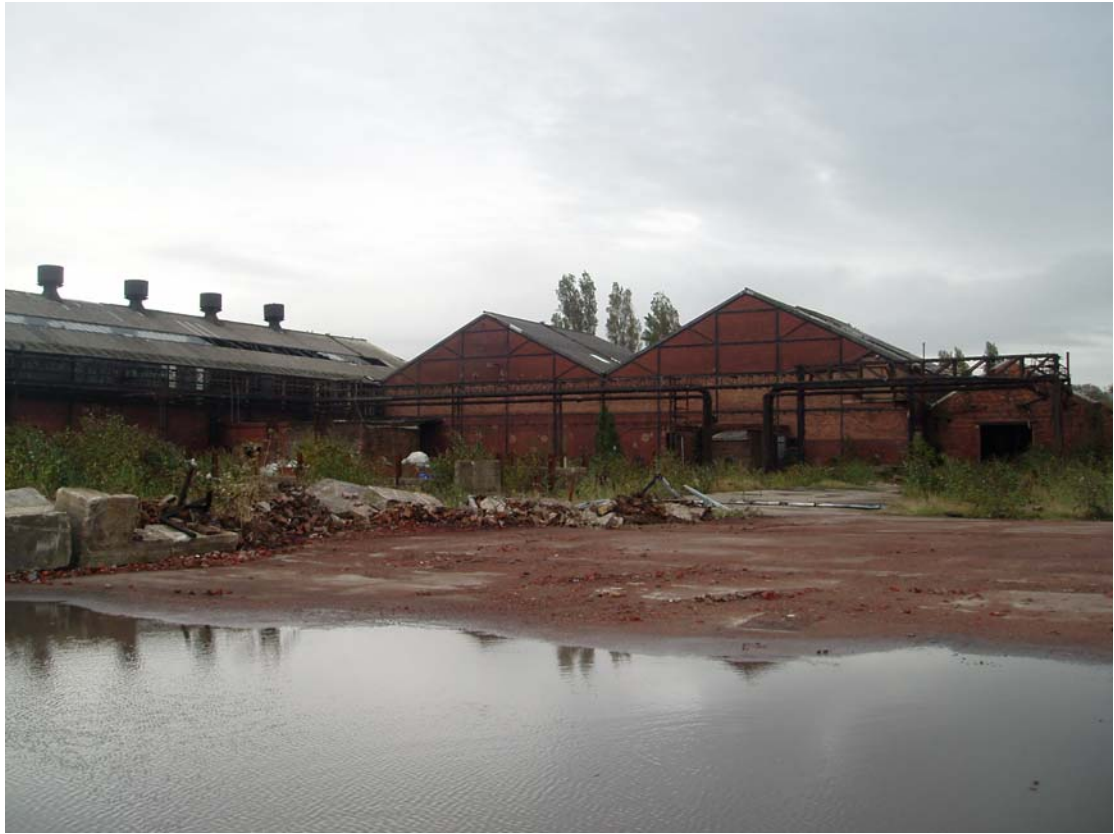
Yard to the south-west of Structure **9**, enclosed into a roofed structure in the twentieth century (Plate 18). The metal roof trusses are higher than those observed elsewhere (especially when compared to those in Structure **21** to the immediate north), and seem to have been inserted specifically to suit the function of the structure created by enclosing the former yard. The roof has now been completely removed and the flooring is obscured by rubble.

Single-storey high brick constructed processing shed with several *in-situ* processing tanks (Plate 18). The lowest c6m of the southern wall was constructed in sandstone rubble, and forms the boundary wall of the site. The remainder is comprises a frame of iron girders infilled with bricks. The north/south aligned metal-trussed roof appears to be a replacement of an earlier, lower roof, and is probably contemporary with that of Structure **20** to the west.

Plate 18: Structures **18** and **19**, looking south

The yard was an important element of the complex, giving an idea of the movement of materials around the complex. The unique roof showed a specific function change to offices in the mid-nineteenth century. As the structure is now demolished there are no recommendations for further work.

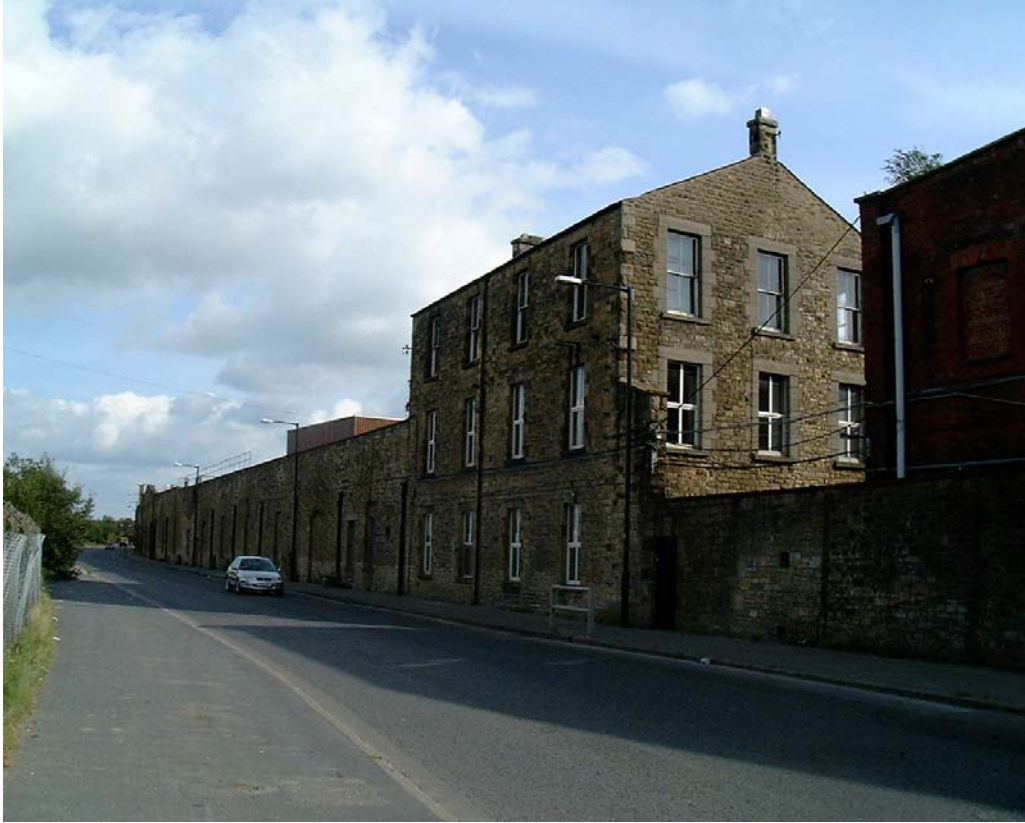
Three-storey sandstone built offices on the northern boundary of the site (Plate 24). Its condition has changed little since the previous assessment (OA North 2002).

Plate 24: Structure **28**, looking southeast (after OA North 2002)

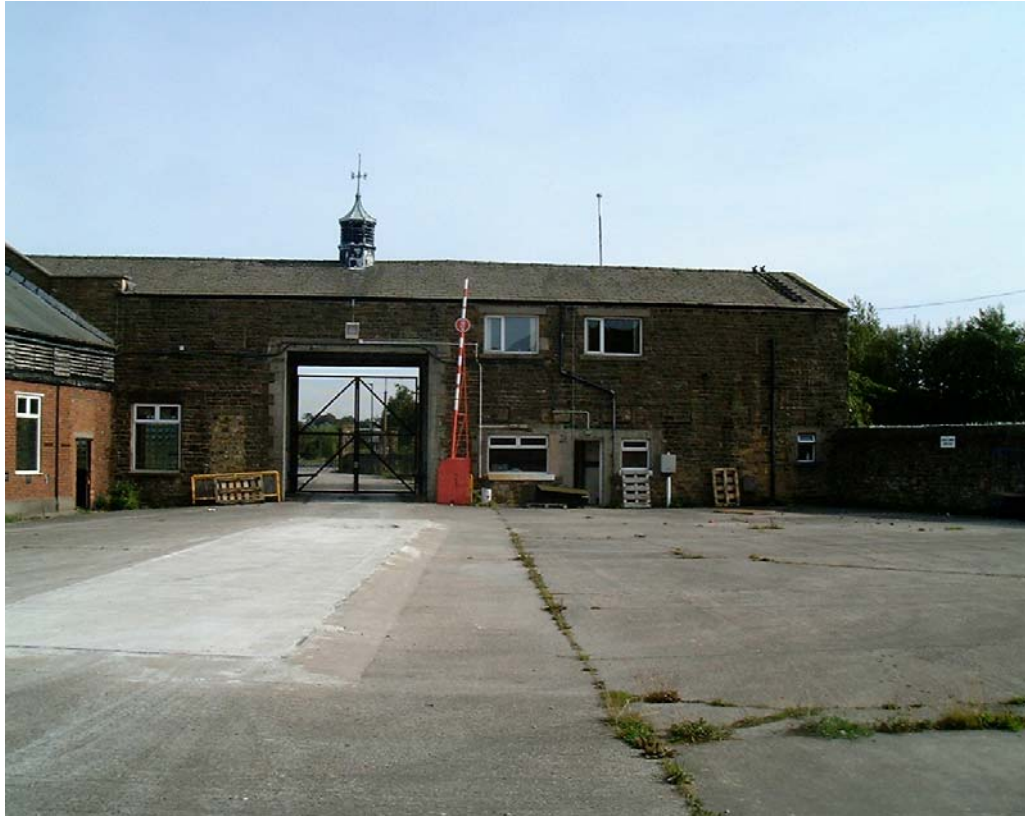
A two-storey sandstone gatehouse, with central octagonal louvered turret and weather vane (Plate 25). The western, internal, face has had alterations during the mid/late twentieth century, but much of the original character is retained. Evidence of high quality stables was observed to the north of the central arch. The early twentieth century Avery weigh-bridge is *in situ* below the arch. It has changed little since the initial assessment (OA North 2002; Plate 25), apart from superficial damage and water ingress.

Plate 25: Structure **1**, looking east (after OA North 2002)
