CATHEDRAL VILLAGE, MARKET STREET LANE, BLACKBURN LANCASHIRE

Building Assessment

Oxford Archaeology North

October 2005

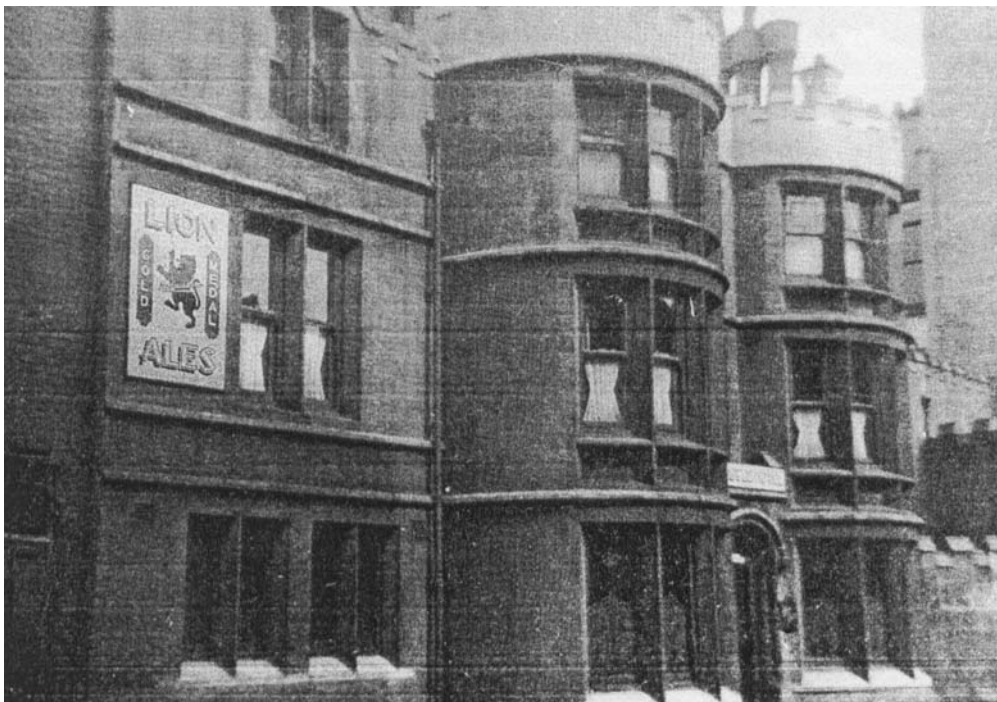
- 3.5.2 The two public houses were of particular local interest: the Castle (Building **2**) was re-built in 1810 with castellated wall-tops and two semi-circular bays (*ibid*). The Dun Horse (now the ZY Bar, outside the study area) was apparently in existence by 1715, and was visited by a Captain Douglas while his Jacobite forces were at Preston (*ibid*). There was also an assembly room on Market Street Lane (now demolished, but to the west of Building **4**), thought to have been in existence since 1795 and known as the New Assembly Room (*ibid*). It is described as '*a large and well-lighted room on the second floor, over a number of shops and warehouses and it was connected with the Colonnade in Fleming square*' (*ibid*). It had a variety of uses in its time including a singing room (used by the Blackburn Choral Society (Hyes 1999, 95)) and school, and was used as a meeting place for the Mechanics Institute, the Blackburn Philosophical Society and the Temperance Society and was even visited by a circus (*ibid*) and waxworks show (Walmsley 1919a). The street was also home to the New Royalty Theatre from at least 1881 (Building **6**), which was later named the Lyceum Theatre (Miller 1957) and was the first place where 'animated pictures' were shown in Blackburn (Duckworth 1999, 174).

Plate 8: An early view of the Castle Hotel (after Baggoley 1996, 65)

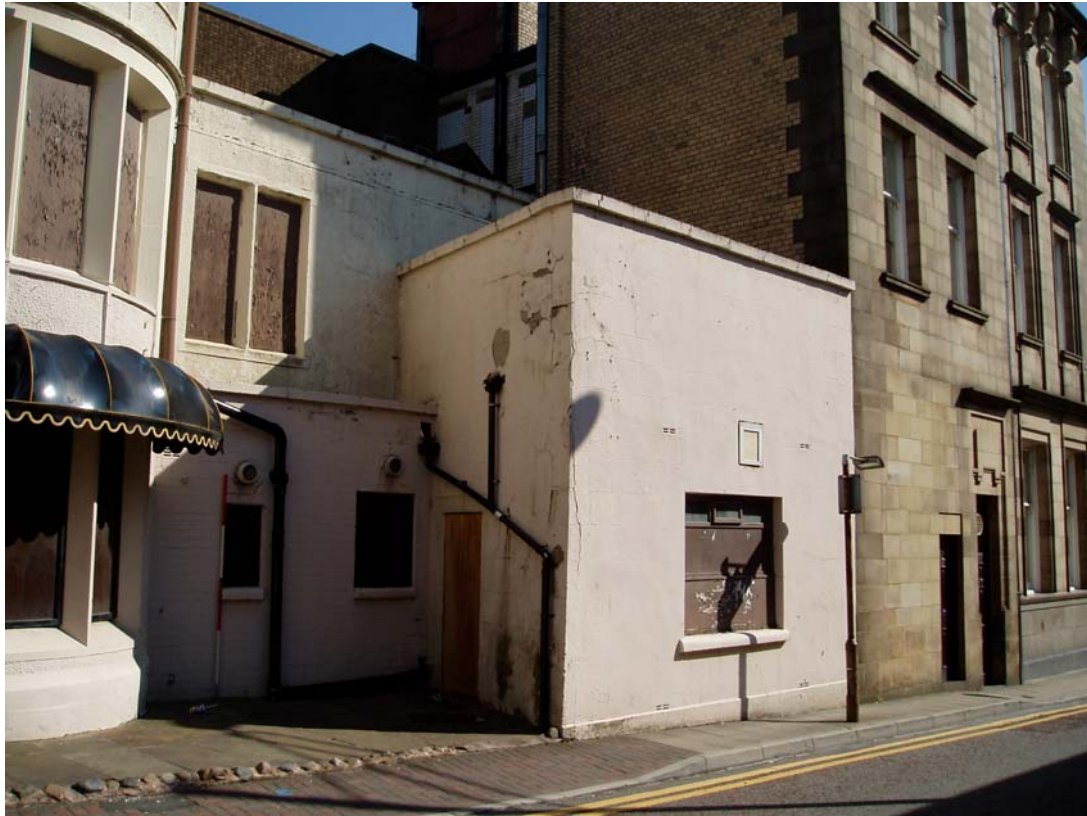
Plate 9: Building 1, looking north-east

Description: This comprises a small, two-storey building at the east end of Market Street Lane, between Building 2 to the west and the bank to the east (Plate 9). The front (south) elevation is rendered and painted off-white. The east end projects from the main part of the elevation, making it flush with the adjoining bank and is finished with render scored to give the appearance of ashlar blocks. There is a single ground floor window within this projection, and a doorway in the return to the north. To the west is a smaller, single-storey, projecting section built of brick in stretcher bond, with two small windows. Behind this the main elevation has a single tall two-light 'mullion' window. The roof above could not be examined but a section of gabled roof, possibly a louvre, was visible. The rear (south) elevation showed evidence for several phases

of construction. The lower part was built of courses of sandstone, above which the majority of the wall was built in hand-made brick. Inserted into this were two small windows, associated with considerable rebuilding with machine-made brick. To the west a butt joint with the adjoining Building 2 could be seen.

Original use: Unknown
Date: Pre-1848, presumably subsequently altered
Further work: RCHME Level II recording

- 6.1.3 It is therefore recommended that all of the buildings identified during the assessment be subject to additional investigation. This should take the form of a RCHME Level-II type survey, including the production of plans of all of the principal floors, cross-sections and drawings of significant features. Additional background research into buildings should also be carried out in order to identify the date of origin, phases of use, owners, occupiers, uses, and so forth.

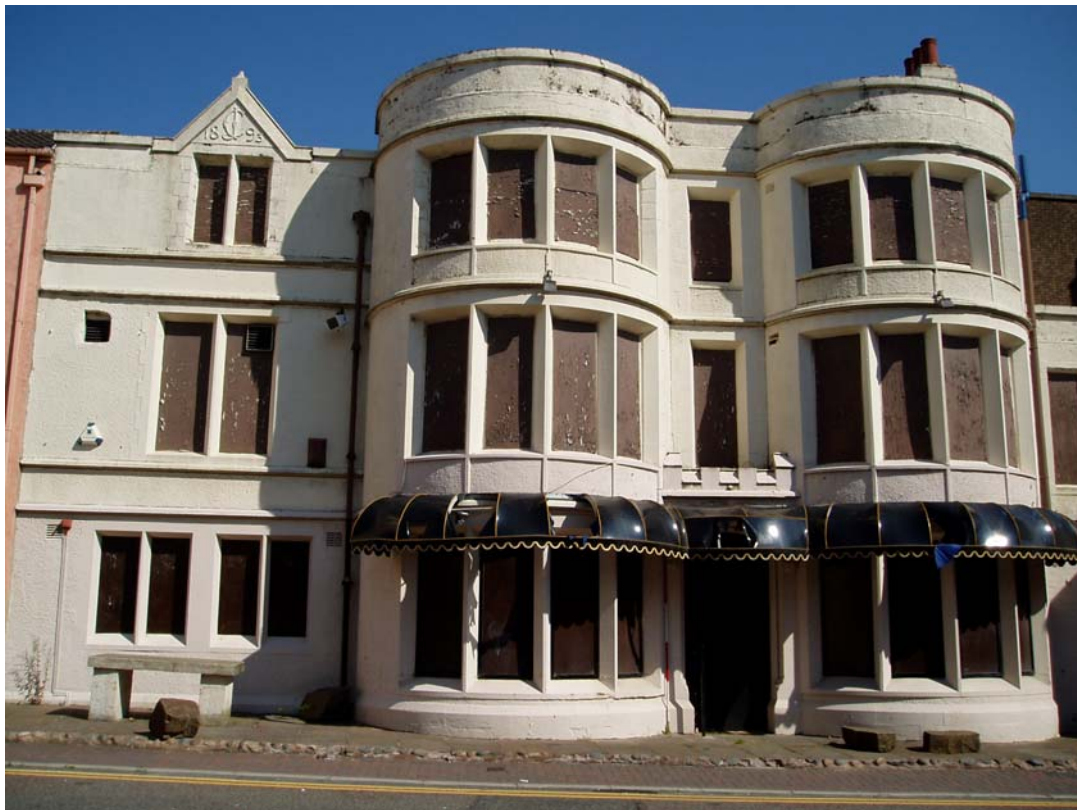
Plate 10: Building 2 looking north

Description: This is situated to the west of Building 1, and between it and Building 3 (Plate 10). It comprises a three-storey former hotel and/or public house. The rear (north) is built of what appear to be hand-made brick in a stretcher bond, but the front (south) is finished with render and painted and its fabric is not discernible. The eastern part of the front is dominated by two semi-circular bay windows, which extend over all three floors, and have long four-light mock Tudorbeathan windows. Each of these is decorated with three moulded string courses (the lower of which is obscured by a later awning) and a flat coping, which extend across the entire elevation. Between the bay windows is the main entrance, on the ground floor, which is decorated with moulded surrounds beneath a semi-circular arch, finished with floral corbels. Immediately above the doorway is a small area of crenellation, above which are single small windows on the first and second floors. The general decorative effect is that of a mock-castle. The west end is flat, with similarly Tudorbeathan windows, diminishing in number as they rise through the floors, and the top is finished with a blind dormer decorated by moulded monogram initials 'CJ' and the date 1893. There is a chimney visible on the east side.

Original use: Public house (Castle Inn)
Date: 1739-c1795, rebuilt 1810 and 1893
Further work: RCHME Level II recording

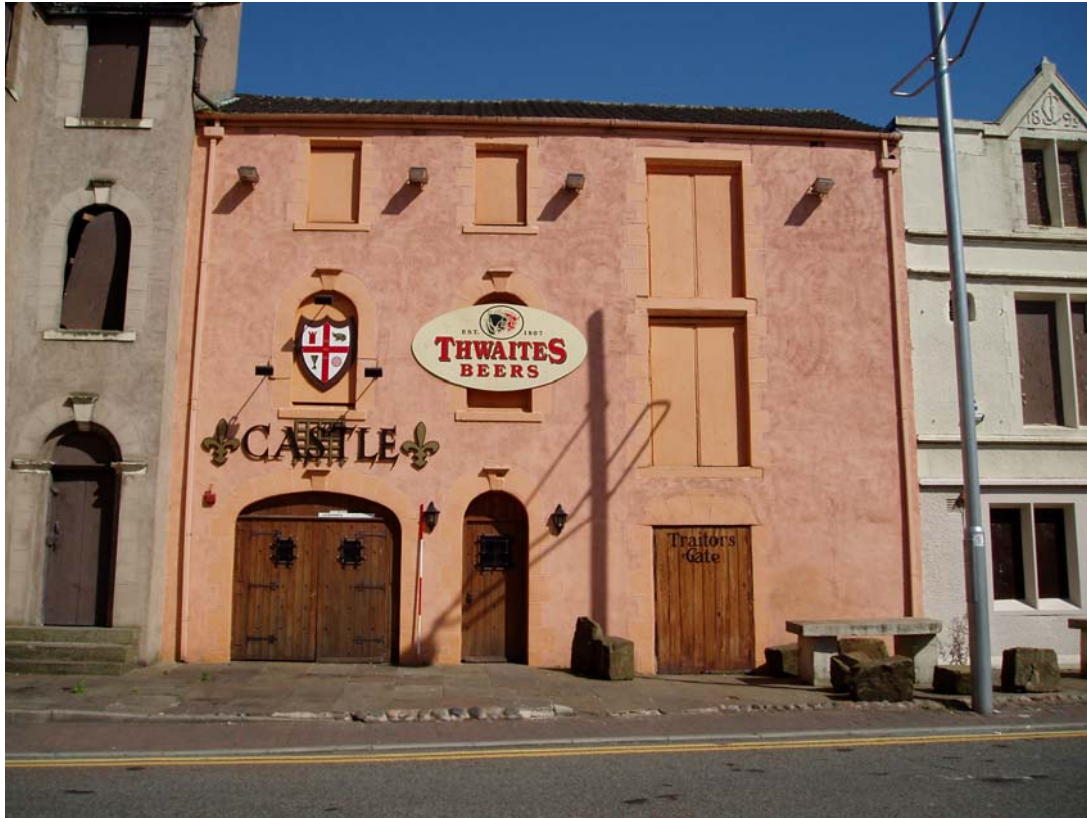
Plate 11: Building 3, looking north

Description: This is situated to the west of Building 2 and between it and Building 4 (Plate 11). It comprises a three-storey warehouse, still with much of its original character surviving. The front (south) elevation is rendered and painted a pinkish-orange and Building 5 obscures the rear. On the east side a row of wide loading doorways is present, one above the other. The ground floor loading doorway has an arch of ashlar-effect render but is actually flat-headed, while all three doorways have ashlar effect scored render. The west side has two windows on both the first and second floors. The first floor windows have round heads with projecting keystones and ashlar-effect surround, while the windows above have only square surrounds in the same ashlar effect. Below are a pedestrian doorway in the centre and a wagon doorway with a rounded arch to the west. Both also have projecting moulded keystones. The roof is finished with ceramic tiles.

Original use: Warehouse
Date: Pre-1822
Further work: RCHME Level II recording

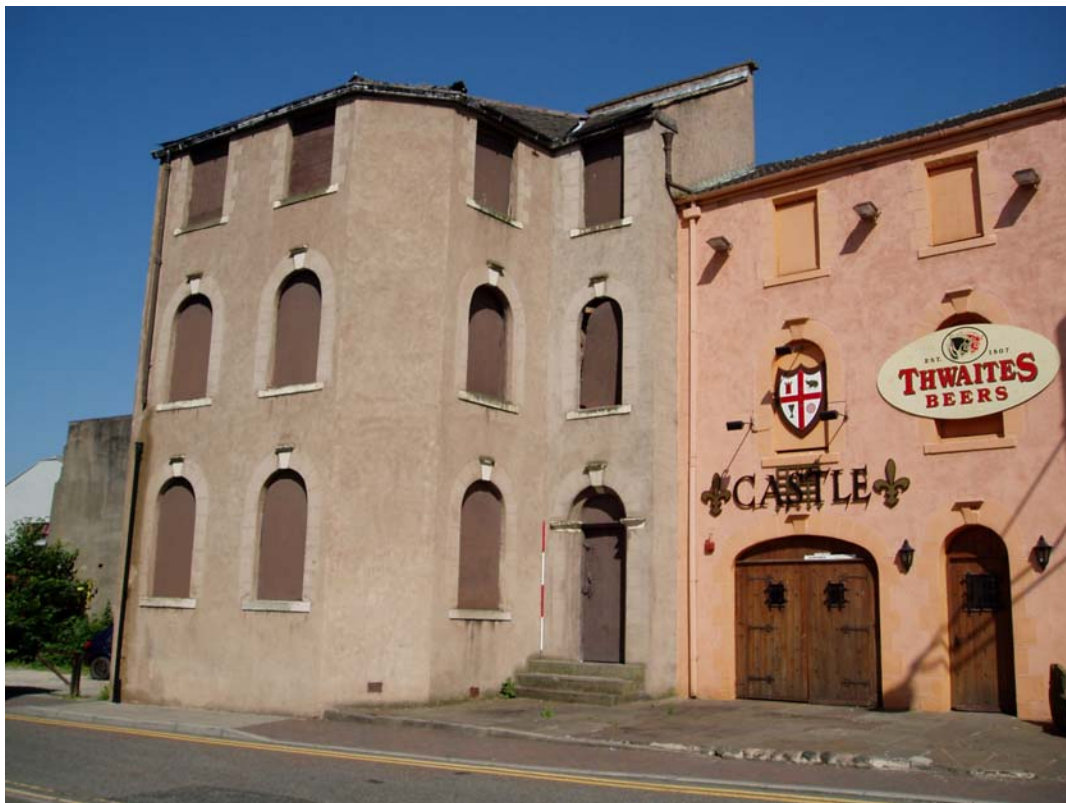
Plate 12: Building 4, looking north-west

Description: This is situated to the west of Building 3 and on the end of the row of buildings facing onto Market Street Lane from the north side (Plate 12). It is also three storeys, but is taller than Building 3. It is rendered, but not painted, and there are four windows on the first and second floors in the same style as those in Building 3. There is a return on the east side, leaving an angled corner, and on the ground floor at the east end there is a pedestrian doorway accessed via a short flight of steps. The doorway has a projecting moulded string-course and similar corbels on top of the jambs. The roof is essentially a single pitch, finished with grey slate.

Original use: Warehouse
Date: Pre-1822
Further work: RCHME Level II recording

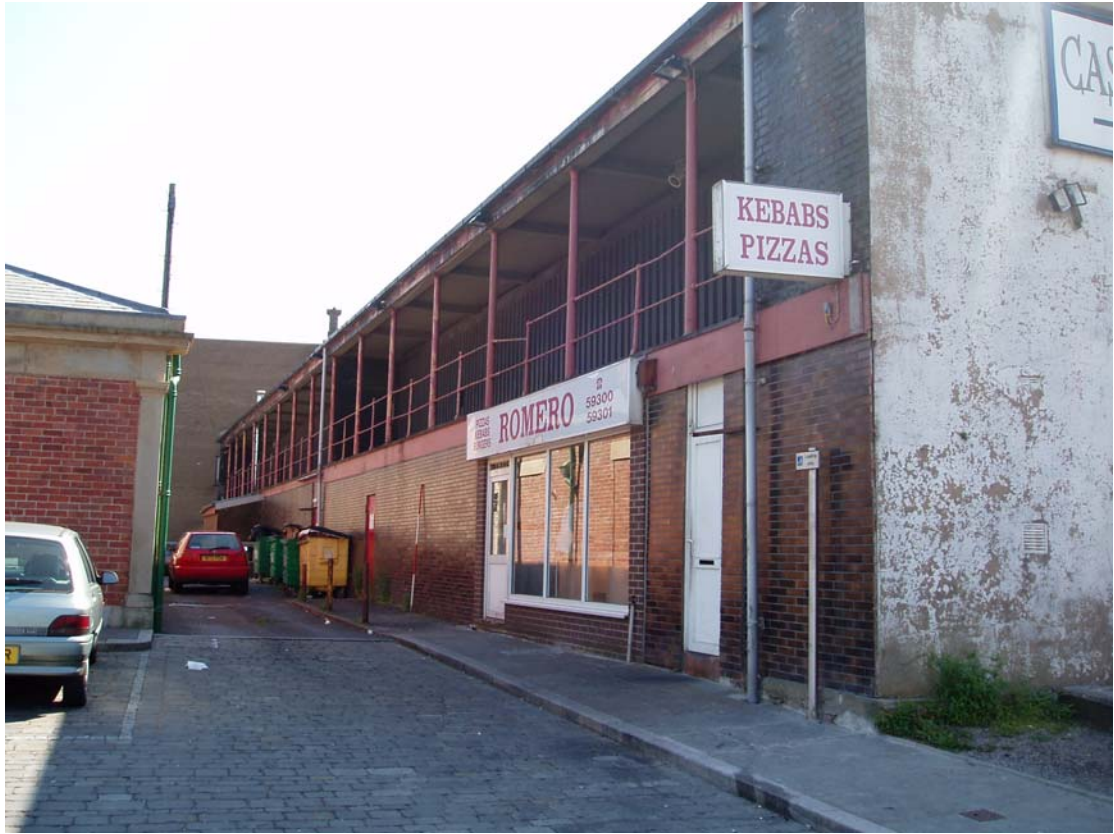
Plate 13: Building 5, looking south-east

Description: This is situated behind (north) the street frontage, facing onto Fleming Square, but runs roughly parallel to it (Plate 13). It comprises a long, relatively narrow building, part of which is visible from Market Street Lane, although this is rendered and shows no features of interest. The remainder is brick-built and apparently quite modern. On the north side the lower part comprises very dark brick and houses a number of pedestrian doorways. At the west end it incorporates a kebab shop. The upper part, which may be earlier, comprises an open colonnade formed by cast iron columns supporting the roof, attached to this is an iron railing covering the opening to the north. To the south is a series of corrugated sliding doors presumably covering rooms of some description.

Original use: Cloth Hall
Date: 1822-1848
Further work: RCHME Level II recording

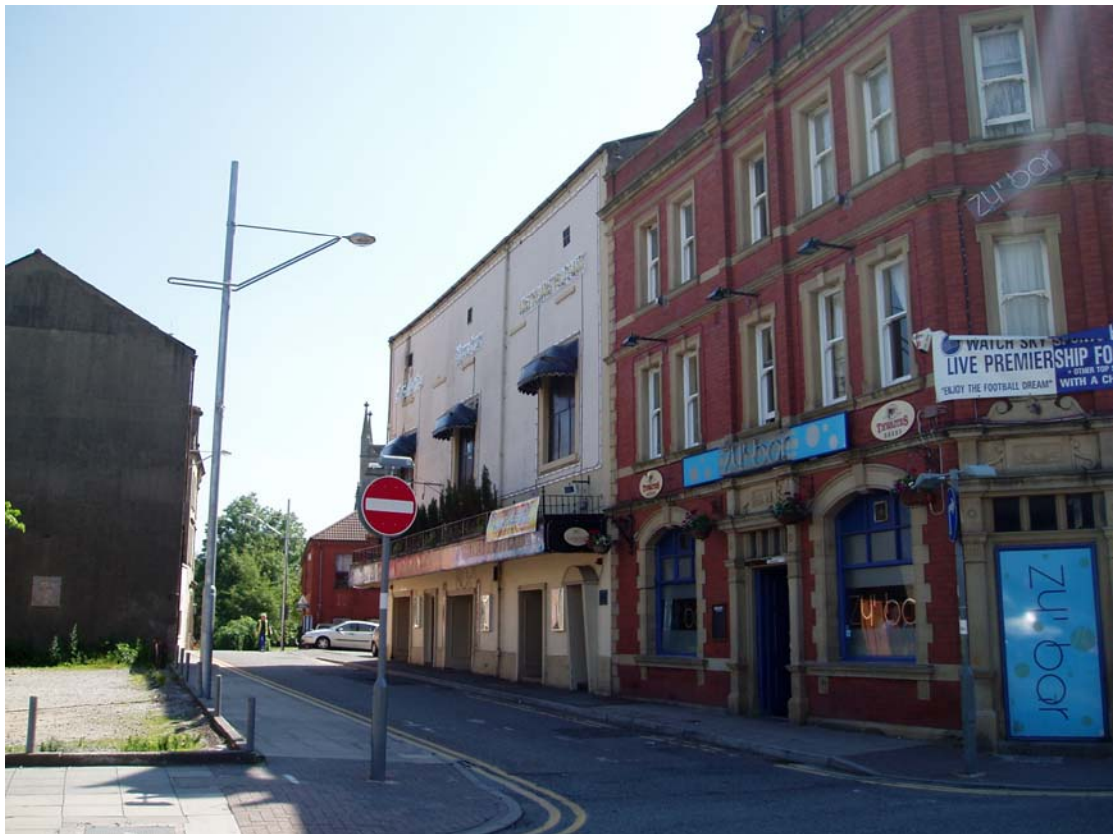
Plate 14: The ZY Bar, formerly the Dun Horse, and Building 6, looking south-east

Description: This is situated at the west end of the south side of Market Street Lane, adjoining the public house on the corner (the ZY Bar, formerly the Dun Horse; Plates 14 and 16). It is currently used as a night club but probably originally formed a large warehouse and theatre. The east gable end is visible and is rendered and painted off-white. There are three modern tie rod ends across the upper part of the wall, and attached to the base are three buttresses. Two of these are modern brick and very short, the third is longer and angled. It is also brick, but finished with render, and probably represents the remains of an earlier adjoining building. Evidence for a wall stub at the north-east corner of the building, flush with its north face elevation, would suggest that this is also the remains of an adjoining building and the fact that this and the larger buttress have remained might suggest that Building 6 is partially built on to an adjoining building. The front (north) elevation, which has been much altered, has three large windows on the first floor and three small vents on the second, probably corresponding to the position of windows. On the ground floor, there are five doorways of varying size below an iron balcony. The rear (south) elevation is rendered but more of the original features appear to be visible. There are three large windows on the first floor, with rounded heads, and there is evidence for similar windows having been present on the ground floor, although there are several inserted doorways. Four or possibly five blocked, smaller windows are evident on the second floor.

Original use: Warehouse and theatre (Lyceum)
Date: 1848-1894
Further work: RCHME Level II recording

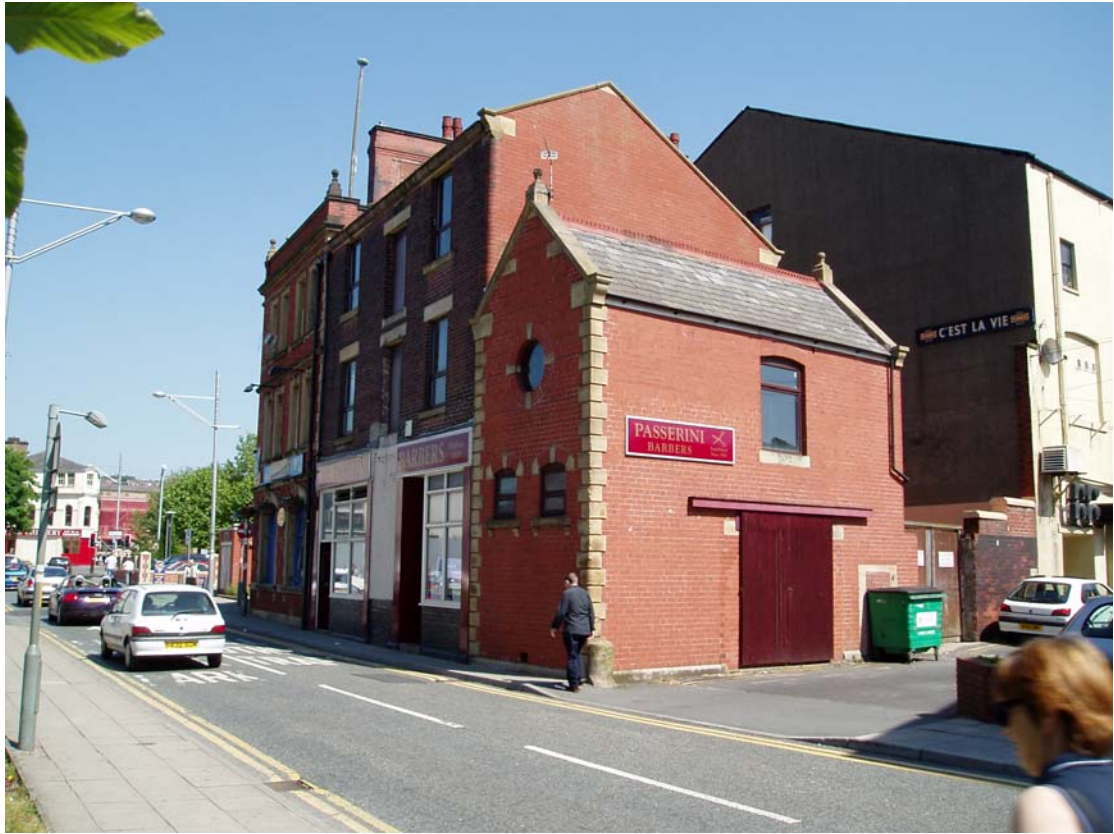
Plate 15: Buildings 7 and 8, looking north-east

Description: This is situated facing west onto Mincing Lane, adjoining the public house at the west end of the south side of Market Street Lane (Plates 15 and 16). It originally comprised a three-storey warehouse, but is now used as a barber's shop. It is built using a very dark brown brick, in English garden wall bond (at a ratio of four rows of stretchers to one row of headers). In the centre on the first and second floors there are loading doorways, and these are flanked by single windows. On the ground floor there are two large later shop windows with associated doorways. The rear (east) side is rendered and partially rebuilt in the style of Building 8, which is presumably a contemporary alteration.

Further work:	RCHME Level II recording

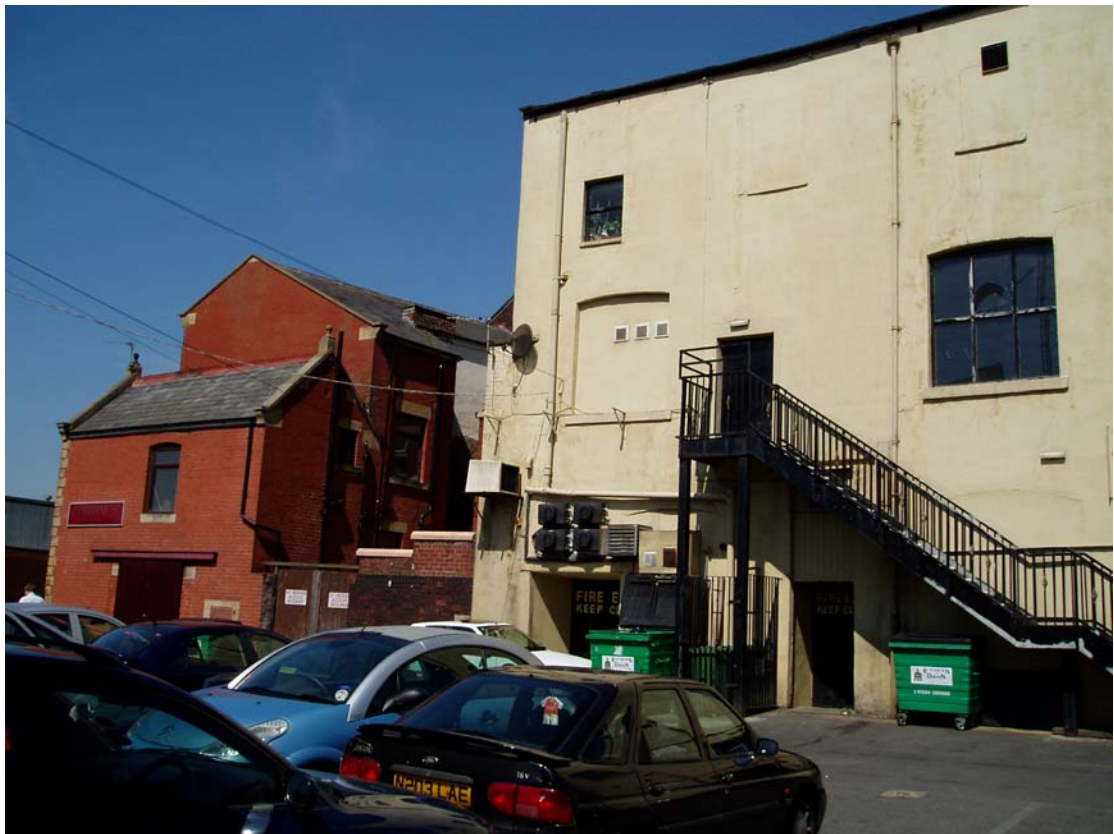
Plate 16: The rear of Buildings 6, 7 and 8, looking north-west

Building No:	8
Description:	This adjoins the south side of Building 7 and faces onto Mincing Lane to the west and the car park to the south (Plates 15 and 16). It is small, two storeys, very narrow and orientated east/west. It is built of machine-made brick, with details picked out in finely dressed sandstone. The west gable end has two small windows on the ground floor and a circular one above. The gable is finished with moulded stone coping, scrolled kneelers and a round finial on a tiered base. The roof is slate, finished with ceramic ridge tiles with a circular impressed decoration. The south elevation is plain, except for a single first floor window and a large wagon doorway on the ground floor with a sliding door. The detail of the west gable is copied in the east, although there is only a single, small window on the first floor.
Original use:	Unknown
Date:	1848-1894, possibly subsequently rebuilt
