# **MILLBROOK BOREHOLES TO LAMALOAD RESERVOIR, PEAK DISTRICT NATIONAL PARK**

## **Archaeological Evaluation and Topographic Survey**

**Oxford Archaeology North**

May 2006

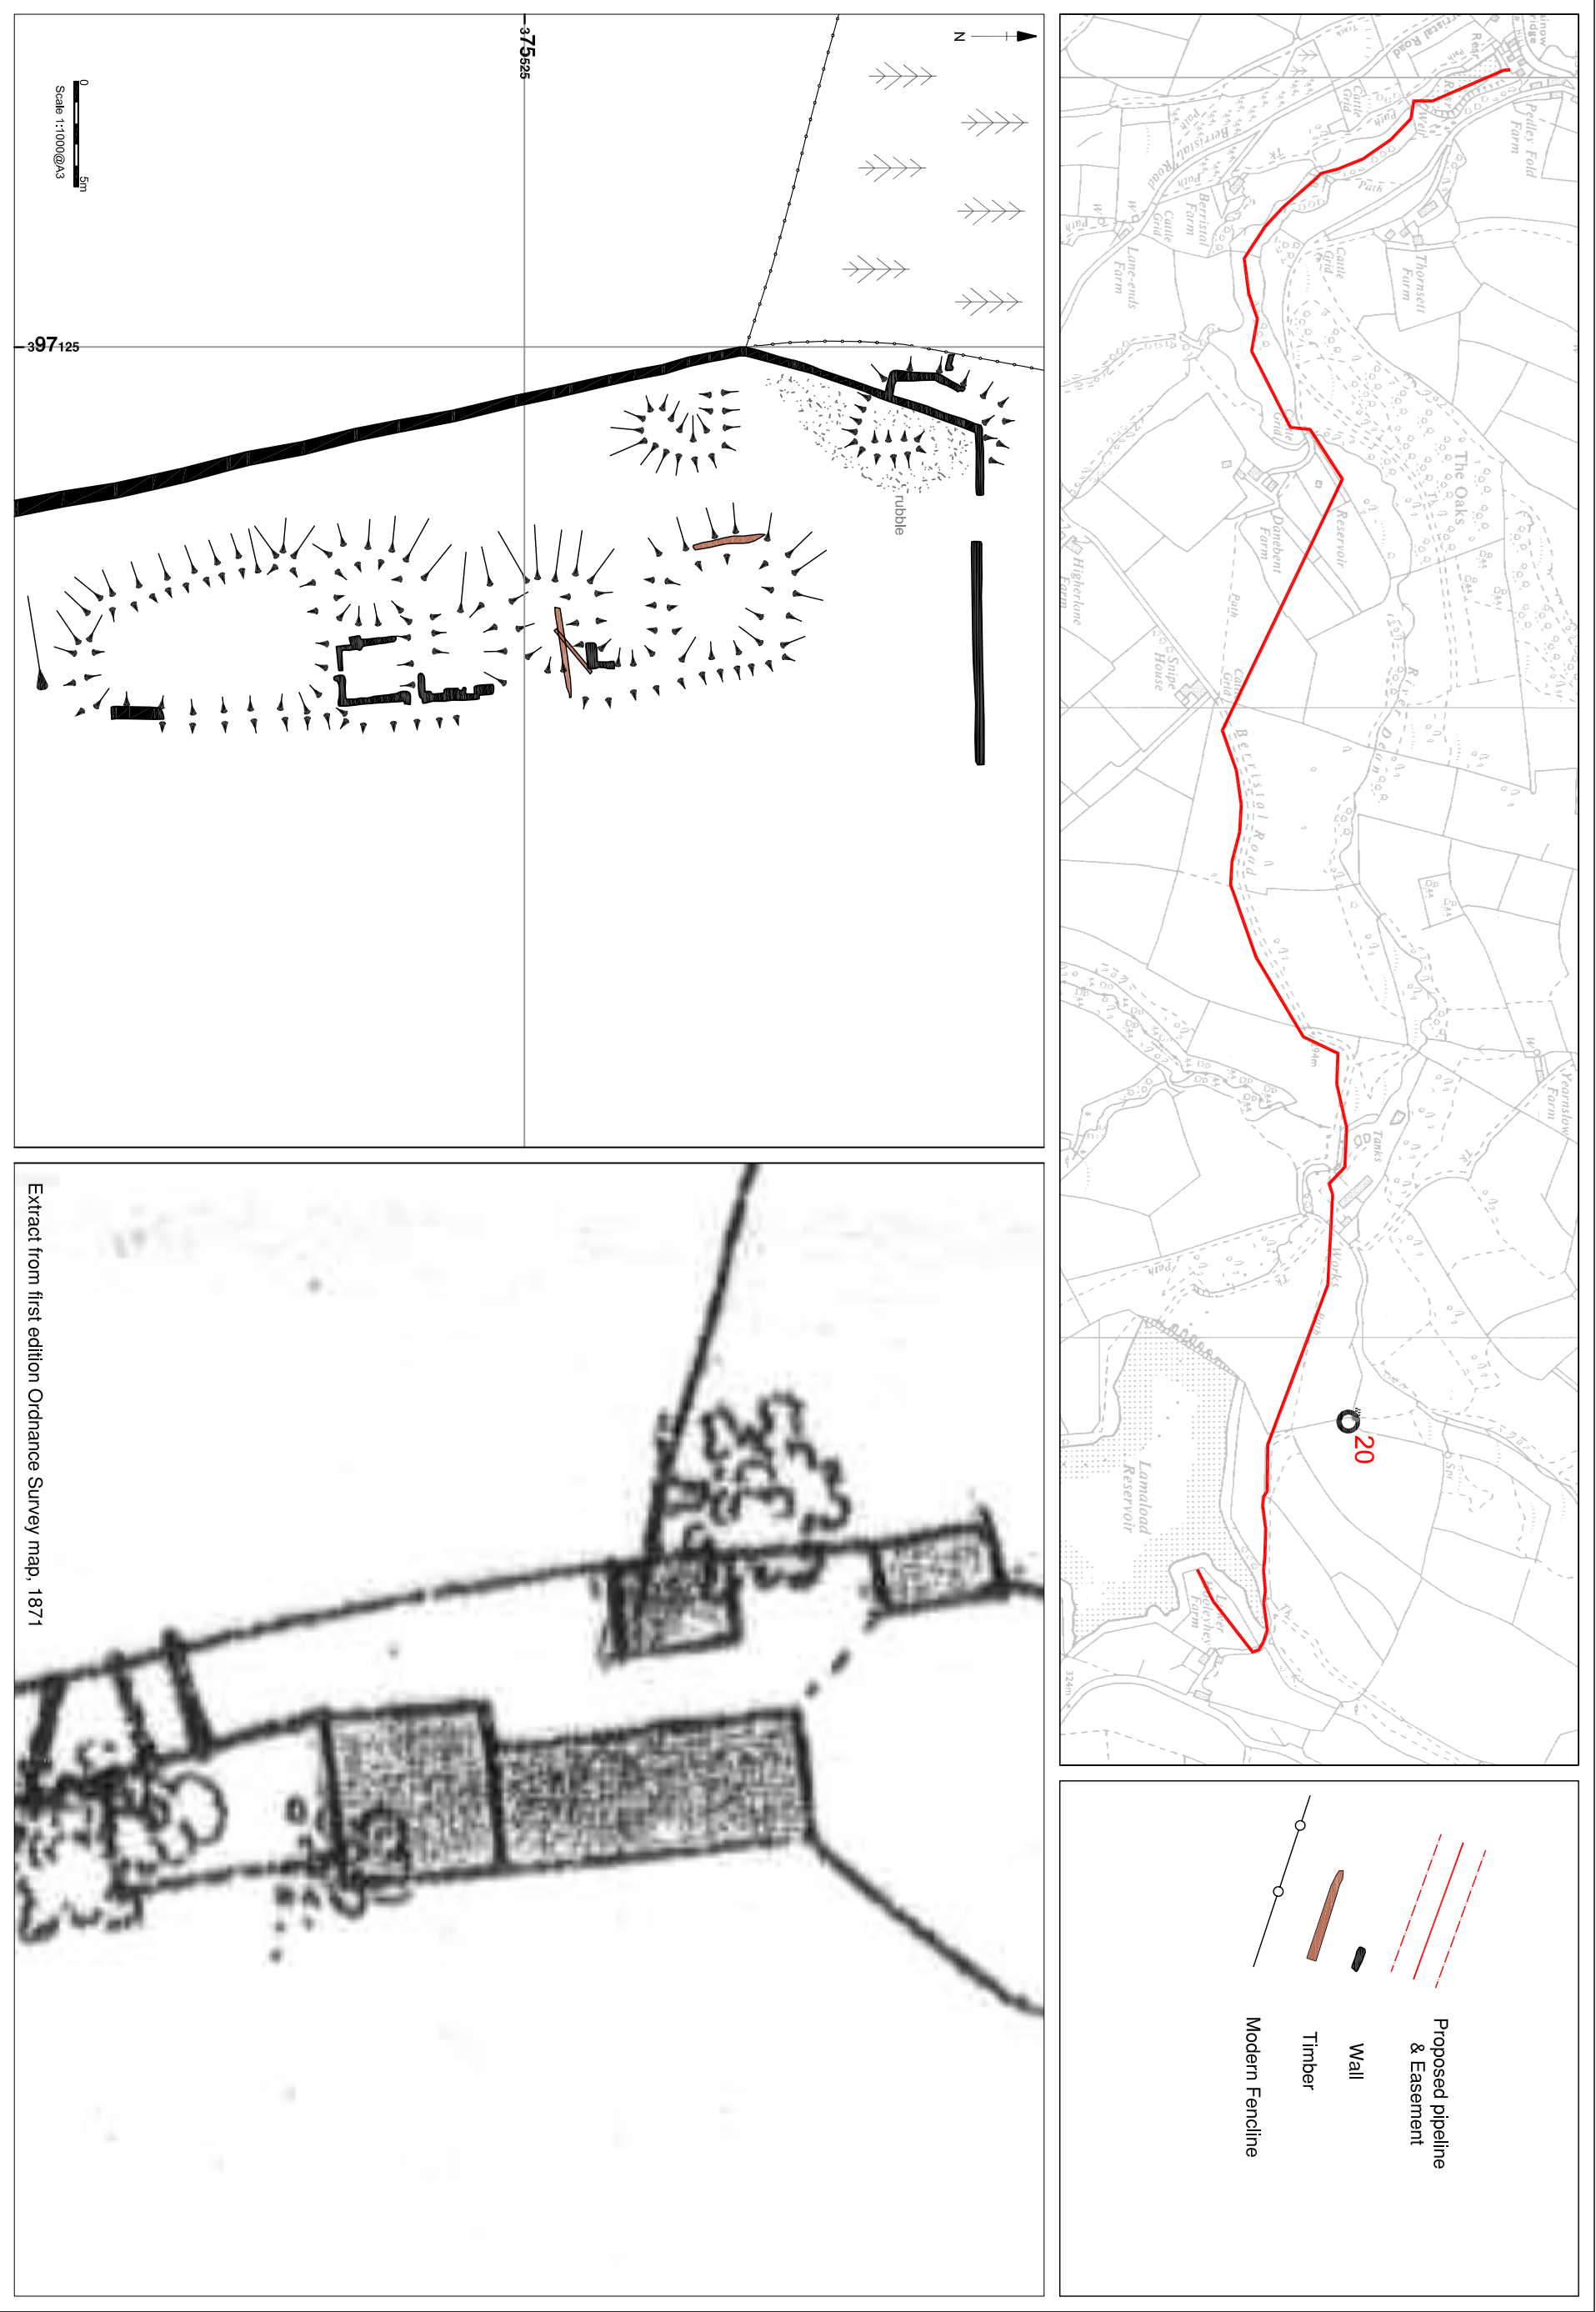
Figure 3: Topographic detail of Site 20, remains of Whiteside Farm

- 4.1.3 The main range of buildings was composed of the earthwork remains of wall foundations, with banks of rubble measuring up to 0.5m high. It had been terraced into the sloping hillside on the eastern side where the slope runs downhill from east to west. Evidence was observed for six individual rooms; five of which were orientated north/south, whilst the sixth room projects in a westerly direction from the side of the southernmost cell. A great deal of demolition rubble covered the grassed-over wall foundations, but in some places walling was still evident at the ground surface. A retaining wall on the east side of the range survives particularly well in places, with some wall recesses evident. The walls are constructed of small squared-off quarried stones and in places reach a height of up to 0.5m (six courses high). The remains of three roof timbers were strewn across the site.

- 4.1.4 On the south side of the building range is a small earth-and-stone banked paddock. It is sub-rectangular in plan and measures up to 15m in length (north/south) by over 5.5m wide. A sunken , which approaches the site from the south, runs north/south alongside a modern field boundary. The trackway continues into a small yard area located on the western side of the remains of the farm buildings. It has a steep earthen lynchet on its east side and measures up to 3m wide by 0.6m in height. The fragmentary remains of wall foundations were apparent on the top of the lynchet.

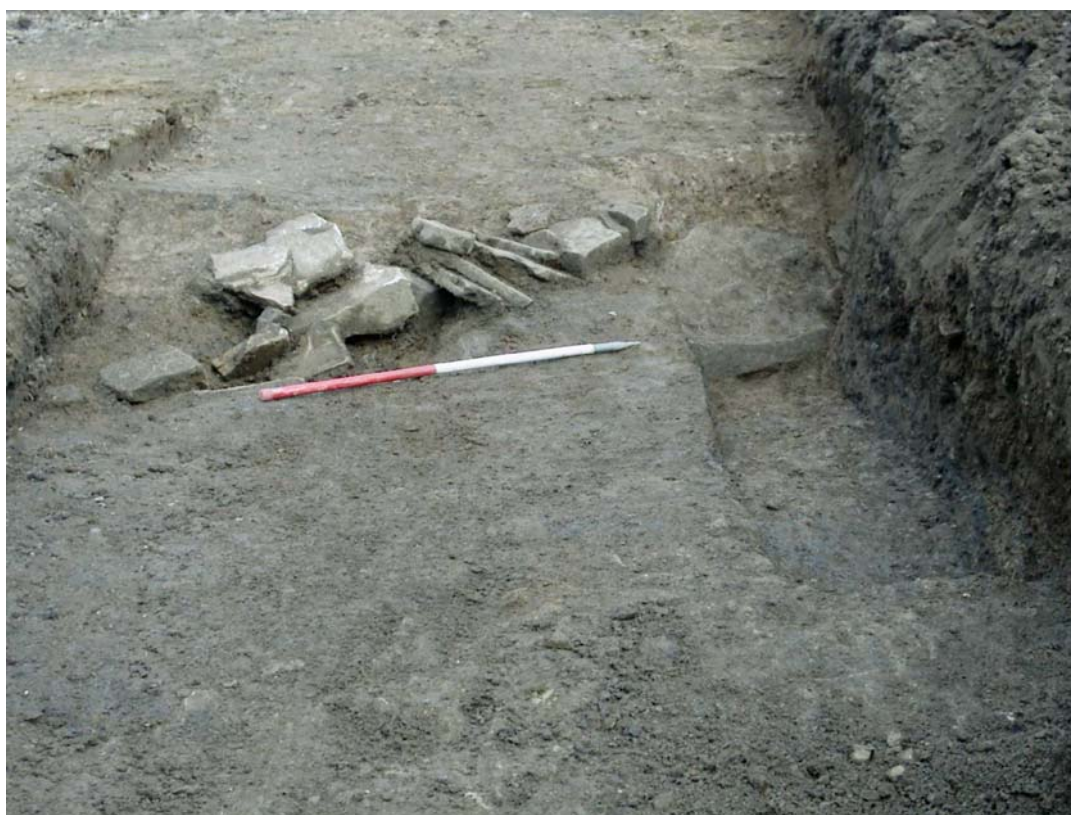
4.2.4 This trench revealed a north-east/south-west aligned wall, **107**, and parallel hedge **108** (Plate 4). The boundary wall was constructed within a foundation trench, **106**, measuring 3.25m in length, 1.4m in width and 0.25m in depth. The wall was cut into a steep incline to the east with the stonework placed against the incline. Large (0.6m by 0.5m+ by 0.2m+), local limestone boulders were utilised for the foundation, with smaller flat (0.34m by 0.33m by 0.22m) limestone boulders above. The absence of bonding material and the irregular nature of the stones was suggestive of a dry-stone construction. The wall was found within a deposit of mid-orange-brown sandy-clay, **107**. To the south-west, running parallel and cutting wall **107**, a shallow depression, **108**, possibly representing the remains of a hedgeline was observed. The depression measured

3.25m in length, 1.06m in width and 0.4m in depth. It contained **111**, a mid grey-brown sandy-silt primary fill, which appeared to have accumulated over a moderately long period of time. This was overlain by **109**, an organic dark blackish-brown silty-clay (Plate 5; Fig 9), seeming to run under natural geology to the west. This was most probably the action of rooting. It is highly probable that deposit **109** was the decaying remains of a hedge, moreover a possible boundary hedge could be seen *in situ* along the same alignment to the south of the excavation. A number of flat limestone boulders consistent with those of wall **107** were observed within the immediate vicinity of this possible early boundary. These features cut natural geology **100**, a dark to-mid-orangy-brown clayey-sand and were sealed by made-ground **102**.

Plate 4: Plan of wall **107**, and cut for hedge **108**, within Trench 1, Site **27**, looking east

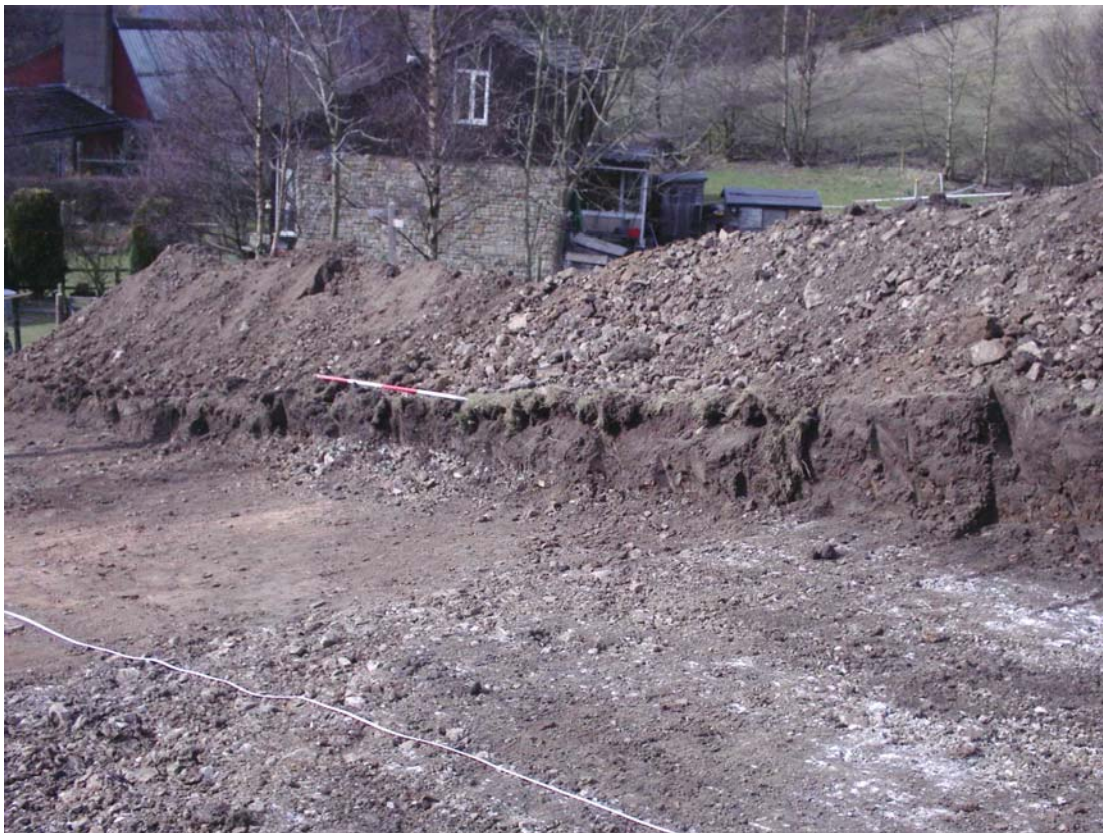
- 4.2.5 Running across the centre of the trench on an east/west alignment was a compact surface, **101**, constructed of white/mid-brown shale and limestone observed for 14m in length, 5.65m in width and 0.25m in depth (Plate 6). This deposit appeared to be the remnants of the haul road associated with the construction of the reservoir during the early 1960s.

Plate 6: East/west aligned haul road **101**, within Trench 1, Site **27**, looking north-west

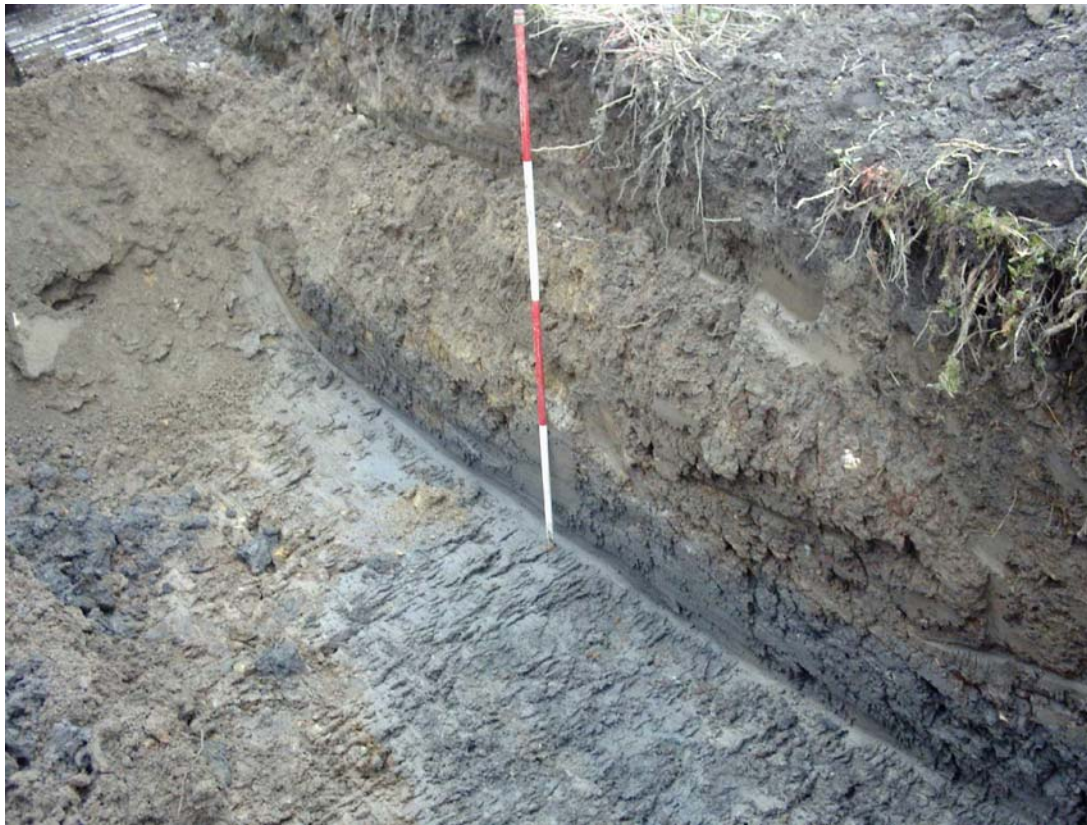
- 4.2.9 The natural geology **315**, a mid-brownish-orange sandy-clay, was encountered at 205.16m aOD. An east/west aligned linear feature **314** was observed in the south-west corner of the trench *c* 5m in length, *c* 1.5m width and 0.5m+ in depth. It contained a dark grey silty-clay and was sealed by **303**, a mid-brownish-orange sandy-clay redeposited natural made-ground layer and **302**, a further made-ground comprising mid-greyish-brown sandy-clay. These made-ground layers appear to have been associated with the construction of the disused reservoir. Also, local knowledge indicates that within the vicinity a village tip was in use, possibly accounting for the proliferation of domestic refuse on the site. Linear **314**, appears to have been a stream or small river possibly associated with the now disused reservoir and cottage **307**, located immediately to the north-east.

Plate 9: South-facing section of east/west aligned linear feature **314**, within Trench 1, Site **53**

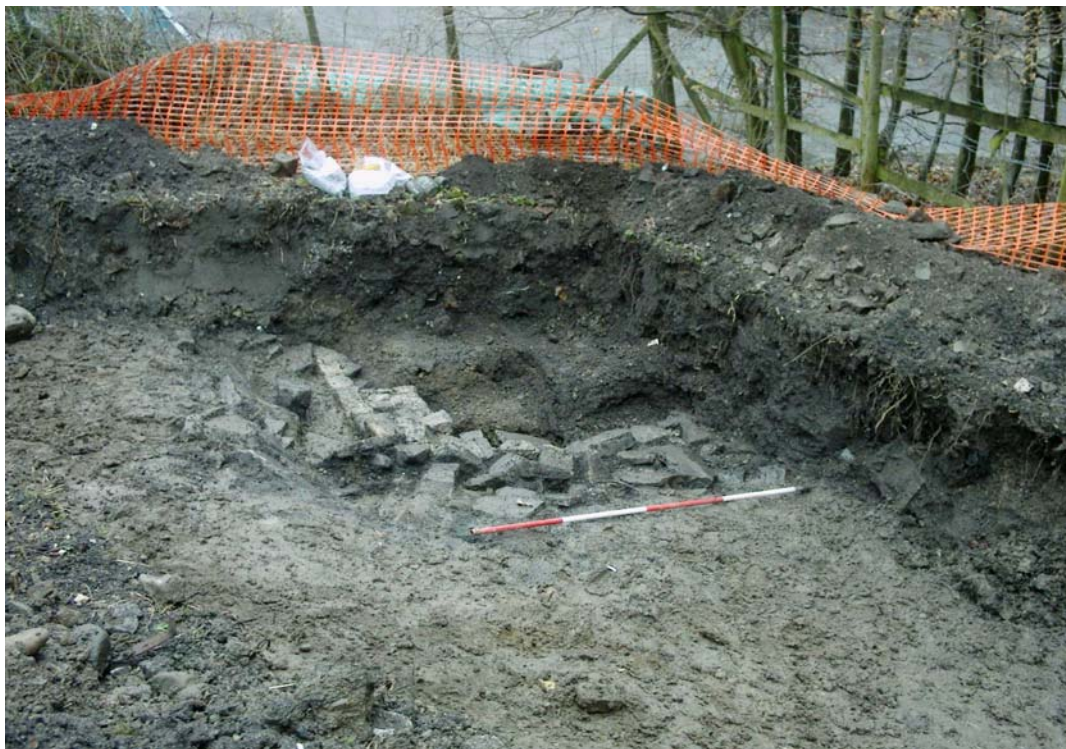
- 4.2.10 Made-ground layer **302** butted up against cottage **307**. Two walls forming the corner of a probable basement were revealed (Plates 10 and 11; Fig 10), and observed on a north-west/south-east alignment for 2m before returning north/east for a further 2m. It was excavated to a depth of 1.4m. The walls were constructed of roughly squared-off limestone blocks *c* 500mm by 300mm by 100mm, of uneven courses, bonded by lime mortar (Plate 12; Fig 11). Twenty courses were observed above a patch of whitish plaster/cement-type material, possibly the original basement floor surface. Within the confines of the walls a basal deposit, **310**, was observed. This comprised 0.3m in depth of a mid-blackish-grey sandy-silt, containing clinker and slag-like material, which was probably laid as a bedding layer for drainage. This was sealed by 0.7m deep of mid-orangy-brown sand with rubble inclusions **309**, used to fill in the basement after its demolition. A layer of greyish-black sandy-clinker **308**, overlaid layer **309**, appearing to be an early twentieth century midden deposit. A scatter of limestone blocks **306**, around the cottage walls and lying within layers **308** and **302** are most likely to be the remains of the cottage after its demolition.

Plate 10: Plan view of stone structure **307**, within Trench 1, Site **53**, looking north

- 6.2.1 The discovery of the corner of a cottage basement **307** (Site **53**) within the pipeline easement suggests that more will be uncovered during the pipe laying process. Therefore, it is recommended that a watching brief should be implemented during all below-ground works within this area. It is also likely that more midden/rubbish pits will be encountered and should be investigated in a similar manner.

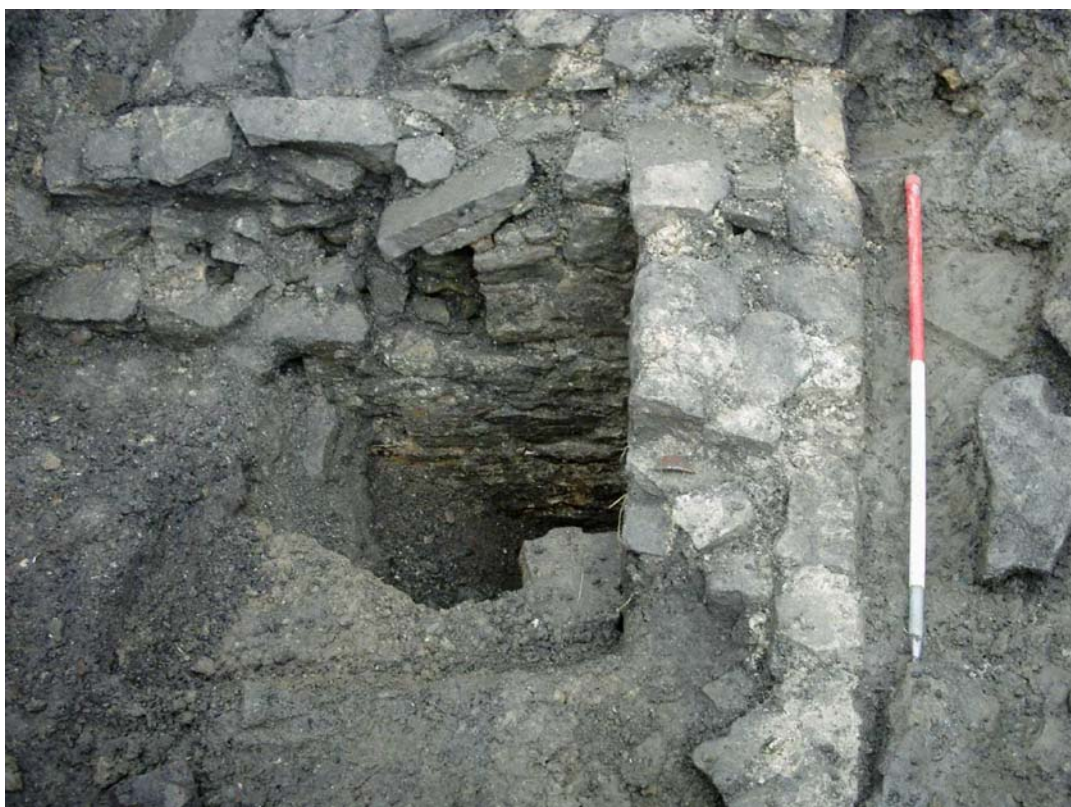
Plate 11: Plan view of north-west/south-east wall, within Trench 1, Site **53**, looking south-east

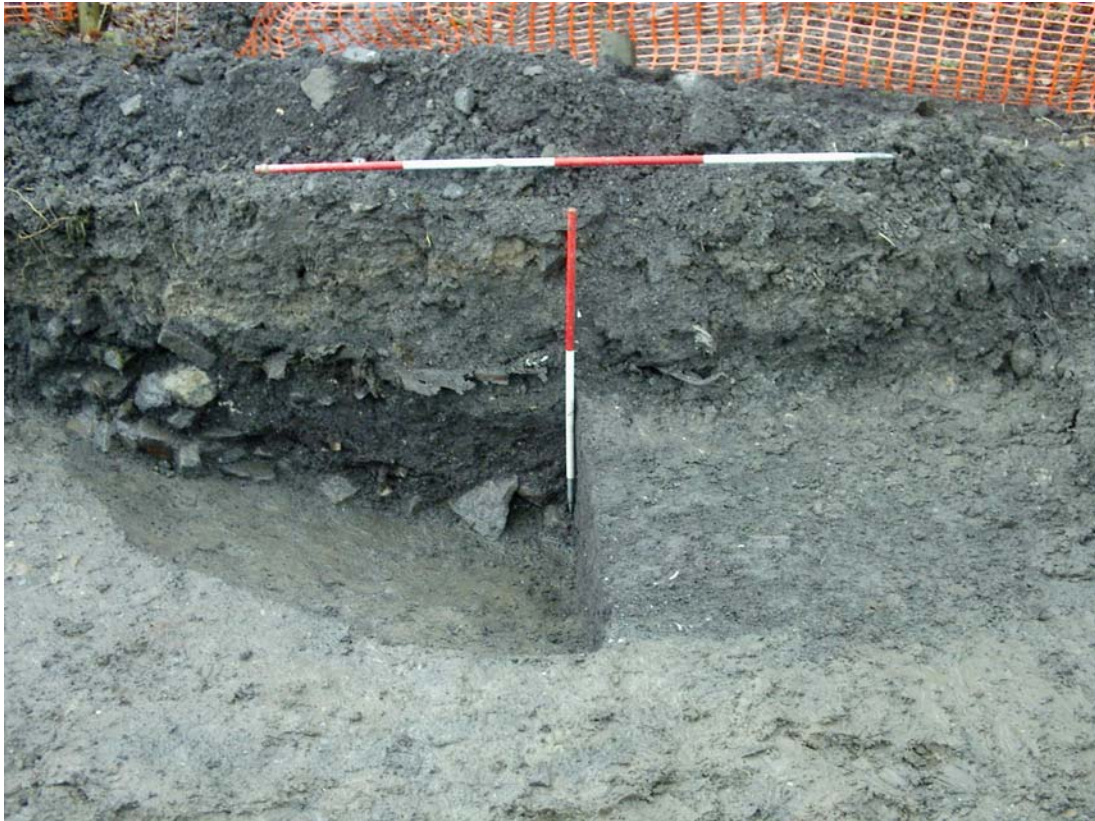
- 4.2.11 Pit **301** was observed cutting made-ground **302**, measuring 3.35m in length, 1.4m in width, and excavated to a depth of 1m. The extent of the pit observed was oval in plan with 45-50° concave sides to a flatish base (Plate 13; Fig 11). This feature was situated towards the centre of the trench and continued under the north-east baulk. It contained a dark greyish-brown humic silty-sand with lenses of dark purplish-black clinker/cinder deposits, **300**. A number of ceramic, glass and bone artefacts of the post-medieval period were recovered from this context. The feature was truncated by a modern drainage pipe to the south-east.

Plate 13: South-west-facing section of pit *301*, within Trench 1, Site 53

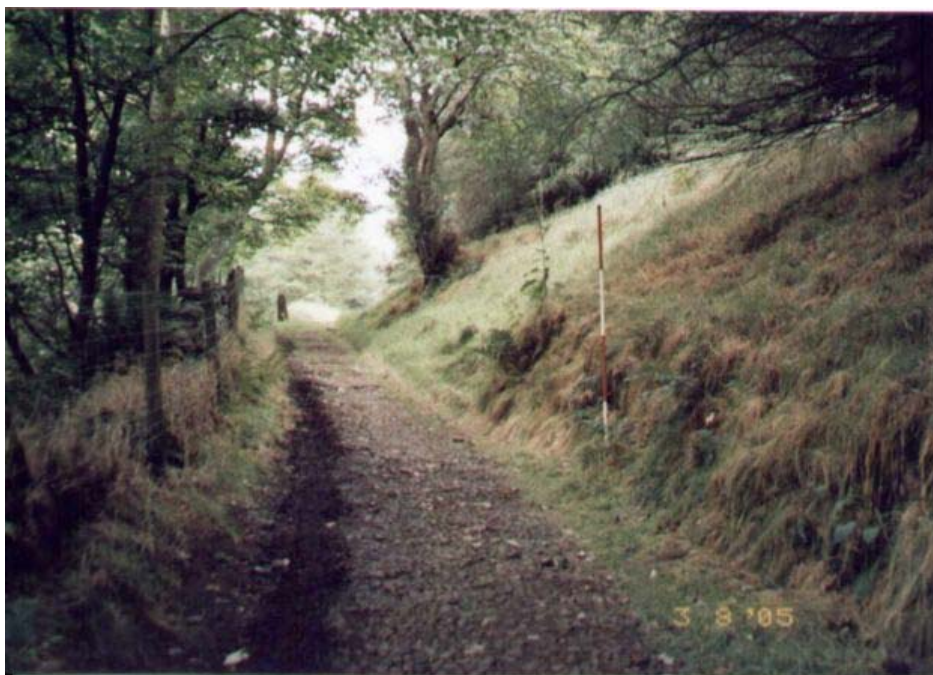
- 4.1.17 Site **81**, comprised a hollow-way/trackway (Fig 8; Plate 21) running between Upper and Lower Hooleyhey Farms, and located to the south-east of Whiteside Farm (Site **20**). The trackway was orientated east/west downhill into modern woodland at its eastern end (just to the north of Lamaload Reservoir). Within the woodland the trackway measured 3m in width, with evidence of a worn and rounded cobbled surface. Also at this location the track was sunk into the ground, and on it's southern side were the extant remains of a walled field

boundary. The north side of the track had a steep lynchet edge with fragmentary evidence for a drystone retaining wall along its length, being up to 1m high. Near to the eastern end a relict gateway (Site **82**) was observed, which would have provided access to the field to the south. The western half of the trackway remained outside of the woodland and survived as a denuded sunken feature. The wall on the southern edge is very fragmentary and had been replaced by a modern fenced boundary. To the north, the lynchet was much less prominent, being only up to 0.6m high and with no retaining wall. There was evidence of a further small section of farm access track with a steep lynchet edge, observed curving to the north from the gateway into the woodland.

Plate 21: Site **81**, Field 19, trackway, looking west
