MILLBROOK BOREHOLES TO LAMALOAD RESERVOIR, PEAK DISTRICT NATIONAL PARK

**Desk-Based
Assessment,
Walkover Survey and
Watching Brief**

Oxford Archaeology North

October 2005

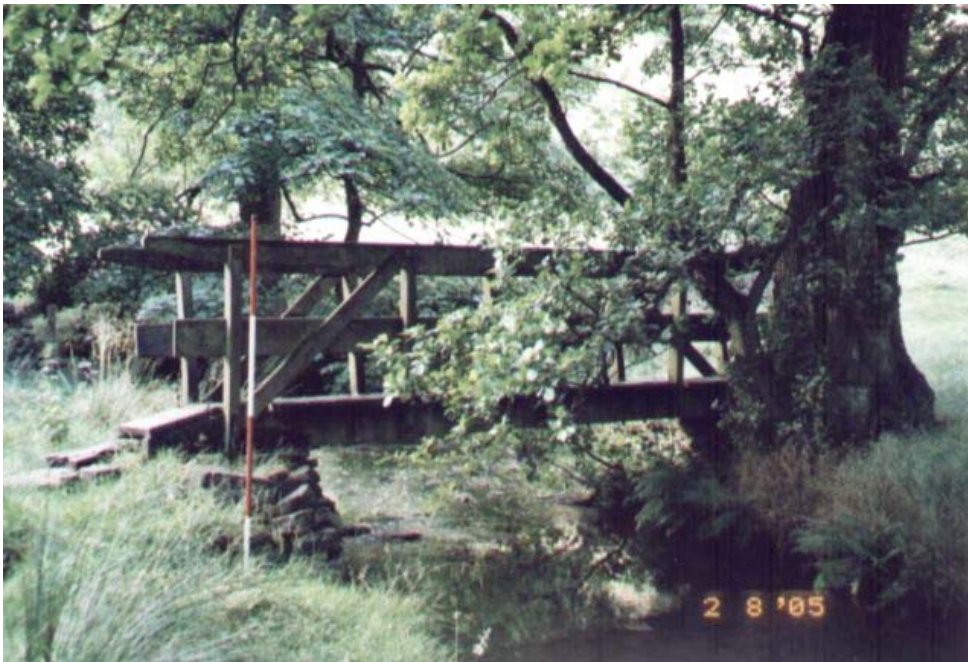
Plate 6: Site **57**, Field 3, footbridge, looking east

- 4.1.8 At the eastern end of the field, near the boundary with Field 4 was a timber footbridge (Site **57**) (Plate 6), which rested on a stone foundation of dry-stone construction, comprising irregular stone blocks, now covered in lichen and moss. To the south side of the bridge there was a continuation of stonework from the base towards an existing field wall, and it would appear that a section of the wall has been demolished, and that the bridge post-dates the wall. There were also notable depressions on either side of the River Dean, immediately north-west of the bridge. These depressions may be the remains of earlier, more informal crossing points. Just north of the ford was a stile leading into the field from Field 28.

Site number	57
Site name	Berristal Farm
NGR	395150 375470
Site type	Ford
Period	Post-medieval
SMR No	-
Statutory Designation	-
Sources	UMAU 2000a; Ordnance Survey 1881
Description	A ford is shown on the Ordnance Survey map of 1881 north of Berristal Road. The field walkover survey showed that the ford is presently a narrow wooden footbridge that rests on a stone foundation. The foundations are dry-stone constructions, made of irregular stone blocks that are now covered in lichen and moss. To the south side of the footbridge there is a continuation of stonework from the base towards an existing field wall and it would appear that a section of the wall has been demolished and that the footbridge post-dates the wall. There are also notable depressions on either side of the River Dean, immediately north-west of the footbridge. These depressions may be the remains of earlier, more informal crossing points.

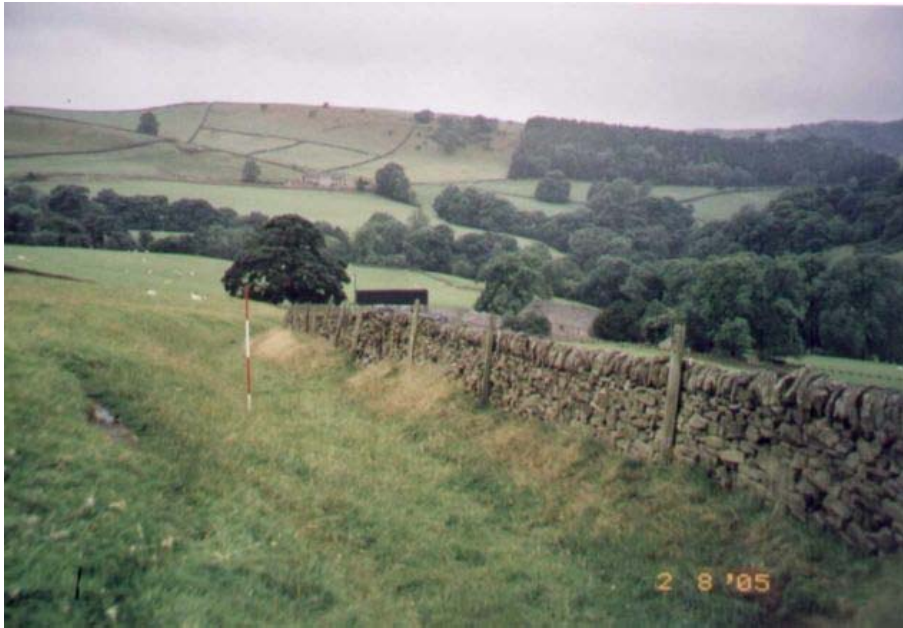
Plate 9: Site **76**, Field 10, field ditch, looking south-west

- 4.1.16 **Field 10:** this is situated to the east of Field 9, and located north-west of Snipe House, and used for grazing. It sloped moderately steeply downwards from the south-east to the north-west and an unmarked footpath ran across the field in generally the same direction, (Plate 1). The desk-based assessment suggested that the field contained Site **45**, a possible field boundary, observed on aerial photographs as having a north-west/south-east alignment and curving to the south-east. A ditch was observed, Site **76** (Plate 9), although it remains unclear whether this is the same feature; it was located along the current north-western and south-western field boundaries. It measured approximately 2m in width and about 1m in depth and was eroded at the entrance points to the field.

Site number 76
Site name Snipe House
NGR 395809 375272 – 396006 375391
Site type Earthwork/Field boundary ditch
Period Post-medieval?
SMR No -
Statutory Designation -
Sources Field Walkover
Description The site lies within Field 10 and may be a component of Site 45. This was a long linear field ditch located along the current north-western and south-western field boundaries. The ditch was approximately 2m wide and about 1m deep. The ditch was grassed over and it was unclear whether it functioned. The ditch was worn away at the entrance points to the field. It did not appear to coincide with Site 45.

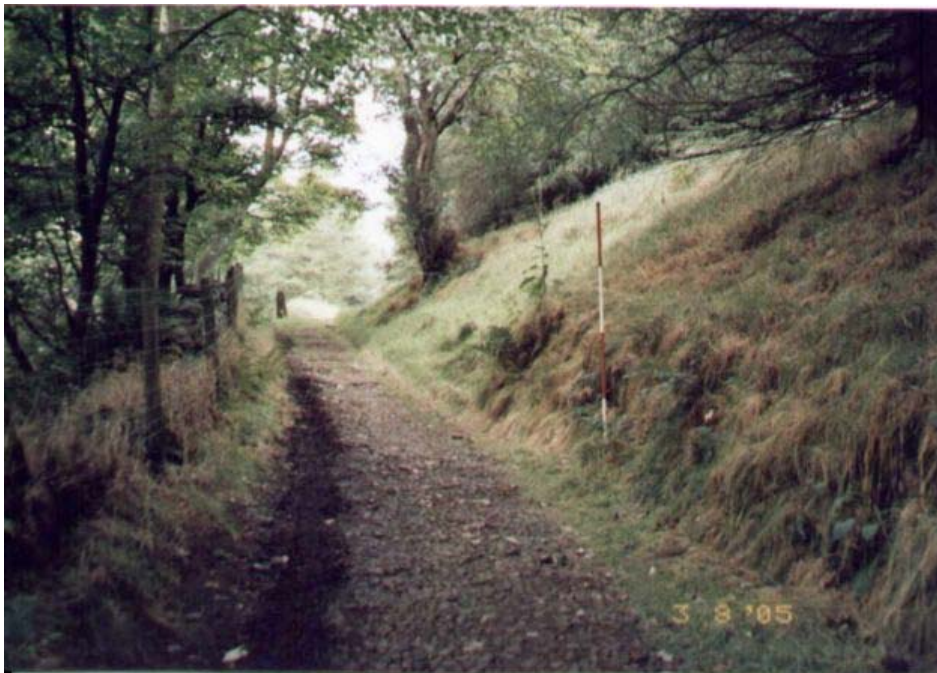
Plate 14: Site **81**, Field 19, trackway, looking west

- 4.1.33 **Field 19:** this is situated to the east of Field 18, and lay immediately north of the trackway and sloped steeply down from north to south. The vegetation cover was evergreen plantation. The trackway, Site **81**, was a linear, sloped trackway, aligned roughly east/west (Plate 14). It was 3m wide and composed for the most part of fine, rounded cobbles. There appeared to be some *in-situ* wear on the cobble surface. Walls were positioned either side of the trackway. The walls were no more than 1m high and were constructed of irregular dry stone blocks, of varying sizes. The date of the trackway is uncertain but it is shown on the Ordnance Survey map of c1872, and therefore its construction must pre-date this.

Site number	81
Site name	Lamaload Reservoir
NGR	396189 375344
Site type	Earthwork / Trackway
Period	Post-medieval
SMR No	-
Statutory Designation	-
Sources	Field Walkover
Description	Located in Fields 19 and 20, this site is a linear, sloped trackway, aligned roughly east/west. It was 3m wide and composed for the most part of fine, rounded cobbles, which had been deliberately laid. There appeared to be some <i>in situ</i> wear on the cobble surface. Walls were positioned either side of the trackway. The walls were no more than 1m high and were constructed of irregular square stone blocks, of varying sizes, in a dry bond. The date of the trackway is uncertain but it is shown on the 1871 mapping and therefore must be earlier than 1871.
Assessment	The site lies in close proximity to the proposed development area and is likely to be directly affected.

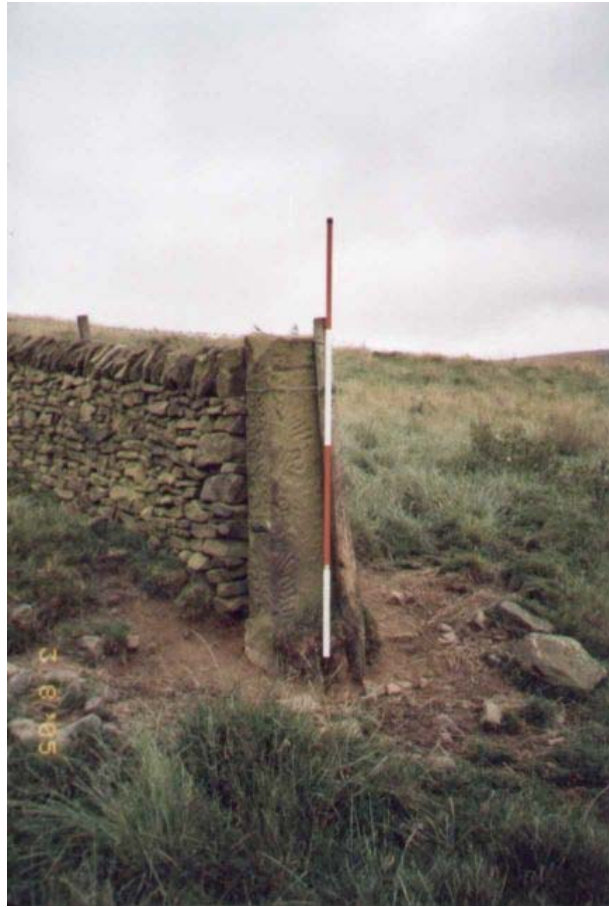
Plate 17: Site **84**, Field 18, gatepost, looking north-east

- 4.1.32 A third site, **84**, was also noted at the junction of Fields 17, 18 and 29, comprising a trio of gateposts. Two appeared to be paired at the eastern entrance to Field 17 while one was at the south-western end of the field wall between Field 18 and 29. All three gateposts were made of stone, with the pair being thinner and having rounded tops. The single gatepost had a squared top and distinctive tooling marks on at least two of the visible faces, (Plate 17).
