TONGE MOOR UNITED REFORM CHURCH BOLTON

Archaeological Building Investigation

Oxford Archaeology North

August 2005

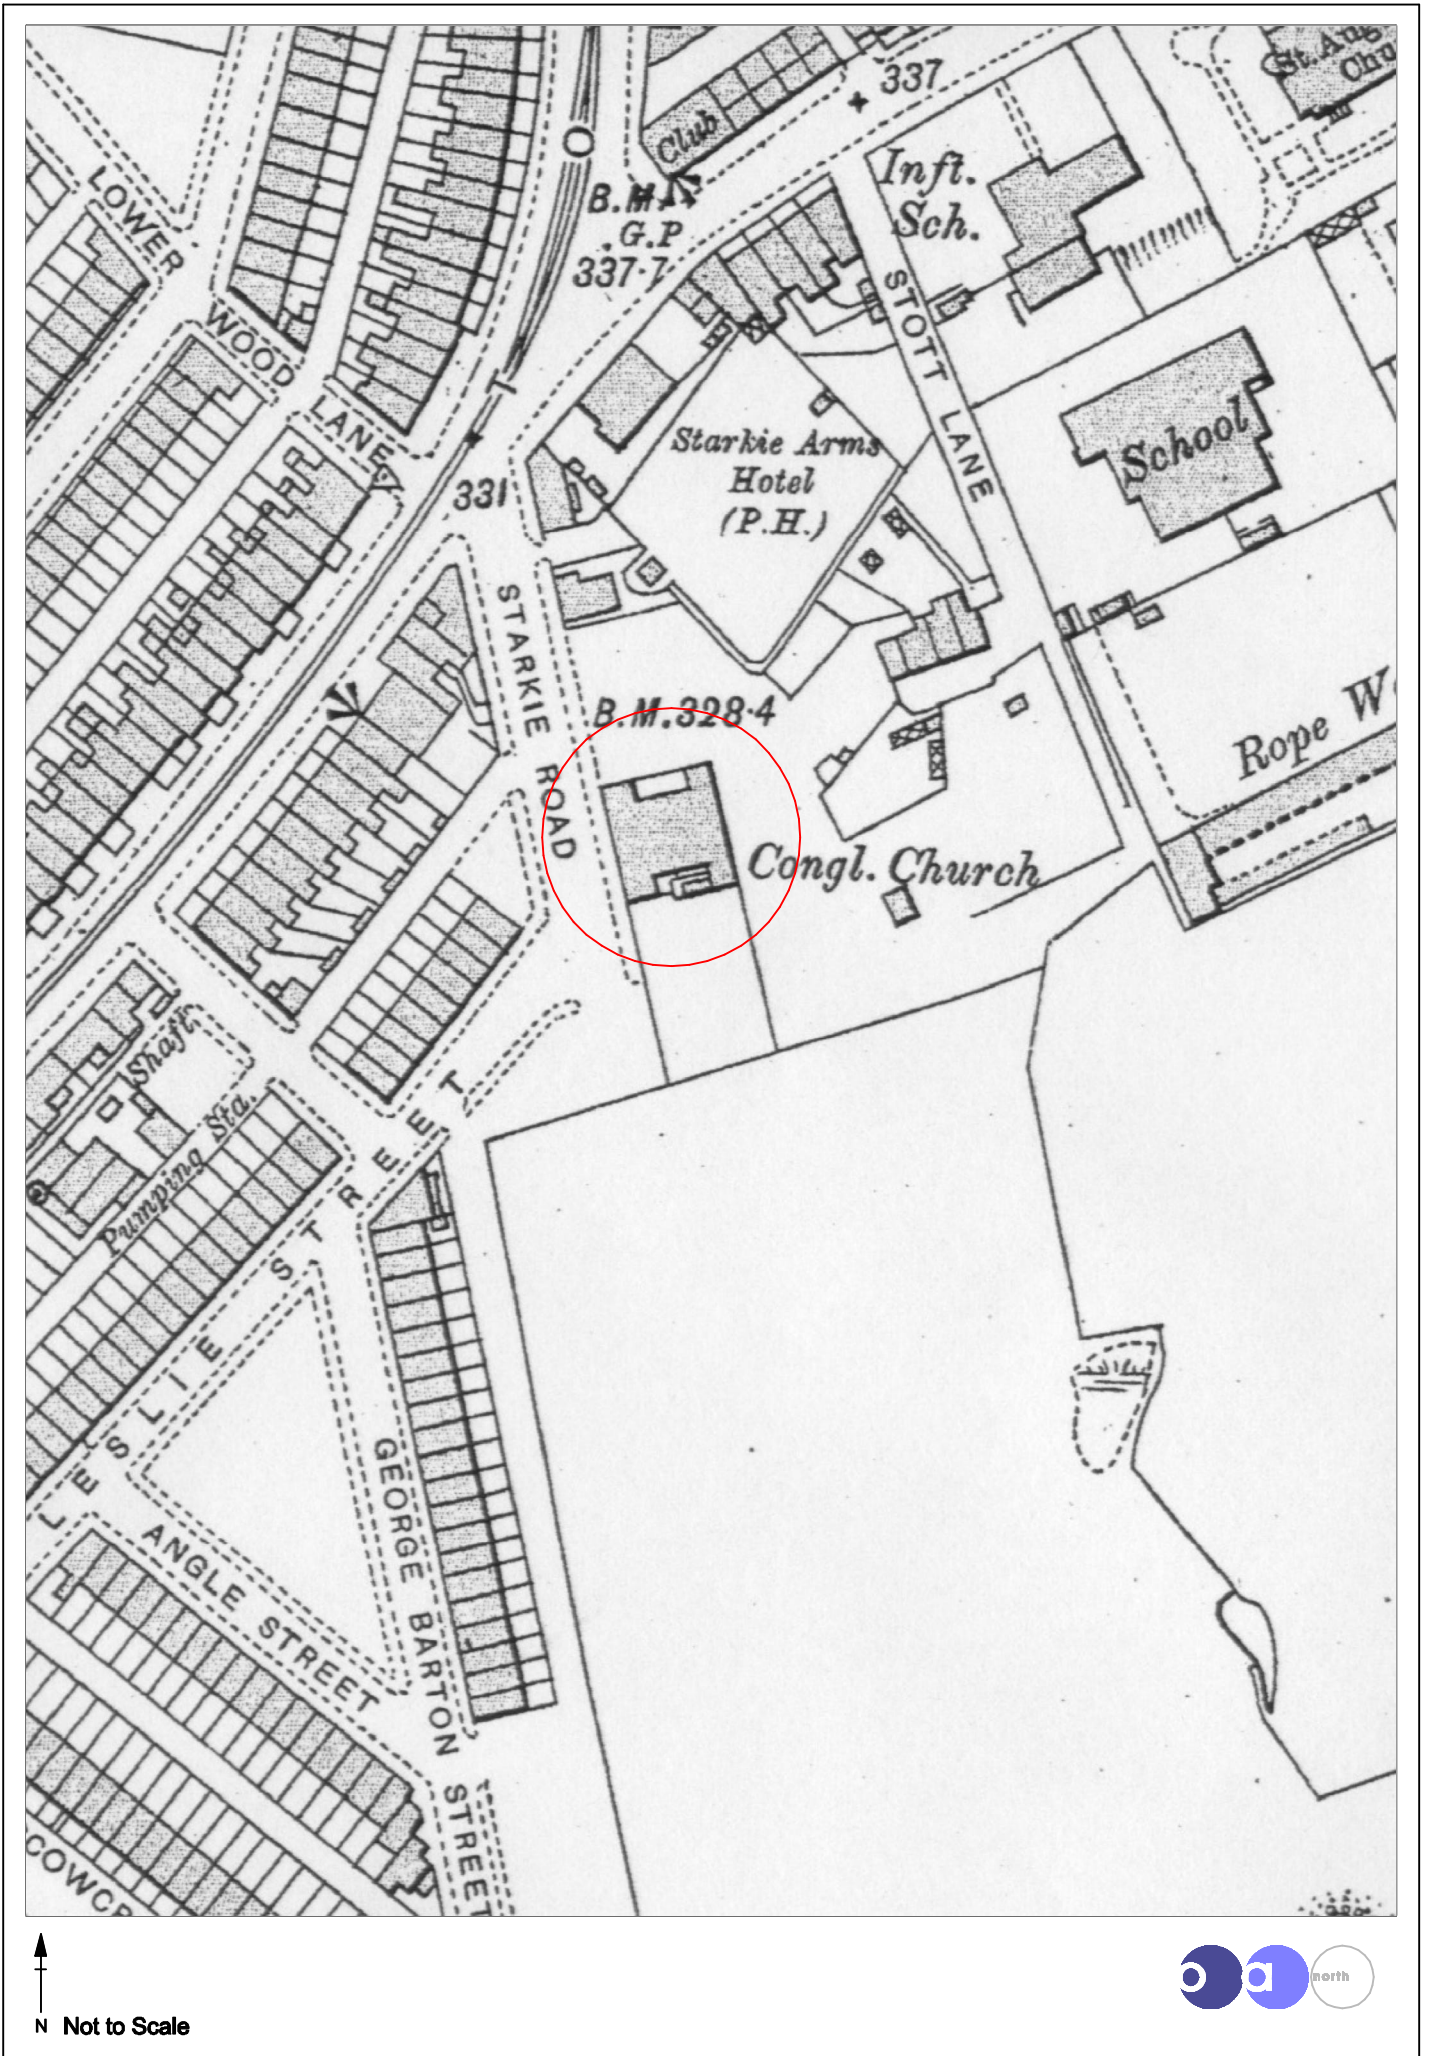
3.2.2 According to the Second Edition Map of 1910, by the year of its publication the church comprised a H-shaped building with the longest faces orientated north south along Starkie Road. In addition, at the south end of the main building there are two very small extensions or outshuts (Fig. 2).

Figure 2: 1910 Ordnance Survey Map of the Church and its Environs

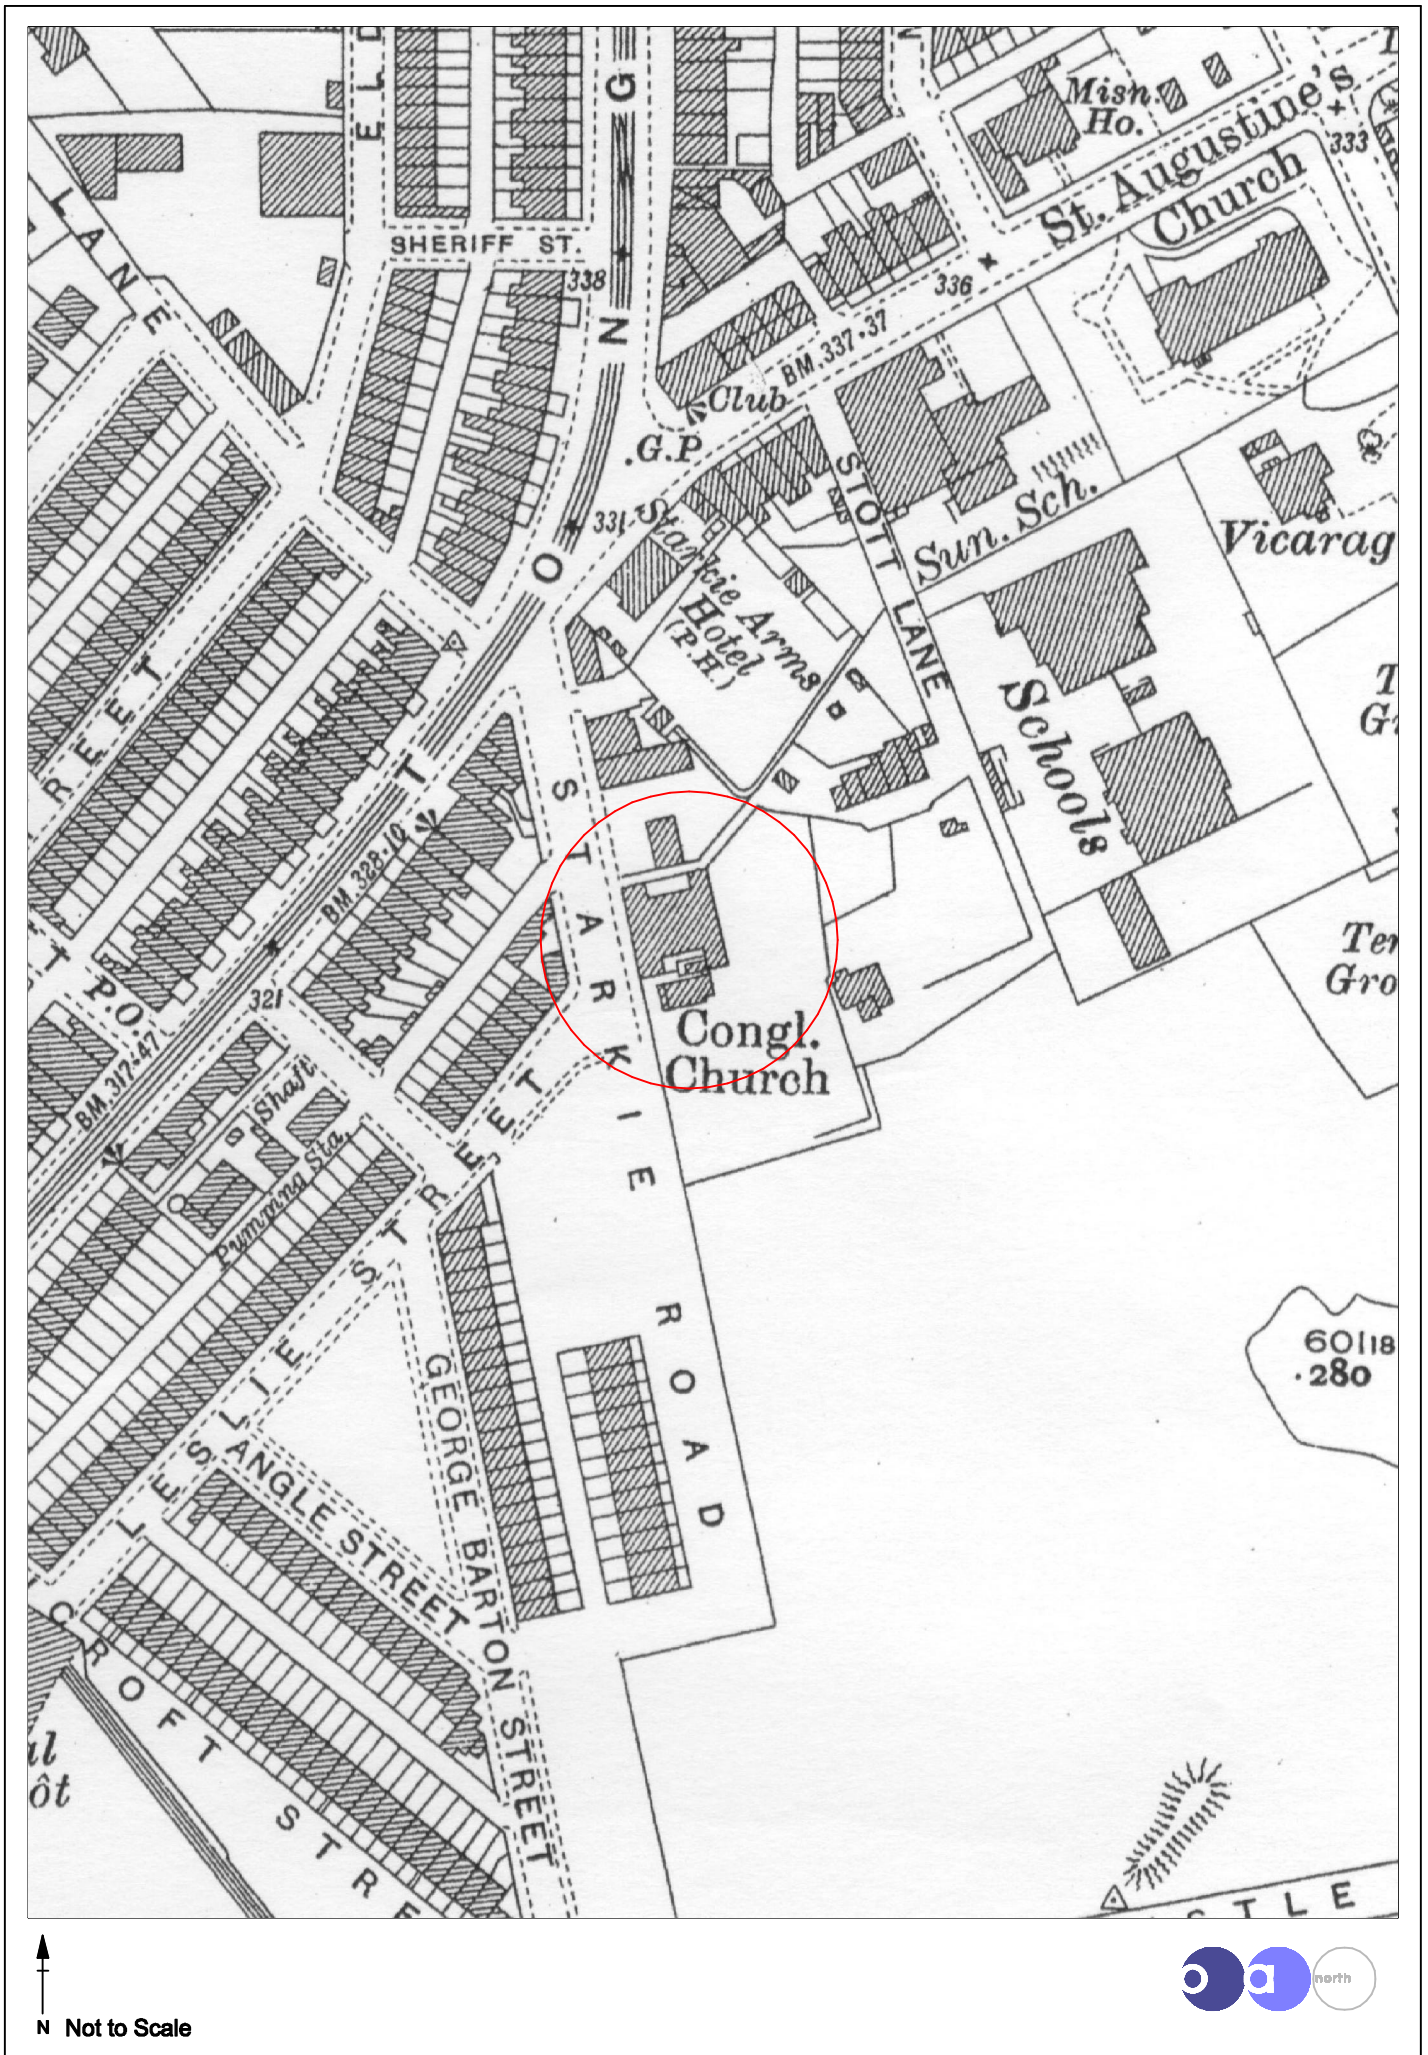
3.2.3 The church underwent a further change during the next twenty years as evidenced by the Third and Fourth Edition Maps of 1930 and 1937 respectively. The building was essentially the same, but with an additional block attached to the south end (Fig. 3).

Figure 3: 1930 Ordnance Survey Map of the Church and its Environs

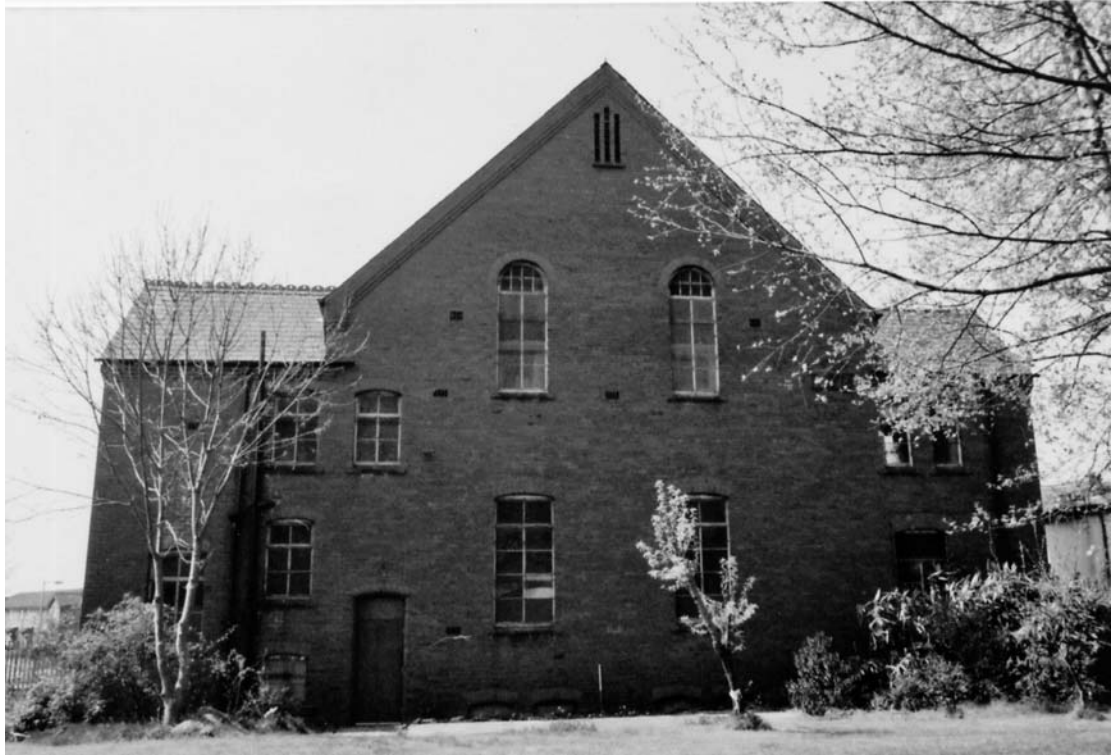
4.2.1 **East Elevation** (Plate 1): This forms the rear gable-end of the church and is generally austere in character, with little decoration apart from a simple, stepped brick cornice. The main focal points of the elevation are the large ground and first floor windows, which have segmental voussoir arches and moulded brick sills. The timber casements have eight lights with an eight-light fanlight above. In addition, there are a further eight smaller windows on the ground and first floors of the wings, and these share the same features as their larger counterparts. At basement height, the remains of four similar windows are just visible. These have been blocked with brick, presumably at the same time the ground surface was raised and levelled, in order to create the patio.

Plate 1: The East-Facing Elevation of the Church

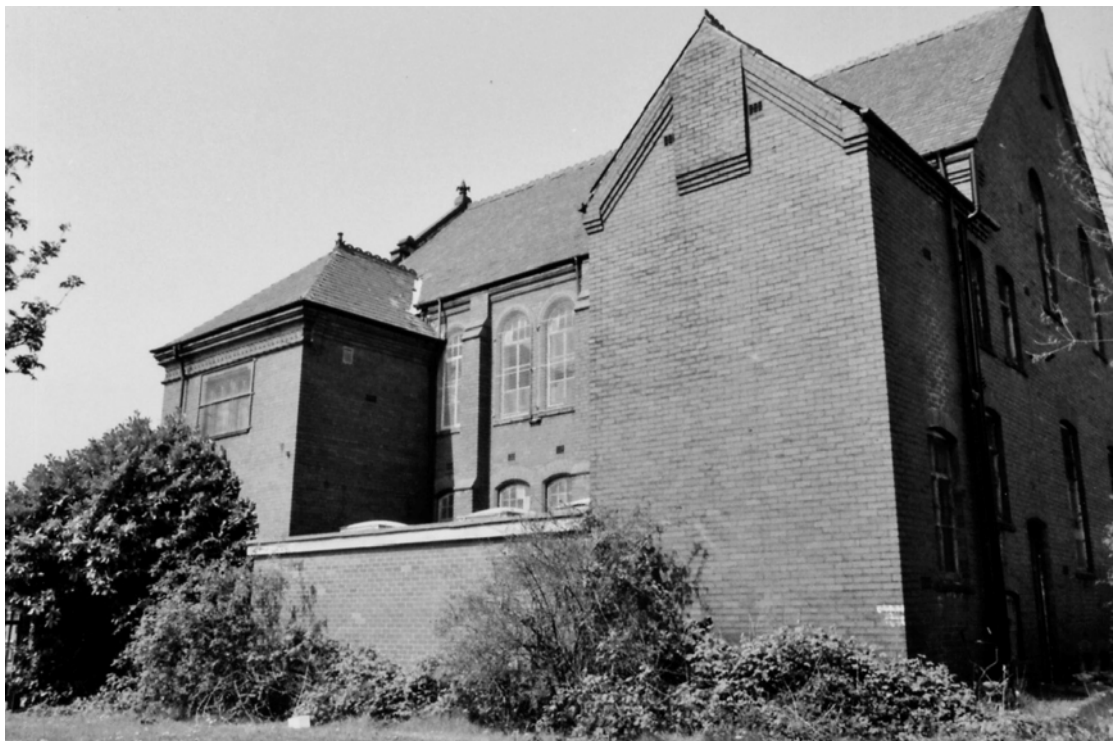
4.2.2 **South Elevation** (Plate 2): This side elevation shares many of the spartan characteristics of the rear of the building. There are five windows on both the first and ground floors, which are of the same design as those on the east elevation. The only difference being that the fanlights of the first floor windows in the chapel are glazed with stained glass. On the west elevation of the gable wing, there are three timber casements, with the same segmental voussoir arch and moulded brick sills as elsewhere in the building. The plain stepped cornice is again evident and there are two brick buttresses on the main body of the church.

Plate 2: The South-Facing Elevation of the Church

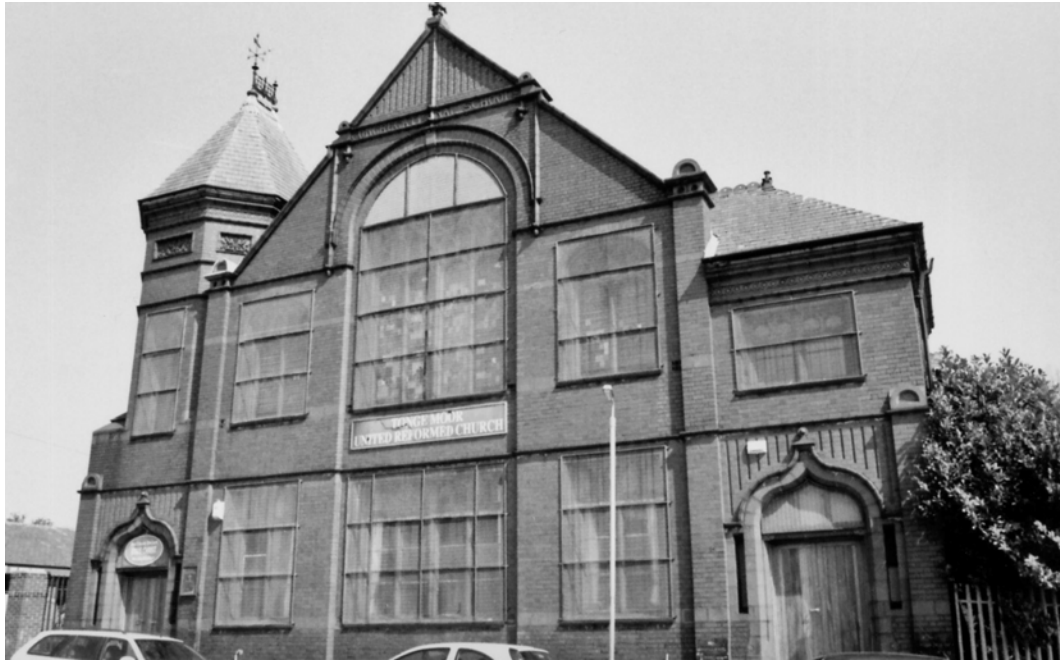
4.2.5 **West Elevation** (Plate 3): This forms the front elevation of the church, and is dominated by the large central window of the first floor chapel (Plate 4). The window has a stepped, voussoir round arch, with moulded brick tracery and

Plate 3: The West-Facing Elevation of the Church

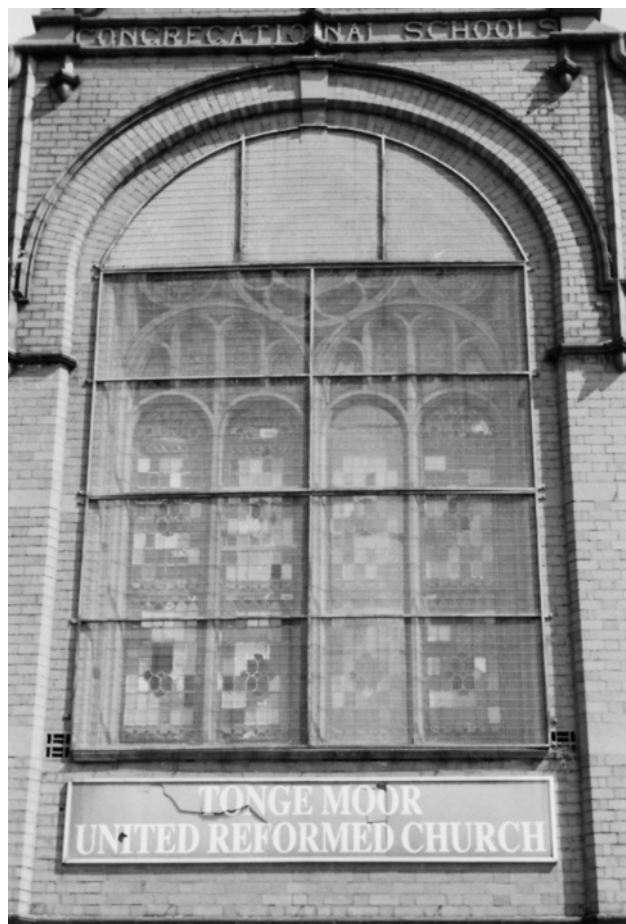
mullions. It contains four lancet-style windows with a simple rose window above, which are glazed with stained glass embellished with geometric, floral and *fleur de lys* motifs. This window is flanked by a smaller window either side, and these share the same characteristics as the central window. To the right there is a first floor window, which has a moulded brick architrave and mullions, and features four lights, with four corresponding arch lights above. In addition, on the left of the chapel windows, there is a further window which reflects the flanking windows of the chapel. On the ground floor there is a large four light window in the centre, which has splayed reveals and is topped by two round arches. This central window is flanked by a pair of smaller, two light windows of comparable design.

Plate 4: Detail of the Chapel Window on the West-Facing Elevation

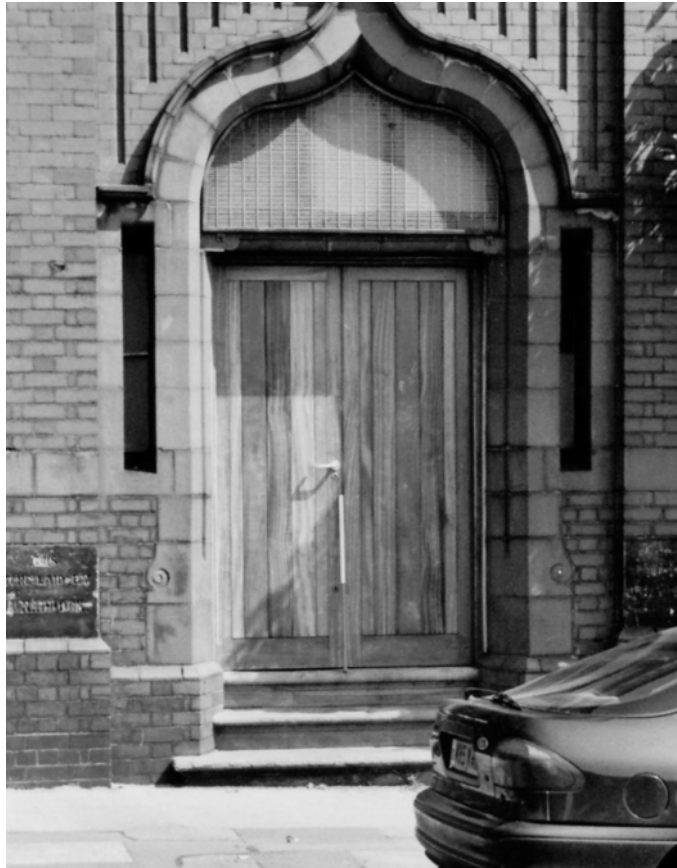
- 4.2.6 There are two entrances at the north and south extents of the church frontage (Plate 5). These are double doors of matchboard construction, which are housed within a stepped, ogee arch. A simple strip window flanks either side of the doors and a plain fanlight sits above. Either side of the doors, there are a pair of foundation stones, dating to April 1895 (Plates 6 and 7). The decorative cornice, which is featured on the south elevation is again evident and a projected foundation course, reaching up to nine courses high, runs along the base of the elevation.

Plate 5: Detail of one of the Entrances on the West Elevation

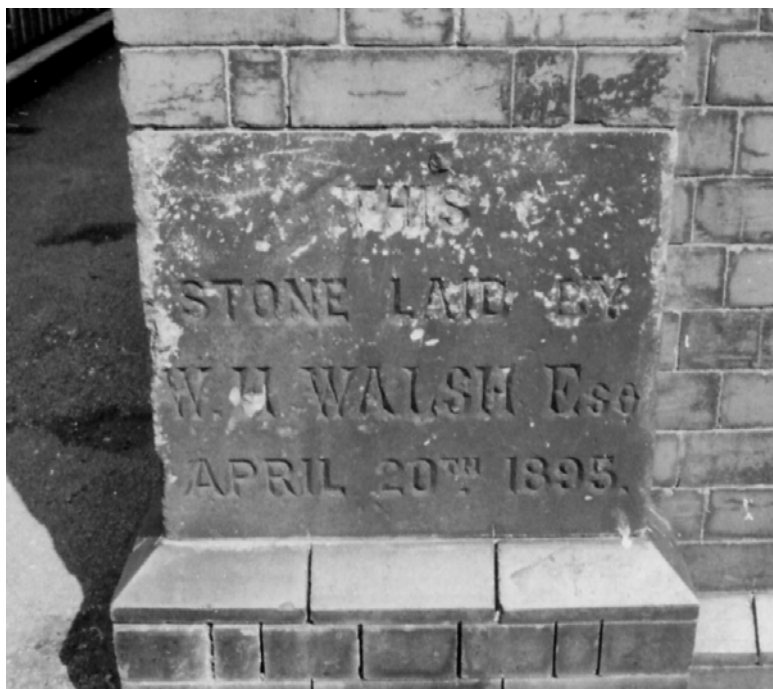
- 4.4.1 It is evident from the building survey and map regression that the Church has undergone three main phases of build over the last century. Construction of the church began in the early months of 1895, as illustrated by the foundation stones laid by Mr Walsh and Mr Harper, the Superintendent and the Secretary of the Mission respectively. The building was finally completed on Thursday May 1st 1896 (Evans 1991; 6). There were at least three buildings added on the south side of the church during the early part of the twentieth century, but these had all been demolished by the publication of the Ordnance Survey Map of 1969, and no discernible evidence remains. Aside from these additions, the main body of the church itself, does not appear to have had any significant changes to its appearance till 1963 (Evans 1991; 17), when the extension for the primary school was inserted on the north elevation. Only the following year, the chapel arch was infilled with fibreboard. The final phase of development involved the addition of an extension on the south elevation in order to create a toilet block. This occurred some time after 1963, but prior to the publication of the Ordnance Survey Map of 1969. In addition, a lift has been inserted into the south-west corner of the building, in order to provide access to the first floor chapel.

Plate 6: Detail of the Foundation Stone at the North-West Corner of the Church

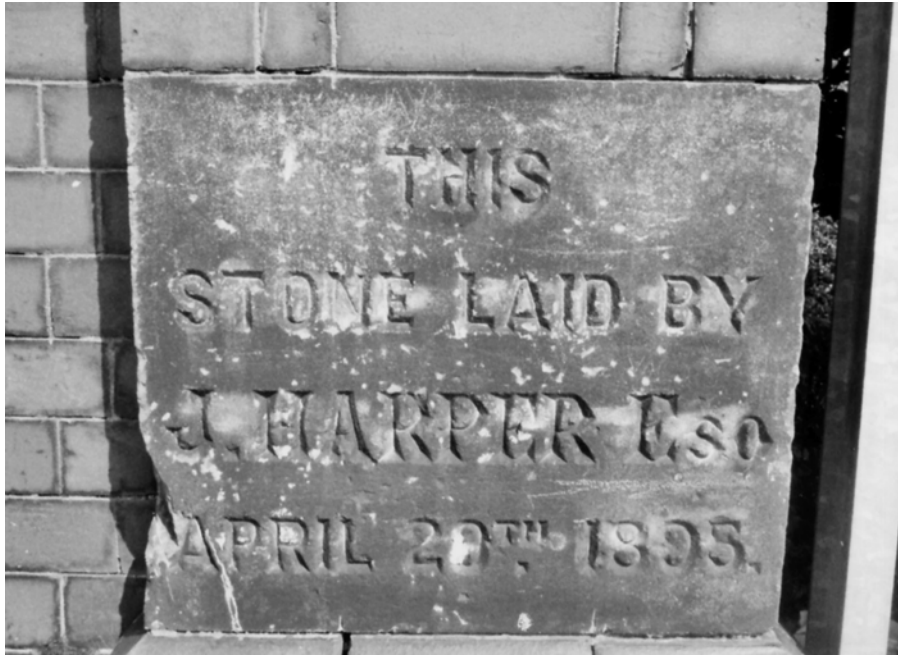
Plate 7: Detail of the Foundation Stone at the South-West Corner of the Church

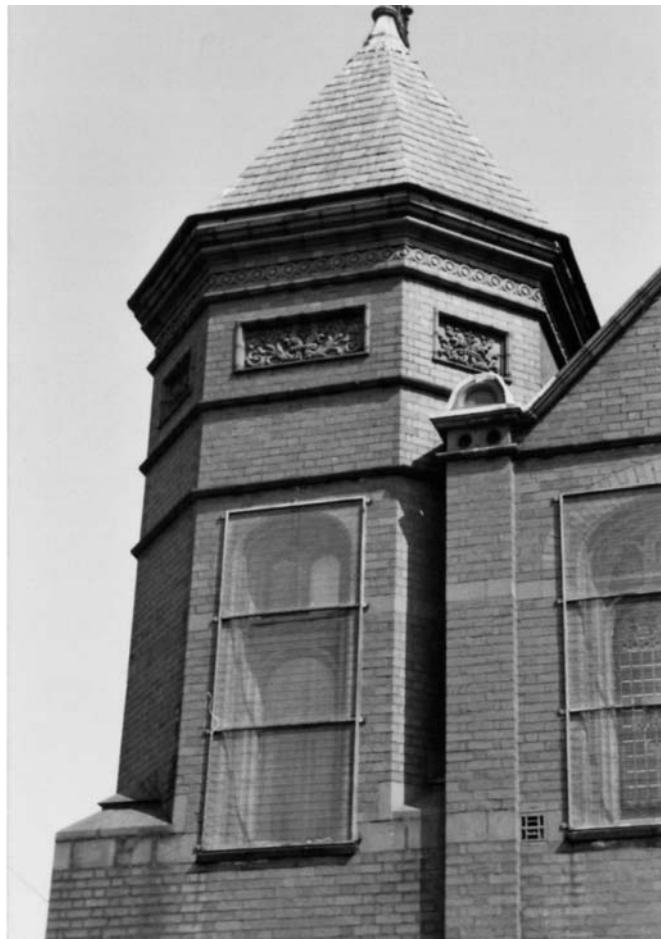
- 4.2.7 The symmetrical design of the front facade is broken only by the inclusion of an octagonal tower on the north extent of the elevation (Plate 8). This rises from the first floor of the structure and is decorated with similar devices to the rest of the building.

Plate 8: Detail of the Octagonal Tower at the North-West Corner of the Building

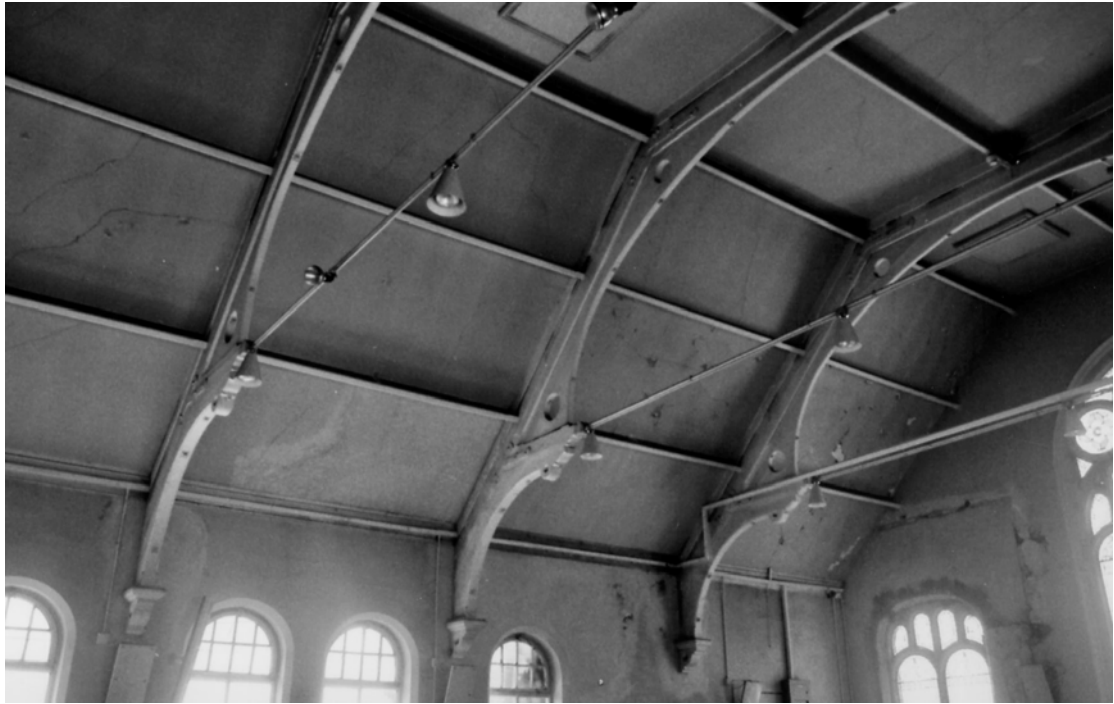
- 4.3.1 The most important room within the church is the chapel, which is located on the first floor of the building. Of chief interest is the roof, which is of hammerbeam truss construction (Plate 9) with seven purlins and three trusses mounted on pairs of corbels. The walls are plaster and paint, but there are extensive plaster repairs to the walls and to the ceiling. In addition, the round arch, which lies to the east of the chapel, has been infilled with fibreboard tiles (Plate 10).
- 4.3.2 On the ground floor there is a large church hall (Plate 11), whose walls and ceiling are finished in plaster and paint. The ceiling is supported by two beams that run east to west and which are supported by two pairs of iron columns.
- 4.3.3 The rest of the rooms within the building have walls and ceilings finished with painted plaster, whilst the floor surfaces are either carpeted or exposed

Plate 9: Detail of the Hammerbeam Trusses in the First Floor Chapel

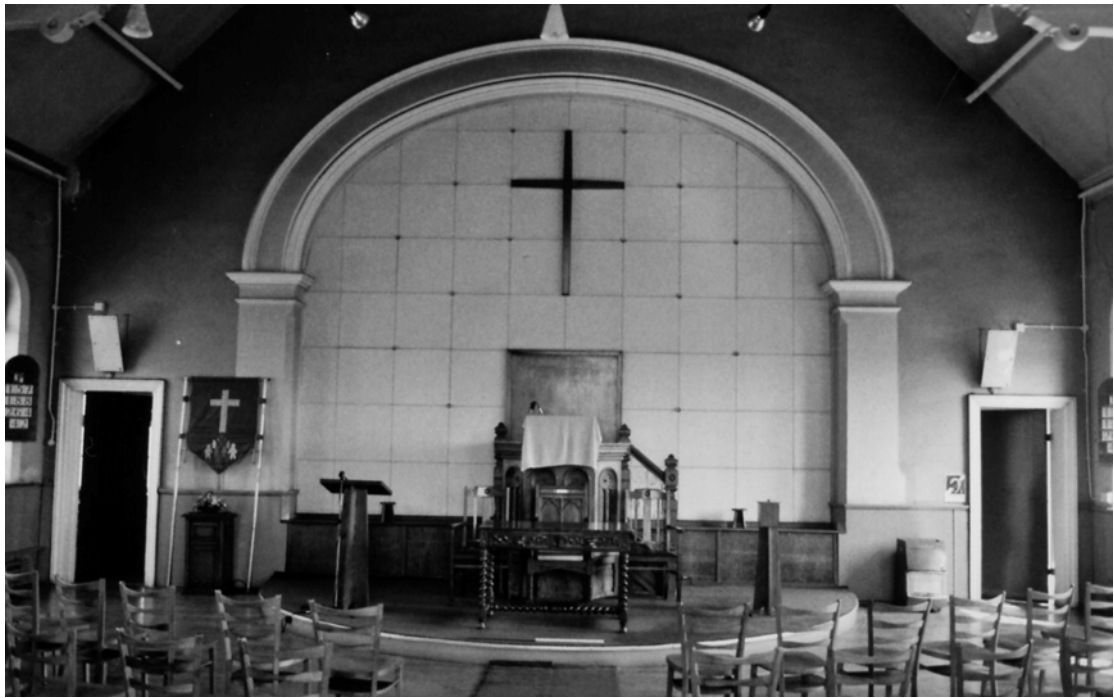
Plate 10: Detail of the Altar and Blocked Archway in the First Floor Chapel

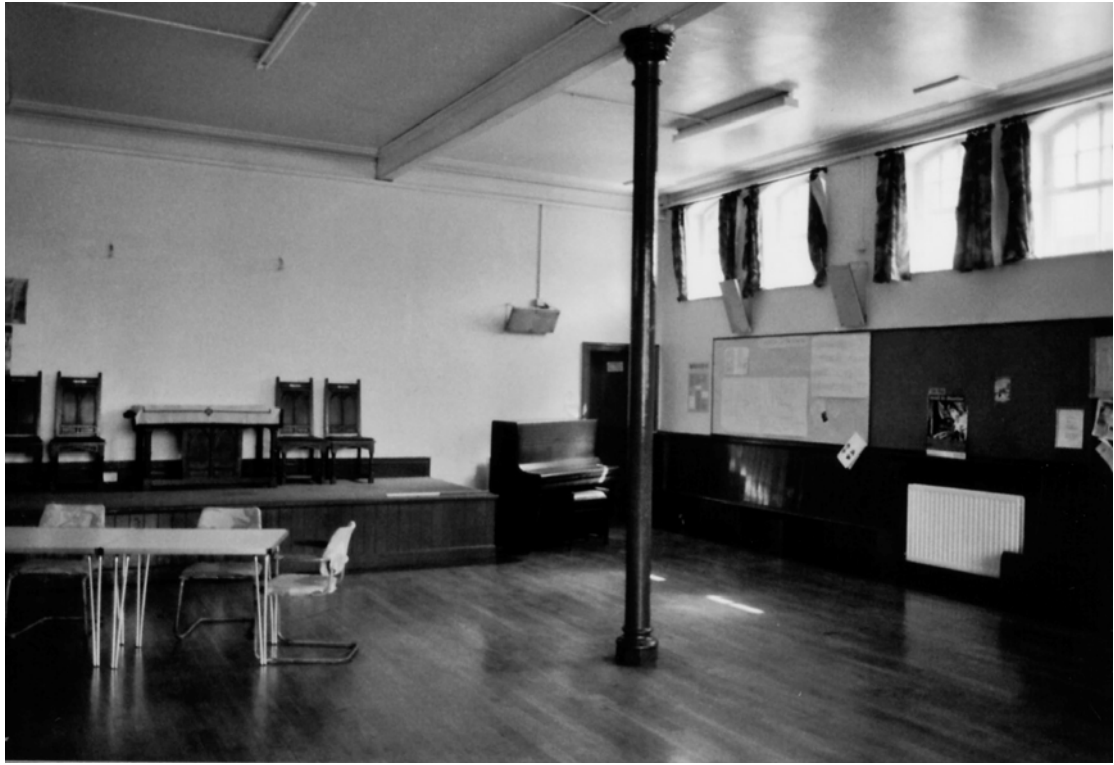
Plate 11: South-East-Facing View of the Ground Floor Meeting Hall
