Dartford, Kent  
Dartford Fastrack Scheme  
Sections E and F

**Archaeological Evaluation  
and Watching Brief Report**

March 2006

**Client: Kent County Council**

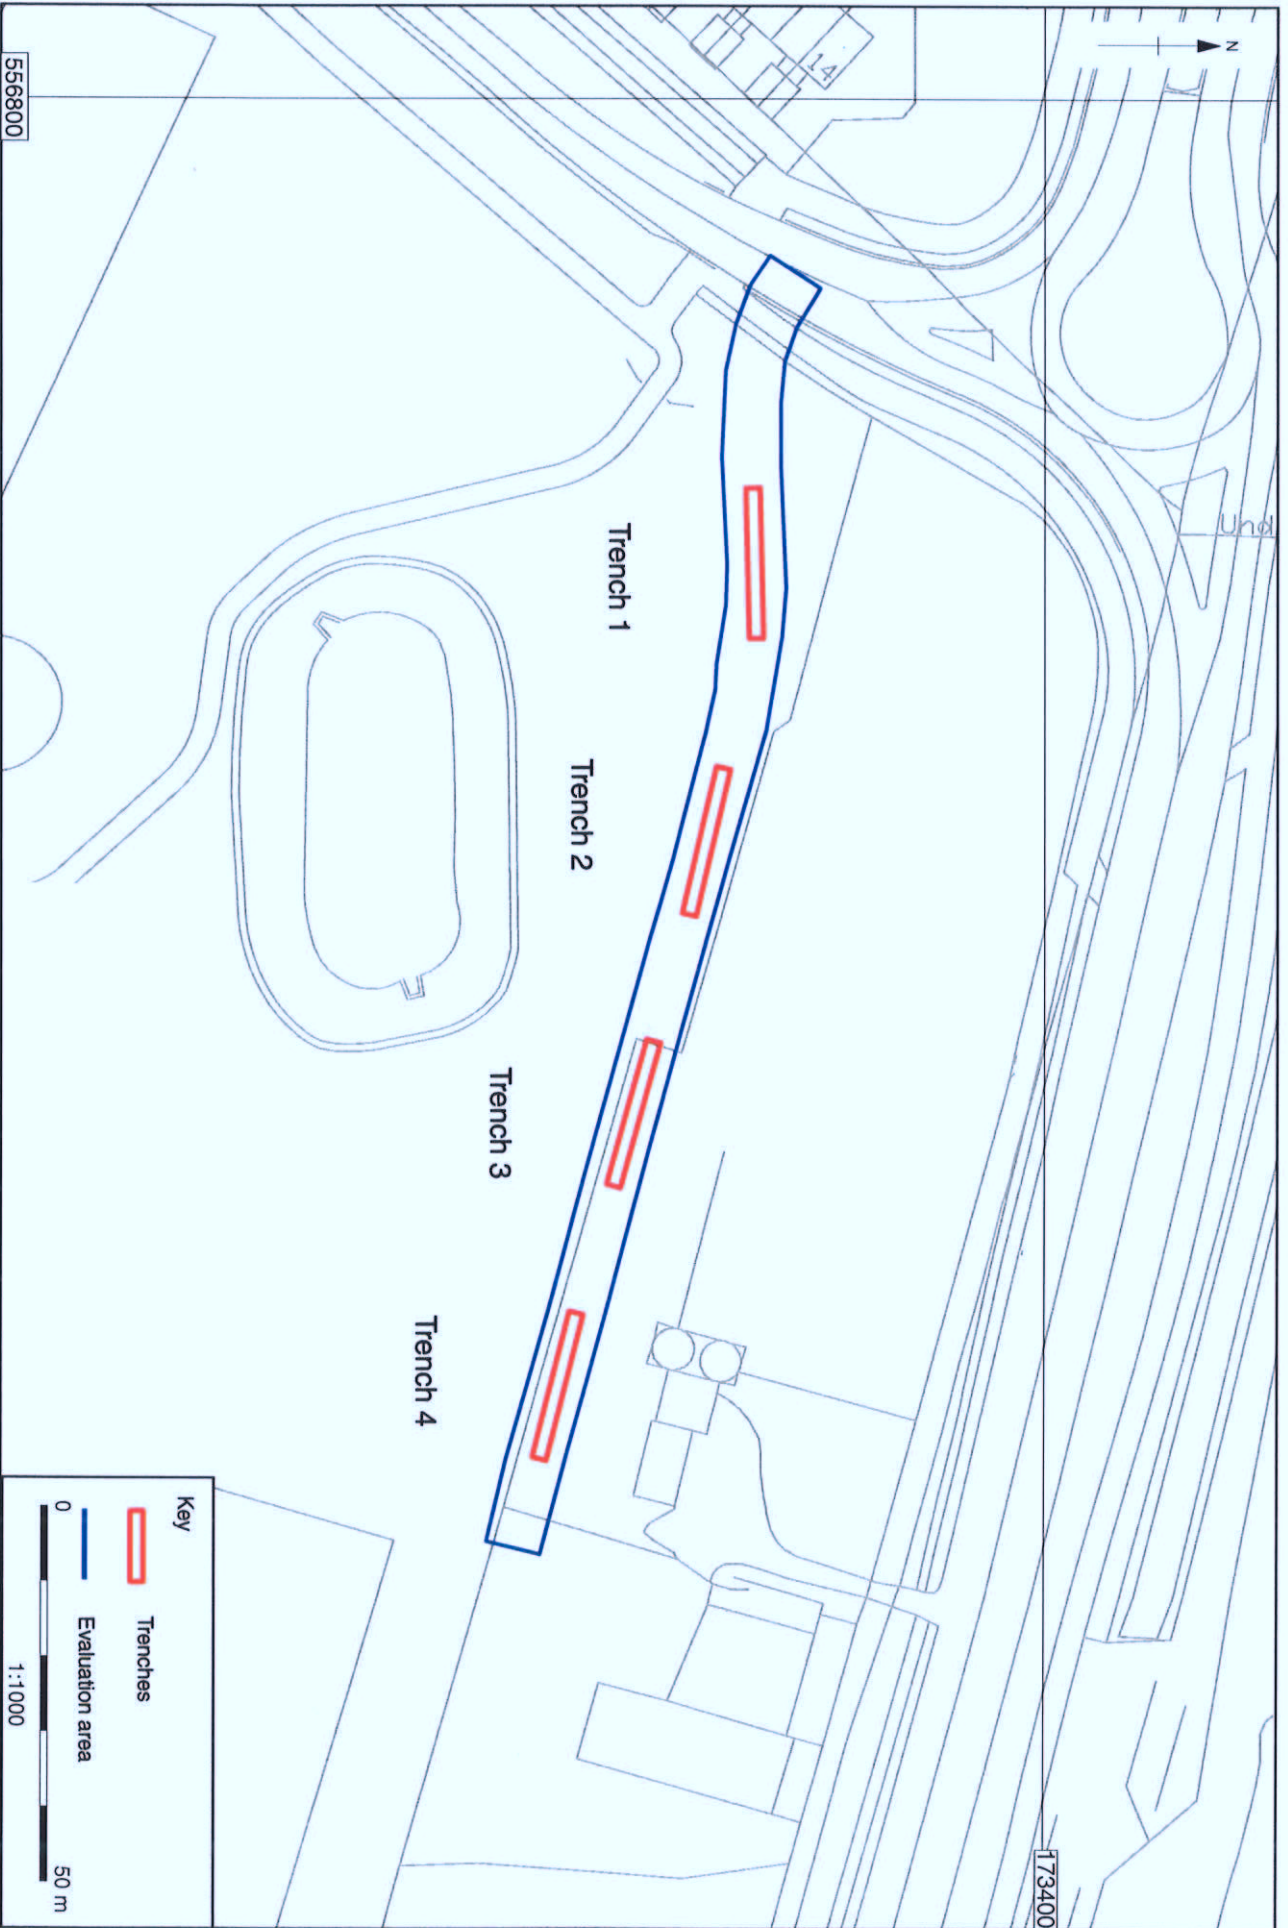
Figure 3: Trench locations

- 2.2.1 Four evaluation trenches were excavated along the line of the Fastrack route in 'Section E' (Fig. 3). Trench 1, an east-northeast to west-southwest orientated trench, measured 20 m long by 1.8 m wide and was the western-most trench. Trench 2, an east-northeast to west-southwest orientated trench, measured 20 m long by 1.8 m wide.

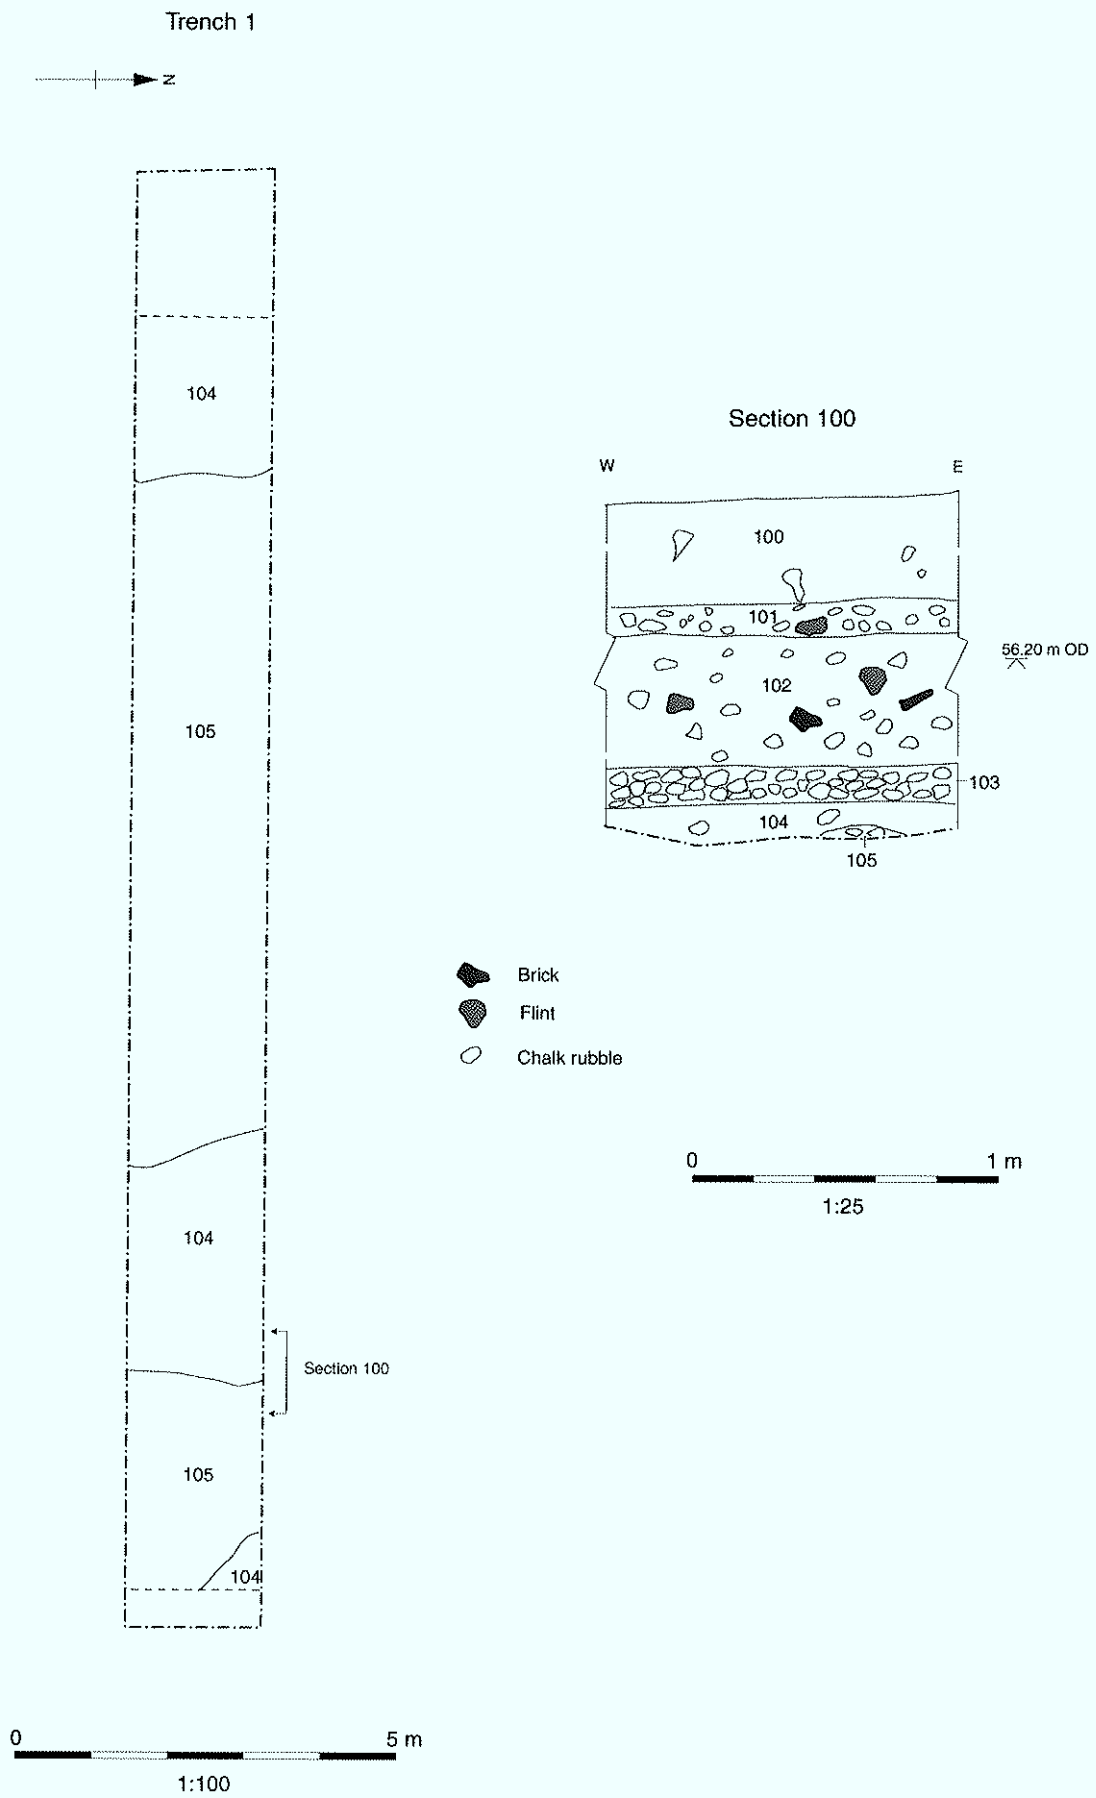
Figure 4: Trench 1, plan and section

3.1.1 Trench 1 (Fig. 4) was situated *c* 50 m east of Gore Road and measured 20 m long by 1.8 m wide. The trench was machined to the top of natural at a depth of 1.15 m. The stratigraphic sequence consisted of recent landscaping topsoil (100) overlying three different layers of modern built up ground (101, 102 and 103). These deposits

comprised re-deposited chalk rubble, flint inclusions and modern brick, concrete and other structural waste. The layers were compacted and were probably mechanically rolled as part of landscaping works.

- 3.1.2 The upper layer of natural was sporadically occurring red/brown brickearth (104), a thin layer with a maximum thickness of 0.15 m. This contained flint nodules and some 'reworked' chalk rubble, both presumably deriving from the underlying chalk. Underlying the brickearth was the chalk solifluction natural (105) in a light brown sandy matrix with flint inclusions. The depth of the deposit was not investigated.

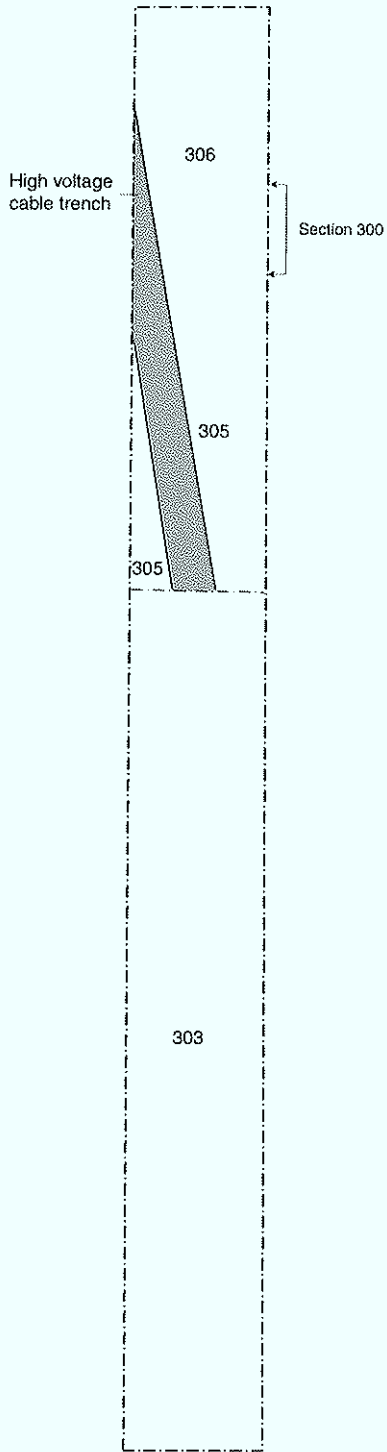
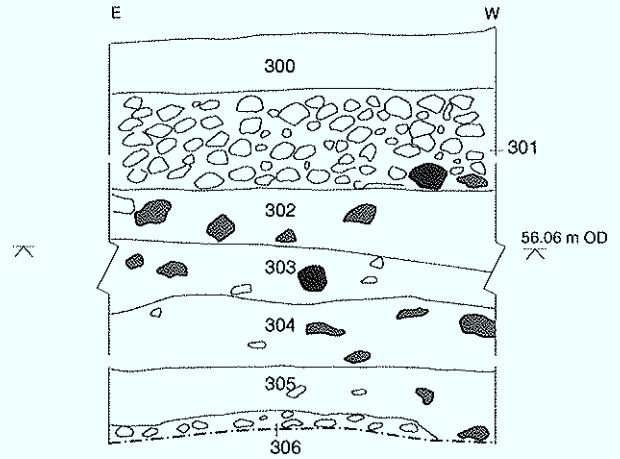
Figure 6: Trench 3, plan and section

- 3.1.5 Trench 3 (Fig. 6) was situated 11 m east of Trench 2 on same east-north-east/west-south-west orientation. It measured 20 m long by 1.8 m wide and was 1.3 m deep. It was only possible to excavate the eastern part of the trench to the natural geology, due to a high voltage electricity cable. There were no archaeological remains present.

- 3.1.6 At the top of the stratigraphic sequence was a landscaped topsoil (300) overlying four layers of modern built up ground (301, 302, 303 and 304). Layer 301 was 0.3 m thick and comprised chalk rubble, modern bricks, concrete and metal. Layer 302 was a mixed rubble deposit in a brown silt matrix. Layer 303 was a very compact chalk rubble layer, probably mechanically compacted during landscaping works and 304 resembled a possible former topsoil but was undated.

- 3.1.7 Underlying the built up ground deposits was a light orange/brown sandy silt (305), which appeared cleaner but contained occasional fragments of brick/tile. It is most likely that this layer represents a remnant of the subsoil, which has survived the landscaping works and it has not been truncated. There were no finds recovered from this deposit in Trench 3. The natural in Trench 3 was chalk solifluction material

(306). Brickearth, which occurs sporadically in other trenches, was not observed here.

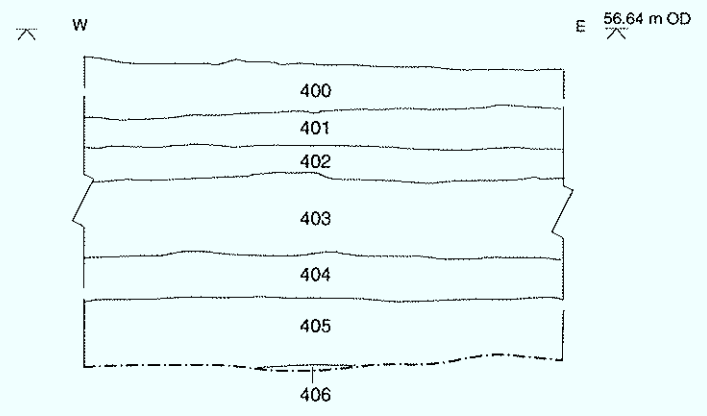
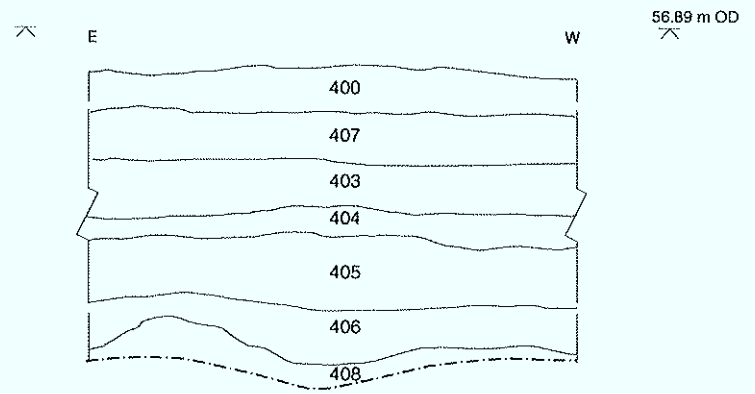
Figure 7: Trench 4, plan and sections

3.1.8 Trench 4 (Fig. 7) was situated some 7 m east of Trench 3 on the same orientation and was the most easterly trench. It measured 20 m long by 1.8 m wide and it was excavated to a maximum depth of 1.1 m. The excavation stopped at the top of natural and there were no archaeological remains present apart from five residual struck flint flakes and a possible scraper found in subsoil layer 404 (see finds section below). The top of the stratigraphic sequence was represented by recent landscaping topsoil (400) overlying several modern layers of built up ground (401, 402, 403 and 407). These layers were similar to those seen in Trenches 1-3. Underlying the made ground deposits were subsoil layers 404 and 405, which probably represent the same deposit, (404) being a slightly darker interface.

3.1.9 This subsoil deposit contained the flint artefacts but they must be residual as the layer also contained modern brick fragments. There is no evidence that the modern inclusions could have been pressed in from the overlying contexts as they have been observed at the very base of the lower part of the subsoil (405). The natural geology in Trench 4 is in accordance with the rest of the trenches. The dark red/brown brickearth (406) overlies soliflucted chalk (408).

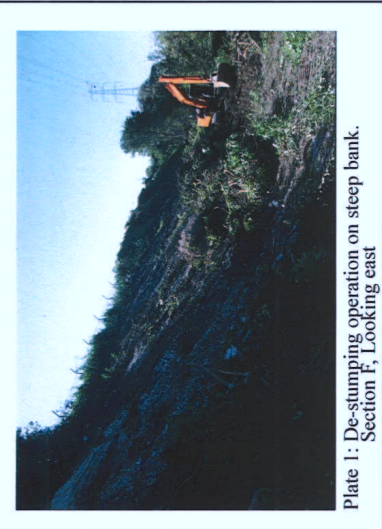
Plate 1: De-stumping operation on steep bank. Section F, Looking east

3.2.1 A small sample section (*c* 1 m) was cleaned and photographed (Fig. 8; Plate 1) at the very top of the slope and it revealed natural geology directly under a thin layer of topsoil. A layer of soliflucted chalk 0.2 m thick separated the topsoil from the chalk bedrock. No archaeological deposits were observed.

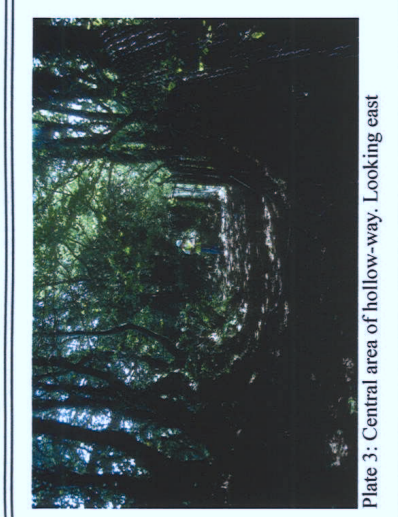
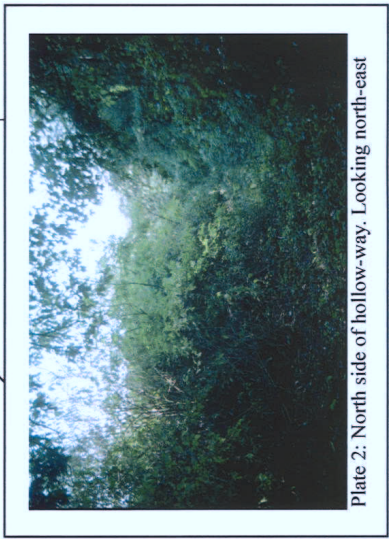
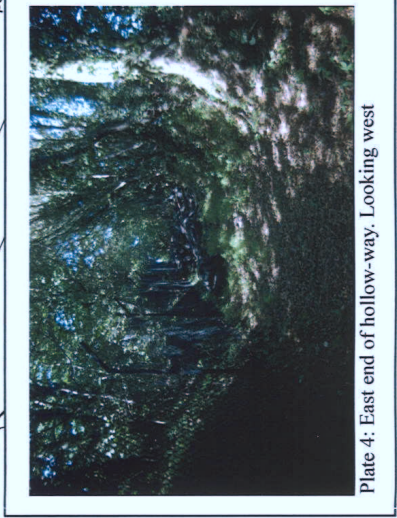
3.3.2 The area starting immediately to the east from the area of tree-stump clearance is occupied by a lane, which is indeed cut into the ground, but it appears to be distinctively modern with fairly neat tree arrangement on both banks, a tarmac surface and evidently respecting the access points at either end. It is beyond its eastern terminal that the vegetation changes into a thick shrub, but the presence of two parallel earthworks can just be seen.

3.3.3 The southern 'bank' is at the same time a slope off from the modern line of Watling Street and as such it may be direct product of the road construction and landscaping.

At its base it appears to have a run off ditch. Several metres to the north, along the very edge of the quarry there is a parallel bank, which is a proper earthwork in its own right. It is heavily overgrown with shrub and small trees and it becomes higher as the ground between the 'banks' slopes eastwards.
