AREA 13 (WATERSIDE), THE CHANNELSIDE AREA, BARROW-IN-FURNESS

Archaeological Watching Brief Report

Oxford Archaeology North

June 2005

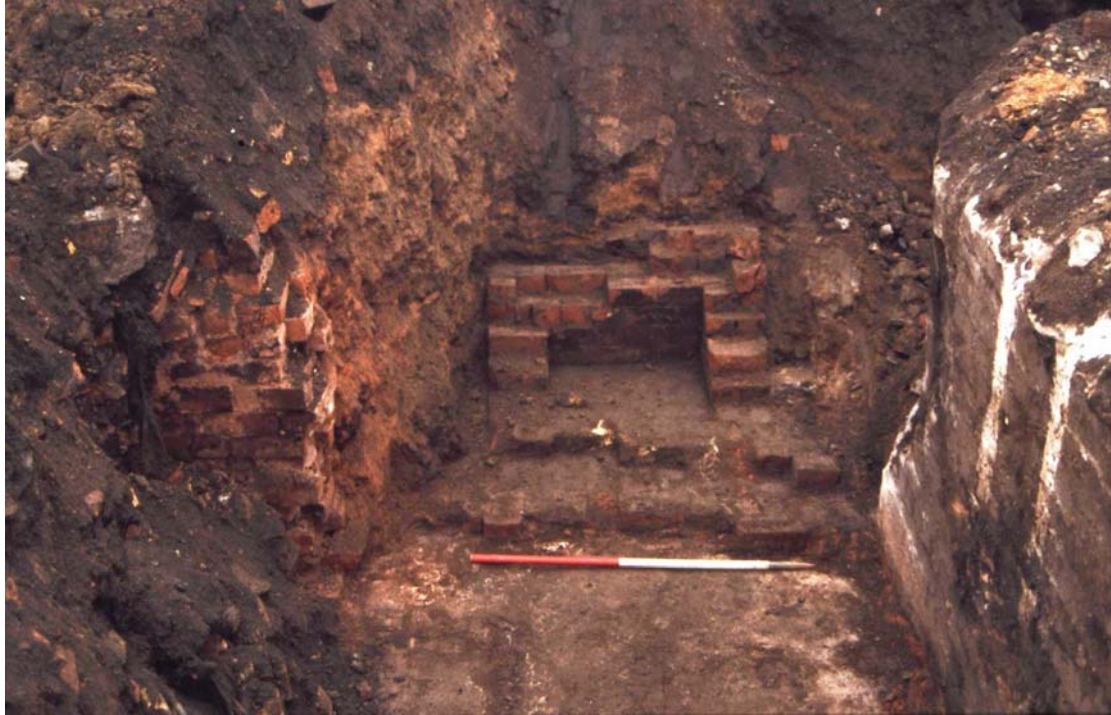
- 3.1.2 Towards the south-east corner of the site there was a concrete block, **103**, that was larger than normal at 3m x 3m x 1.7m deep (Figs 2 and 3), possibly to support a greater load from the building. A small trench excavated on the east side of this revealed the remains of a heavily truncated earlier structure at a depth of 2m. This was supported by another concrete base, **104**, which at the south end was overlain by a single layer of red bricks, **105**, 0.08m thick. On this surface was three sides of a brick structure, **107**, with walls about 0.23m thick (Plate 1). It was 1.3m wide on its south side, with its east and west walls truncated at 0.80m and 0.92m respectively. Within the walls were the remains of a yellow brick surface, **106**, 0.08m thick, extending 0.62m from the south wall. This structure is interpreted as relating to an earlier phase of industrial activity, in the late nineteenth or early twentieth century. However, the extent of the surviving remains was so limited that the type of structure it represents and its function is unknown.

Plate 1: Structure *107* viewed from the north

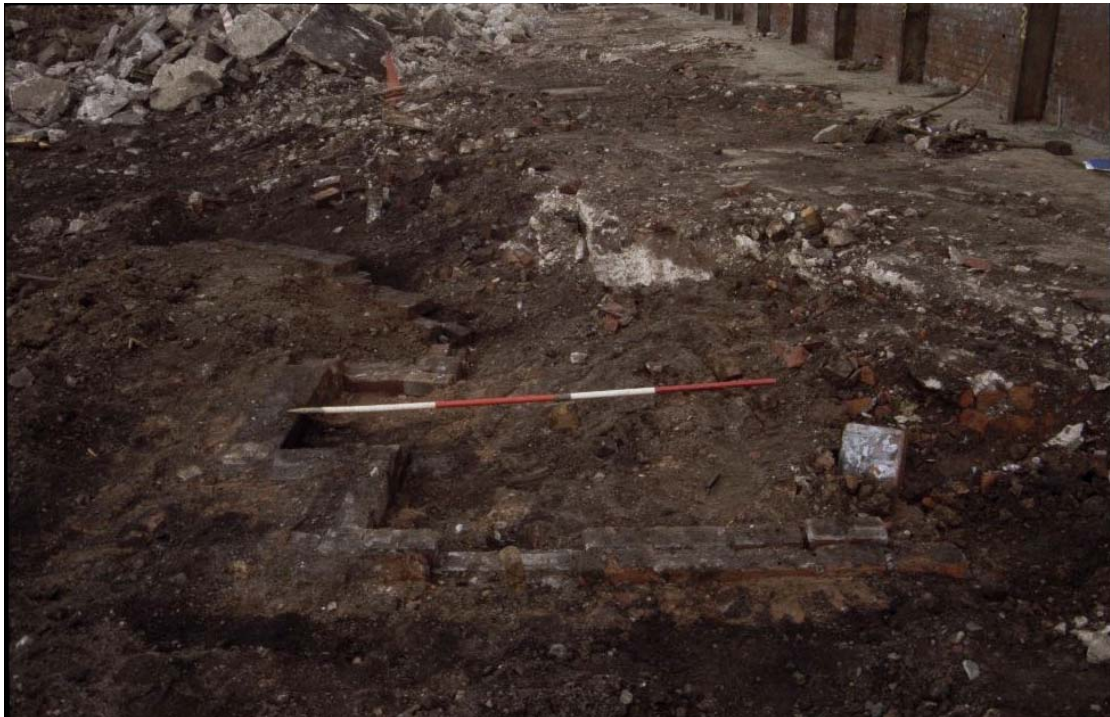
- 3.1.3 Part of a brick-built structure, **116**, was also revealed close to the south-east corner of the site (Fig 2, Fig 4, Plate 2). The surviving elements of this consisted of a south wall, 2.2m long, and a west wall, 2.8m long, which turned north-west for a further 2.8m. The walls were 0.23m thick, and the bricks were of local manufacture. The depth of the walls is not known, as only the top layer of bricks was visible at the time of recording. The walls were set in a cut, **114**, with the external side packed with a yellow clay backfill, **115**.

Plate 2: Structure *116* viewed from the west

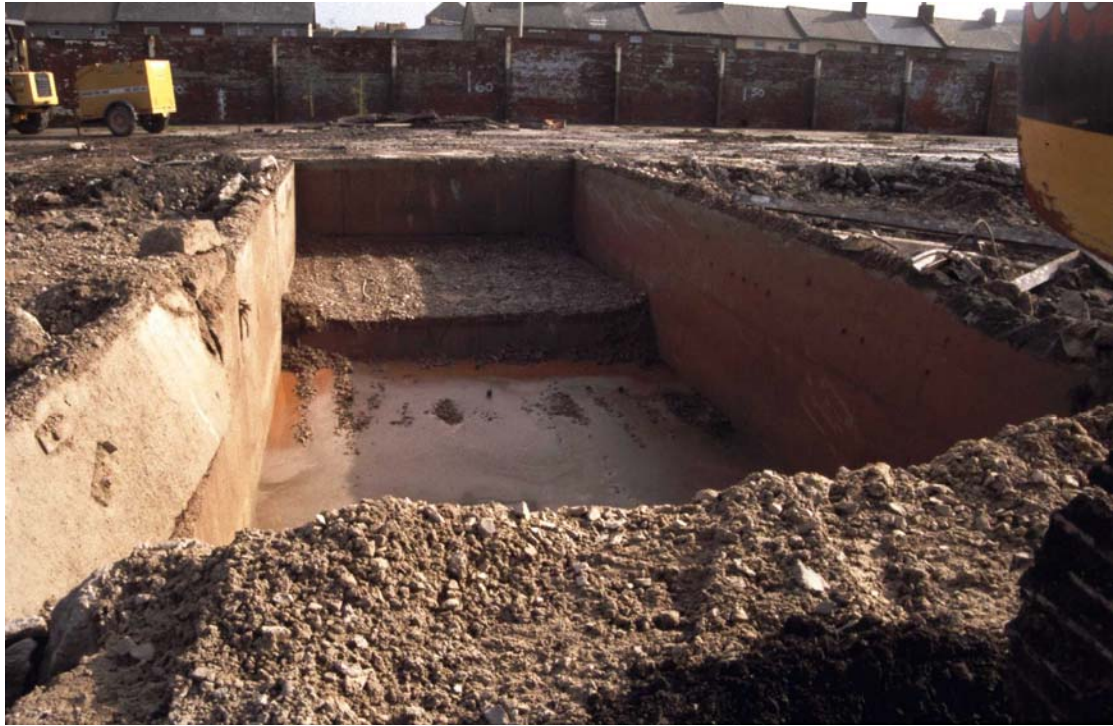
- 3.1.4 Two reinforced concrete pits were revealed in the south-east part of the site (Fig 2). Rectangular pit **112** was 9m north/south, 3m east/west, and 3m deep. Constructed of concrete, the east and west sides were 0.4m thick, reinforced with steel girders. The other pit, **101** (Plate 3), was situated 30m to the north. This measured 12m x 6m, running east/west. The base was stepped in the middle, being 1.6m deep on the west side and 2m deep on the east side. Again, these pits have an unknown function, but were part of the large industrial building.

Plate 3: Pit *101* viewed from the east

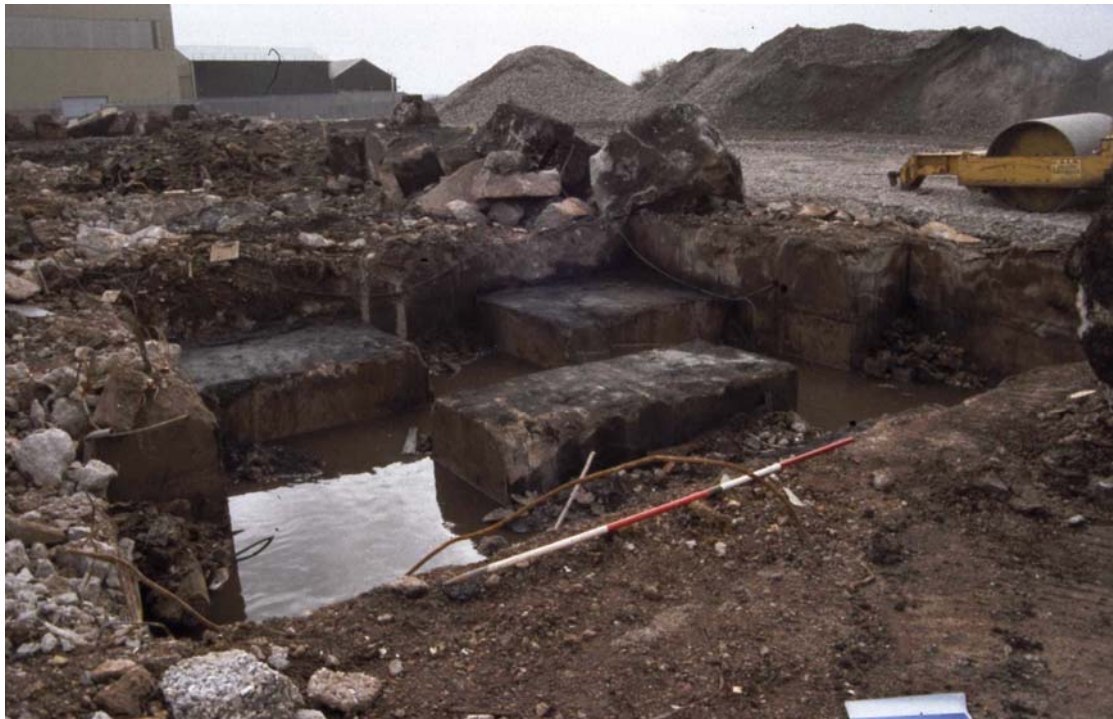
- 3.1.5 Two more pits were found towards the north-west corner of the site, parallel to each other and 4m apart (Fig 2). Pit **102** measured 7.3m north/south and 8.9m east/west, narrowing to 7m at the south end (Plate 4). There were four plinths

built into the pit, also constructed of concrete. Two plinths in the south-east and south-west corners measured 2.55m x 2.1m. The other two both measured 3.3m x 1.3m, one of these being against the north wall, and the other being parallel to it, a further 1.3m to the south. These plinths were 0.6m lower than the top of the pit. This pit is interpreted as a base for large machinery in the recently demolished industrial building. Pit **109** was rectangular and ran 8.2m east/west by 4.2m north/south. The base was 0.5m deep in the centre, stepping up 0.15m, 1.95m from each end. This pit is interpreted as part of the same building, but its specific purpose is not known.

Plate 4: Pit *102* viewed from the north-east

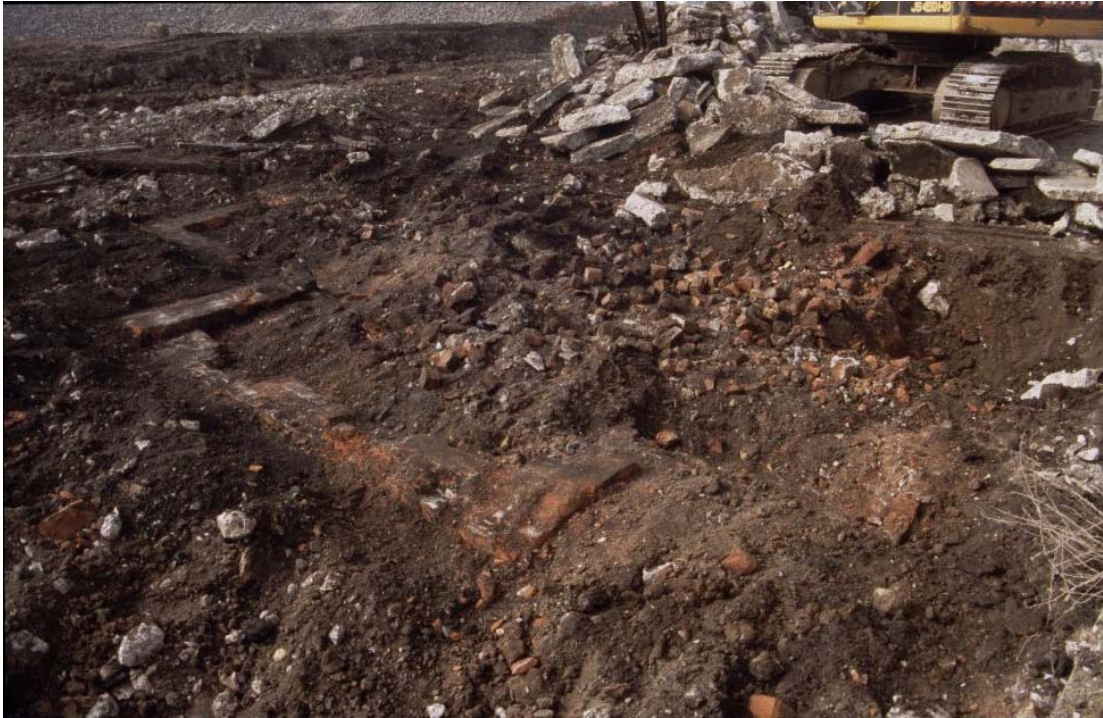
- 3.1.6 On the east side of the site, 1.4m from the boundary, a row of four of the concrete blocks running north/south at 12m intervals were smaller than usual, at 1m x 1m x 1m. Adjacent to the most southerly of these was a red brick structure, **117**, 6.0m x 6.9m, the walls being 0.3m thick and at least 0.7m deep (Fig 2, Plate 5). This was constructed of bricks of local manufacture, its west side and part of its north wall were missing, and the interior had been backfilled with building rubble, **120**. On the east wall in the south corner there was a recess measuring 1.15m x 1.35m. The concrete block, **118**, was set against the outside of the east wall, and against the north side of this recess, and the impression of the walls had been retained in the concrete. The concrete and the brick structure were therefore associated, so the brick structure can be interpreted as another part of the same building.

Plate 5. Structure *117* viewed from the east
