111 Ock Street, Abingdon, Oxfordshire

Archaeological Evaluation Report

June 2017

Client: Orion Heritage

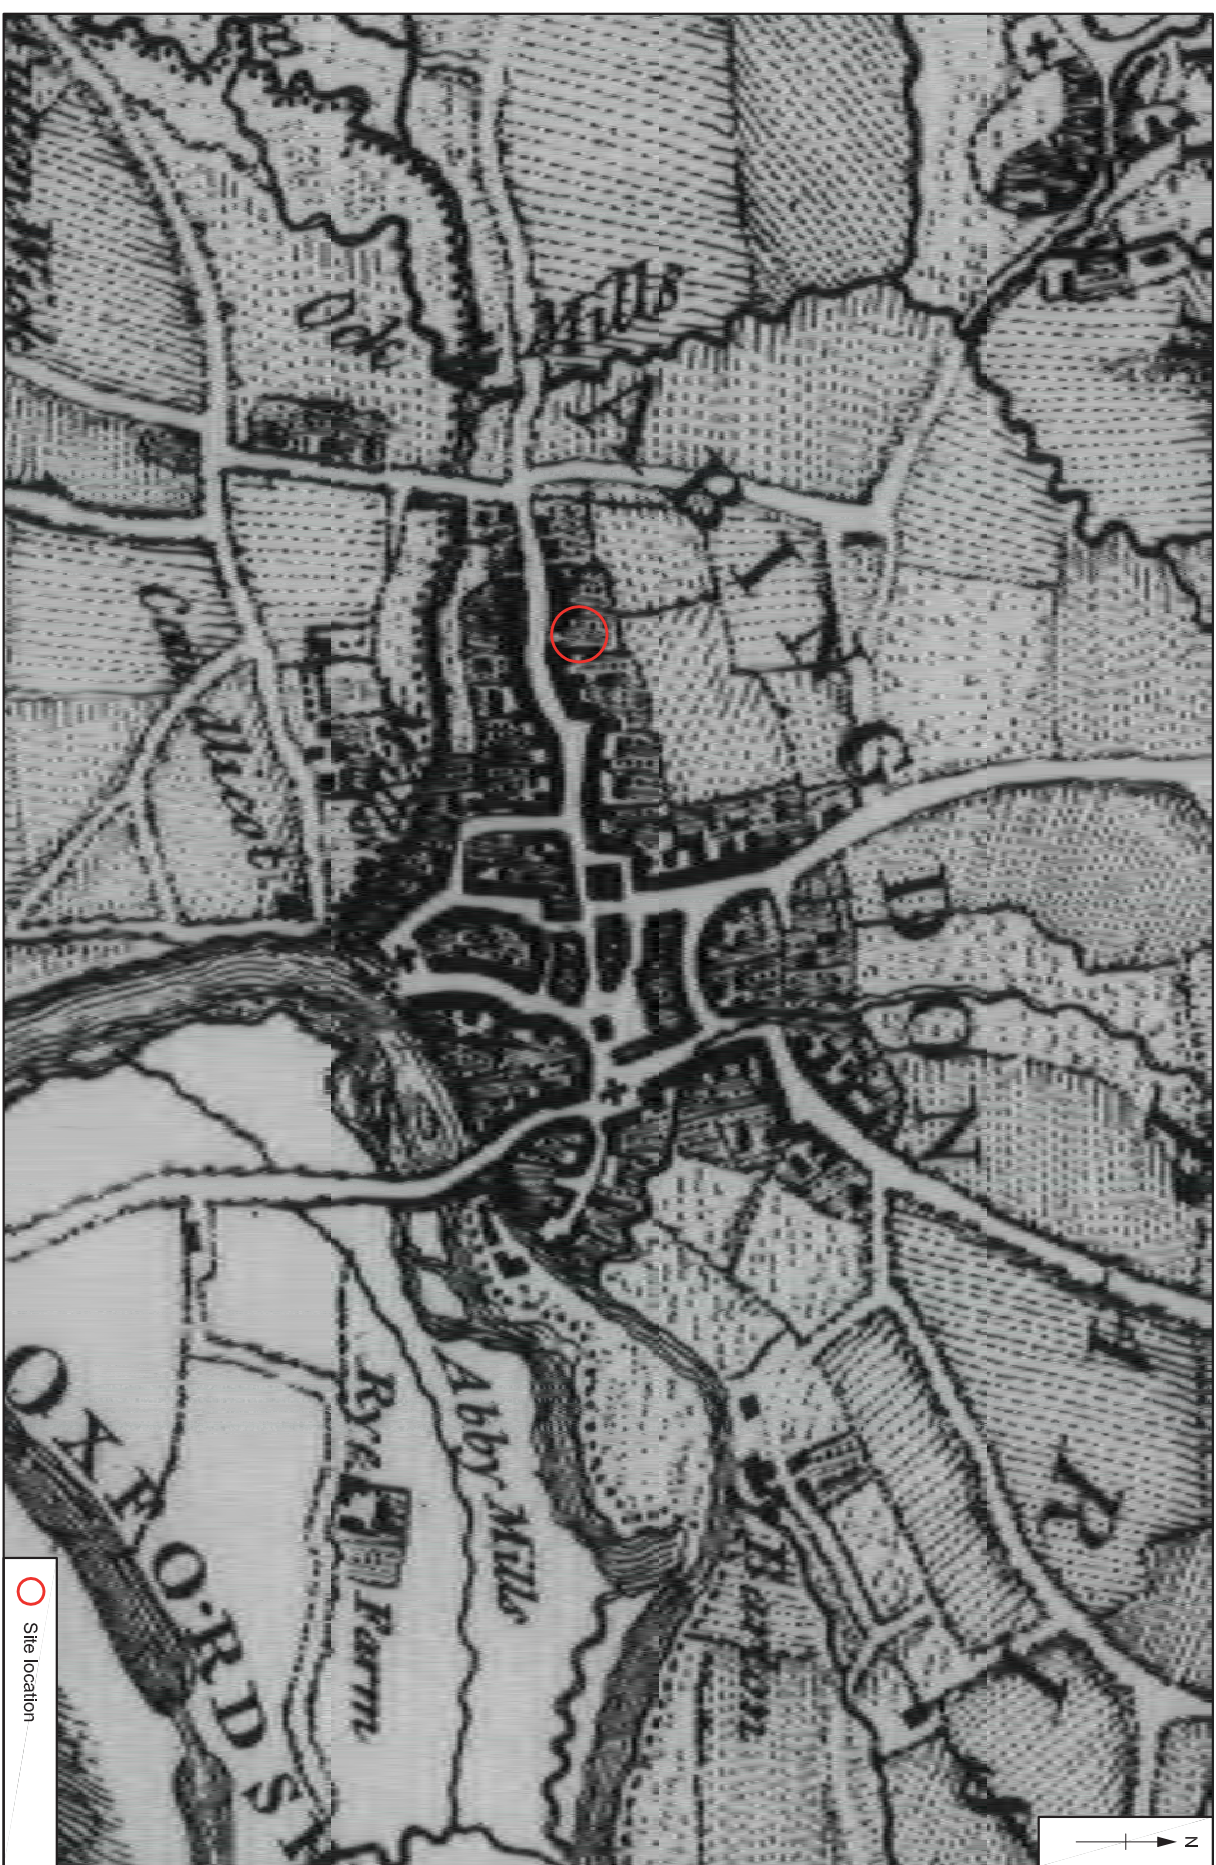
Figure 6: 1761 Rocque's Map of Berkshire

- 1.3.9 The earliest map of Abingdon showing a detailed illustration of Ock Street is Rocque's 1761 map, which clearly indicates buildings on both the north and south frontages (Fig. 6).

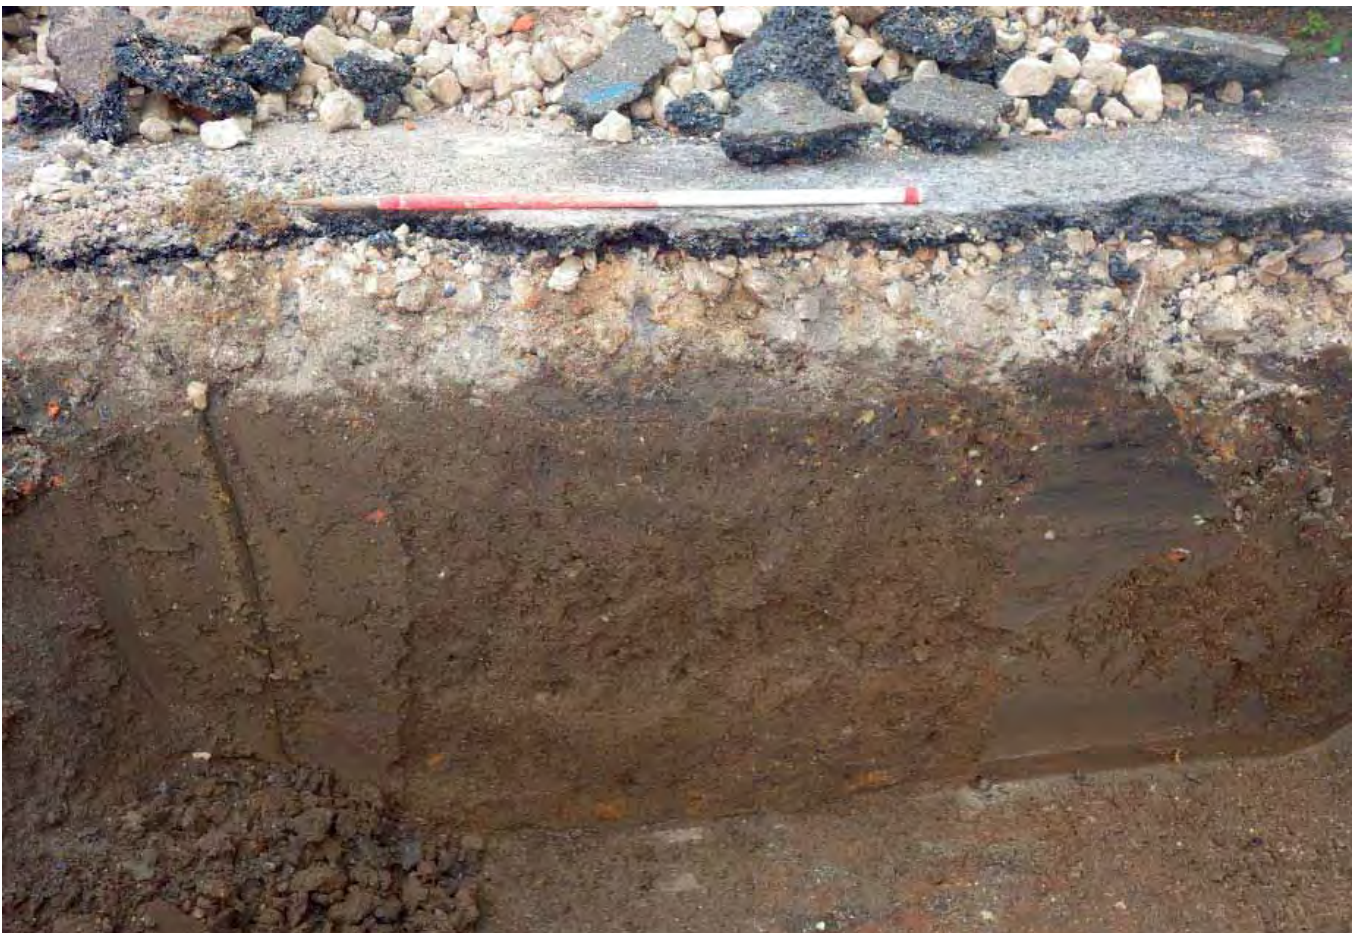
Plate 2 - Trench 1 - Deposit sequence, view to NE

- 3.4.1 The natural geology was not reached in Trench 1. The earliest deposit recorded within the trench was a mid greyish brown silty sand made ground layer (1003), which was more than 0.7m thick (Plate 2).

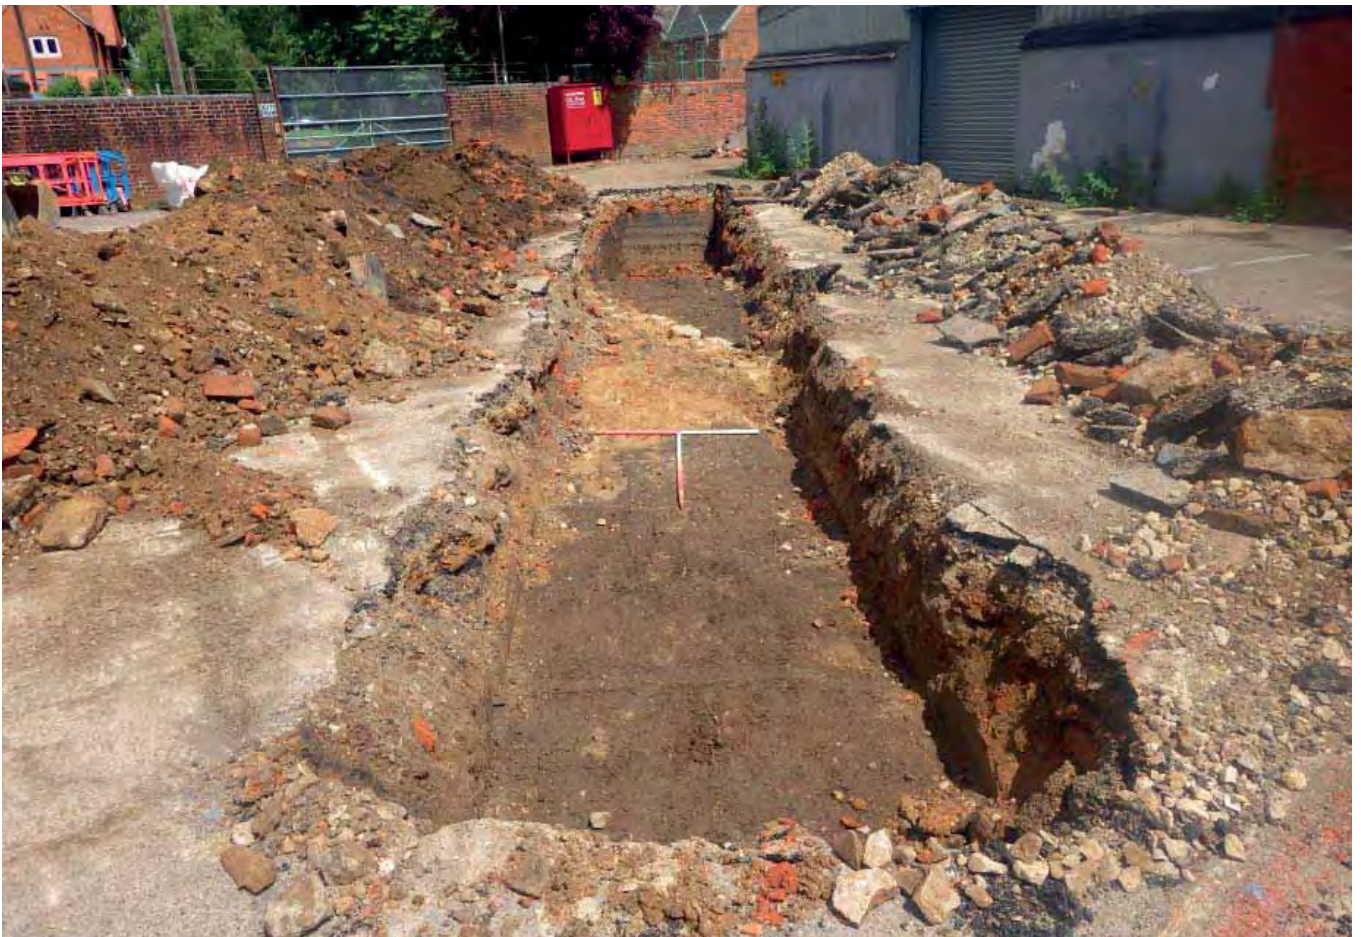
Plate 5 - Trench 2, view to SW

3.5 Trench 2 (Figs 4 and 5; Plates 5-7)

- 3.5.1 Natural geology, comprising yellow sand, was observed at approximately 2m below the modern ground level. The sand was overlain by a series of levelling deposits (2009, 2005 and 2004) with a combined depth of c 1.66m. The uppermost of these deposits (2009) was cut linear feature 2010 (Fig. 4; Plate 6). Due to safety restrictions, the feature was unexcavated and was recorded in plan only. The feature extended across the trench on a NW-SE alignment and measured 1.2m wide at its south-east end and 1.8m at its north-west end. Its fill consisted of broken roof tiles (2008).

- 3.5.2 Ditch 2010 was overlain by a further made ground layer (2005), which was cut by stone wall 2007 (Fig. 4; Plate 7). The wall was similar to those found in Trench 1. It was aligned N-S, parallel to the walls in Trench 1, and was 0.4m wide and 0.2m high. It was constructed of roughly shaped light grey stone blocks of varying size, averaging 0.3m by 0.2m by 0.1m, bonded by a light yellow sandy mortar. The stone blocks sat atop a single layer of CBM tiles bonded with the same mortar (Fig. 5). The remains of a possible floor surface, or bedding layer were present along the western side of the wall, indicating the interior of the structure. The deposit comprised a layer of compacted yellow sand with CBM fragments.
