# Magdalen College School All Weather Sports Pitch

## Archaeological Watching Brief Report

# Magdalen College School, Oxford: All Weather Sports Pitch

*Archaeological Watching Brief Report*

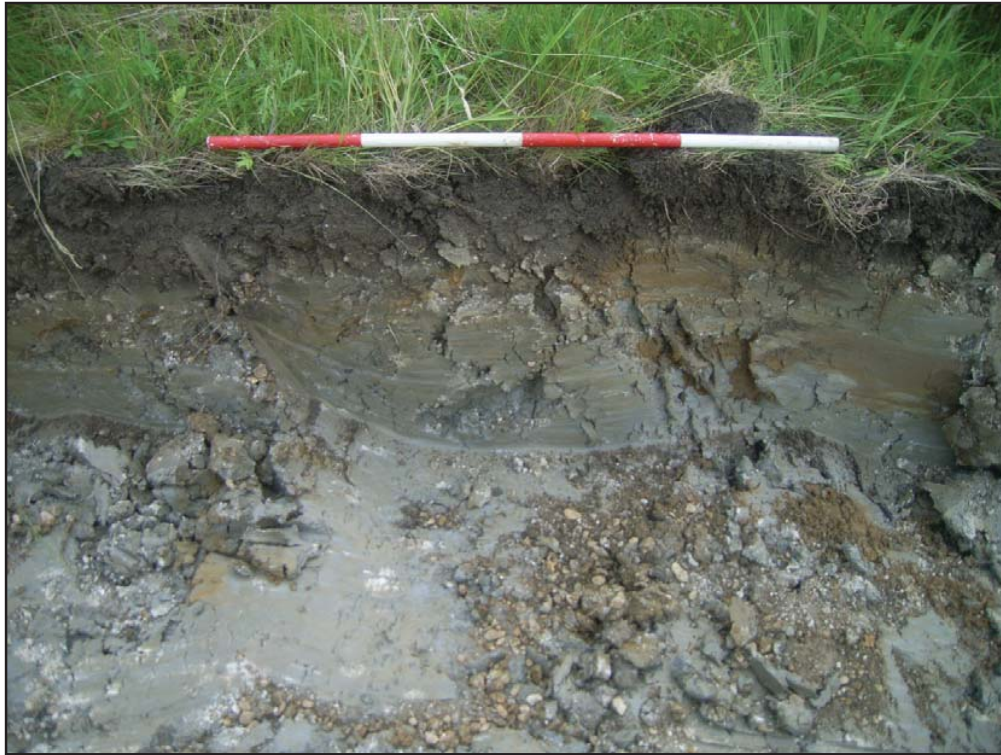
Plate 1: Section 4

- 3.1.10 The reduction in level showed that the clay, 4, was in excess of 0.45m in depth was no additional stratigraphy exposed (Section 4).
- 3.1.11 During the grading operation the ground reduction was confined to the eastern half of the site, with the eastern edge of layer 3 being truncated, exposing a continuation of the blue-grey clay 4 underneath. Layer 2 was not impacted upon and was sealed below the redeposited material during the grading operation.
