**Abbey Fields, Thorney, Peterborough:  
Archaeological Site & Desk-Based Survey  
and Conservation Restoration Plan  
– Interim Report**

**Cambridgeshire County Council**

Report No. 776

December 2004

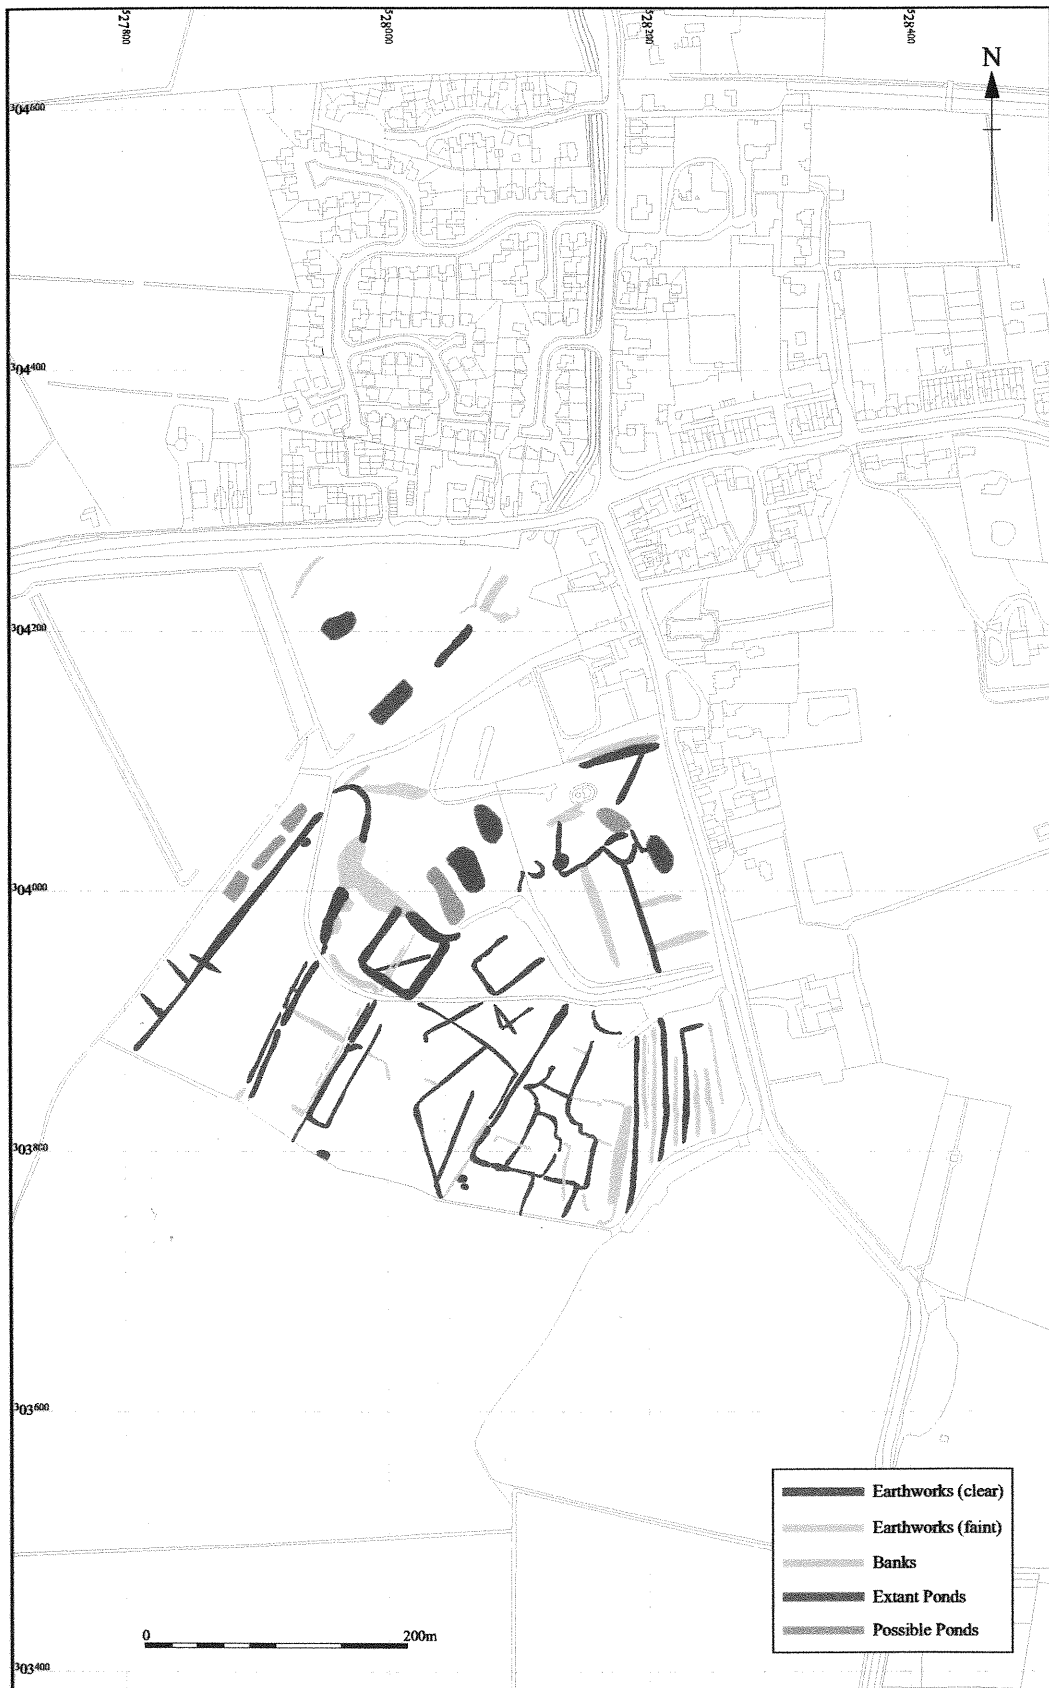
Figure 9 Earthwork Survey

Initial inspections showed a strong correlation between the remaining earthworks and the aerial photographs. Except in a very few cases the remains visible on the ground are very low.

An earthwork survey of Abbey Fields was undertaken in December 2003 and January 2004, the results of which are detailed in Appendix 4. The survey was undertaken by officers of Cambridgeshire County Council's Archaeological Field Unit.

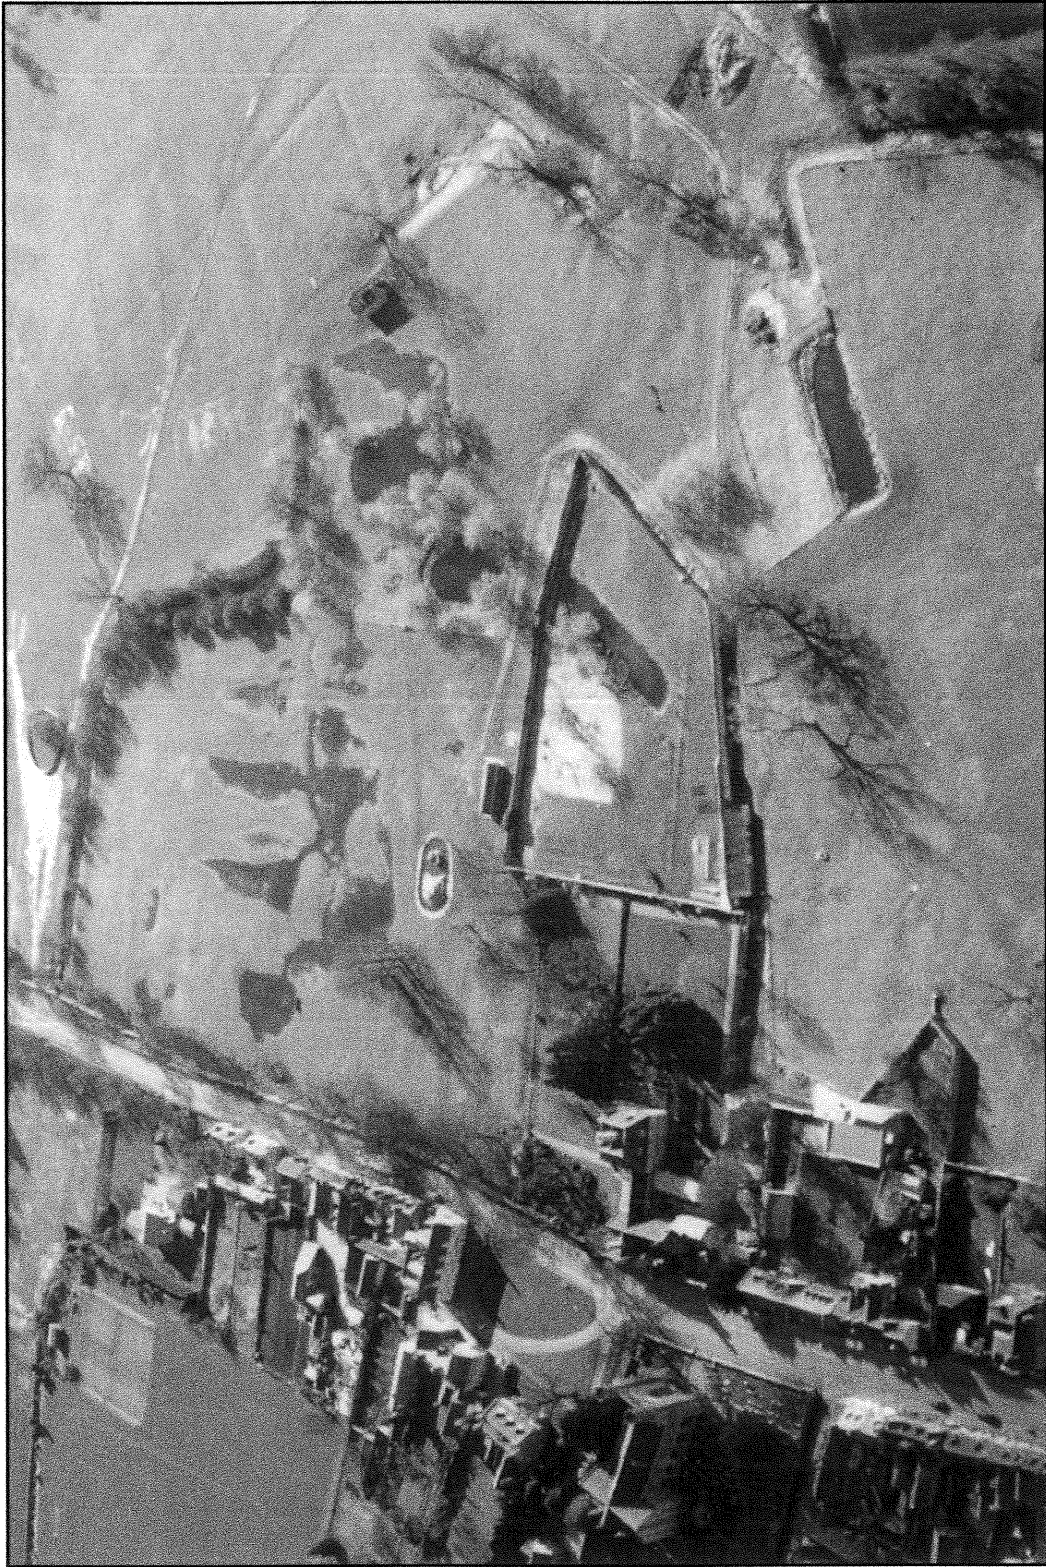
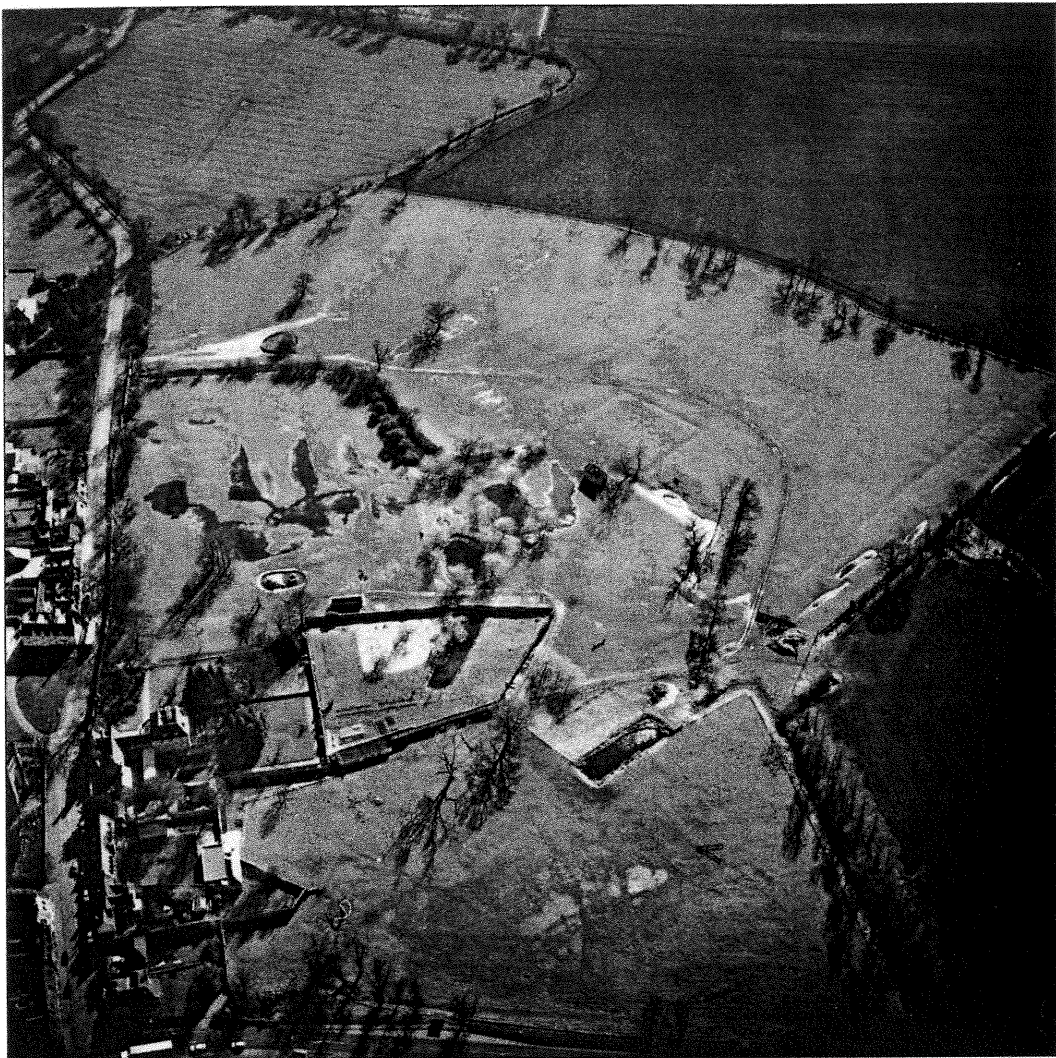
*At least 2, perhaps a complex of up to 4 possible medieval fishponds, not immediately obvious but detected in certain conditions (see Plates 5 & 6).*
