# St Thomas of Canterbury Church

Goring on Thames  
Oxfordshire

## Archaeological Evaluation Report

July 2010

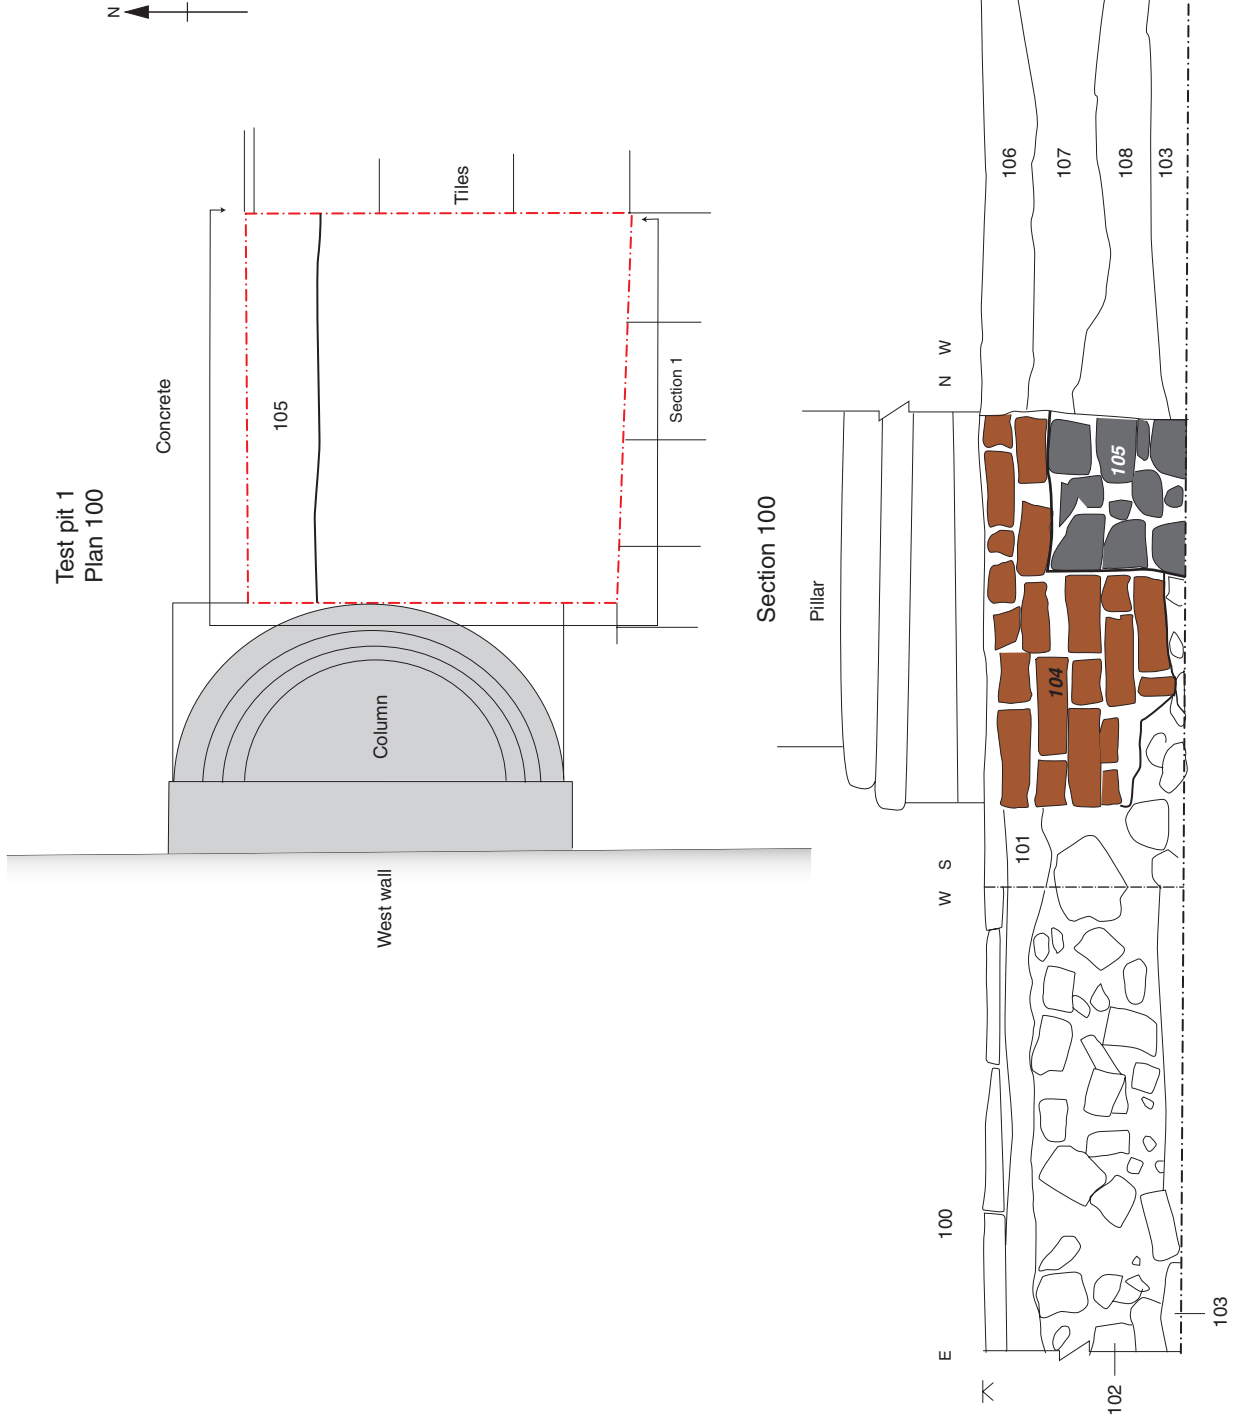
Figure 3: Test pit 1, plan and section

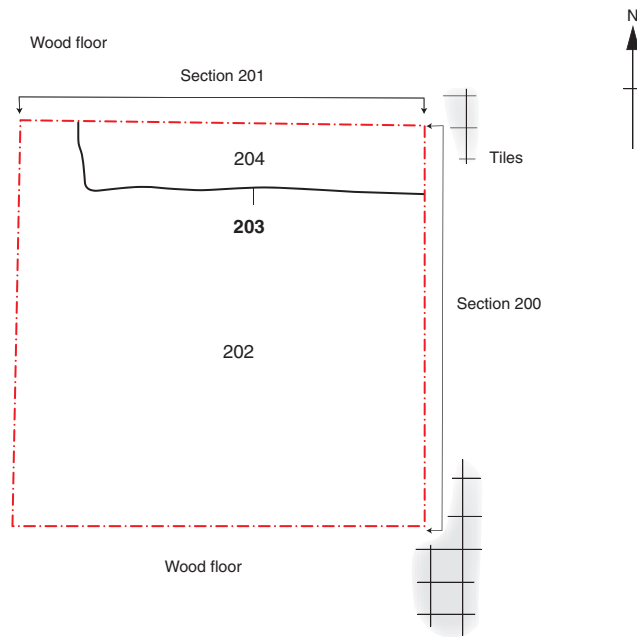
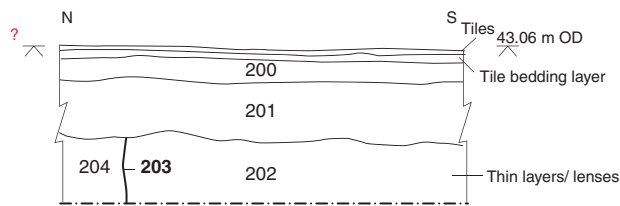
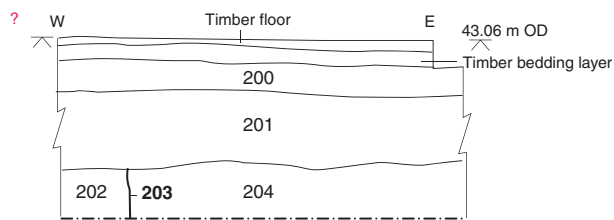
Figure 4: Test pit 2, plan and section

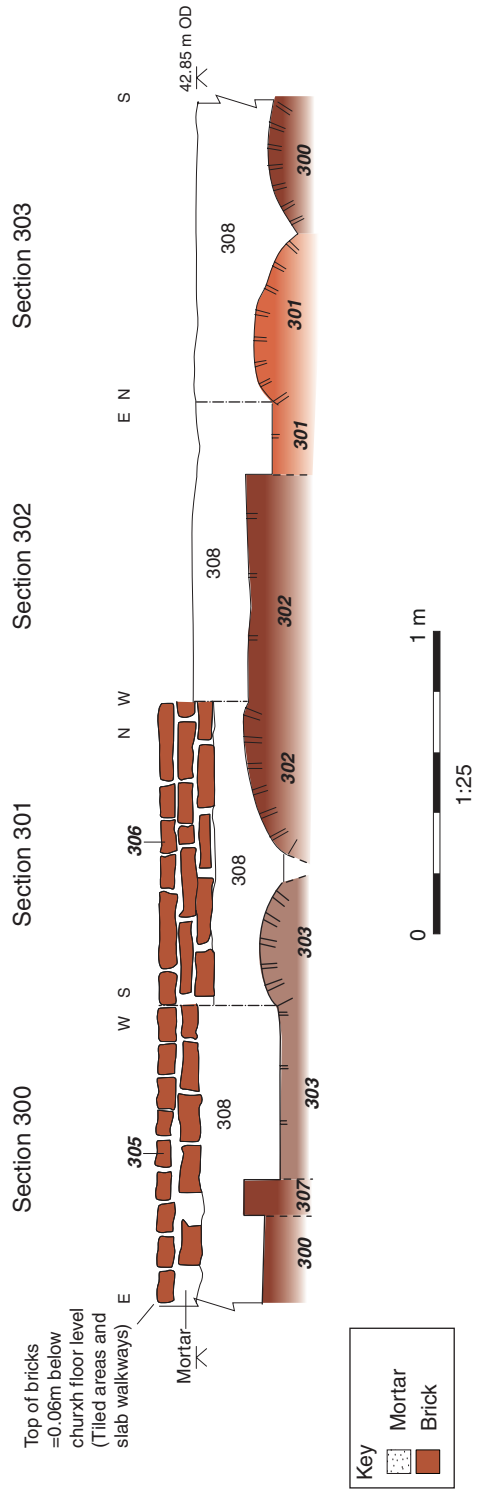
Figure 5: Test pit 3, Plan and sections

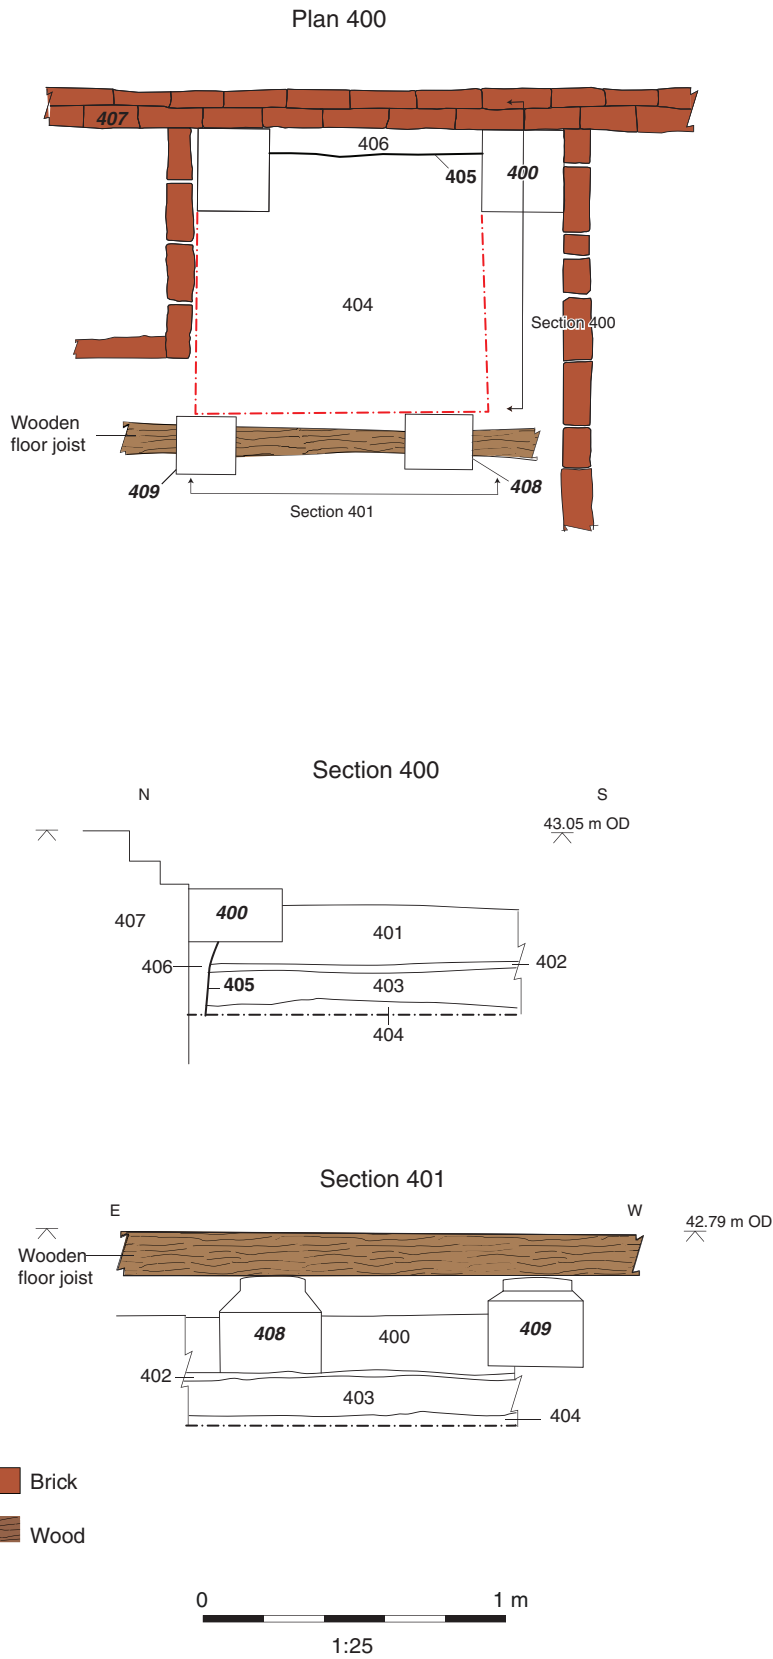
Figure 6: Test pit 4, Plan and section

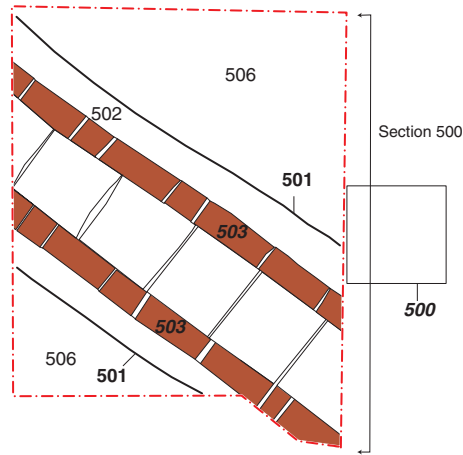
Figure 7: Test pit 5, Plan and section

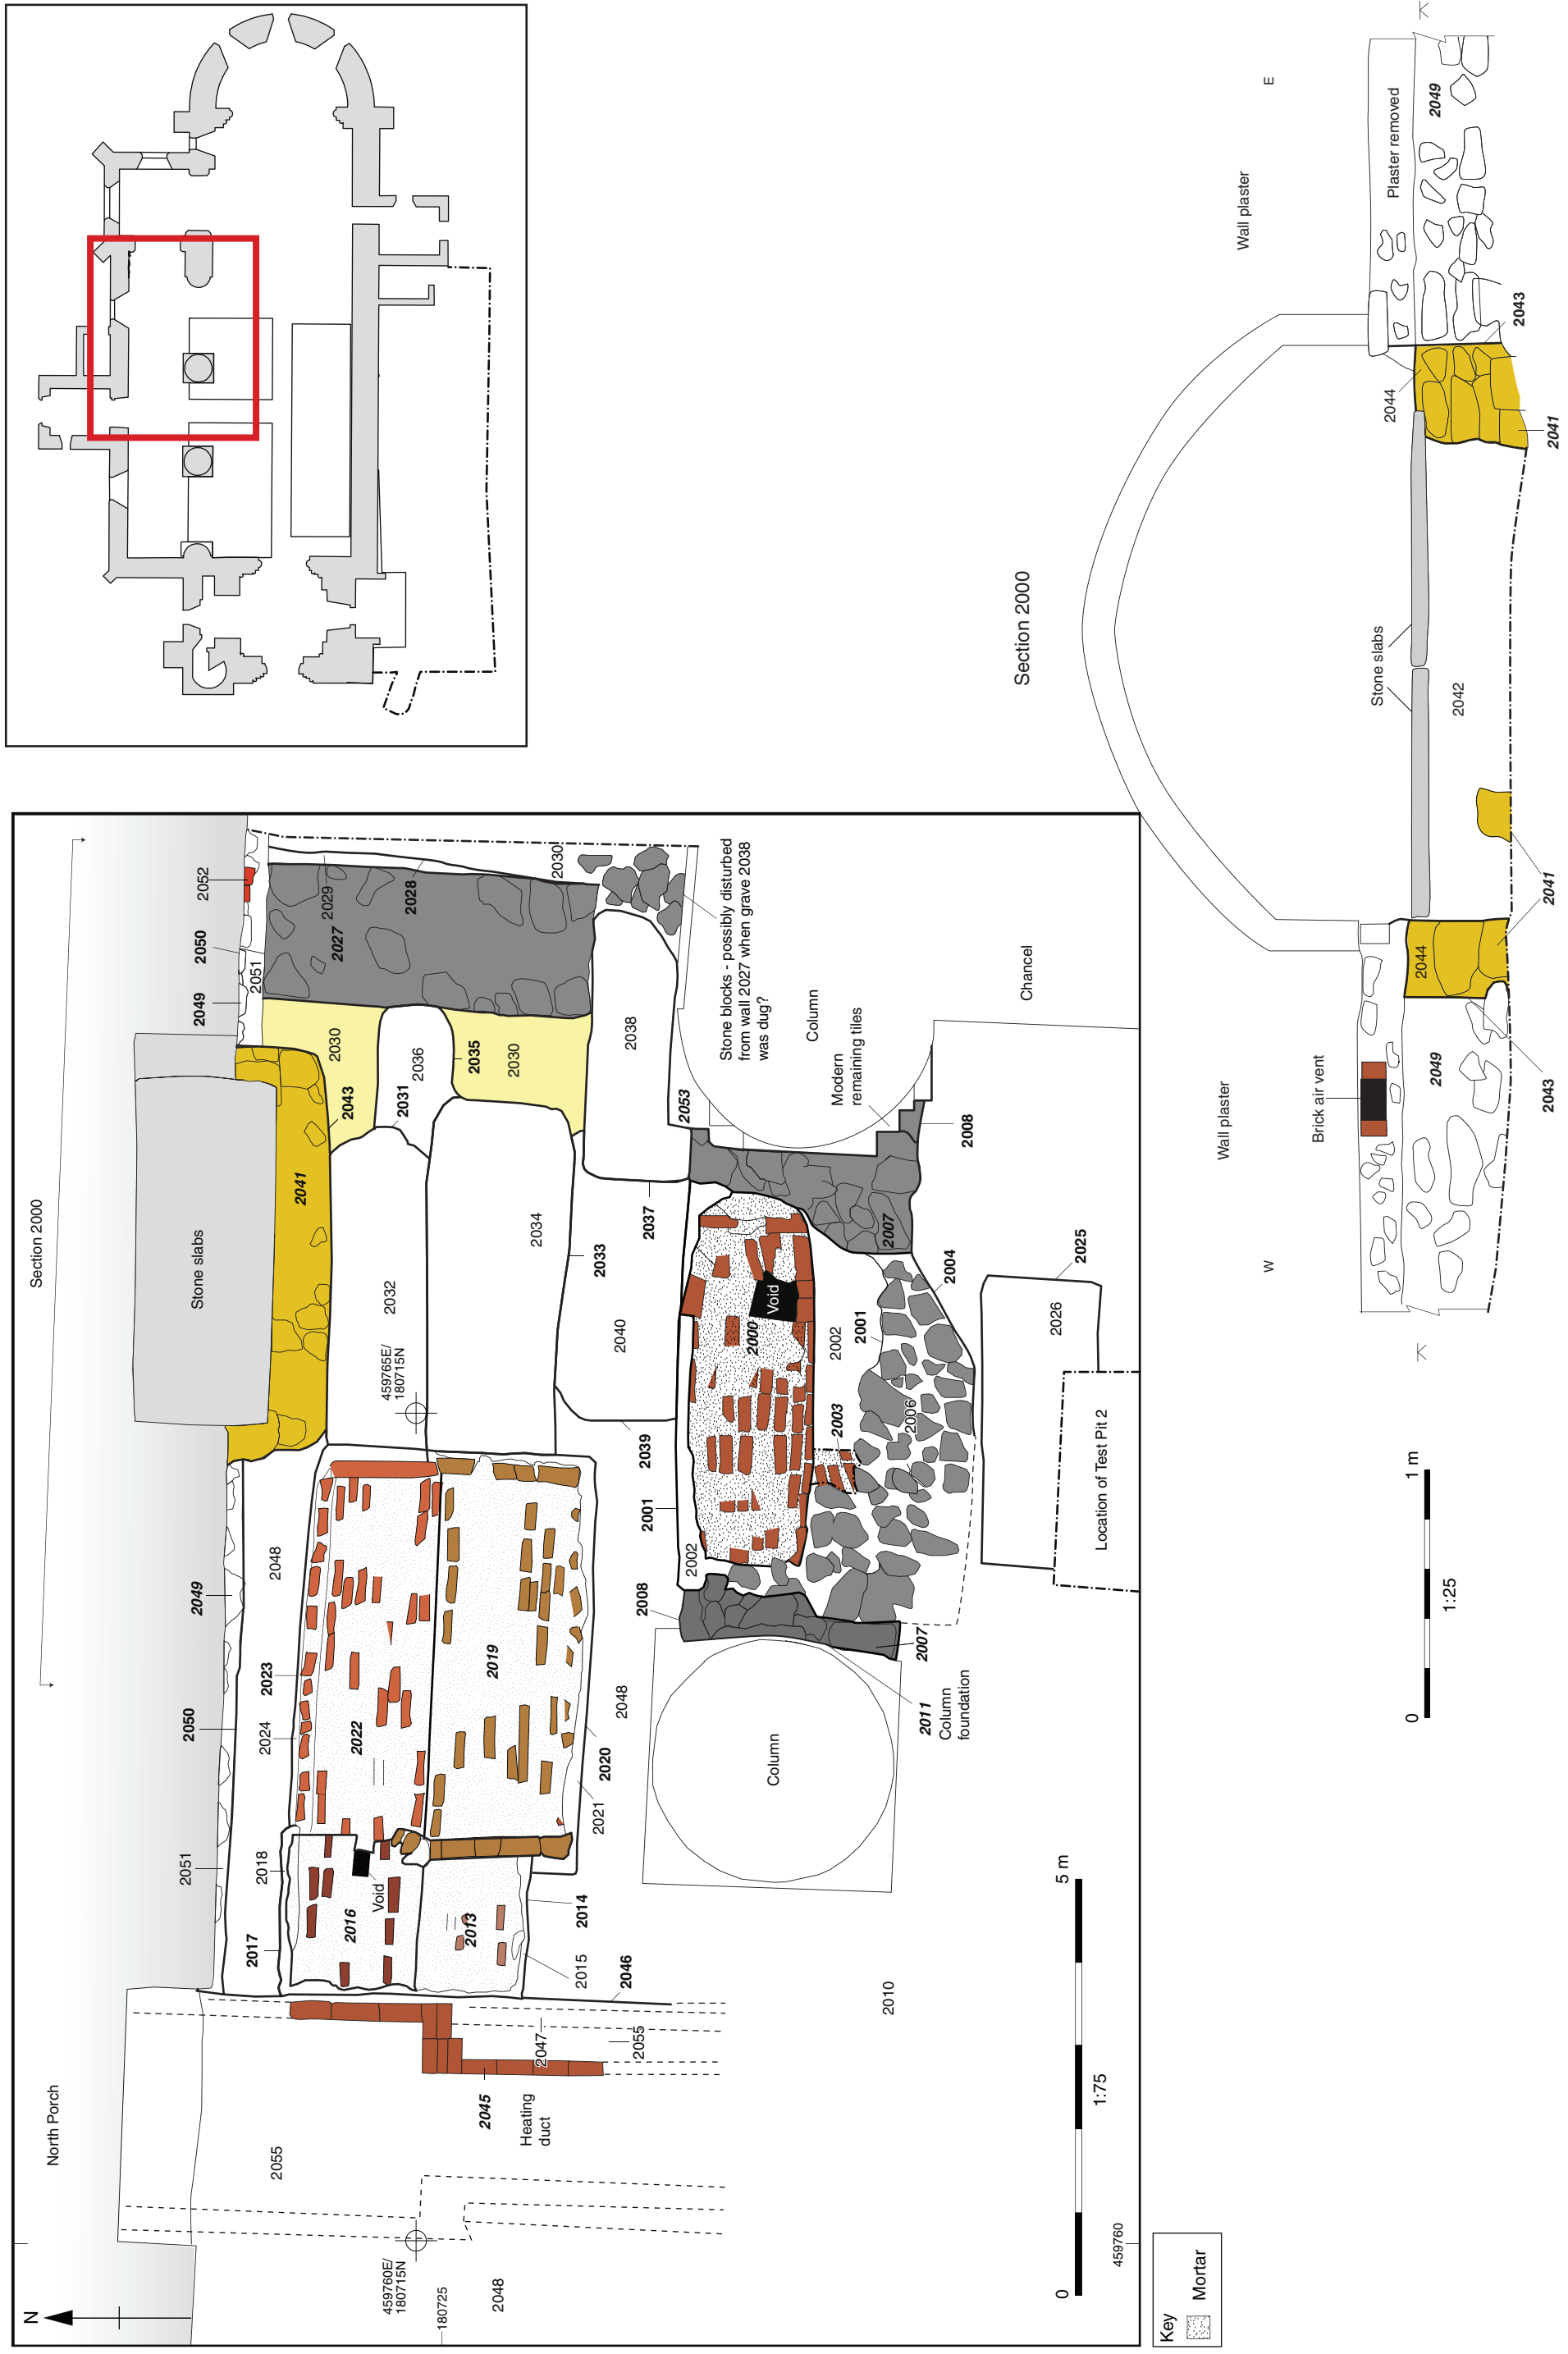
Figure 9: Plan of archaeological features encountered intramurally

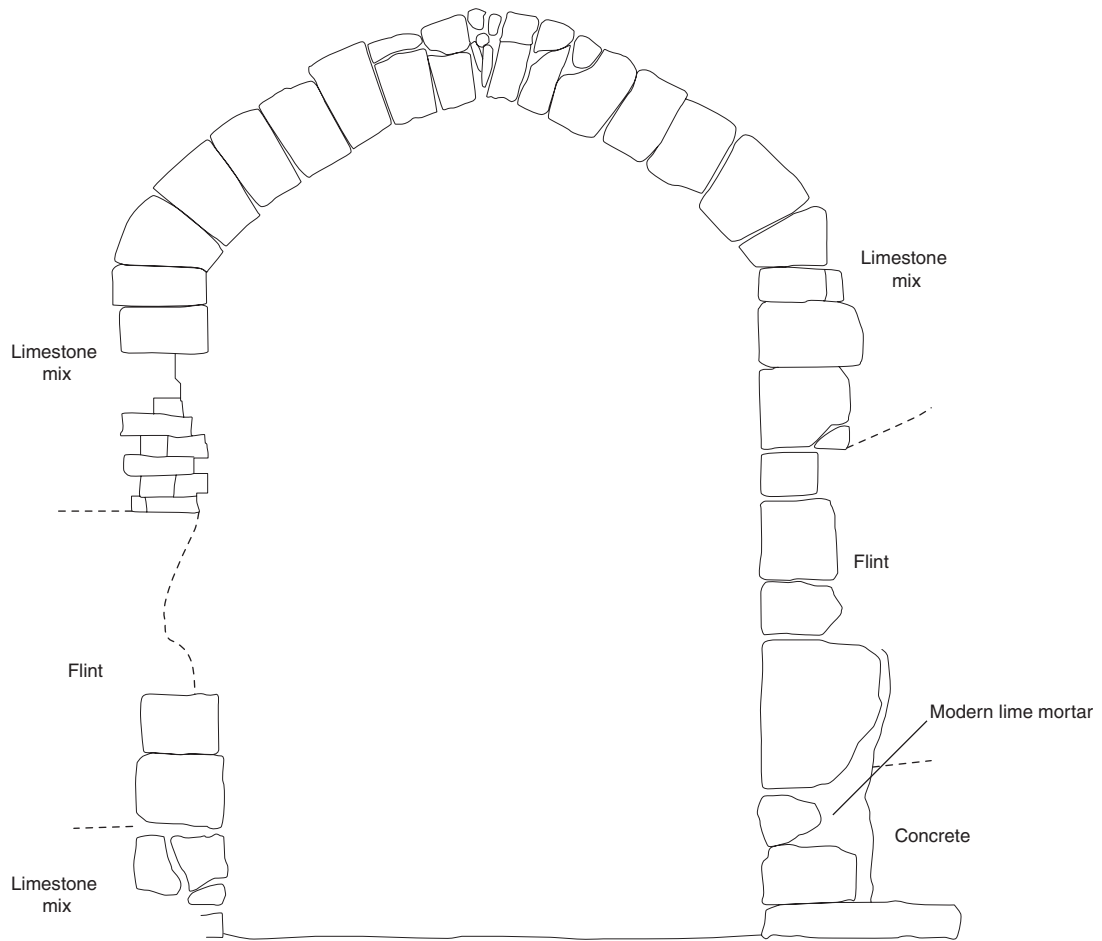
Figure 11: Nun's Doorway, South elevation after removal of render and infill

1.1.123 The Nun's doorway is most likely to be contemporary with the original church building although the arches may be later with some voussoirs replaced over time. Both arches are constructed with good quality and well worked limestone and are in relatively good condition but the doorway itself is a fairly simple false arch structure. Rendering and plaster were probably removed from the passage when the blocking was inserted sometime in the 19th century.

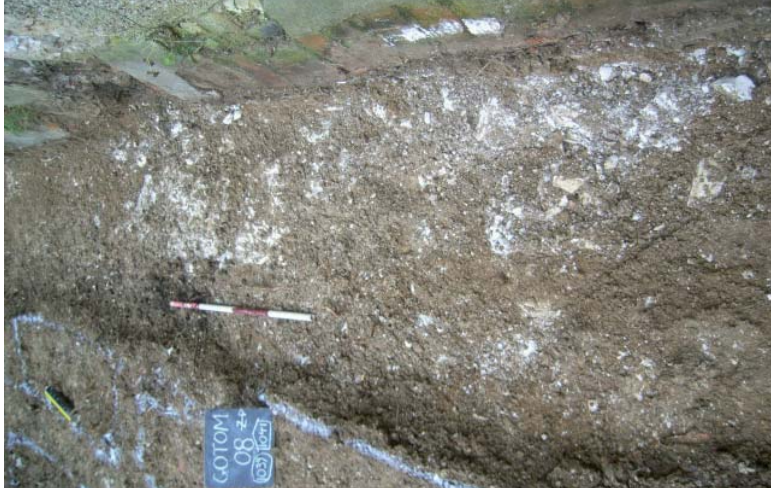
Plate 1: Remains of stone step/doorstep

1.1.124 The extramural ground reduction revealed a number of structural features relating to the priory complex. The remains of what appeared to be a step footing (1041) were revealed against the south wall of the church, in line with the Nun's doorway. Just to the east of this step, also against the south wall, was a possible robbed out column/respond base (1038). Further to the south, robbed out wall feature 1010 was revealed. The E-W orientated section of this wall seems consistent with the south wall of the north ambulatory of the cloister, found by Stone in 1892-3, and the wall found in OA's 2001 evaluation (Trench 3). Stone's plan however, shows the wall to continue westwards until reaching the eastern wall of the western Range. The extramural excavations found this not to be the case, with it clearly turning at a right angle to run N-S, roughly in line with the above mentioned column/respond base and the eastern edge of step, against the south church wall.

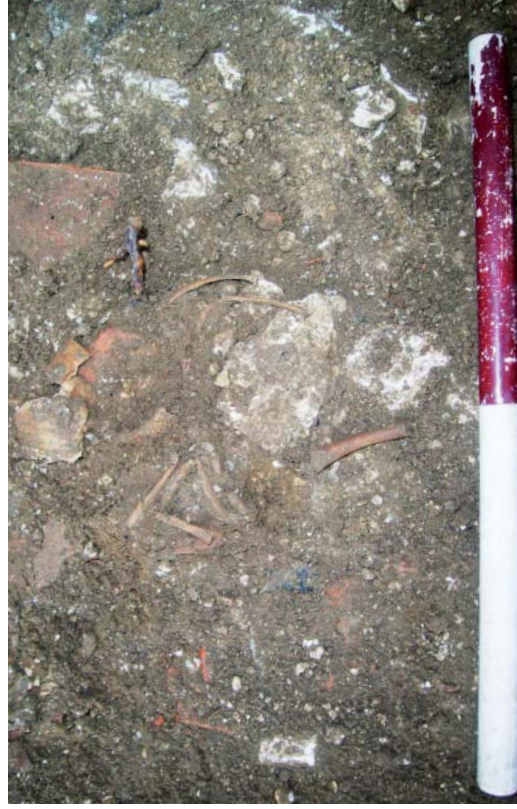
Plate 2: Neonate skeleton (1012)

1.1.130 Skeletons were revealed in just two graves. Assuming that it was a later burial added to an earlier grave plot as suggested, it is likely that neonate skeleton 1012 was buried at a relatively shallow depth because of its age and size. Infant burials are occasionally found at a shallow depth such as that excavated by Oxford Archaeology at St. Nicholas' Church, Forest Hill, Oxon in 2003. The only adult burial revealed (1082), was from the deepest part of the excavation area, in the trench excavated for the insertion of a manhole (0.9m below GL).

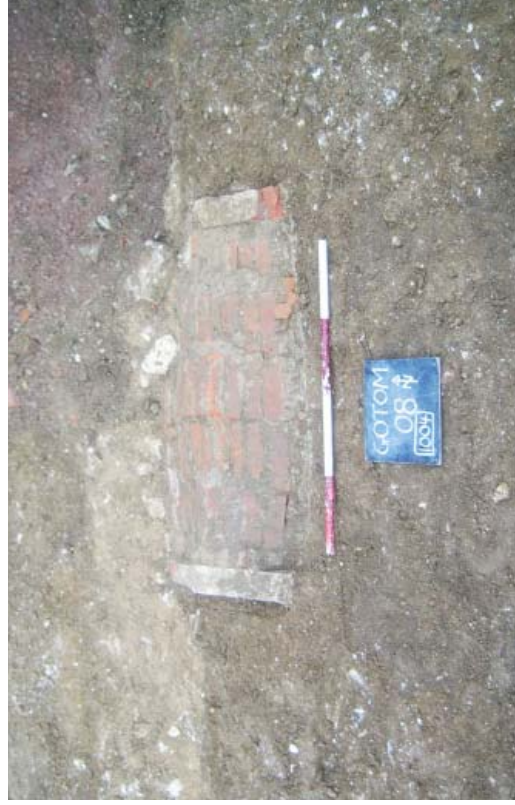
Plate 3: Brick vault

- 1.1.67 Two of the graves were found to contain brick structures. In grave 1003, a brick, barrel vaulted roof was revealed at 42.77m aOD (0.59m below GL). The bricks were hand moulded and bonded with lime mortar. This vaulted roof lay over, vertical brick walls, lining the sides of the grave, only the very upper courses of which were revealed within the impact depth. The structure (1004) (Plate 3) was single-break in shape, with a width of 0.55m at either end, and 0.72m at shoulder level. The total length of the structure was just 1.4m. These dimensions are of subadult size and its location indicates that it was the burial vault of the five infant children of the Parrott family (Grave Memorial 19) (Plate 4).

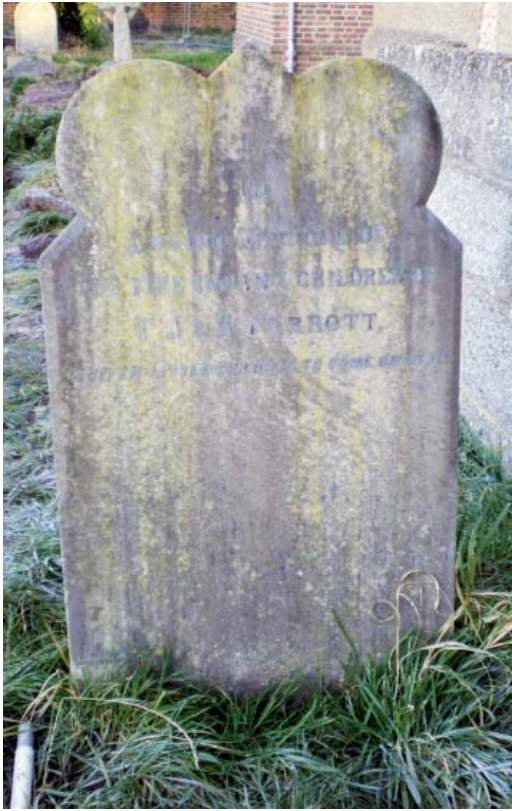
Plate 4: Grave memorial 19

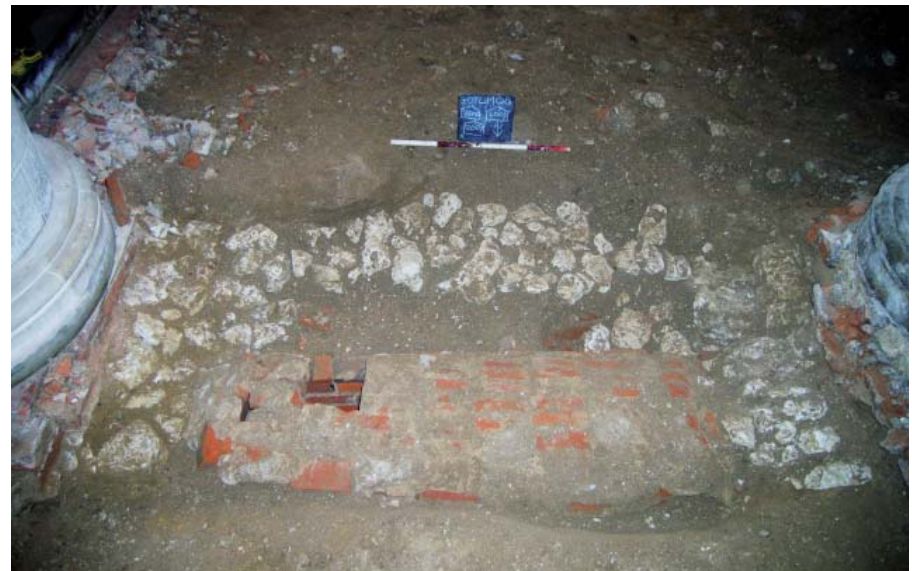
Plate 10: Intramural ground reduction (2000)(2003)(2007)

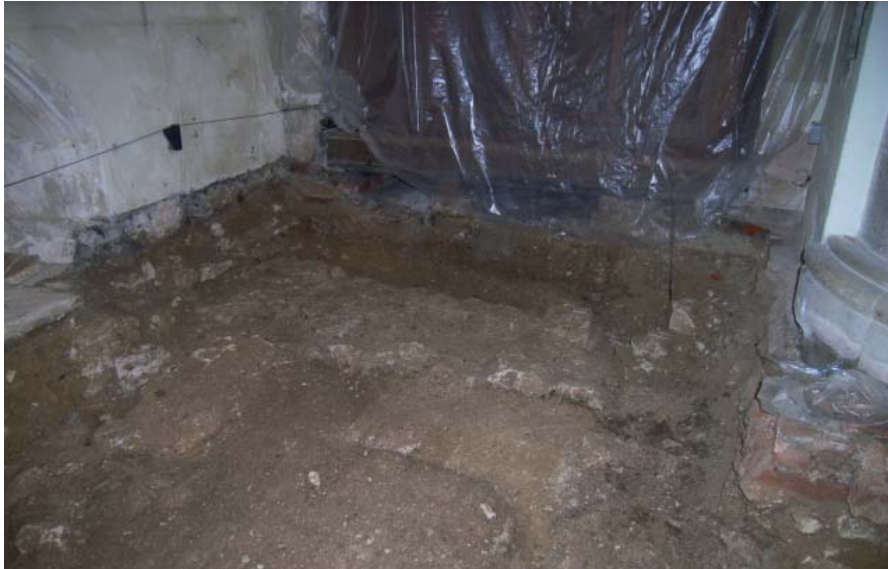
Plate 11: Footings of a wall at the east end of the north aisle (2027)

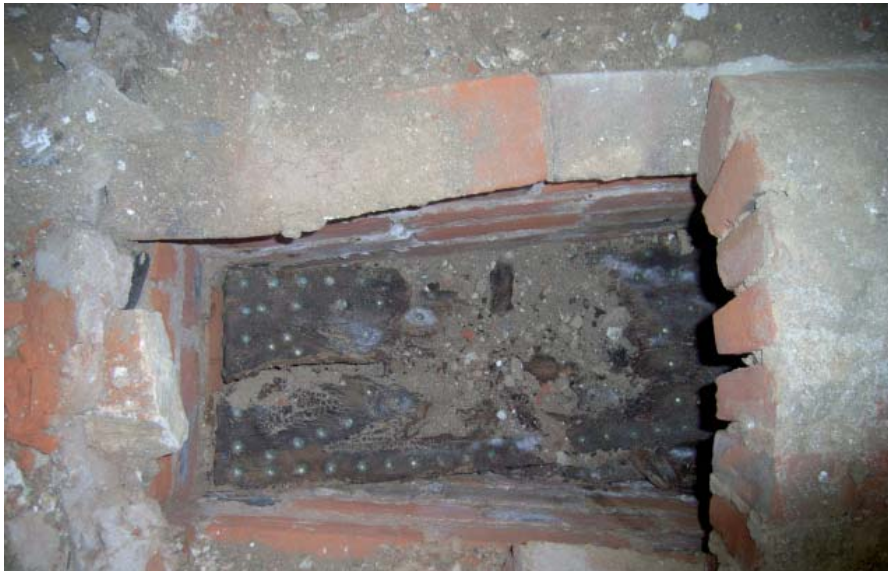
Plate 13: Brick vault (2003) truncating E-W section of original north wall (2007)

- 1.1.98 A coffin (2059) was clearly visible near the top of the vault (Plates 13 and 14). It was a wooden coffin with numerous brass upholstery studs, the pattern/arrangement of which could be clearly defined. No coffin grips (handles) or other coffin furniture were visible however. Rather than the lid of the coffin facing upwards, as would be expected, the right (southern) side panel faced upwards. It did not appear that the coffin had decomposed/collapsed to have caused this, rather the coffin appeared to

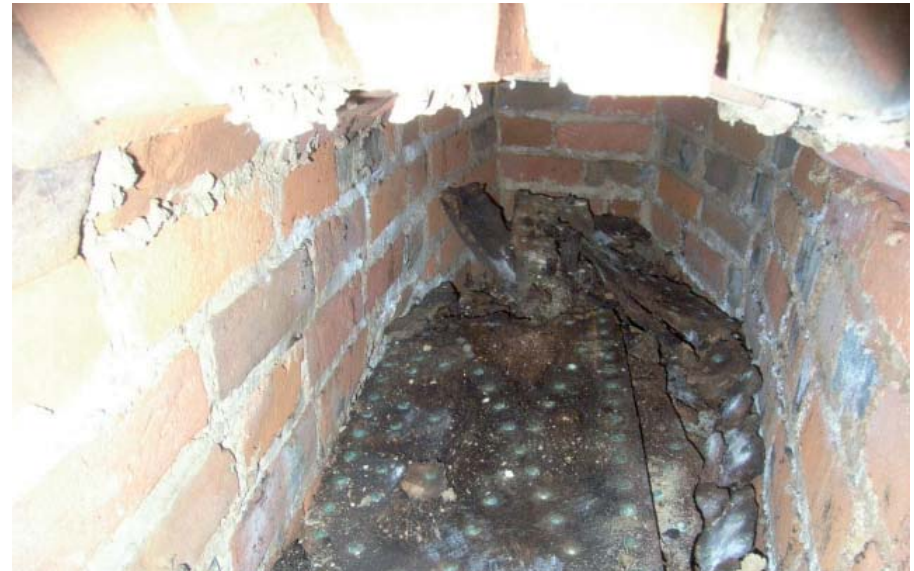
Plate 14: Coff n (2059) visible near top of vault (2000)

- 1.1.140 A fairly well preserved coffin (2059) was visible inside brick structure 2000. From the late 17th century onwards it became customary to cover the coffin with upholstery and to decorate the lid and side panels of coffins with studs and metal coffin fittings such as escutcheons, lid motifs and depositum plates (breastplates, footplates and headplates inscribed with the name of the deceased, their age, date of death and other particulars) (Litten 1991). Numerous brass upholstery studs were visible on coffin 2059 but no other metal coffin fittings were observed. It is particularly surprising that no metal grips (handles) were observed, particularly given that the side of the coffin, where grips are most commonly located, was facing upwards in the grave. Grips are usually observed on even the most low status coffins, although they may be very plain in their design. Their absence here, on a coffin within a brick structure, inside a church, thus almost certainly of a higher status individual, is probably the result of stylistic choice. A number of the coffins revealed at Hammersmith (Boston 2009) were also found without grips.

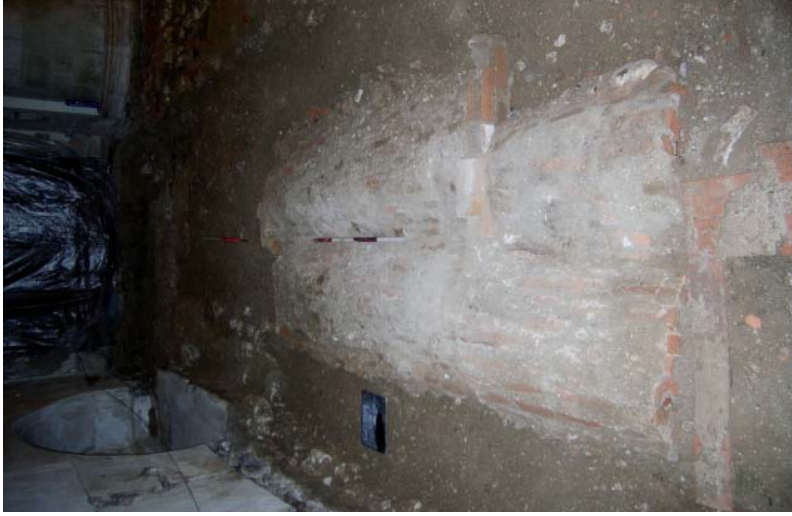
Plate 15: Brick lined vaults revealed within north wall

- 1.1.106 The western ends of vaults 2016 and 2013 were truncated by the construction cut (2046) for brick heating duct 2045 (Plate 15). The duct, constructed of machine made bricks measuring 230 x 110 x 730mm, ran below the N-S walkway from the north porch, into the duct (probably late 19<sup>th</sup> century) running below the central aisle walkway (407), revealed in test pit 4. The large cast iron heating tank relating to this duct was revealed under the walkway of the western end of the central aisle (Figure 2). The backfill (2047) of the construction cut (2046) comprised a loose, light brown silt-clay with chalk and CBM fragments. The heating duct itself was also found to be backfilled (late 19th-early 20th century), both along the N-S walkway and the central aisle. The backfill (2055) was a loose, dark grey-brown silt-clay with frequent chalk and CBM inclusions.

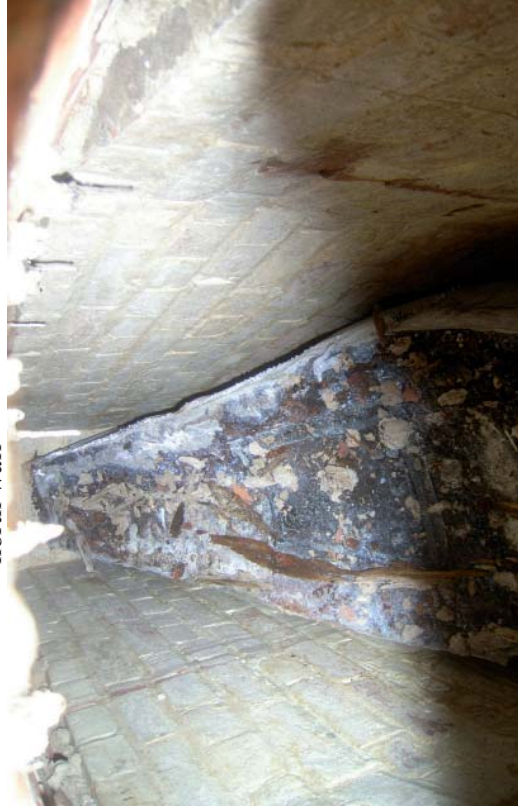
Plate 16: Coffin (2063) visible inside vault (2060)

- 1.1.141 Another well preserved coffin (2063) was observed within later vault 2060. The main outer surface appeared to be made from metal, possibly lead, although fragments of wood and upholstery studs on the surface of the metal were perhaps indicative that there had originally been an outer wooden case. Throughout much of the 18th century, the typical coffin for burial vaults and brick-lined graves was a triple shell coffin.

These comprised an inner elm coffin, a lead shell with a depositum plate, and an outer wooden case covered with velvet (usually black or red), and with gilt and upholstery studs, and grips and grip plates amongst other metal motifs (Litten 1991, 100). Although the structure is thought to be slightly later in date (19th century), it is possible that coffin 2063 was of this type. It is perhaps odd that no coffin furniture (grips, grip plates etc.) was observed, but it should be reiterated here that the other coffin (2059) was also without metal fittings, other than upholstery studs.

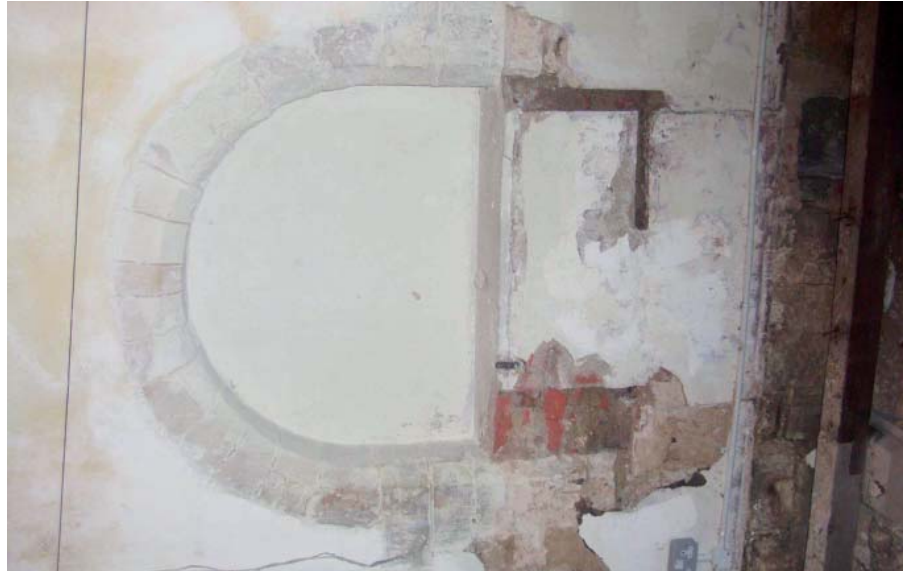
Plate 19: Nun's doorway before unblocking;  
interior

- 1.1.49 The Nun's doorway is located in the western half of the south façade. It consists of a round arch on the interior (Plate 19) and a pointed arch on the exterior which has been rendered over. At each side of the doorway, the arches are made with well worked white limestone voussoirs, although they do not have a key-stone. The voussoirs are not all the same size but they do not look reused either as they fit perfectly to compose the arch's radius of curvature. However, some are quite worn out while others seem to be preserved in very good condition. Presumably those in better condition are secondary replacements. They have joints of about 0.5-1cm between them which seem to be in some way decorative (they also appear in windows and pillars in the church). The arch inside is shorter than that one outside so it has a spandrel above to fill the space between the structure and the ceiling that covers the passageway. The jambs are made of a rougher and light beige limestone but the western jamb of the outer arch is missing. They are alternating long and short blocks. The threshold seems to be preserved in situ. It appears that the doorway is made up of different types of stone for different elements rather than featuring two different phases. It is covered by the render outside and is partially bricked inside as the upper part (the arch feature) is used as some sort of vaulted niche.

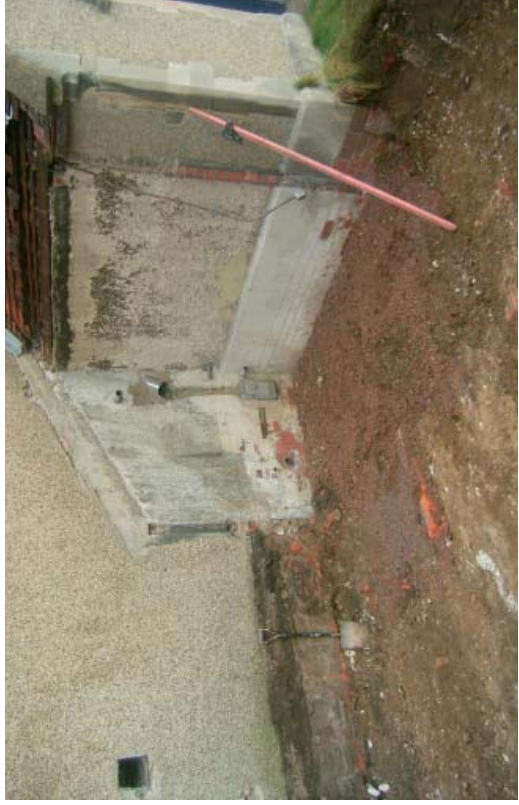
Plate 21: South wall of church after removal of boiler room

1.1.115 Once the boiler room structure was knocked down, a footprint of modern bricks remained protruding from the floor so the elevations were likely to be built with the same material (Plate 21). The roof has left a mark on the wall where the render is missing and where we can see that it is up to 4cm thick. This, along with the fact that the render was on the boiler's room's walls as well, makes us think that the render is

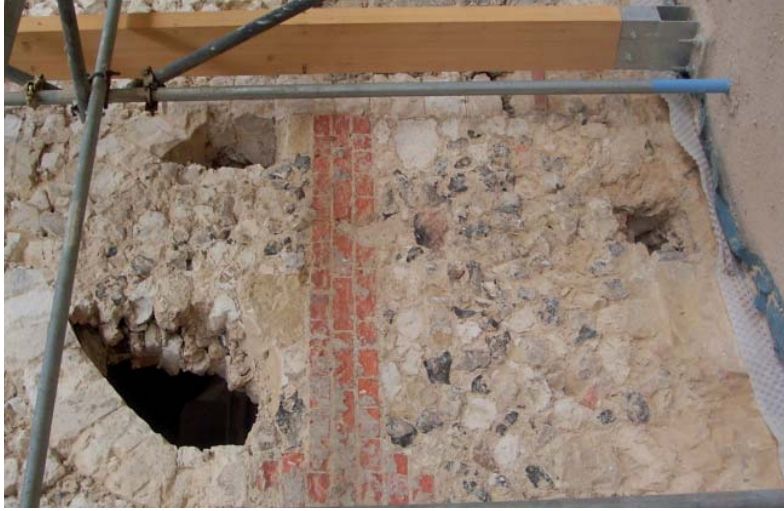
Plate 22: South elevation showing exterior of Nun's doorway after removal of render

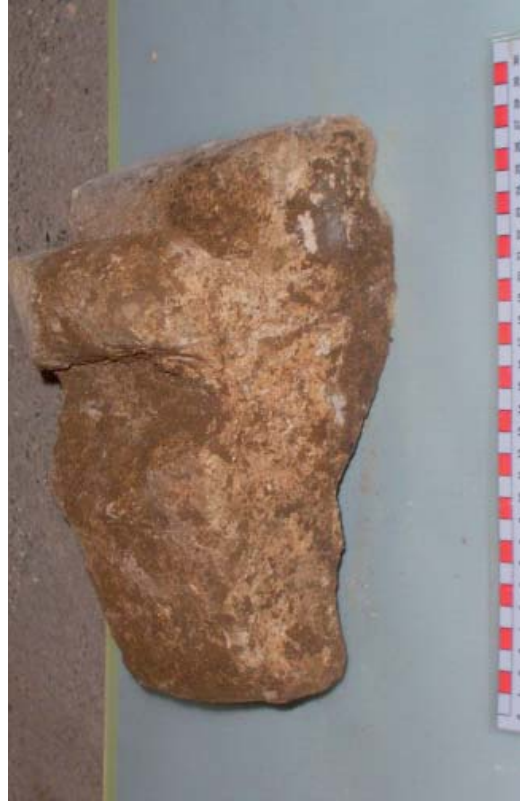
Plate 23: Moulded stone from infill of Nun's doorway

1.1.118 Underneath this vaulted niche, the blocking is filled with rubble masonry and a pale, very earthy lime mortar. Most of the rubble is made up of irregular stones of different sizes. There are also frequent broken red bricks and tiles. Within this rubble there were three moulded stones. Two of these appeared to be door jambs (although they are unlike the jambs of the nuns doorway) and the third appears to be part of a string course or cornice (Plate 23).

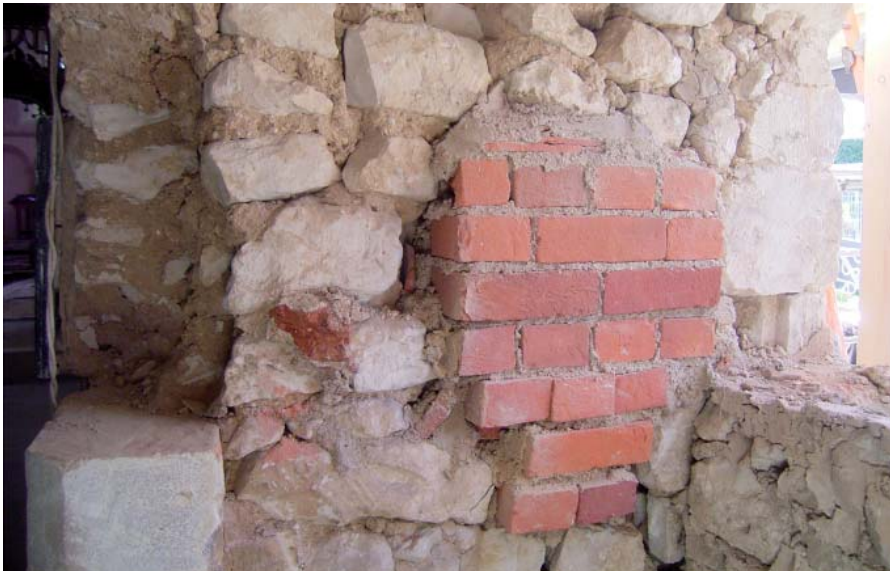
Plate 25: West wall of Nun's doorway passage showing red brick repair

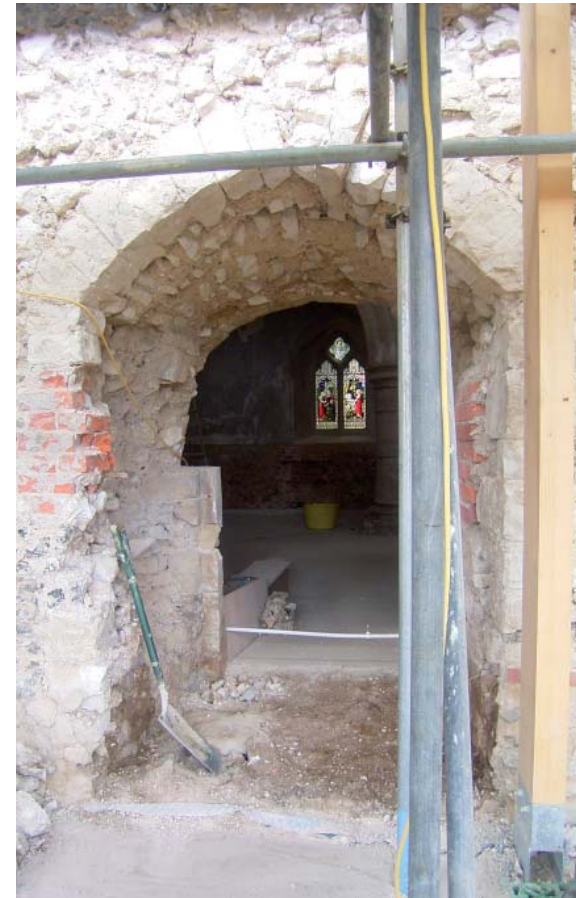
Plate 26.: South elevation showing Nun's doorway after unblocking

1.1.120 On the east side of the passage, there is the remains of some compact, grey render low down on the wall. Some patches also remain on the lower eastern impost of the interior arch. With the exception of this, all plaster and render seems to have been removed from the passage and the soffit before it was infilled. The wall is missing at both sides of the passageway and deep gaps feature. The eastern wall has been roughly filled with red bricks (Plate 26).
