Drainage Repairs
Old Abingdon
Road

Oxford

**Archaeological
Watching Brief Report**

Archaeological Watching Brief Report

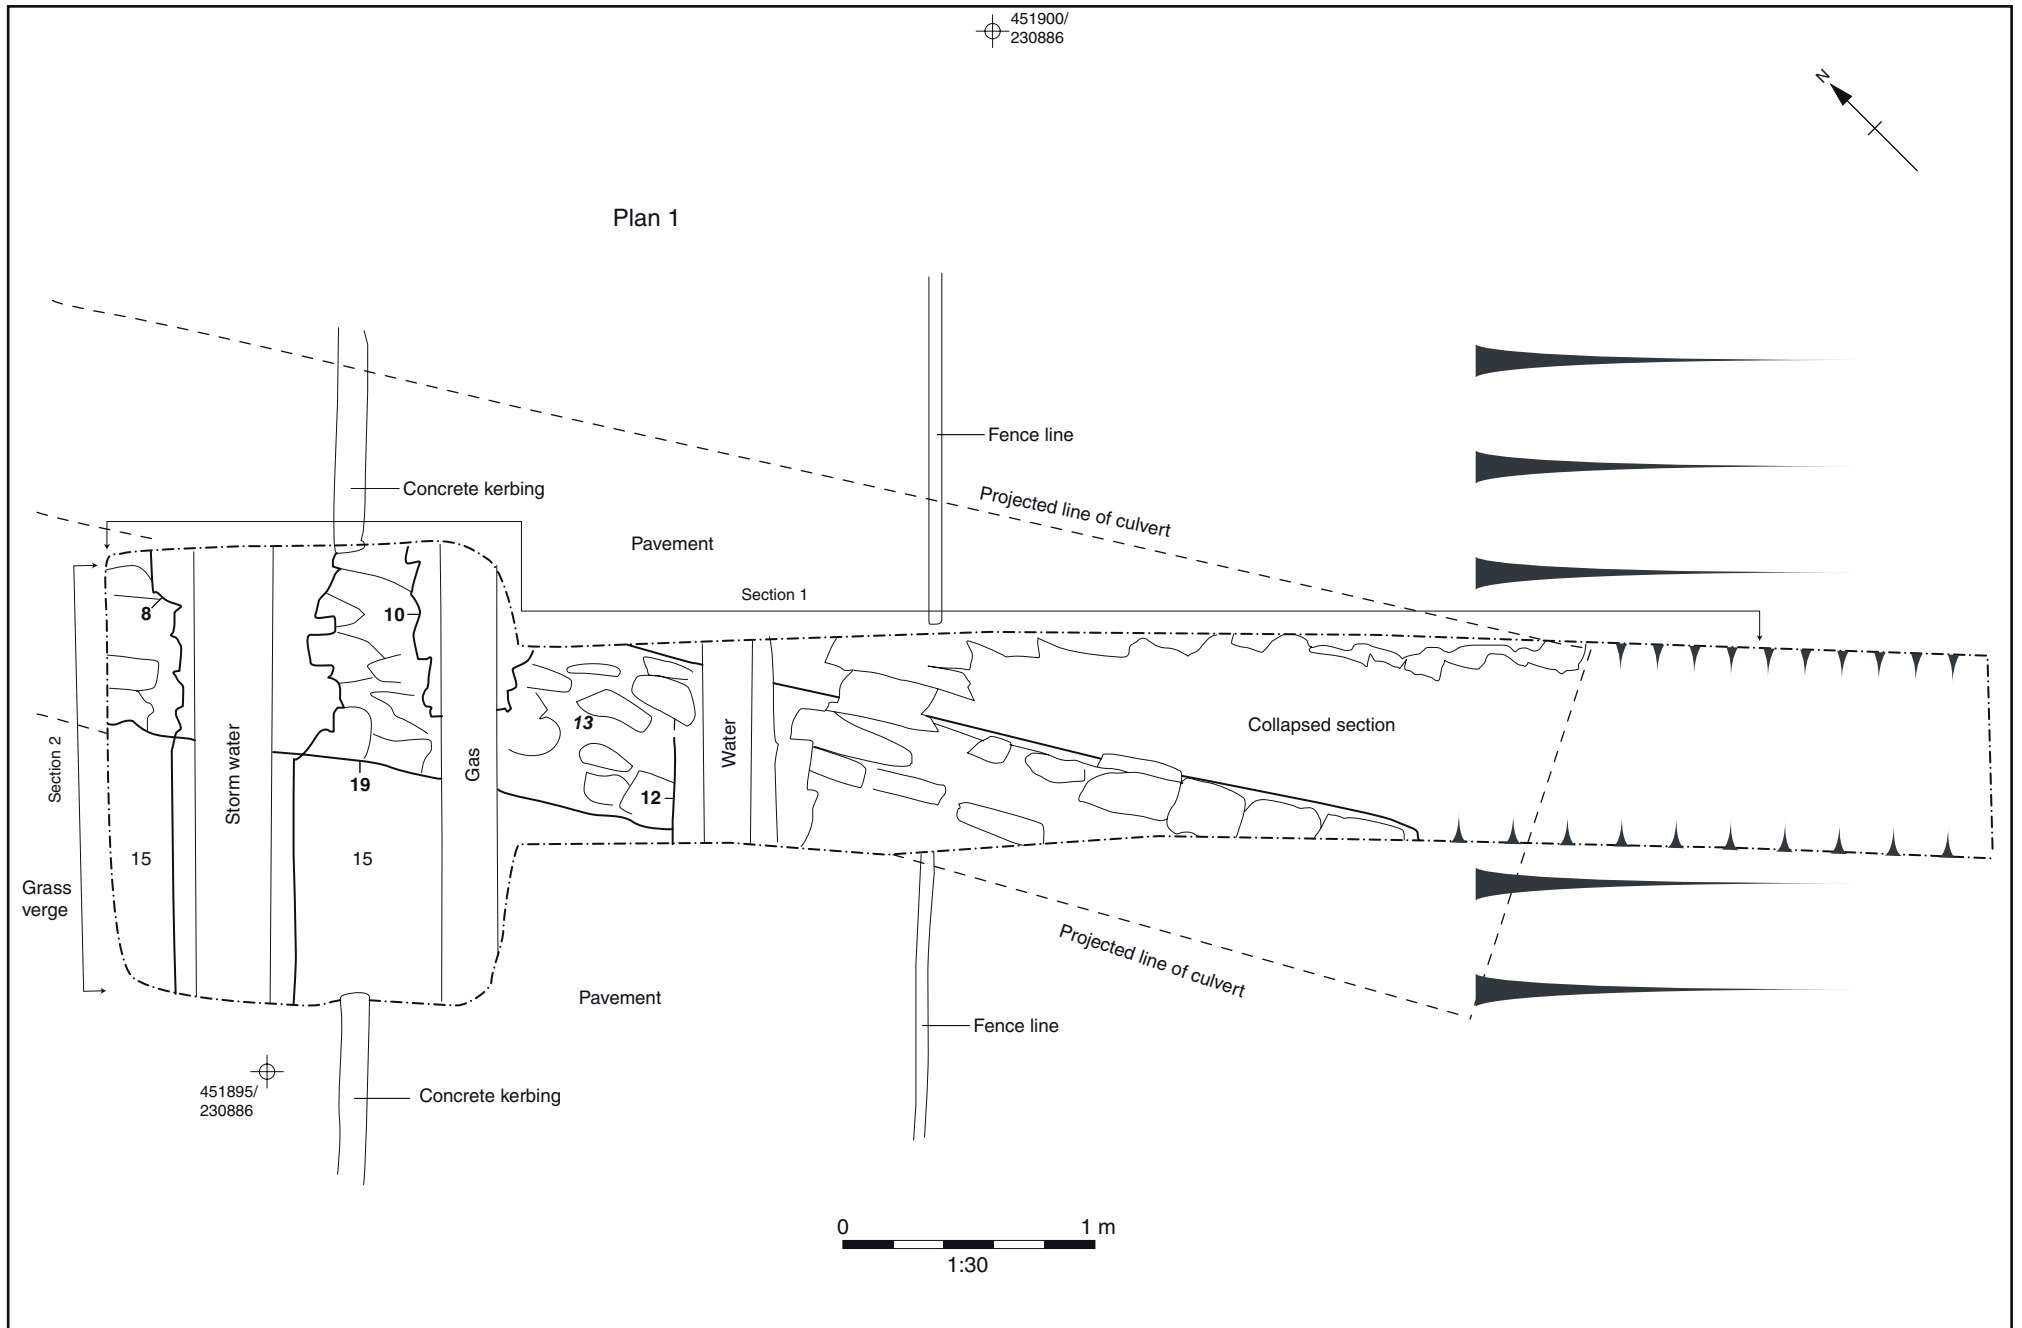
Figure 2: Site plan

- 3.1.2 At the deepest point of the excavations, 1.7m below the level of the pavement, a layer of fine dark grey clayey silts was encountered (15) (Fig. 2 and Fig. 3, Sections 1 and 2). Observed within this deposit were a number of irregular blocks of ragstone up to 0.3m x 0.2m x 0.15m in size. The placing of these stones appeared to be random with no obvious structure. This layer had been cut by the construction trench for the standing culvert (19). The limited depth of excavation did not exposure the full extent of this feature, but it is probable that the cut was in excess of 0.5m in depth and measured 2m wide.

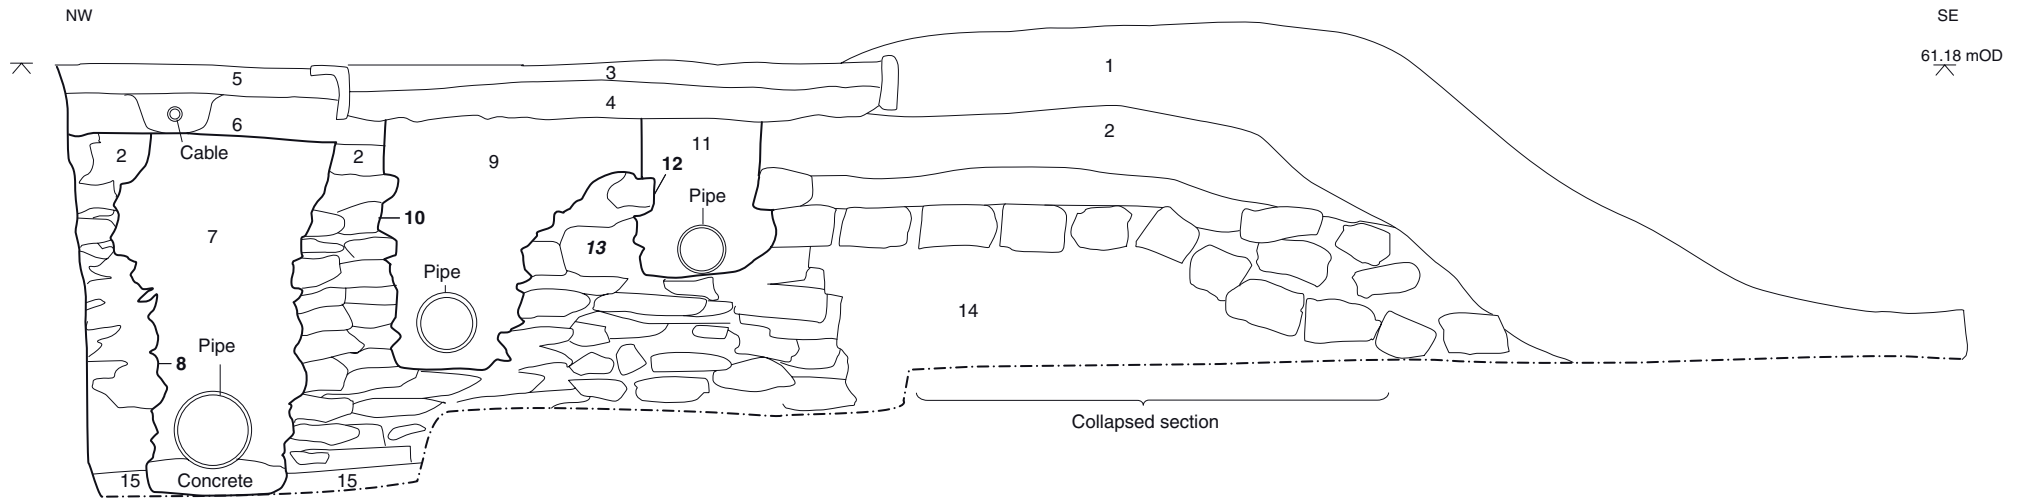
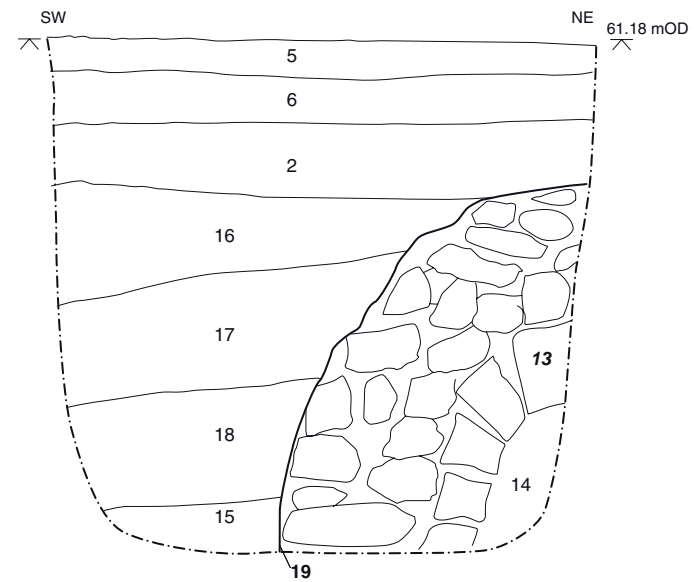
Figure 3: Sections

- 3.1.3 Built within the construction cut was a barrel arched stone culvert or covered channel. The pink tinged limestone blocks forming the arch had been well dressed, but had no surface marks evident. These stones measured up to 0.4m x 0.25m x 0.18m in size. The stones had been tapered forming a semi-circular arch bonded with an orange-brown lime mortar. Similarly dressed and sized stones had been used to construct the interior faces of the channel. The remainder of the construction cut had been filled with bulk masonry formed using roughly dressed/ irregular blocks bonded with a coarse

- 3.1.5 Butting up to the exterior of the culvert was a sequence of deposits of made ground (Section 2). The earliest deposit consisted of a compacted layer of medium sized ragstone blocks within a greyish orange-brown clayey silt matrix (18). This measured approximately 0.3m in depth. Above 18 was a 0.4m deep layer of grey-brown sandy clay silt (17). This also appeared to have been compacted and contained sand and gravels as well as medium sized stones.

- 3.1.6 Finishing level with the top of the culvert was a layer of orange brown clayey silt mixed with sands, gravel and small to medium sized stones and measuring up to 0.4m in depth (16).

- 3.1.7 Above 16, and sealing the top of the culvert, was a layer of reddish brown silty clay (2). This were more friable in nature and contained smaller stones and gravel. Measuring on average 0.2m in depth this deposit tapered away at the southern end of the trench disappearing into the collapsed section of the culvert. None of this sequence of deposits produced any dating evidence.

- 3.1.8 Truncating the made ground and the structure of the culvert were a number of modern service trenches. The deepest of these was the trench for the storm water drain (8). This ran parallel to Old Abingdon Road and measured 1.5m in depth and 0.6m wide. This had been excavated through the western side of the culvert severely damaging/truncating the fabric of the culvert. It was unclear if the drain continued thought the eastern side of the culvert or if it had originally discharged into it. The storm drain consisted of a 0.3m diameter salt glazed pipe laid on a concrete bed. The trench had been backfilled with a mixture of redeposited materials including stone blocks (7).

- 3.1.9 South of the storm drain and also running parallel to Old Abingdon Road was a 1m deep and 0.55m wide trench containing a gas main (10). This had truncated the top 0.8m depth of the culvert and again had been backfilled with redeposited material (9).

- 3.1.10 South of the gas main and running along the edge of the pavement was a water main. This had been laid within a 0.6m deep and 0.5m wide trench (12). The trench had truncated the top of the arching within the culvert. Backfilling the trench was a grey-brown silty clay (11).

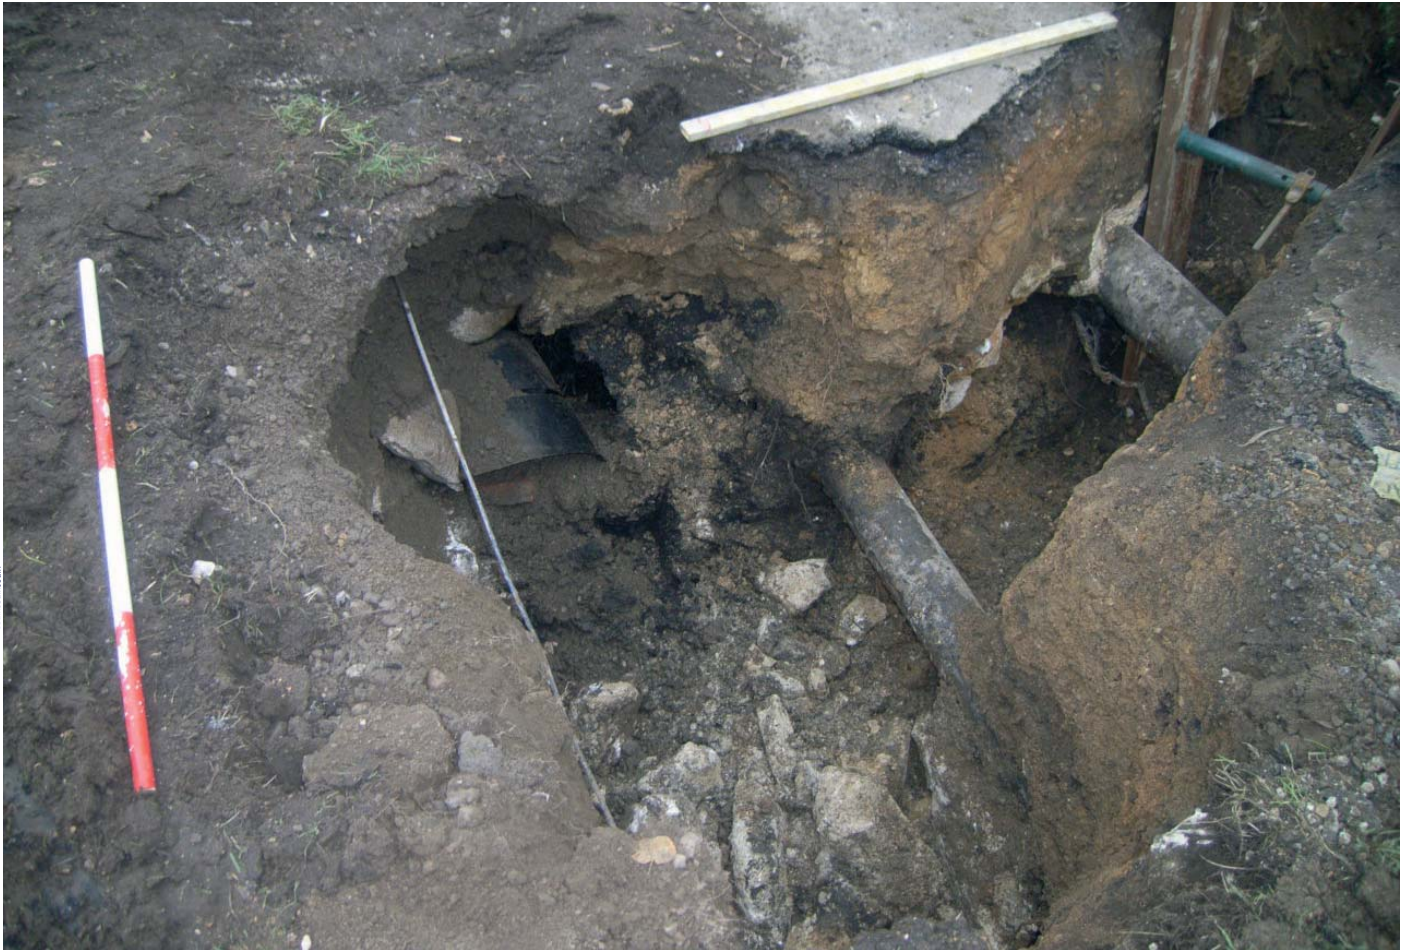
Plate 1: North end of section 1

- 3.1.4 The structure was aligned roughly north-south, running under the present course of Old Abingdon Road. The southern extent of the structure had collapsed forming an irregular mass of loose masonry which had apparently been used as the foundations for the corner of the boundary wall along the eastern edge of Red Cottage. It was unclear if the end of the structure had been decoratively finished or if there had been any abutments present. Completely filling the interior of the culvert was a friable very dark grey/black silt (14). This deposit contained some organic debris such as twigs. Some plastic was observed within the top of the context, but this was probably deposited by later, modern, intrusions. It is probable that the silting occurred following the collapse/blocking of the end of the culvert.

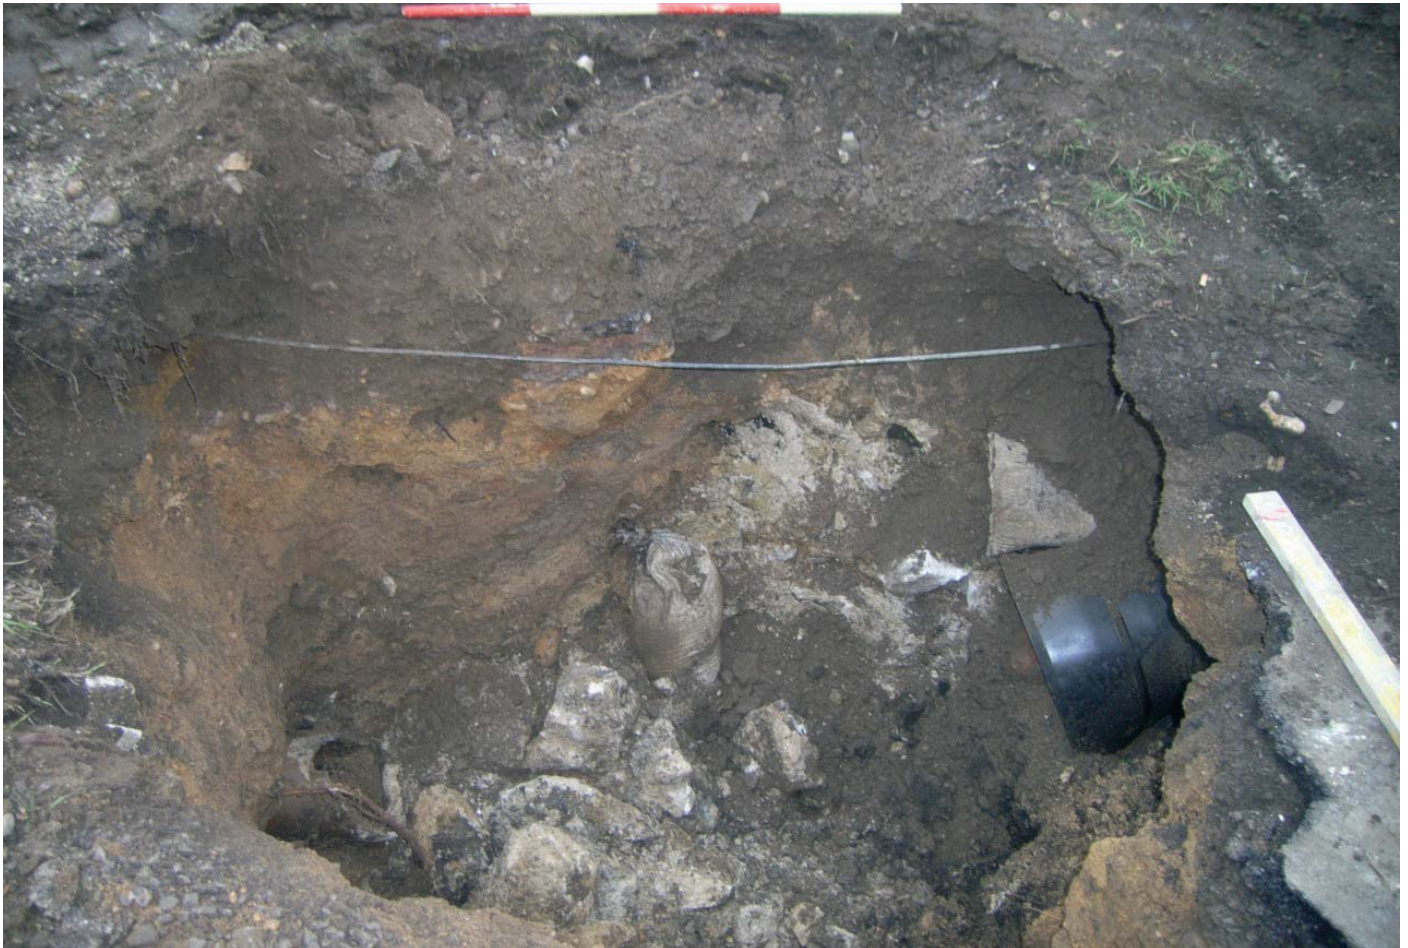
Plate 2: Section 2

- 4.1.8 The absence of any earlier road surface exposed within Section 2 would also suggest that the culvert exposed was outside the line of the existing causeway.
