## St Andrew's Church, Wimpole, Cambridgeshire

## **CCC AFU Report Number 838**

**St Andrew's Church, Wimpole,  
Cambridgeshire**

### **An Archaeological Watching Brief**

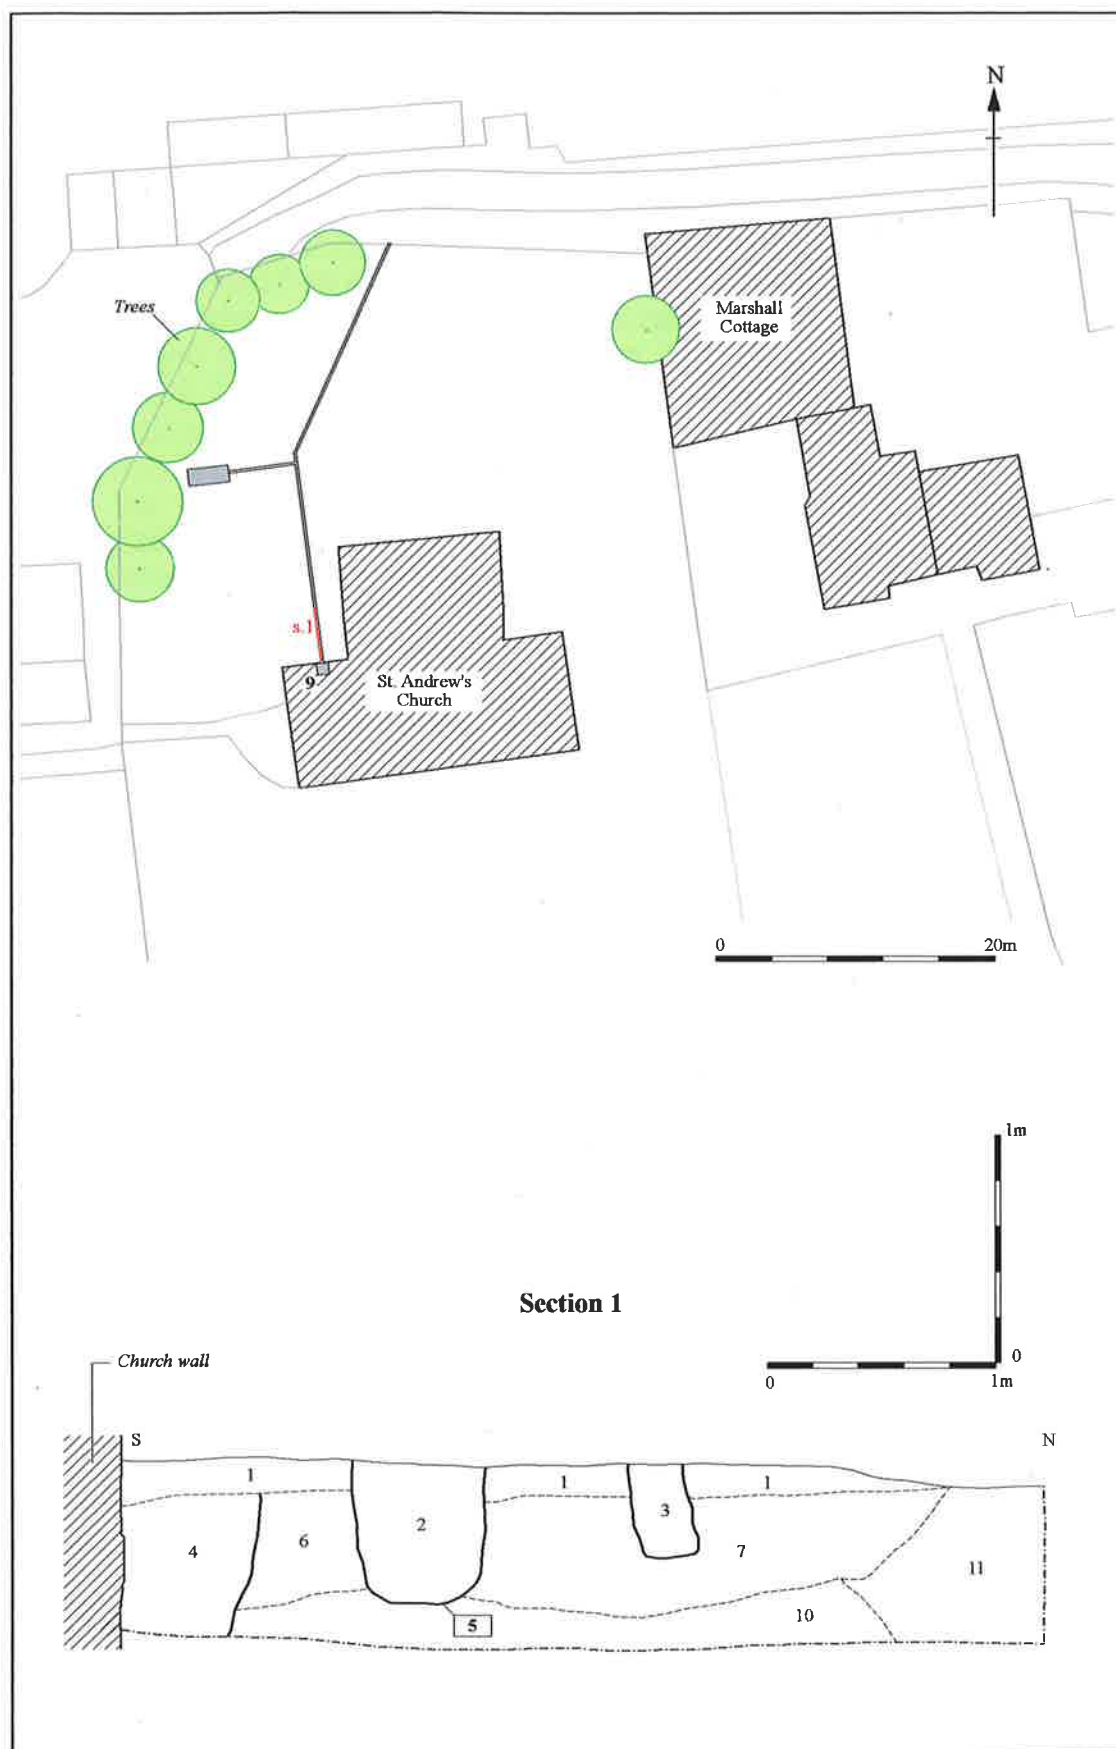
Figure 2: Site plan and section drawing

The 0.30m wide pipe trench ran for nearly 25m across the churchyard to a depth of 0.75m. The natural subsoil was not uncovered within the trench. A possible medieval layer (10; Fig.2) was uncovered near the church running for about 3m and more than 0.3m deep. This layer was cut by the construction trench (5) for the 1749 church. Within the construction trench was a light grey brown silty sandy clay with a few brick and tile pieces. The 1749 wall foundations continued down to more than 0.75m below the modern ground level and consisted of a mixture of limestone and clunch stone courses as well as a single reused medieval floor tile course, all set in lime mortar.

In the majority of the trench was a thick homogenous post-medieval burial deposit (11), presumably representing intercutting 19th- and 20th-century burials. 'Layer' (11) was more than 0.50m thick and consisted of a light to mid grey brown silty sand with a little clay as well as a few small chalk pieces and the occasional human bone fragment (not kept; see above). Presumably the articulated burials were below the level of the trench. Near the church this post-medieval burial 'layer' was overlain by modern layers (6 and 7; Fig. 2), which were themselves sealed by a 0.25m thick topsoil layer (1). This layer was cut by modern service pipes (2 and 3).

The 0.7m<sup>2</sup> trench excavated within the church was excavated to a depth of c.1.25m below the ground level. Within the trench was a single layer (9) which continued below the level of the trench and consisted of a mixture of mid brown silty clay with some lime mortar pieces (60%+ of the fill) and stone rubble. The stone consisted largely of small clunch pieces (eight of the larger pieces with worked faces were kept) as well as the occasional limestone piece. There was also a fragment of vessel glass (near the base of the excavated layer) and a clay pipe fragment.

The 0.7m<sup>2</sup> trench within the present church has shown that the 1749 rebuilding was built on top of a large thick layer of rubble (9) largely from the former medieval church. This use of the rubble explains why the 1749 rebuilding is c.0.60m higher than the 14th-century Chicheley Chapel. It is possible that medieval features survive below this deposit.

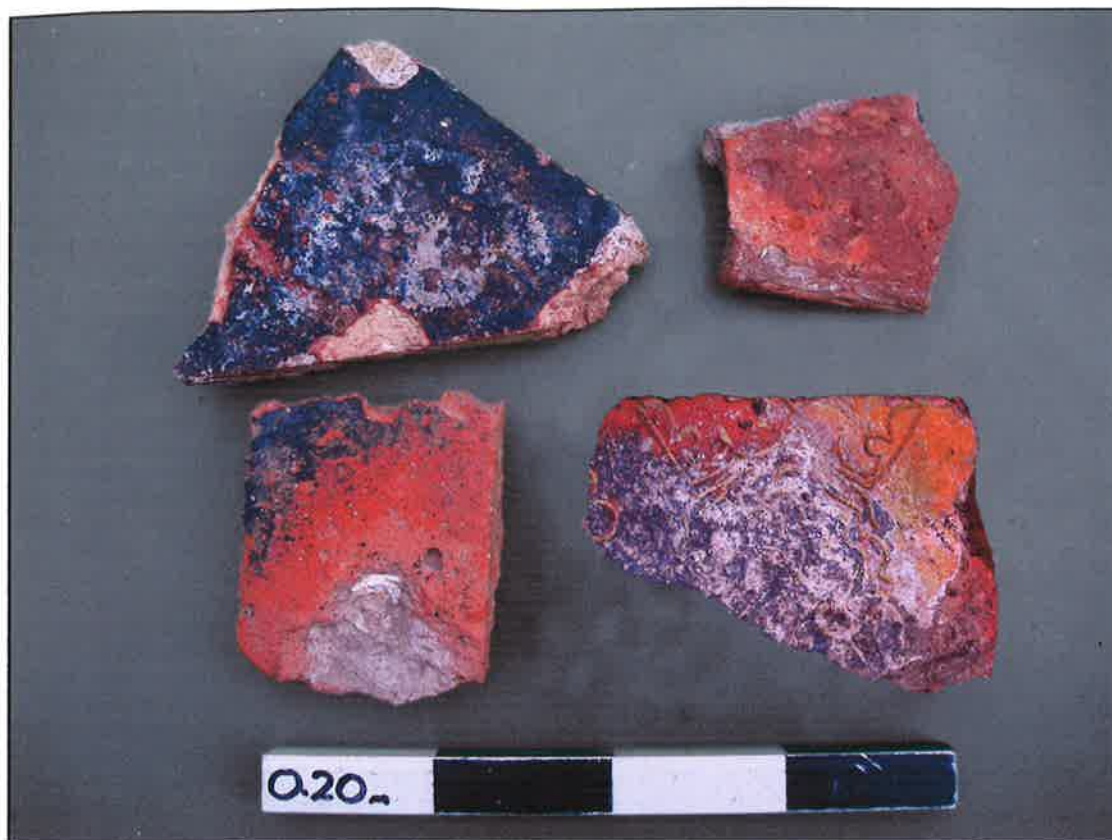
*Plate 2: Medieval and late medieval floor tiles from 1749 construction trench*

Four tile fragments were recovered from context 4, two from the high medieval period and two late medieval (Plate 2). These comprised:

- 1) Significant part of a decorated stamp designed tile (11.5cm+ long x 8cm+ wide) and 2.4cm thick. Edges very slightly chamfered. A mid orange grey fabric, full of voids due to leaching or burning spherical calcareous inclusions. Probably not a local fabric. The tile is heraldic with a king's head and tripartite crown. Filled generally with a non-specific white slip and then a clear glaze over the top to give a yellow finish. 13th century to 14th century (probably the latter).

- 2) Fragment of tile (8cm+ long x 6.3cm+ wide) and 1.8cm thick. Moderately chamfered. Mid orange/grey fabric which was poorly mixed and slightly calcareous. Origin unknown. Lost surface. Probably before 1400.

- 3) Most of a triangular tile (19.5cm x 14.4cm x 13.4cm) and 2.5cm thick. Edges slightly chamfered. It is a white clay fabric made locally in the Cambridgeshire/Fenland area. Mosaic tile with a single colour. There is a red slip with a green glaze over the top to give a dark green appearance. Late medieval, c.15th century- perhaps into the 16th century.

- 4) Part of a rectangular tile (8cm+ long x 7cm wide) and 2.4cm thick. Edges slightly chamfered. Same fabric as 3) but more orange. Dark green glaze (no red slip) as darker fabric colouration meant that a red slip was not needed to give the dark green appearance. Late medieval.

From the 1749 construction trench (5) in the trench outside the church came red ceramic roof tile, implying at least part of the former medieval church was probably roofed in this material. The four floor tile fragments included two fragments of high medieval and two late medieval floor tiles, showing that other parts of the medieval church were floored in ceramic tile from at least the 14th century.

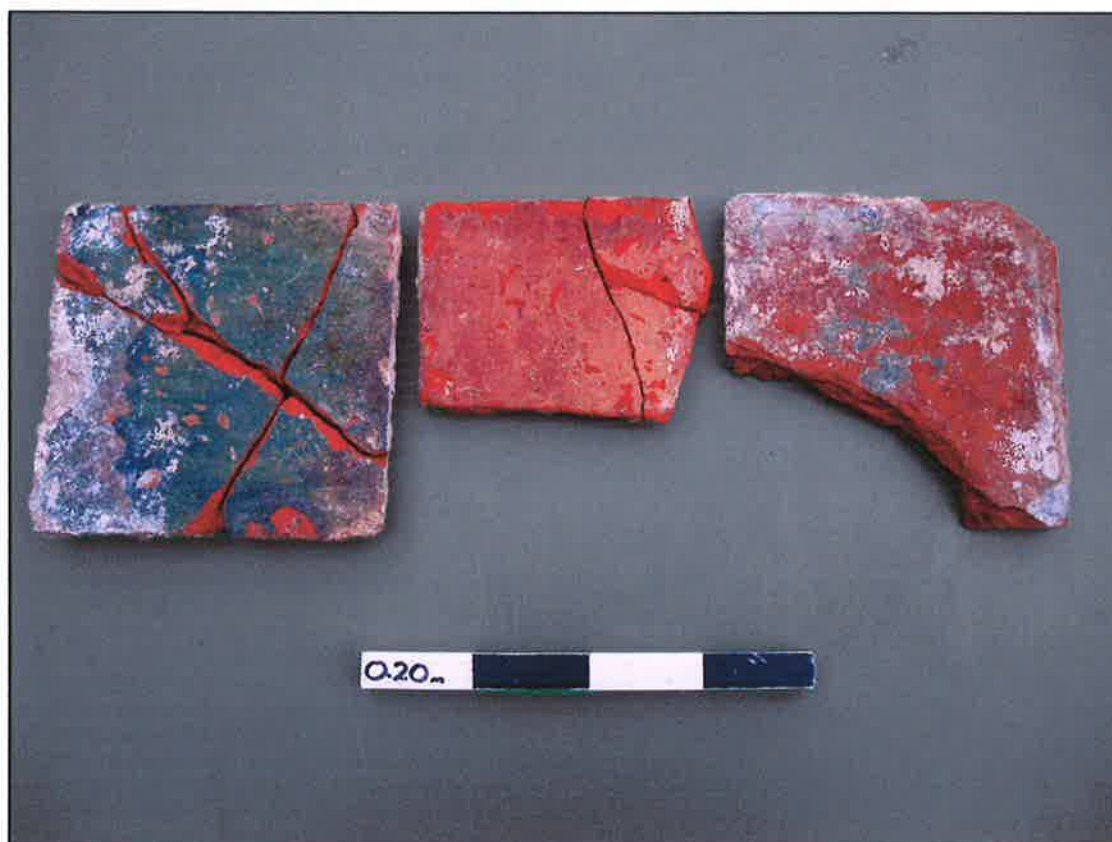
*Plate 3: Late medieval floor tiles from rubble layer (9) within church*

Context 9 contained one complete and two fragments of identical square tiles 15.5cm<sup>2</sup> and 1.8cm thick which had been from the same pavement (Plate 3). Edges upright. All the tiles had been later reused with mortar adhering to top of the glaze. The fabric was an oxidised soft silty clay reminiscent of local bricks made in the Bourn/Caxton area and these floor tiles would seem to have been locally made in South Cambridgeshire.

One of the tiles had a clear glaze which gave an orange finish and the other two had a clear glaze given a green finish (copper added to glaze). These are standard type monochrome late medieval floor tiles used in a combination of shapes and two colours to make geometric patterns on the floor. Dating is post-1400 but before 1550.

Deposit 9 may have come from a single area of the former medieval church as within this layer were the remains of three monochrome late medieval floor tiles (Plate 3) from a two coloured reused geometric pavement (as opposed to the four pieces of different floor tiles found the trench outside the church).

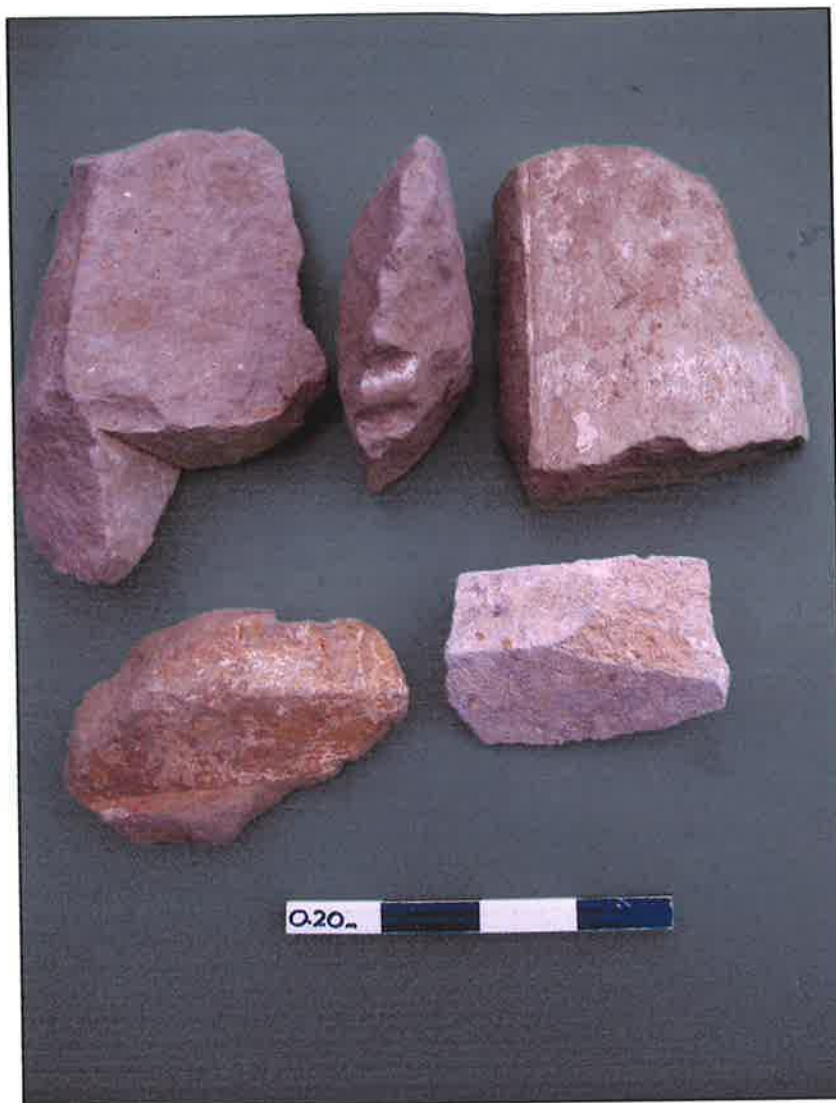
*Plate 4: Building stone from rubble layer (9) within church*

Nine pieces of worked stone were retained from layer 9 within the church (Plate 4). Eight of the pieces were clunch, several with limewash still attached. Wave moulds were recorded on two pieces (post-AD 1275 but probably no later than 1350). One of these pieces was probably a door jamb and this also had some graffiti inscribed on one face although this was a illegible doodle. All the other clunch pieces probably dated from the same period including part of a probable cluster pier. A single piece of ?Barlston limestone was also recovered and is likely to have been a fragment of stone used in the 1749 rebuilding.

The artefacts in this deposit generally consisted of a substantial amount of worked clunch and some medieval floor tiles. Stylistically, the clunch was post-1275 but probably before 1350 (Plate 4). The documentary evidence shows that a church existed here from at least the early 13th century. This stone work was therefore from later medieval rebuilding or expansion of the church. The original medieval church was probably built wholly or substantially of clunch. The surviving Chicheley Chapel, also of clunch (c.1390), was an even later addition to the church (Plate 1). Medieval churches in neighbouring parishes are also built of clunch from local quarry pits. Some of the clunch had limewash attached showing that the medieval church interior was at least partly white in appearance. There was no evidence for the presence of wall paintings.
