NEW ISLINGTON MILL, ANCOATS, MANCHESTER

Archaeological Evaluation

Oxford Archaeology North

July 2004

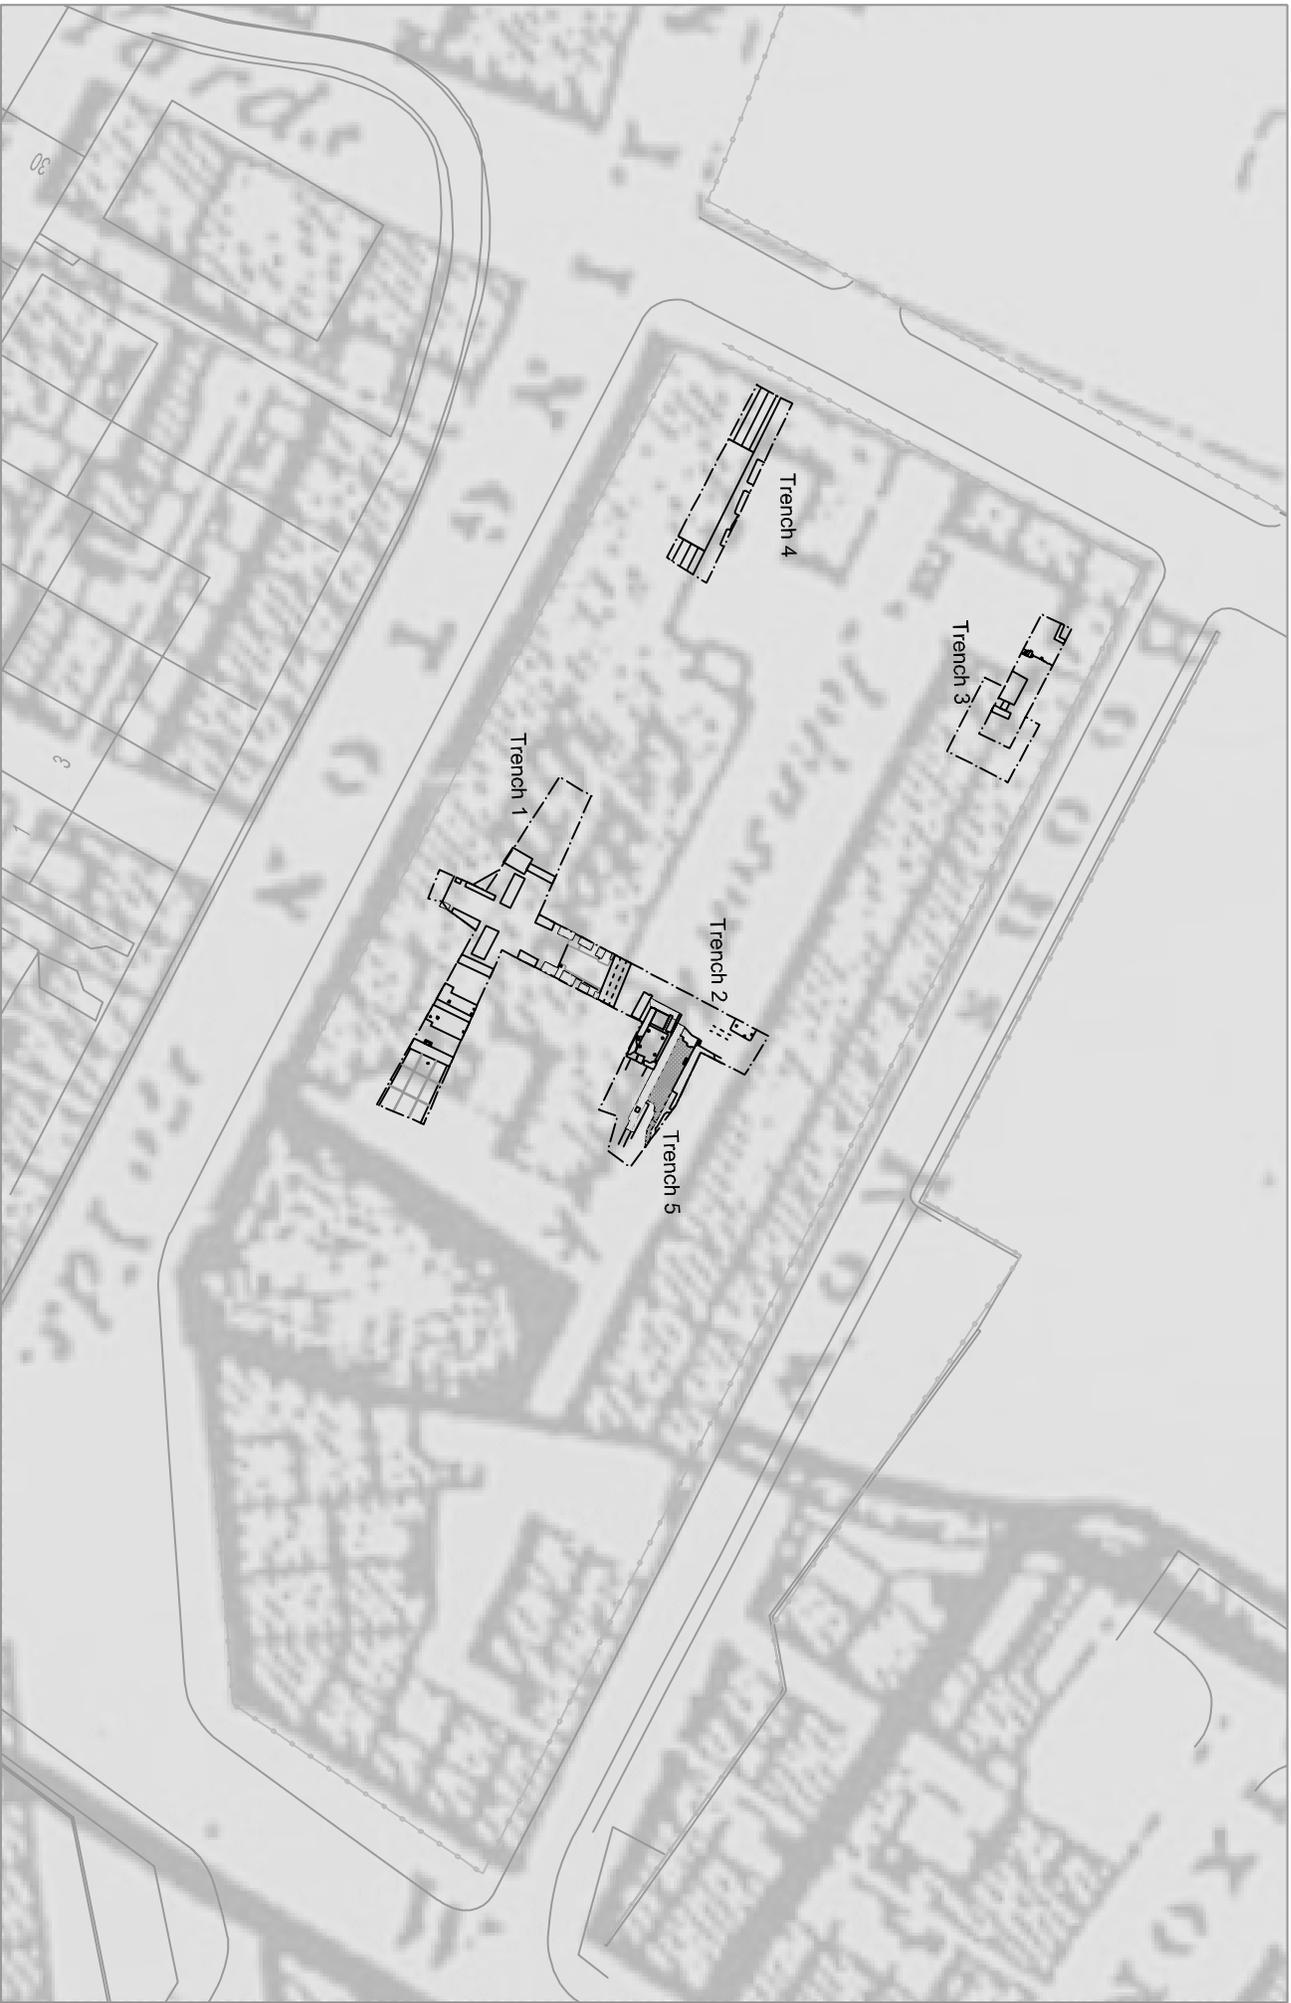
3.2.1 **Trench 1:** the trench was placed within the approximate centre of the former mill complex, and was aligned approximately north-west/south-east (Fig 7), with the intention of investigating the level of survival of internal features and the original east wall of the mill. The trench was excavated for a distance of 24.50m, and to a maximum depth of 3.00m. Despite the depth of the trench, however, the natural subsoil was not exposed.

Figure 7 : Evaluation trench location map, superimposed on Bancks and Co's map of 1831

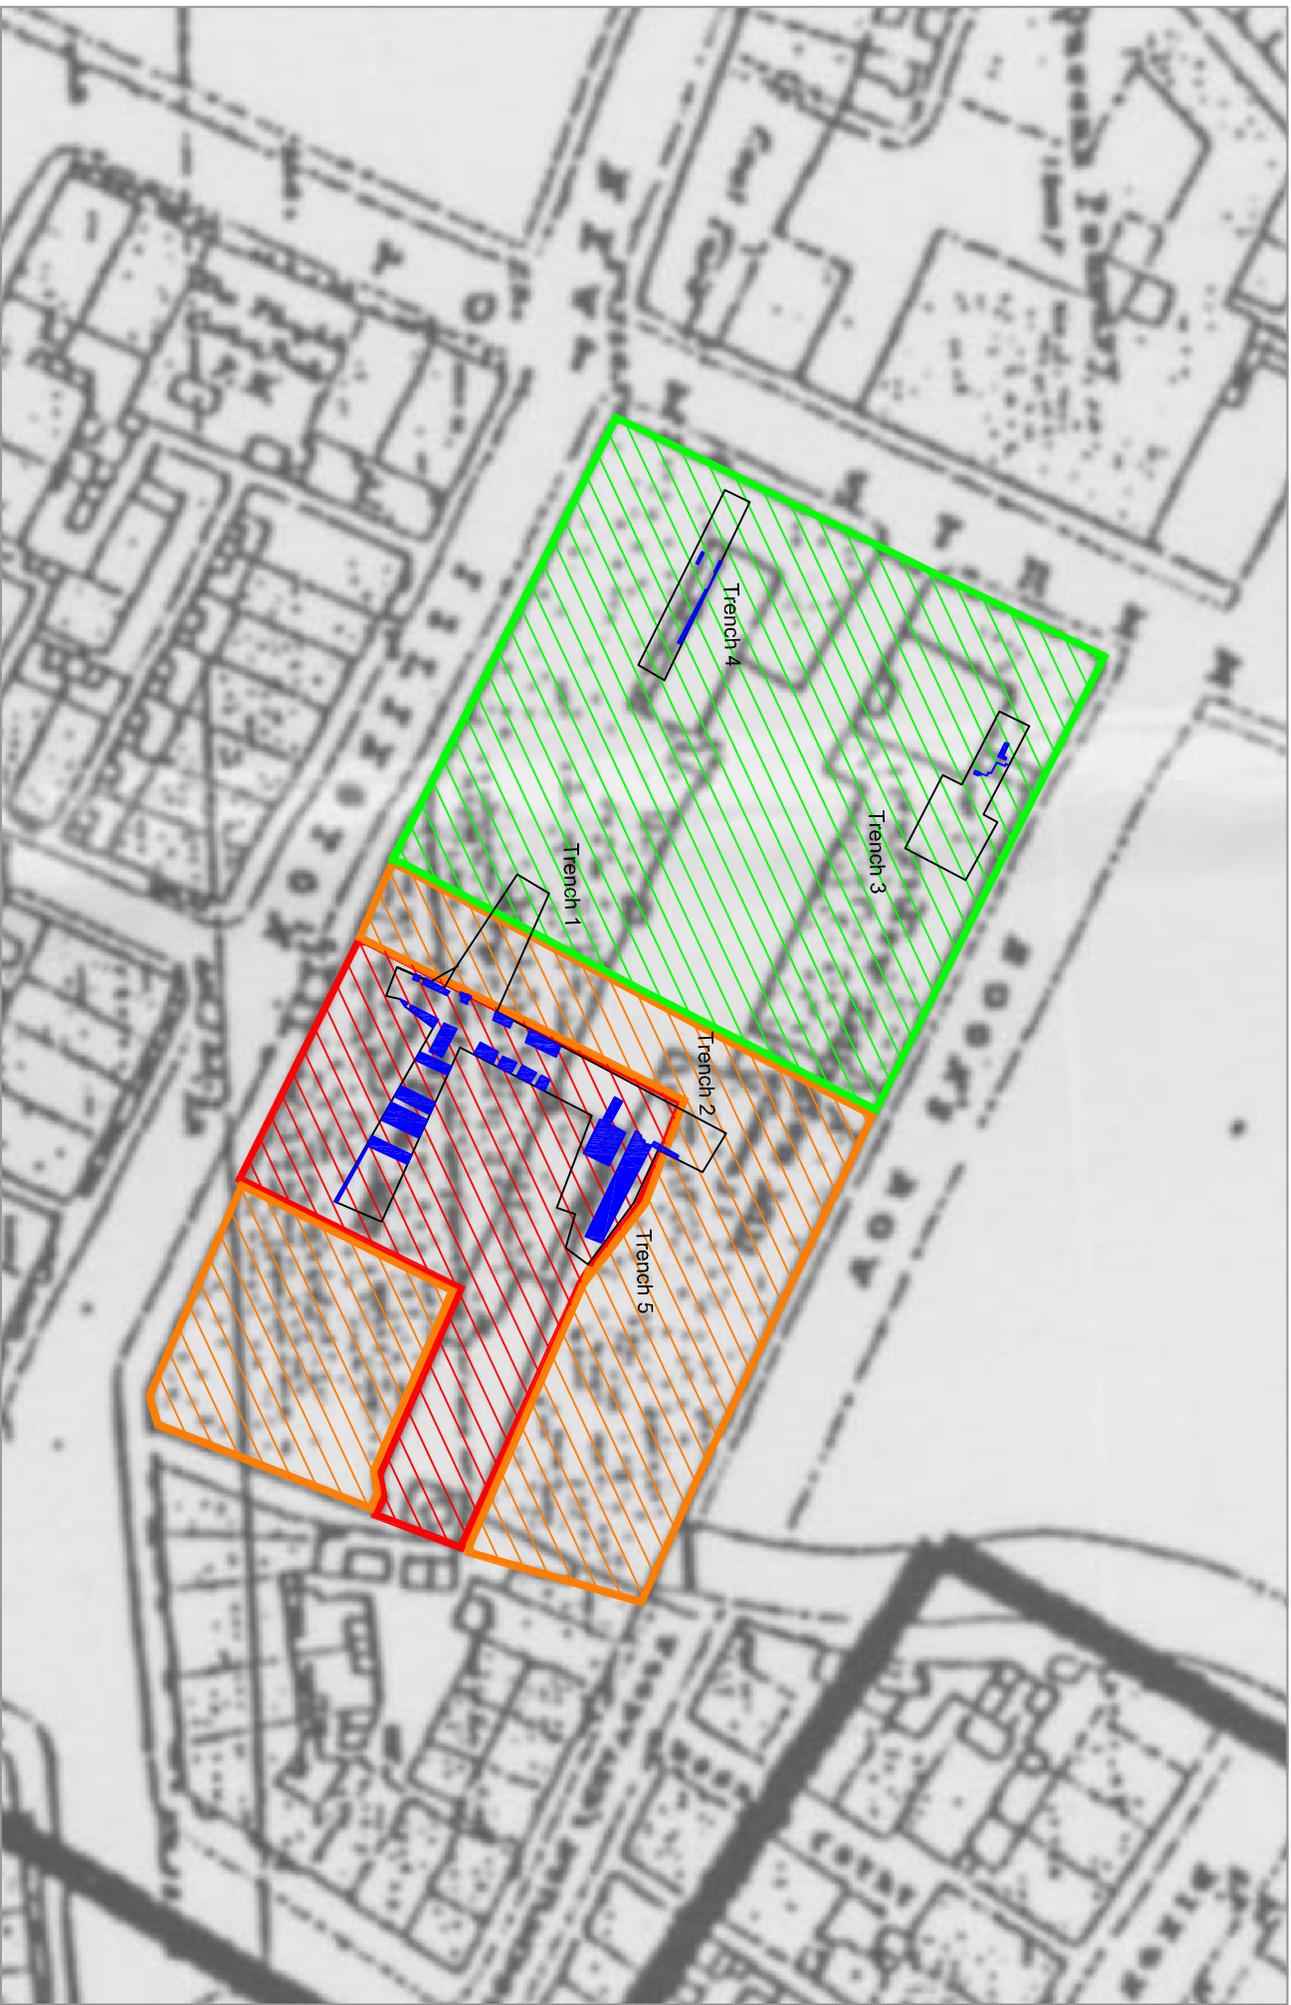
- 5.2.2 The archaeological potential of the study area has been divided into three zones, as depicted on Figure 9, and is based on the significance of the features exposed during the evaluation. In the event of a requirement for any substantial earth-moving works within the area of maximum archaeological potential, it is recommended that further archaeological excavation will be required. Similarly, it is recommended that any disturbance of the area deemed to be of medium archaeological potential is subjected to an intensive watching brief, with a view to the rapid excavation of significant remains should they be encountered. A standard watching brief may be the appropriate course of mitigation for the remaining portion of the site, which is deemed to be of a lower archaeological potential but may nevertheless contain important archaeological structures.

Figure 9: Zoning of the archaeological potential within the study area, superimposed on the Ordnance Survey map of 1851

- 5.2.3 It is further recommended that a watching brief be undertaken during any topsoil stripping within the southern part of the study area in order to record any structural remains that may survive *in situ* immediately below the modern ground surface.

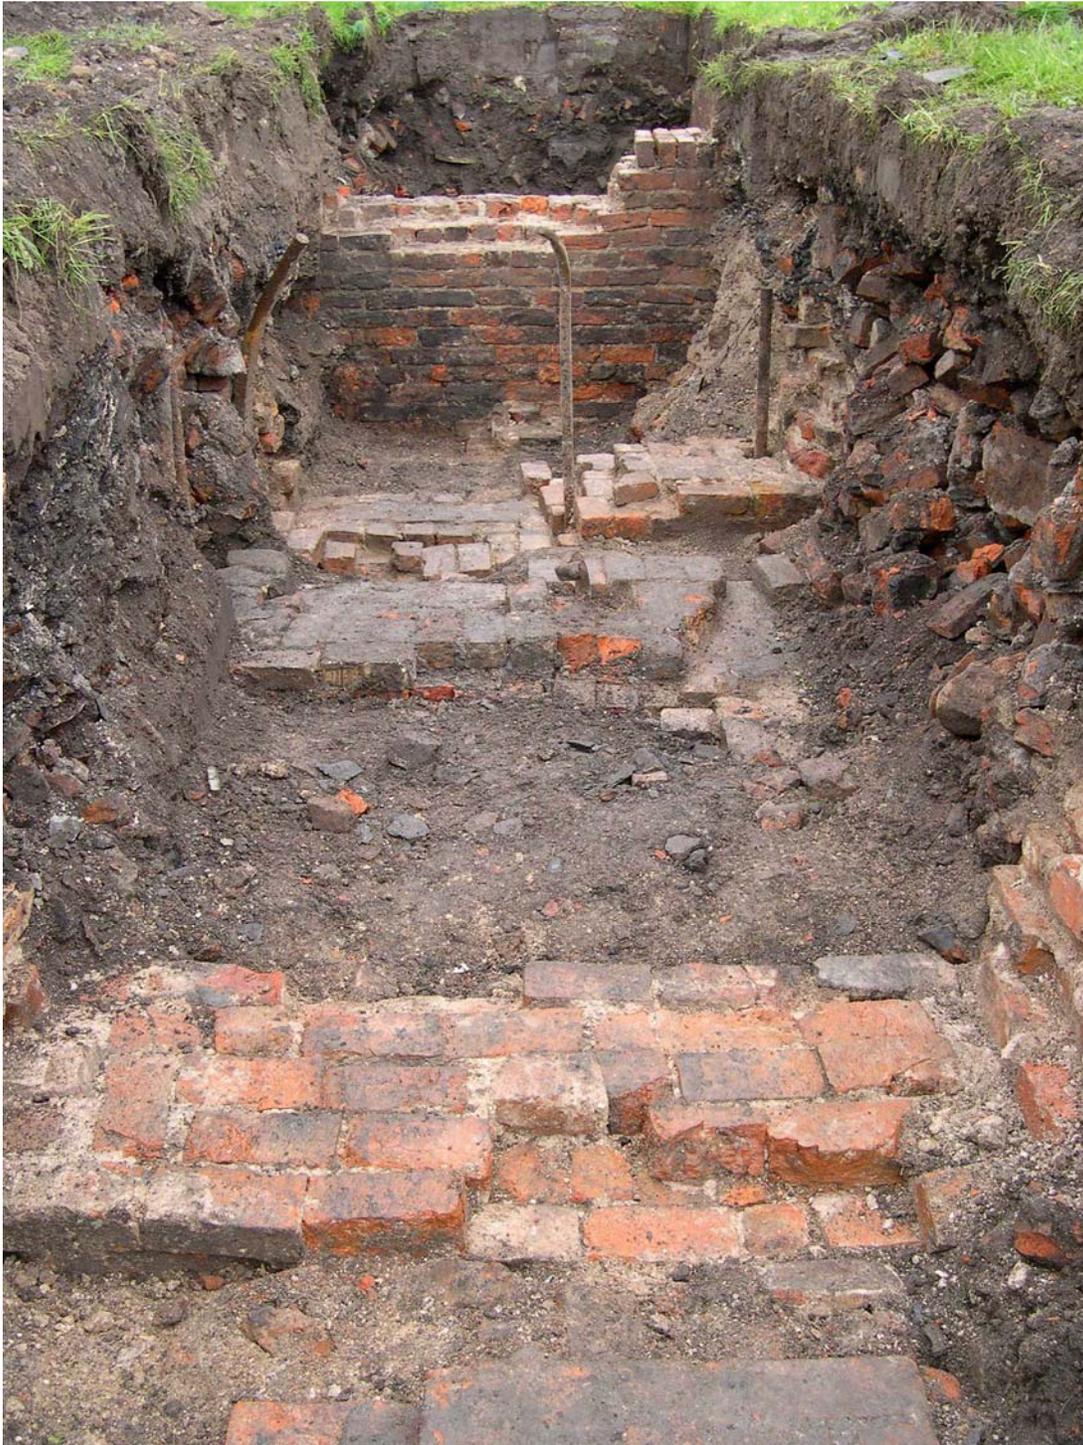
3.2.2 The earliest structural remains encountered within the trench were revealed within the south-eastern part of the trench (Plate 1). These remains comprised walls **04** and **06**, and large brick structures **05** and **11** (Fig 8). The uppermost surface of walls **04** and **06** were exposed at depths of 0.28m and 0.42m below modern ground surface respectively. Brick structures **05** and **11** were revealed at a lower level, lying at a depth of 1.4m below the modern ground surface (Plate 2).

3.2.3 Walls **04** and **06** were aligned broadly north-east/south-west, and set 5.80m apart. Both walls were 0.57m wide and comprised hand-made bricks, bonded with mid-grey lime mortar, suggesting a late 18th or early 19th century date. The width of these walls implied that they had been load-bearing, rather than representing internal partitions.

*Plate 1: Structural remains encountered within the south-eastern part of Trench 1. Wall **04** lies in the foreground and wall **06** to the rear, with the foundations (**05** and **11**) for a steam engine situated in between.*

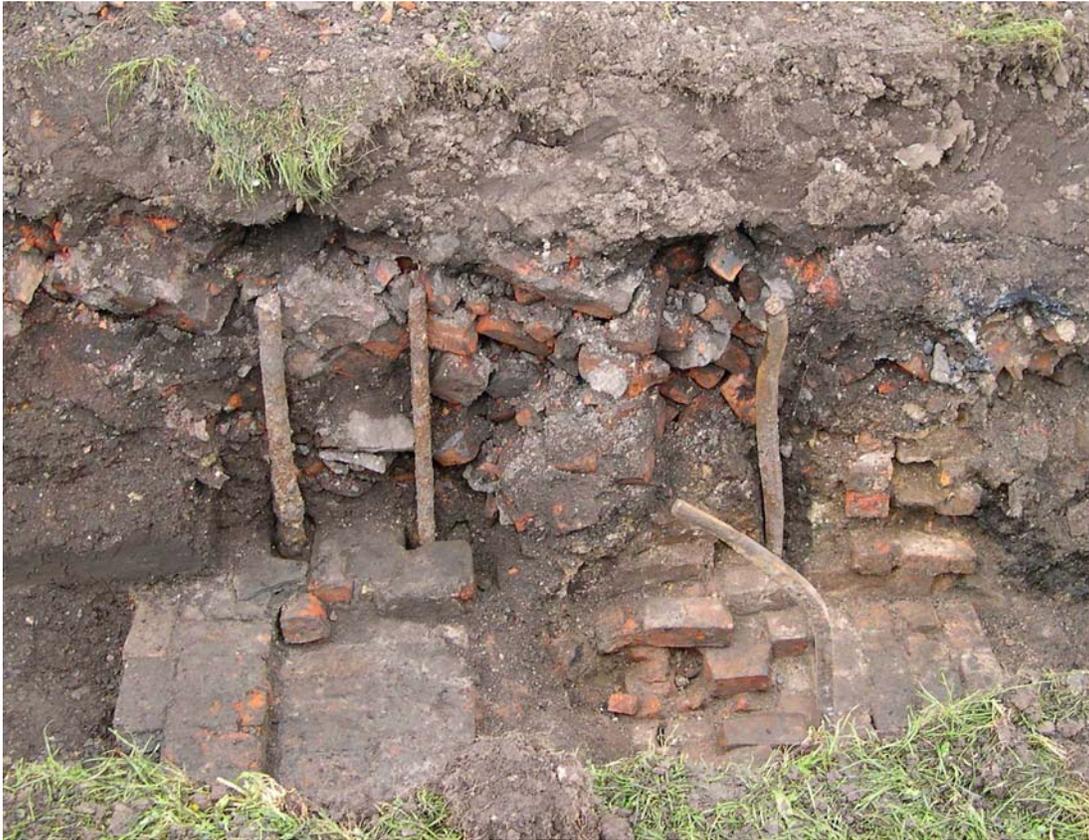
3.2.4 The two large, seemingly associated brick structures (**05** and **11**) were exposed at depths of 1.35m and 1.45m respectively, and were again constructed of hand-made bricks and bonded with a lime mortar. Structure **11** appeared to be the larger of the two, with a maximum width of 1.17m, whilst structure **05** measured 0.83m wide; the full dimensions of these structures were not ascertained as they extended beyond the limit of excavation. Both structures had metal rods, or restraining brackets, projecting vertically from their surface (Plate 2), indicating that they were elements of the foundations for a steam engine.

*Plate 2: Brick structures **05** and **11** and engine restraining rods within Trench 1*

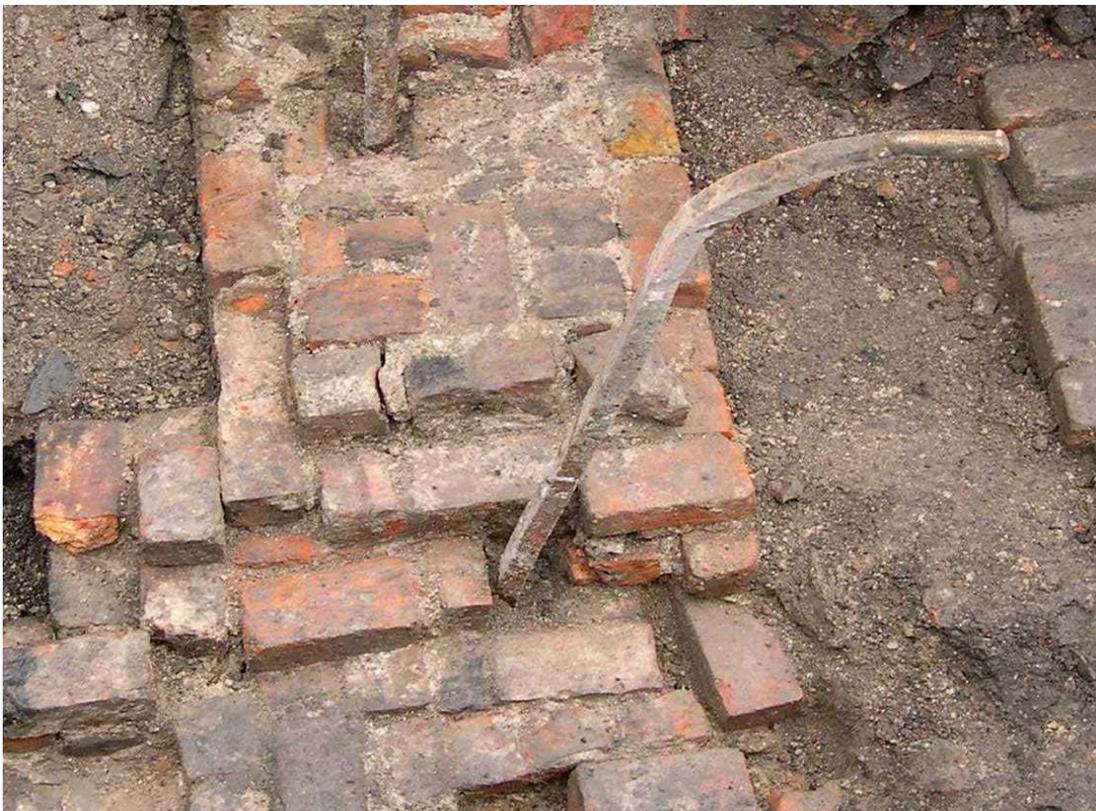
3.2.5 Foundation **05** had three exposed metal rods arranged in a roughly linear alignment. The central rod had a square section (Plate 3), but a cylindrical thread on the end, indicative of a late 18th or early 19th century date. The exposed part of foundation structure **11** also had three restraining brackets, which formed a triangular arrangement with two cylindrical rods and a square-sectioned rod with a cylindrical thread. Foundation **05** had a recess on its south face, whereas foundation **11** had a recess on its north face (Fig 8).

*Plate 3: Engine restraining rod within central part of foundation structure **05***

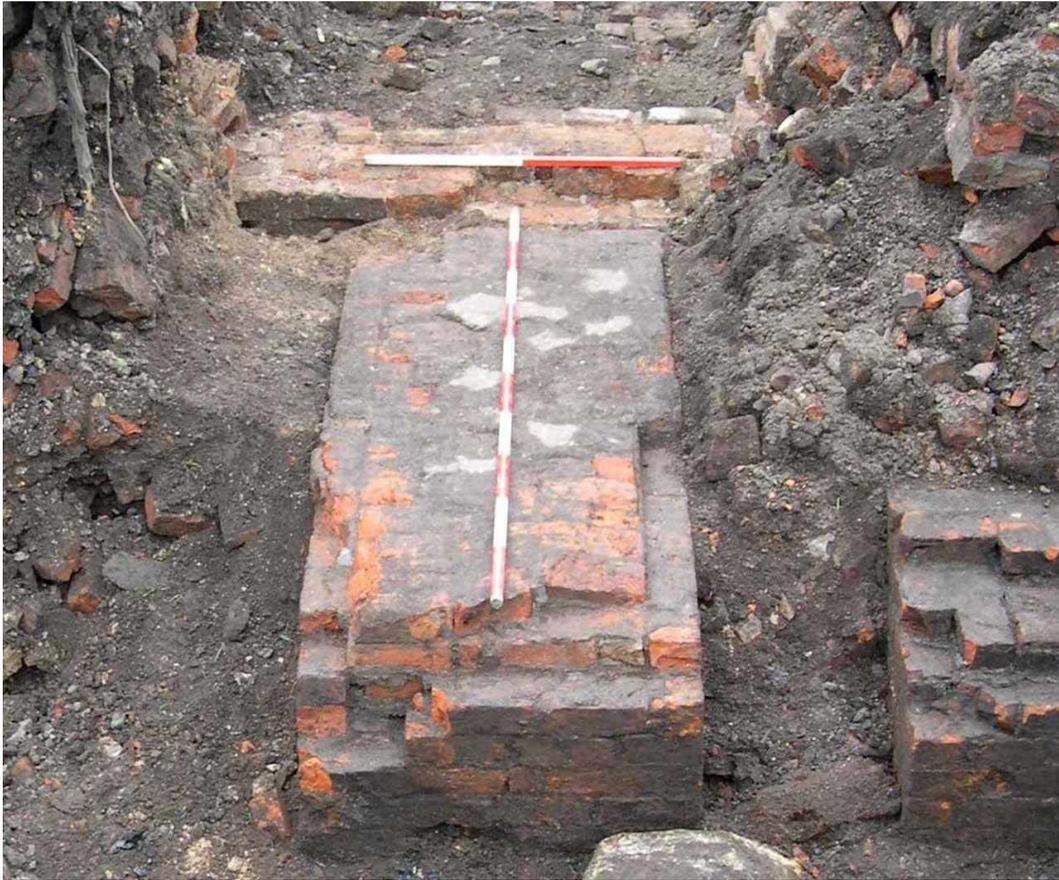
- 3.2.6 Situated between wall **06** and wall **10** (3.2.7 below) were two brick piers (**07** and **08**), set 1.57m apart. Each pier measured 2.11m by 0.75m, and were exposed at a depth of 0.30m below the modern ground surface (Plate 4). These structures were associated with a series of similar features that was revealed within Trench 2 (3.2.13 below).

Plate 4: Looking south-east across brick pier 07 within Trench 1

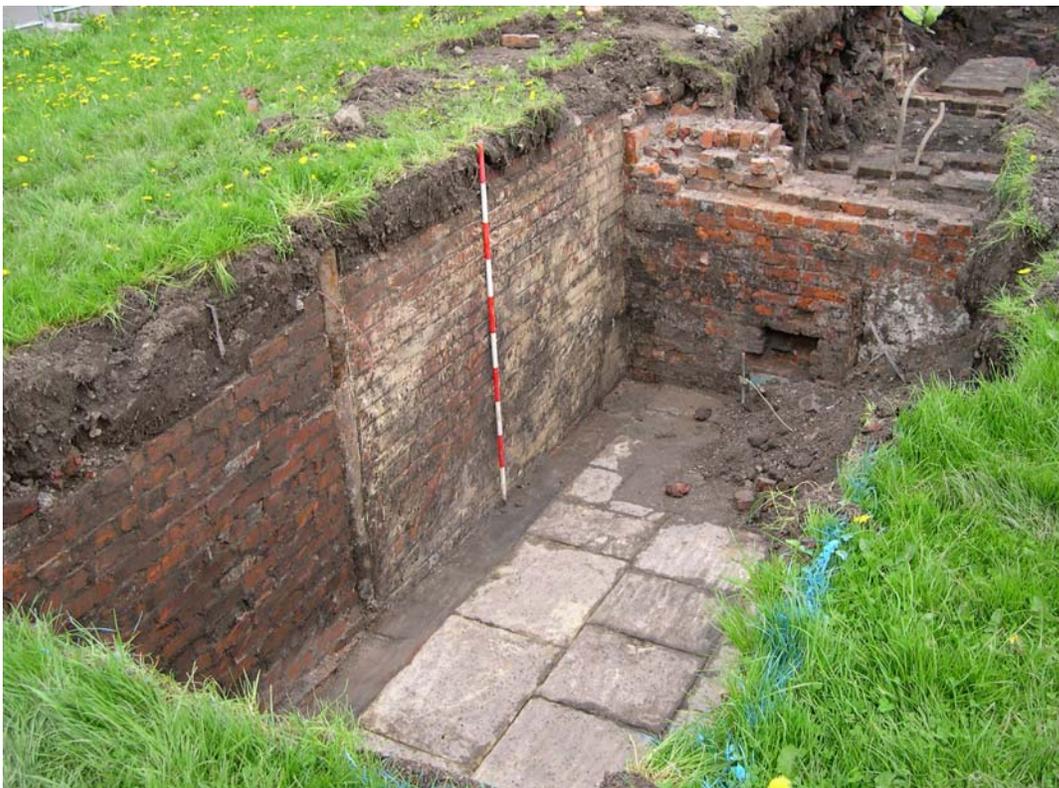
- 3.2.9 At the base of the south-eastern end of the trench, and at a depth of 2.17m below the ground surface, was a flagstone surface (**01**). Surface **01** appeared to be associated with adjoining walls **02** and **03**, which were aligned north-west/south-east, and were situated immediately to the south, against the edge of the trench (Plate 5). The junction of the walls was marked by a vertical iron drainpipe, which extended to the full height of the wall from a point below surface **01**. Walls **02** and **03** comprised machine-pressed bricks that were bonded with a hard cement mortar, and were thus thought to relate to a later date than wall **10**. The uppermost surface of walls **02** and **03** were exposed immediately beneath the topsoil.

Plate 5: Flagstones 01 and walls 02 and 03 at the south-eastern end of Trench 1

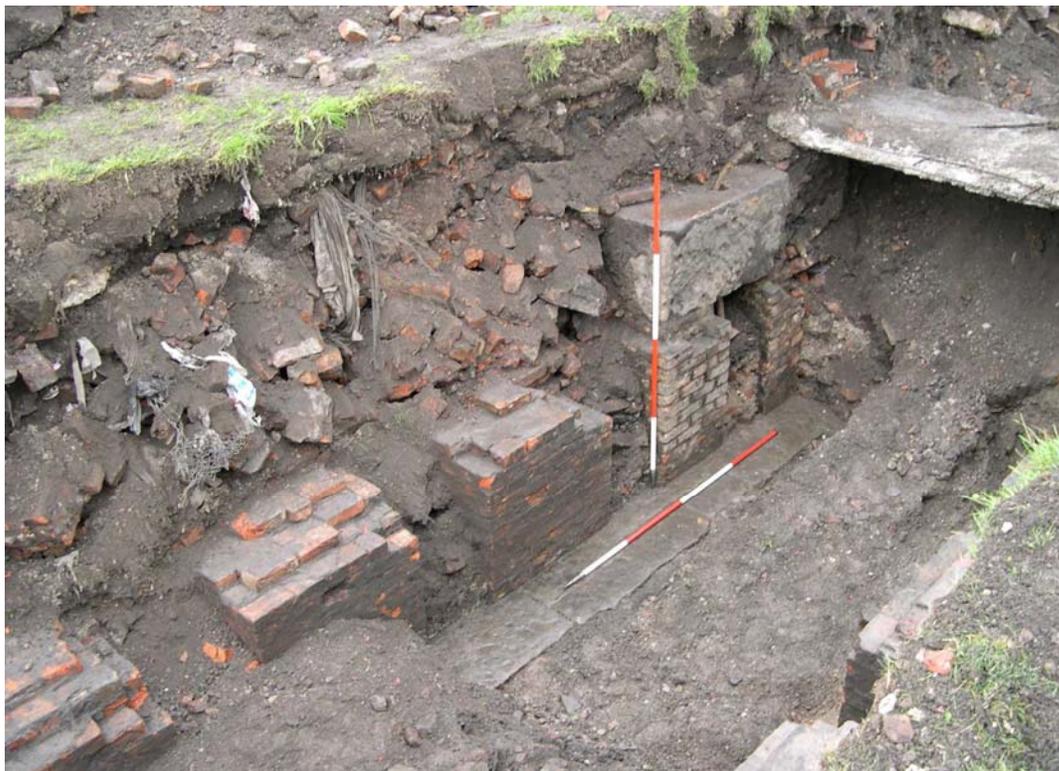
- 3.2.13 A series of rectangular brick piers, set at regular intervals, were exposed along the south-western half of the trench (Plate 7). This series of brick piers was clearly associated with piers **07** and **08**, exposed within Trench 1 (3.2.6 above)

and lying partially within Trench 2. Each of the piers comprised hand-made bricks and were bonded by a harder mortar than had been used in the construction of walls **04** and **06** and structures **05** and **11** (Trench 1). The piers were all well-preserved, and were exposed at an average depth of 1.52m below the modern ground surface.

- 3.2.14 The brick piers varied in size from 1.27m by 0.36m to 2.11m by 0.9m, and occurred in eight opposing pairs (**12** and **13**; **14** and **15**; **7** and **8**; **18** and **19**; **20** and **21**; **24** and **25**; **26** and **27**; **28** and **29**). The positions of the brick piers are depicted in Figure 8.

Plate 7: Part of a series of brick piers encountered within Trench 2

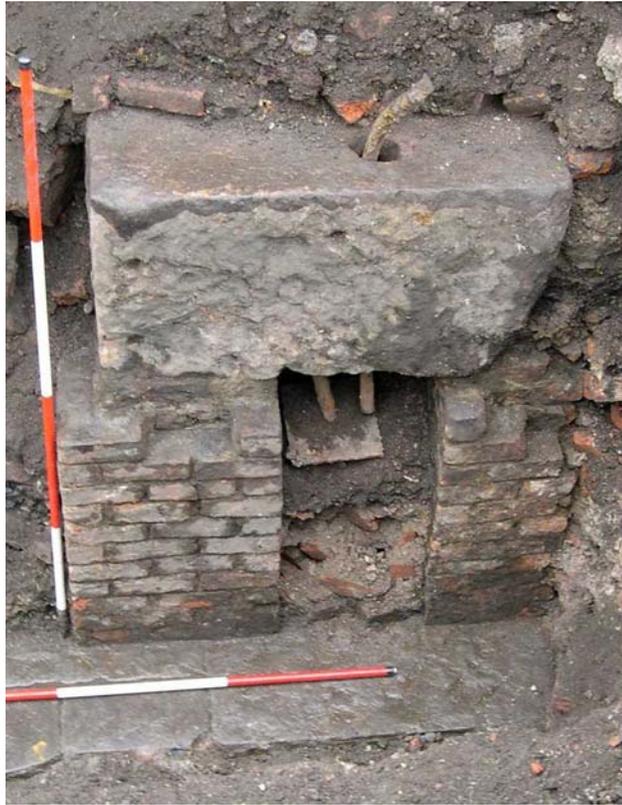
- 3.2.15 A single, large freestone block (**30**) was revealed to be resting *in situ* across the top of brick piers **27** and **29**, within the central part of the trench. The block measured 1.20m long by 0.60m high, and incorporated a single iron bar that passed through vertically (Plate 8).

- 3.2.17 In all probability, it would seem likely that the brick piers and the large freestone blocks represented the vestiges of the mill's power system. Freestone block **30** was almost certainly part of a mounting for a steam engine, and is likely to have been associated with the two similar blocks (**09**) that were exposed within Trench 1 (3.2.8 above). It is possible that the rubble-filled area between flagstones **22** and **23** represented a flywheel pit associated with the steam engine, although this could not be confirmed due to health and safety constraints.

Plate 8: Engine mounting block 30, Trench 2

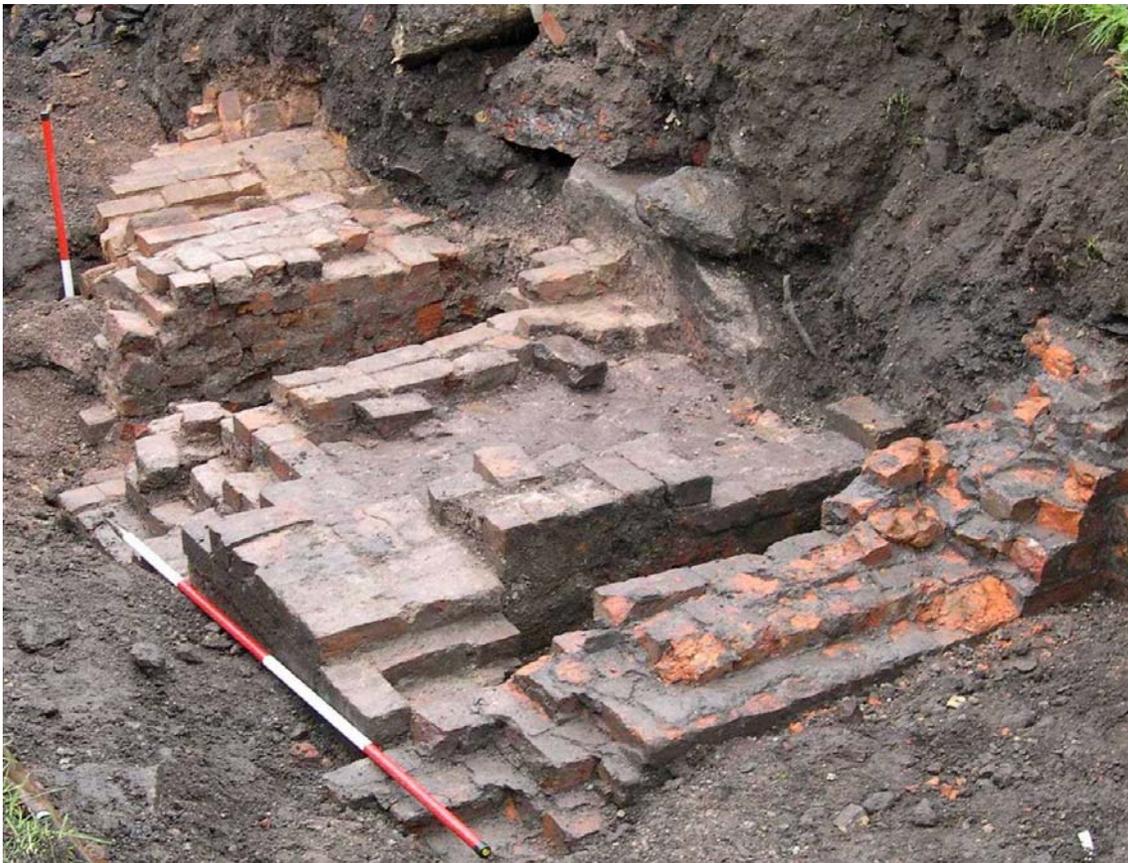
- 3.2.19 Adjacent to the north-east of wall **32** was series of brick structures (**33**, **34**, **35** and **36**), seemingly of a contemporary date (Plate 9). The central component was a crude surface (**35**), composed of whole bricks and fragments bonded in a clay matrix. It was encompassed by brick structures (**33**, **34** and **36**). Structure **33** comprised a single course of bricks, and measured 0.11m wide. Structures **34** and **36** represented the remnants of walls, and were both composed of hand-made bricks. Wall **36** was directly to the east of surface **35**, measuring 0.24m wide and 1.18m long, with a dog-leg continuing eastwards a further 0.75m. It was bonded to wall **34** to its north (Fig 8).

Plate 9: Brick structures 33, 34, 35 and 36

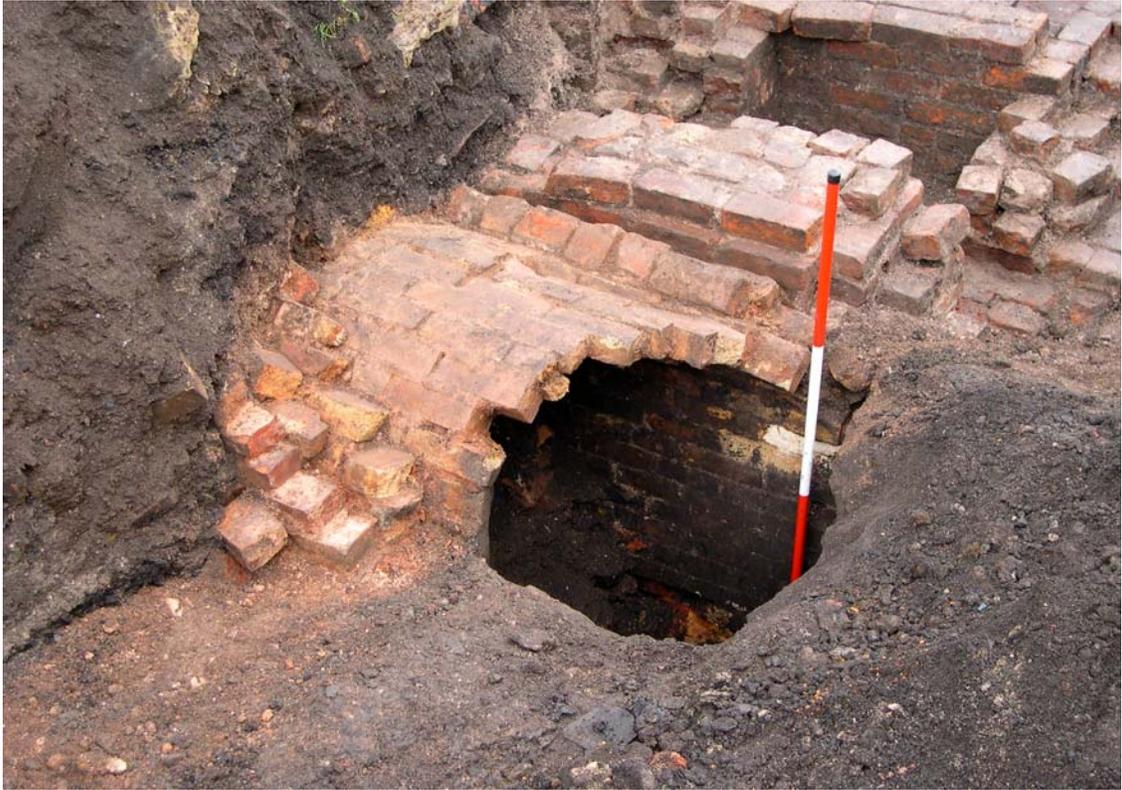
- 3.2.20 Immediately to the north-east of wall **36** were two brick walls (**38** and **40**), aligned north-west/south-east, and situated either side of a section of a vaulted flue (**39**). Wall **38**, situated to the south-west of flue **39**, was 0.53m wide, whilst wall **40** was only 0.23m wide. Both walls comprised hand-made bricks, and were exposed at a depth of 0.9m below the modern ground surface. These

walls appeared to act as retaining structures for the flue, although the increased width of wall **38** suggested that it was also load-bearing.

Plate 10: Flue 38 within Trench 2

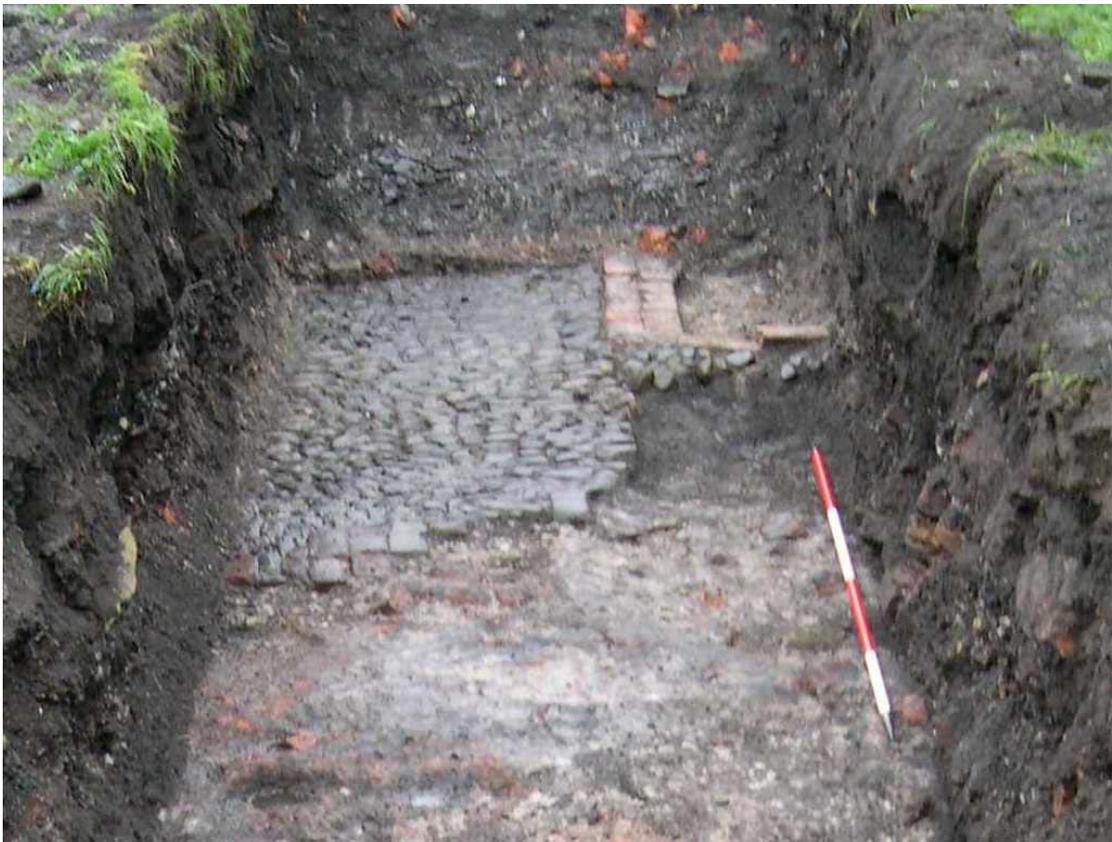
Plate 11: Looking north-west along Trench 3, showing cobbles 45

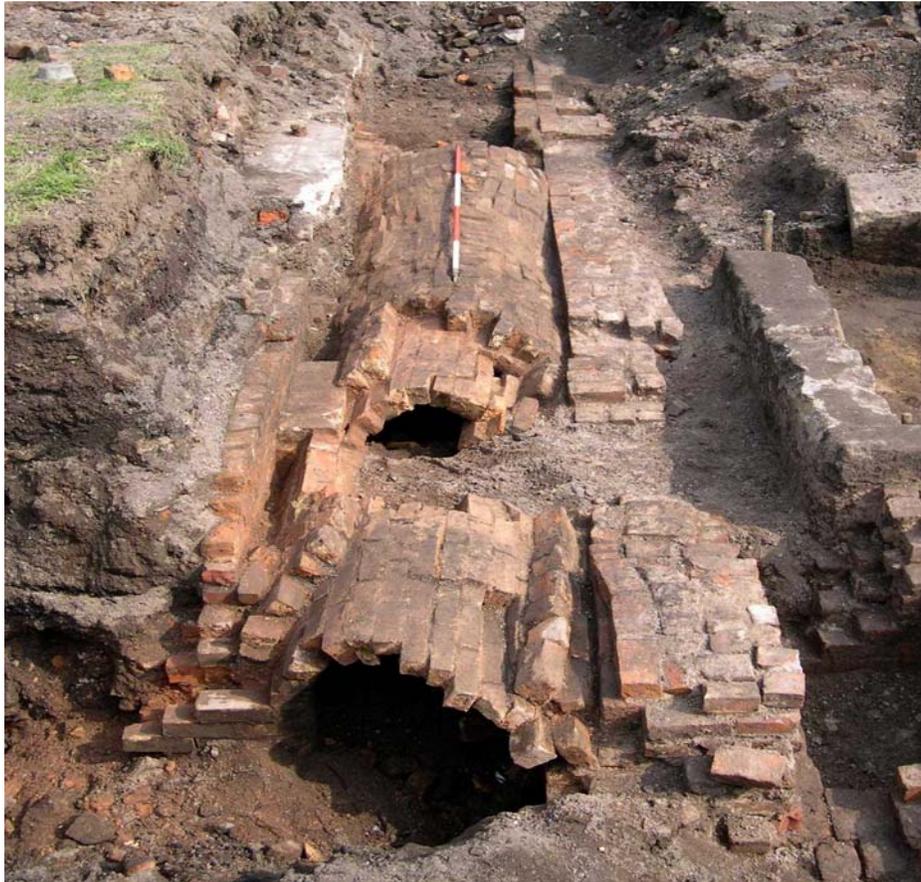
- 3.2.38 Flue **39** continued along the entire length of the excavated trench, rising slightly to the south-east, presumably on its approach to a chimney. The foundations of the chimney were not exposed during the course of the evaluation, but are likely to survive beyond the south-eastern extent of the trench. A hinged iron plate was revealed to have been built into the flue on the north-east-facing side of the vaulted roof, probably representing an access point.

Plate 12: Looking south-east along Trench 5, showing flue 39

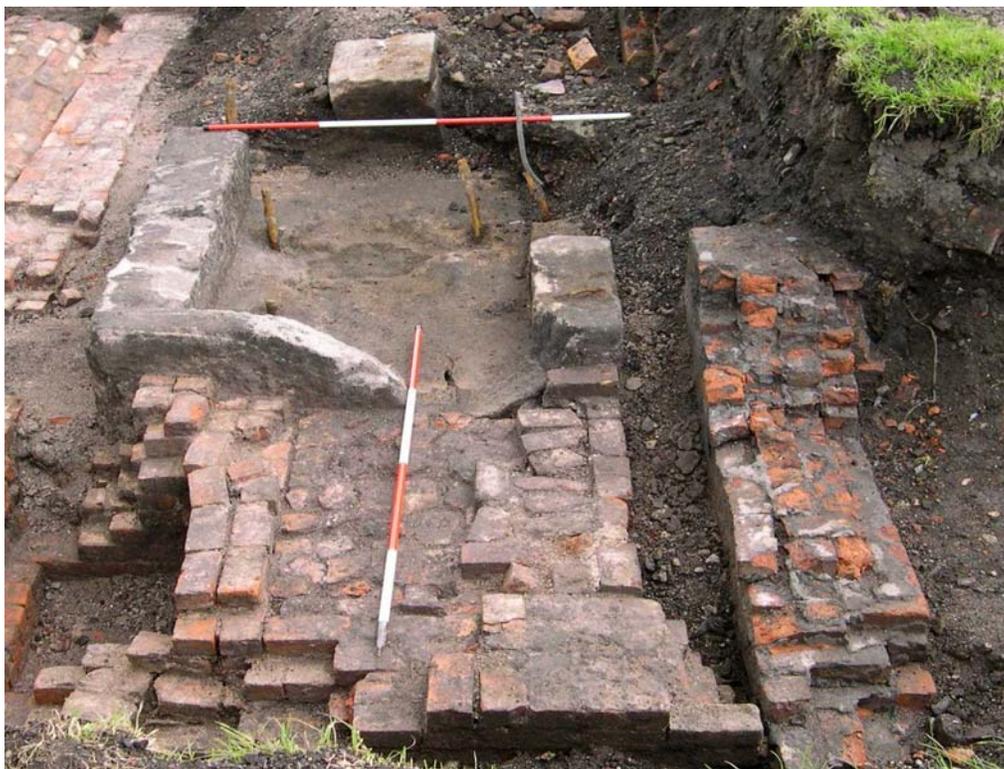
Plate 13: Machine base 41 within Trench 5
