MILL STREET MARYPORT, CUMBRIA

Archaeological Watching Brief

Oxford Archaeology North

November 2002

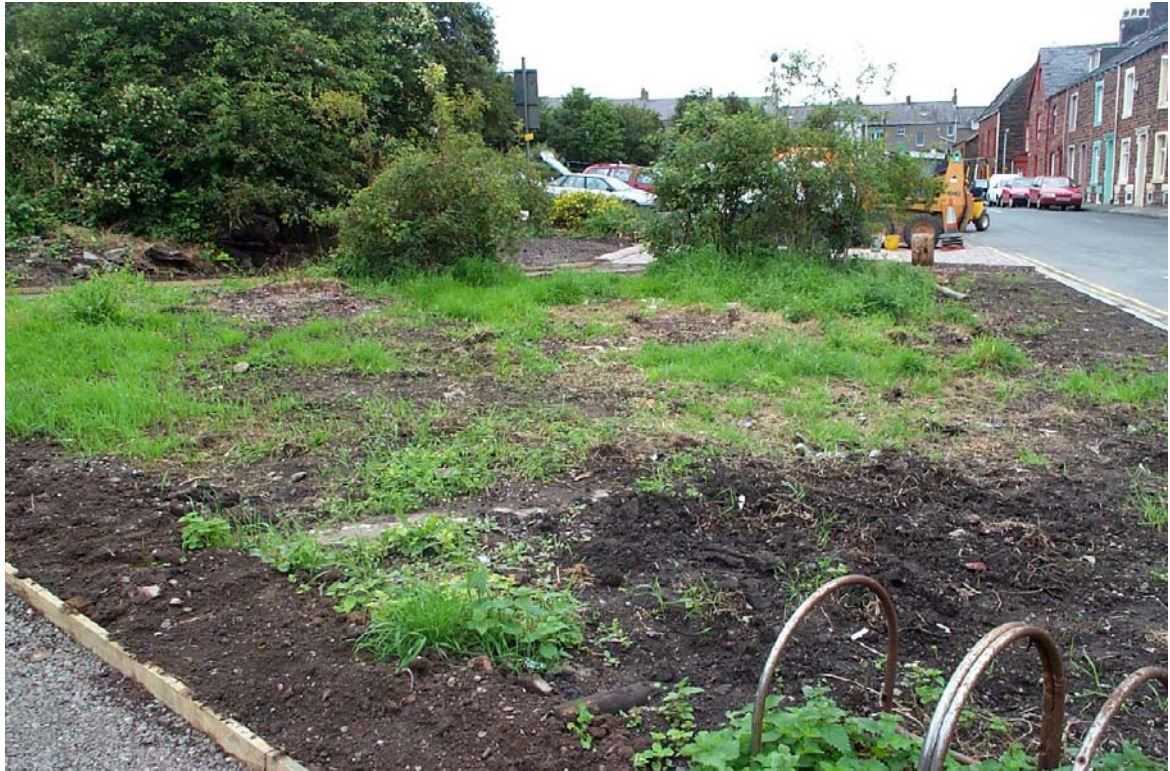
Plate 1: The site prior to work being carried out, looking north-west

4.1.1 A small area of open ground with scrubby, low level, ruderal vegetation, through which the edges of a curved feature could be seen was investigated. The vegetation was manually cleared, allowing for the determination of the full extent of the feature (Plate 1). Subsequently the ground around the annular feature was taken down by an average depth of 0.3m, which exposed the character of the structure (Fig 3). A full photographic record was made and, once the feature was totally exposed, it was carefully recorded. At the completion of the work deeper areas of excavation were carefully backfilled so as not to constitute a risk to pedestrians, but the overall feature was left exposed.

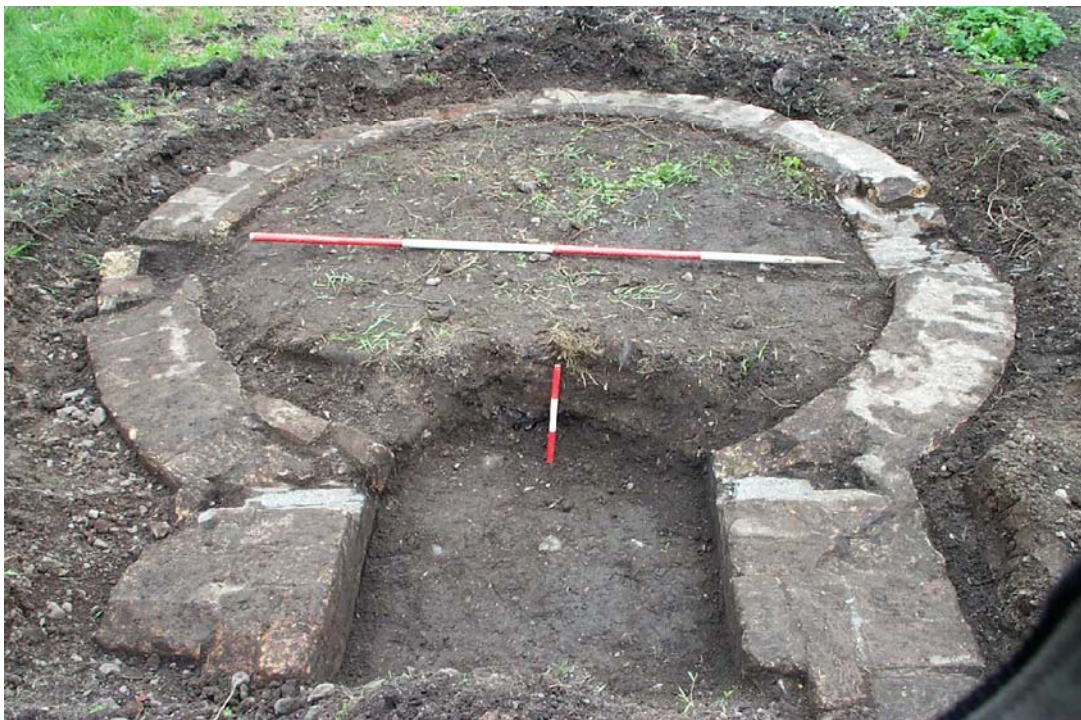
Plate 2: The brick structure following excavation, looking east

4.2.1 The structure was a brick built interrupted annulus (ring), with an external diameter of 3.0m and an internal diameter of 2.3m. The western arc of the annulus was incomplete, being interrupted by a deliberate slot to enable access to the interior of the structure (Plate 2 and 3). The structure was composed of unfrogged bricks, each measuring 0.26m x 0.11m x 0.08m. These were arranged with their long axes in a radial pattern and around the inner side was a single line of yellow, probably refractory, bricks which apparently served as a lining (Fig 3). In three areas around the annulus there were no upper bricks but their positions could be determined from the ridges of mortar which remained. The bricks were bonded together with a mid-grey mortar and the uppermost extant coarse of bricks had the remains of mortar bonding indicating that the structure may have had at least one more additional coarse. In total four courses were visible and the structure was almost certainly deeper; however, insufficient time, and the limited scope of the project, meant that it was not possible to expose the feature to any great depth or examine the base. The slot, which interrupted the annulus, consisted of two protruding, parallel walls, 1m apart and aligned north-west/south-east. The walls were keyed into the primary build of the circular wall. It was not clear where the wall stubs ended, as they seemed to continue under the newly laid path. At the junction of the annular wall and the two protruding walls, were two small recesses with slate bases, it is unclear what purpose they may have served but one possibility is that they acted as a lintel rest (Plate 3).

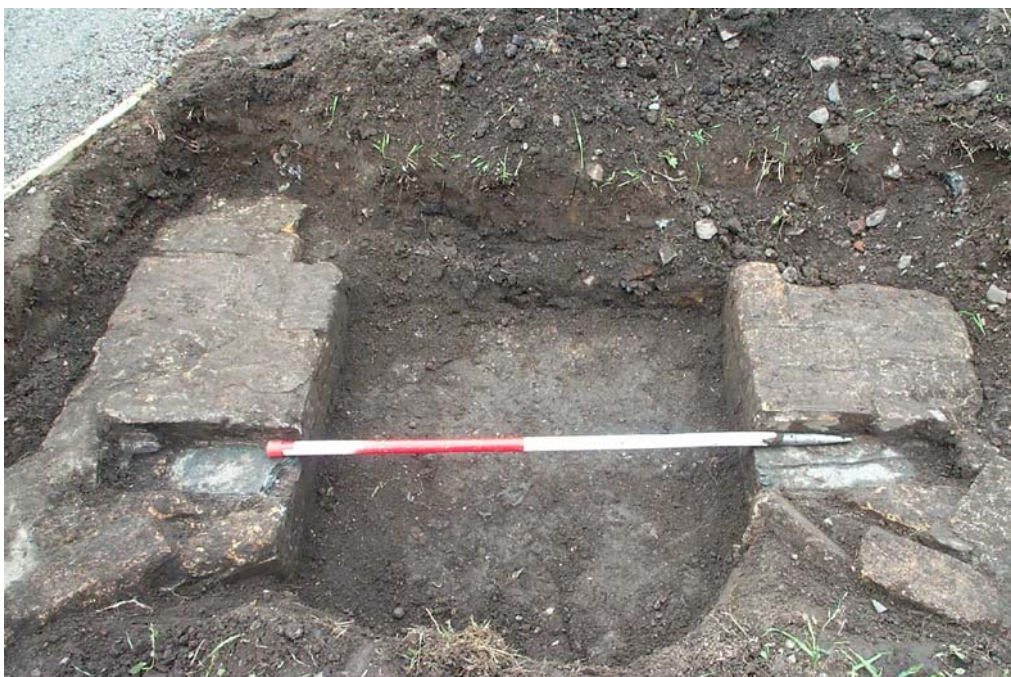
Plate 3: The aperture with slate bedded recesses, looking west

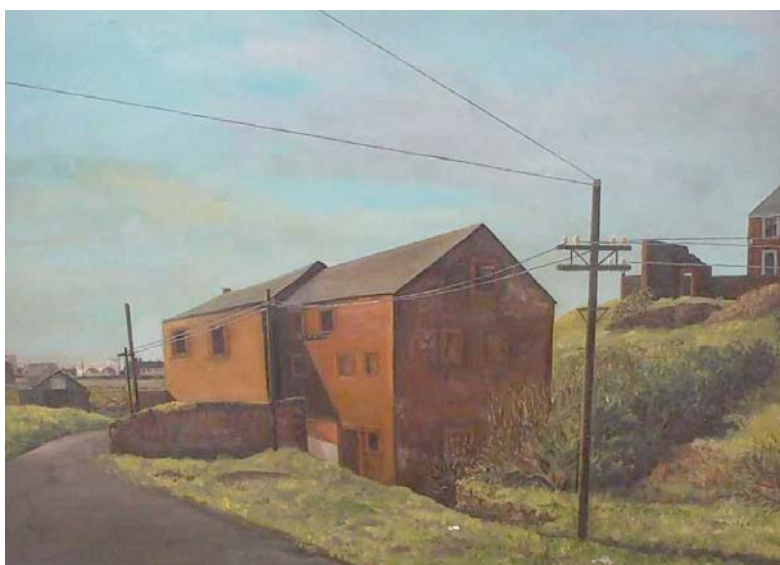
Plate 4: Original painting held by the resident of No 15 Mill Street; produced in 1973, which shows the former corn mill

have affected the Furnace Corn mill which, although derelict, survived as a standing structure until it was burnt down in 1976; a resident at No 15 Mill Street owns an original painting, of 1973, showing the standing mill building (Plate 4).

5.1.1 The watching brief produced evidence of an annular brick structure which was visible until very recently, it is shown on a painting by a local artist in the 1970s (Plate 4). The scope of the project did not allow for fuller excavation of the structure and therefore it was not possible to fully investigate it, however, the most likely suggestion is that it was the remains of a corn drying kiln and the access chamber would have allowed for the insertion of the corn or stoking fires. Although there was little direct evidence of heat affecting the brick structure; the yellow bricks lining the structure are refractory bricks indicating that the structure was required to sustain substantial temperatures. The latter suggestion would seem to best fit with the location adjacent to a corn mill, and the structure is comparable to the circular sandstone feature recorded in the course of the excavation of the corn mill, and which was interpreted as a corn drying kiln; the sandstone kiln is of a very similar size being 2.92m in diameter. Corn-drying kilns are highly varied in form but compatible examples may be found in Scotland (Hay and Stell 1986) and Northumberland (Phillipson 1977), all dating to the same post-medieval period, with this current example being of nineteenth century date.
