Milton Garden Machinery, Milton Road, Drayton, Oxfordshire Archaeological Evaluation Report

September 2019

Archaeological Evaluation Report

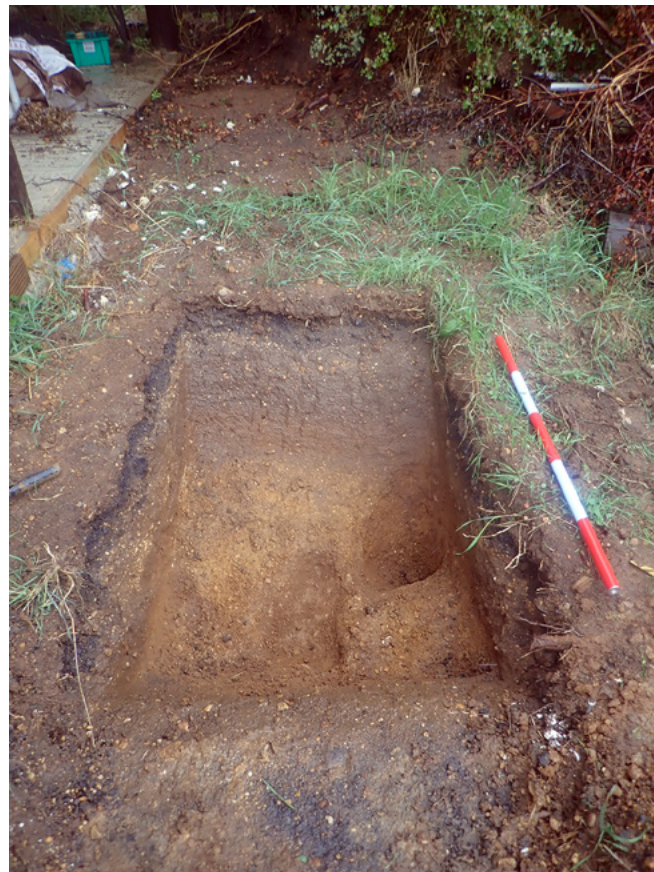
Plate 4: Trench 3 showing natural features 13 and 15.
View to north

3.3.1 Trench 1, which was situated close to the circular cropmark visible on aerial photographs (Fig. 2), revealed a modern cut (5) at the east end, which contained a modern loose backfill of bricks, clay and sand (Plates 1-2). The cut was narrower than the upper part of the trench so was visible in plan but not in the section of the trench. Trench 3 contained two natural hollows (contexts 13 and 15) with fills that were very similar to the subsoil (Plates 4-5). Archaeological features were not present in any of the trenches.

4.3.2 Trenches 2 and 3 were located in an area that from aerial photography appeared to have been truncated by quarrying. No evidence of quarrying was identified in either trench, and the area appears to have remained undisturbed. The natural hollows, (contexts 13 and 15) recorded in Trench 3 were typical of natural features observed within the gravels in the area.
