# **RIBBLE LINK MAIN, BOWLAND FRINGE AND PENDLE HILL LANCASHIRE**

## **Archaeological Evaluation and Watching Brief**

Issue No: 2006-07/418

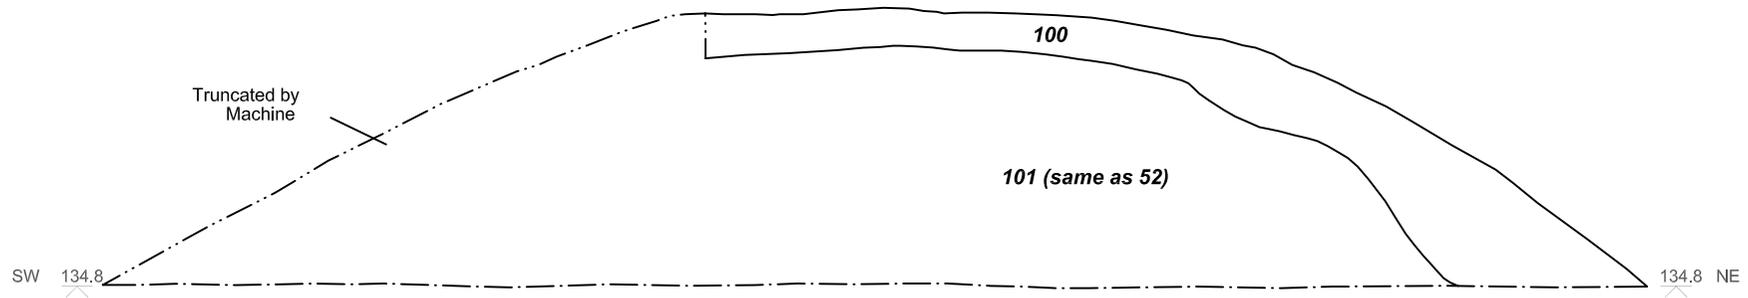
Figure 6: Bank profile observed north of Trench 1, Site **04**, during the watching brief

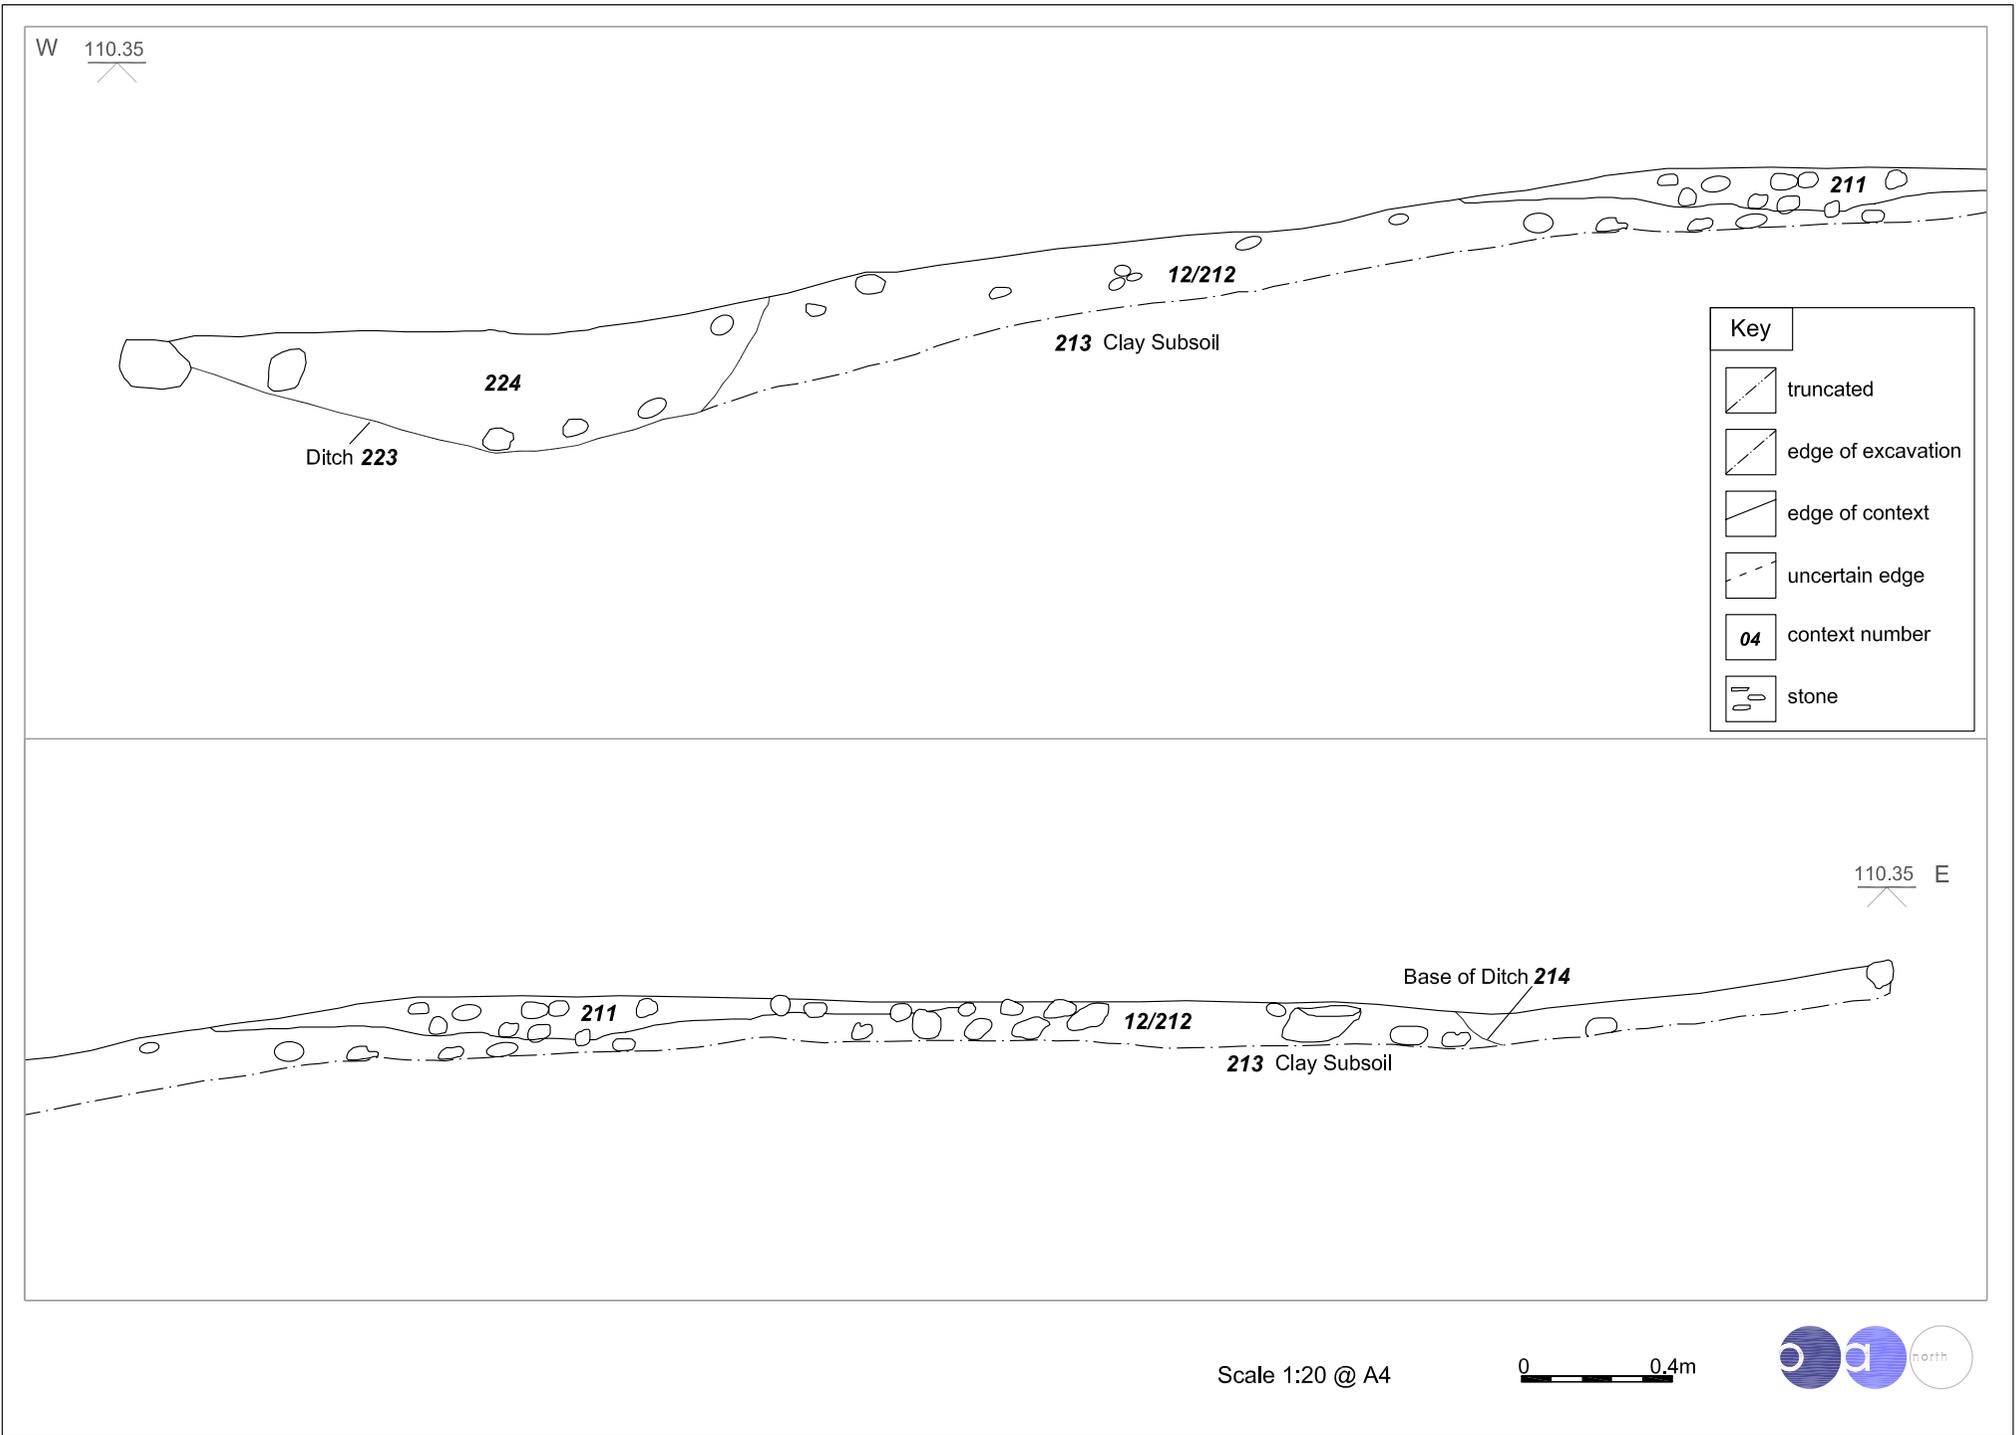
Figure 9: South-facing section through Roman Road in Trench 5, Site 09

- 4.3.8 Traces of a 1.2m wide ditch (**223**) backfilled with pale red silty-sand (**224**), were observed along the western edge of cobbles **12/212** (Fig 9; Plate 7). The ditch followed a similar alignment to that of the cobbles and survived to an overall depth of 0.40m. The possible remains of a second drainage ditch (**225**) represented by a thin band of red/brown silty-sand were detected along the southern edge of the stones, and appeared to run along a north-east to south-west alignment. Little evidence of its dimensions survived as its eastern edge was truncated by a later drainage ditch (**214**), although it appeared to run south beyond the limit of excavation. Drainage ditch **214** was placed along a north-south alignment, following the topography of the field.

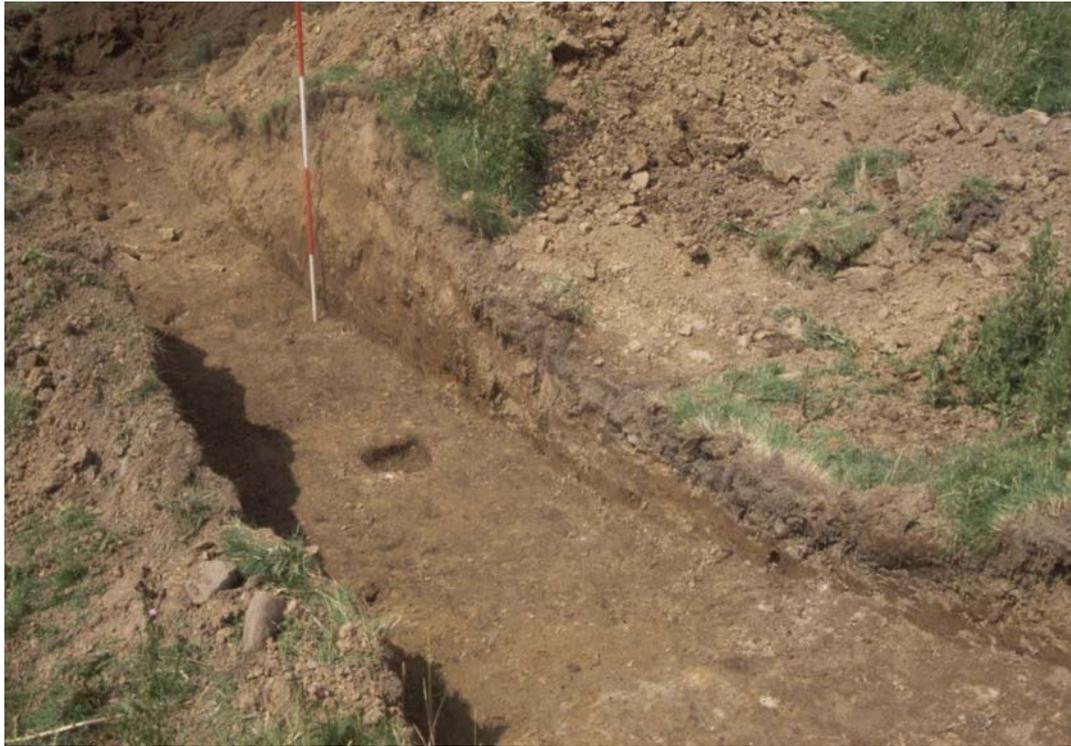
Plate 3: South-facing section through bank (Site **04**, Trench 1)

4.2.5 The fabric of the bank (**52**) comprised reddish-brown clay-silt with frequent stone inclusions (Plate 3) that had mostly been excavated from ditches **51** and **53**, and also possibly imported from quarried features in the vicinity, giving the bank an overall width of 4m. The western area of the bank contained lenses of sandy-clay ranging in colour from grey to yellow, with frequent decayed organic matter. It is possible, therefore, that this area of the bank was at some time lined with trees. The material around the summit of the bank had

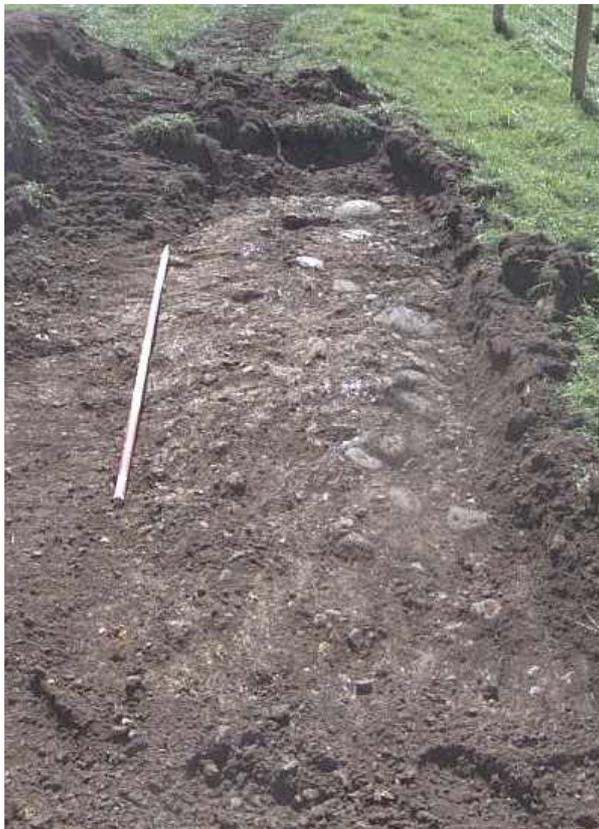
Plate 10: Site **09**, example of cobble preservation (220) along the course of the Roman road, looking south

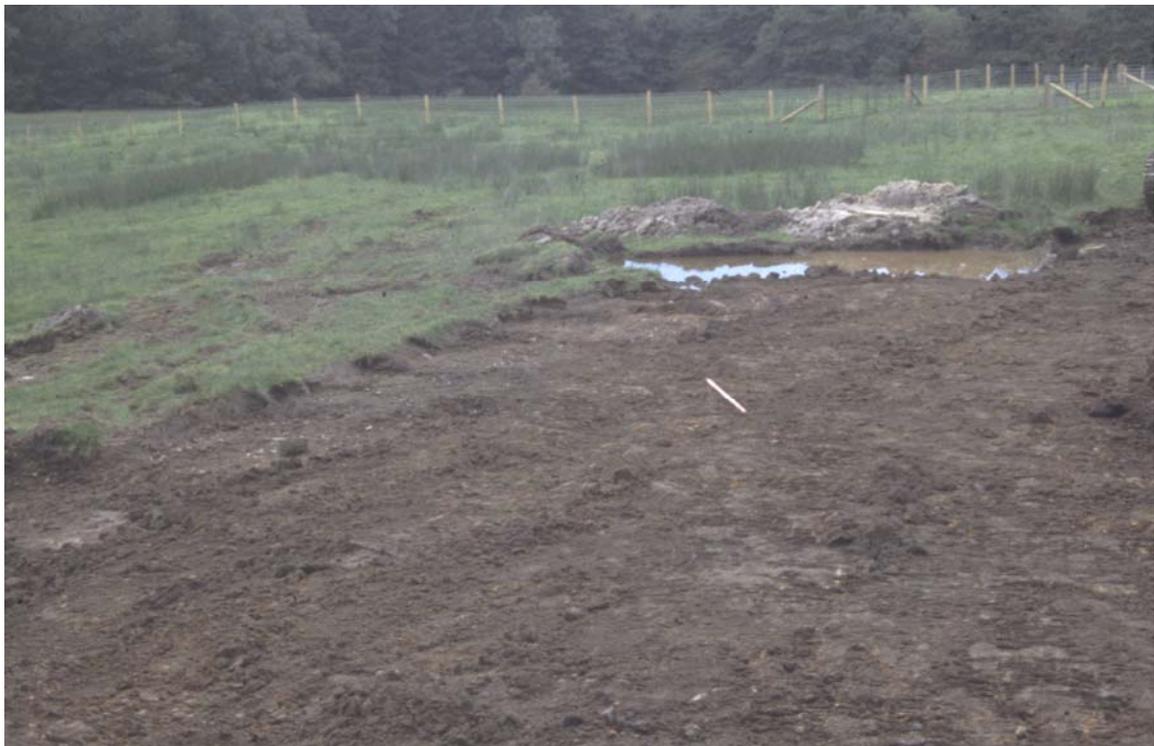
Plate 12: Site **09**, Roman road deviation, looking south-west along bank **216**

- 4.3.14 **Road Deviation:** the line of the Roman road, at the point of Trench 5, appeared to deviate from the projected course, on an alignment through the trees of New Plantation. The deviation was clearly defined by an 11m wide raised bank (**216**) that traversed the field along a north-east/south-west alignment (Plate 12) heading towards the river. The alignment suggests an attempt was made to avoid the marshy areas at the bottom of the field. Two 15m wide hollows (**I3**) observed at the west end of the bank may possibly be the remnants of the quarries used to construct the earthwork.

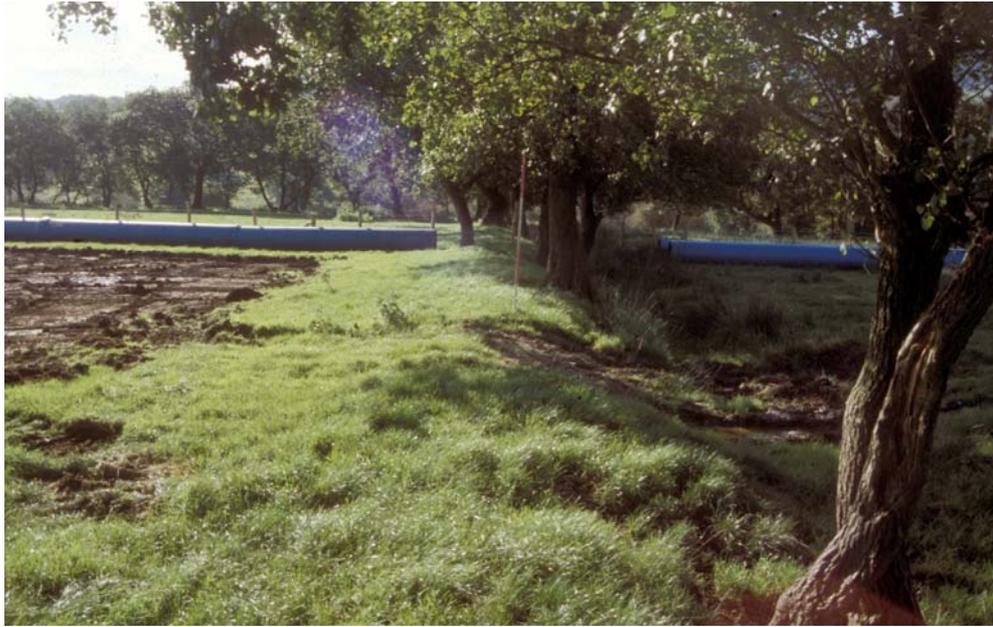
Plate 13: Field boundary 7 in Field 3

- 5.3.3 **Field 3:** the easement transected the southern edge of the field along an east/west alignment. A single ditched-and-hedged field boundary (**7**) was observed on a north/south alignment at the western end of the field (Plate 13). The boundary comprised a slight earthen bank and ditch lined along the summit with young oak trees. The bank survived to a height of 0.5m and 2.5m in width. The ditch extended to a width of 1.2m and survived to a maximum depth of 0.37m. A maximum 0.10m in depth of topsoil was removed from the top of the bank exposing the bank material, which comprised heaped, large round pebbles, probably intended to stabilise the earthwork.
