# **ESHTON HALL, GARGRAVE North Yorkshire**

## **Desk Based Assessment**

**Document Type:** Archaeological Desk Based Assessment

**Client Name:** Dare Northern

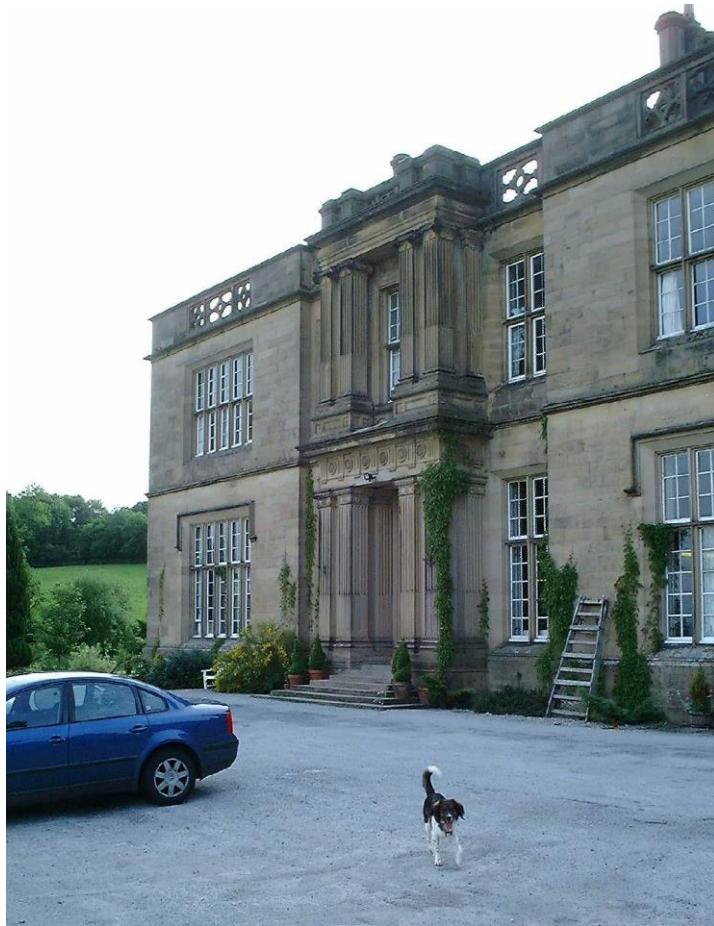
Plate 3: Front, East, External Elevation, South End, Looking South-west

- 4.1.3 Externally there was little evident alteration to the building. The main block still retains all of its original features, the projecting porch, strapwork parapet and even the five-light windows (Plate 3). The service wing on the north side has also been left virtually untouched, with only minor cosmetic alterations visible (Plate 4). The courtyard to the rear is more revealing as some of the outbuildings have evidently been heavily modified, with several doorways being blocked, and parts being added at a later date (a blocked window on the east side has an outbuilding butting onto it). The north elevation of the main block, visible from the courtyard, has a very evident scar from a gable wall visible, with brick blocking what is probably a former flue (Plate 8). It is not clear whether this is a former gable, which has been extended into a taller, flat topped wall, or the mark from a gable roof that butted against this wall, although the stonework around it is of a very rough, non-ashlar, finish.

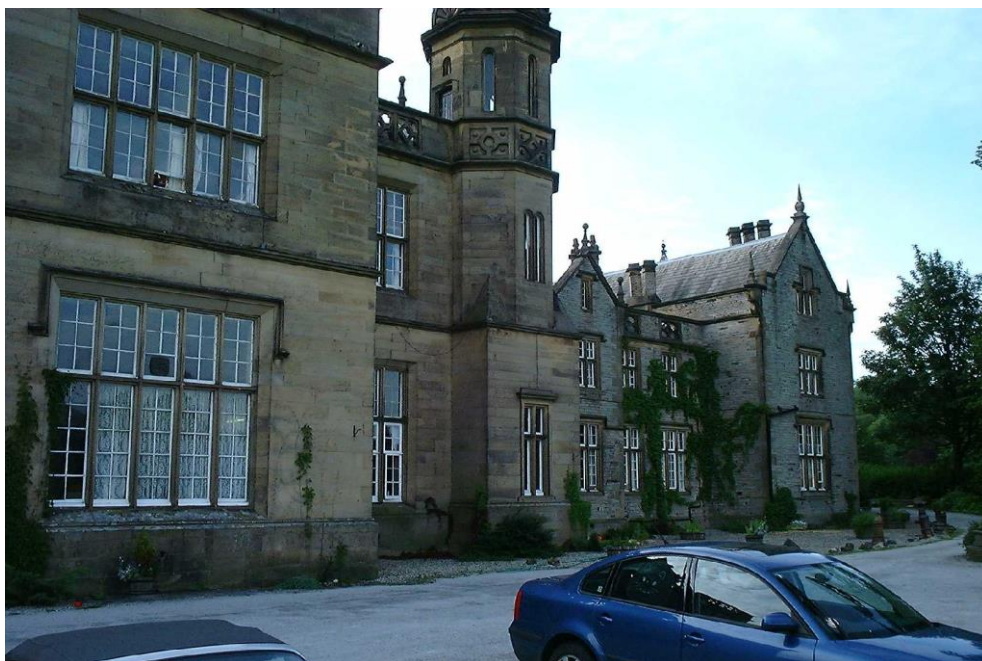
Plate 4: Front, East External Elevation, North End, Looking North-west

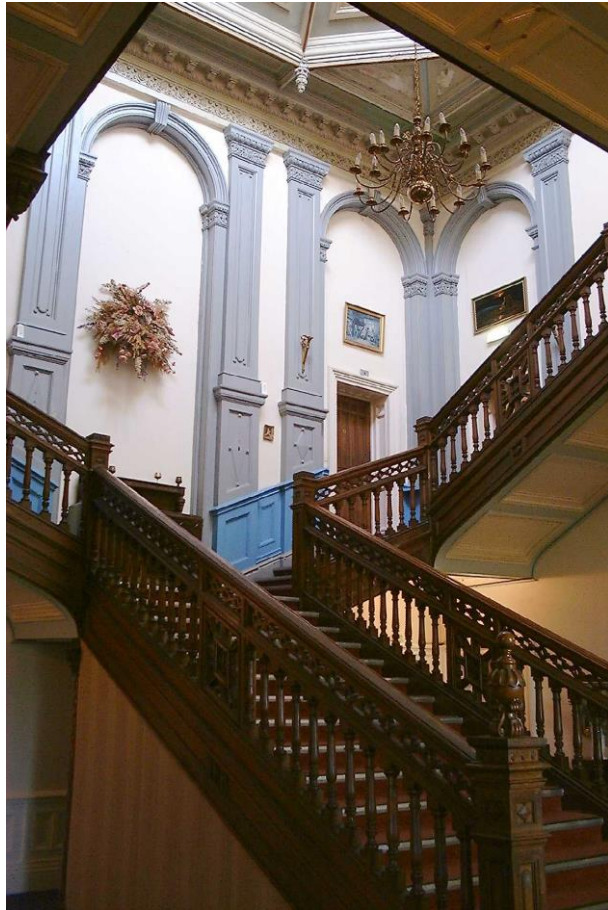
Plate 5: Main Staircase, Looking North-west

- 4.1.2 The five main front rooms of the entrance hall, main staircase, two library rooms, and dining room are in a remarkably good state of repair. The decorative pillars on the walls of the entrance hall, the bookcases in the library (Plate 10), the decorative plaster ceilings and cornices and the marble fire surrounds (Plate 9) are all still intact, as is the main staircase (Plate 5) and glass dome above. The adjoining rooms were not examined, but it was clear on the first floor that numerous modern partition walls had been added to form smaller bedrooms.

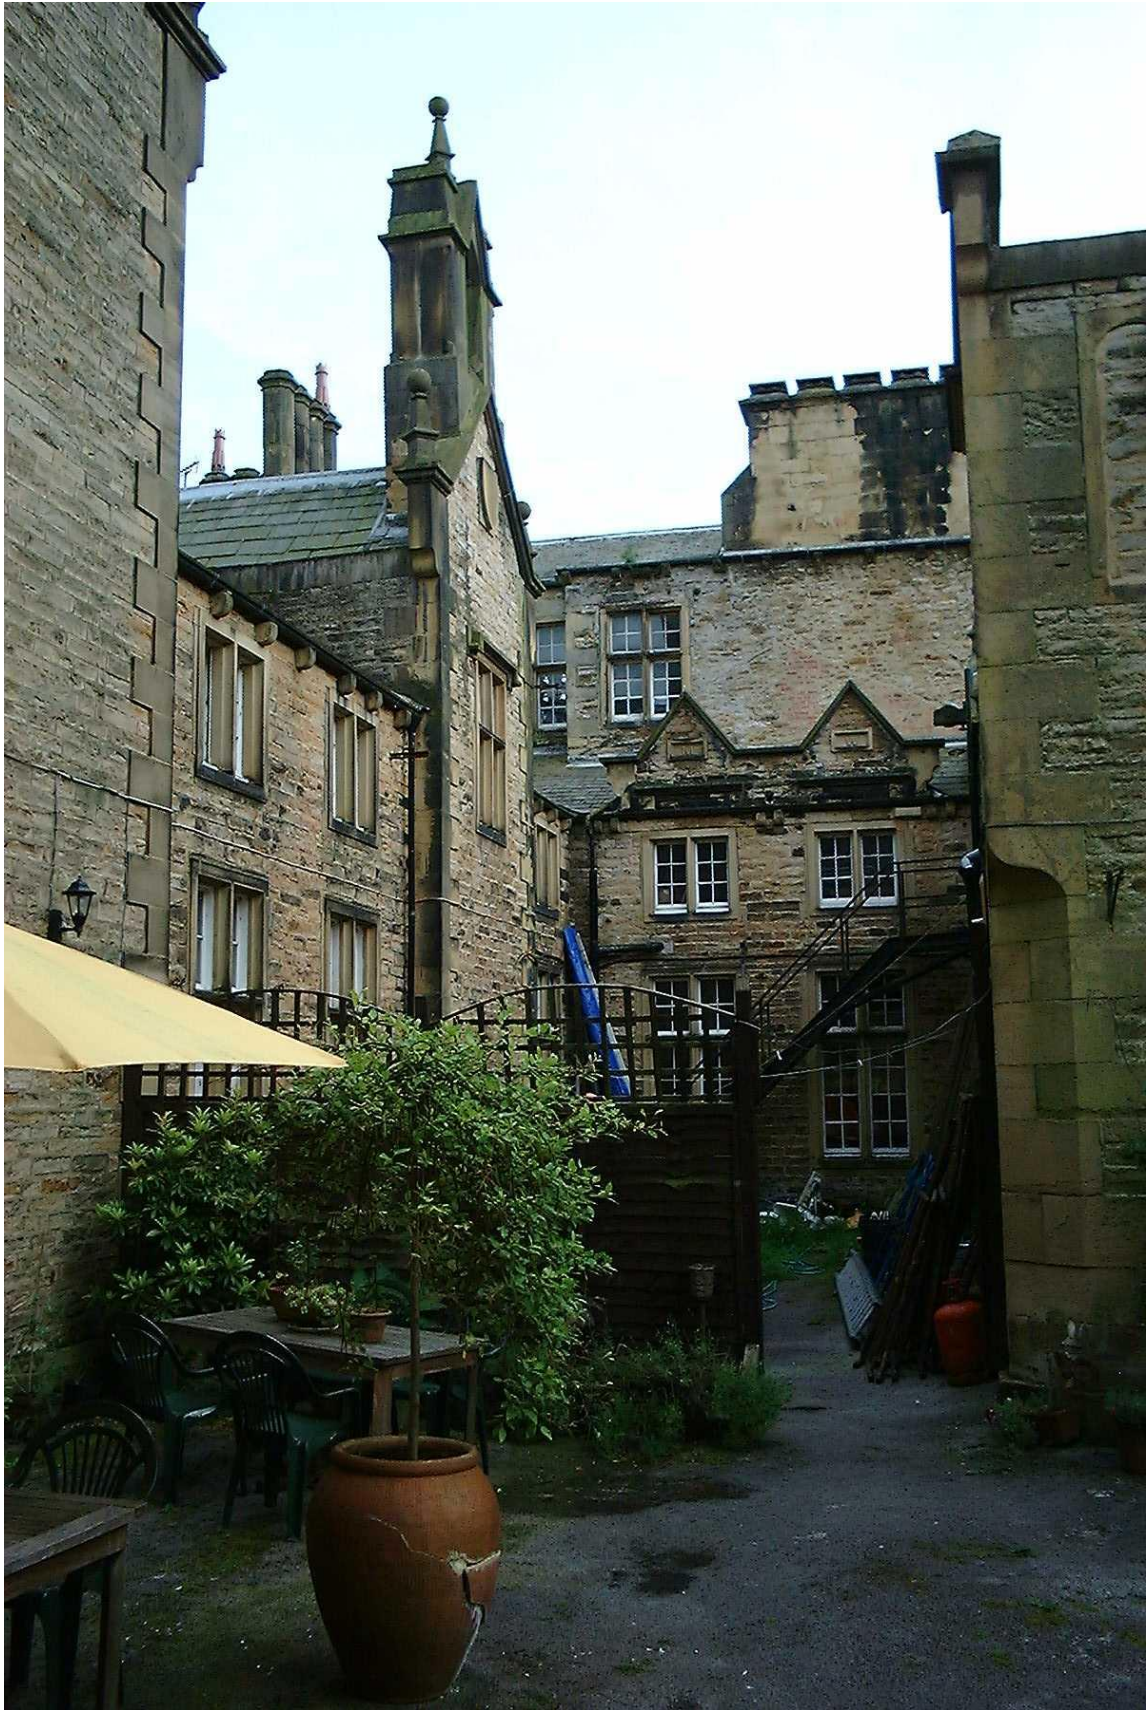
Plate 8: Detail of Courtyard, Showing Gable Scar, Looking South

- 5.2.2 The site visit revealed only one area where remains of an earlier building were evident. However, the large-scale of this one piece of evidence might suggest that other parts of an earlier building survive within the fabric of the current hall. It may, in fact, be the case that the ashlar stonework of the main hall block is simply cladding parts of an earlier building. The reference to possible mullioned windows in the cellar further suggests that the remains of an earlier building may be present within the fabric of the current hall.

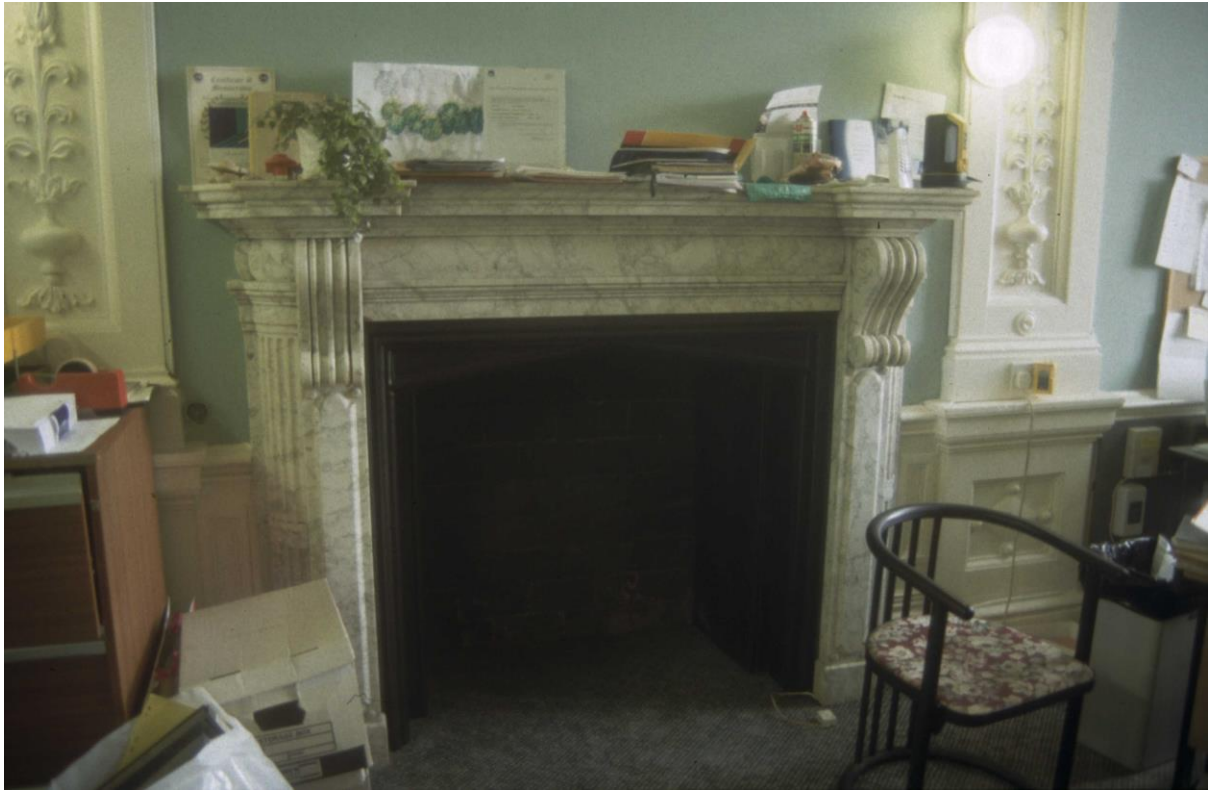
Plate 9: Marble Fireplace in Entrance Hall, Looking North

186; Anon 1885) (Plate 10). She was evidently closely involved in the design of the new hall, not only creating the library, but also adding fireplaces (Anon 1885). These were evidently also designed by Webster, as the ledger for 1828 to 1836 (SCMS 417/29) ‘under Miss Currer’s Payments’, states: ‘Feb 3<sup>rd</sup> 1831: Paid Mr Webster of Kendale the balance of his bill for Marble fireplaces, Marble Table, a slab...’ (Plate 9). Further work was carried out on the hall between 1835 and 1839, and, although it is not clear how extensive this was, it included ‘alterations at the back part of the house’, as well as the entrance ‘pillars and walls’, and work on the garden and roads (SCMS 417/15/10-11).

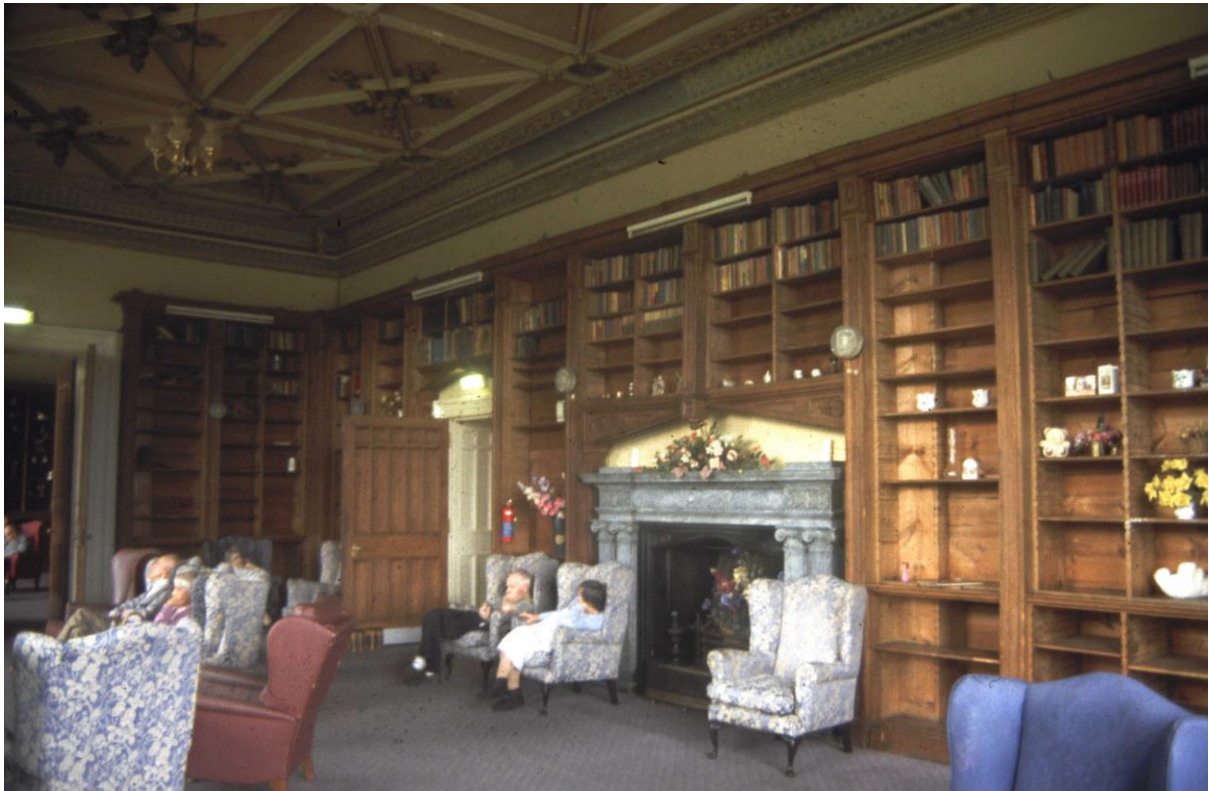
Plate 10: East Room of Library, Looking West

- 3.2.12 Miss Richardson-Currer had her own unique impact on the development of the hall by assembling a huge library of historical and topographical works, housed in two large rooms on the south side of the building (Montagu 1838,
