PARKHOUSE FARMHOUSE

Barrow-in-Furness, Cumbria

Watching Brief

Document Type: Archaeological Watching Brief Report

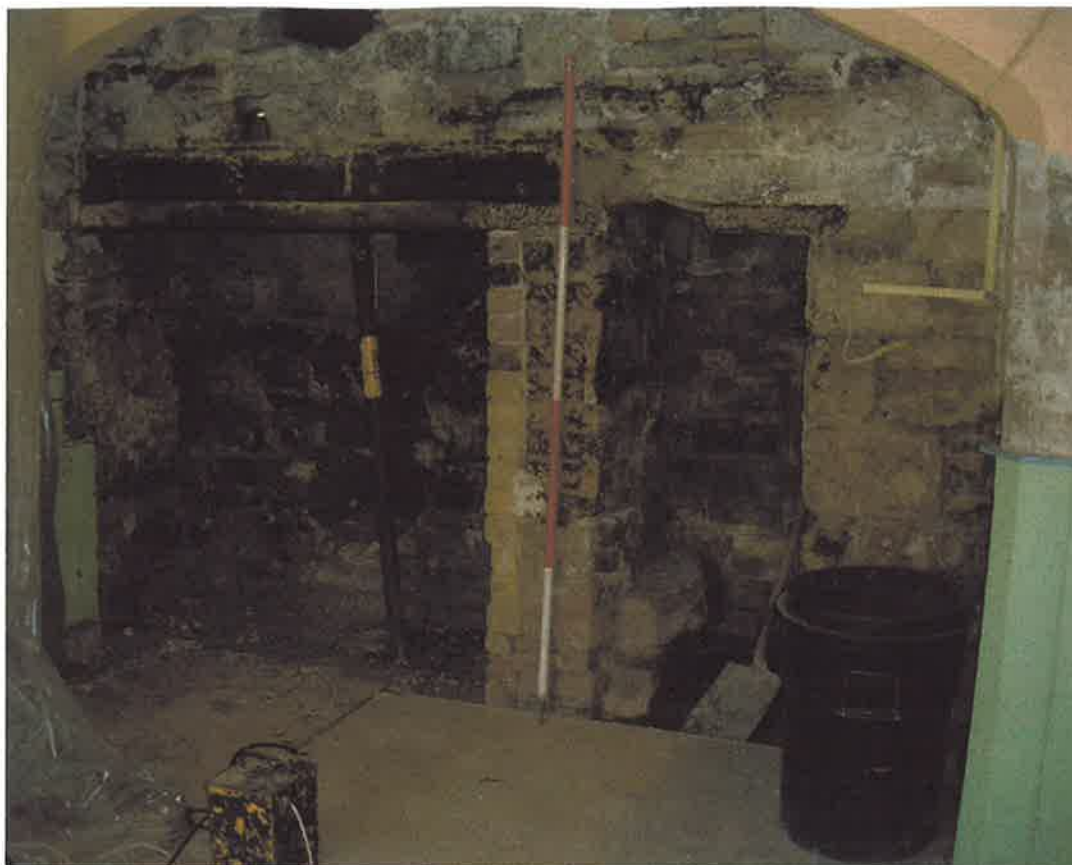
Plate 1: Fireplace following the removal of the range and unblocking of oven *106*, looking west

4.2.2 The fireplace, following the removal of the range and unblocking of the aperture to the right, consisted of a large opening to the left (south) where the range had been (*102*), with a stone lintel supporting stone infilling above (*105*) (Plate 1). A further RSJ-type lintel also supported this (*107*), although it was largely concealed behind the stone arch. The back of this opening was sandstone, part of the original wall (*101*), although a large hole was broken through it for the new window. The aperture (*106*), once cleared, could be seen to be an oven or smoke room, as there was a slate lined flue linking it to the main flue of the chimney to the south. The aperture was formed by the addition of the stone infill, *105*, above and to the right, and a brick pillar (*104*) to the left, with a stone lintel. South of this brick pillar was another, one brick thick (*103*), which had presumably been added to fit the range. The back of the oven utilised the original stone wall of the fireplace, although it had been augmented by the addition of bricks to support the slate flue, and there was a further small opening above the lintel (*110*), apparently linking into the flue, although it was not clear how (Plate 2). This aperture was blocked with a mix of

- 106** – oven formed between **104** and **105**. 0.62m wide, 0.7m deep, 1.6m high. Flue in the top links it to the main chimney and possibly to **110**.

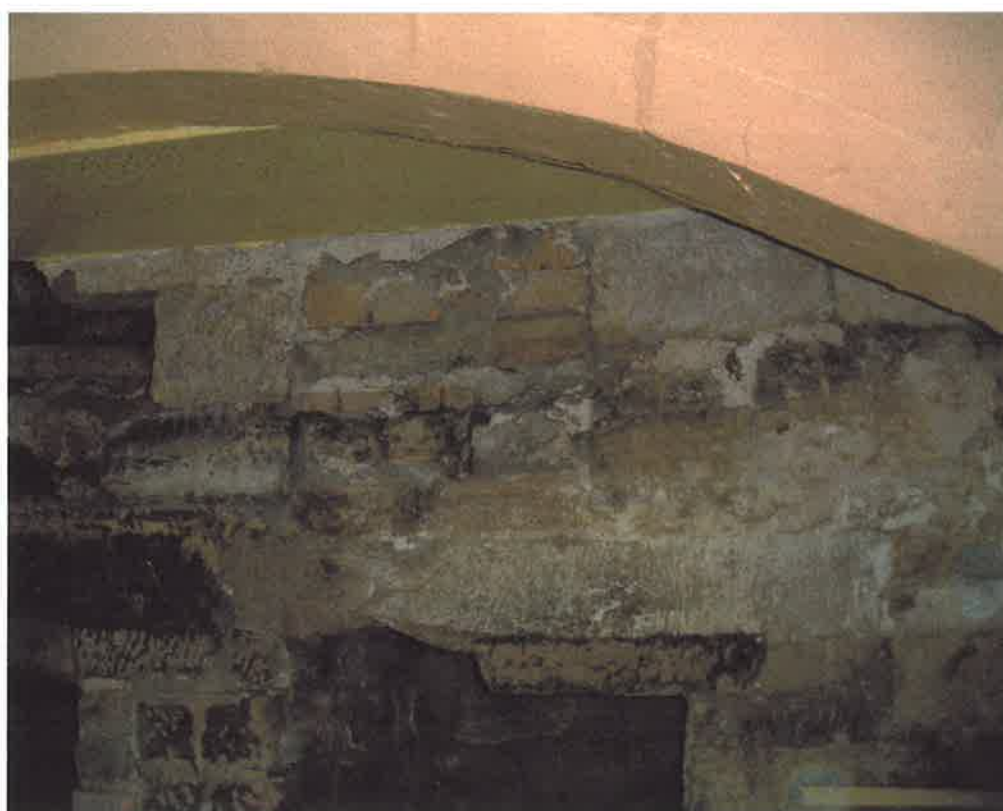
Plate 2: Detailed shot of the smaller aperture, *110*, looking west

brick and stone, with timber wedges around the edges, which would have originally supported a doorframe, and may have been a spice cupboard (Denyer 1991, 20). At the base of the lower, larger aperture (**106**), there were large unfinished sandstone blocks c 0.3m higher than the floor level, which presumably indicate the level of the base of the oven.

- 110** – small aperture above **106**, 0.4m wide by 0.5m tall. Unclear function but appears to link to the flue from **106**. May have been a spice cupboard, blocked with brick and stone.

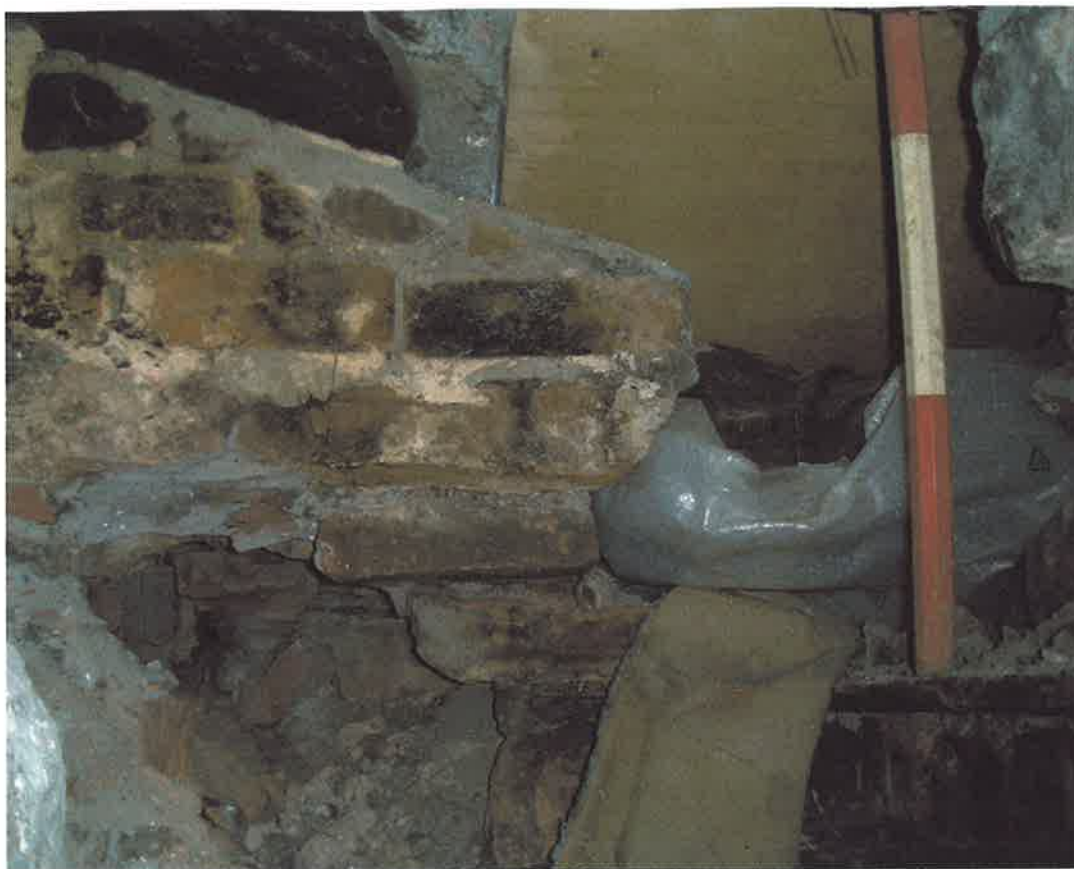
Plate 3: Detail of the brick and slate construction of the flue within *106*

4.2.3 After brick pillars **103** and **104** had been removed and the lintels forming **102**, **106** and **110** had been taken down, it was possible to examine in more detail the interior of the fireplace opening. It was clear that the stone and brick infill (**105**) was far more extensive than was evident from outside. The reduced opening above **102** was even further reduced at the top to form a funnel-like flue or canopy. This in turn linked into the flue from **106** and also turned southward into the wall, presumably connecting with the chimney above the internal gable to the south (Fig 3; Plate 3). Once the majority of the infill had been removed it was evident that it had not only been infilled but also partially broken into the original wall, presumably to provide support for the weight of stone above. The result was that in places fabric **101** was unrecognisable from the fine finish seen elsewhere in the building. Indeed, in the back of the chimney, through the back of the fireplace, the wall was almost ruinous and only covered by modern timber boards, which form what appears to be an outshut roof externally (see Section 4.3.1).

- 105** – stone infill containing **106**, **110** and probably **109**. A mix of roughly-finished sandstone courses and the occasional brick, with brick and slate forming the flue linking **106** to the main chimney. Included sandstone lintels over **102** and **106**. Also forms a canopy-style flue within the main chimney. Bonded into **101** but later.

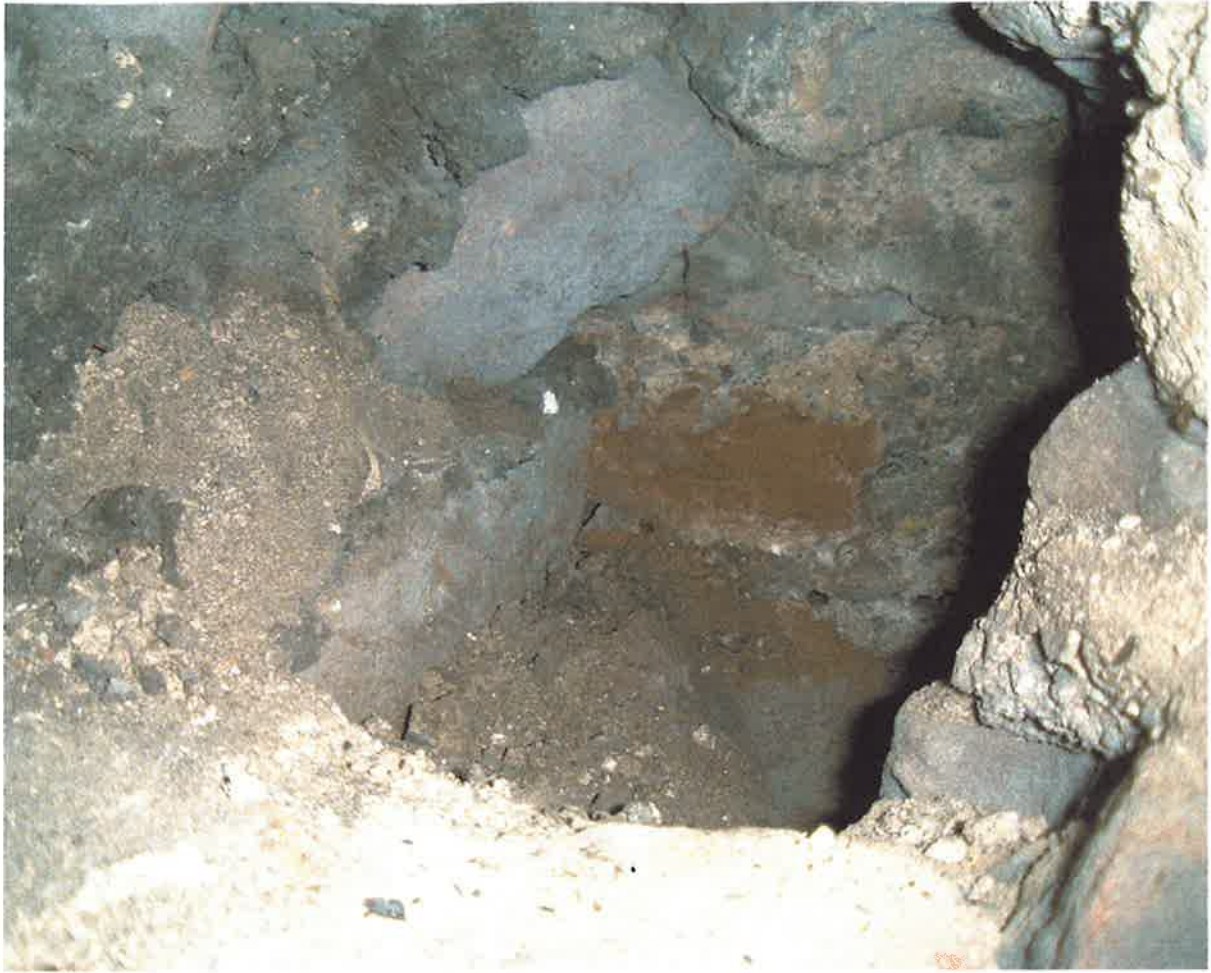
Plate 4: Inside of side oven **109**, looking north

4.2.4 To the right of **106**, but still within the original fireplace opening, was an area of apparent rebuilding and voids within **101**. This was not exposed during the renovation but further investigations revealed it to be a probable oven (**109**), blocked with loose sandstone (**108**). This appeared to be a later addition, inserted into the wall, as the stone finish was very poor compared to the rest of **101**. The oven was 0.5m wide and 0.34m deep, with a U-shaped plan and roughly finished faces, all in sandstone (Plate 4), and there was at least one hole drilled into the surrounding stonework, perhaps to support a doorframe.

- 107** – RSJ-type lintel, supporting **105**.
- 108** – loose sandstone blocking side oven **109**.
- 109** – small side oven, 0.5m wide by 0.34m deep. U-shaped plan, stone lined and probably inserted into **101**.

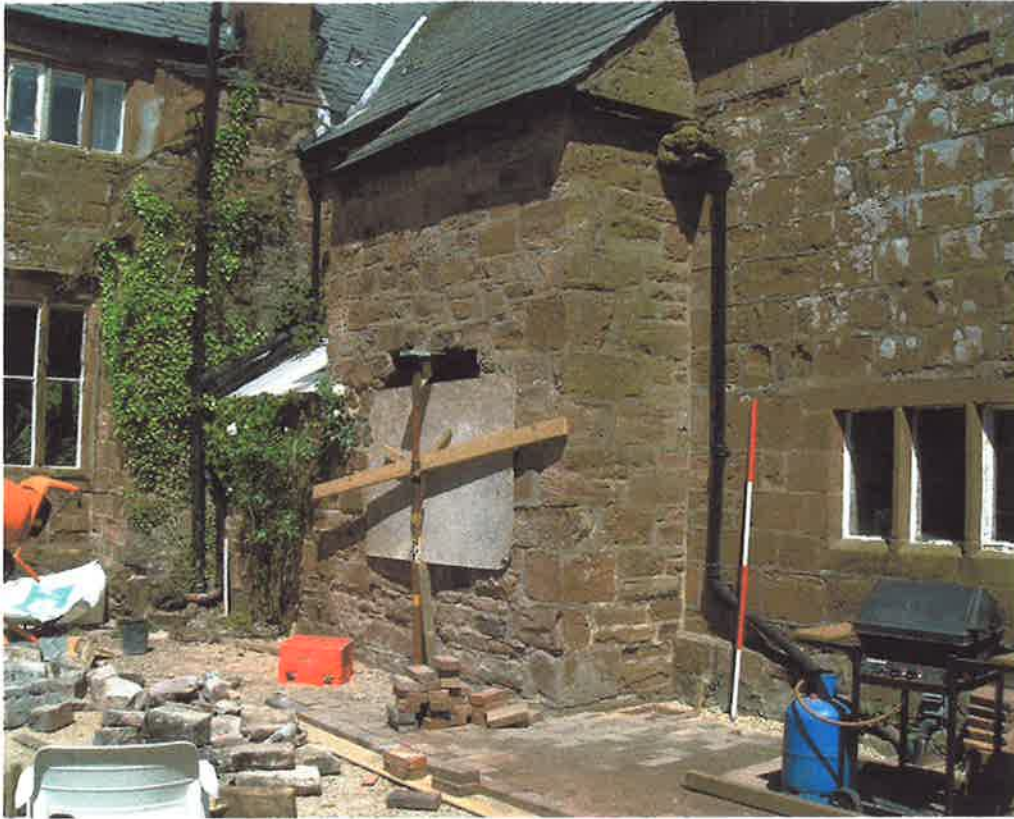
Plate 5: The chimneybreast from the outside, showing the gargoyle and relationship to the parlour, looking north-east

4.3.1 *The chimney:* examination of the relative external elevations revealed several features of interest. It was clear that there had originally been a large chimneybreast on this side of the building, like that attached to the parlour, connected to the kitchen fireplace. In this case, however, it had been significantly reduced in height to only 12 courses of poorly finished ashlar blocks with quoined corners. It had evidently been remodelled at least once as the stonework appeared to butt the main wall, covering a plinth course, and incorporated a reused gargoyle (presumably a part of the Abbey) (Plate 5). The reuse of material from the Abbey would suggest a late sixteenth century date, at the earliest, for rebuilding of the chimney.
