Fritwell Goose Farm

Archaeological Evaluation Report

July 2014

Client:
Lady Georgina Bowman-Shaw

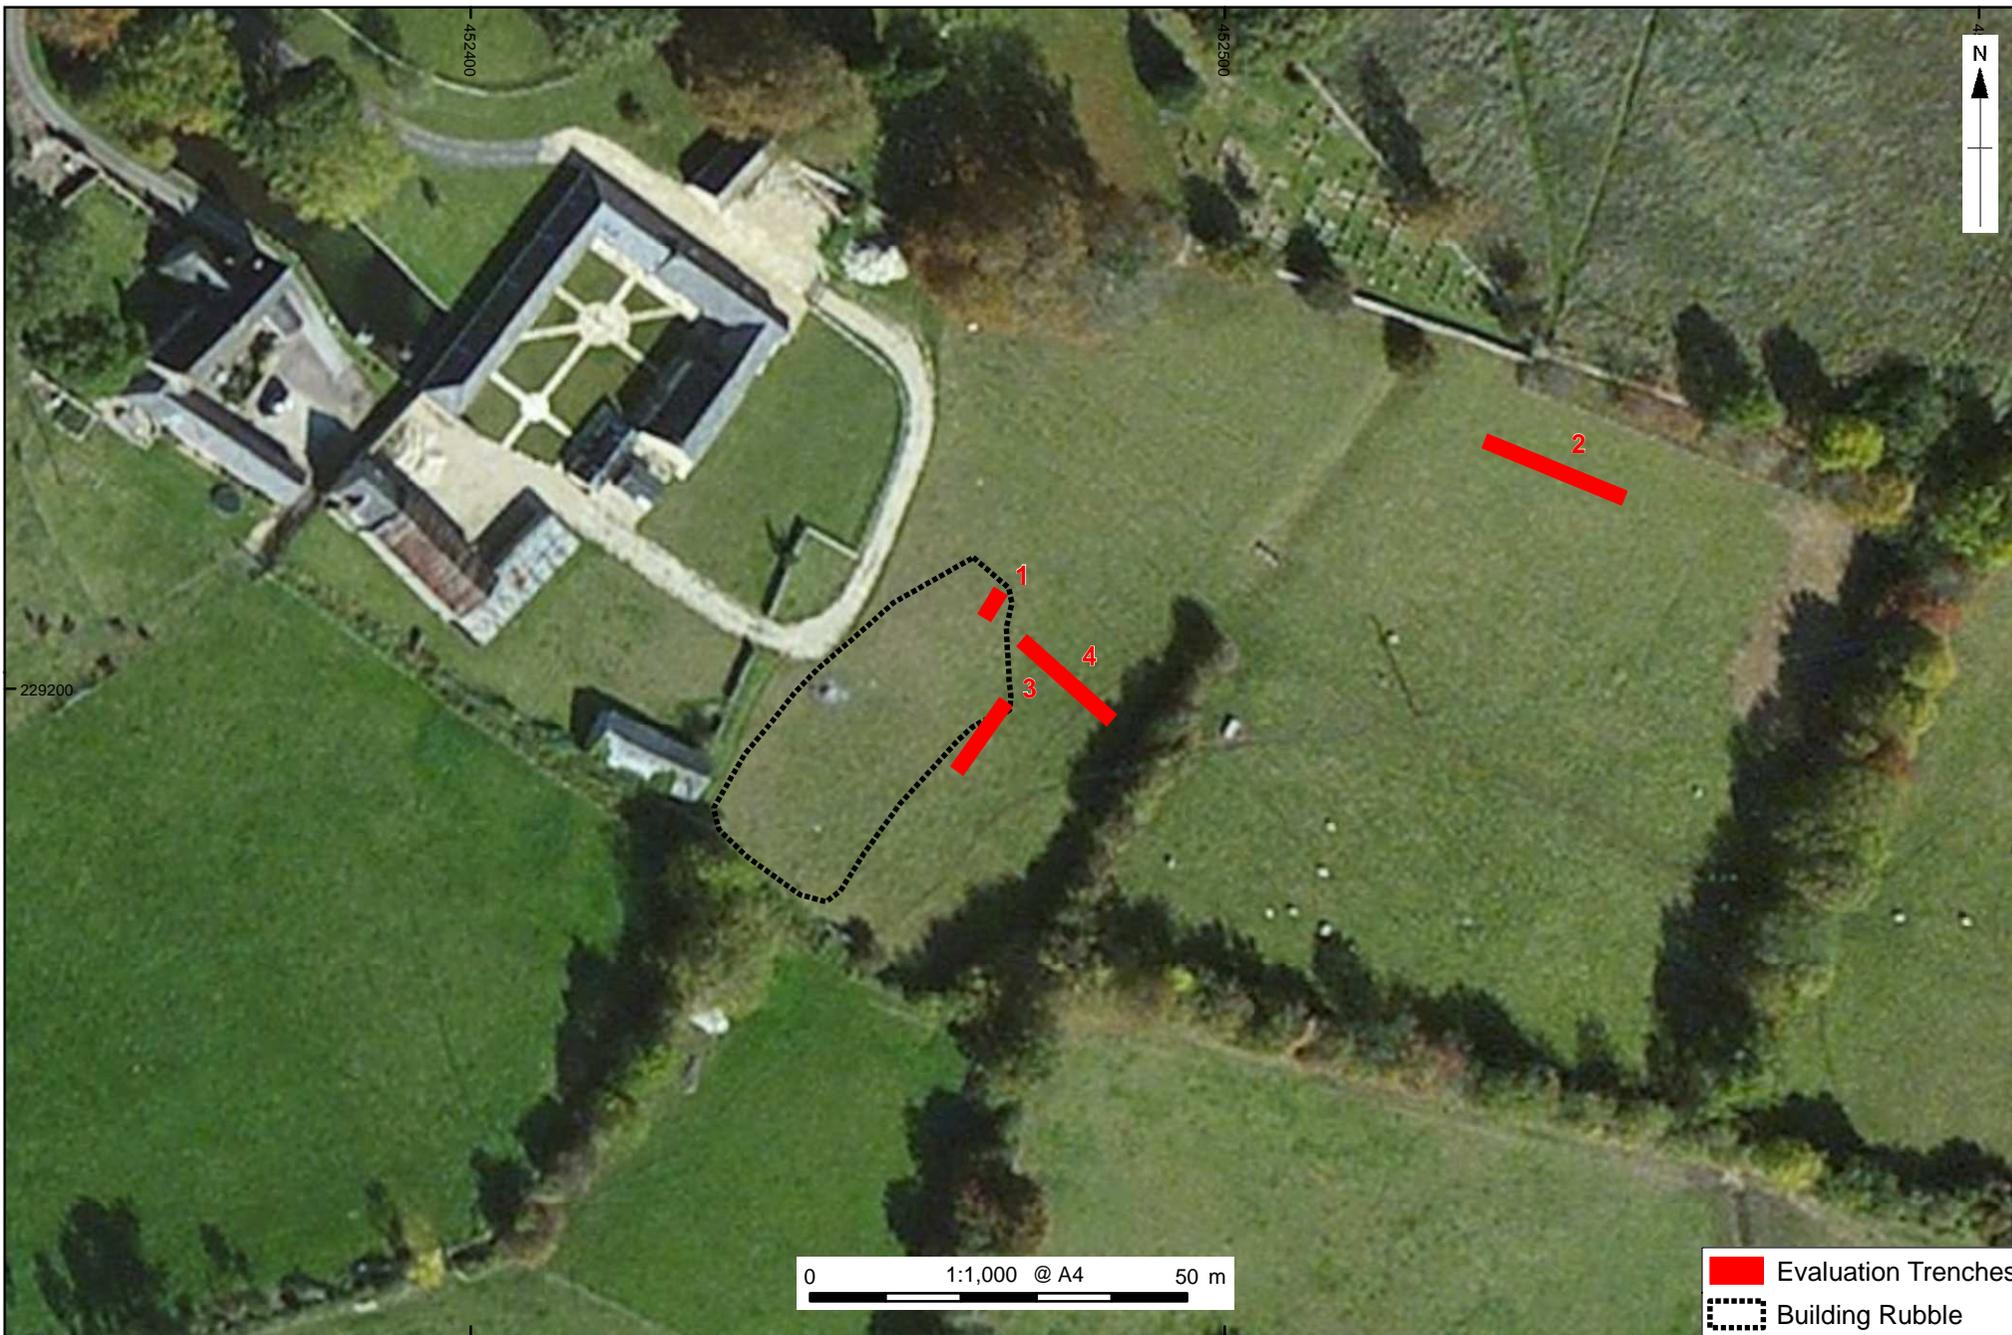
Figure 2: Trench locations

- 2.2.1 A programme of four trenches were excavated across the site targeted on the proposed development areas (figures 2 and 3). It was initially proposed within the WSI (OA 2014) to excavate 2 trenches, each 20m by 1.8m across the site to investigate the areas of the proposed pond and woodland planting.

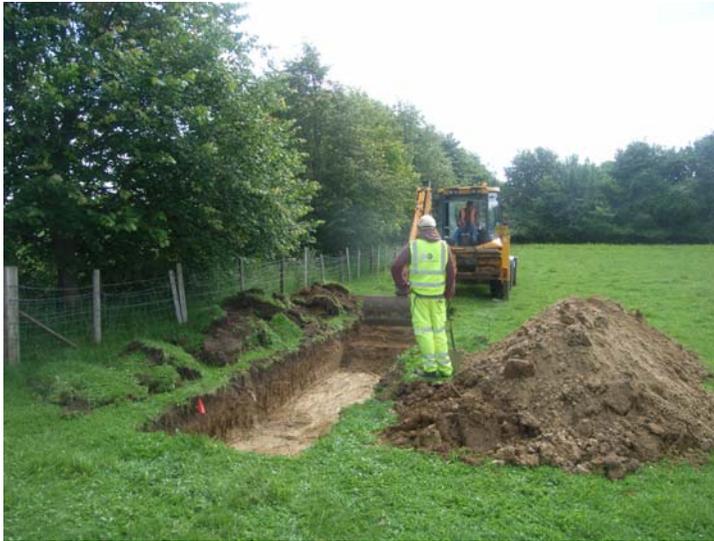
Plate 1: Machine excavation of Trench 2 looking south-east

- 2.2.4 Each trench was excavated using an appropriate mechanical excavator fitted with a toothless bucket under the direct supervision of an archaeologist (plate 1). Spoil was stored adjacent to, but at a safe distance from the trench edges.

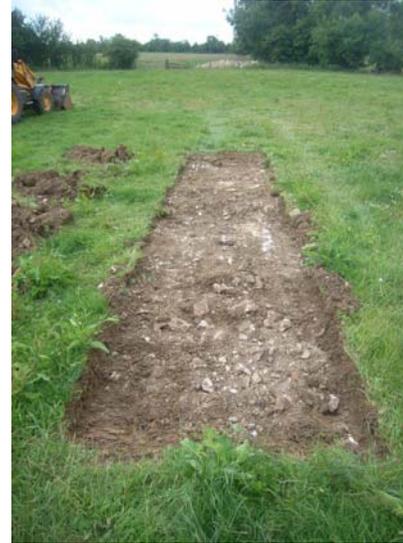
Plate 2: Trench 1 looking north-east

3.4.1 The trench measured 1.8m by approximately 5m and orientated north-east to south west. The trench was initially moved approximately 5m to the south from its proposed position to avoid suspected services. The trench was abandoned after 5m following the discovery of modern demolition rubble containing suspected asbestos roof tiles directly underneath the turf (plate 2).

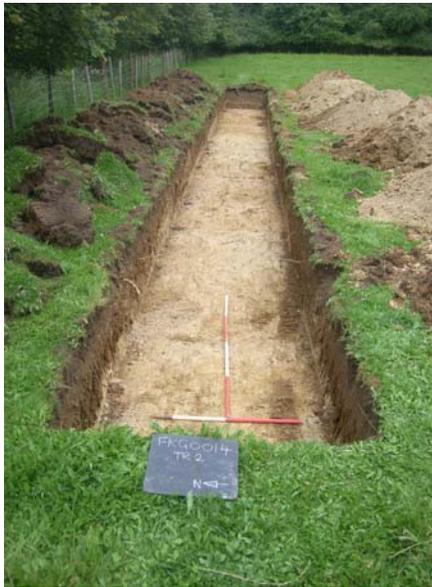
Plate 3: Trench 2 looking south-east (1m and 2m scales)

3.5.2 The natural limestone was encountered at the base of the trench at an average at 0.7m. This was overlain by 0.5m of subsoil and 0.2m of topsoil. No finds were recovered and no archaeological features were identified (plates 3 and 4).

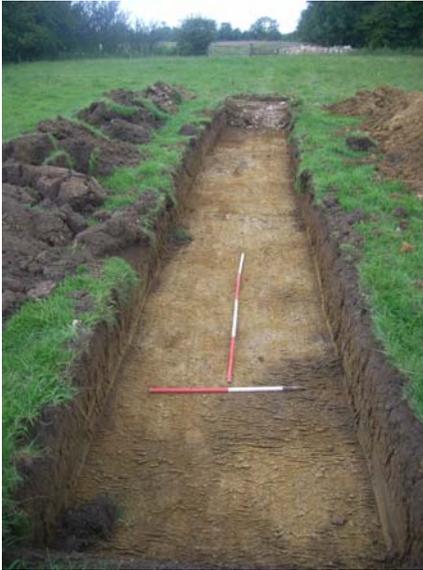
Plate 5: Trench 3 looking north-east (1m and 2m scales)

3.6.1 The trench measured 1.8m by 10m and was located along the same alignment as proposed Trench 1. The natural deposits at the base of the trench were overlain by 0.3m of subsoil and 0.2m of topsoil. Similar demolition debris as uncovered in Trench 1 was also found at the north-western limits of this trench and was abandoned (plates 5 and 6).

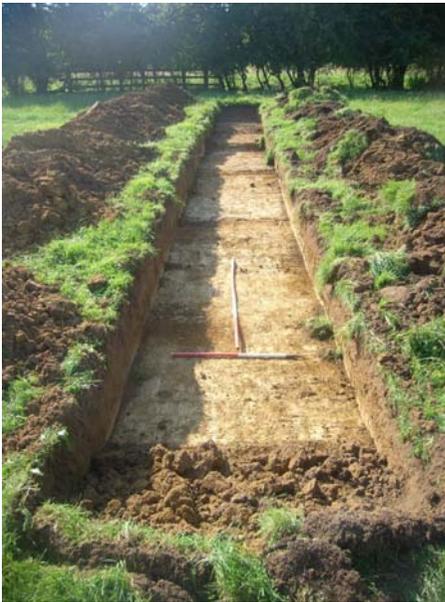
Plate 7: Trench 4 looking south-west (1m and 2m scales)

3.7.2 The trench was excavated to natural limestone at a depth of 0.55m (plate 7). The natural was overlain by 0.25m of subsoil and sealed by 0.30m of loamy topsoil (plate 8).
