# Land at Croston Hall Estate, Croston, Lancashire

## Archaeological Strip, Map and Record Report

February 2018

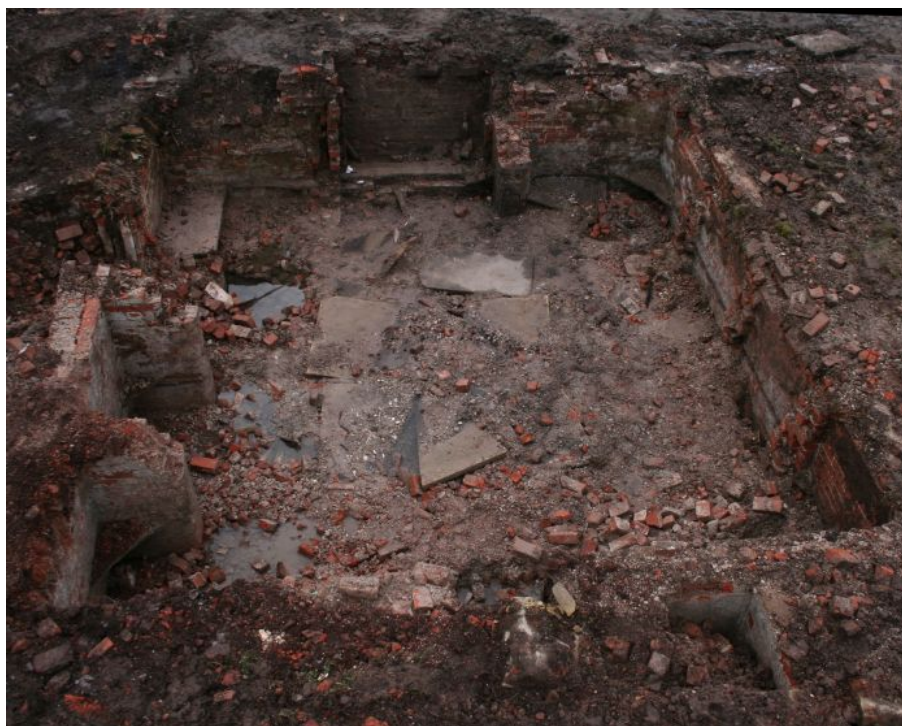
Plate 1: South-facing view of Room 12

3.2.3 There were five cellars situated beneath the house, Room 12 being positioned to the east of the main house. Room 12 comprised red brick walls and had the best-preserved stone flag floor (although still very fragmentary) of all the cellars (Plate 1, Fig 3). Recesses were present around each wall, each set with a stone shelf. A dumb waiter was recorded on the southern wall, with slate weights found *in situ*. Amongst the demolition rubble, stone sinks were observed, suggesting

the main function for this cellar was storage, perhaps associated with the kitchen, or a utility room. The room was accessed from stairs located on the eastern side of the room. The walls were unstable, so detailed recording was not carried out.

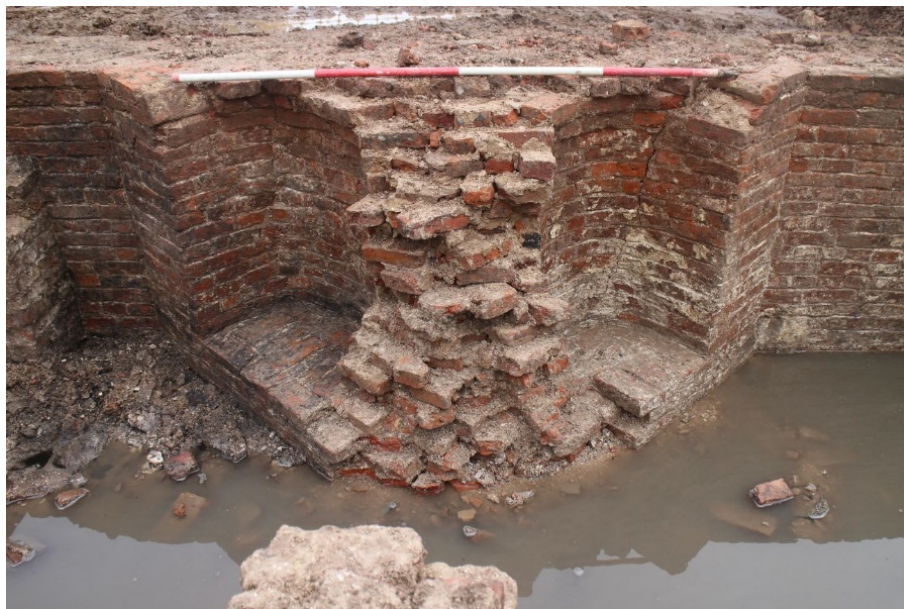
*Plate 2: East-facing view of boiler stands 102*

- 3.2.6 **Room 3:** Room 3 was adjacent to Room 1, to the north (Fig 4), and incorporated Room 2 in the south-west corner. The wall between Rooms 1 and 3 had a bricked-up relieving arch. Two semi-circular brick-built boiler stands (**102**) were observed built into the eastern wall (Plate 2). They were built side by side, one facing north-west, the other south-west. Each measured 2.7m along the back, and 1.6m wide at the deepest point. Each recess was 0.8m wide. It was likely that the two boiler stands were originally on either side of a dividing wall, in different

rooms. Wall **103** probably went all the way across the width of the room, with a doorway situated halfway across. It is not clear if the unconsolidated state of the wall between the two boiler stands was the result of the demolition process or whether the wall was left in this 'rough' state when the eastern part of **103** was demolished, presumably at the time that walls **106**, **105** and later **104** were added to from Room 3.

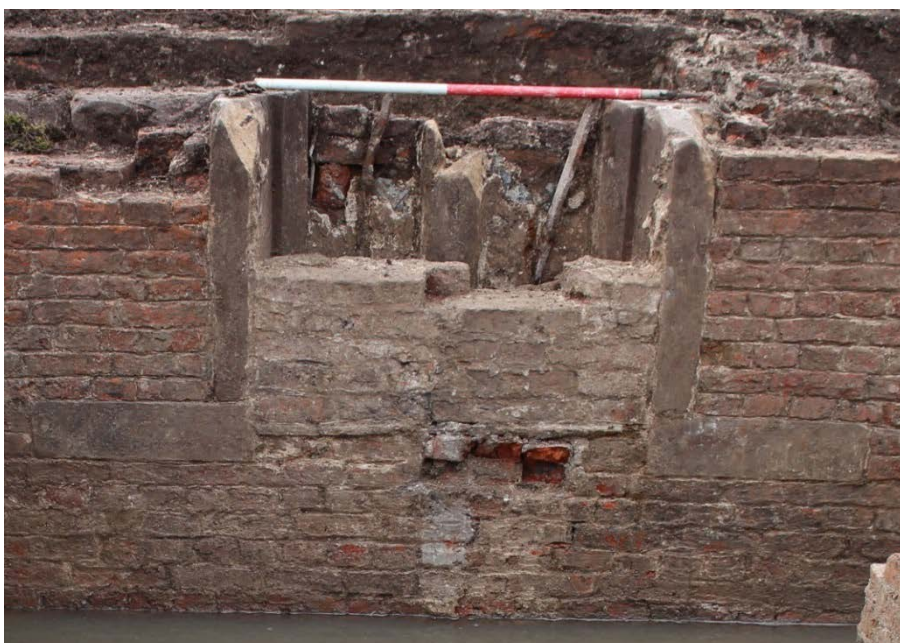
*Plate 3: West-facing view of window 123*

3.2.7 On the western wall, mullioned window **123** was observed (Plate 3). The window was 1.2m wide, 0.65m deep, and survived to a height of 0.92m. The central mullion was stone, and vertical iron bars divided the window further, into four panes. The original glass was preserved behind the bricks that had been used to block the window once it had gone out of use.

- 3.3.2 **Glass:** the sheet glass from window **123** is of interest, as it is likely to pre-date the Victorian house. The relatively thin greenish sheet glass is typical of that produced in the later seventeenth and early eighteenth centuries and is likely to be muff-blown. Two fragments retain grozed edges and one of these is an almost complete triangular window quarry (Plate 7), differential weathering indicates that it was set within lead came, and several fragments of came were recovered from the same context. The deep H-section of the came, and the wide spacing of the internal milling, suggest an eighteenth or nineteenth-century date, and considered alongside the window quarries, might suggest a window light with eighteenth-century origins, presumably deriving from an earlier incarnation of Croston Hall, built in the seventeenth century.

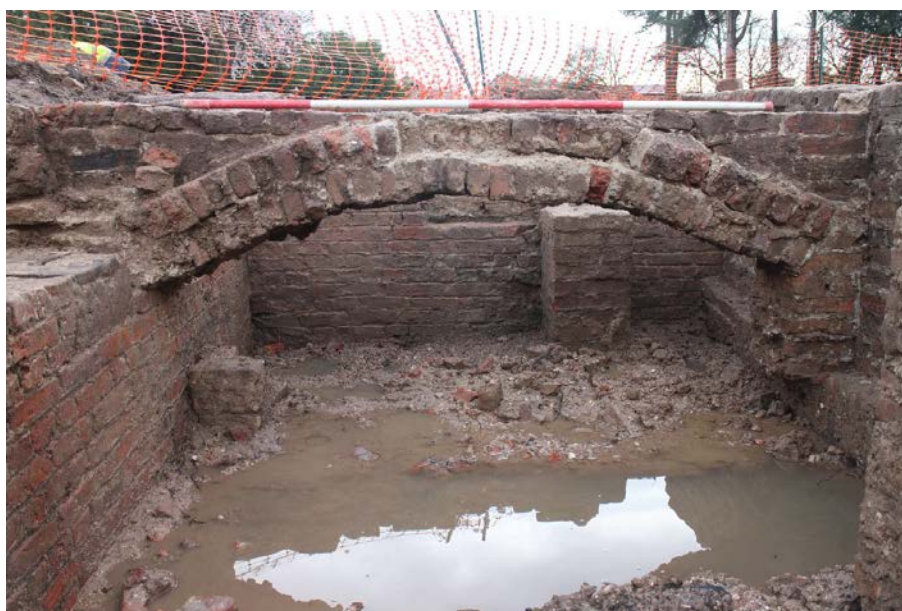
*Plate 4: East-facing view of the arch added to Room 4*

- 3.2.9 Room 4 was further modified, rearranging the space, and presumably how it was used. A north/south-aligned arch was added across the eastern side (2.7m long; Plate 4, Fig 4), perhaps signifying a change to the internal structure of the house above. In order to accommodate the arch, the floor level was dropped (although no evidence of this was visible due to the high water table obscuring the base of the excavation). Additional buttresses were built against wall **112** on the western side of the room, with corresponding buttresses against the eastern wall.

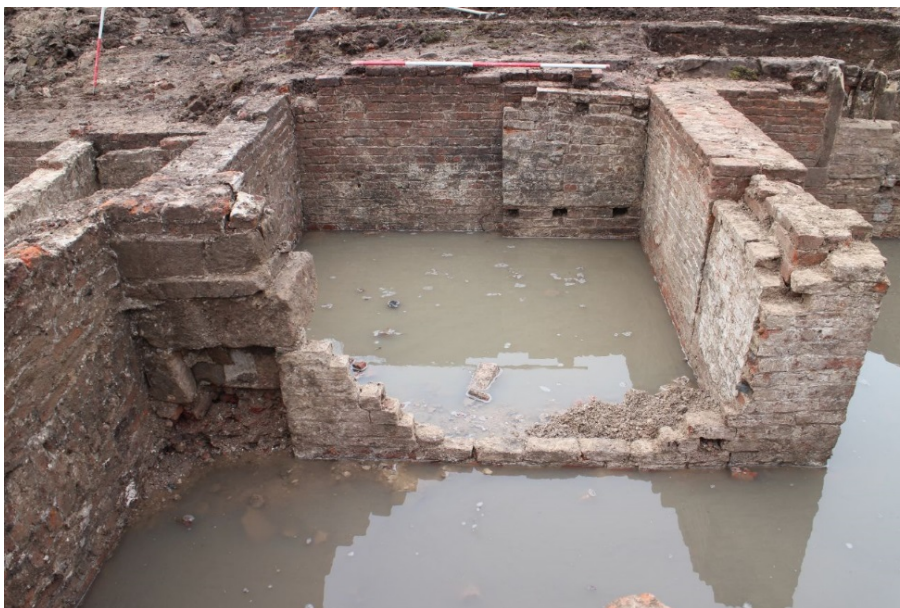
*Plate 5: Room 2, west-facing view*

- 3.2.5 **Room 2:** Room 2 was built in the south-western corner of Room 3, and had obviously been constructed in several phases. The northern side of the cellar comprised wall **103**, which was extended with the addition of wall **106** (0.9m long) which was not tied in. A further short section of wall, **105** (0.6m long) formed the southern part of the eastern side of cellar 2. A short section of wall was built up against the western wall at the northern end, which had holes for east/west-aligned joists at the base and approximately 1m above (Plate 5). The gap between this and wall stub **106** was eventually bricked up by wall **104**, which was a single skin (2m long).

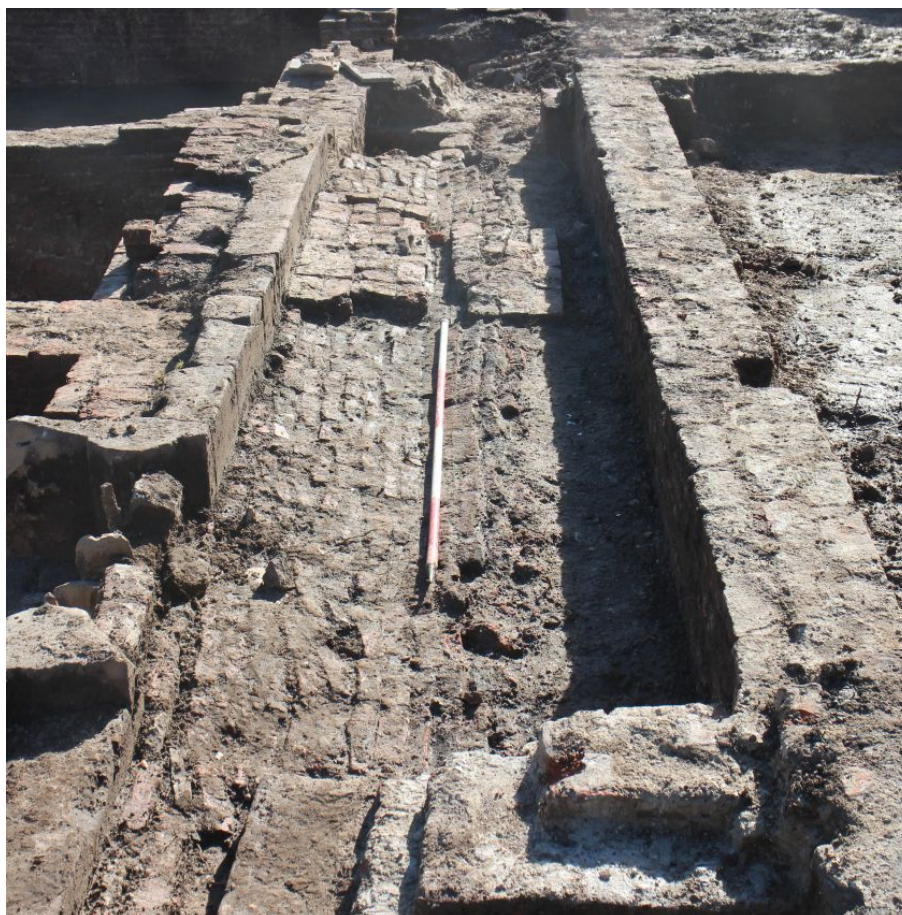
*Plate 6: South-facing view of Corridor 108 with window 123 to the left of the shot*

3.2.10 A floor surface was observed west of Rooms 2 and 3 forming a corridor between Room 6 to the west. Narrow corridor **108** was 1.2m wide, and 5.8m long, and the floor comprised a brick surface (Plate 6, Fig 4). This was in use as part of the later phase of building, as it cut across window **123** in Room 3.

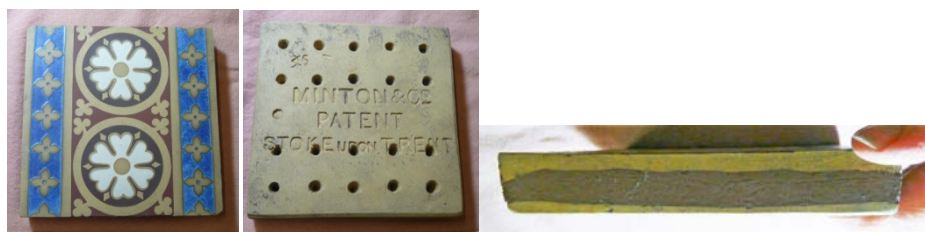
Plate 8: Encaustic floor tile, showing the ‘sandwich’ of different-coloured clays from which they were produced

bearing a Gothic letter-T) remain set in mortar or cement, so that the maker cannot be identified, although Minton seems most likely. The third (Plate 8), made using the ‘plastic clay sandwich’ technique (Durbin 2014, 47), bears the legend ‘Minton & Co - Patent - Stoke upon Trent’, suggesting it to have been produced after 1845. There were also much thinner plain tiles, in buff and dark brown, again made by Minton, but using a slightly later technique (Prosser’s dust-pressing technique, invented *c* 1840, but probably not in significant use by Minton until *c* 1854). Of the four buff tiles, three are marked ‘Minton, Hollins & Co – Patent tile Works – Stoke upon Trent – No 2 Buff’ and one is just marked ‘Minton & Co - Stoke upon Trent’; all six of the brown tiles are marked ‘Minton & Co’. Both variations on the company name were in contemporary use for some time during the second half of the nineteenth century.

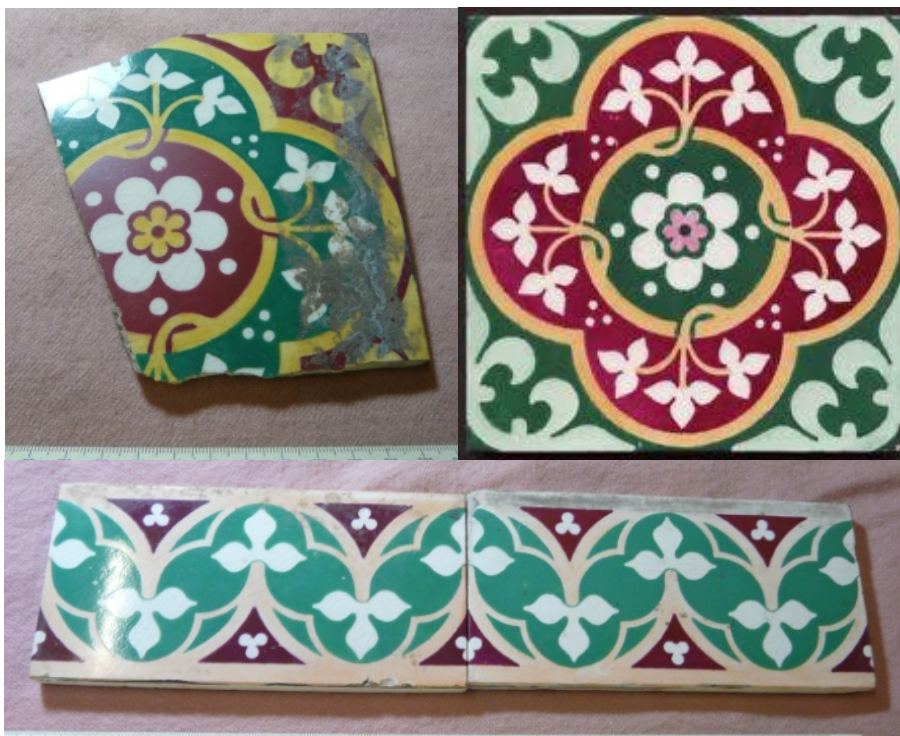
Plate 9: fragmentary tile from Croston, alongside an illustration of the complete tile (colours differ) and two of the associated border tiles, also from Croston

- 3.3.7 The best represented design (Mintons Tiles *c* 1885, sheet 2, No 797 G), with fragments from five polychrome tiles, is shown in Plate 9, and seven border tiles (similar to *ibid*, sheet 13, No 580 G) show a similar arrangement and can probably be regarded as being used together to create larger tiled panels.

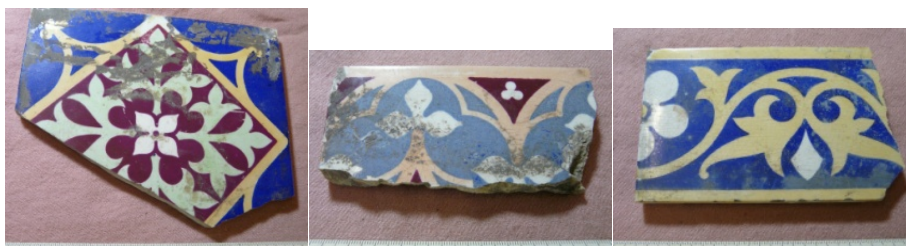
Plate 10: fragmentary tile and the associated border from Croston, alongside a second, broadly similar, border tile

- 3.3.8 The next most frequent tile design is shown in Plate 10, although in this case, only two tiles were identified (*ibid*, sheet 11, No 602 G), and a single closely related border was also present, which appears to be a variation of that seen, above, but in blue, brown and yellow. A second broadly related border tile (*ibid*, sheet 13 No 809 G) was also recorded.

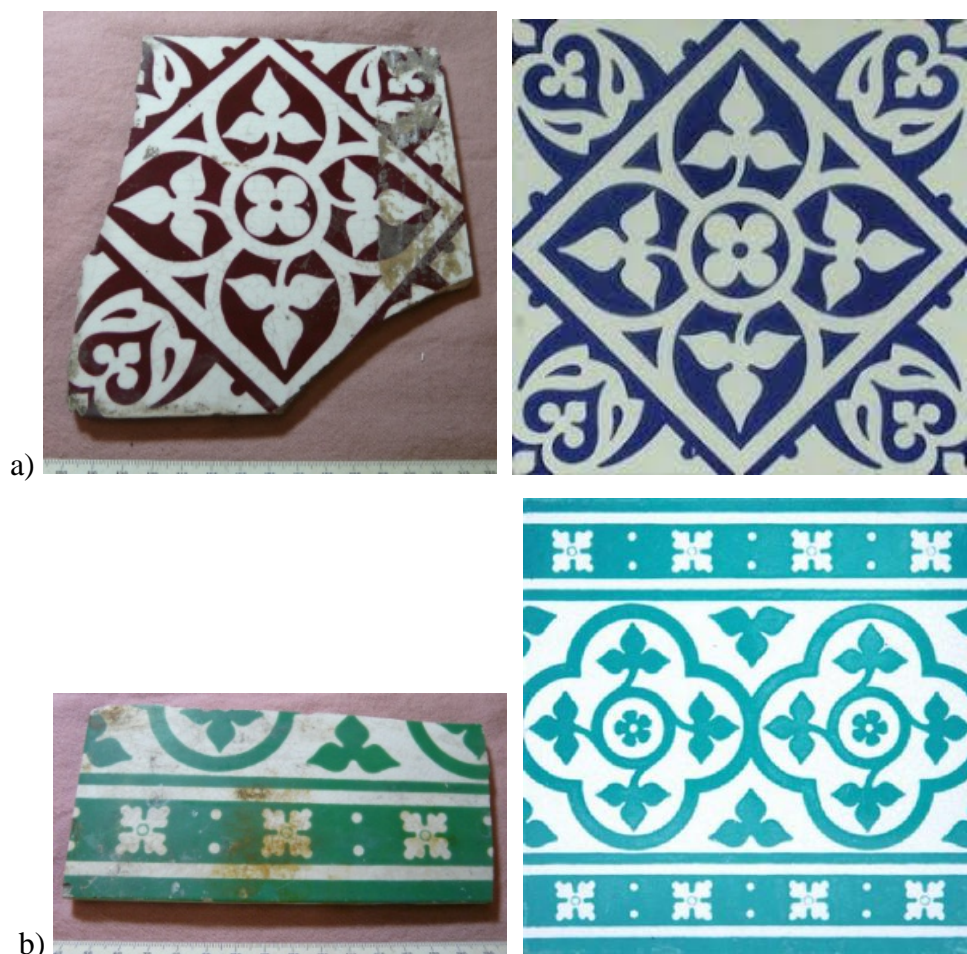
Plate 11: Fragmentary tiles from Croston, both set alongside an illustration of the complete tile (colours differ)

- 3.3.9 The remainder of the tiles are monochrome: two are again in Gothic style (Plate 11), whilst two more are less obviously in this oeuvre. That seen at Croston in brown (a) appears in blue in Minton's 1885 catalogue (Sheet 4, as No 1091 X, that in green (b), appears in the catalogue as design No 416, G.

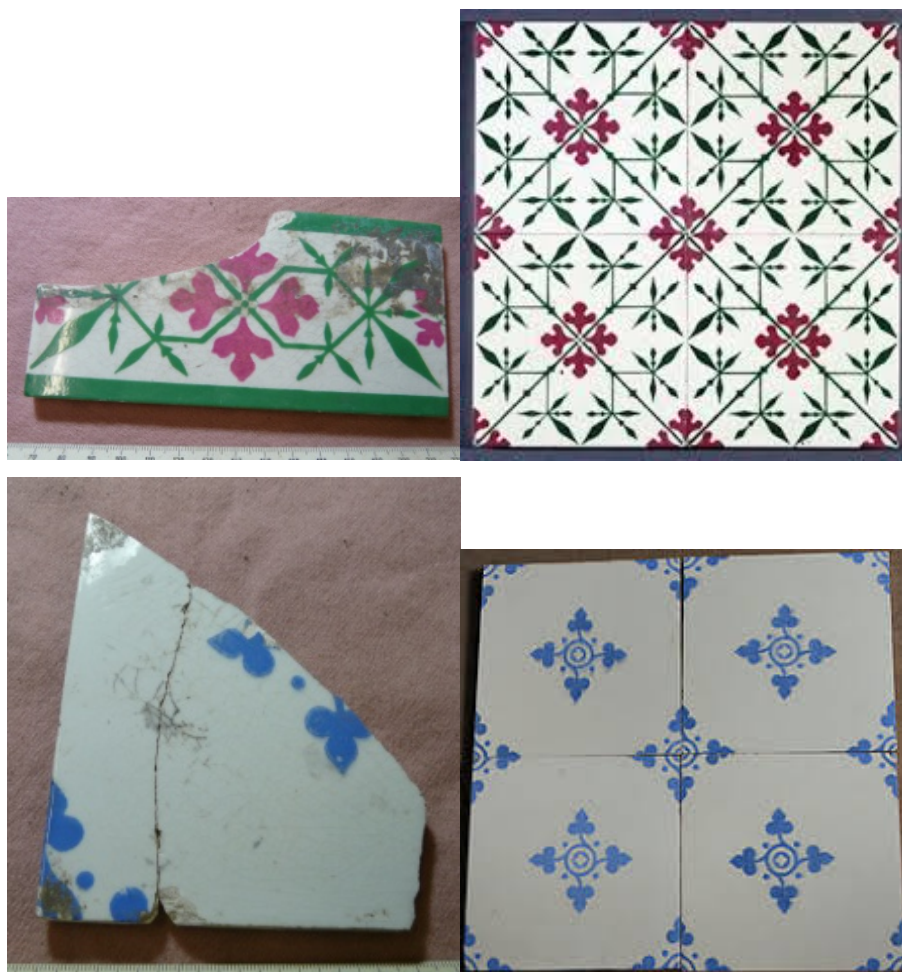
Plate 12: A fragmentary border tile from Croston, set alongside an illustration of full-sized tiles in the same pattern), and a small fragment of blue and white tile, set alongside a group of four complete tiles

3.3.10 A border tile with a green and pink quasi-floral design can be identified as a border for full-sized tiles with the same design (*ibid*, sheet 11 No 753 G), and a small fragment in blue and white, reminiscent of some of the simple designs seen on earlier tin-glazed (Delft) tiles, can be identified as pattern No 545 G (*ibid*, sheet 11) (Plate 12).

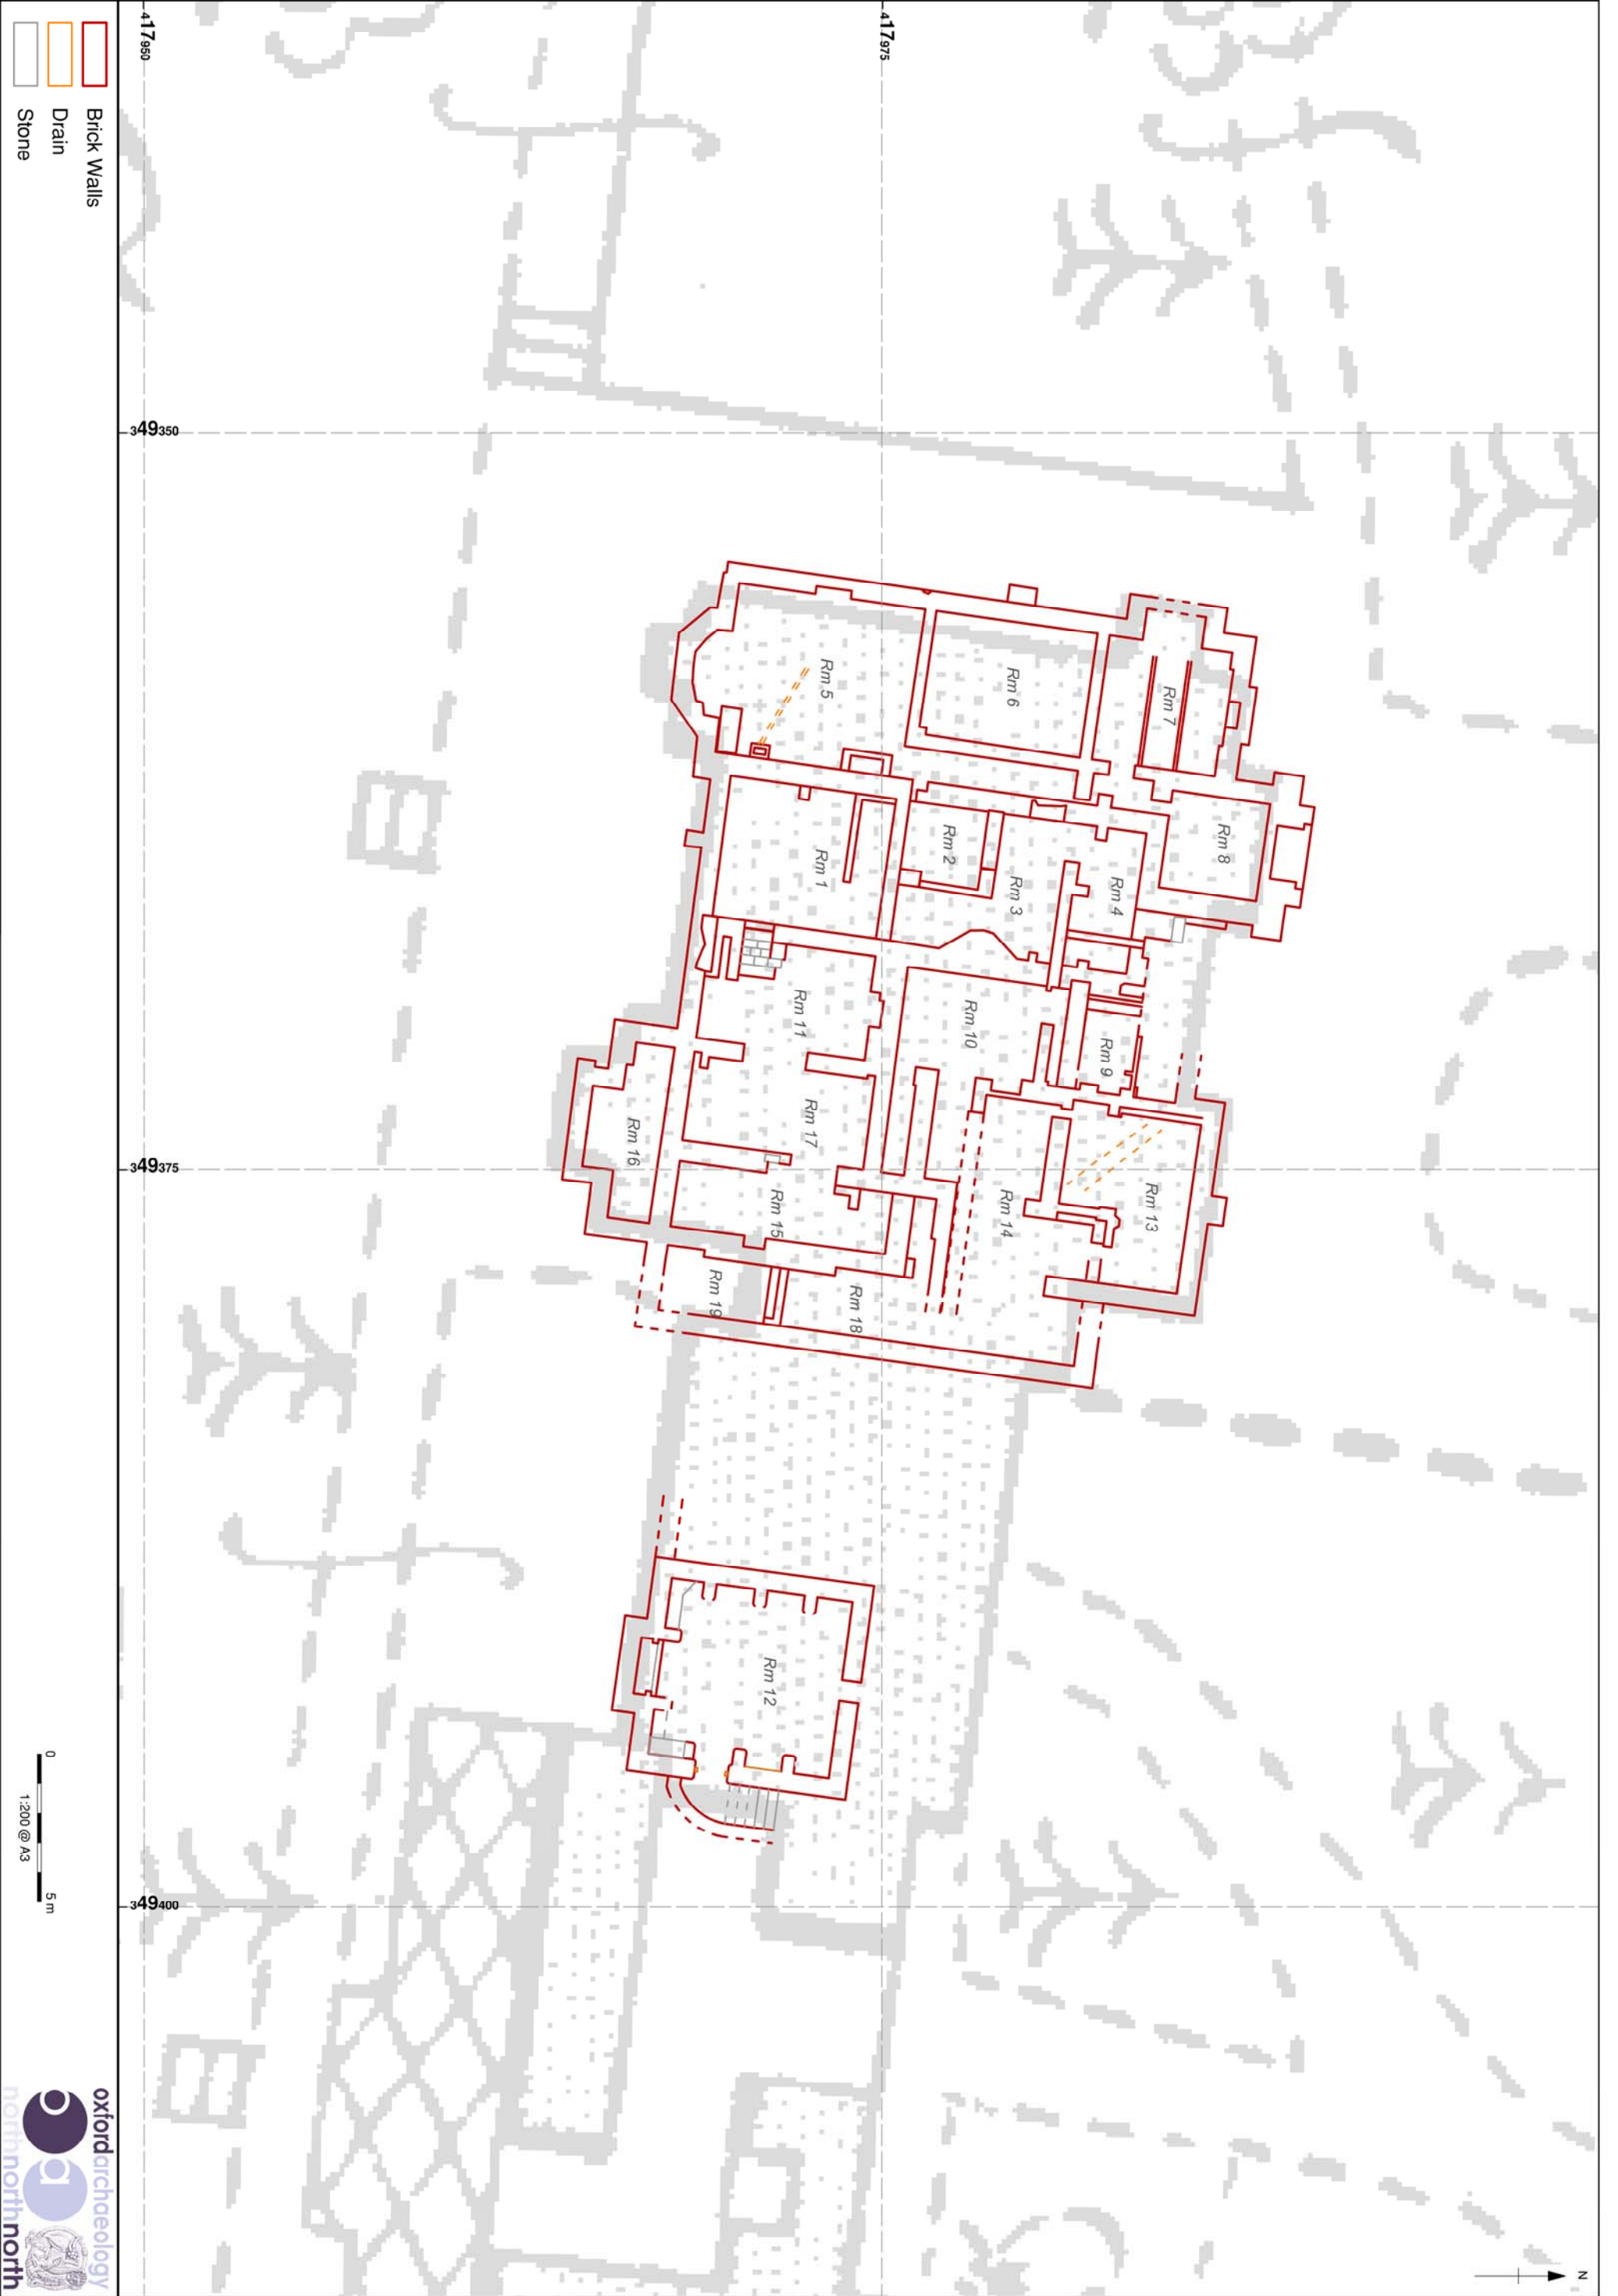
Figure 2: Results of strip map and record superimposed on the Ordnance Survey 25":1 mile map of 1910

3.1.1 An area approximately 940m<sup>2</sup> (40m max east/west x 25m max north/south) was excavated during the course of the investigations (Fig 2). Within that area, the footprint of Croston Hall was exposed, together with associated infilled cellars. The turf and topsoil (0.1m – 0.3m thick) directly sealed the demolition deposits within the cellars. A summary of the results is presented below, with a room and context list provided in *Appendix 2*. Those rooms (Rooms 1-4) that were excavated as part of the sunken garden are described in the following section.

3.2.2 The main layout of the hall was exposed (Figs 2, 3 and 4). The majority of those spaces determined to be rooms (Rooms 5-11, 12 and 13-19) were only foundation levels, with no trace of cellars and largely devoid of significant features. All of the floors in the main part of the house had been robbed out, presumably when the house was demolished. The dimensions of these rooms are listed in Table 1.

- 4.1.2 The foundations of the hall show two phases of works. Both brick built, they likely relate to the later stages of building, rather than that of the earliest medieval Hall. The foundations match the plans as seen on the Ordnance Survey 25" map of 1910 (Fig 2).

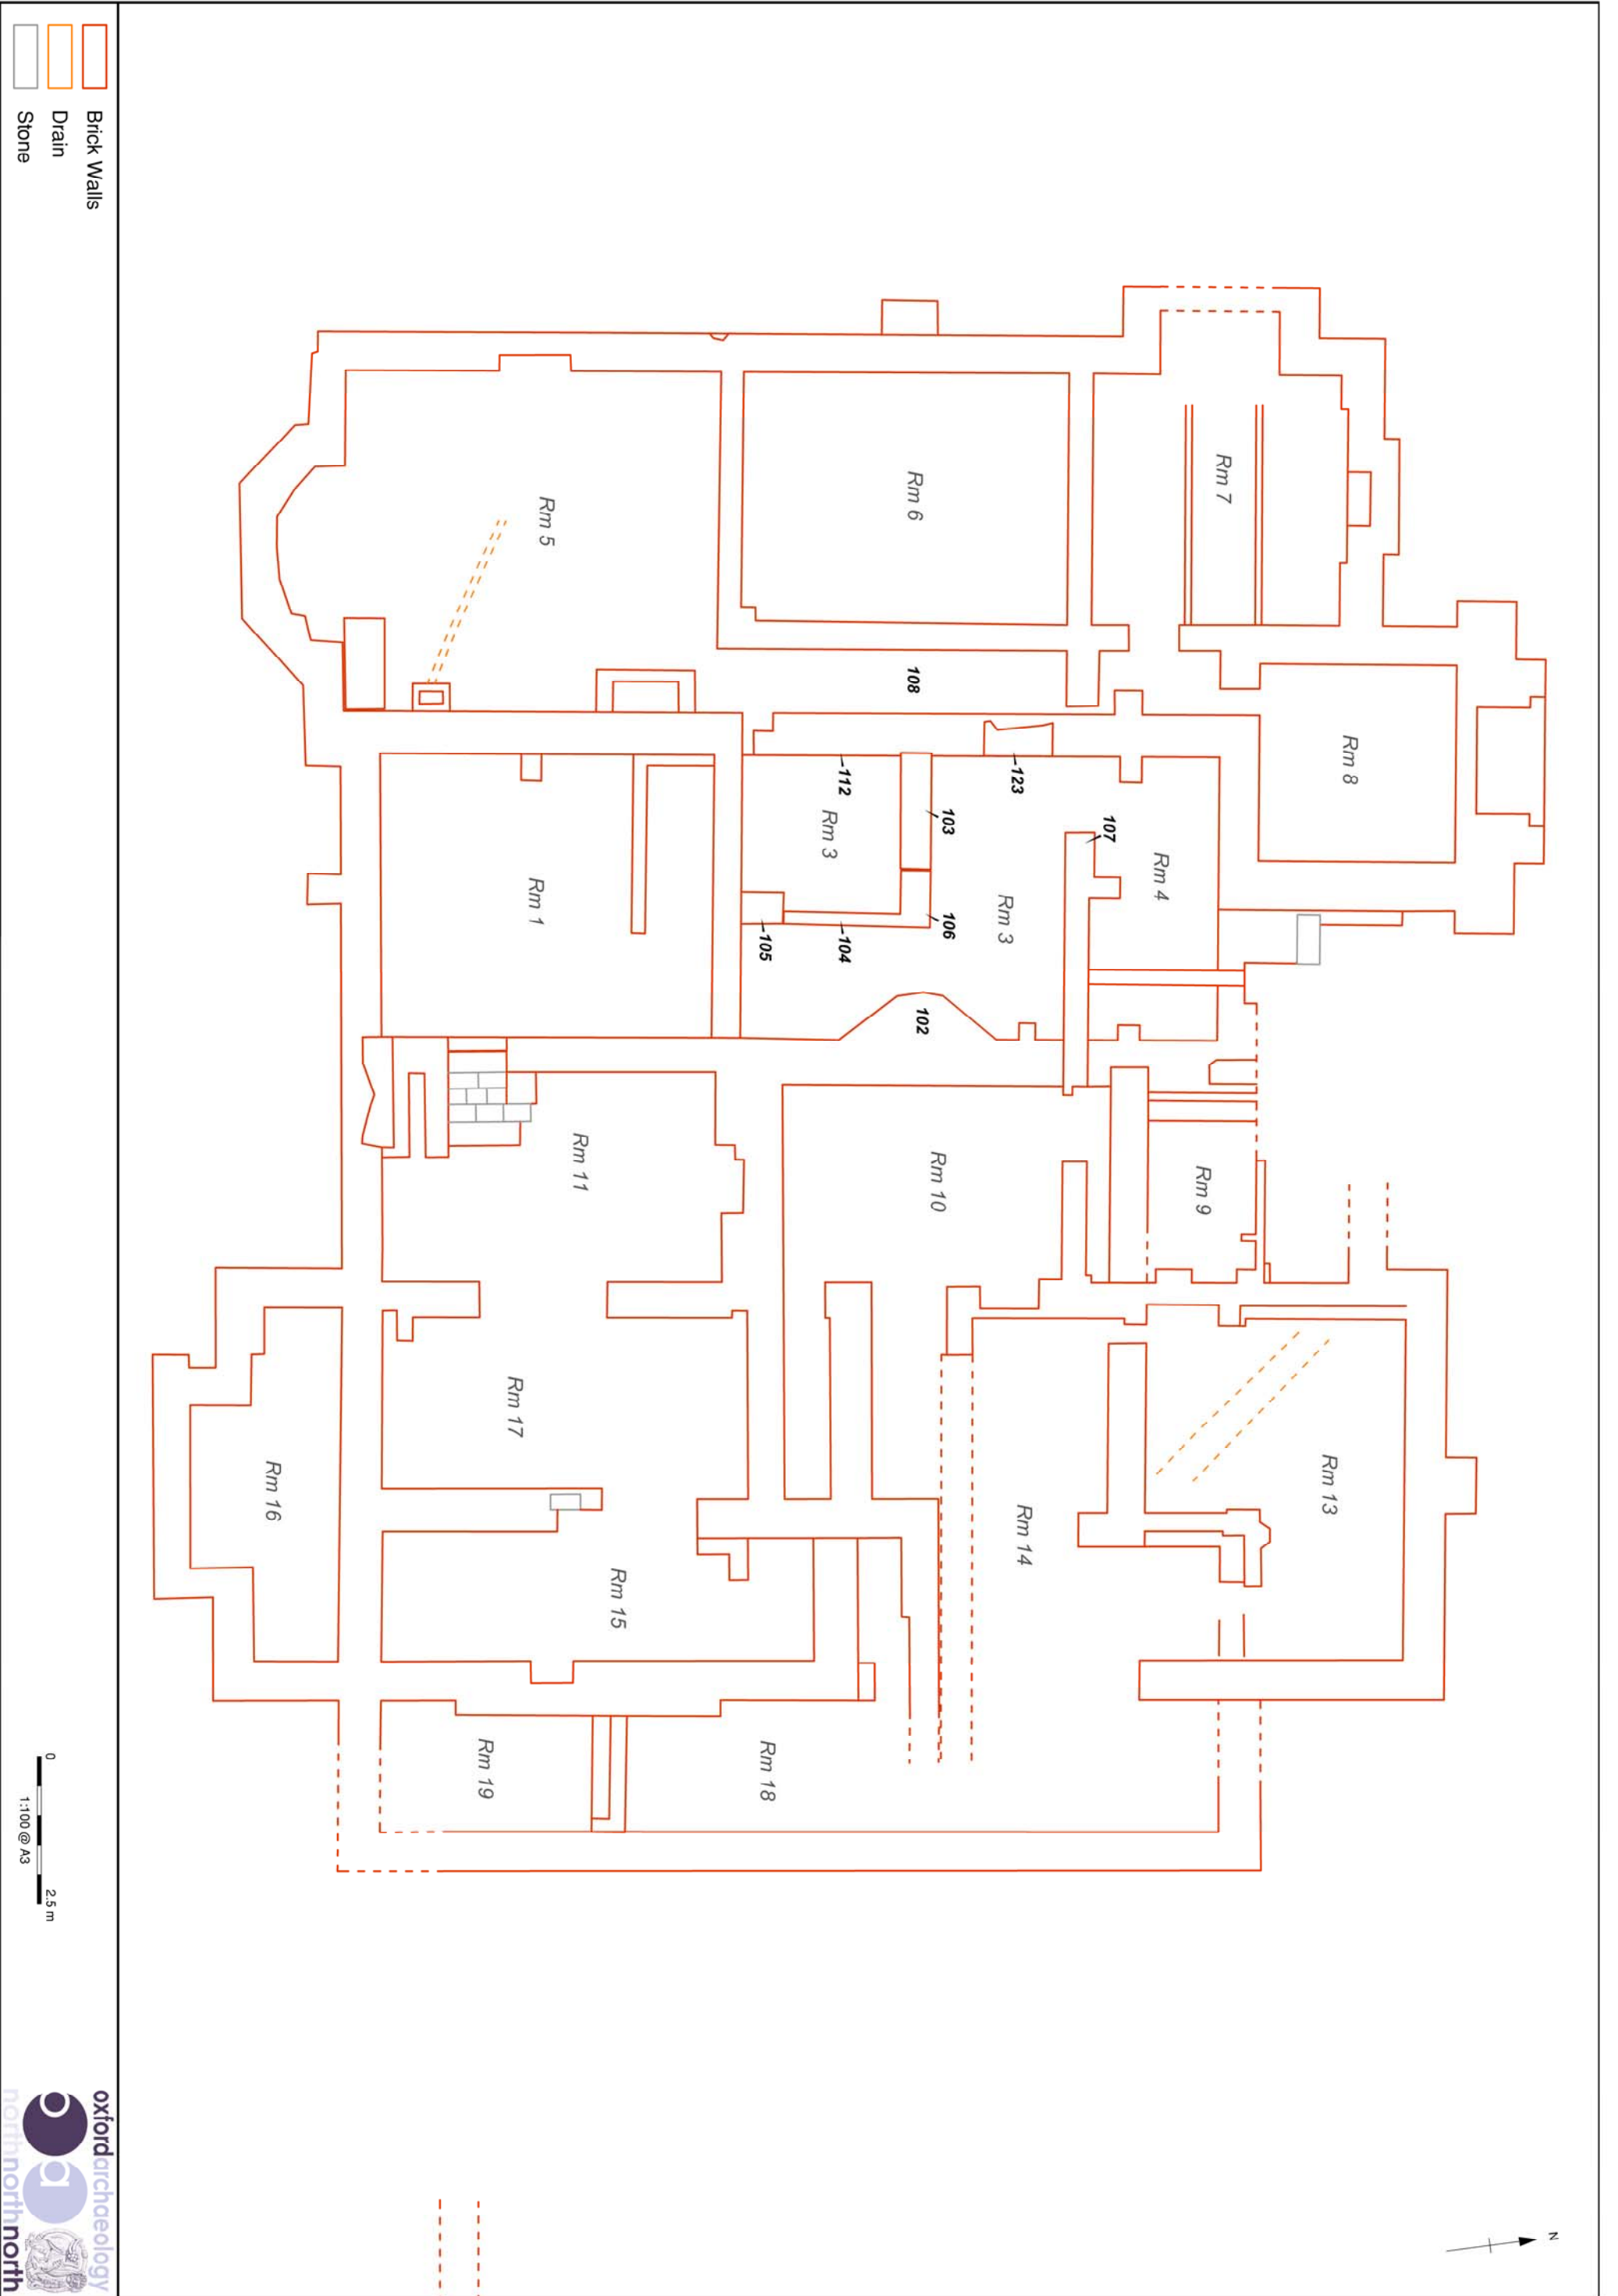
Figure 4: Plan of Rooms 1-19

- 3.2.4 **Room 1:** Room 1 was the southernmost cellar room below the main part of the house (Fig 4) and was accessed from a staircase on the eastern side (1.6m x 1.6m), which appeared to descend from within the house (Room 11), and another from the west (1m wide at the door), which had been truncated. Both had been bricked up. A short section of wall had been added to the northern wall of Room 1 to the south, with holes for with east/west-aligned joists. It was unclear how far the joists protruded east, as the structure had been bricked up along the southern end, leaving the eastern end open

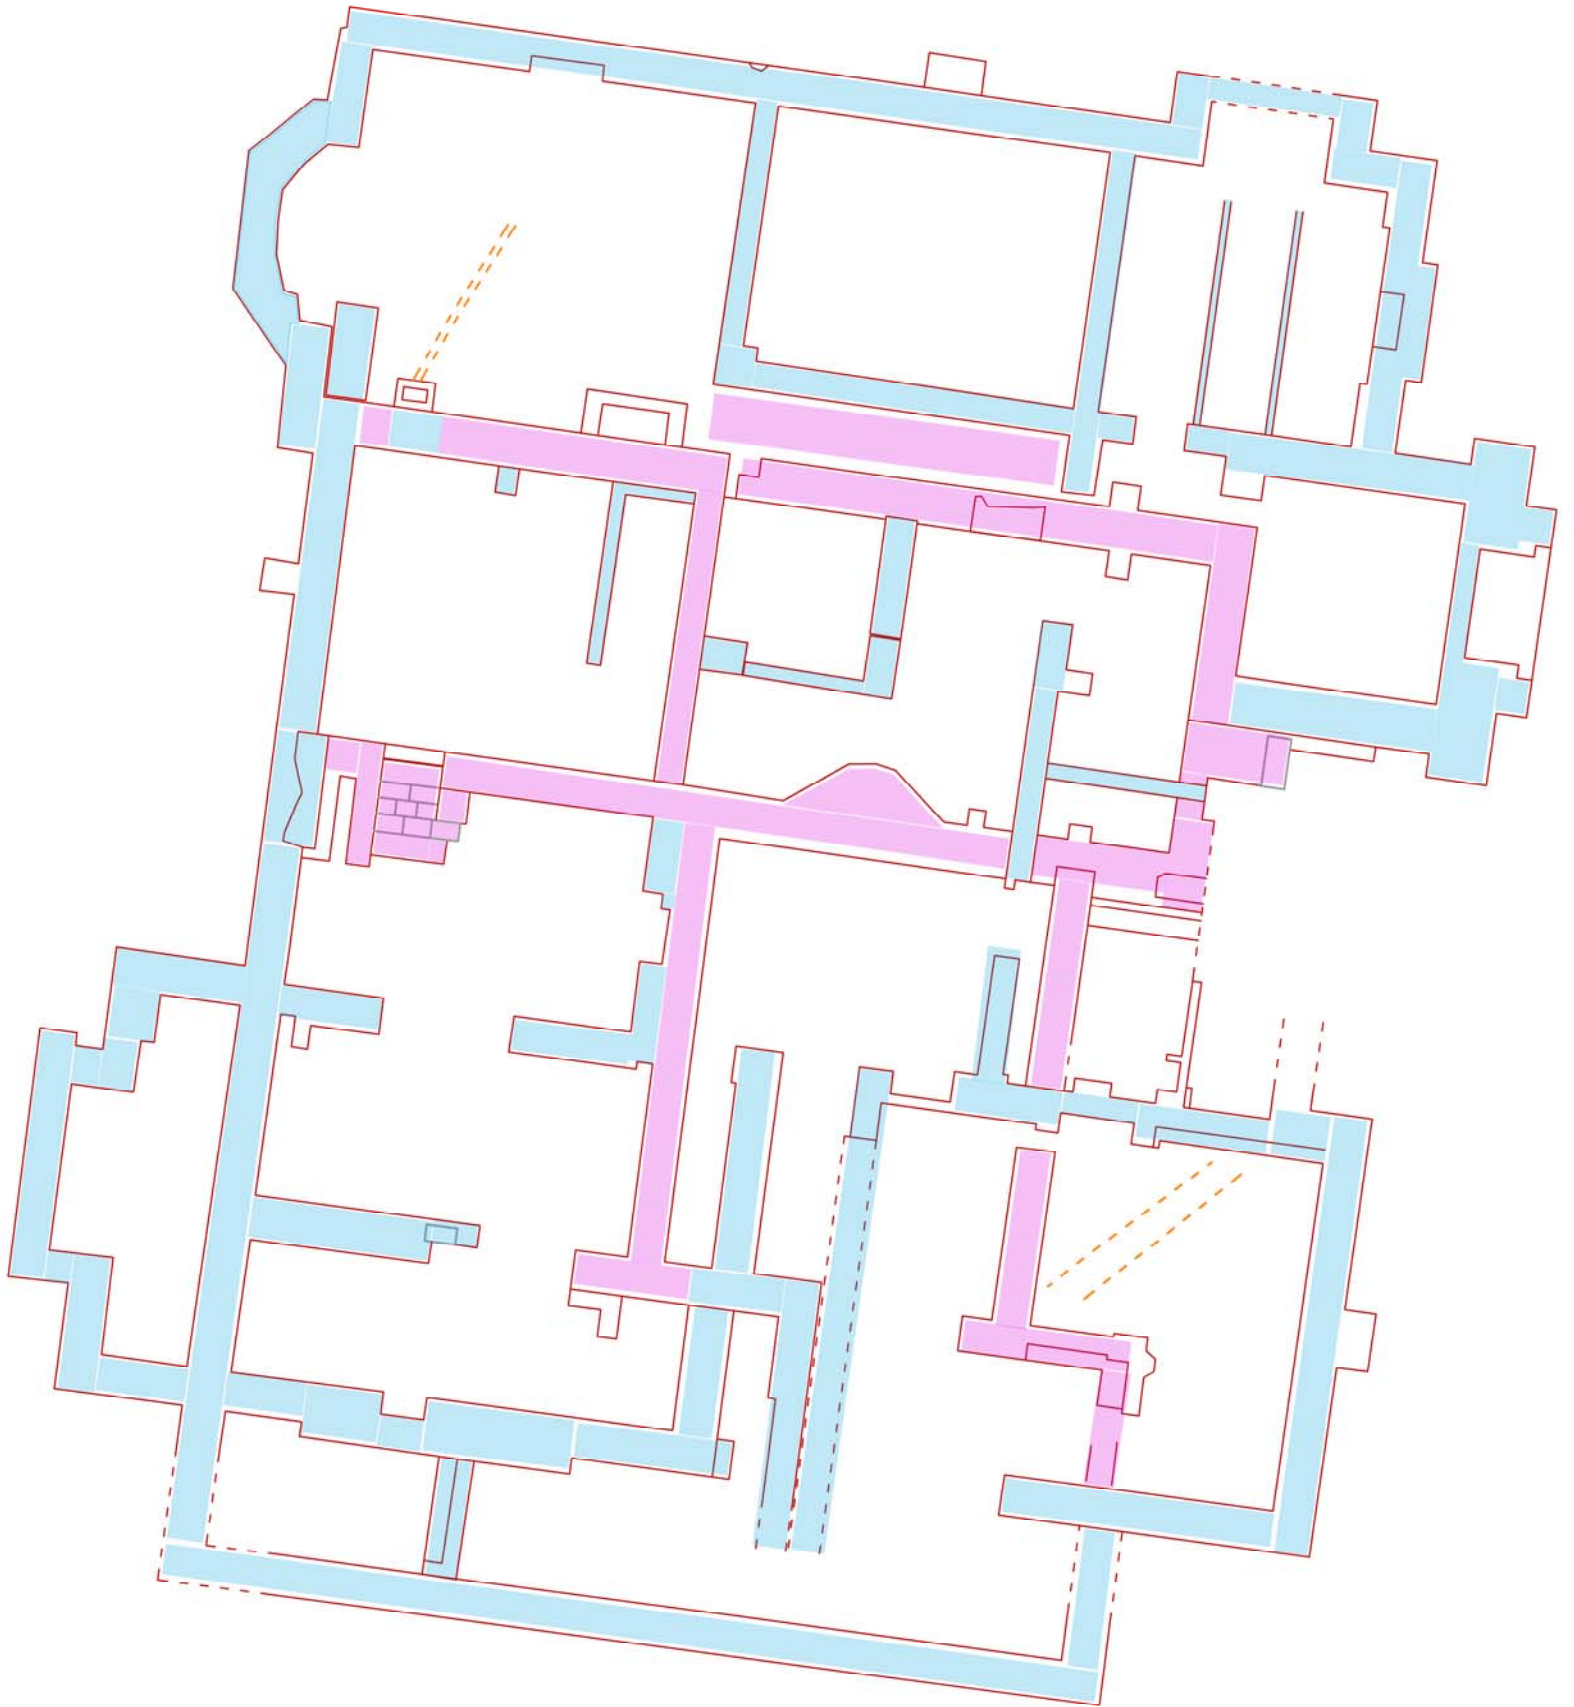
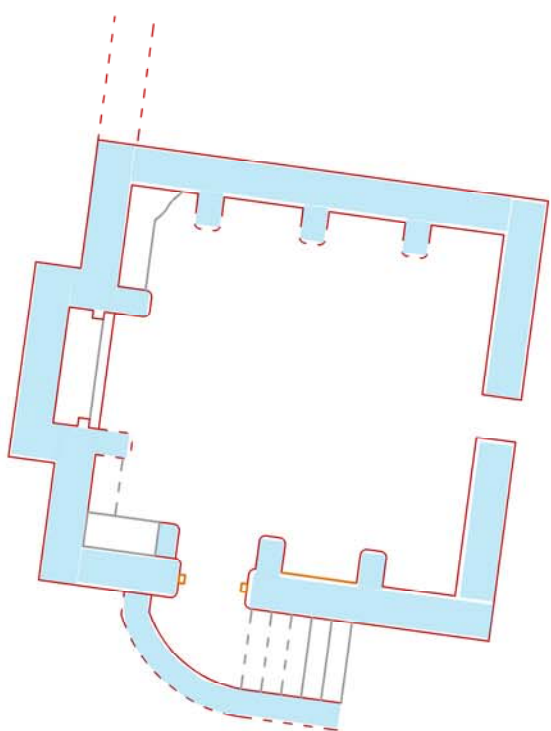
Figure 5: Phased plan of the strip map and record results

- 3.2.11 The remaining house foundations demonstrated two main phases of construction (Fig 5). The first was characterised by hand-made brick with a light yellowish-grey mortar. The later additions and modifications were machine-cut bricks with a harder greyish-white mortar. The earlier elements were mostly confined to the cellars described above, but two other east/west-aligned walls were observed continuing from the eastern wall of Rooms 3 and 4.
