Tameside Wellness Centre, Denton, Greater Manchester Archaeological Evaluation and Excavation Report

January 2018

Client: The Environment Partnership Ltd

Issue No: 2018-19/1970

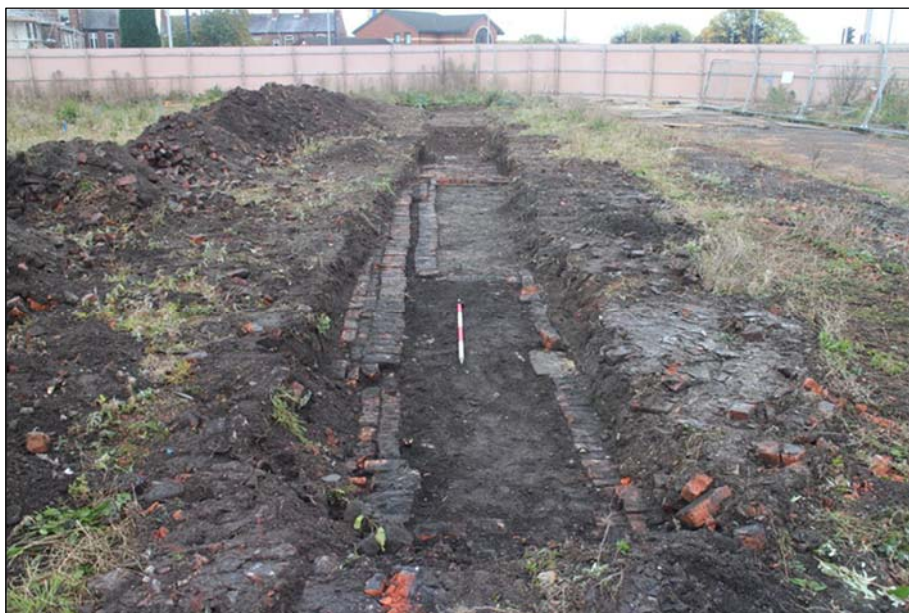
- 3.4.1 Trench 1 was located to the western half of the PDA (Fig 3 and Plate 1) targeting several buildings associated with the former hat factory to the south of Amelia Street. The trench measured 30m long by 2m wide and was aligned east/west. The general stratigraphic sequence observed comprised natural clay **102** overlain by **101** a mixed overburden containing demolition rubble and clinker. The initial 5m from the western end of Trench 1 was excavated to a depth of 3m before backfilling to safe working standards. No archaeological features were present within this western area and overburden **101** was the only deposit observed; this suggested that the building targeted at this end of the trench, fronting onto Stockport Road, had been completely removed during demolition. However, archaeological features were encountered throughout the remainder of the trench at a depth of 0.2m.

Plate 1: Trench 1 looking west, scale 2m

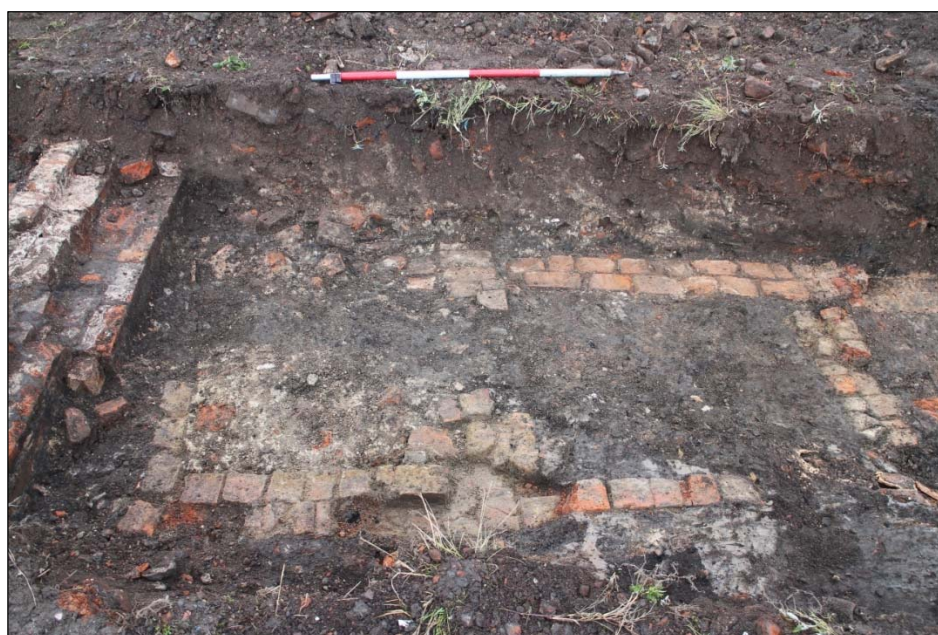
Plate 2: Rectangular Structure **104** looking south, scale 2m

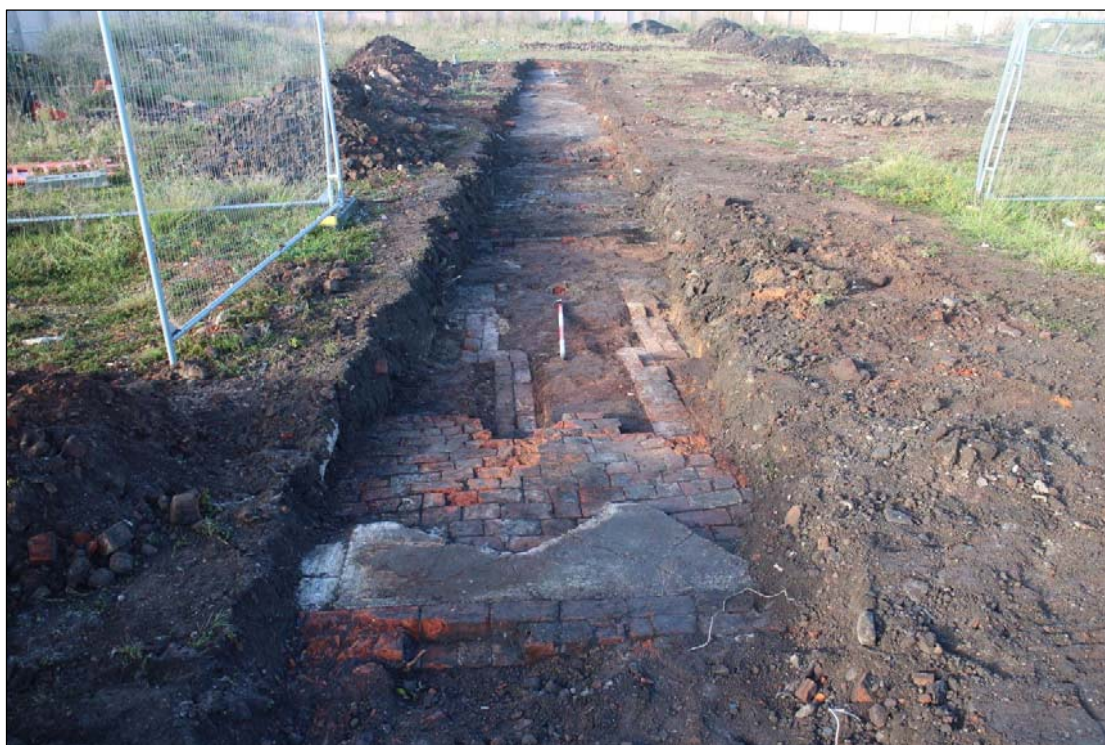
- 3.5.1 Trench 2 was located to the south-east of Trench 1 (Fig 3 and Plate 3) targeting several structures in the middle of the former hat factory, measured 30m long by 2m wide and was aligned east/west. The archaeological features present within Trench 2 resulted in the subsequent excavation of the south-western part of the PDA. As such, the whole Trench was subsumed by excavation Area 1, the details of which are described in greater detail below.

Plate 3: Trench 2 looking west, scale 2m

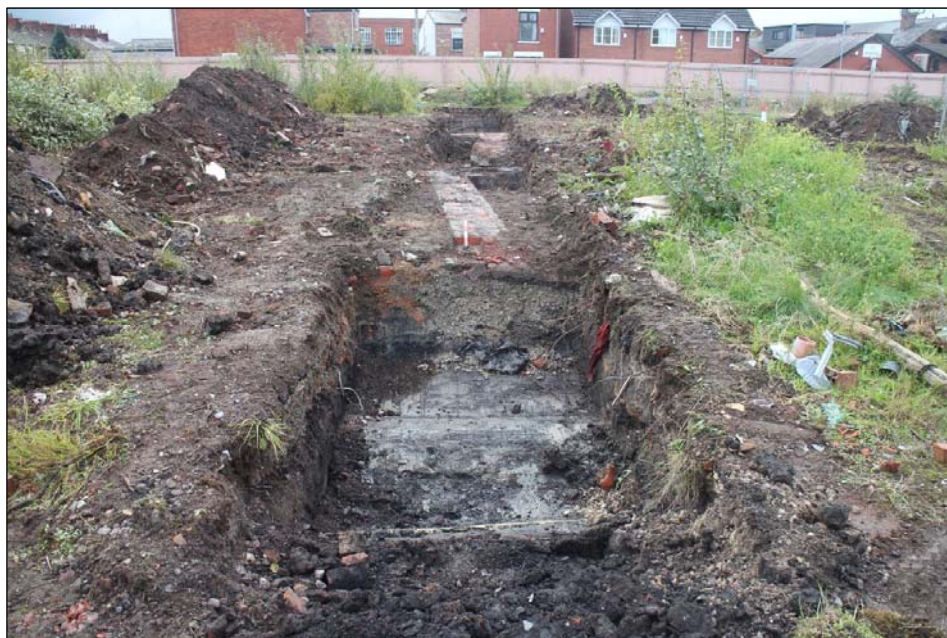
- 3.6.1 Trench 3 was located between Trenches 2 and 4 (Fig 3 and Plate 4) targeting several structures to the east of the former hat factory, measured 30m long by 2m wide and was aligned north/south. The general stratigraphic sequence was similar to that in Trench 1 and comprised natural clay **308** overlain by a mixed overburden **307**.

Plate 4: Trench 3 looking south, scale 2m

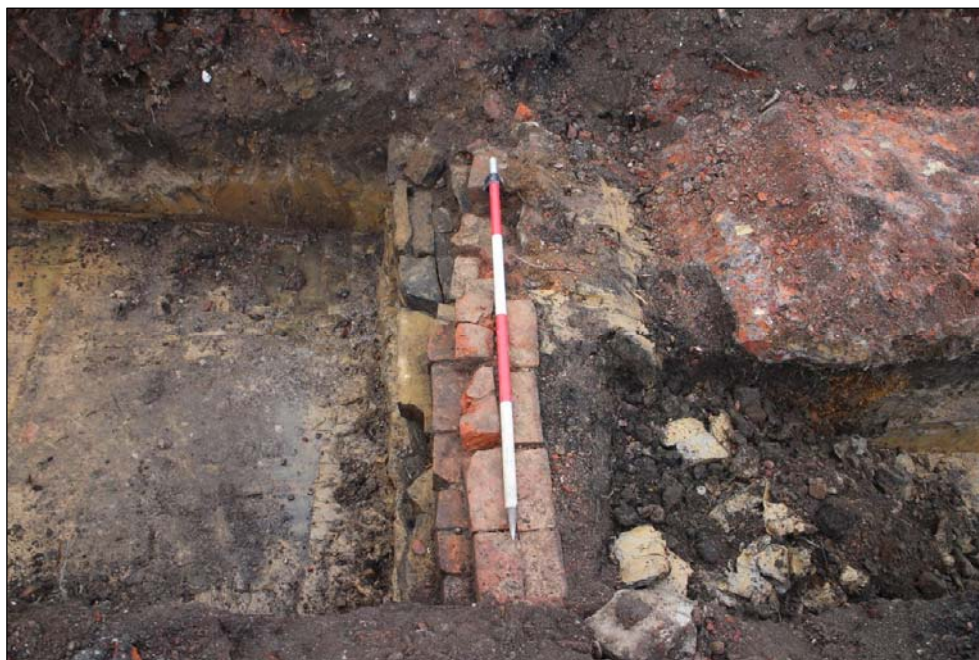
- 3.6.3 Archaeological features were encountered at a depth of 0.2m. The earliest feature being **301**, a single brick wide wall aligned roughly east/west (Plate 5); constructed using handmade bricks and bonded using a light brown sandy mortar, the wall spanned the width of the trench. **301** was sat upon a single brick foundation course with a coursed rubble foundation below. The foundation course was laid directly on the natural clay **308**, with no evidence for a construction cut being visible. Wall **301** appeared to relate to the northern wall of a large structure of the former hat factory fronting Annan Street (Fig 6); further remains of this structure had been identified in Trench 2 and then Area 1 (Section 3.9).

Plate 5: Wall **301** looking west, scale 2m

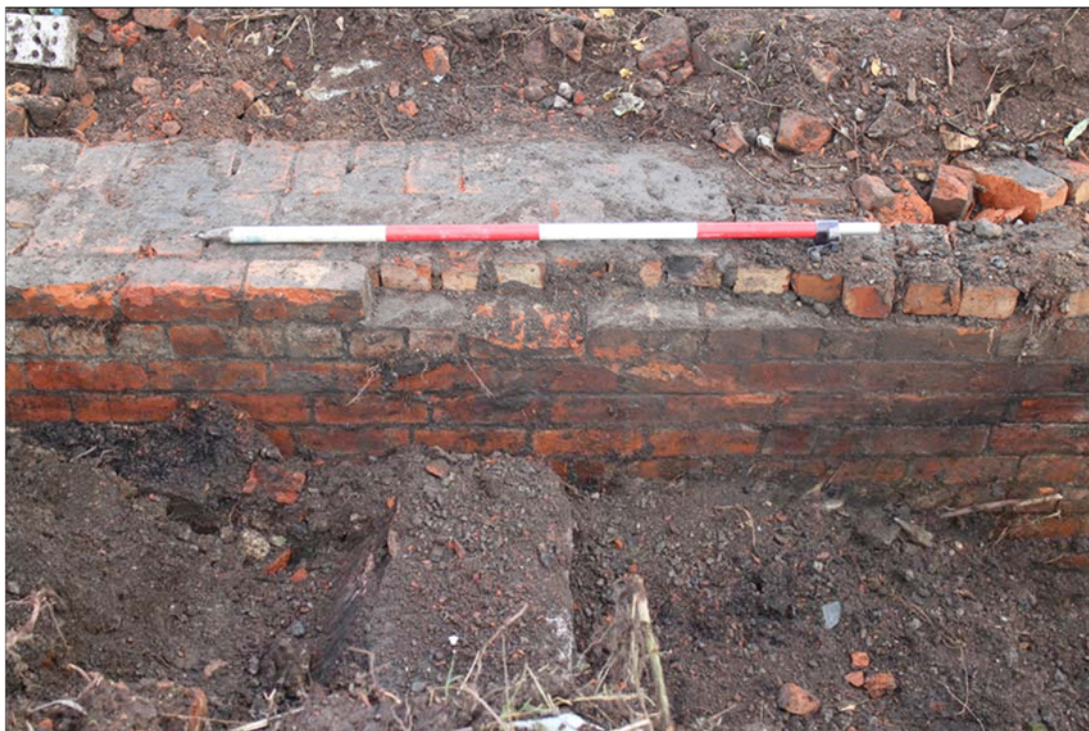
- 3.6.6 To the north of the concrete machine bases **302** was a sequence of substantial brick walls. The earliest of these appeared to be wall **304** (Plate 6), a north-west/south-east-aligned, two and a half bricks wide wall surviving to a height of ten courses. **304** was constructed using machine-made bricks, laid in an English Garden Wall (EGW) bond and bonded using a dark grey cement-like mortar. The wall entered the trench approximately 12m from the southern end of the trench and then continued for approximately 10m, at which point it appears to have been truncated. Wall **304** appears to form a dividing wall between a large building, identified on the historic mapping as 'Hat Manufactory' and smaller buildings to the east (Fig 6).

Plate 6: Wall **304** looking north-east, scale 2m

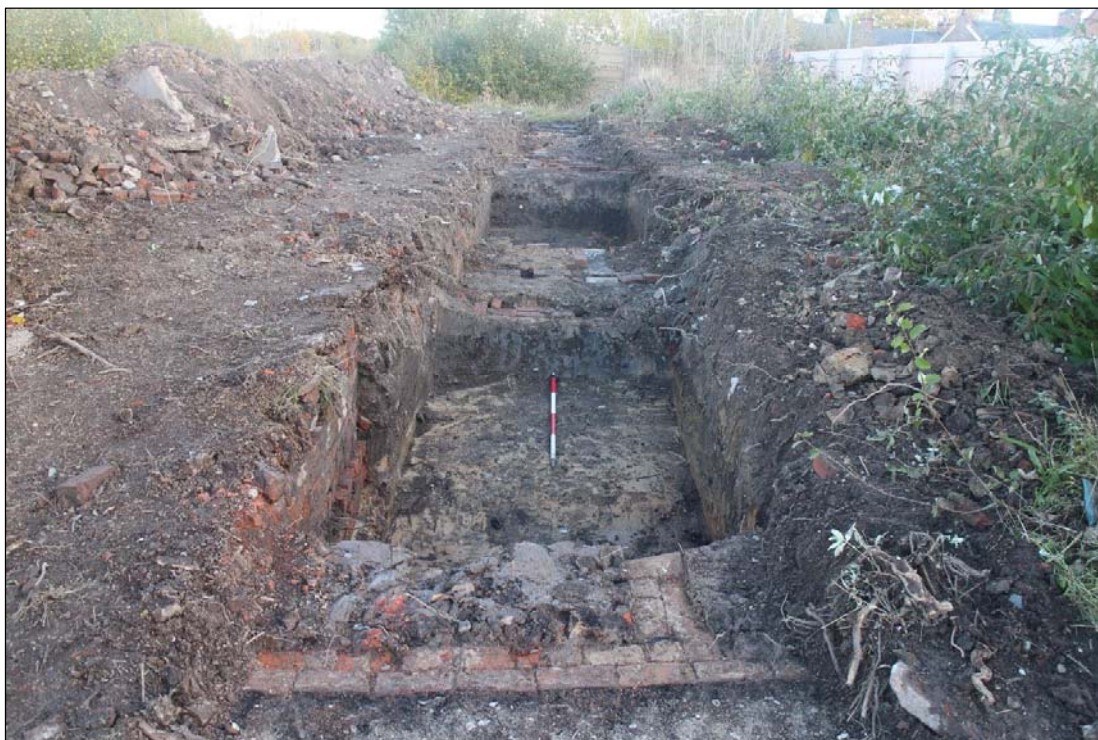
- 3.7.1 Trench 4 was located to the south-east of the PDA (Fig 3 and Plate 7) targeting a row of four terrace houses fronting Annan Street, measured 30m long by 2m wide and aligned roughly east/west. The general stratigraphic sequence observed natural clay **412** overlain by a relict subsoil **411** and redeposited natural **410** and capped by a mixed overburden **409**. Archaeological features were encountered at a depth of 0.4m

Plate 7: Trench 4 looking east, scale 2m

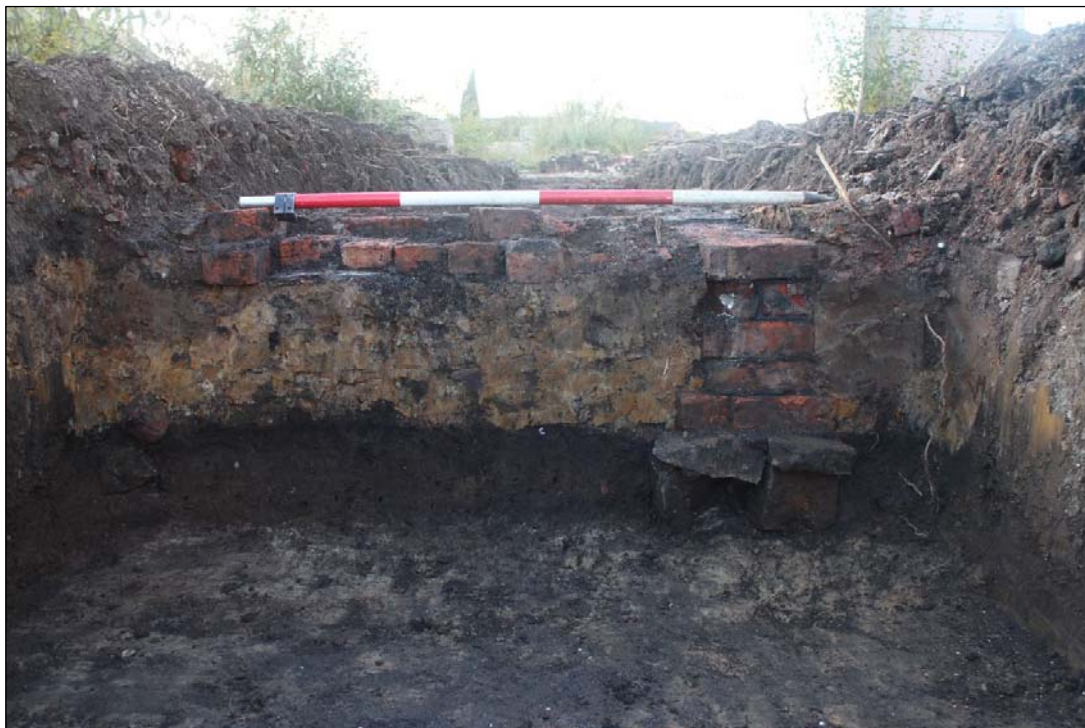
single, brick wide buttress with a later range-like structure to the south. The buttresses survived to a height of five courses, supported on stone foundations. Wall **405** appeared to be the dividing wall between the central two houses in the block of terraced housing (Fig 6).

Plate 8: East-facing section of wall **405**, relic soil horizon **411** and redeposited natural **410**, scale 2m

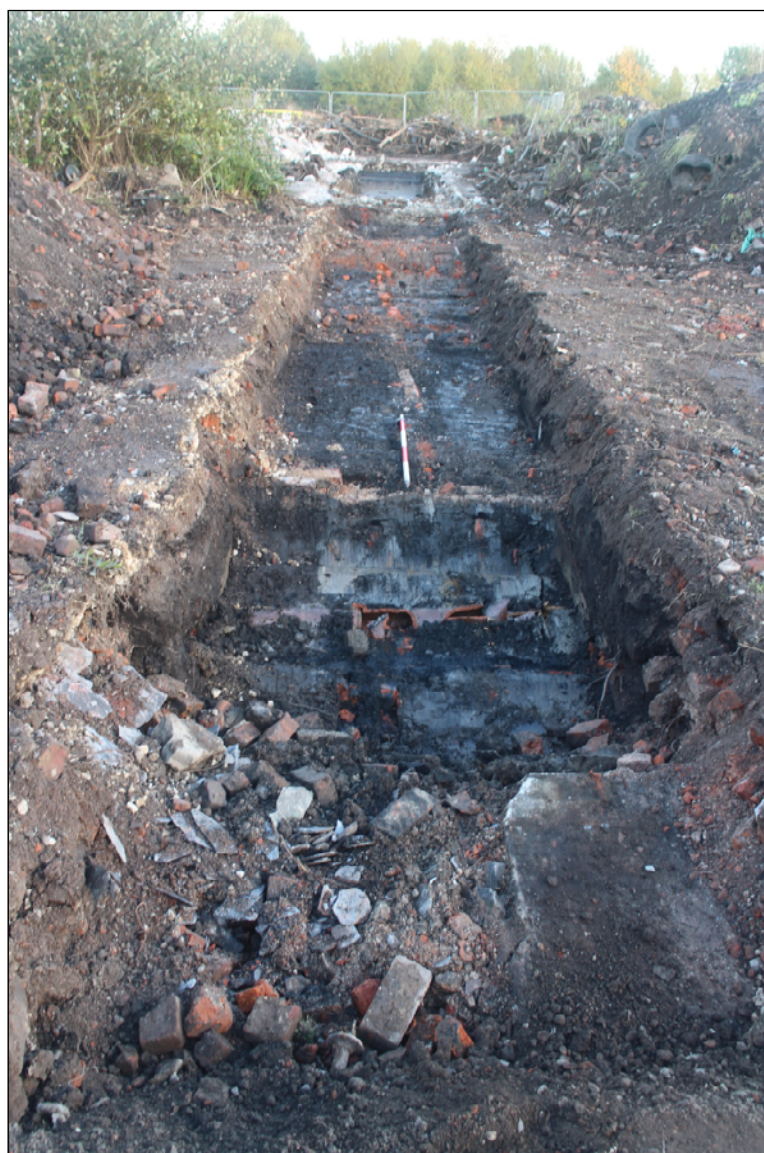
- 3.8.1 Trench 5 was located to the north of Trench 3 (Fig 3 and Plate 9) targeting a block of three terraced houses to the north of Amelia Street, measured 30m long by 2m wide and was aligned roughly east/west. The general stratigraphic sequence observed

Plate 9: Trench 5 looking east, scale 2m

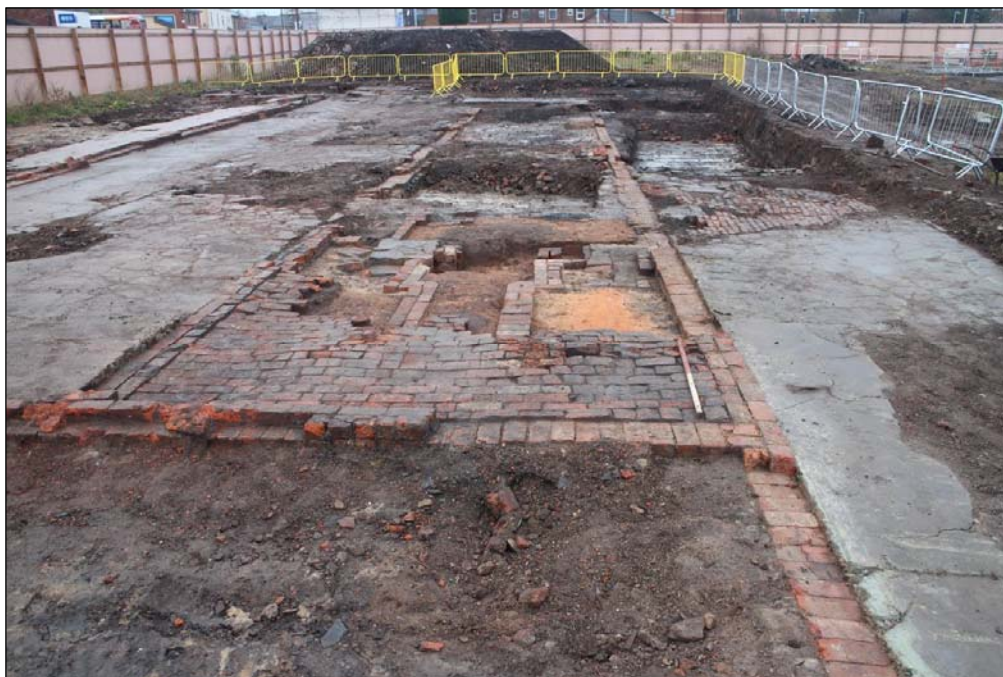
3.9.1 Area 1 was located across the extant remains observed within evaluation Trench 2 and measured 37.50m long by 20m wide (Fig 4 and Plate 10). The purpose of Area 1 was to establish the potential for, and characterise any earlier fabric pertaining to the former hat factory observed on historic mapping (Fig 7).

Plate 10: General Shot of Area 1 looking west, scale 1m

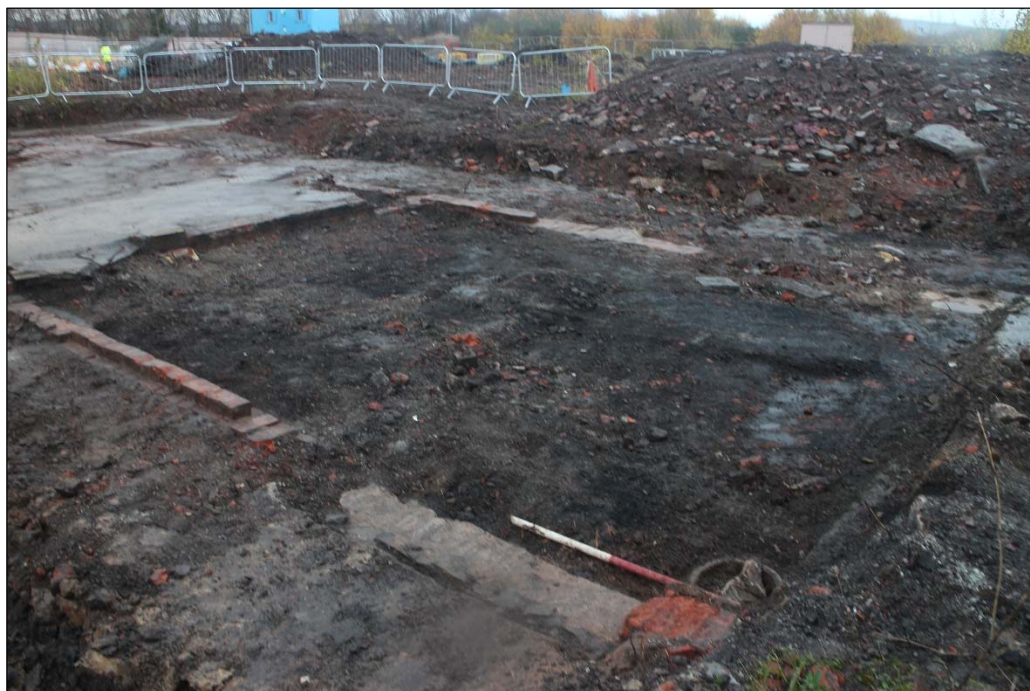
3.9.3 Rooms **1004**, **1005**, **1006** and **1007** are all shown as a single long building fronting Annan Street on the historic mapping (Fig 7). Room **1004** was located to the south-east corner of Area 1 and measured 5.7m x 4.4m (Fig 4 and Plate 11). The room was rectangular in shape, aligned north/south and bounded by brick walls to the west, north and east.

Plate 11: Room **1004** looking north-east, scale 1m

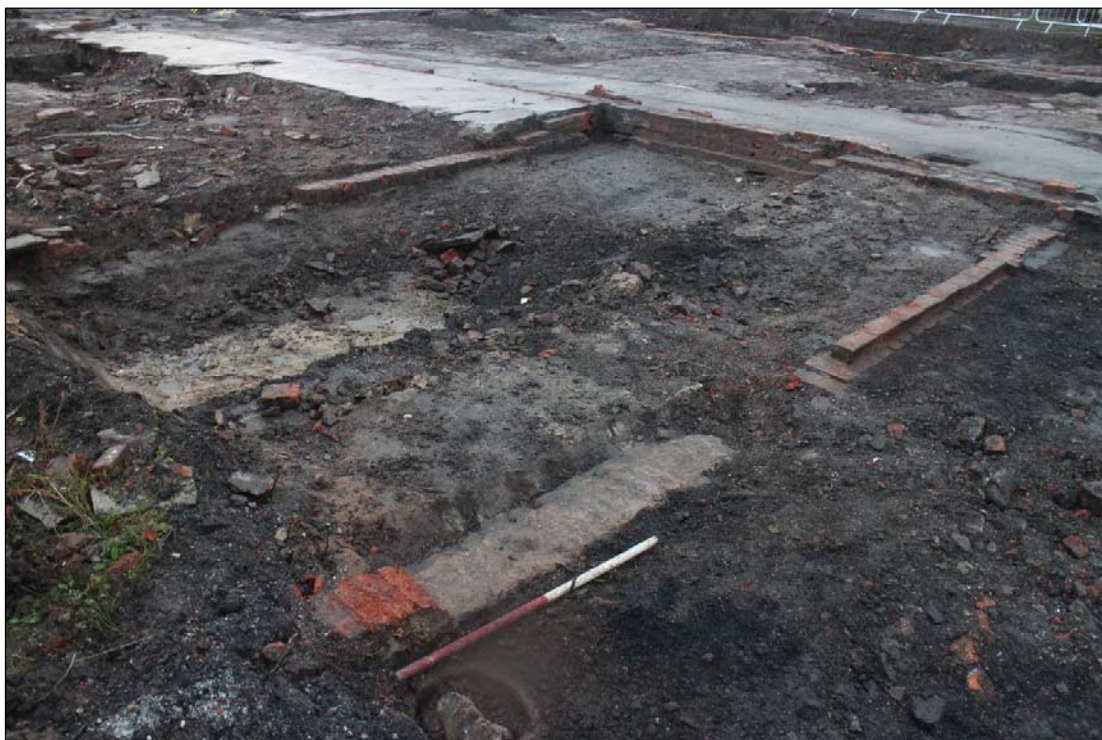
- 3.9.7 Room **1005** (Fig 4 and Plate 12) was located to the immediate west of room **1004** and very similar in size and construction. The northern and eastern elevations were shared with room **1004** and described above. The western elevation was tied into the fabric of the northern elevation, constructed using a single course of hand-made bricks and bonded with a light brown sandy mortar. A single, 'soldiered' step and coursed rubble masonry formed the foundation. No features were identified.

Plate 12: Room **1005** looking north-west, scale 1m

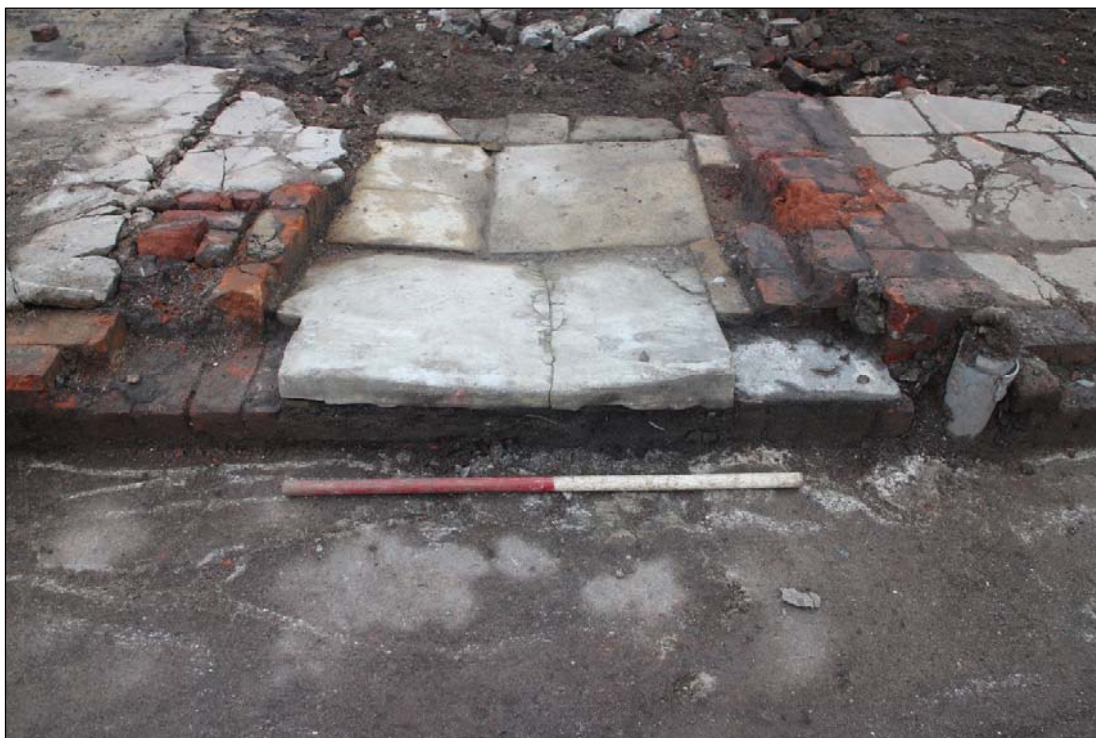
- 3.9.9 A formal entrance (Plate 13) measuring 1m x 1m and bounded by two, north/south-aligned brick walls, was located within the northern elevation at 4m from the western extent of room **1006**. The entrance comprised a stone-flagged floor, flanked by two, 3-course walls constructed using machine-made bricks and a dark grey cement-like mortar. The southern extent of the entrance was heavily truncated, but remnants of brick masonry may suggest that the western wall may have extended southwards to form the boundary of room **1006**. This would also have been roughly 4m from the western pillar base described above.

Plate 13: Formal Entrance in northern elevation of room **1006** looking south, scale 1m

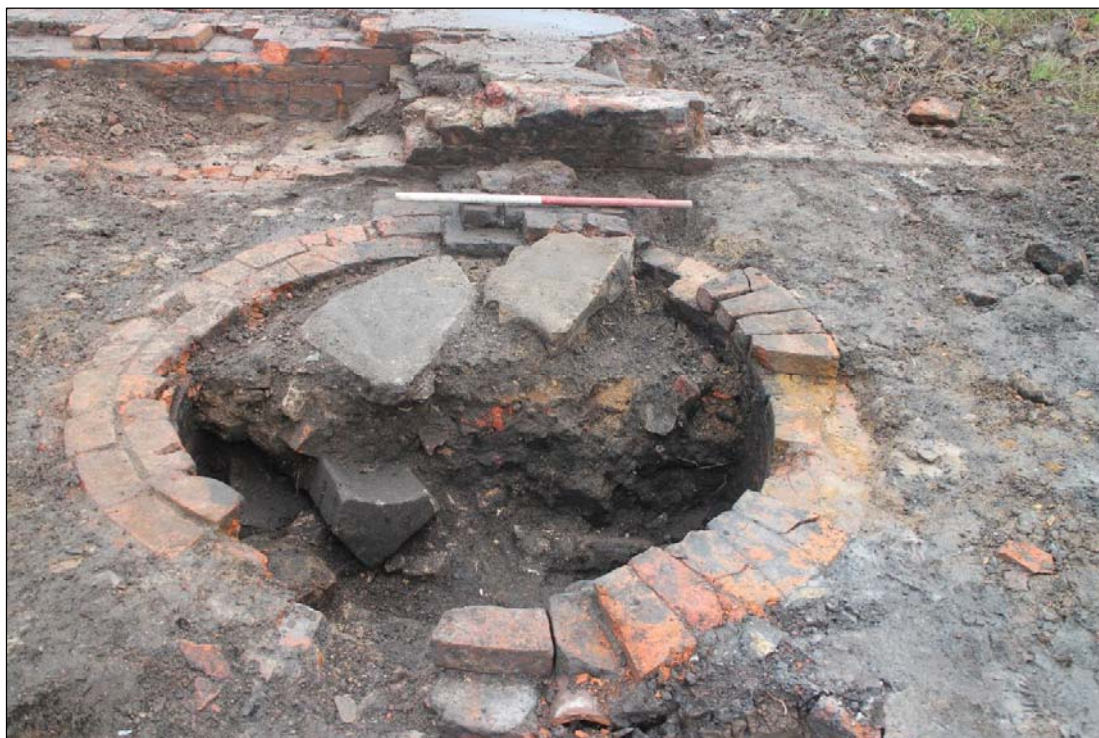
- 3.9.11 Room **1007** was located at the south-western corner of Area 1 and measured 6m x 4.5m (Fig 4). The room was probably rectangular in shape with the eastern and northern elevations continuing west and south through the baulk. The only feature observed within room **1007** was a brick well (Plate 14) measuring 2m in diameter with an internal span of 1.5m. The well was constructed using hand-made brick laid in an EGW style and bonded with a light brown sandy mortar. The hand-made bricks were specifically engineered to be slightly curved or trapezoidal forming a more circular structure. Later repairs or additions were noted to the western and eastern sides of the well and comprised machine-made brick, bonded with a dark grey cement-like mortar. The western repairs contained the truncated remains of ceramic drainage. The entire feature had been backfilled with a mixed deposit containing demolition debris and seemingly capped by cement/stone flags.

Plate 14: Brick well within room **1007** looking east, scale 1m

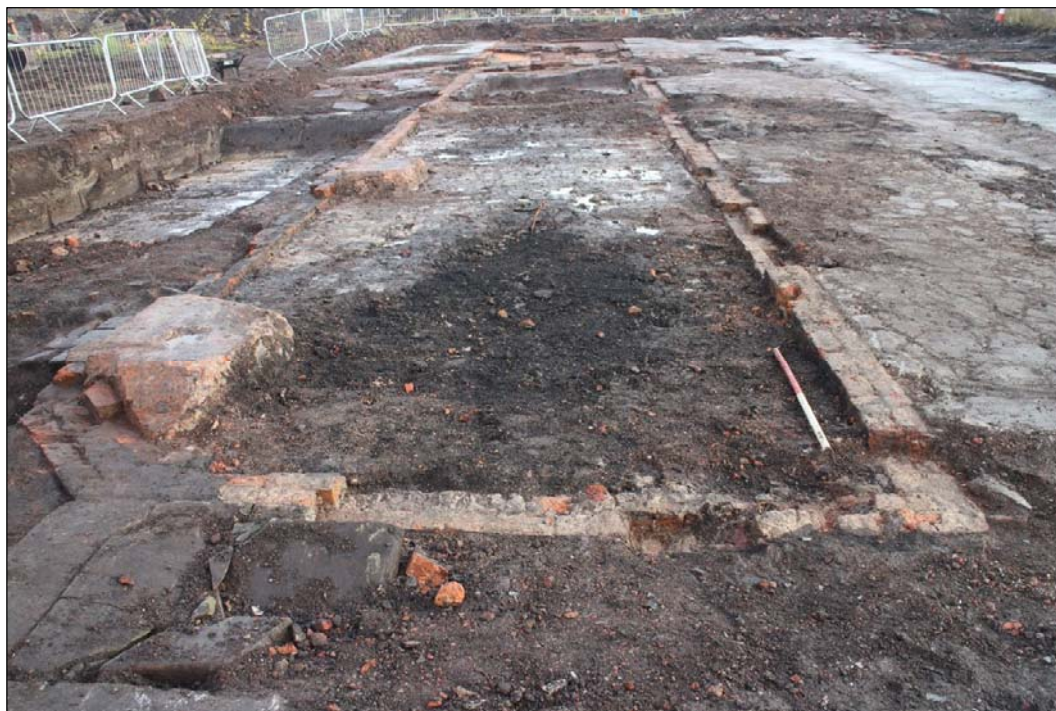
3.9.13 Room **1009** was located within the northern half of Area 1 (Fig 4 and Plate 15), between rooms **1010** and **1011**. **1009** was roughly rectangular in shape, with the north-western corner instead angled at approx. 45°. The whole room measured 22m x 3.15m and was bounded on all sides by a single brick wide wall, constructed using hand-made bricks and bonded with a light brown sandy mortar. A single brick foundation step was observed with coursed rubble masonry beneath. A single coursed partition wall of similar construction divided the room at 10.35m from the western extent. The entire area was initially covered with a concrete floor surface (identified as context **209** in evaluation trench 2) which was exposed and subsequently removed during excavation. Below this surface several features were identified. These included

Plate 15: Room **1009** looking east, scale 1m

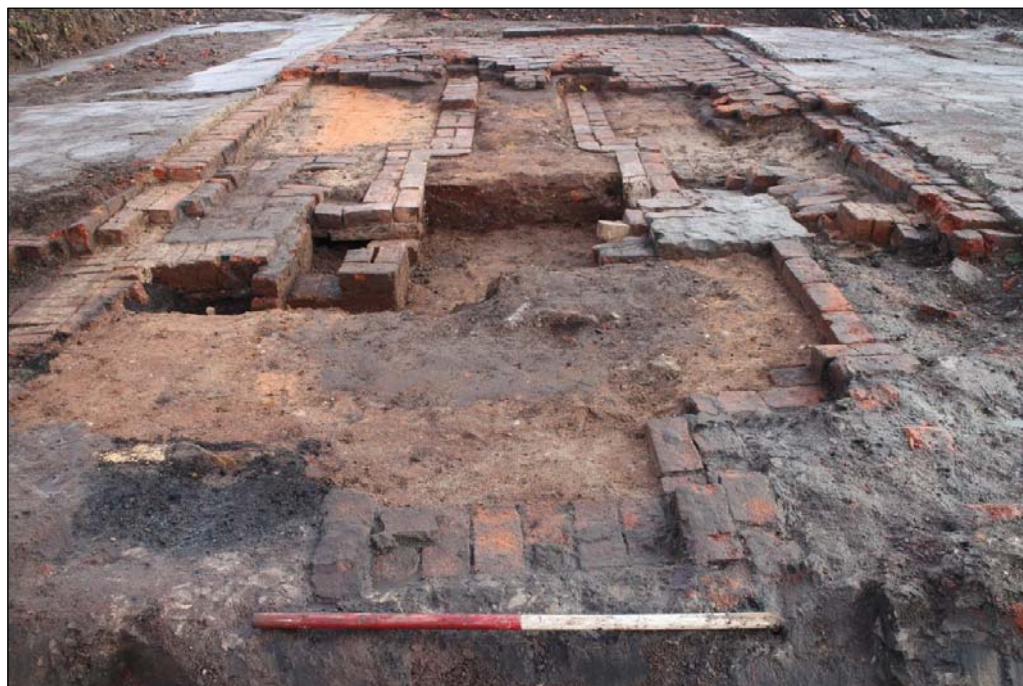
- 3.9.15 A potential flue system and stoking area for an earlier boiler measuring approx. 5.2m x 2.25m (Plate 16) was identified beneath the brick floor within room **1009**. The whole structure was constructed using handmade bricks, a single brick wide and bonded with a light brown sandy mortar (eastern half) or a light grey sandy mortar (western half and platforms to north and south). The eastern half of the structure comprised refractory bricks forming the internal coursing with bull-nosed headers at stepped junctures. The whole structure had been filled/covered with a mix of sharp sands and demolition debris. Coal fragments were observed below these deposits within the western extent of the structure.

Plate 16: Flue system for a potentially early boiler within room **1009** looking east, scale 1m

- 4.3.8 Rooms within **1008** included the documented remains of the hatwork’s boiler house and engine room (Whitehead 2018; TEP 2018). The internal structure of the boiler house was partially observed before fieldwork in this area was curtailed by the presence of contaminants; it was constructed with typical, refractory fabrics associated with high temperature environments. Documentary evidence also states the chimney was located just beyond the western limit of excavation. No evidence for the engine house was observed within **1008**. The boiler house remains in room **1008** likely relate to the final location of the structure, with evidence that the structure was still upstanding in 1985 (Whitehead 2018).

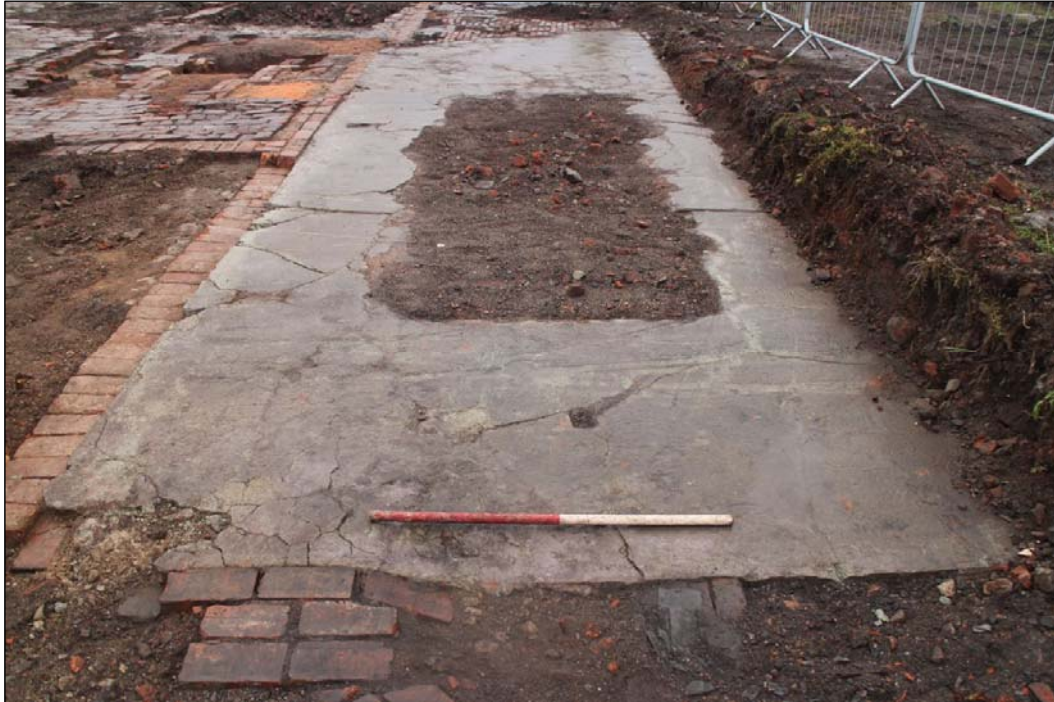
3.9.16 Room **1010** was located at the north-eastern extent of Area 1 and measured 14m x 3.6m (Fig 4 and Plate 17). The room was rectangular in shape and bounded by a coursed rubble masonry foundation to the west, room **1009** to the south and a truncated modern brick wall to the east. An additional north-east/south-west-aligned wall continued from the eastern extent of **1010**, through the eastern baulk and towards Trench 3. This may have been the return of wall **303** therein. **1010** appeared to correlate well with a rectangular building identified on the historic mapping (Fig 7), which appeared to lie between the large building identified as ‘Hat Manufactory’ and the building fronting Annan Street, which has been the main focus of the excavation of Area 1. The two buildings shown on the historic mapping to the west of **1010**, do not appear to have survived.

Plate 17: Room **1010** looking west, scale 1m

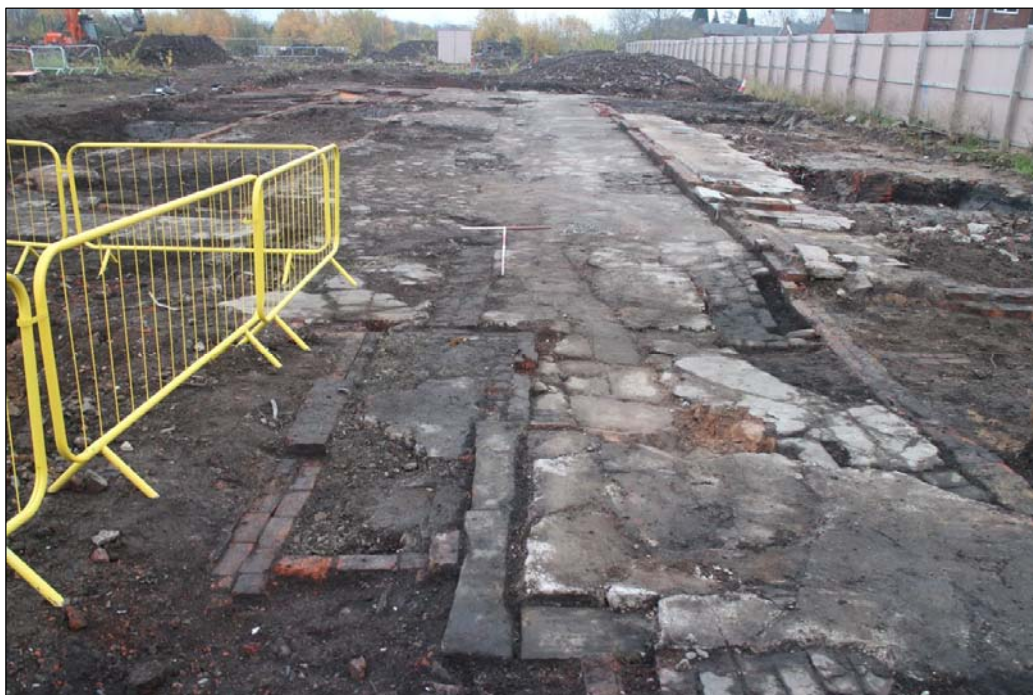
- 3.9.18 External Yard **1011** was located across the centre of Area 1 and comprised an open area of hard-standing approx. 132.5m² (Fig 4 and Plate 18). The whole area was covered with a 0.2m layer of concrete with a central, stone drainage runnel aligned east/west. Several small cobbled areas were observed along the south western extent at irregular intervals. External Yard **1011** is clearly shown on the historic mapping (Fig 7).

Plate 18: External Yard **1011** looking east, scales 1m and 2m

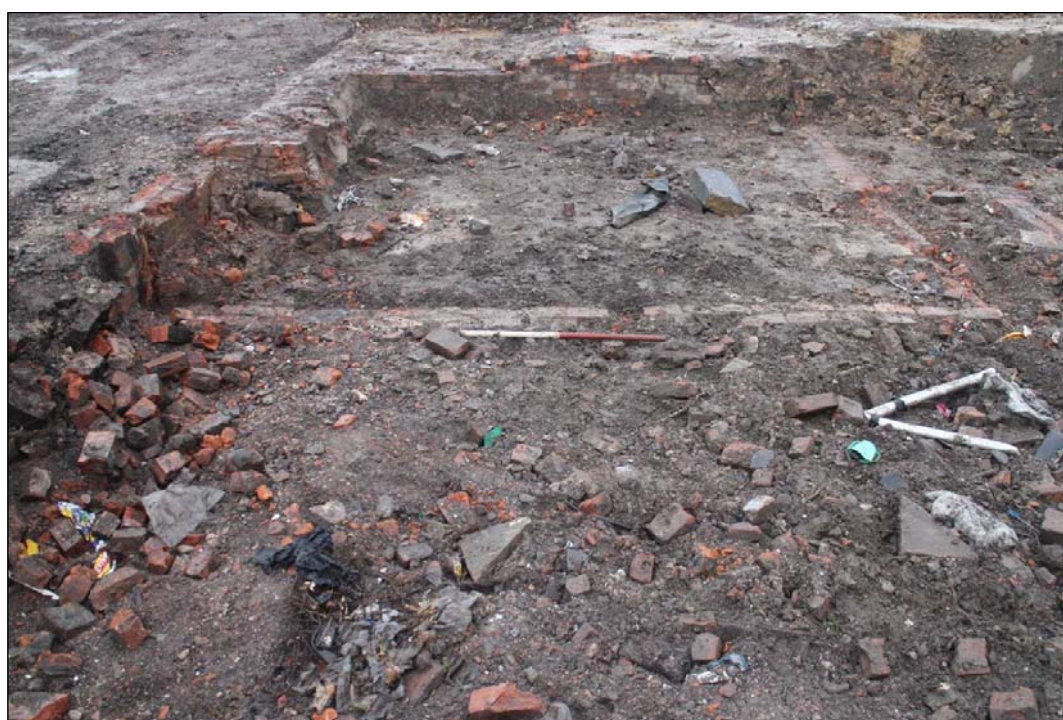
3.10.1 Area 2 was located across the extant remains observed within evaluation Trench 4 and measured 13m long by 8.5m wide (Fig 5 and Plate 19). The purpose of Area 2 was to establish the full footprint of a single domestic property observed within this area on historic mapping (Fig 7). The layout observed comprised three rooms which are described below.

Plate 19: Area 2 looking north, scale 1m

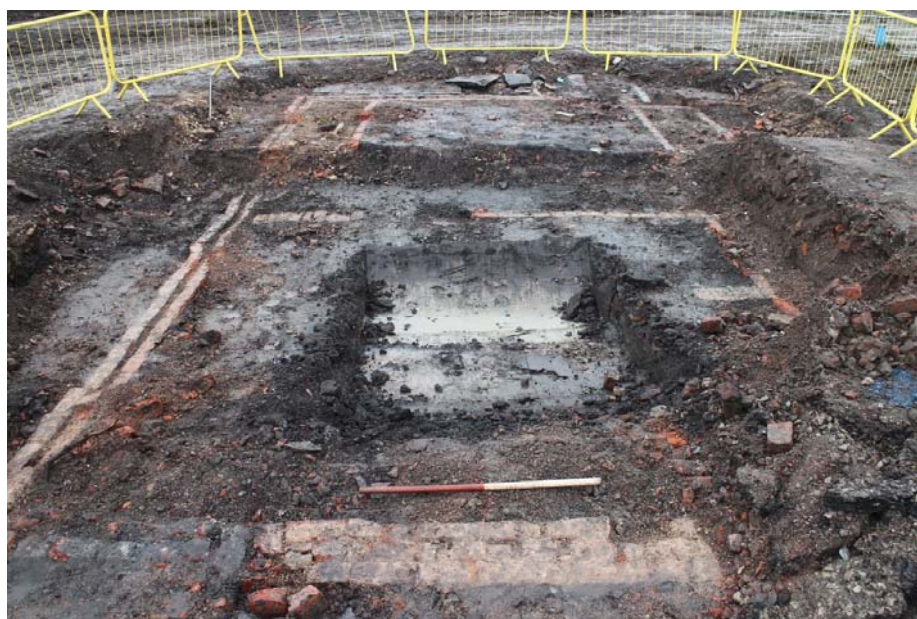
- 3.11.1 Area 3 was located across the extant remains observed within evaluation Trench 5 and measured 11.5m long by 7m wide (Fig 5 and Plate 20). The purpose of Area 3 was to establish the full footprint of a single domestic property observed within this area on historic mapping (Fig 7). The layout observed comprised two rooms which are described below.

Plate 20: Area 3 looking north, scale 1m
