# Darwen Market Square, Darwen, Lancashire Archaeological Evaluation Report

**Client: Capita on behalf of Blackburn and  
Darwen Borough Council**

Issue No: 2018-19/1941  
OA Reference No: L11169  
NGR: SD 701 225

### *Archaeological Evaluation Report*

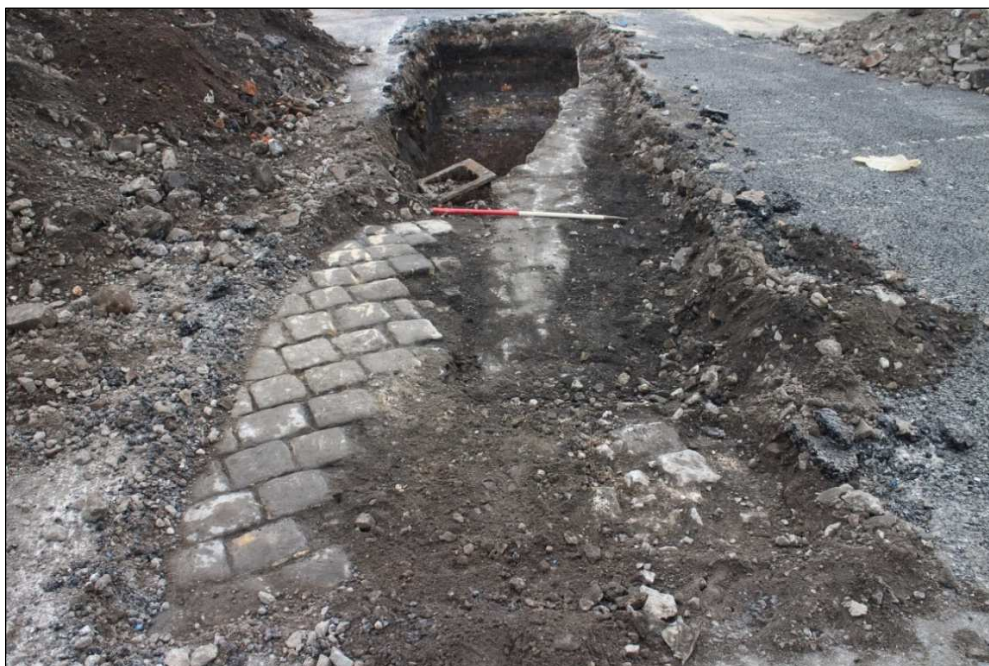
Plate 1: Trench 1 facing south, scale 1 x 1m

- 3.4.1 Trench 1 the northernmost of the three trenches (Fig 2 and Plate 1), was aligned north/south and measured 8.80m long by 2m wide. The trench targeted the northern wall of the bleach works, as identified on the historic mapping (Fig 3). The location of the trench was moved from its intended position by 1.60m to the south, due to spatial constraints on site for the movement of vehicles, this also resulted in the trench being shortened slightly by 1.20m, this did not impact upon the detection of the intended structure.

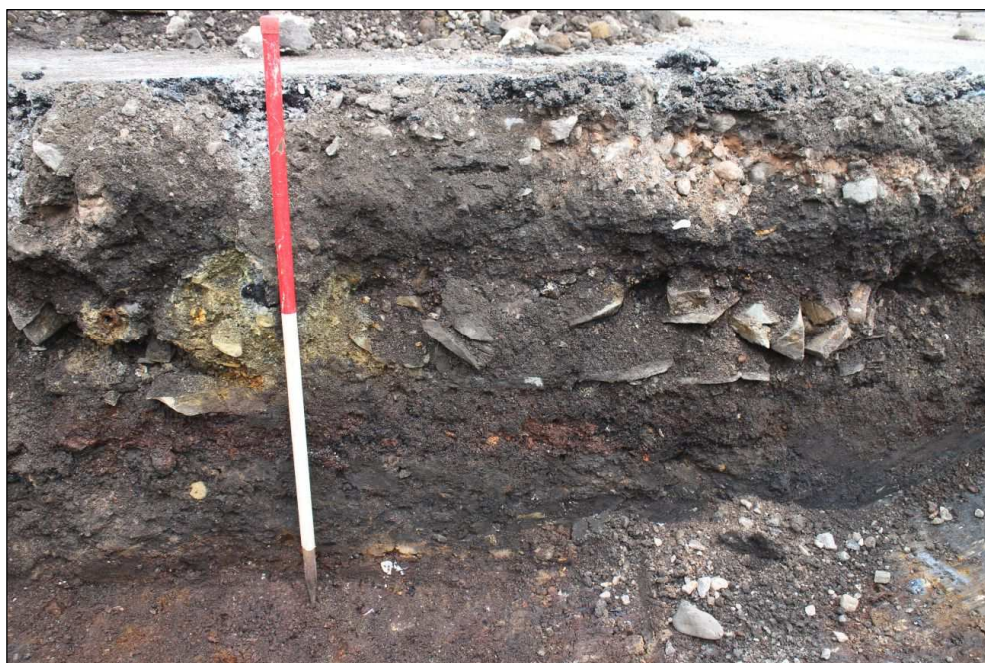
Plate 2: West-facing section of demolition layers at the southern end of Trench 1, scale 1 x 1m

3.4.2 The trench was excavated to a depth of 1m bgl, with the earliest deposits being identified at the southern end of the trench, and likely relating to the demolition of the bleach works (Plate 2). The earliest of these deposits was **106**, a mid-red brown sandy silt containing oxidised metal debris, 0.10m thick as exposed within the trench. This deposit was overlain by **105**, a dark grey compact silty sand with flecks of yellowish orange silty clay, and was approximately 0.20m thick. Overlying **105** was a thick layer of demolition rubble, **104**, which was dark grey silty sand containing a large amount of angular sandstone and industrial debris, including part of a cast-iron pipe visible in Plate 2.

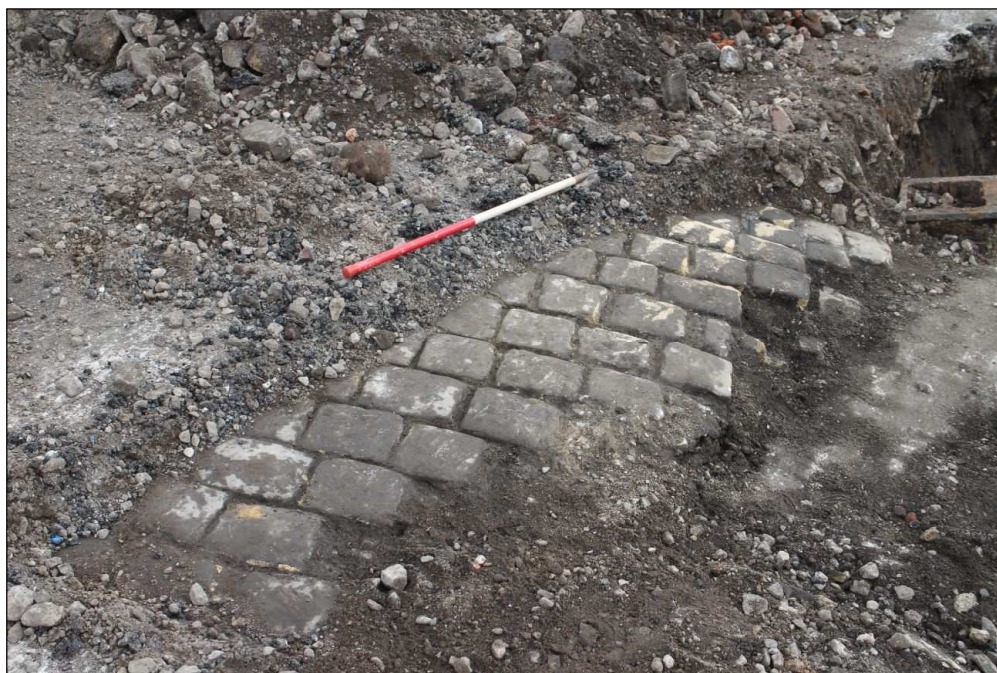
Plate 3: Sandstone Cobble Setts **102** looking south-east, scale 1 x 1m

3.4.3 A sandstone cobble sett surface **102** (Plate 3), was identified at the northern end of the trench. The setts measured approximately 0.20m long by 0.15m wide and were laid in regular rows. Cobble surface **102** was truncated by a concrete encased drain running through the trench north-east/south-west. A cast iron drain cover, identified at the southern extent of cobble surface **102**, may also be part of the concrete encased drainage system. The drainage was not disturbed during the trenching due to concerns that it was still live. These features and deposits were subsequently overlain by hardcore **103** and tarmacadam **101**.

- 4.4.2 Although the cobble sett surfaces (**102** and **203**) survive at such a shallow depth there is likely to be minimal impact upon them from the proposed development. In the areas of the trenches, the existing ground level is due to be built up by between 0.3m and 0.8m and therefore will produce very minimal below ground impact. The only impact would likely be caused by relatively shallow drainage.

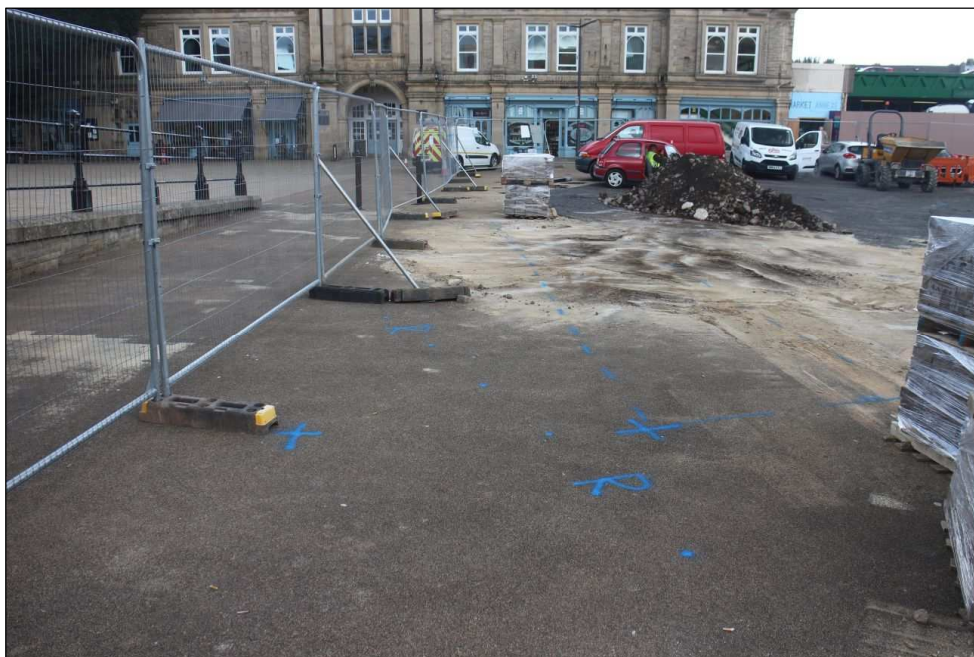
Plate 4: Location of Trench 2 prior to excavation showing original trench location to the left of the image with the dotted line showing the presence of an electric cable detected in Radio mode on the CAT, drainage visible at the northern end of the trench.

3.5.1 Trench 2 the westernmost of the three trenches (Fig 2 and Plate 4), was aligned north-west/south-east and measured 8m long by 1.90m wide. The trench targeted the western walls of the bleach works, as identified on the historic mapping (Fig 3). The location of the trench was moved to the east of its intended position, using the eastern co-ordinates of the proposed trench location, owing to health and safety reasons, after the presence of a potential cable was detected running on the same alignment as the trench between two lamp posts (Plate 4). The trench was also shortened by 1.30m due to drainage identified at the northern end of the trench.

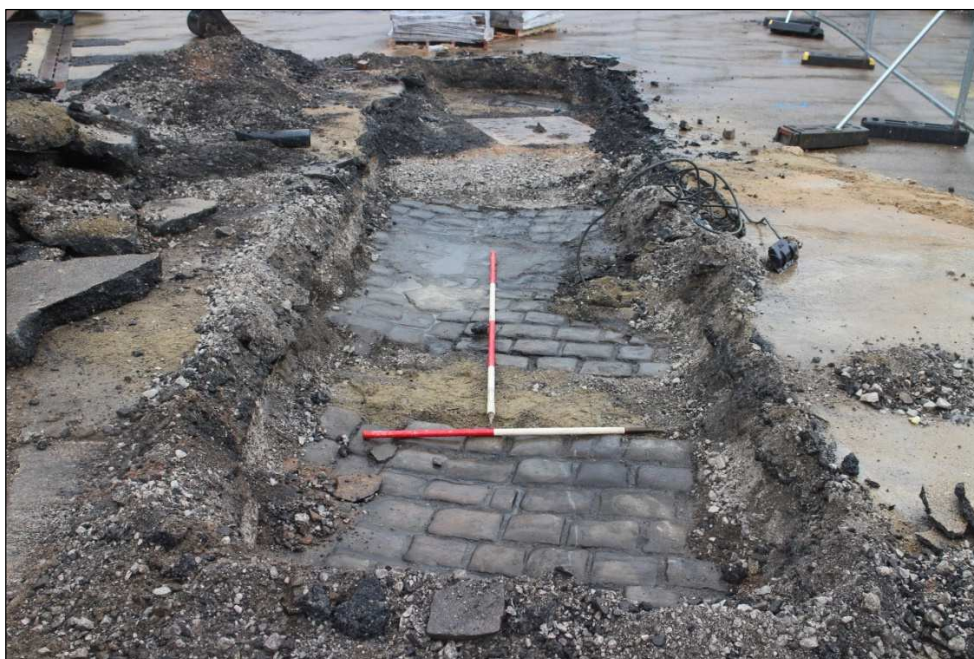
Plate 5: Trench 2 looking south-east, scales 1 x 1m and 1 x 2m

3.5.2 The trench was excavated to a maximum depth of 0.30m, with the earliest feature comprising a sandstone sett cobble surface **203**, which was identified throughout the trench (Plate 5). The setts measured approximately 0.20m long by 0.15m wide and were laid in regular rows. The surface was truncated by several modern services, not identified by the CAT, these included a cable duct, a pot-ended cable and a large concrete base at the southern end of the trench, likely for a lamp-post. Cobble setts **203** were overlain by hardcore **202**, which was subsequently overlain by tarmacadam **201**.

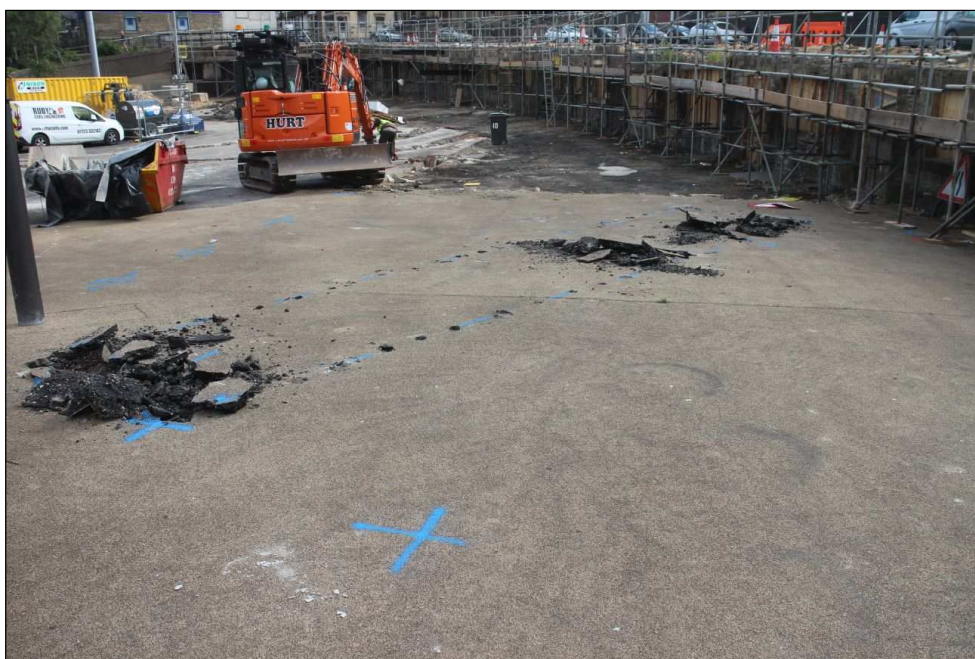
Plate 6: Location of Trench 3 prior to excavation showing the original trench location in the foreground of the image, the 2m gap visible towards the far end of the trench.

3.6.1 Trench 3 the southernmost of the three trenches (Fig 2 and plate 6), was aligned east/west and measured 10m long by 1.80m wide. The trench targeted the eastern wall of the bleach works, identified on the historic mapping (Fig 3). The location of the trench was moved from its intended position to the north using the northern co-ordinates of the proposed trench location, owing to its proximity to scaffolding erected around the market square. A 2m gap was also left in the trench, due to health and safety reasons, after the presence of a potential cable was detected aligned north/south, this easternmost part of the trench contained the same deposits as the rest of the trench.

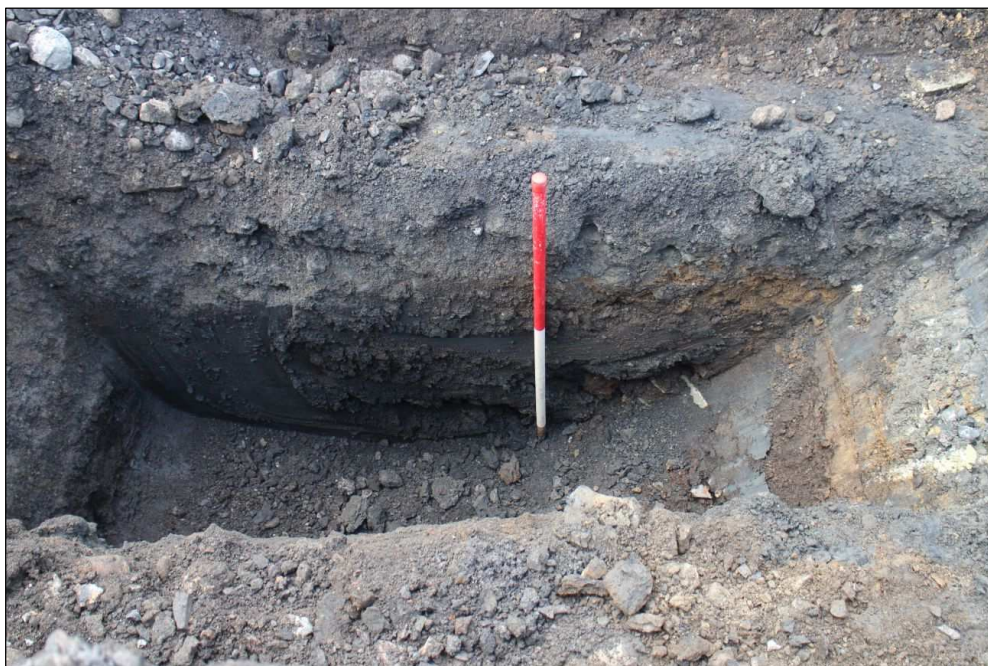
Plate 7: North-facing section of sondage excavated in Trench 3 over the potential location of the bleach works eastern wall, scale 1 x 1m

3.6.2 The trench was excavated to a depth of 1m bgl, although a sondage was excavated to a maximum depth of 2m bgl in the potential location of the bleach works eastern wall identified on the historic mapping (Plate 7). The earliest deposit within this sondage was **310**, a dark grey-blue silty clay, almost peat-like, which was identified 1.50m bgl and continued beyond 2m bgl. This deposit was overlain by **309** a thin orange-yellow silty clay layer approximately 0.20m thick. Deposit **309** was overlain by a light blue-grey silty sand, **308**, which was identified in the base of the trench at 1m bgl and was 0.30m thick within the sondage.

- 3.6.3 Deposit **308** was identified at the base of the trench at 1m bgl throughout the eastern half of the trench and was overlain by a layer of sandstone rubble, **305**, a mid-brown yellow matrix containing a large amount of sandstone rubble, approximately 0.34m thick (Plate 8). Concrete foundation **307** was laid directly on layer **305** towards the western end of the trench, the foundation was 1m long by 0.52m wide and 0.10m thick, and extended south beyond the limits of the trench (Plate 9). Wall **306** was partially built on foundation **307**, although the wall followed a slightly different alignment, north-west/south-east, and extended beyond the foundation to the north of the trench. Wall **306** survived to a height of five bricks at most, and extended through the trench. The bricks were machine-made and individually measured 0.12m long by 0.09m wide and 0.06m deep, laid as stretchers in two skins bonded by Portland cement, with a narrow cavity, which appeared to be filled by concrete (Plate 9). Both wall **306** and concrete foundation **307** appeared to be of modern twentieth century construction and likely not relating to the walls of the bleach works.

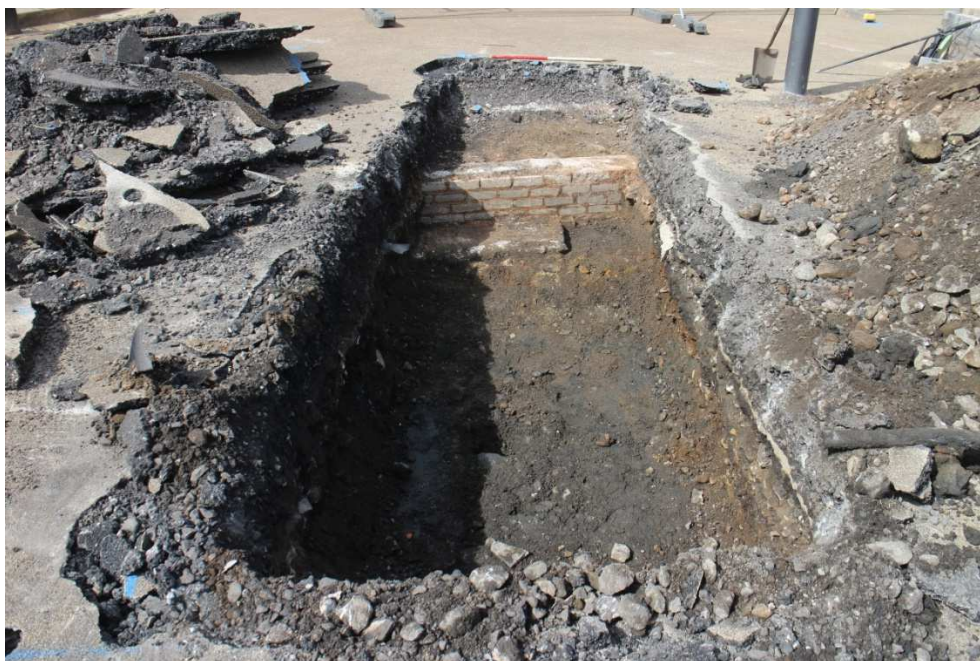
Plate 8: Trench 3 looking west, scale 1 x 1m

- 3.6.4 Demolition layer **304** appeared to overly concrete foundation **307** and butt up to wall **306**, suggesting that it had been deposited once the wall and foundation had been constructed. There was no evidence of a construction cut for either of these features. Demolition layer **304** was observed as a dark blue-grey silty sand containing brick rubble and sandstone rubble approximately 0.16m thick.

- 3.6.5 Demolition layer **304** and wall **306** were sealed by a thin levelling deposit **303**, which was observed as light to medium white-grey sand, containing a small amount of brick rubble and stone, approximately 0.10m thick. This layer was subsequent overlain by hardcore **302** and tarmac **301**.

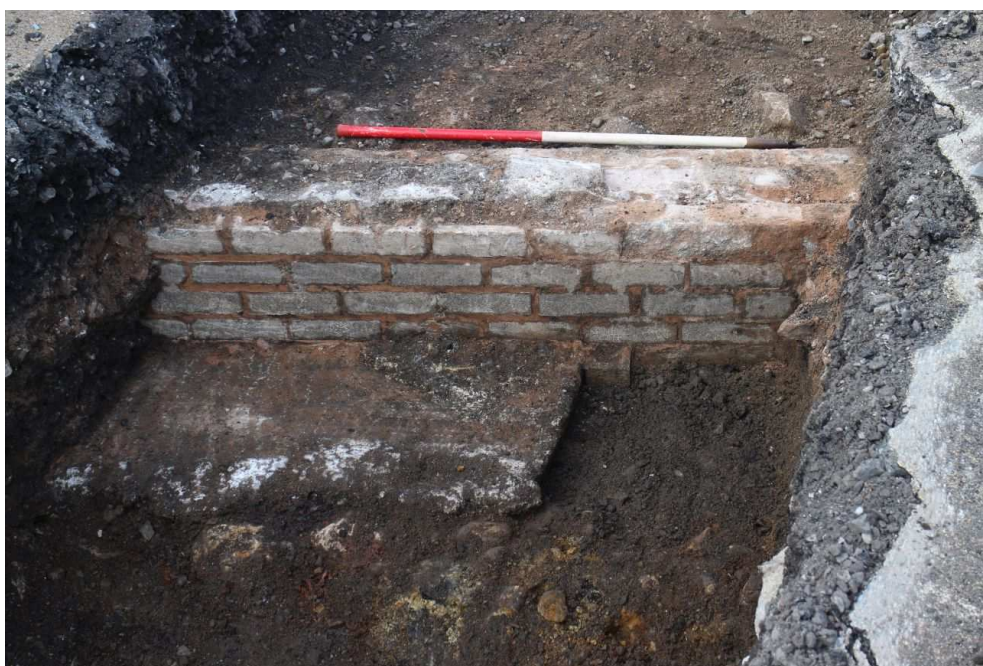
Plate 9: Wall **306** and Concrete Foundation **307** looking west, scale 1 x 1m

4.3.2 Wall **306** and foundation **307** were of a form and construction identified as modern, machine-moulded bricks and Portland cement mortar, and therefore not relating to the bleach works. This wall likely related to a small building on the market square identified on satellite imagery dated 31/12/2000 (Google Earth 2018), seemingly erected after 1960 and then demolished by 2005. The absence of cobble setts in the southern half of Trench 1 and throughout Trench 3 may relate to the construction of this small building.

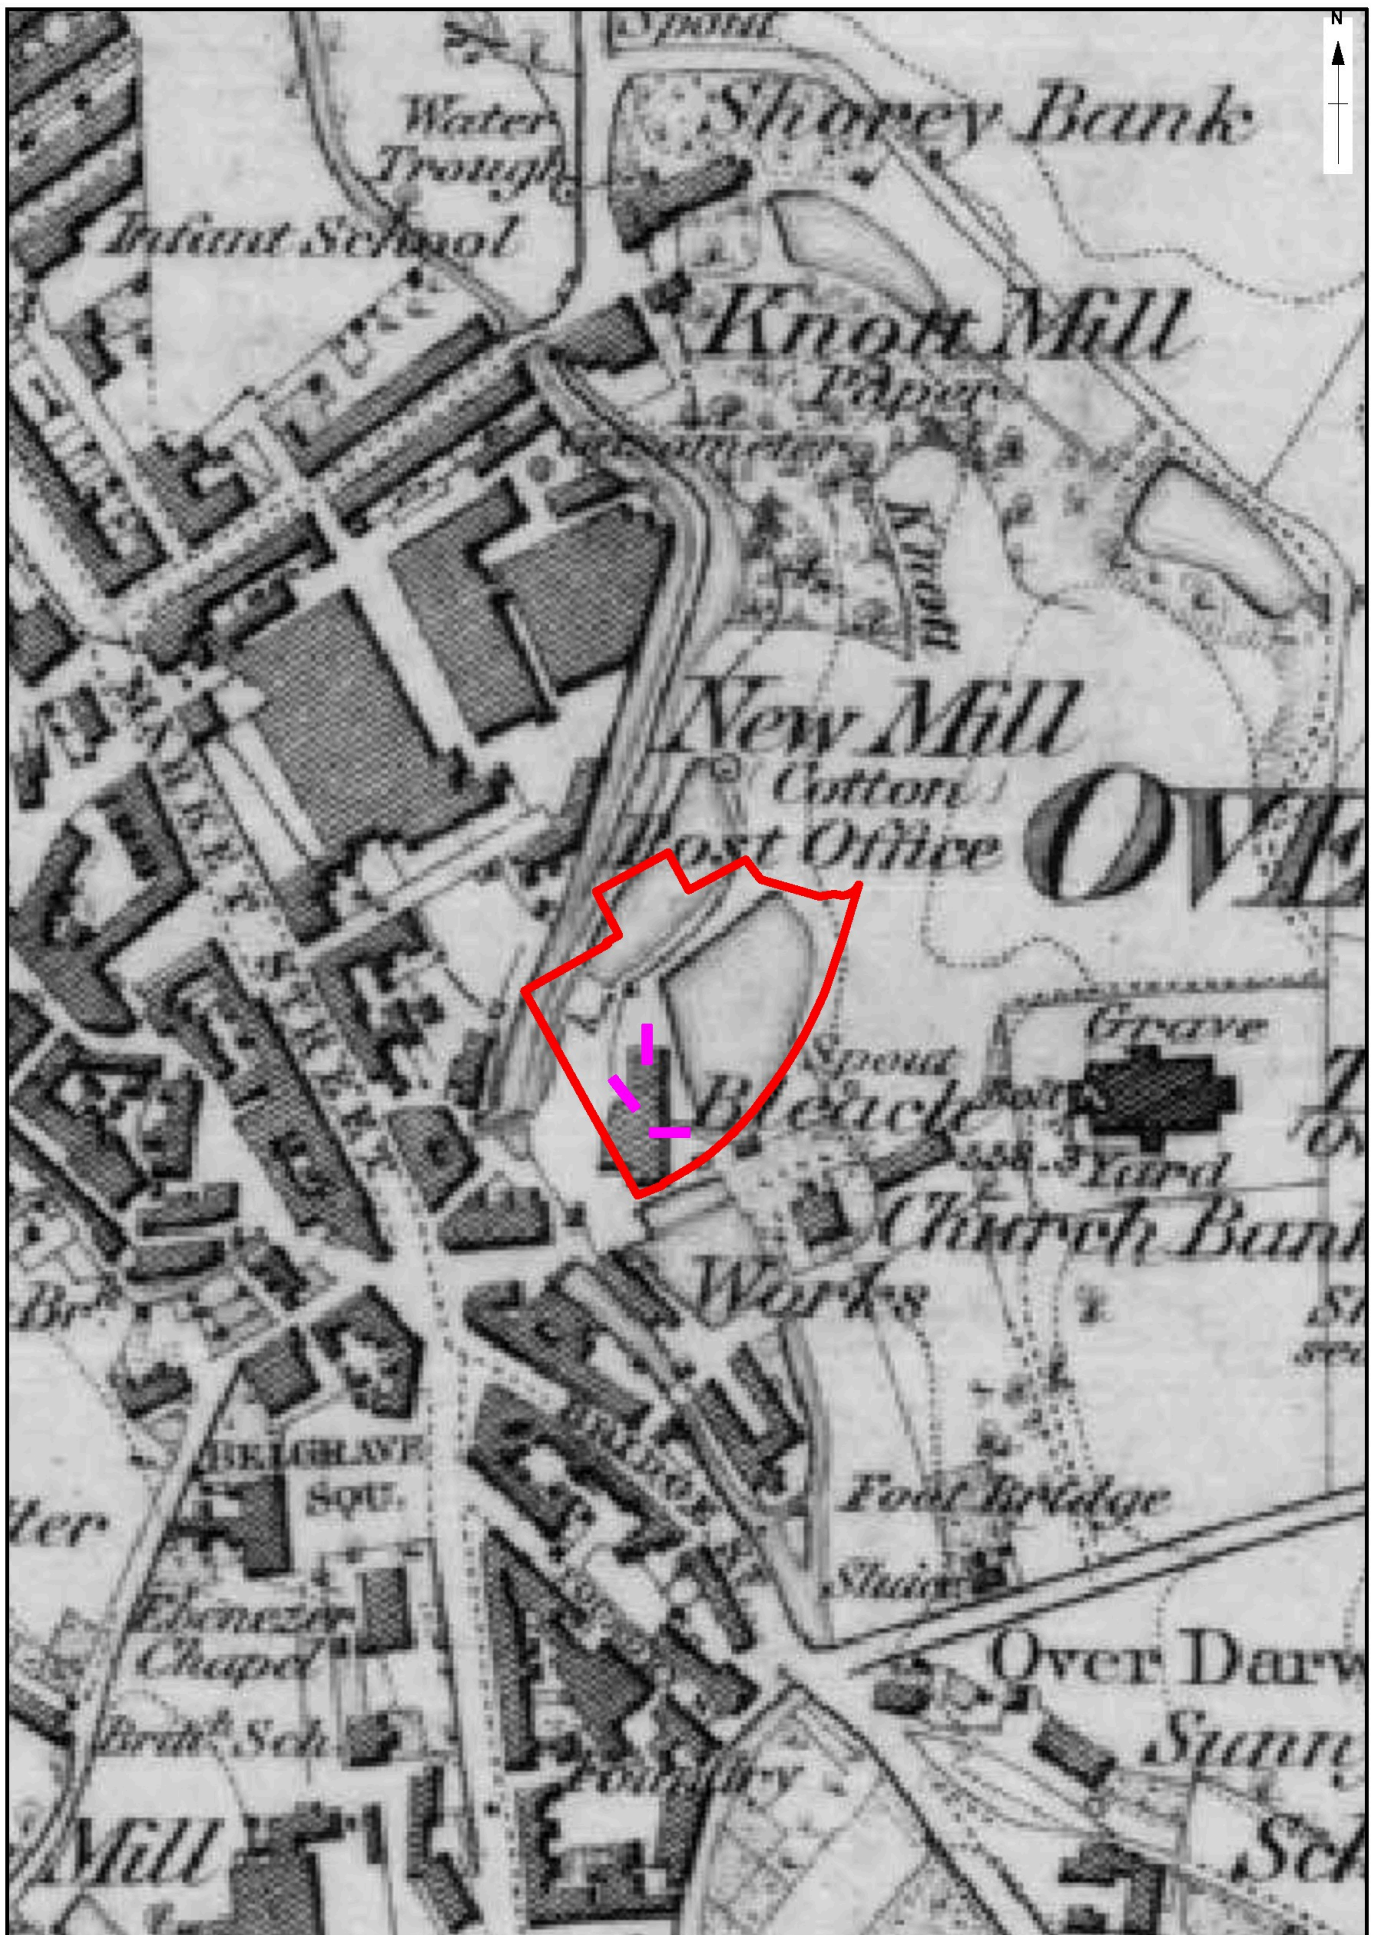
Figure 3: Proposed evaluation trenches

Site Boundary
  Proposed Trenches

2.1.1 Given the archaeological potential of the PDA primarily resides with potential buried remains relating to the former premises of the Readford Bleach Works, held to be of local historical and archaeological significance and identified on historic mapping to be located towards the southern extent of the area, the aim of the evaluative works identified in this document will be to establish the presence/absence and state of preservation of any features relating to the works. A scheme of targeted trial trenching, comprising three small trenches, has therefore been devised, which will hopefully allow investigation of the target area and potential structures (Figure 3, *Section 3*).

- 3.2.1 As the primary aim and objective of the work programme is to establish the state of preservation of below ground remains associated with the former premises of the Readford Bleach Works, a scheme of targeted trial trenching has been devised with which to achieve these goals. Based upon historic mapping of the area, primarily the 1<sup>st</sup> Edition OS Map of Darwen (Figure 2), three 10m x 2m trenches have been positioned in order to test the mapped position of the former building and its current state of preservation (Figure 3).
