Moto Service Station, A1(M), Junction 45 Wetherby, North Yorkshire

Archaeological Evaluation

Document Title: MOTO SERVICE STATION, A1(M) JUNCTION 45,
WETHERBY, NORTH YORKSHIRE

Issue Number:
OA Job Number: L9821
Site Code: WMSA 07

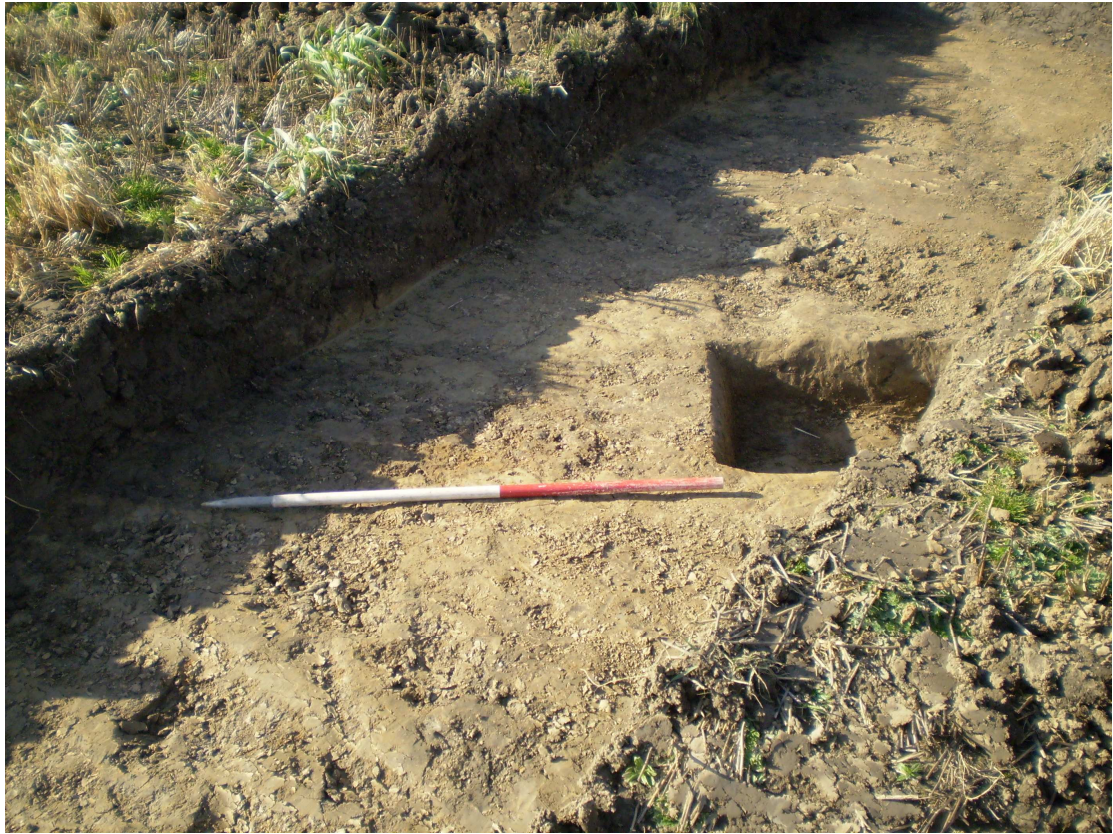
- 3.1.3 **Trench 2** (Fig 3): was aligned east-west and excavated to a maximum depth of 0.38m. It comprised a topsoil **106**, containing post-medieval pottery fragments, and light orange-grey sandy-clay natural **107**. A shallow ditch **108** (Plate 1) was observed and investigated towards the western end of the trench. It was orientated north-west/south-east, and measured 0.56m in width and 0.21m in depth. The ditch had been truncated on its western side by an animal burrow, traversing the feature from east to west. Residual fragments of glass, clay pipe and post-medieval ceramic were recovered from this area, but cannot be used to confidentially date the feature. Three modern ceramic field drains were observed at 2.7m, 4.9m and 6m from the east end of the trench.

Plate 1: boundary ditch *108*, Trench 2, looking to the south-west

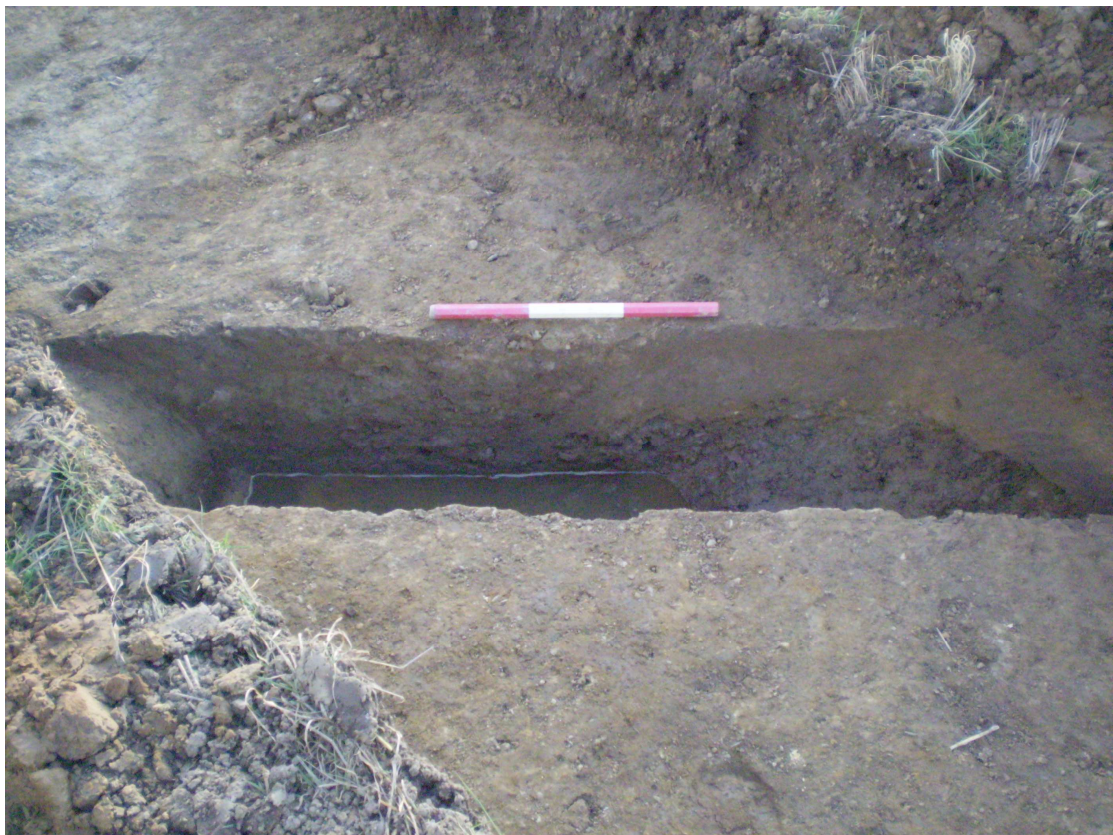
- 3.1.4 **Trench 3** (Fig 4): was aligned north/south, and excavated to an average depth of 0.4m. It comprised dark-brown clay-silt topsoil **100**, and dark yellow sandy-clay natural **101**. A ditch **110** (Plate 2) was located at approximately 5m from the northern end of the trench. It was orientated north-west/south-east and contained a dark-grey silty-sand fill **111**. No finds were identified. Ditch **110** had been cut on its the southern side by a modern ceramic field drain, so its complete form remains unknown. A second field drain was observed 17.2m, to the south of the first.

110	3	0.22m	Cut for boundary ditch: linear in plan and u-shaped in profile, measuring 0.9m in width, with gradual sides and a concave base. Aligned north-east/south-west, the ditch had been truncated by a modern field drain

on its southern side.
111	3	0.22m	Fill for boundary ditch 110 : dark-grey compact silty-sand, with a bluish tint. Contains >1% charcoal flecks, >1% small rounded stones. No finds were recovered from the deposit.
112	1	-	Natural: mix of orange-grey boulder-clay with >5% small stone inclusions, orange-grey clay-sand and orange-yellow loose sand with 2% rounded stone inclusions.

Plate 2: north-east facing section through boundary ditch *110*, note the modern ceramic drain cutting the ditch, Trench 3, looking to the south-west

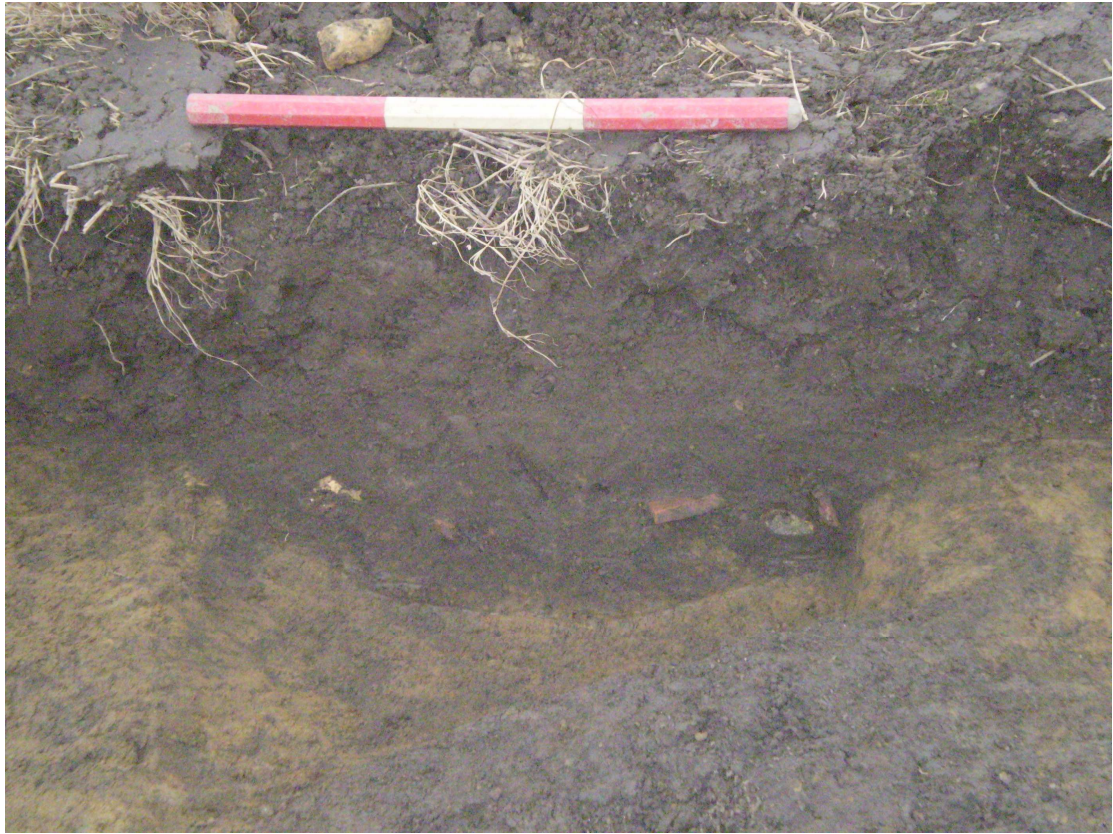
- 3.1.5 **Trench 4** (Fig 4): was aligned north/south, and excavated to a maximum depth of 0.46m. It comprised topsoil **100** and natural **101**. A shallow ditch **105** (Plate 3) was observed and investigated 6m from the southern end. Orientated north-east/south-west and measuring 0.9m in width, it produced several fragments of glass, pottery and iron objects. A number of ceramic roof tiles, concentrated in the southern half of the trench, were recovered from the topsoil **100**.

Plate 3: north-east facing section through boundary ditch *105*, Trench 4, looking to the south-west
