ADELPHI STREET, SALFORD Greater Manchester

Archaeological Building Survey and Excavation

Oxford Archaeology North

March 2008

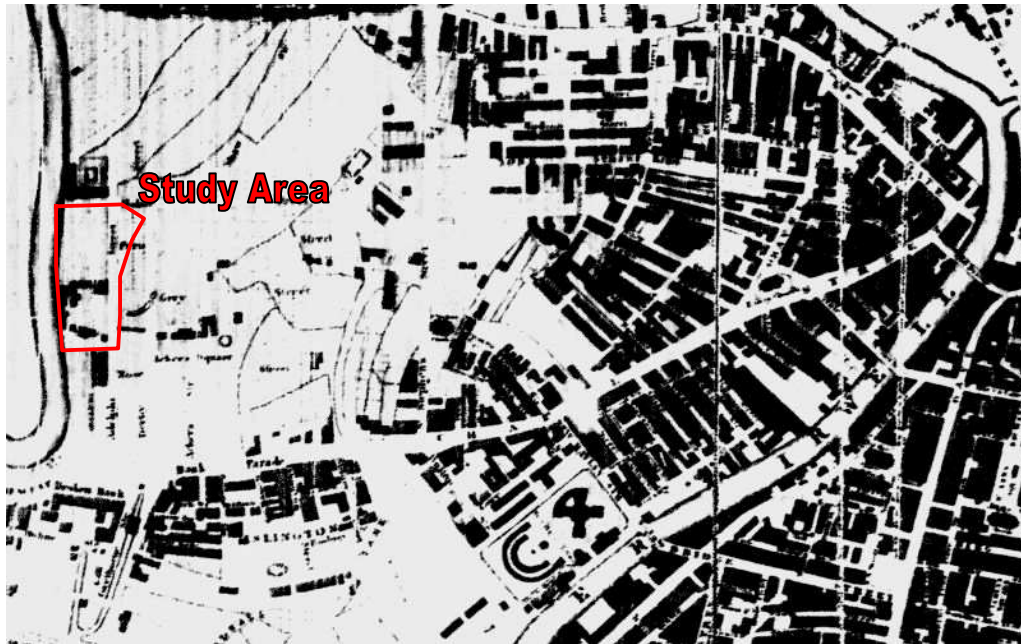
Plate 3: Extract from Pigot's map of 1820, showing the initial development of the study area

3.3.2 It seems that industrial buildings had been erected within the study area by 1820, as shown on Pigot's map of that year (Plate 3); this is the first map to depict Adelphi Street. The area certainly emerged as an important focus for factory-based dyeing, printing and finishing of cotton and silk goods during the 1820s, and trade directories for this period list several cotton merchants, printers and dyers on Adelphi Street and Blackburn Street to the east of the site boundary (eg Pigot 1828). Several dyers are listed at Adelphi Grove in a trade directory for 1821-2, and whilst Isaac Bury is not mentioned, it is interesting to note that a Thomas Bury is entered as a dyer at the nearby Middleton's Court in Salford (Pigot and Dean 1822, 246).

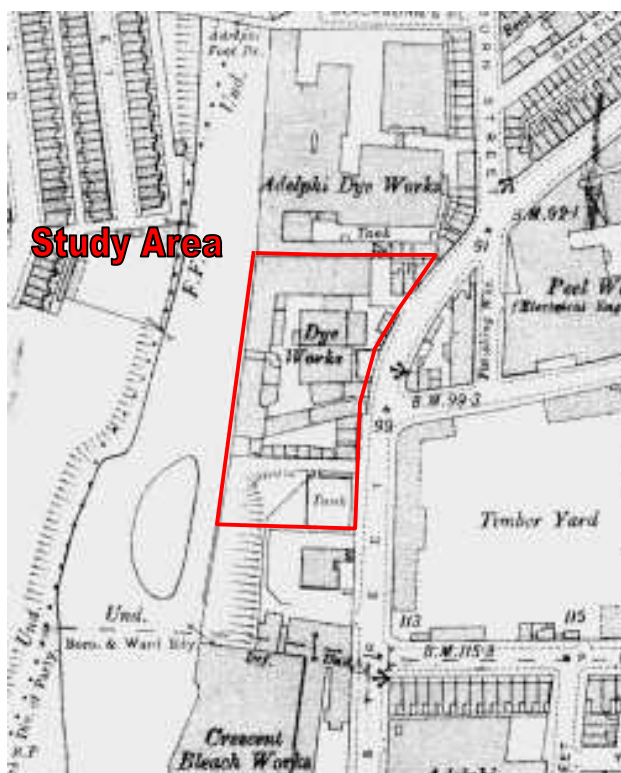
Plate 4: Extract from the Ordnance Survey map of 1908

3.3.8 There is no record of the fire having spread to Brierley’s Court, although these houses are shown on the Ordnance Survey map of 1892 to have been replaced by a large industrial building, which formed the northern edge of the study area (Fig 5). The dye works to the north of the study area is labelled as ‘Adelphi Dye Works’, suggesting that it also formed part of Isaac Bury’s works. Significantly, the map shows Adelphi Street to have been realigned, which necessitated the in-filling of a large reservoir immediately to the east of the study area. This also allowed several new houses to be built in the north-eastern corner of the study area together with a new road, Walker Street, which provided access to the dye works to the north. The 1908 Ordnance Survey map shows that further modifications to the site had been carried out. In particular, the reservoir located centrally within the site had been largely in-filled and built over, leaving only a small reservoir adjacent to Adelphi Street. Several new structures are shown to have been erected in the northern part of the site, including one against the south elevation of the building along the northern boundary of the study area (Plate 4).

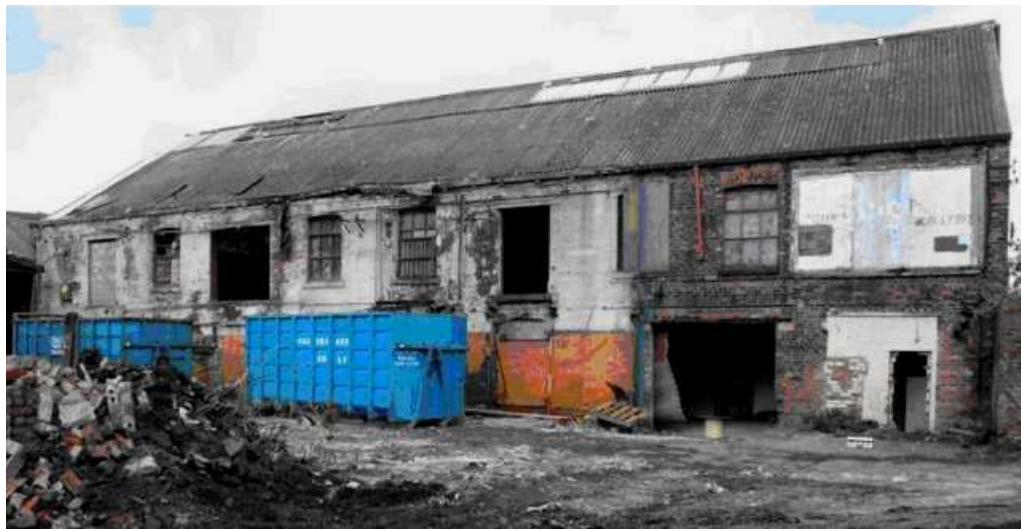
Plate 6: South-facing elevation of the building

- 4.3.1 **The South Elevation:** this formed the main elevation, and also provided the principal access point into the building. This was through a large, steel shuttered doorway located at the east end of the ground floor, whilst a smaller partially blocked doorway was present at the east end of the elevation (Plate 7). The only other form of access was provided by a small flight of stairs from the adjacent shed to the east. The blocked doorway appeared to have replaced an earlier door to its immediate right, which had also been blocked with brick. In addition, on the first floor, there are three loading bay doorway with projecting sandstone sills and flush lintels. These were arranged as large double doors to the centre of the elevation, with a further pair of ancillary doors at the west extent and towards the east end of the elevation. Only the central and east doors were still open apertures, as the western loading door has been in-filled with cinder block.

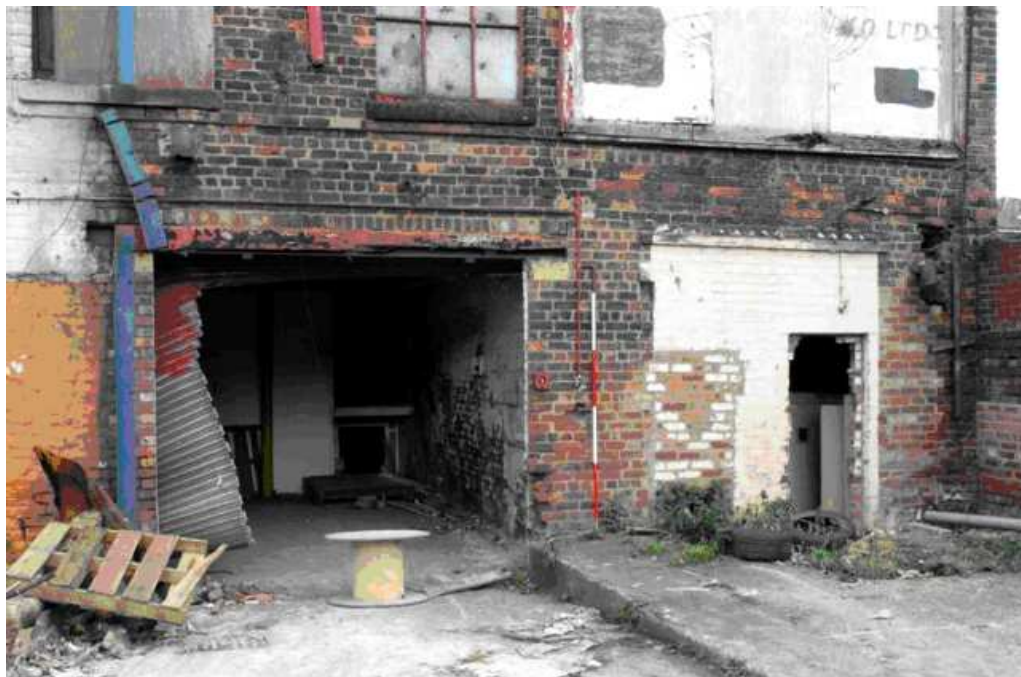
Plate 7: Entrance arrangement at the eastern end of the ground floor

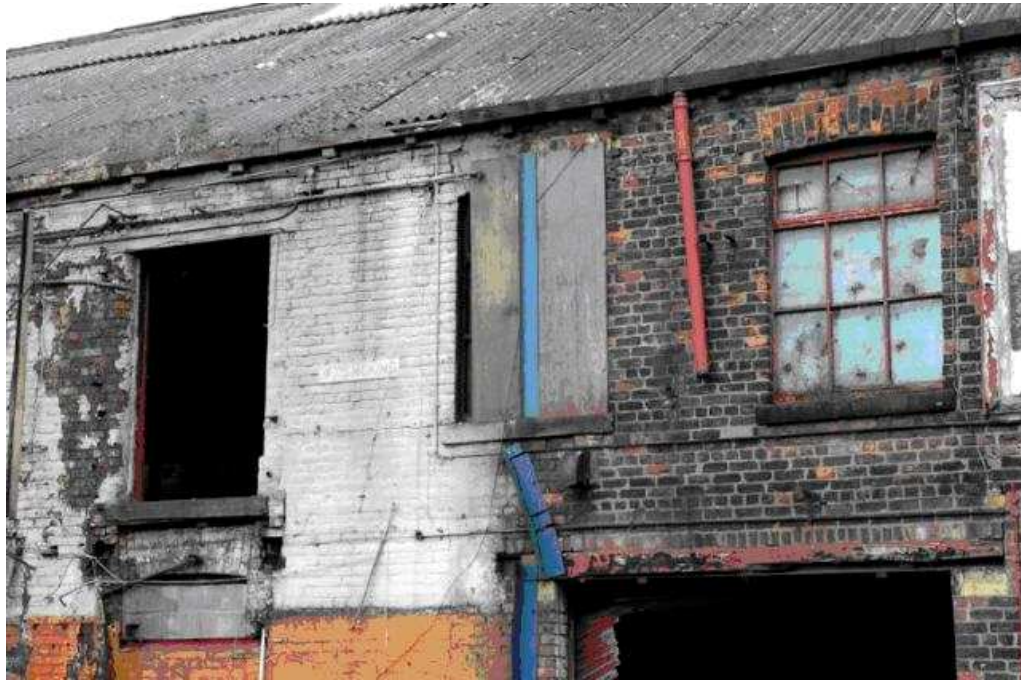
Plate 8: Detail of the windows and loading door on the first floor of the south elevation

were all blocked externally with brick and cinder block. Despite the blocking in the majority of these windows, all appeared to have originally been nine-light top-hung ventilator casements featuring segmental arched heads, flat brick rubber voussoirs, and slightly projecting sandstone sills (Plate 8).

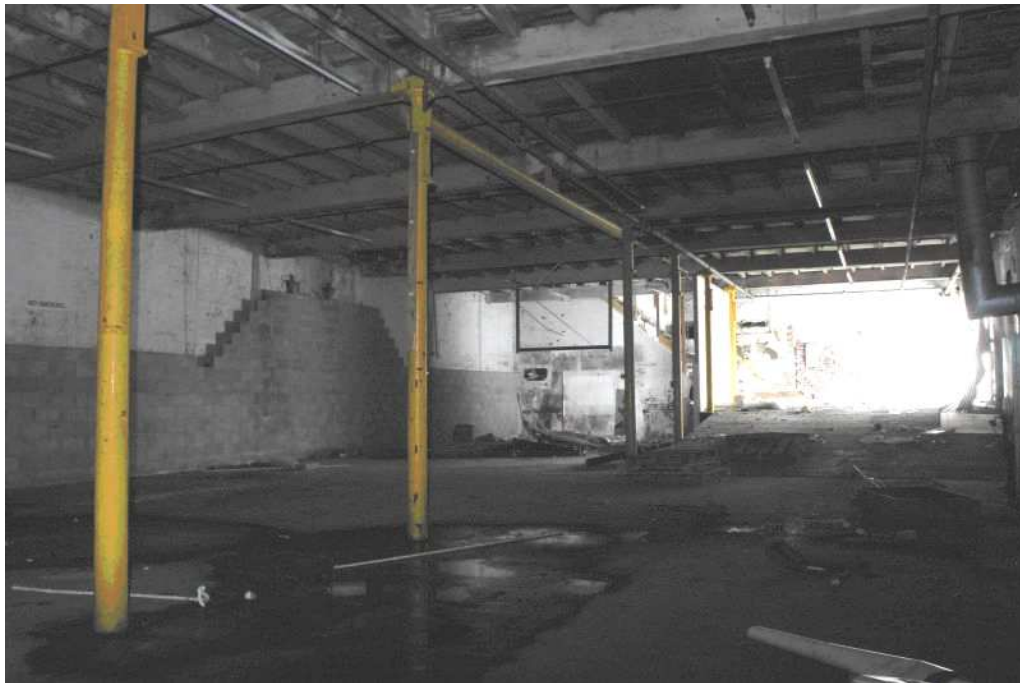
Plate 9: View looking north-east across the ground floor, with the cinder block wall to the left

4.4.1 **Ground floor:** the principal room on the ground floor was nine bays long from east to west, and was constructed from hand-made bricks and lime mortar, laid in a four to one English Garden Wall bond, with bullnose detail on the aperture surrounds. Similarly, bullnose detail had been added to the brick piers, which were inset with sandstone pads to support the machine-cut beams of the ceiling.

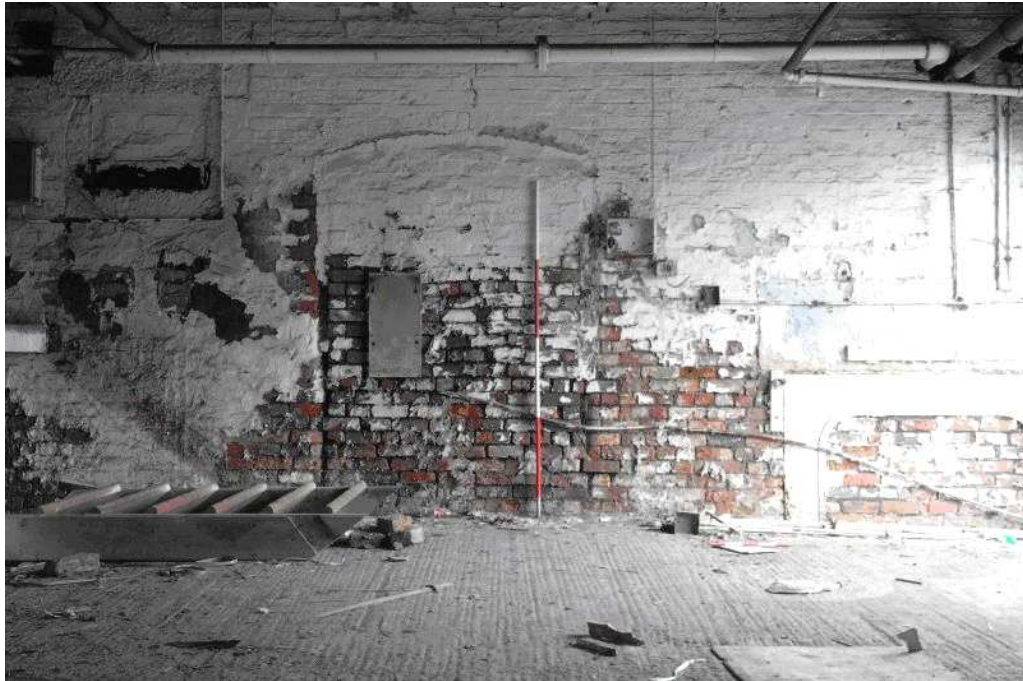
Plate 10: Detail of the dividing wall at the east end of the building

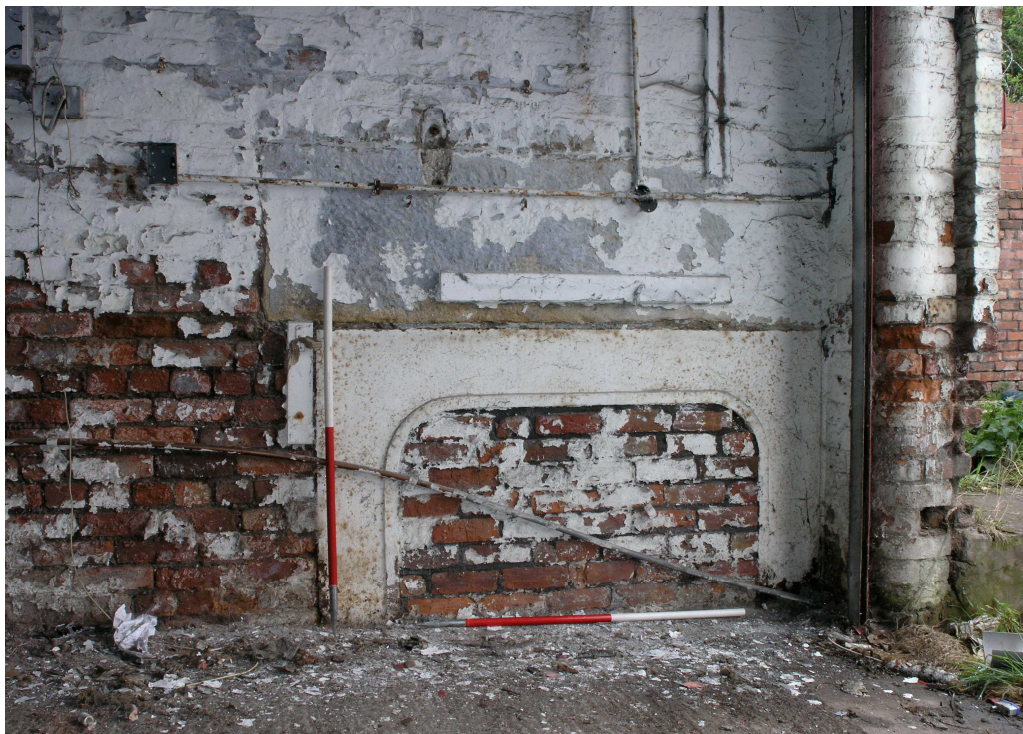
Plate 11: Detail of a primary transmission bearing box, in-filled with brick

cast-iron primary transmission boxes, and two smaller bearing boxes towards the centre and north of the wall. The more central bearing box had a groove worn into the surrounding brickwork, presumably representing the friction from a belt pulley on a lineshaft (Plate 12). All of the cast-iron casings were in-filled with brick or cinder block.

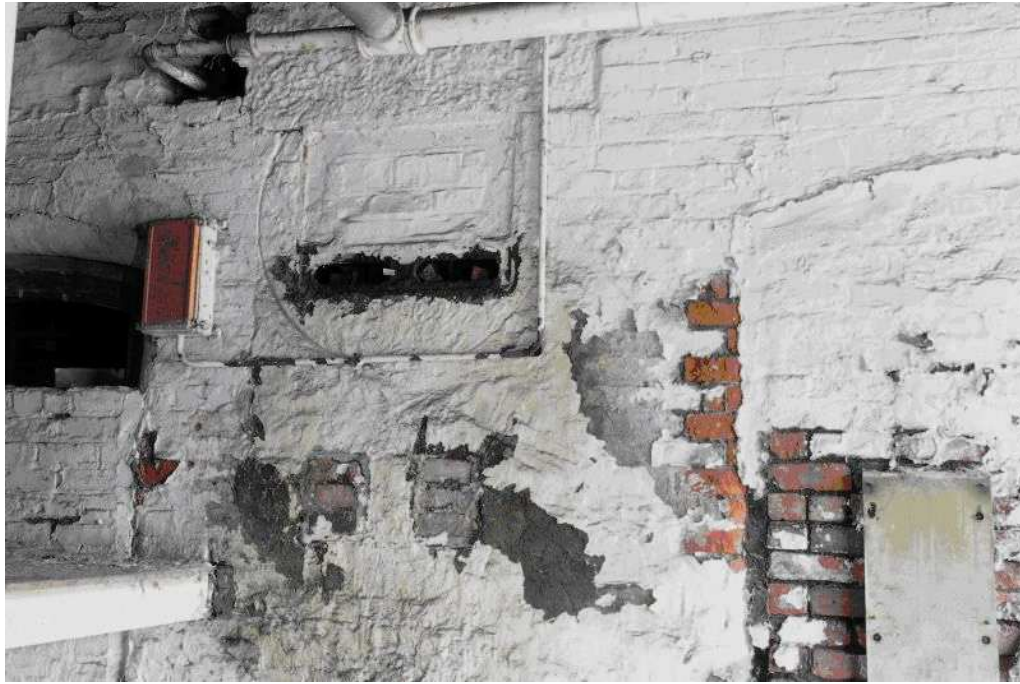
Plate 12: Detail of the in-filled central bearing-box, showing friction groove

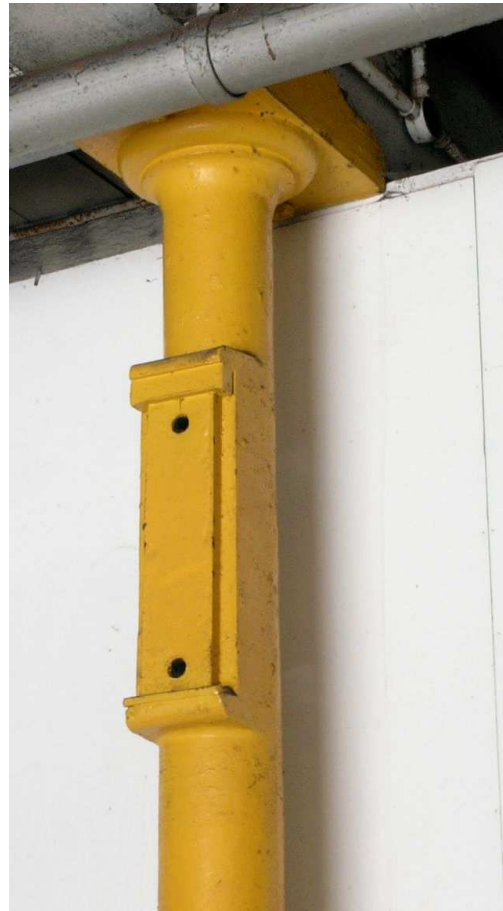
Plate 13: Detail of lineshaft bracket housing

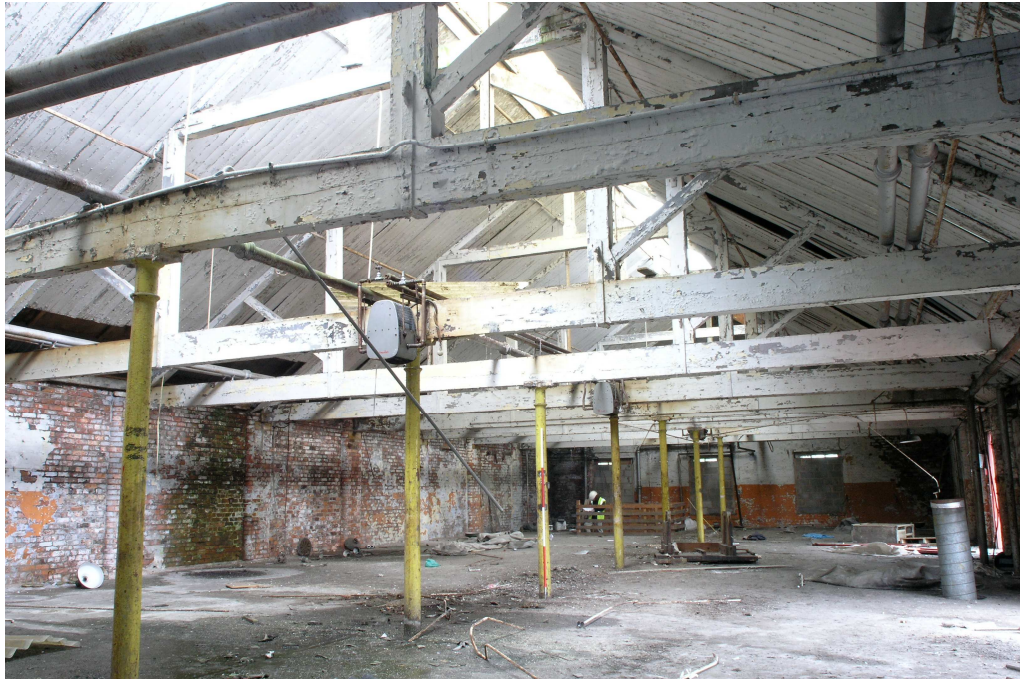
Plate 14: General view looking east across the first floor

- 4.4.5 **First floor:** as on the ground floor, the main build of the first floor was of hand-made brick and lime mortar, which had been repaired throughout with patches of cement render. The distinctive west elevation was again concrete with machine-cut bricks laid in a stretcher bond, whilst a small matchboard partition had been inserted at that end of the building in order to create a small office area. The floor comprised timber floorboards measuring 0.23m (9 inches) wide, overlaid with a bitumen surface up to 0.02m deep, which unfortunately masked the presence of any beds or scarring from machinery.

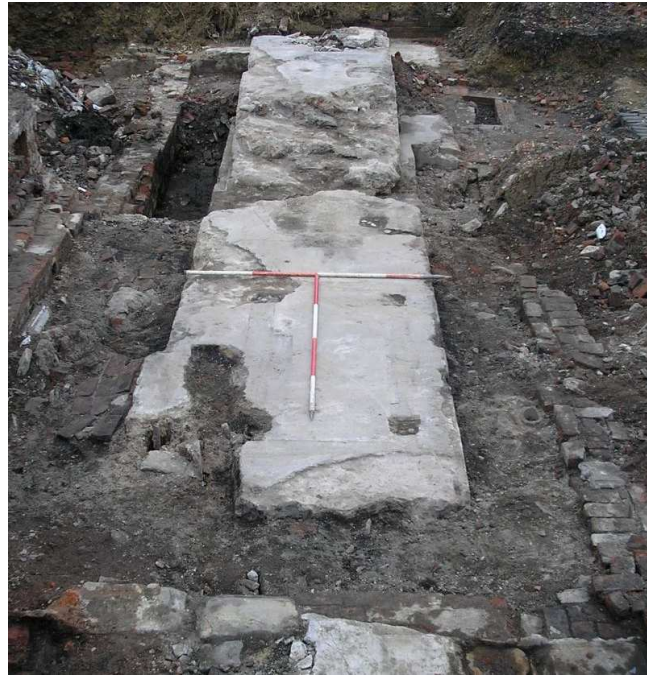
Plate 18: The excavated remains of the engine foundation

4.5.3 The floor of the engine room was composed largely of concrete, although the position of the engine was represented by a stone ashlar foundation bed (**602**), which measured 4.35m long, 1.8m wide, and 0.6m thick (Plate 18). The southern end of foundation **602** abutted wall **611**, although a 1.08m void separated the western side of the foundation from wall **603**, suggesting this to have been the position of the engine's flywheel. Foundation **602** contained two rows of *in-situ* circular threaded rods, spaced 0.88m apart and measuring 40mm in diameter, representing the engine's tie-down rods. A rectangular depression at the southern end of foundation **602**, measuring 1.67m long by 0.88m wide, represented the position of the southern end of the engine. This contained another four metal tie-down rods embedded within each corner.

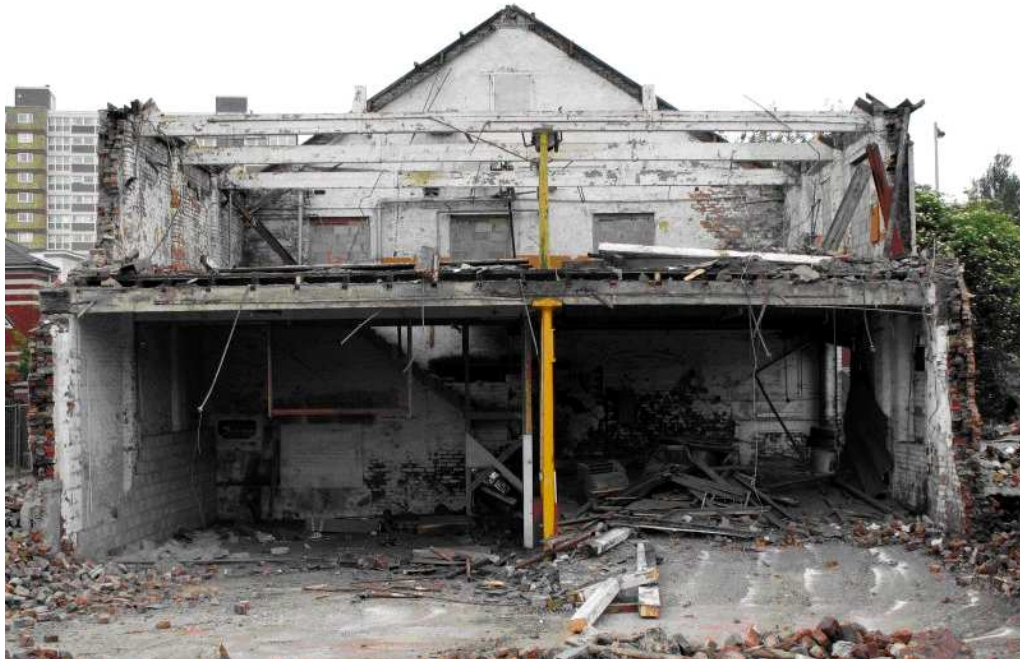
Plate 19: Cross-section of the building during demolition, looking east

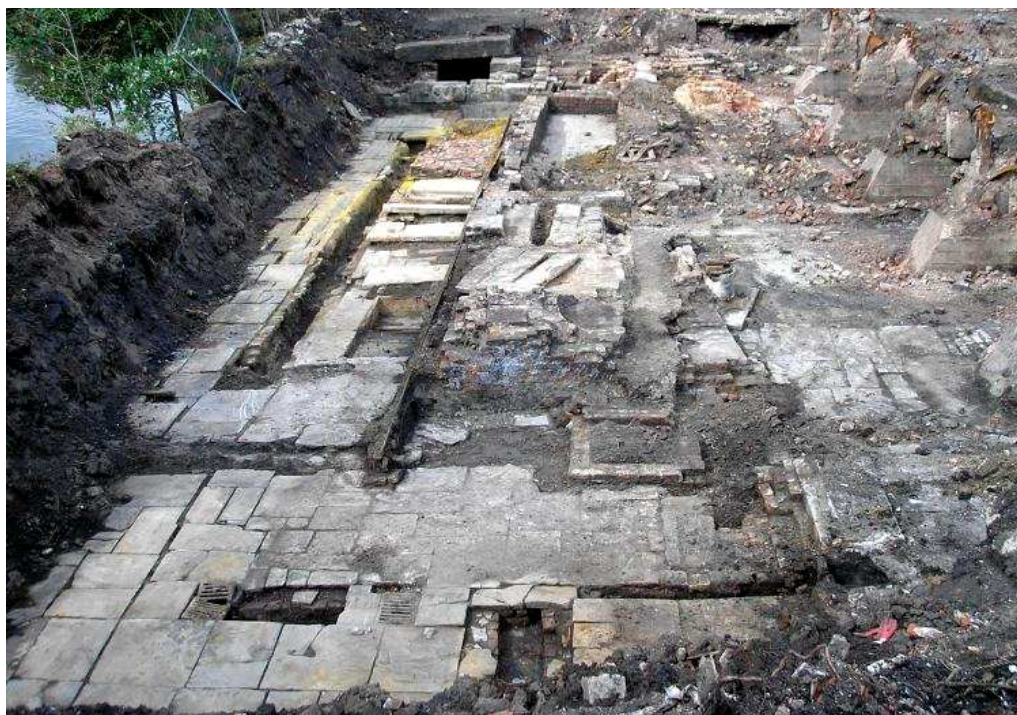
Plate 20: View of the excavated remains, looking north

5.1.1 The Adelphi Dye Works was investigated initially via four evaluation trenches (Trenches 3, 4, 5 and 6), which were placed across the south-western and north-eastern parts of the former works (Fig 2). Significant and well-preserved buried remains pertaining to at least five phases of development were revealed in the trenches. The structural remains represented the key elements of the dyeing process, including dye mixing, fixing, washing and drying, and spanned the period of technological transition from the use of natural dyes to chemically processed dyes during the mid- to late nineteenth century. Several vats and tubs containing dyes and chemical residues were exposed, together with a flagged floor (**148**) at the southern end of the site, which had possibly been associated with the drying of newly dyed cloth. Other remains included the foundations of a steam engine at the northern end of the dyeing room, a chimney, and a boiler room. In addition, a thick layer of clay (**115**) along the eastern side of the site represented the probable location of a reservoir shown on historical mapping. Further remains pertaining to the later nineteenth-century development of the dye works were represented by modifications to the flues at the northern end of the boiler room, and the remains of ancillary buildings built over the former reservoir in the eastern part of the site. The foundations of the engine house within the building at the northern limit of the works (Area B; *Section 4, above*) also belong to this period. The twentieth-century use of the site as an iron foundry/engineering works was represented by rows of concrete stanchions, and the well-preserved remains of an air-raid shelter.

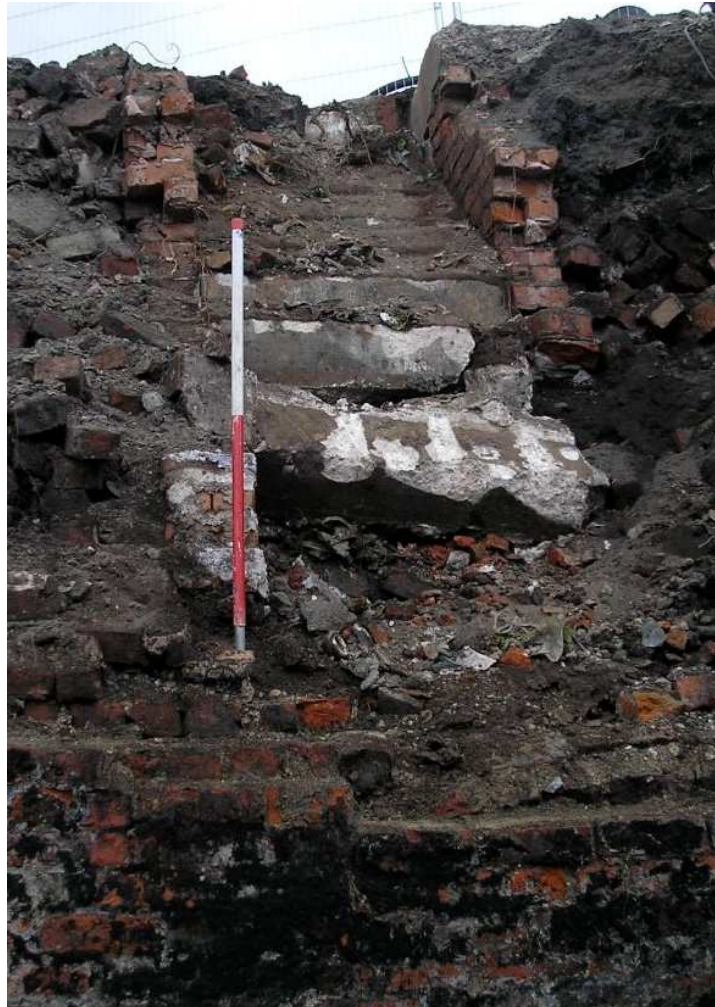
Plate 21: Steps rising above wall (**187**) to Bury's Court

- 5.3.3 The rear wall (**187**) of the range of buildings that had formed the boundary between the dye works and Bury's Court was exposed for a maximum distance of 6m during the watching brief. The wall was aligned north-east/south-west, and measured 0.42m wide. In total, 14 courses of bricks survived, providing a height of approximately 3m above a flagged floor. A flight of six stone steps (Plate 21), rising up from the flagstone floor to the level of Bury's Court, was exposed at the western end of wall **187**. The top step was revealed at a depth of 0.25m beneath the modern ground surface. A

void at the base of the steps probably housed at least three more steps, although these had evidently been destroyed during demolition. The steps were abutted along their eastern and western sides with two brick walls, comprising machine-cut bricks married with white cement mortar, clearly representing later additions. The northern face of the wall was heavily sooted, although traces of whitewash were observed beneath the soot. A vertical recess within the wall was filled with traces of purple dye, suggesting proximity to the processing area.

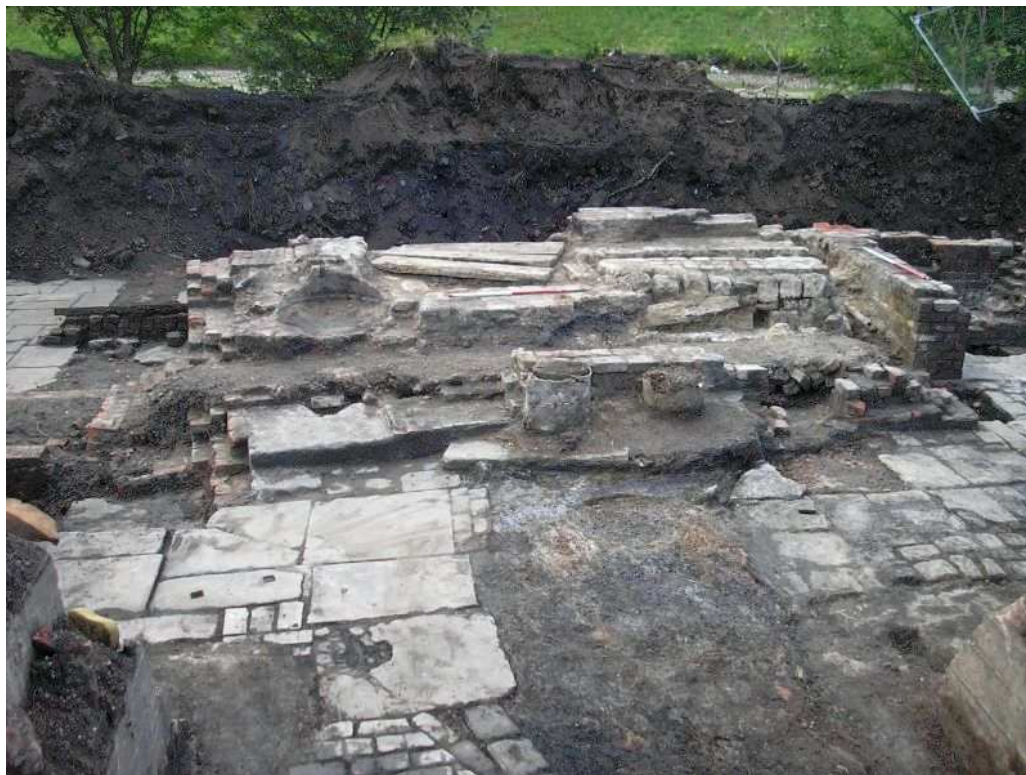
Plate 22: Dye mixing area and external courtyard, looking west

5.3.5 **Dye mixing area 145:** the area comprised a substantial brick foundation, which measured 5.7m by 2.5m and survived to a height of 0.8m (Plate 22). During the watching brief, a 4.5m long north/south-aligned machine-cut section through the foundations provided evidence for the structural phasing of the dye mixing area. The earliest remains encountered included the vestiges of four dye tubs, which overlay a stone plinth foundation across the eastern side of the dye mixing area. The plinth was laid above a course of stone slabs, measuring 0.15m thick, which were aligned north/south. This seemingly represented part of the original working surface for the preparation of the dyes.

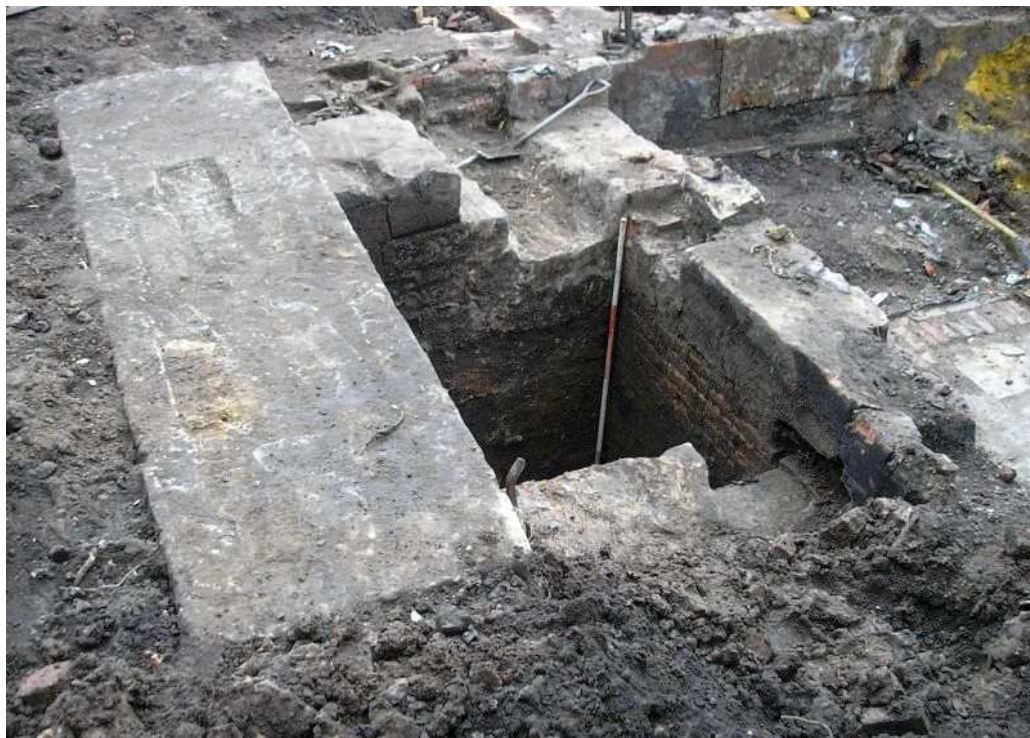
Plate 23: The foundations for a steam engine adjacent to the wash room, looking south-east

5.3.9 **Engine room 136:** the footprint of a room measuring some 3.1m by 2.75m was revealed in the north-western corner of Area A (Fig 12). This contained the foundations for a steam engine, which had almost certainly been intended to power machinery used in the dye wash room (**135**), located directly to the south. The engine foundations comprised two 2m long, north/south-aligned stone walls (**191** west and **192** east respectively), set 1.5m apart, which abutted the northern wall (**186**) of wash room **135** (Plate 23). A large stone block overlay the northern limit of the stone walls, and whilst this was not *in-situ*, it was likely to have been part of the original layout of the room. The block overlay an east/west-aligned brick wall forming the northern end of the room.

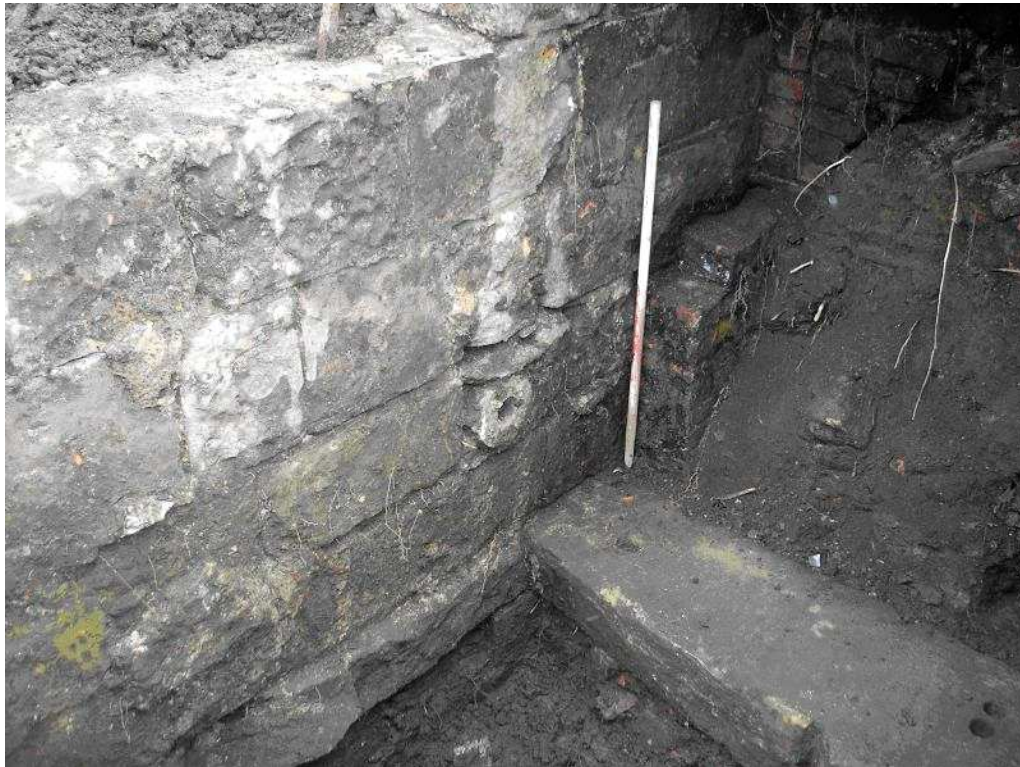
Plate 24: West wall of engine room **136**, showing the northern brick wall and sandstone block

5.3.10 The original phase of the room was represented by a vertical iron rod, secured into wall **191**, which probably formed a means of restraining an engine to its foundations. This iron tie-rod was square in section, suggesting it to be of an early nineteenth-century date. Other physical evidence for an engine was provided by the remains of a large rectangular yellow sandstone block, measuring 0.35m deep, which was aligned east/west across the natural clay between walls **191** and **192**. The upper surface of the block contained three holes, which were similarly identified as housing for iron tie-rods. A brick-lined culvert surviving beneath walls **191** and **192** probably supplied the engine with a source of water for condensing purposes (Plate 24).

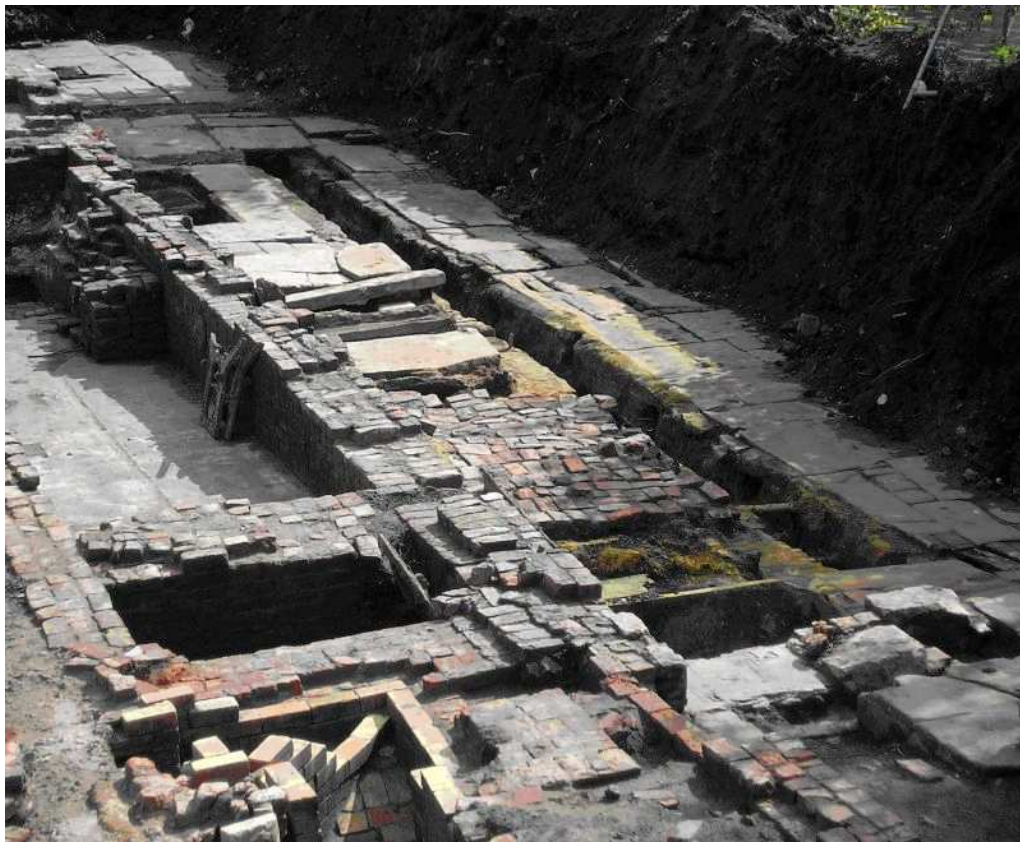
Plate 25: Dye wash room **135**, looking south-west

5.3.13 **Dye wash room 135:** the western side of the site was dominated by remains of a rectangular-shaped room, which measured 24m by 4.4m, and was situated immediately to the west wall **138**. The floor of the room was exposed at a depth of 2.5m beneath the upper surviving brick course of the southern external wall. Approximately three quarters of the room was exposed, with the remaining part extending beyond the excavated area. This room contained the remains of dye vats (**137** and **153**) and a dye tub (**156**), and an associated trough (**157**), channel (**139**), metal pipes and drains, and brick and stone slab surfaces (**158** and **159**). These features were all laid above a stone flagged floor (**140**), representing the working area between the washing and fixing stages of the process. The surviving fabric provided evidence for at least two phases of cloth dyeing, dye washing, and fixing processes. A later development of the room was represented by the remains of an iron rail, which overlay many of the structures along the eastern side of the room, and a randomly laid brick surface. The brick surface covered approximately 70% of the floor area, and represented the abandonment of vats **153** across the eastern side of the room.

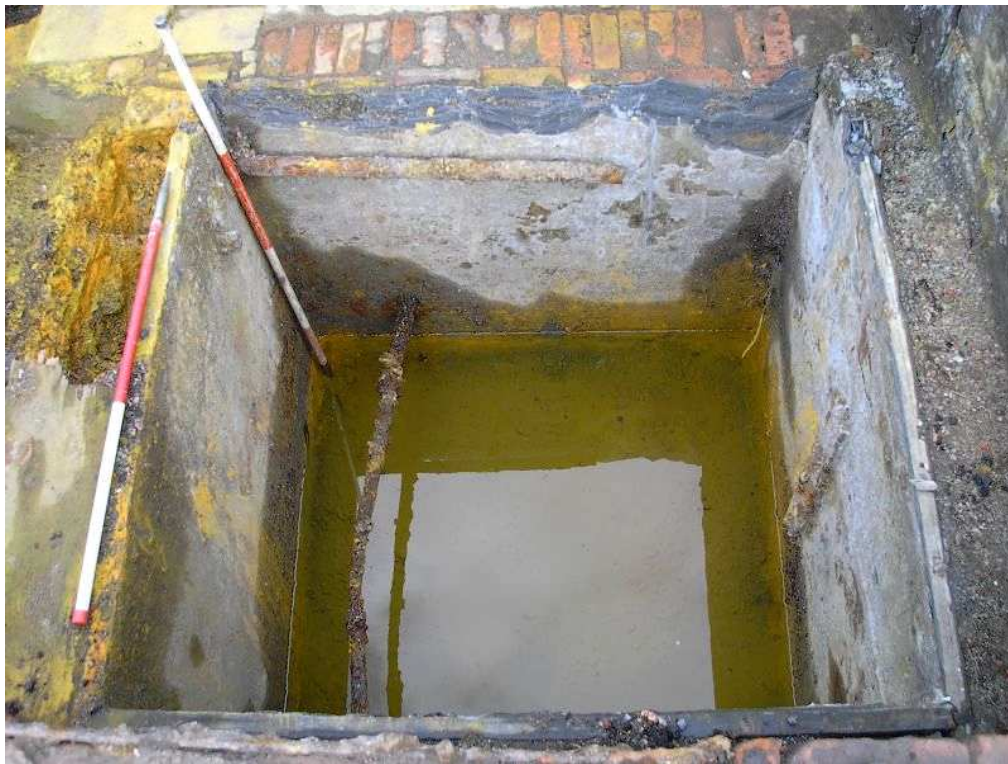
Plate 26: Dye vat **137** after the removal of yellow dye sediment

of wall **138**. Vat **137** measured 1.74m², with a maximum depth of 1.68 beneath the floor surface. Each side of the vat was lined with large slate slabs, each measuring 50mm thick, indicating that the vat had been intended to contain corrosive chemicals. Several metal pipes of varying sizes passed through the vat. The vat was supported along its southern edge by a 1m wide east/west-aligned brick wall, composed of hand-made bricks bonded with a lime-based cement mortar. The wall was four-bricks thick, with two strings of stretchers laid side-on and overlain by a string of stretchers and half-edged bricks. However, the wall did not abut wall **138**, as the gap between both walls was filled with clay and fuel waste. During the watching brief, wall **138** was exposed behind the slate vat to a depth of 25 courses, providing a height of approximately 3m. The entire vat was backfilled with fuel waste, which had seemingly been deposited during the mid-twentieth century.

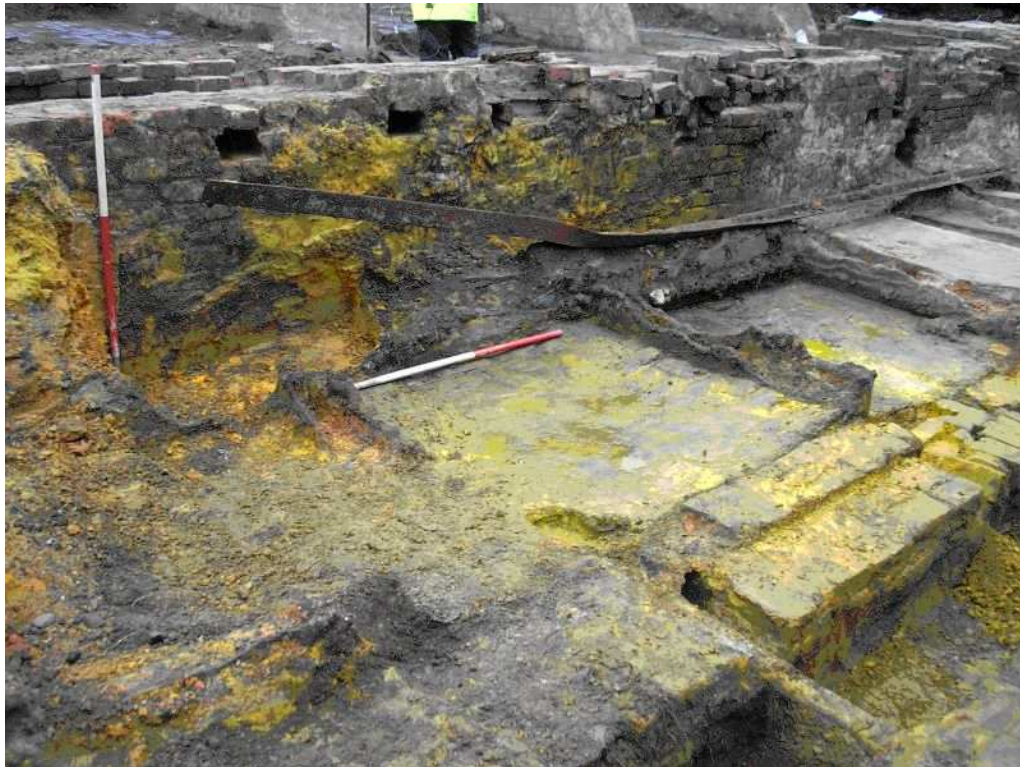
Plate 27: Dye vats **153** after the removal of brick surface **158**

lined with two courses of evenly laid brick. A section of a working area providing access to the southernmost vat comprised a 2m long by 1.2m wide levelled stone slab (**159**) and horizontal wooden supports. The slab and supports were 0.07m thick, with one course visible laid above a two-brick thick wide base. The base extended to a depth in excess of 1m beneath the southern edge of the vats. A cast-iron pipe measuring 0.10m in diameter extended east/west beneath the stone surface from the mixing area, feeding directly into channel **139**. The pipe was fixed at the eastern end by a 0.05m thick flanged collar. The presence of the pipe suggests that the dyes in the vats were steam heated.

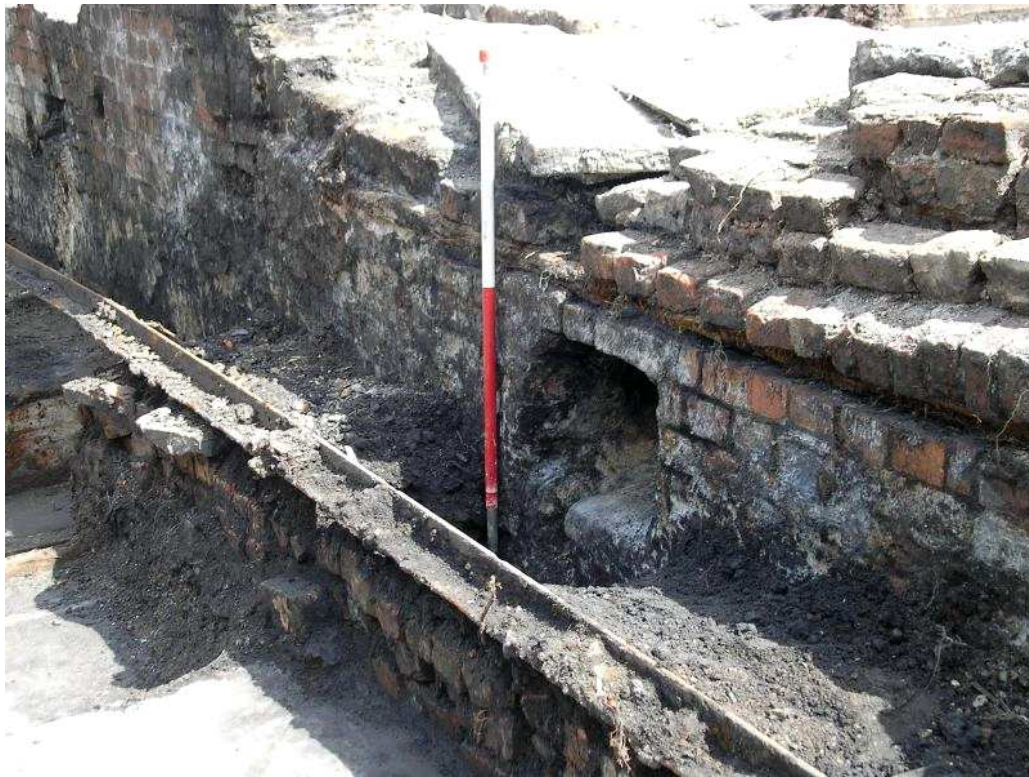
Plate 28: Drain within wall **138** connecting the dye mixing area to room **135**

- 5.3.19 The western face of wall **138** retained several rectangular sockets at a height of 0.74m above the floor, and spaced between 0.35m and 0.48m apart. Three of the sockets were localised above the cloth dyeing vats at the northern end of the wall, and a further three in the central area of the wall. It is possible that the sockets provided housings for a wooden floor above the dye vats. Other features within the wall included several metal pipes and drains. A drain from the mixing area entered the fixing area of the room at the southern end of the wall (Plate 28). The drain was 0.45m wide and 0.36m high, and situated at a height of 0.17m above a wood-lined stone tub (**156**).

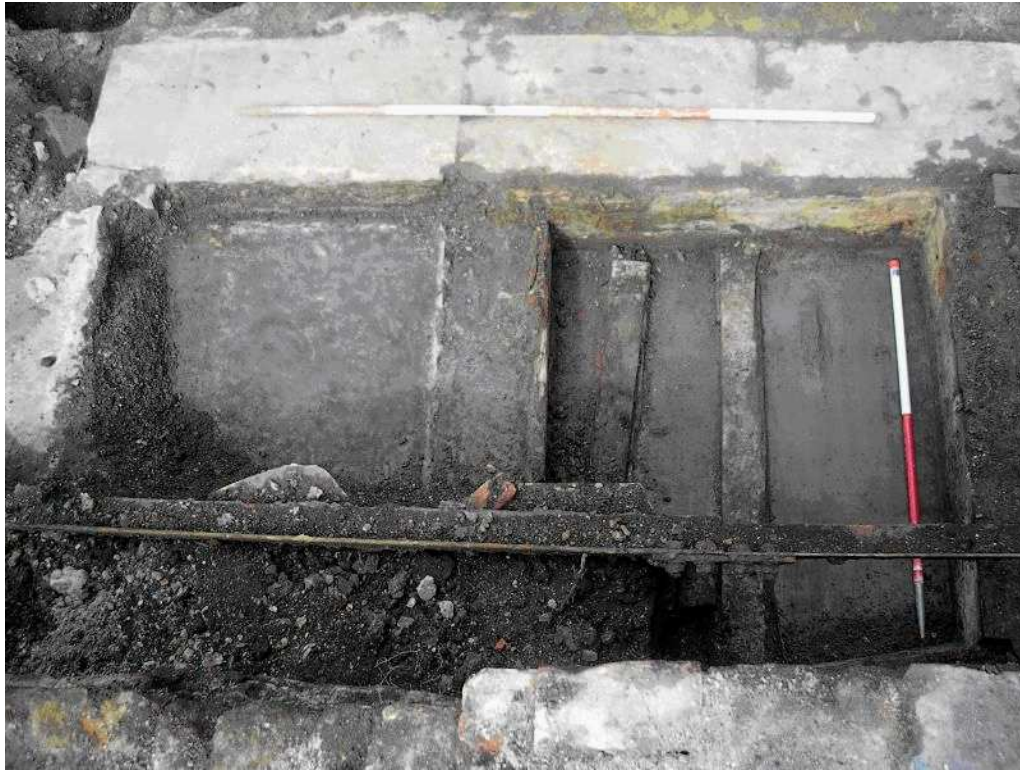
Plate 29: Wood-lined tub **156**

above the floor next to the works' southern external wall. This would suggest that the slabs were probably used as foundations of apparatus that hung cloth over the sink and tubs. Further remains of the fixing area were exposed during the watching brief, which revealed a further two slabs beneath slab **159** and **160** separated by clay.

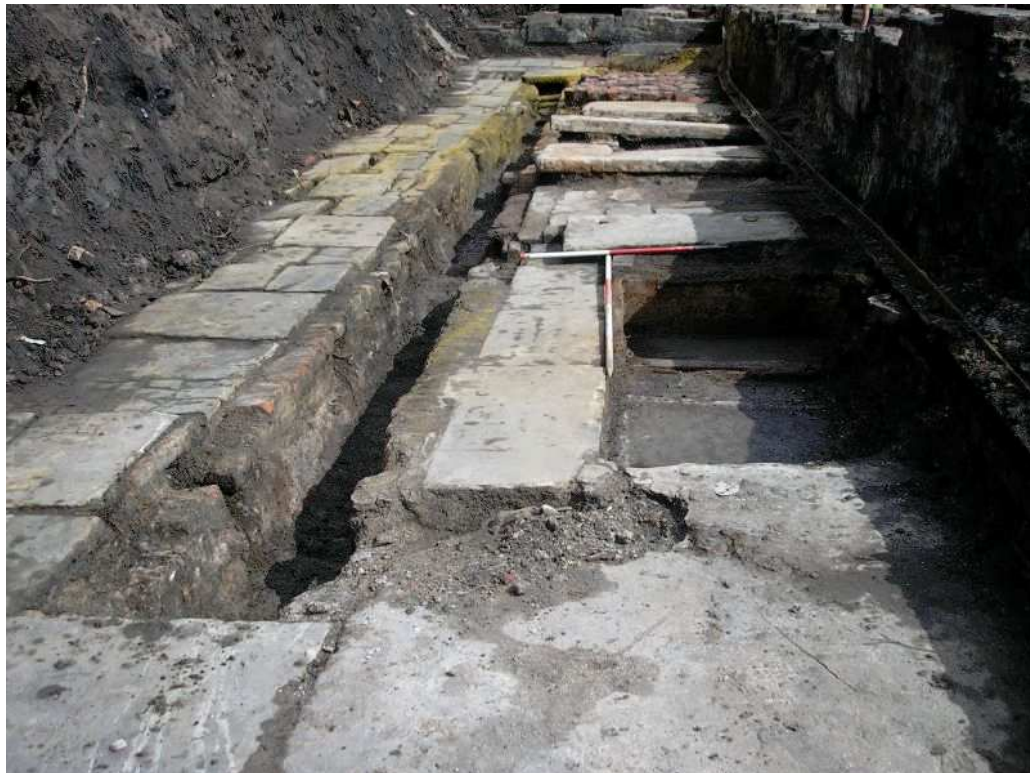
Plate 30: Channel *139* within the floor *140* of the dye room

undulated somewhat although it generally sloped slightly downwards to the north, reaching a maximum depth of 0.66m beneath the flagged floor. It appeared to be made entirely of brick, although much of it was heavily worn and degraded from exposure to corrosive waste. However, the surviving bricks measured on average 200mm by 110mm by 75mm, concreted across the base. Various pipes were observed running west/west into and through the channel, at various heights. A stone block projecting from the eastern wall of the channel appeared to be a later intrusion that possibly blocked an earlier channel deriving from the dye mixing area, thus relating to probable rearrangement of the vats and tubs in the vicinity. Other features in the channel include several rectangular-shaped voids or sockets that were spaced at 1.6m intervals along the western wall. The voids varied in size although each were located at a depth of 0.2m beneath the floor, above the base of the channel. The voids extended west beneath the flagged floor, suggesting that they may have been used to drain excess liquid overflowing from the channel. The channel was largely filled with cream-coloured sediment (*151*) caked across its base, that was probably formed from residues of fixing mordants. The southern end of the channel was sealed beneath capping stones. The fill at the southern end of the channel, however, contained large amounts of blue dye.

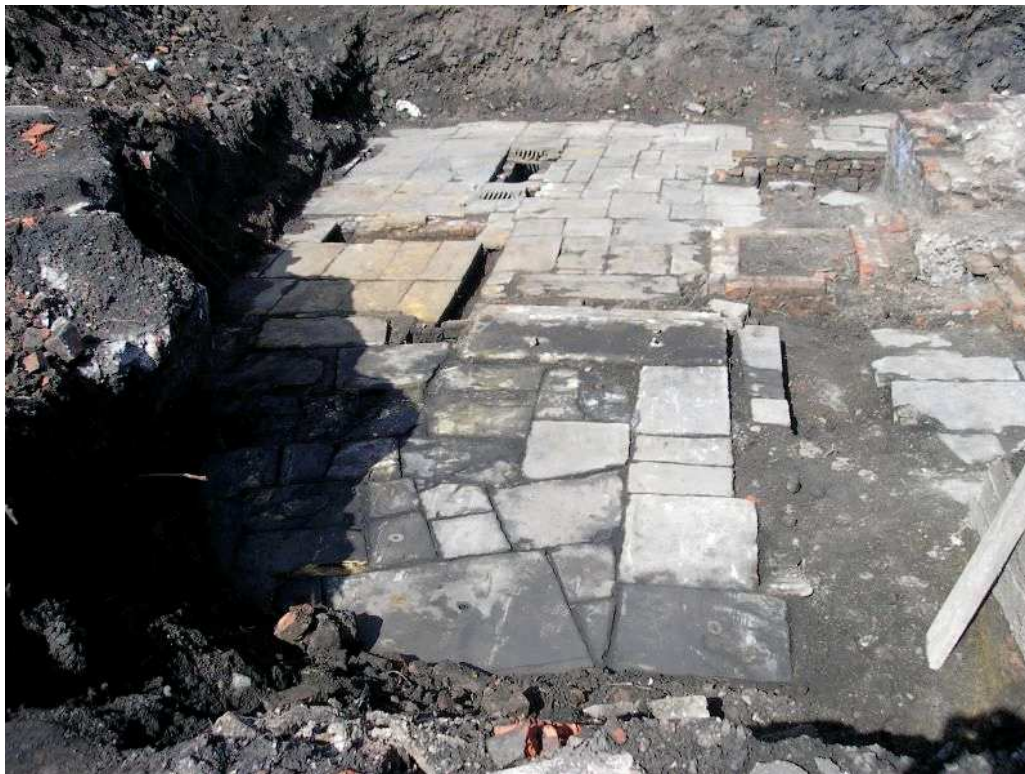
Plate 31: Floor 148 of drying area, looking west

5.3.24 **Drying area 148:** an extensive flagged floor (similar to floor **140** within room **135**) across the southern part of the site represented part of the drying area. The area was bordered in the north-east by the dye mixing area **145**, and in the north-west by the dye wash room **135**. It is possible that the floor continued further east and may have originally been housed within the north-east/south-west-aligned building attached to the southern end of the main works, as shown on the 1848 Ordnance Survey map. The floor contained an east/west-aligned brick-lined drain (**185**) capped with timber, and a north/south-aligned stone-lined trough (**184**), both filled partially with splashes of dye residue. The entire area measured 11m east/west by 5m north/south, which included the remains of small engine beds (**161** and **182**) located along the eastern side of the room. The flagstones were laid on a bedding layer of fuel waste, which in turn overlaid the natural geology (**149**).
