ADELPHI STREET, SALFORD Greater Manchester

Archaeological Building Survey and Excavation

Oxford Archaeology North

March 2008

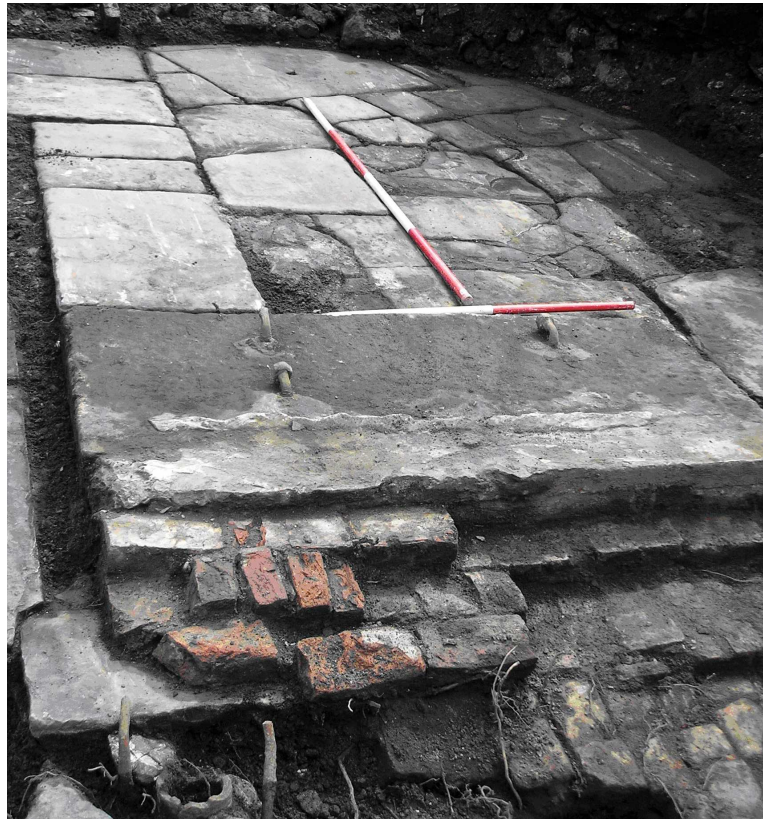
Plate 32: Machine bed 161 within floor 202

0.75m above floor 148 with its upper course level with the machine bed. No other wall was observed along the northern side of the machine bed, suggesting that it was a free standing feature, although the northern edge of the floor had been disturbed by the installation of a modern service trench, which had possibly obliterated any evidence of another wall.

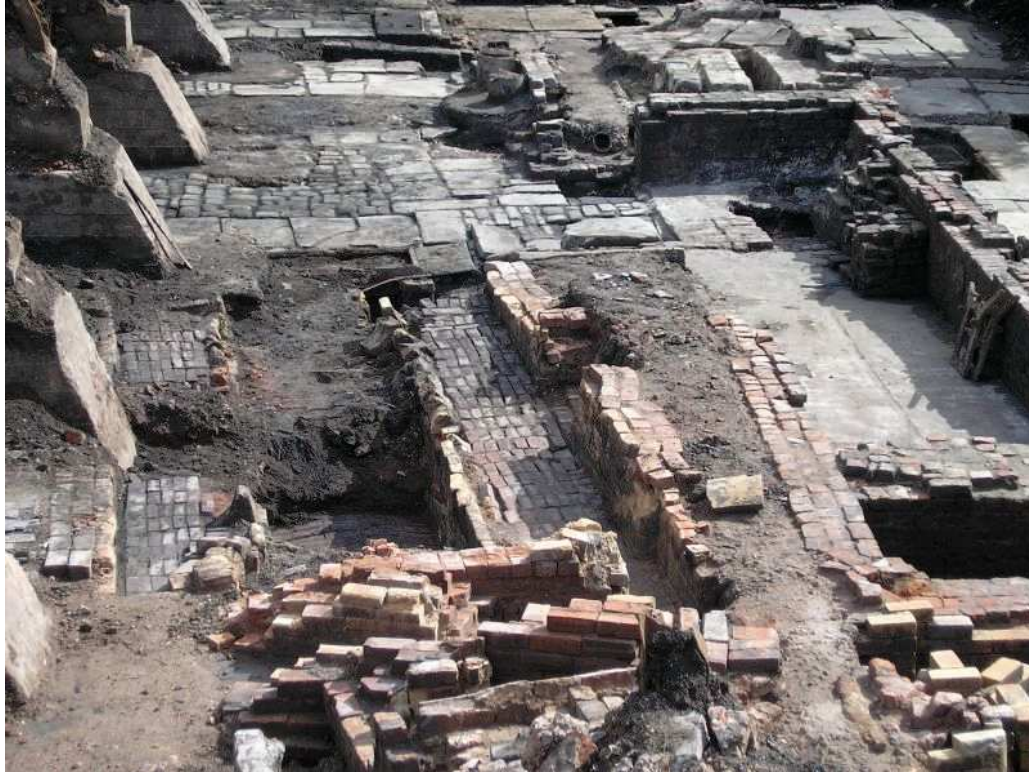
Plate 33: Remains of boiler foundation 141

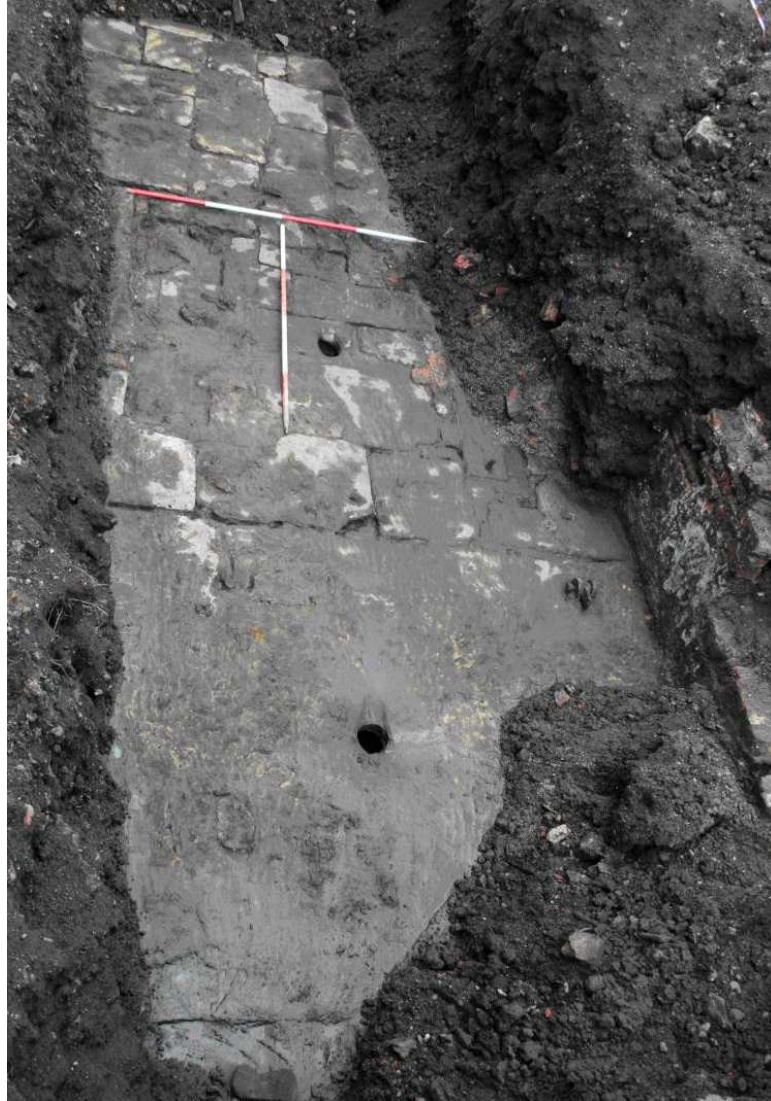
Plate 34: Floor **178** in Trench 5

5.3.30 **Floors:** the concrete entrance to the air-raid shelter (*Phase 5, below*) was constructed above the floor of the earlier dye works basement (178). This floor of large flagstones with occasional brick patches continued beyond the limit of excavation to the west and north, and butted the external wall of the principal building (138/179), partly exposed in the east section of the trench (Plate 34). This was of two-brick thickness (0.45m), surviving up to 12 courses above the floor level, and contained a cellar-light (180) at the exposed southern end. This was (1.52m) wide, with a brick sill, and possibly had the wall of the cellar-light butting its southern jamb. An iron rod projected through the wall at sill level, suggesting that it may have had a timber sill above the extant brick one. A further bar, situated 1.67m to the north, and positioned slightly higher up the wall-face, was most probably associated, and would suggest that a machine was fixed to the wall in this position. This was further supported by an eye-bolt attached to the floor, 0.30m from the wall, to the north of the window. This appeared to be the north-eastern attachment bolt of a group of four,

positioned around a drain hole, 0.15m in diameter, cut into the centre of a very large flagstone (**181**), which was wider than the evaluation trench (Plate 34). This may have represented part of washing machine, the drain running into a void below the floor, presumably into a culvert which would almost certainly have discharged into the river Irwell, less than 10m to the west.

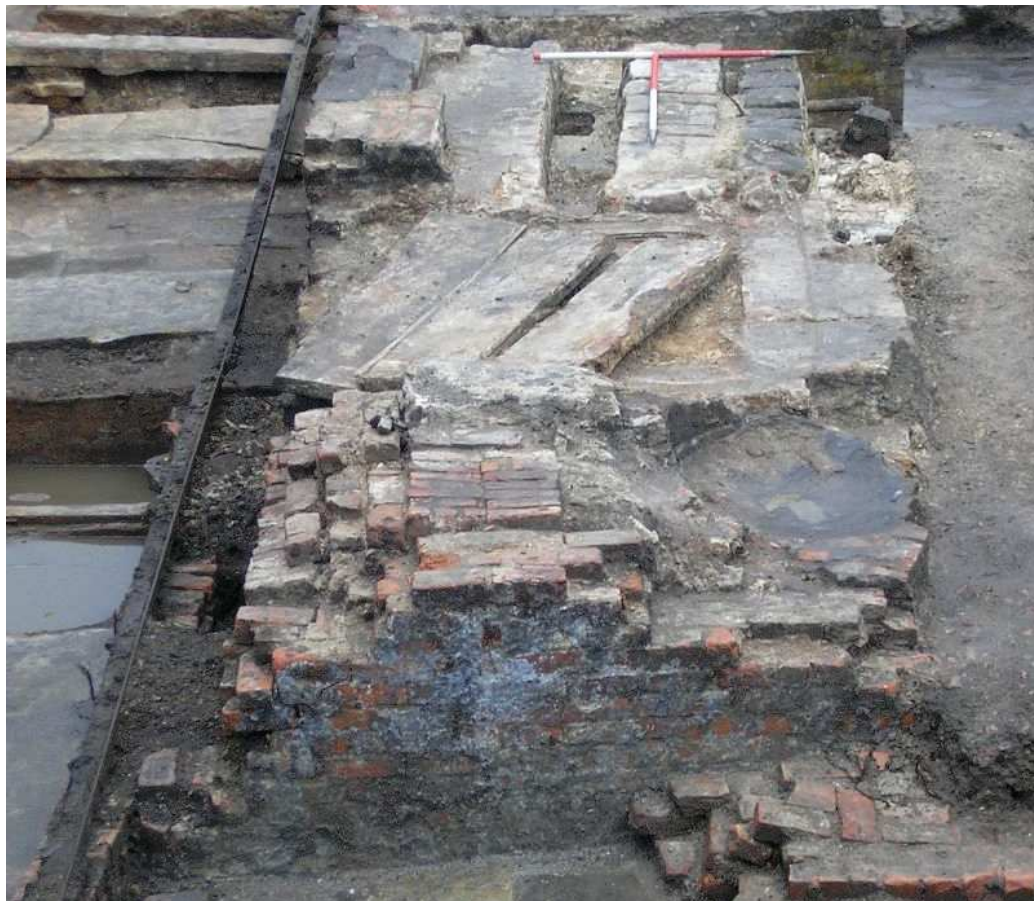
Plate 35: The later phase of the dye mixing area **145**, looking north

5.4.2 **Dye mixing area 145**: a substantial brick foundation measuring 5.7m by 2.5m, and surviving to a height of 0.8m, was located close to the position of the tubs marked on the 1848 Ordnance Survey map. The foundation was defined by two brick walls extending east/west across the northern and southern sides of the structure, and a short north-west/south-east-aligned wall along the eastern side. The eastern side of the structure was truncated by a concrete-filled water main, which had destroyed part of the room's external walls and internal features. The southern and northern walls were three-brick skins wide, with a blue whitewash adhered to their internal face. The wall comprised hand-made brick, each measuring an average of 210mm by 90mm by 120mm, bonded with a dark grey-black mortar, indicative of late nineteenth-century construction. A small internal section formed by a screen wall was located within the northern end of the room. Remains of a threshold that had provided access into the mixing room were suggested by a gap along the eastern external wall. Other internal features include a stone block serving as a short partition, parallel with a dye channel.

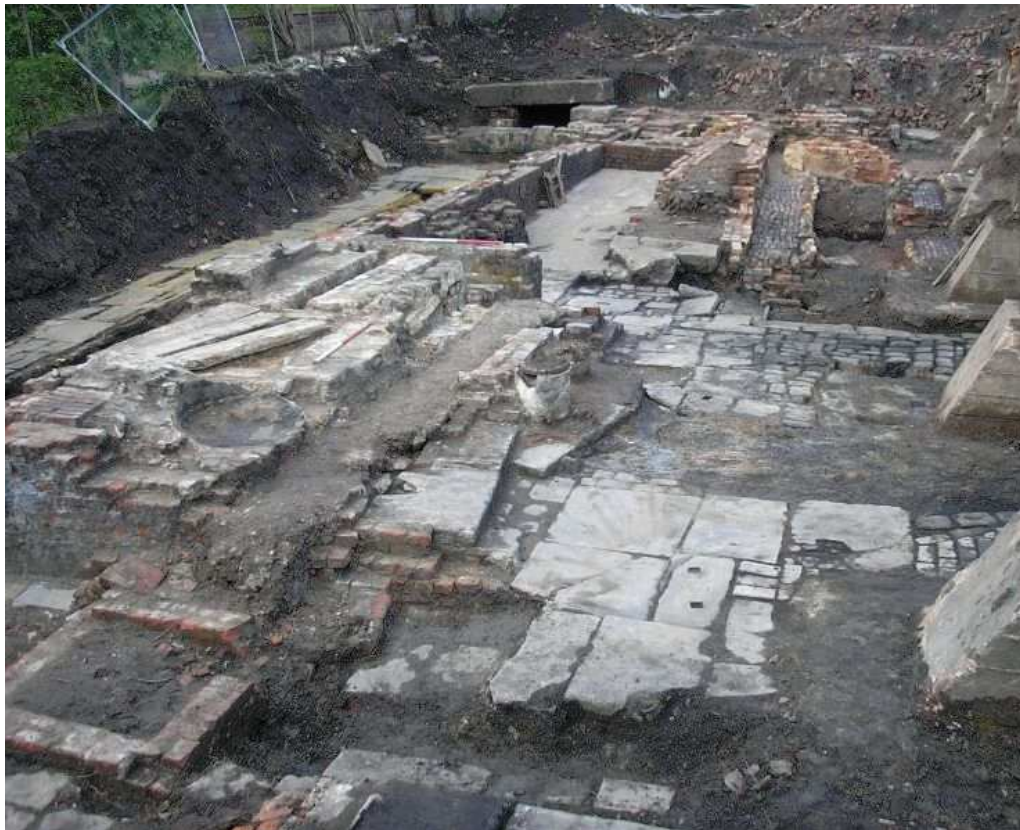
Plate 36: Remains of containers along the eastern side of the mixing area 145

- 5.4.4 The entire room would have probably been used in the mixing of the dye from disparate compounds into a usable product. The channels may have drained excess water or liquid created during these processes. The physical remains pertaining to the mixing of dyes included a stone hollow (**150**). It measured 0.90m in diameter, and survived to a height of 0.20m. In addition, two plywood tubs (**146**) situated within the eastern part of the room, probably pertained to the room's later use. Their position outside the mixing area was perhaps due to safety issues, or the need to keep the mixtures pure, prior to another process. One of the tubs retained a metal lid. The remains of a further two containers (**193**) were identified directly east of the wooden tubs, although these had degraded badly, suggesting they may have been discarded after use. The degraded containers were contained within a concreted dump of charcoal, friable silt and waste chemical residue of varying colours. The dump overlay a cobbled surface (**144**), representing a yard area directly west of the later road surface (**147**). This suggests that the waste material was removed from the site via the road.

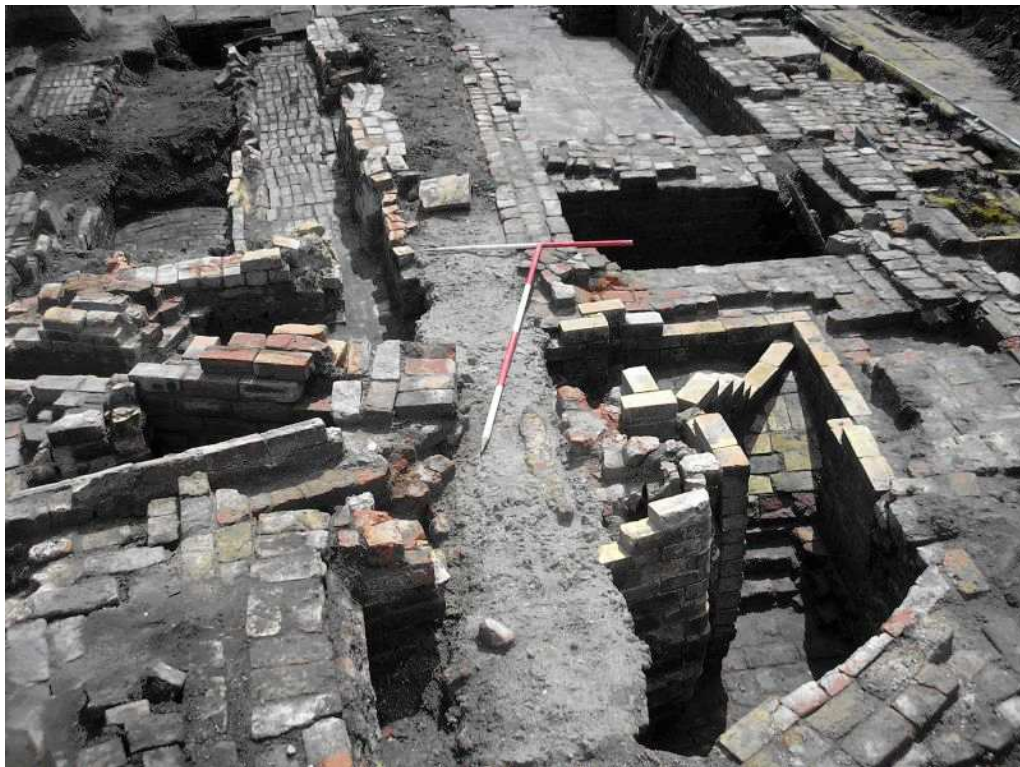
Plate 37: Foundations of the chimney **143** and flues **195**

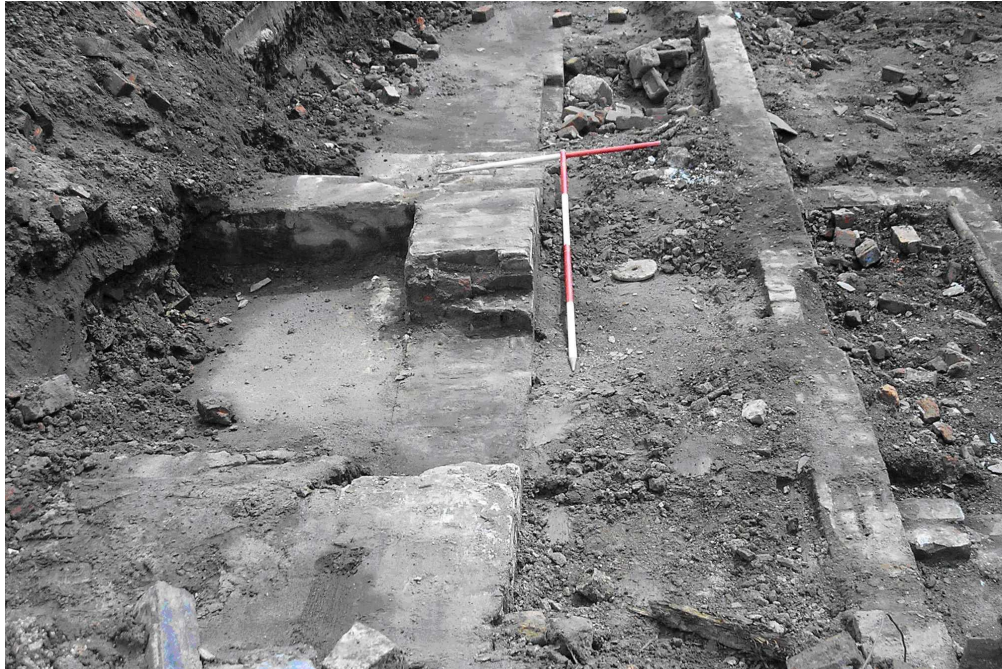
Plate 38: The west wall (**189**) of a building overlying the reservoir in the centre of the site

- 5.5.1 Physical remains dating to the early twentieth century included the western wall (**189**) of a building overlying the southern reservoir. In addition, several internal modifications to the works were noted. Room **142** overlaid the location of a former boiler shown on earlier historical maps. Other remains pertaining to this period included remodelled boiler flues (**195**).
- 5.5.2 A substantial wall (**189**), measuring 1m wide and aligned north/south along the eastern edge of the excavated area (Plate 38), probably represented the western external wall of a building shown on the 1908 Ordnance Survey map.

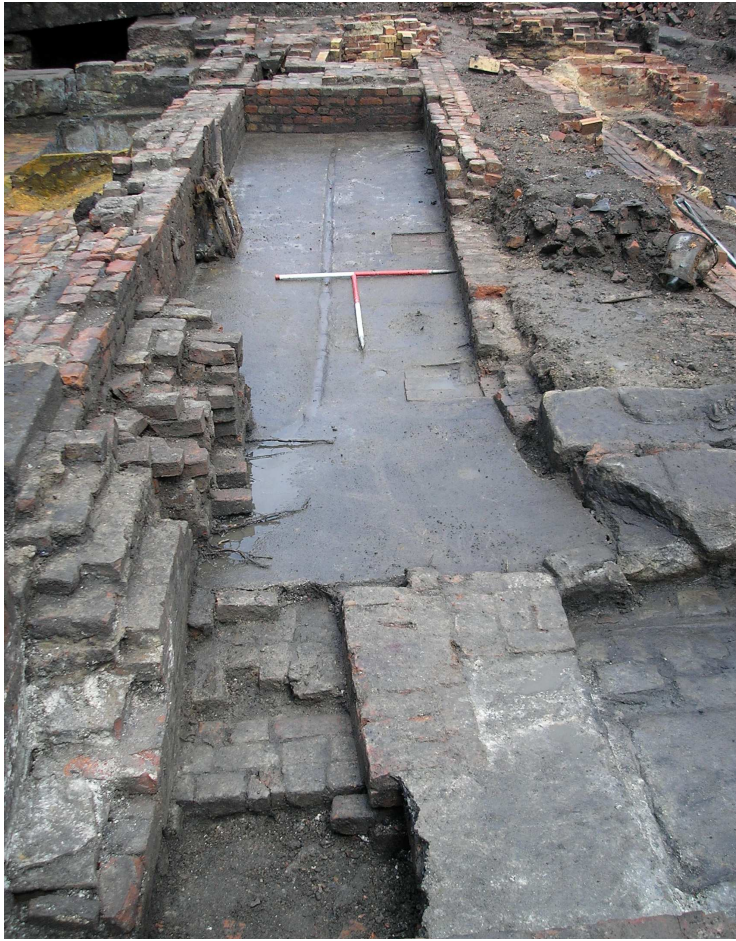
Plate 39: Room **142**, looking north

- 5.5.5 The room contained a sloping concrete floor (Plate 39), which lay at a depth of 0.8m below the top of wall **138** at the southern end, rising to 0.4m at the northern end of the room. It contained a 0.10m wide by 0.08m deep groove, oriented north/south across the centre of the floor, serving as a drainage channel. No evidence of an earlier floor was encountered.

- 5.5.3 **Room 142:** this north/south-aligned room was located along the eastern side of wall **138**, situated between the boiler room (**141**) in the east, and the chimney (**143**) attached to its northern wall, and in the south by the dye mixing area **145**. The room measured 5.5m by 2m. The configuration of the room does not appear on any historical map, although it is likely it sealed an earlier boiler house, shown on the 1848 and the 1892 Ordnance Survey maps.

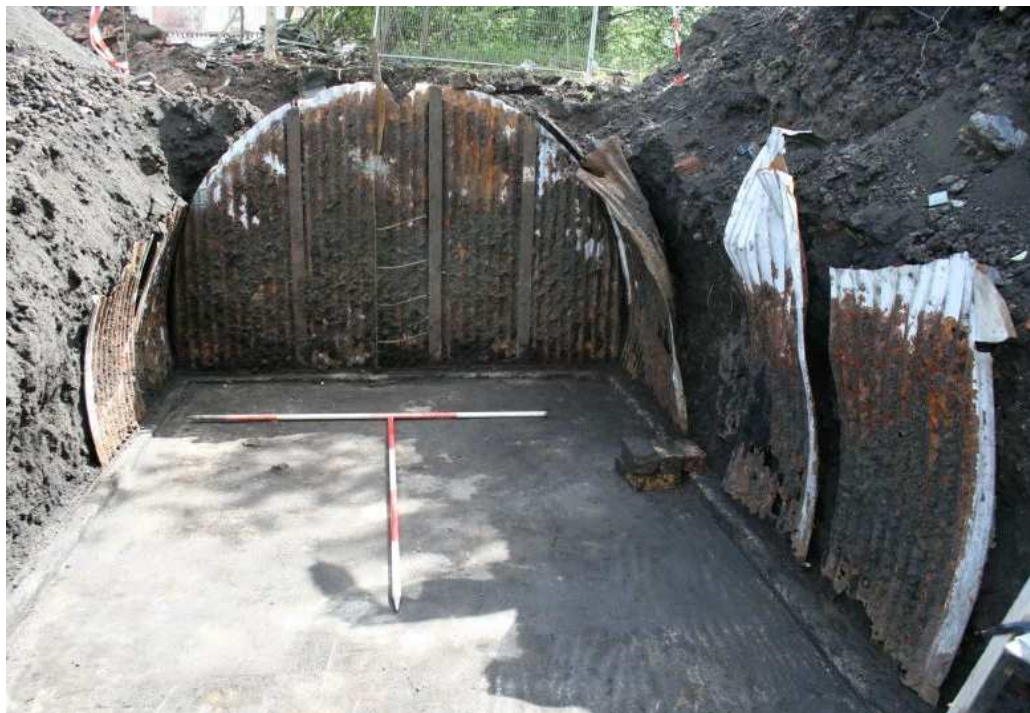
Plate 40: Remains of the southern part of the air-raid shelter, looking south

5.6.5 The shelter had channel-section rails, as used in the Anderson Shelters, supporting the 26-gauge curved corrugated sheeting, the rails raised on a 0.30m wide and 64mm high concrete plinth. The southern end of the shelter was formed of vertical corrugated sheets, supported by three T-section vertical members. Remarkably, these survived almost undamaged, showing the half-round profile (more typical of the Anderson Hut than the bulging Nissen Hut), with a maximum internal height of 1.83m (6'). Positioned centrally immediately to the north of the south wall was the eastern stile and lowest four rungs of an eight-rung, 0.3m (1') wide steel ladder (Plate 40).

- 5.6.4 **Air-raid shelter:** the well-preserved remains of a World War II air-raid or bomb shelter (**177**) were exposed in evaluation Trench 5, which was excavated along the western edge of the site (Fig 2). The shelter measured 7.46 by 2.74m (24'6" by 9'), and appeared to have comprised four bays and, given the position of cleats within the floor at the mid-point, seemingly had additional bracing, or possibly a division, between the northern and southern halves (Fig 13). No evidence for timber purlins was observed.

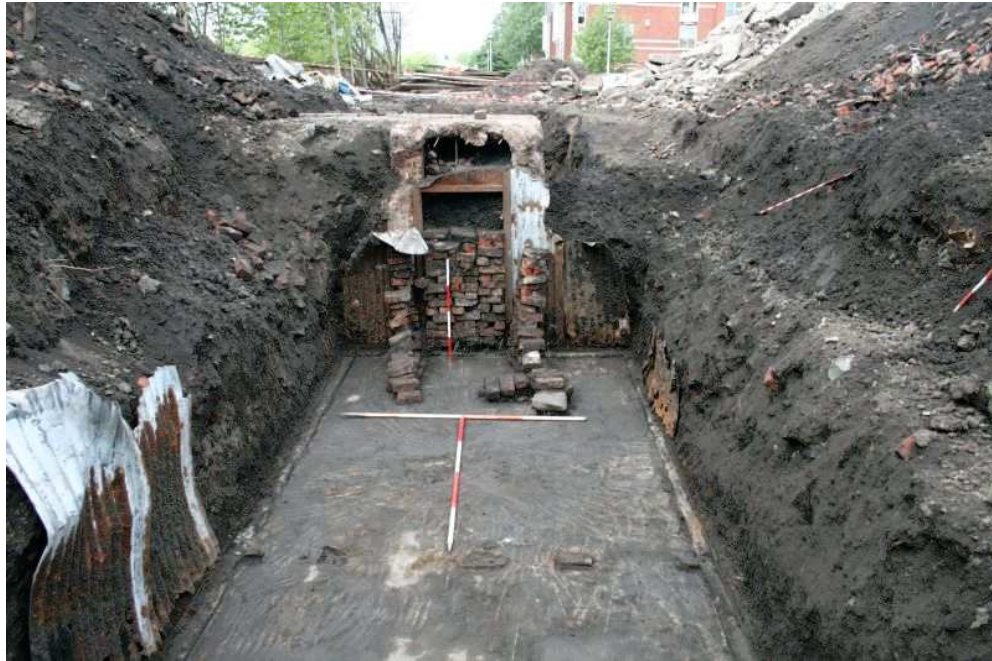
Plate 41: The northern end of the air-raid shelter, showing the concrete entrance

5.6.6 At the northern end of the shelter was an L-shaped concrete structure, 2.44m (8') long, and returning to the west beyond the limit of excavation (Plate 41). This formed an entrance into the shelter, presumably from ground level above, to the west, and was contemporary with the shelter, as the concrete adjoining the corrugated panels was imprinted with their corrugations, demonstrating that it had not set when the panels were placed into position. It was presumably constructed to give a more blast-proof entrance to the shelter, and was constructed in a typical 'trench-dug' style, of concrete poured into wooden shuttering to produce side-walls, topped with concrete slab. The framing of a heavy steel internal door also survived at its southern end. Two unbonded walls extended south into the shelter, either side of the doorway, for a distance of up to 1.6m. Both comprised mould-thrown, refractory and frogged bricks, and almost certainly post-dated the structure's use as an air-raid shelter. They appeared to be broadly contemporary with the unbonded brick blocking of the lower part of the doorway to the north.

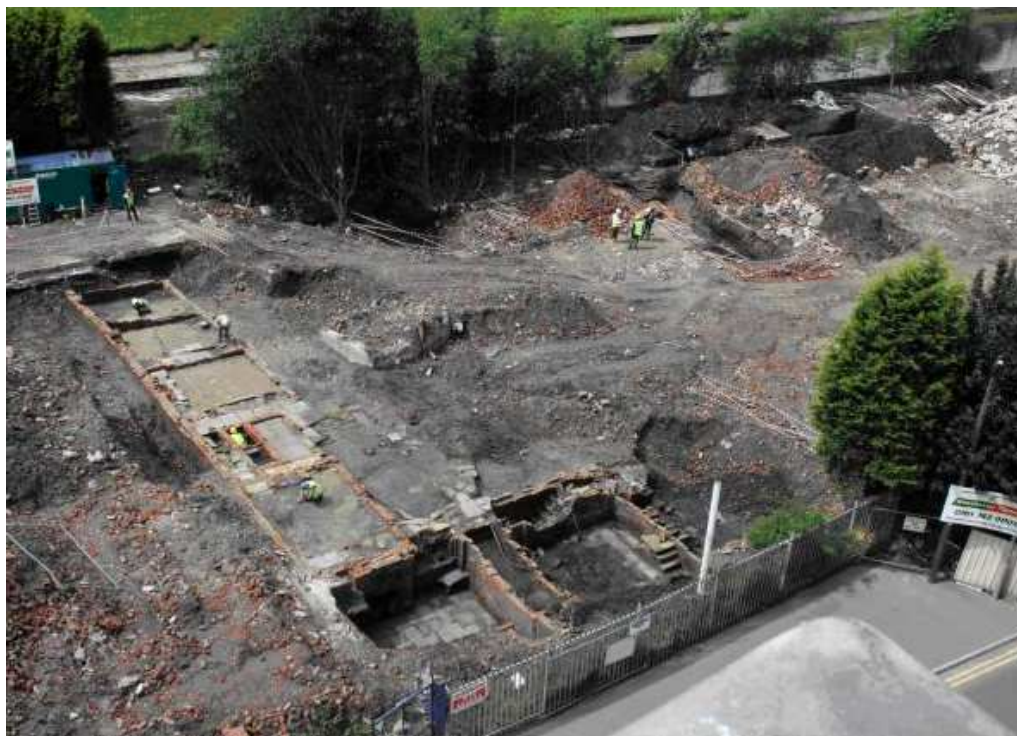
Plate 42: Overview of the excavated remains of Bury's Court, looking west

5.7.1 The initial investigation of the structures around Bury's Court comprised two evaluation trenches (Trenches 1 and 2), arranged to form an L-shape (Fig 2). Each trench measured approximately 25m by 1.6m, and revealed well-preserved elements of structures along both the southern and eastern sides of Bury's Court, which are first depicted on Pigot's map of 1820. Following a meeting on site with the Assistant County Archaeologist, the Salford Conservation Officer, and representatives of Vermont Development, the evaluation trenches across this part of the study area were extended into larger single excavation trench (Area C), measuring approximately 20m by 30m, and comprising the maximum feasible area across the footprint of the Bury's Court properties (Plate 42). The excavation revealed the well-preserved remains of three distinct dwelling types, all of which appear to have comprised single-room dwellings. These appeared to have been constructed in two phases, the latter overlying the waste tip of a nearby clay pipe manufactory.

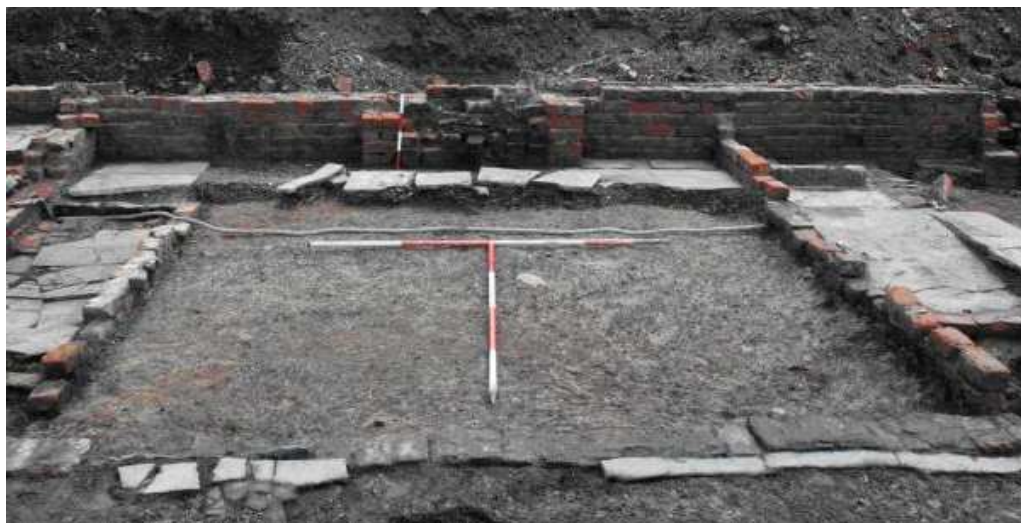
- 5.7.9 The fireplace (**159**) was well-preserved, and comprised two distinct constructional phases, with the earlier having two brick piers, each keyed into the front wall (**102**) above floor level. It was narrowed subsequently on both sides by 1½ bricks (0.35m), leaving a central hearth only 0.36m (14") wide, suitable for an ash-box below a range. The remodelling was undertaken in a black sooty mortar, typical of the end of the nineteenth and early twentieth centuries, a period when ranges became popular (OA North 2006). Elements of the floor survived within the base of the hearth, with several fragments of metalwork, presumably relating to the later range recovered from the vicinity.

Plate 44: View of the fireplace within Room 2

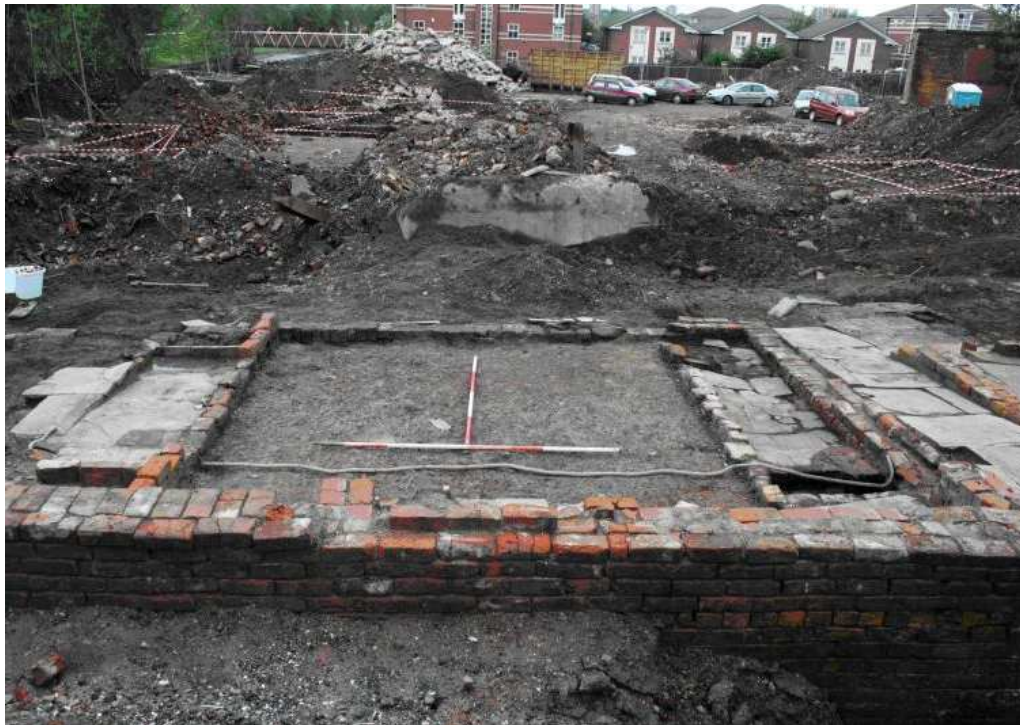
- 5.7.10 **Room 3:** this room formed the eastern end what appeared to be a single construction of Rooms 1, 2 and 3. The eastern wall (107) was the external wall of the block of dwellings, and was of full-brick thickness, keyed into the rear wall (102), which also continued further to the east, suggesting that these structures were of contemporary construction. At its northern end, wall 107 returned to the west as wall 104, projecting beyond the smaller structures to the east (Fig 14).

- 5.7.11 At a distance of 1.3m from its return into wall 107, wall 104 had a gap, 0.76m wide, in-filled with an edge-set flagstone, possibly representing a crude threshold, although not aligned with the northern end of what was presumably a further stair passage (132) along the eastern wall. The western wall of this differed slightly from those in Rooms 1 and 2, in that it continued to within 0.3m of the front wall (104), although this only survived to below floor level, meaning that a doorway into the main room would still have been plausible. Only at its southern end did it return to abut the east wall (107), immediately to the north of which a 0.3m wide drain of 0.18m depth had been inserted into the stone floor, with brick in-filling of the floor on its northern side. It had a rough, unbonded brick base, laid in the same fuel waste matrix observed below the surviving elements of the flagstone floor (131). It housed a junction spur in a lead water supply pipe, which was continuous across Room 3, and appeared to have once continued through Rooms 2 and 1 to the west. The lower spur passed through wall 107 into the privies within Room 4, whilst the other rose vertically and had been cut, although presumably serviced Room 3. The remainder of the stair passage comprised cracked sandstone flags, which slumped slightly to the north, similar to the re-laid floor within the stair passage of Room 2.

Plate 45: View of Room 3, looking north

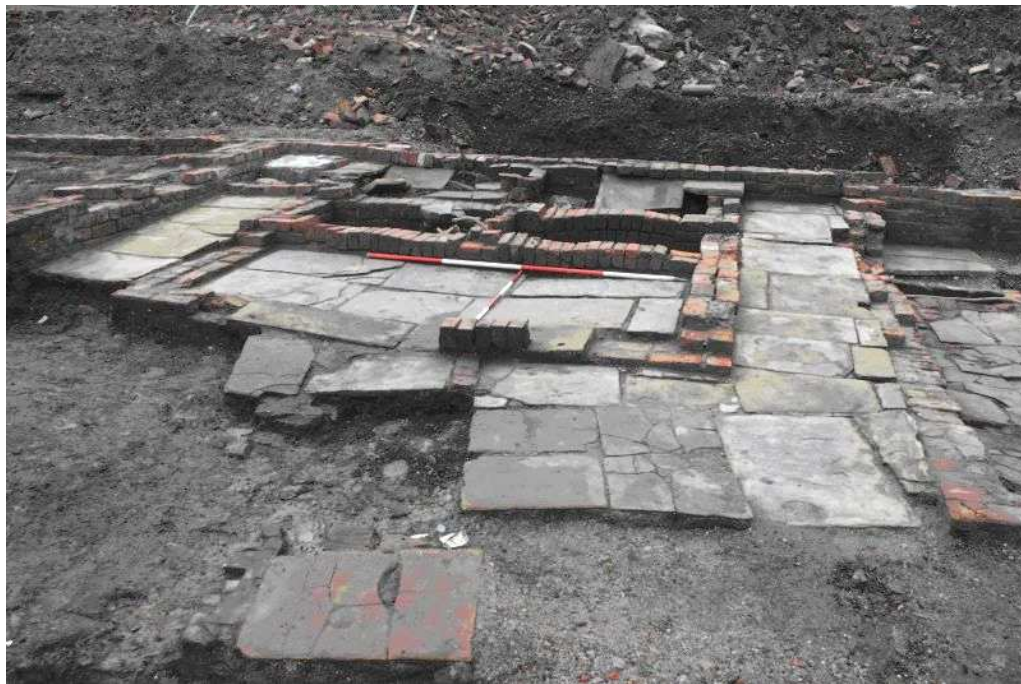
- 5.7.14 The block comprised a rectangular structure, 3.76m by 3.12m (12' by 10'3"), with a passageway either side leading from the courtyard to the north to the rear wall (**102**). It was of brick construction, using similar materials to the dwellings to the west, comprising walls of full-brick thickness, surviving to two courses in height. The north wall of the structure (**109**) had a 2.13m wide central opening, containing two threshold flagstones, at the same level as the floor within the internal chamber they serviced. This comprised a rectangular room, with internal dimensions of 2.69m by 1.14m, bounded on its southern side by a wall of full-brick thickness (**112**), keyed into both the east (**111**) and west (**108**) walls of the building. The room had a flagstone floor, comprising two rows which sloped from the east and west towards the centre of the room. This suggested that the floor had been laid with drainage in mind, and had perhaps served as a washroom adjoining the privies to the immediate south. These comprised four chambers, each measuring 1.30m by 0.74m internally, divided by brick partitions. The east/west-aligned partition (**113**) was also of a full-brick thickness, and was abutted on both faces by single-skin north/south-aligned walls, which also abutted walls **102** and **112**. All the chambers were filled with fuel waste, to a depth of 0.71m, above roughly laid brick floors. The central, east/west-aligned wall (**113**) contained segmentally arched apertures of the full depth below floor level, whilst the northern wall had similar sized, but flat linteled apertures. These chambers almost certainly represented ash-closets, with the large openings allowing drainage down the slope into the natural geology below the courtyard to the north. All were modified subsequently, presumably during the twentieth century, with the insertion of ceramic pipe drainage, which would have served flushing toilets.

5.7.15 The passages either side of the closets afforded access into each individual closet, which were arranged back-to-back, facing outwards. Both passages sloped from north to south, with the courtyard level to the north being lower than both street level to the south, and the floors within the dwellings. Both had flagstone floors, which were continuous into the rear chambers. The eastern passage had a rough brick cross-wall immediately to the north of a broken flagstone at the southern end of the passage, probably representing the base of a small step to a small 'landing' outside the closet. In the western passage, the threshold step was positioned 0.10m higher than the passage level, further suggesting that the rear closets were set slightly higher. The western passage also continued beyond the southern extent of Room 4, for an area of approximately 2.4m², representing the largest survival of the surface of the courtyard of Bury's Court. It comprised similar flagstones to those within the dwellings, and those surviving were poorly levelled and generally cracked.

Plate 46: View of closets within Room 4

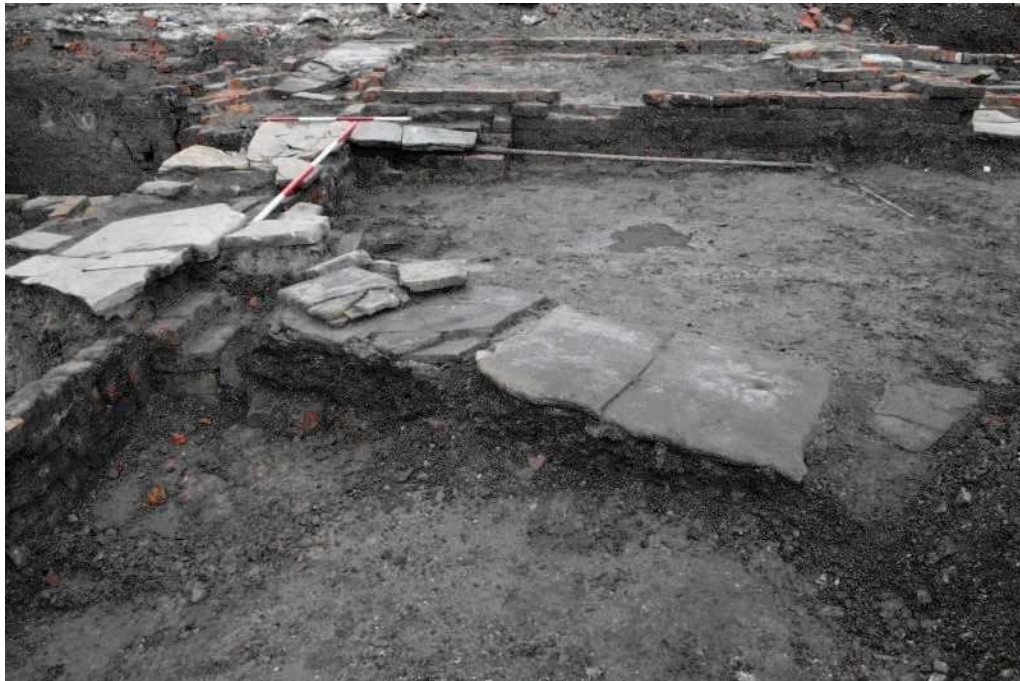
5.7.16 **Room 5:** this represented a different phase of construction to the buildings to the west. It is shown as a continuous part of the building to the east, fronting Adelphi Street on the Bancks & Co's map of 1831 (Fig 3), but excavation revealed that it was a later construction, abutted onto the western face of the external wall. The new structure was constructed of similar mould-thrown bricks, bonded in a slightly more yellowish pale lime mortar than that utilised during the construction of the dwellings to the west. The external wall (*III*) was of only a single-brick thickness, in English Garden Wall bond, and was continuous around the south, west and northern sides of the structure, abutting the west face of Room 6 (*II6*) to the east. The structure was of a more rectangular shape than the other dwellings, being less deep along its north/south axis, having internal dimensions of approximately 3.66m by 3.20m (12' by 10'6"). As with Rooms 1 to 3, there was a probable staircase along the internal face of the east wall, the west, single-skin wall of which appeared to butt the south wall (*III*), and terminated 0.66m from the north

- 5.7.17 The remains of the base of a fireplace also survived, positioned on the western wall, unlike those in the dwellings to the west, where the fireplaces were positioned against the back, southern, wall. It was of similar construction, comprising two brick piers of a full-brick thickness, but differed in that they projected further into the room (0.36m), as the external wall did not reduce in section to accommodate the flue. The feature was also significantly narrower than those in Rooms 1 to 3, having an internal width of only 0.91m (3'). There was also no evidence for it having been remodelled, with one of the internal flagstones surviving *in-situ* in the southern part of the original hearth aperture.

Plate 47: View of the northern side of Room 5

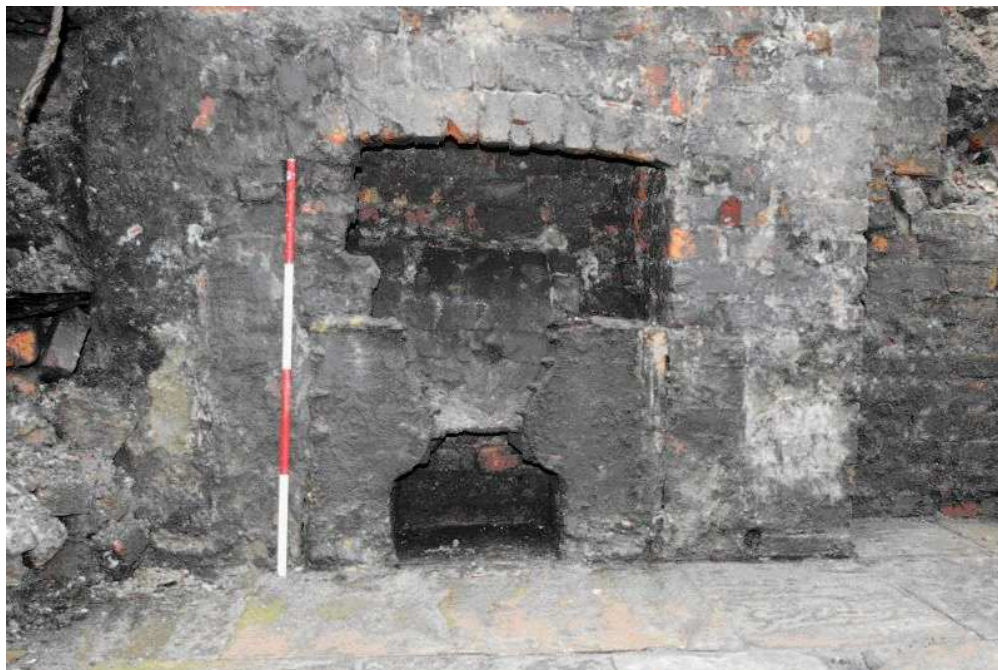
- 5.7.19 The western return of the wall housed a fireplace (**133**), 0.76m (2'6") from the south wall. This was remarkably well-preserved, and was of a different construction than those to the west. The original hearth aperture was 0.91m (3') wide, similar to that in Room **5**, but flanked by 0.45m wide brick piers of single-skin hollow construction with the overall width of the chimney breast being 1.82m (6'), wider than those within Rooms **1** to **3**. The original aperture also had a double row of header bricks forming a segmental arch, the apex of which was 1.21m (4') above the flagstone floor (**114**). This aperture was narrowed at the base by 0.23m on either side with brick piers, forming the sides of a fire-basket. The piers were faced with decorative cast-iron plates, each with embossed elliptical motifs. Both piers were also capped with cast-iron plates, that on the southern side being covered subsequently with a further episode of remodelling, suggesting the flue had been narrowed.

Plate 48: View of the fireplace within Room **6**

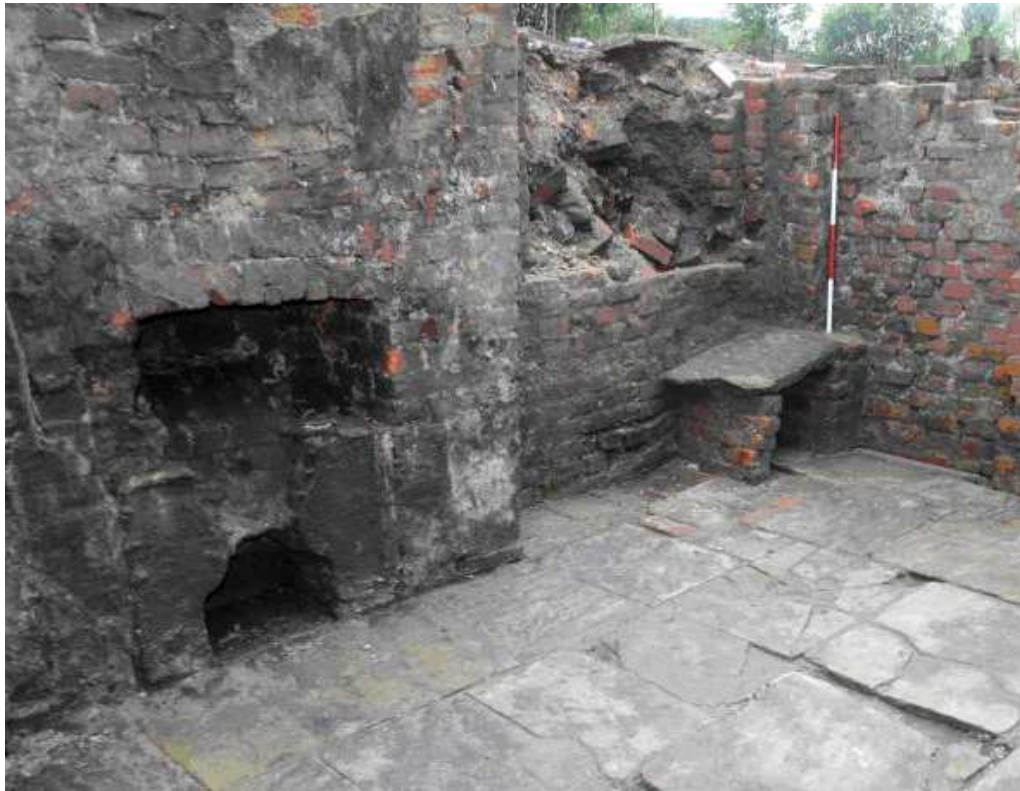
- 5.7.20 Immediately to the north of the chimney breast, which projected 0.36m into the room, was a relatively large window (**164**), providing a modicum of light from the southern end of a passage running northwards (**163**). The window was 1.21m (4') wide, rebated on the inner face, and surviving to 0.91m in height (Plate 49), although there was no evidence for a lintel, which would presumably have been positioned at wall-head height. The internal sill was brick, although this may have been overlain by a timber board. The aperture had been damaged during subsequent in-filling of the passage, which did not have any apparent related blocking of the window, suggesting that the passage

Plate 49: View of the window above the wash stand in Room 6

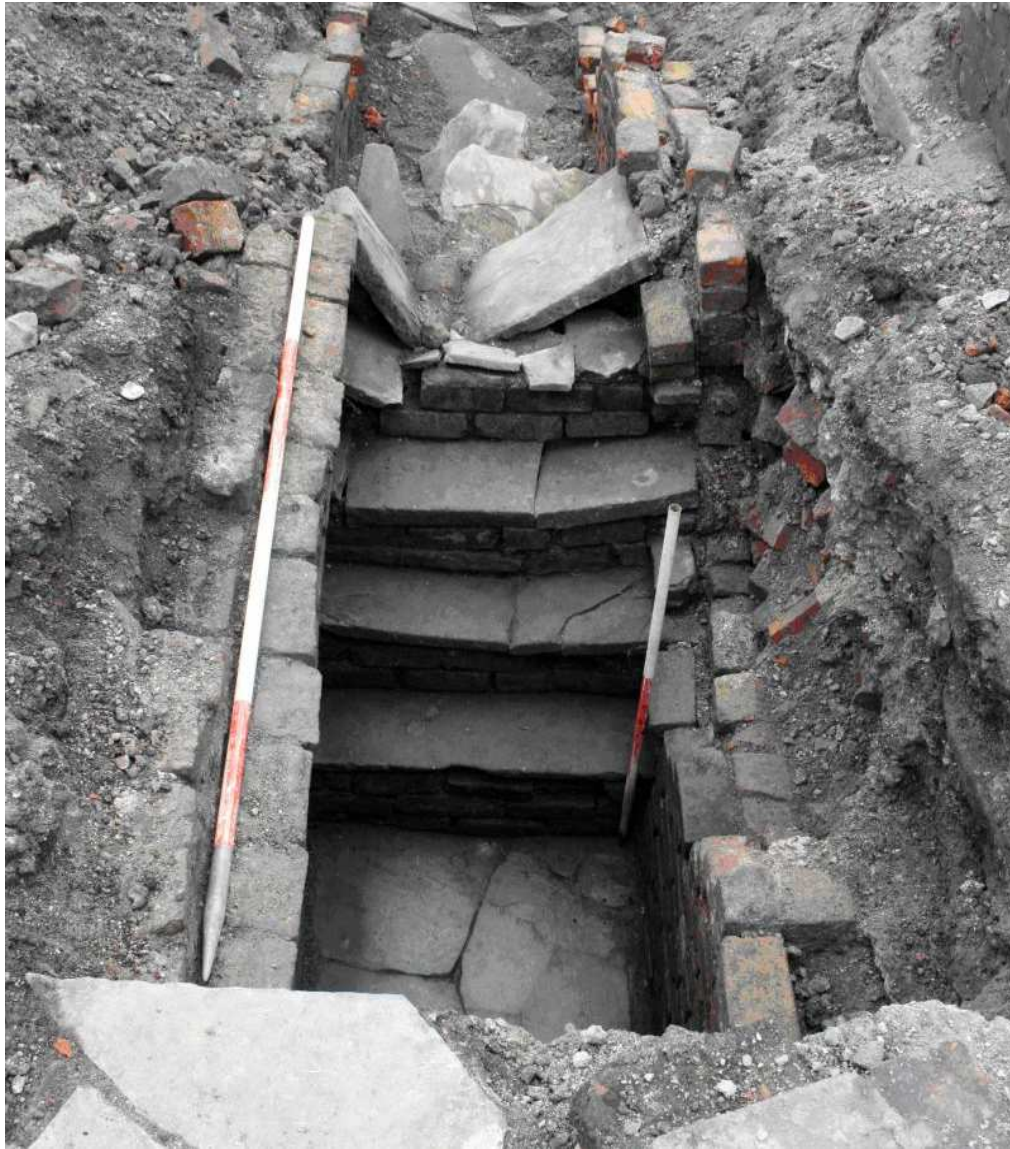
- 5.7.25 At its western end, the passage originally joined a contemporary north/south-aligned return, affording access from the courtyard to the west. At its southern end, the passage terminated at the southern jamb of window **164**, whilst at the north it terminated in a straight stair (**167**), of four sandstone steps on brick risers, elevating it to the level of the courtyard (Plate 50). This stair is clearly depicted on the Ordnance Survey map of 1848, which also appears to show a passage through the properties fronting Adelphi Street at ground floor level (Fig 4). The only surviving evidence for this passage were two flat cast-iron beams, of 6mm (¼") section, and 57mm (2¼") width, which carried a wall supporting the landing of the ground floor passage over the junction of the two below, at cellar level. At some point, possibly after the in-filling of the lower passage, the bars had failed structurally, and had bowed significantly under the stress of pressure from above. A further stair is depicted on the Ordnance Survey map of 1848 at the northern end of the passage (Fig 4), and evidence from the excavation suggested that this was oriented in the same direction, with the northern end at ground level. The buried remains within this part of the site had been largely destroyed during the twentieth century, but a two-course high brick wall (**167**) across the passageway, immediately to the south of its extant northern end, appeared to represent the riser of the bottom step of the stair.

Plate 50: View of stairs 167 along the northern end of the back passage in Room 6

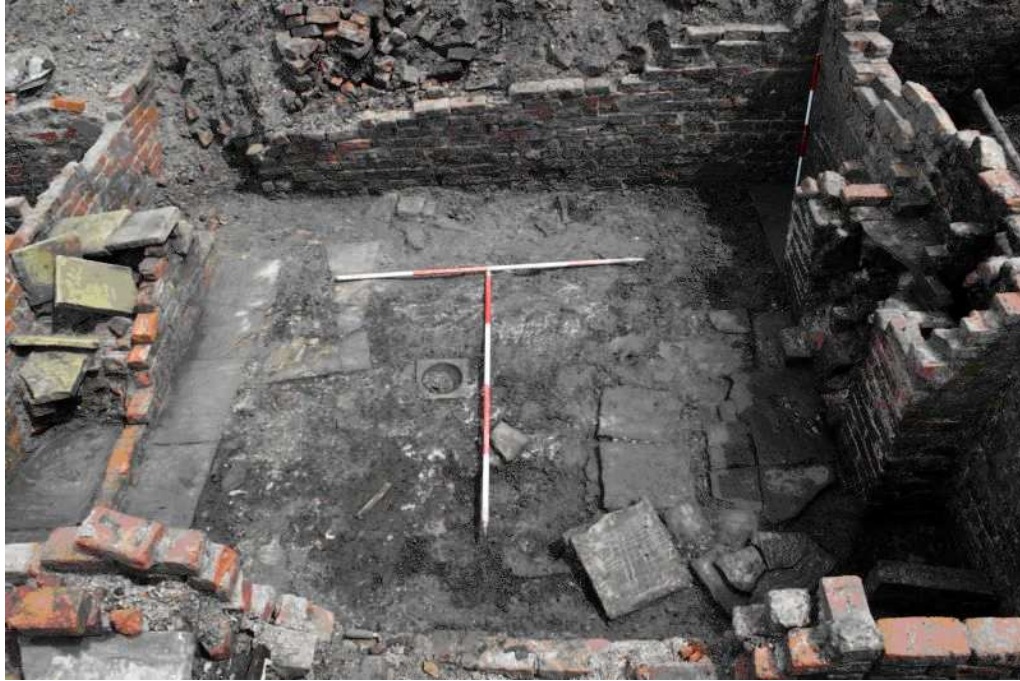
5.7.27 **Room 7**: this formed the rear cellar of a further property fronting Adelphi Street, and was of roughly similar size. As in Room **6**, what appeared to be a contemporary door aperture afforded access into the front cellar at the north end of the east wall (**119**). This single-skin wall was poorly preserved, with no evidence surviving for a fireplace on its western side. The position of the fireplace within Room **7** differed from that in Room **6**, in that it was positioned on the southern, rather than the western, wall. This suggested that there was a central window in the western elevation, providing light from the passage, as with Room **6**, and occupying the space that might otherwise have housed the chimney breast. This central section of the west elevation was also poorly

Plate 51: View of Room 7

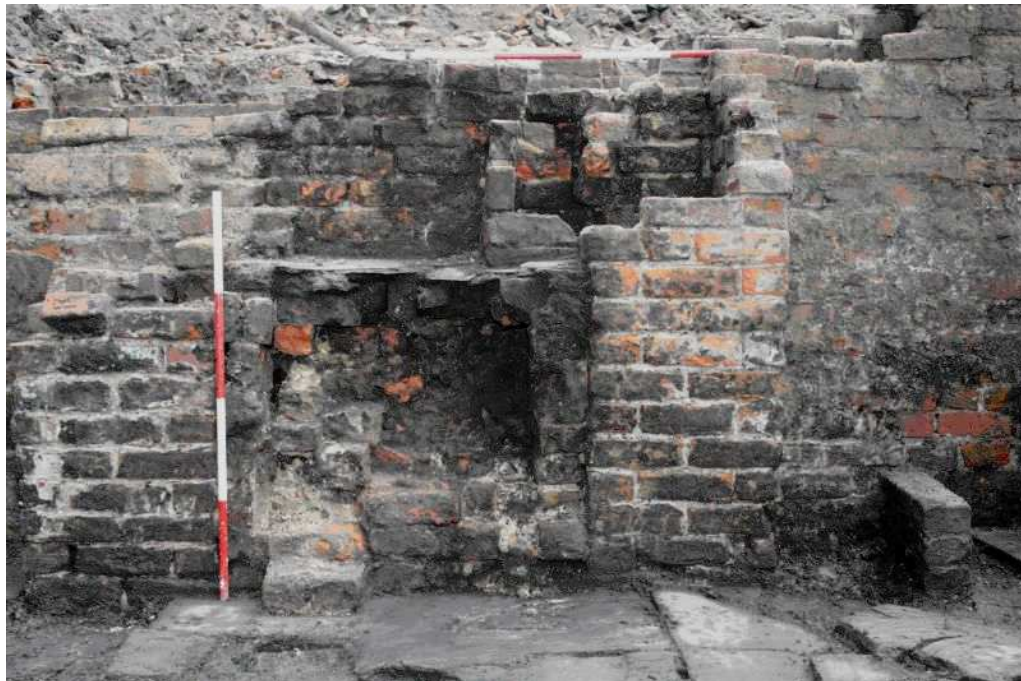
5.7.28 The fireplace (**169**), positioned centrally on the south wall, was of similar construction to that in Room 6, although less well-preserved, comprising two hollow brick piers of single-skin thickness. These were 0.45m wide, and projected 0.36m into the room. The external wall to passage **162** was reduced to a single-skin in thickness around the back of the hearth, to maximise its size without compromising that of the room. As with the other fireplaces within the dwellings, it had been modified significantly, with the whole of the original aperture partly in-filled. A slate course appeared to have been inserted 0.66m above floor level, capping the hearth. The flue appeared to have been re-routed on the western side into the western pier, which was expanded by one brick's width. The area below the capping appeared to have been reduced in size to fit a back-boiler, with part of the blocking extending beyond the front of the original hearth, suggesting that a new frontage was erected at this time. To the west of the fireplace, a three-course high single-skin wall (**170**), abutting and perpendicular to the south wall, appeared to represent the base of a wash-stand, although no evidence for an associated pier survived. It appeared to have been similar to that in Room 6, and would have almost completely concealed the blocked doorway into the passage to the west. Interestingly, the extant eastern pier for the wash-stand was positioned in an area where the floor did not survive, but continued below the level of where the floor would have been, suggesting that it was already absent at the time of the construction of the wash-stand. The survival of the floor elsewhere within the room was

Plate 52: Fireplace within Room 7
