ADELPHI STREET, SALFORD Greater Manchester

Archaeological Building Survey and Excavation

Oxford Archaeology North

March 2008

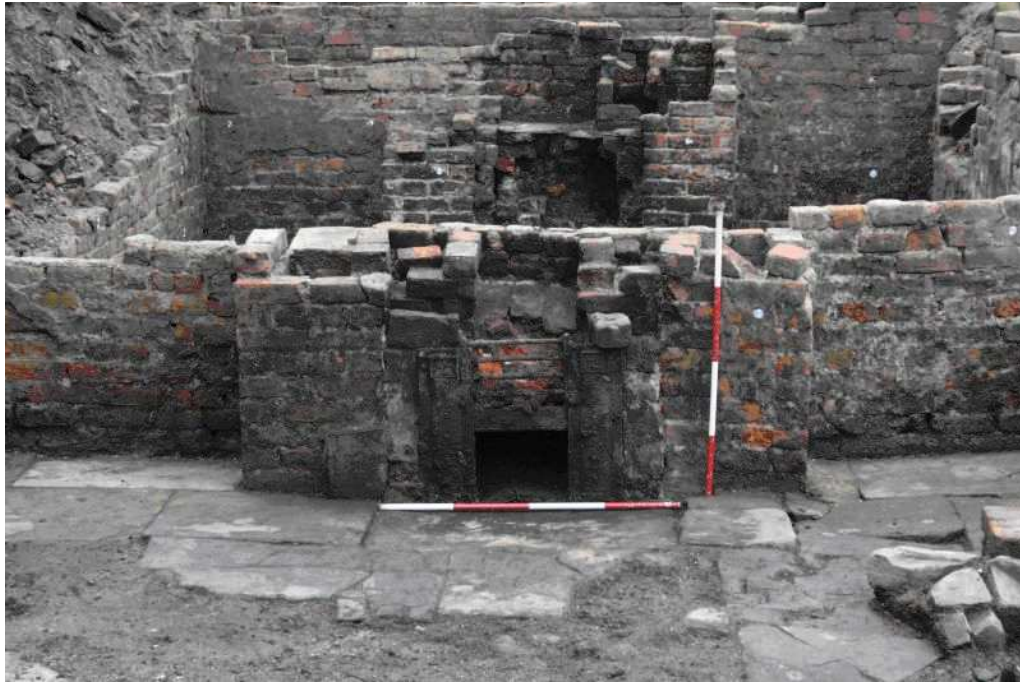
- 5.7.33 The central fireplace (**I28**) within the southern wall appeared to be keyed into it, and comprised several phases. The original fireplace appeared to be identical to that in Room **7**, comprising 0.45m wide hollow brick piers of single-skin thickness, projected 0.36m into the room. The lower part of a thin sandstone surround survived *in-situ* at the base of the eastern pier, and was presumably similar in style to the broken, but more complete example revealed in Room **3**. The hearth was in-filled subsequently by a brick's width (0.23m) either side for the insertion of a fire-basket, similar to that in Room **6**, but far more ornately decorated, with pyramidal embossed studs within geometric designs, flanked by fluting. Panels atop either side-piece contained a figure, which appeared to have a cherubic head, and the body of a beast with a tail, and possibly wings, laying in a couchant pose. The most likely figure is a Greek Sphinx, popular in nineteenth-century romantic styles. Behind the fire basket, which had four horizontal rails across the front, the base of the flue was formed of angled brick. This was overlain by a later extension to the front of the fireplace. It was of the same width as the original aperture (0.94m), extending 0.79m beyond the front of the fireplace. It survived to a maximum height of seven courses at the rear, but only two at the front, where a 0.37m wide raking pit survived. This represented a significant impact on the floor-space within the room, and it is unclear why the original aperture was not remodelled, rather than added to, with only the flue remaining in use from the earlier feature.

Plate 53: Fireplace within Room 8

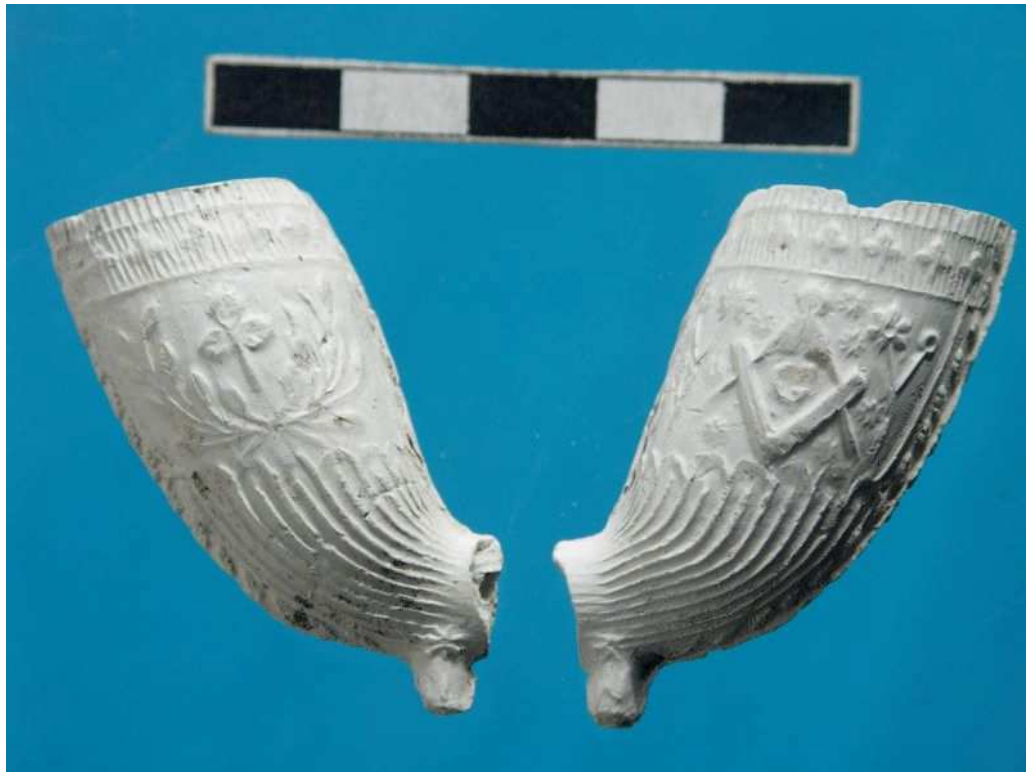
Plate 54: Examples of the clay tobacco pipes with masonic design and stars on spur

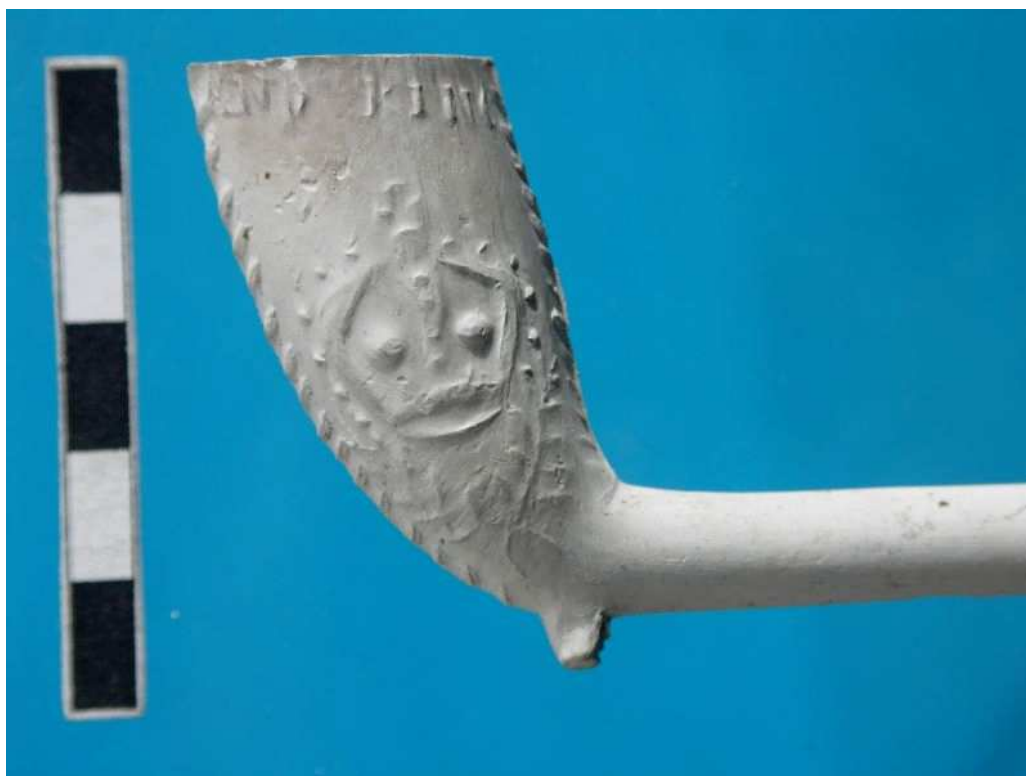
Plate 55: Examples of the clay tobacco pipe with Church and King motif

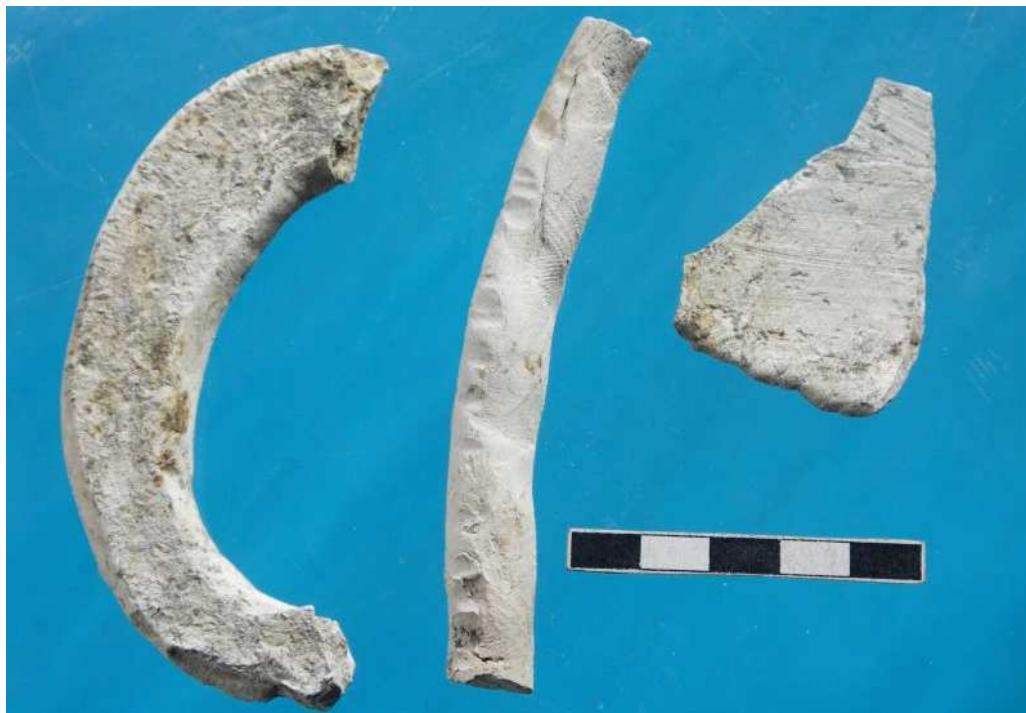
Plate 56: Kiln debris, including wad roll and sheet

6.3.18 A substantial quantity of kiln waste was also recovered (1,461 pieces). Although there are only a few small scraps that may have come from the muffle itself were recovered, the waste clearly shows that a developed muffle kiln was in use, which would have had a stack of mushroom supports within the muffle. A wide range of rolls, straps, wads and sheet are represented, as well as slag laminate from the kiln covering. This is a very good assemblage of kiln debris, which is not only the largest ever to have been recovered from Greater Manchester, but also one that compares favourably nationally.

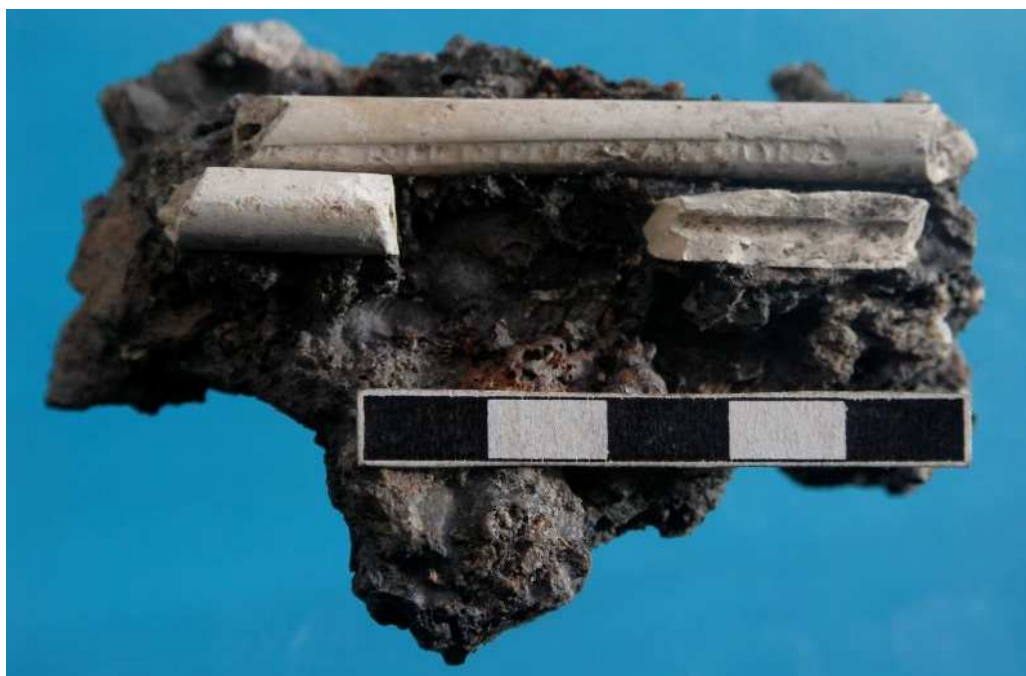
- 6.3.12 By far the most numerous mark recovered is that of W Griffith of Salford, examples of which were also found embedded in the kiln waste itself. There is no doubt that this mark identifies the source of the kiln dump. There were probably three different William Griffith's, presumably three generations of the same family, who were making pipes in Salford and Manchester from at least 1797-1884.

Plate 57: Slag laminate from kiln, with W GRIFFITH mark embedded in waste

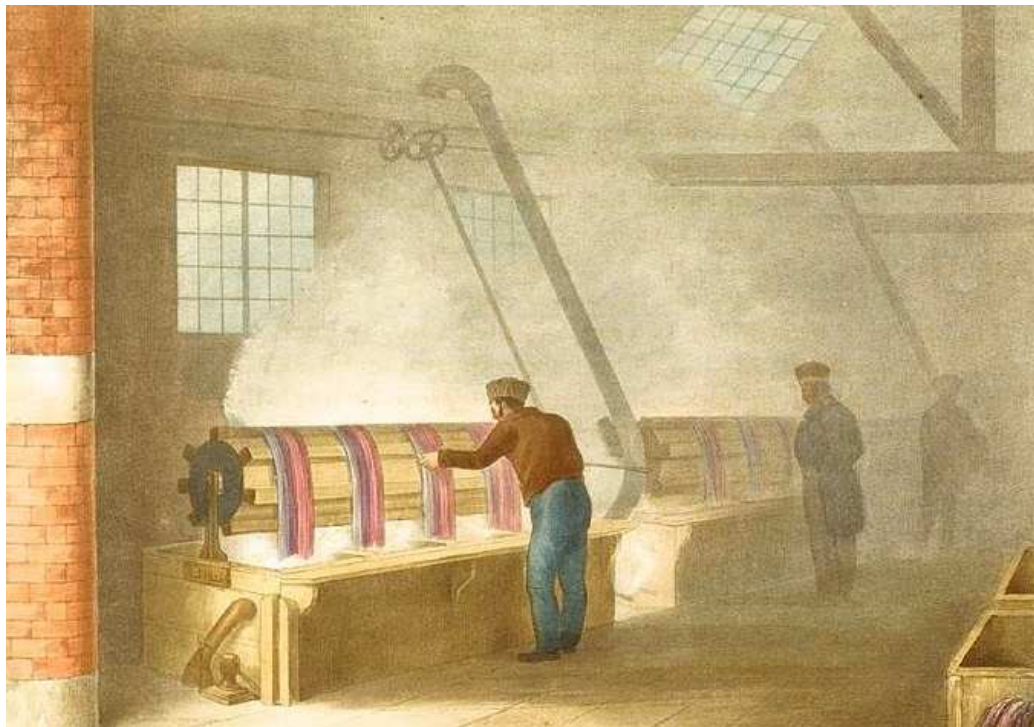
Plate 58: Steam-assisted dyeing technique in the 1840s (reproduced from Barfoot 1840)
