BARN AT 110 MAIN STREET, WARTON, LANCASHIRE

Archaeological Building Investigation

Revised November 2005

Document Type: Archaeological Building Investigation

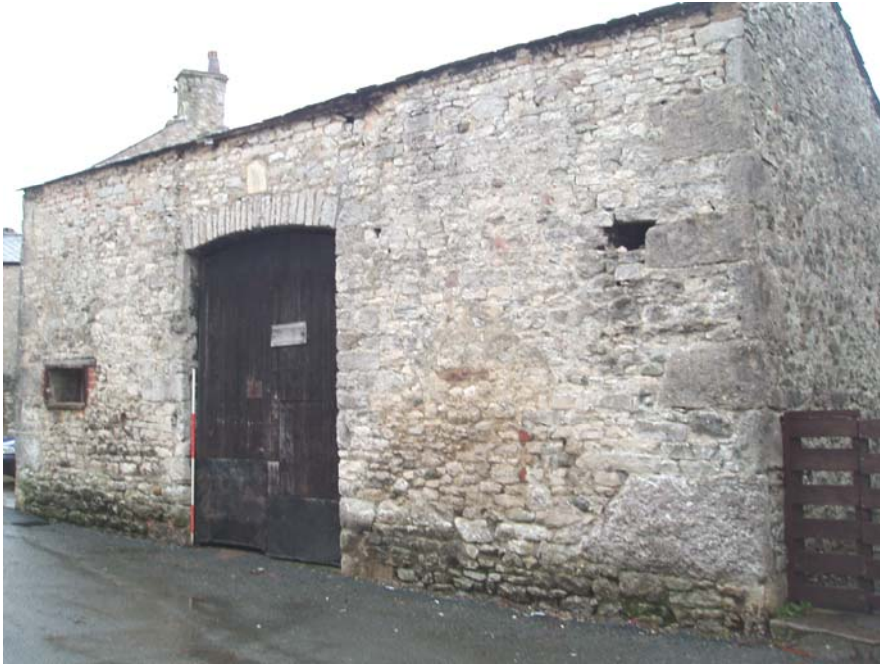
- 3.2.1 **South-east:** this comprises the front elevation of the building (Plate 1). It features roughly-coursed small to medium sub-angular and sub-rounded sandstone blocks. There is the suggestion of foundation courses and the elevation is finished with large rectangular and sub-angular quoins, as are the central wagon doors (Plate 2). These are large flat-arched harr hung doors of matchboard construction with iron hinge posts and brackets. The right door has a small pedestrian door, which is blocked with timber battens on the inside. A wooden business plaque and a rusted horseshoe have been hung over this pedestrian door and to its left, there is a small tarnished handle on the main right door. On the left door, there is an iron plate for the relatively modern padlock, and modern graffiti, 'MO', has been carved into the wood to the right of this. There are also iron sheets across the base of both of the doors. Above these wagon doors, there is a cambered voussoir arch, above which, a section of rebuild is apparent, with a re-used foundation stone of sandstone bearing the inscription 'W J 1795' (Plate 3). There is a further area of repairs or rebuild to the right of the wagon doors, featuring random brick inserts and evidence of re-pointing and, on the east corner, there is a damaged ventilation hole or beam socket. At the other end of the elevation, there is a small, rectangular window, recently boarded over, which has red brick alterations to the reveals, a rough sandstone sill and a timber lintel. The remains of a rusted iron grill are still attached to the lintel and brick reveals. There is a small, wall-mounted, iron ring to the right of this window.

Plate 1: South-east-facing elevation

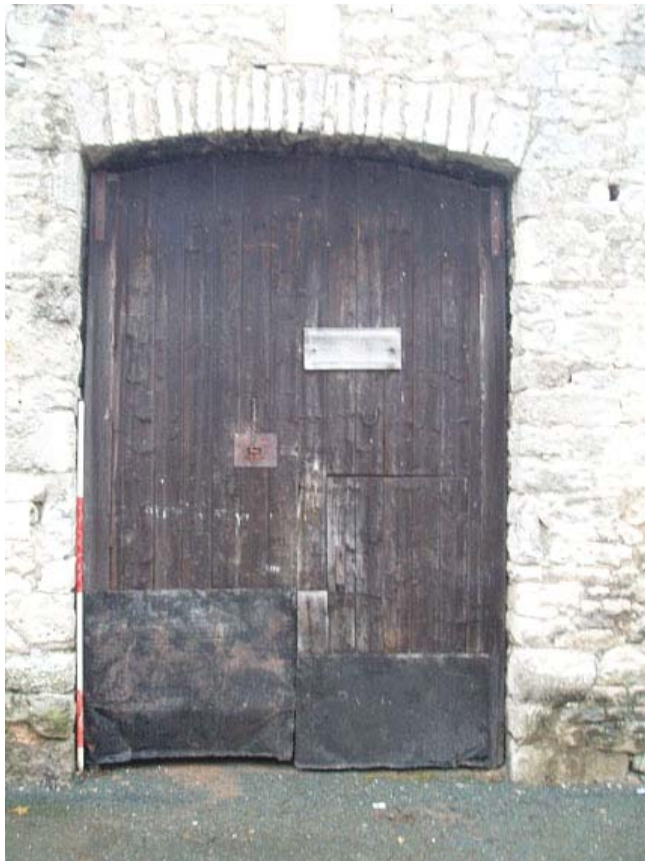
Plate 2: Detail of the wagon door on the south-east elevation

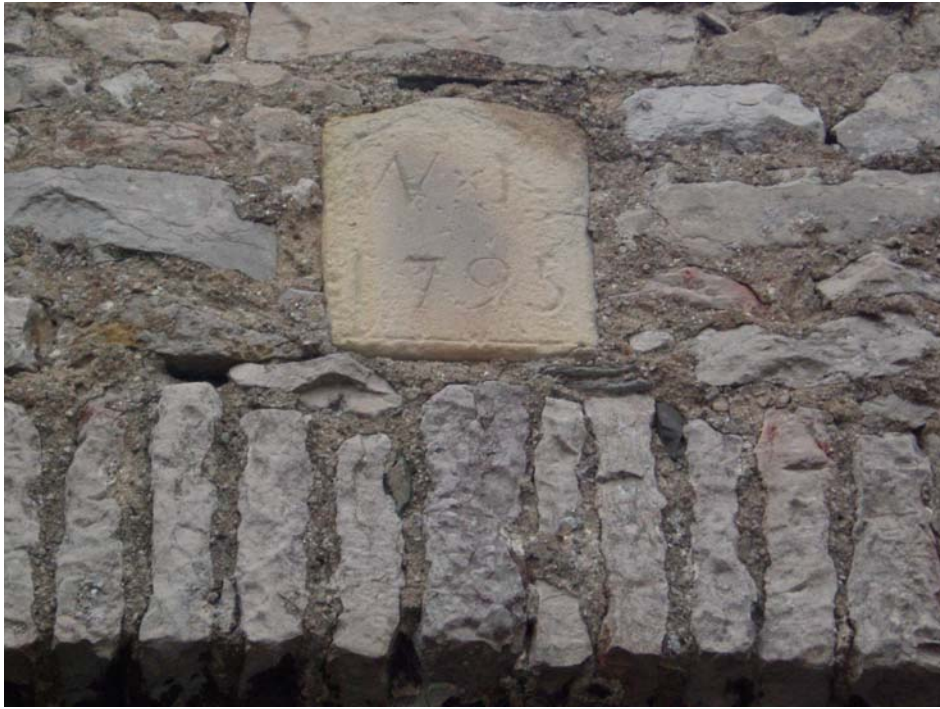
Plate 3: Detail of the re-used foundation stone above the wagon door

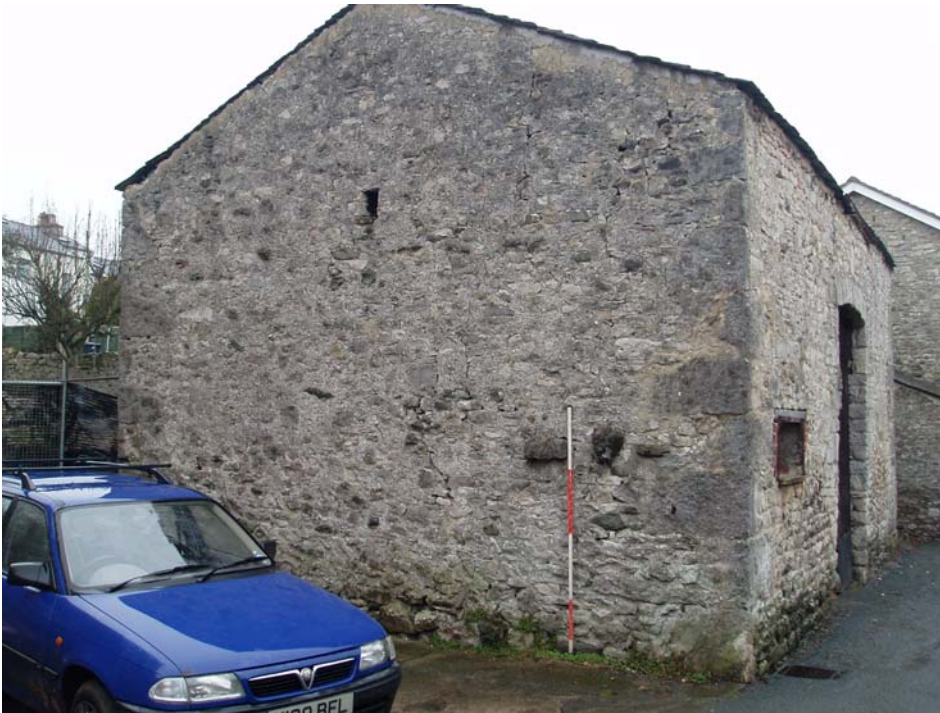
- 3.2.2 **South-west:** this wall forms the south-west gable (Plate 4) and has similar characteristics to the front elevation. However, unlike that elevation, the stone appears to be more randomly coursed and there are three pronounced foundation courses (Plate 5). There is re-pointing to the south corner and towards the apex of the gable, while in the middle of the elevation, there is a ventilation hole, which stands at first floor height only.

Plate 4: South-west-facing elevation

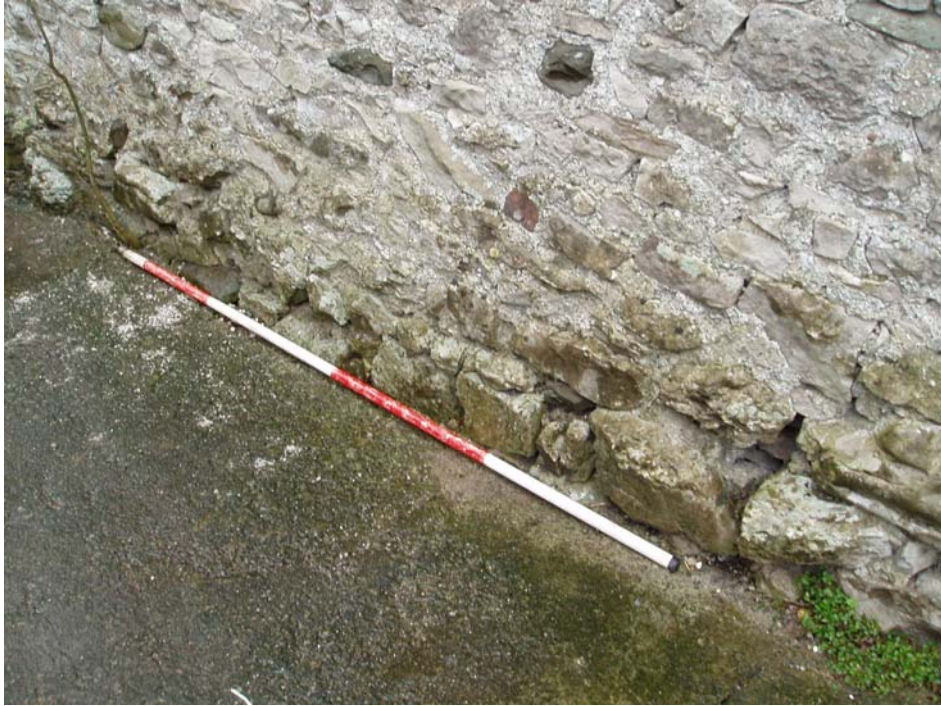
Plate 5: Detail of the foundation course on the south-west elevation

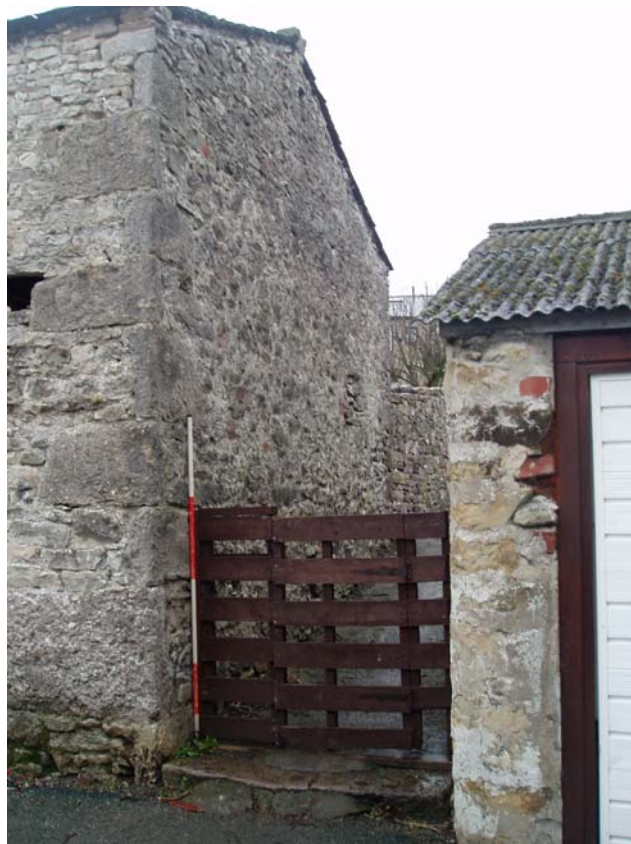
- 3.2.3 **North-east:** this gable elevation (Plate 6) is comparable in fabric to its south-west counterpart. There is an opening at the base of the wall, which features a

large stone lintel and is blocked by stone. On its right side, there is a small recess of unknown function, which is lined with modern red brick. This brick also features in the repairs to the right extent of this feature. A patch of repairs or rebuild, which may be a blocked window, is located towards the north-west end of the elevation, and a possible timber socket is sited near the apex of the gable.

Plate 6: North-east-facing elevation

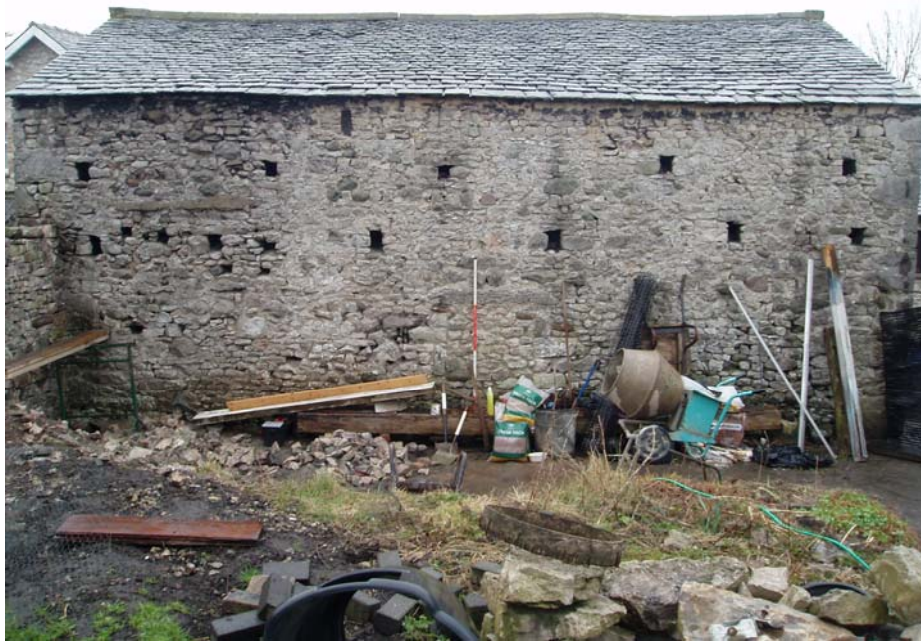
- 3.2.4 **North-west:** this elevation forms the rear of the building (Plate 7) and is similar in character to the gable ends. There is a small blocked door in the centre of the elevation (Plate 8), which is capped by a rough stone lintel and finished with undressed angular and sub-angular quoins. There are two rows of ventilation holes at first floor level and just below the eaves. Within the latter, the tie beam from the principal rafter truss is clearly visible. It is blackened by sooting or smoke damage, and this is characteristic of the upper courses of the build. On the left side of the elevation, there is the suggestion of an outshut (Plate 9). A series of small sockets near the lower tier of vents is clearly evident, as is the thin band of cement above.

Plate 7: North-west facing elevation

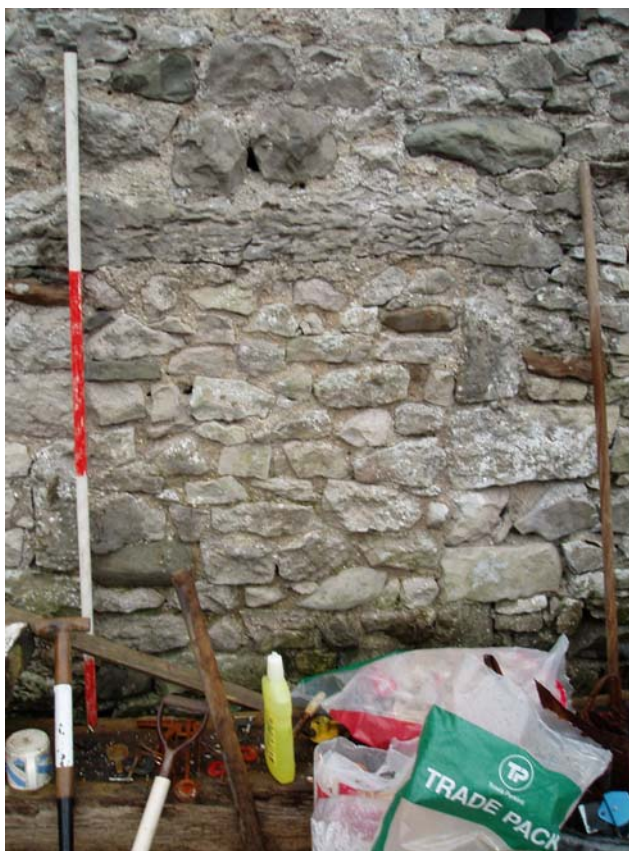
Plate 8: Detail of the blocked door on the north-west elevation

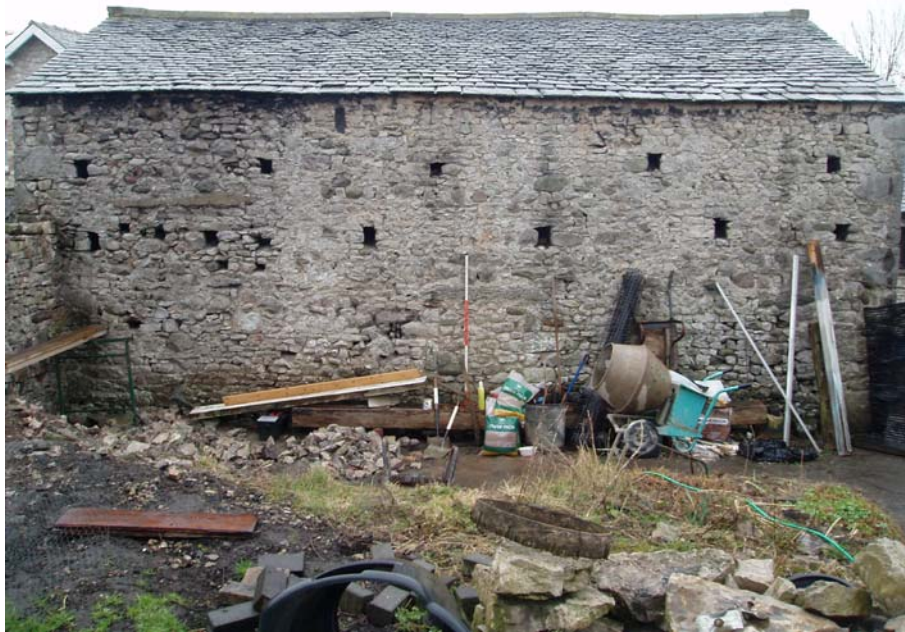
- 4.1.4 The outshut, which would have stood at the north corner of the rear elevation, was built at this time. It is unlikely to have been included or certainly planned in the original build because the outshut roof would obscure the lower tier of ventilation holes at that end of the barn.

Plate 9: The south-east elevation, including evidence of an outshut at the north-west end

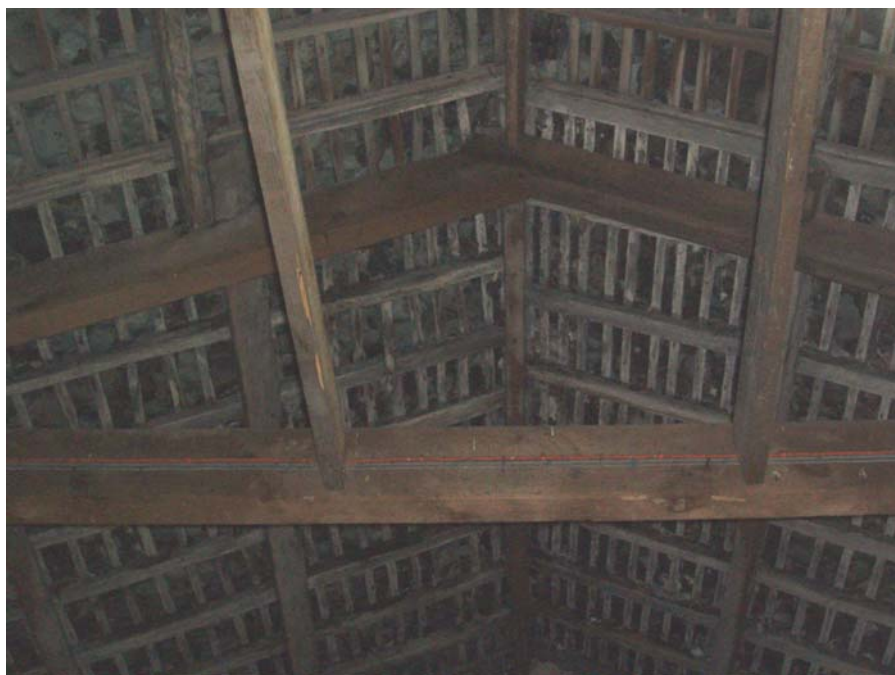
- 3.3.2 The roof is constructed from timber, with a principal rafter truss to the north-east of the doors (Plate 10) and a principal rafter truss with inserted brace to the south-west (Plate 11). The tie beams of these trusses have been joined together by two narrow, modern timbers for structural stability. There are five roughly hewn timber purlins, which have staggered joints at the principal rafters, but the roof laths appear more modern. Beneath the south-west tie beam and at first floor level, there are three machine-cut timbers. Two of the pieces have been joined together with an iron plate to create a continuous beam, which in turn, has been affixed to the third timber, in order to produce a more robust cross-beam. In addition, there is a second beam at this first floor level, which is given increased support from iron brackets attached to the south-west wall. The sockets for the both the tie and cross beams have stone and plaster repairs. The floor is concrete, with a smooth finish at the south-west end of the building and a rough stone aggregate elsewhere.

Plate 10: Detail of the north-east principal rafter truss

- 4.1.3 ***Phase 2 – intermediate repairs and alterations:*** the barn has obviously been re-roofed in the last century. The roughly-hewn purlins appear to be of a date comparable with the original build, but they may be re-used from the old roof or from another building entirely. In marked contrast, all the other timber components of the roof appear to be much later. The timbers used for both the principal rafter trusses and tie beams, and the laths, appear to be machine-cut and are, therefore, relatively modern. The stone and plaster repairs around the beam sockets support this interpretation. At some point following the roof repairs, the south-west principal rafter truss must have shown signs of stress, and this necessitated the insertion of the kingpost-type brace.

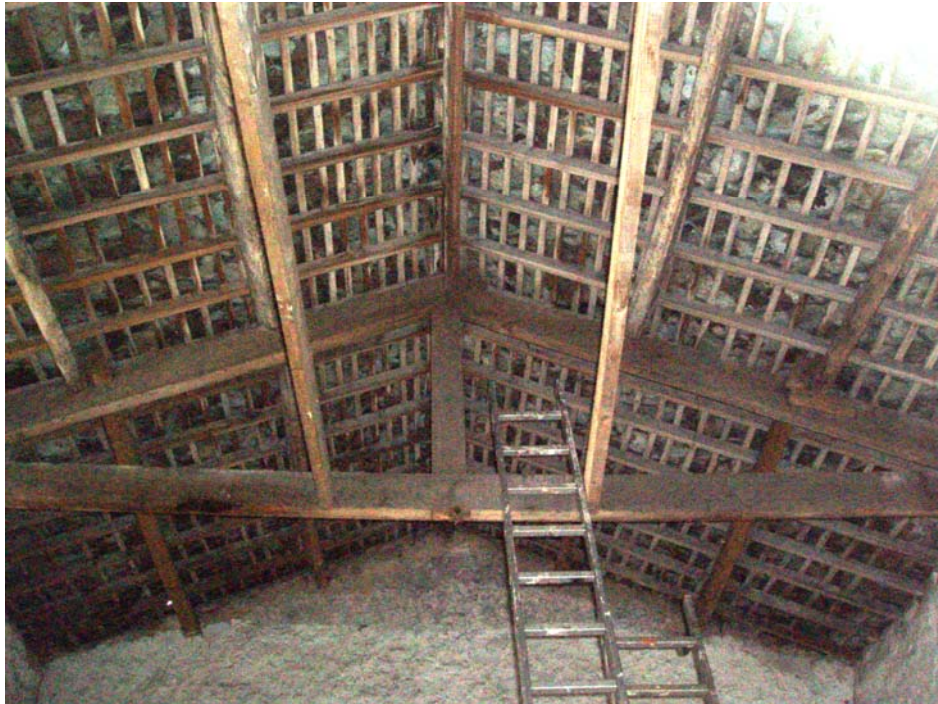
Plate 11: Detail of the south-west principal rafter truss

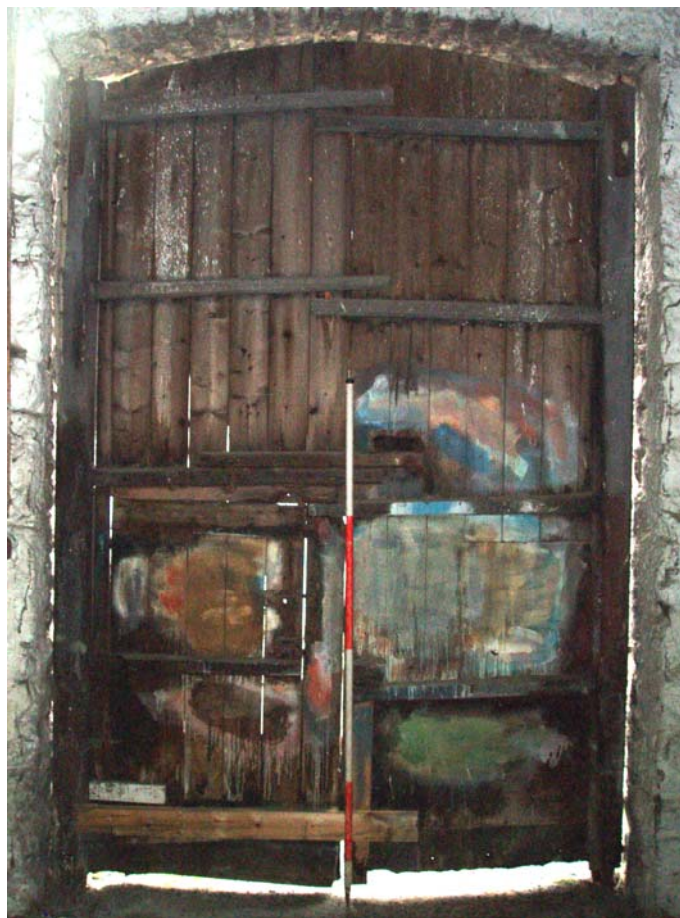
- 3.3.3 The wagon doors (Plate 12) are as described for the external elevation. In addition, there are five ledges and additional modern timbers to block the

pedestrian door and support the main doors. As on the front of the doors, iron sheeting has been nailed to the base of the right hand door. The small pedestrian door has an iron latch and lock, and there are two iron hooks on the central ledge.

Plate 12: Detail of the internal face of the wagon door

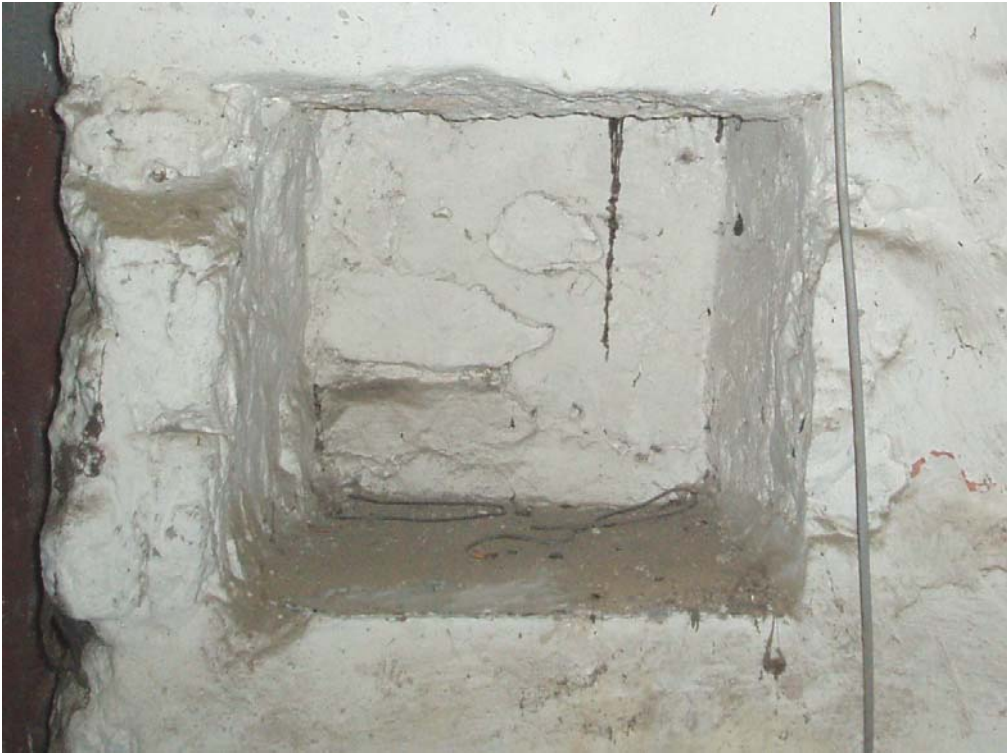
- 3.3.4 There is a single window, which has already been noted on the external elevation. In addition, it has a whitewashed timber lintel with a plywood support. Furthermore, there is a small square recess to the right of the doors, which has splayed reveals that are plastered and painted, and a slate sill (Plate 13).
- 3.3.5 There are two lights suspended from the north-east principal rafter truss, the switch for which is located on the left of the doors. Directly opposite the switch, there is a double plug socket and to the right of this sits a fusebox. In addition, there are several fuseboxes and a junction box in the east corner of the barn.

Plate 13: Detail of the recess to the right of the door
