# **Boundary Wall, Middleton House, Derby, Derbyshire**

## **Survey Report**

**Oxford Archaeology North**

Issue No: 2008-09/934

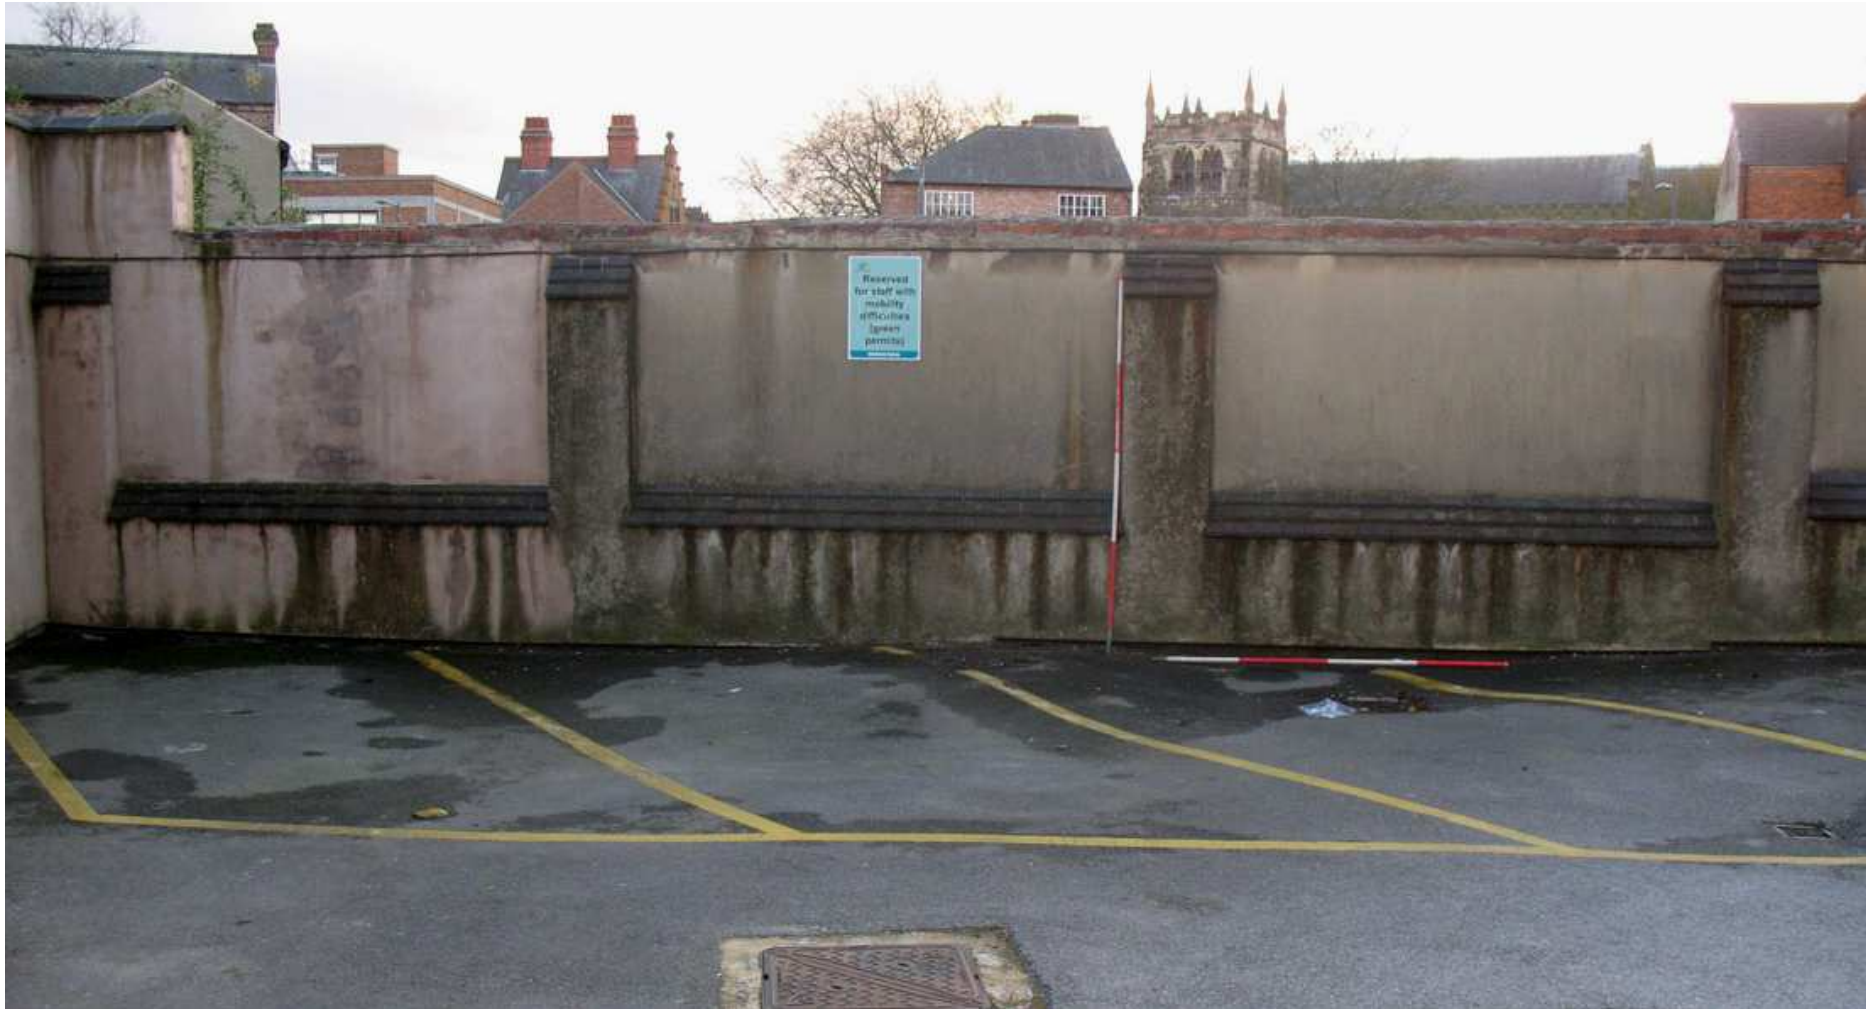
Plate 3: Photograph 1, south-eastern end of the boundary wall

4.2.2 **Southern section:** the southern eight bays of the wall were covered with a pale grey render, unlike the other sections. The extreme south-eastern end of the wall was 0.5m higher than elsewhere, and retained a V-section capping, almost certainly designed as a roof ridge tile (Plate 3). To the north, the render had been removed from the upper course of the uncapped wall for almost four bays length, to the position of an adjoining wall on the rear face (Plate 4), suggesting that the intervening wall had probably been reduced in height to 2.3m. Beyond this point, the wall was again capped with a V-section tile. The bays were divided by projecting brick piers, 1½ bricks wide, and 2.13m (7') high, with raking chamfered Staffordshire Blue brick cappings (Plate 3). There was some variation within the bay widths, but they were typically 2.74m (9') wide. Each pier was connected by a plinth, with similar raking capping of three courses. This was typically positioned 0.61m (2') above floor level, but was often stepped at the bay division, to account for the gentle north/south slope of the ground.

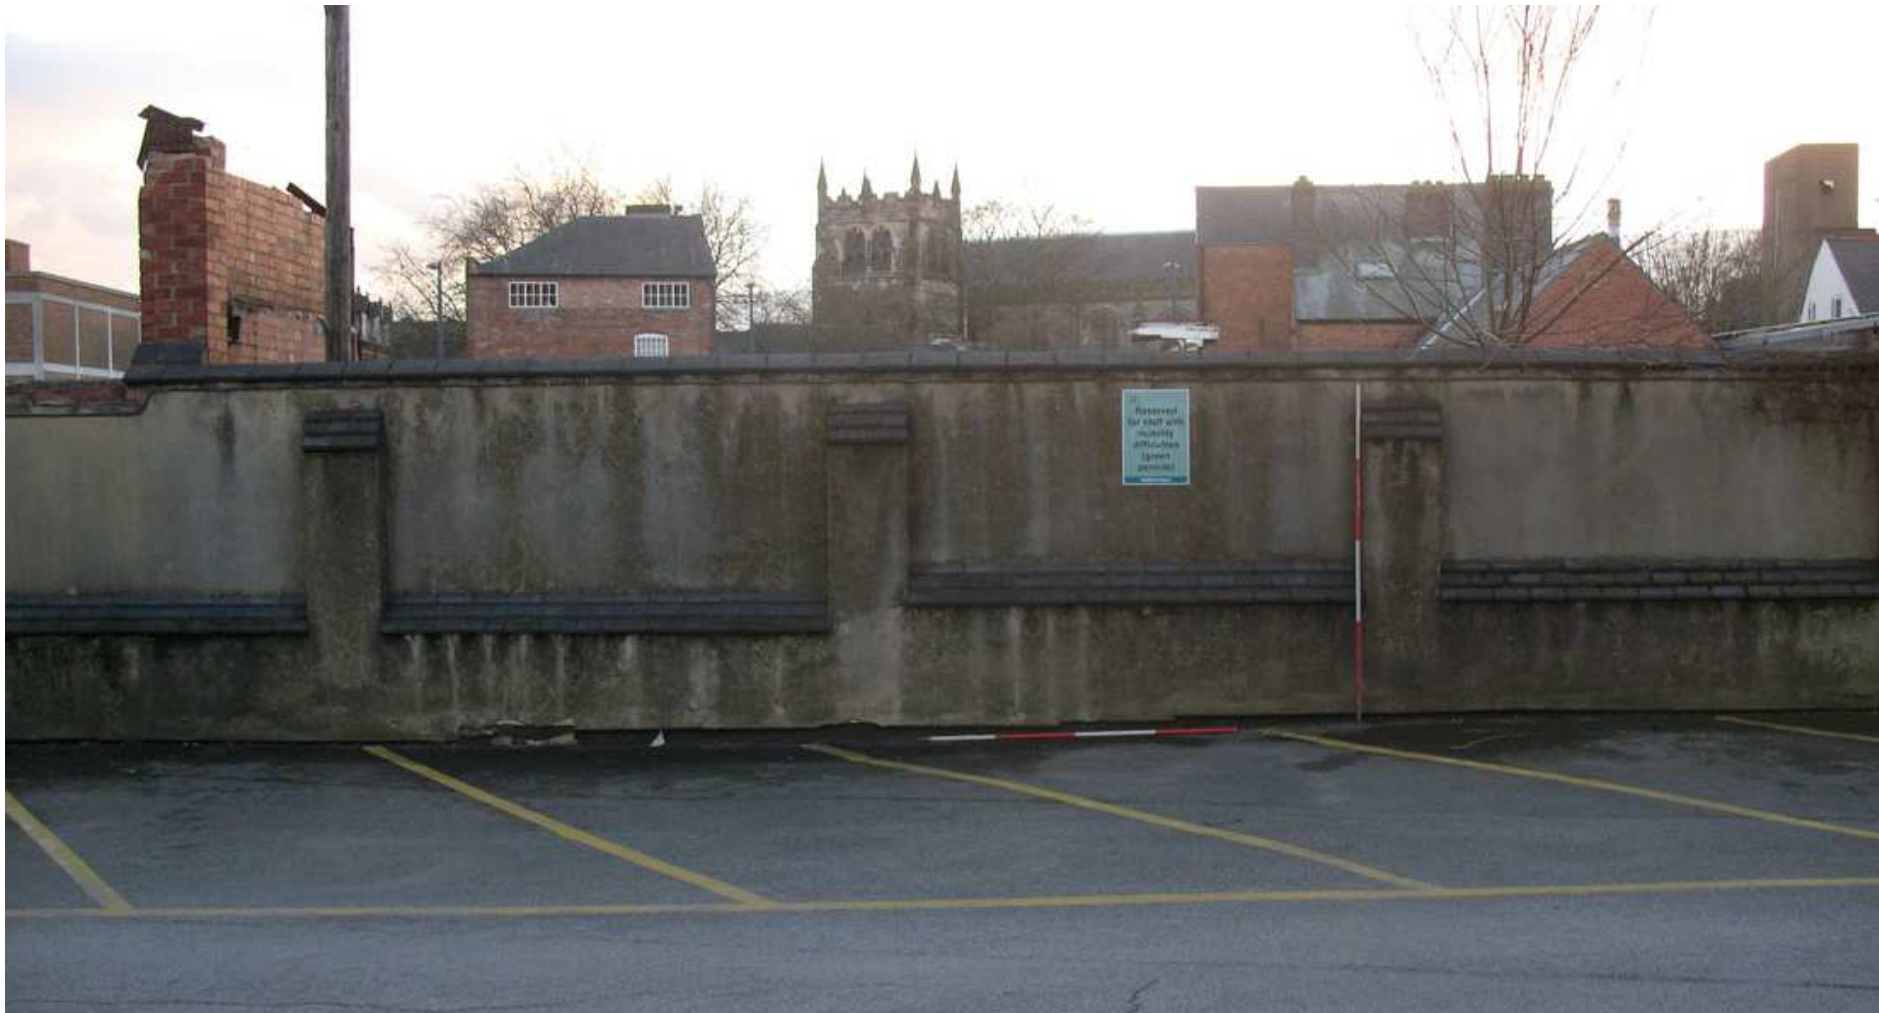
Plate 4: Photograph 2, south-eastern central section of the boundary wall

4.2.3 **Central section:** the five central bays were significantly higher than those either side (3.7m), and were of a more uniform width (2.79m). The plinths comprised only two chamfered courses, whilst the piers between bays were flat-topped below a scar in the mortar bed, suggesting that there had been a roof on this side of the wall. Piers at either end of this section of wall butted piers from the sections either side, suggesting different phases of construction. The wall, including the Staffordshire Blue brick plinths, retained remnants of white paint adhering to its surface, suggesting that the paint was not part of the original construction. A doorway, blocked in stretcher bond brick, was observed in the second bay (from the south) of this section of wall (Plate 5). It was 1.0m wide and 2.01m high, below a 0.40m thick concrete lintel measuring

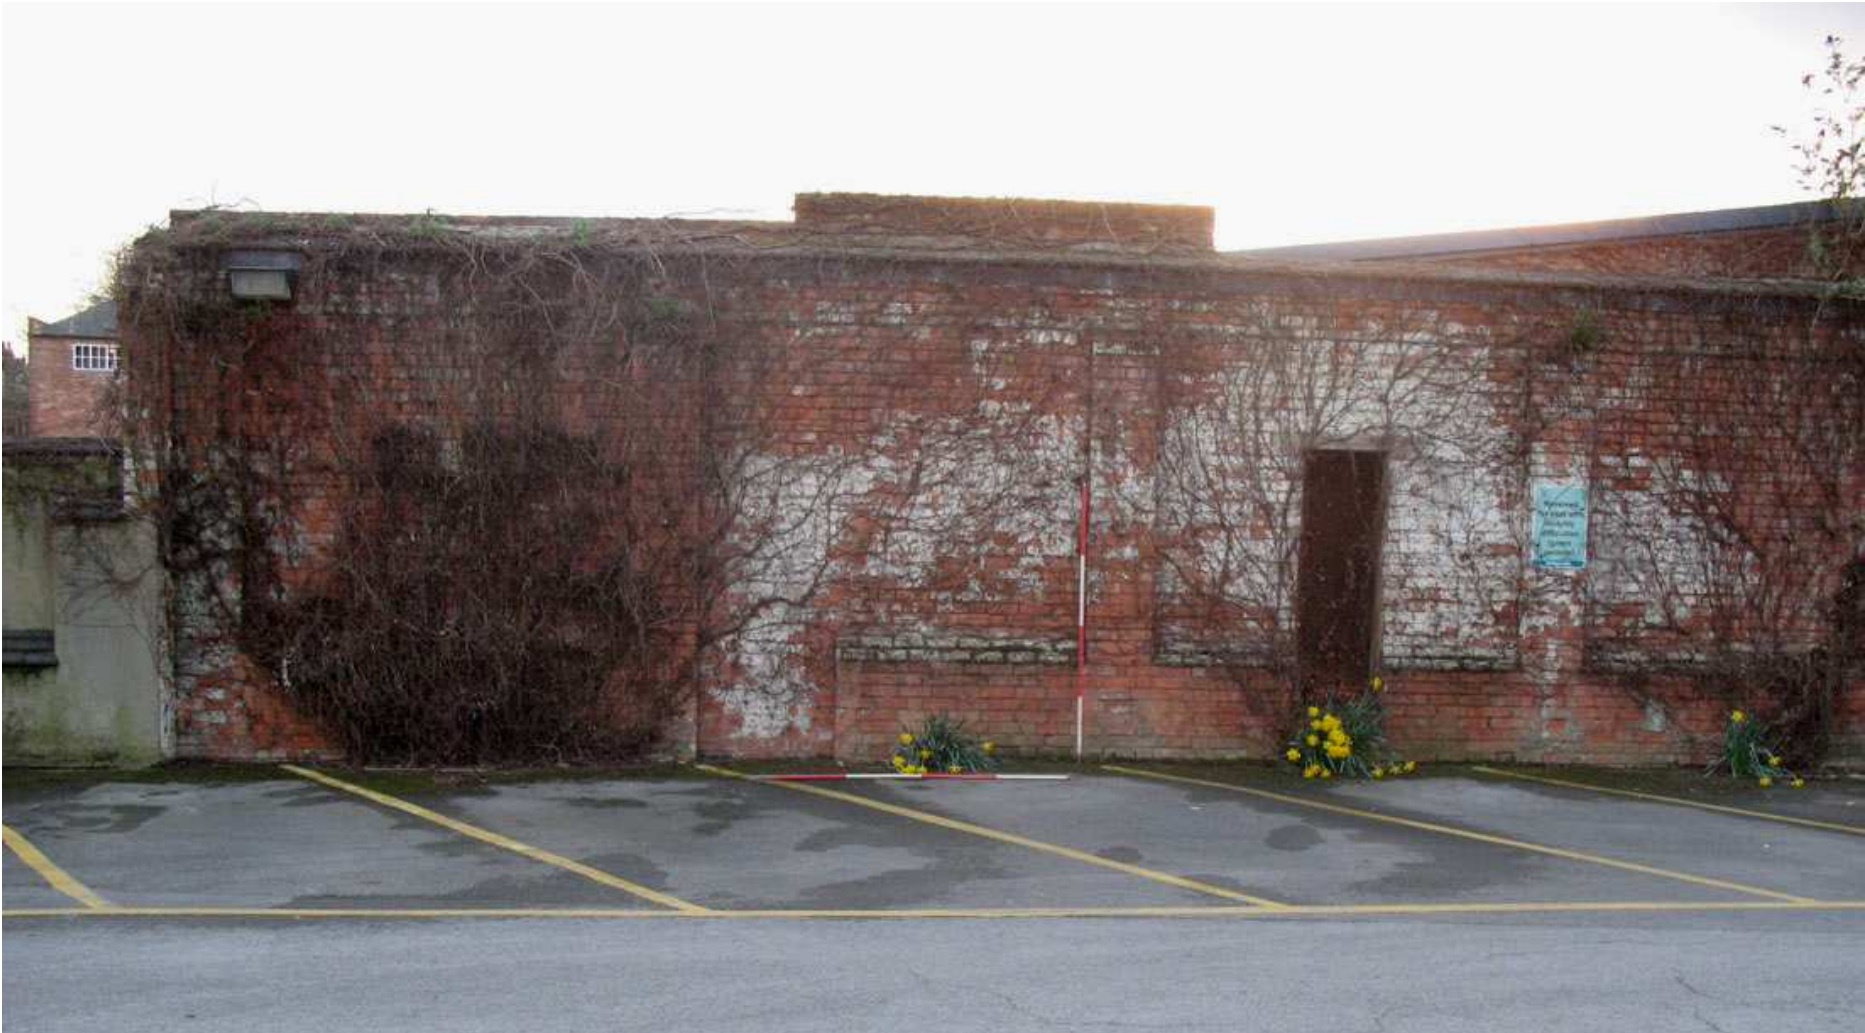
Plate 5: Photograph 3, central section of the boundary wall

1.13m long. A further aperture in the bay to the north (Plate 5) was blocked with plywood boarding. It was 1.83m (6') high, 0.66m wide and was placed 0.45m (18") above floor level. It also had a concrete lintel and cement rendered jambs, suggesting that it had been inserted into the wall, cut raggedly through the brickwork and rendered. Whilst the aperture did not extend to floor level on this side of the wall, it probably represents a narrow doorway, into a structure with a raised floor, with the paint on the wall face suggesting that this may have been on the eastern side of the wall.
