SELBY FLOOD ALLEVIATION SCHEME, SELBY, YORKSHIRE

Watching Brief

Oxford Archaeology North

July 2006

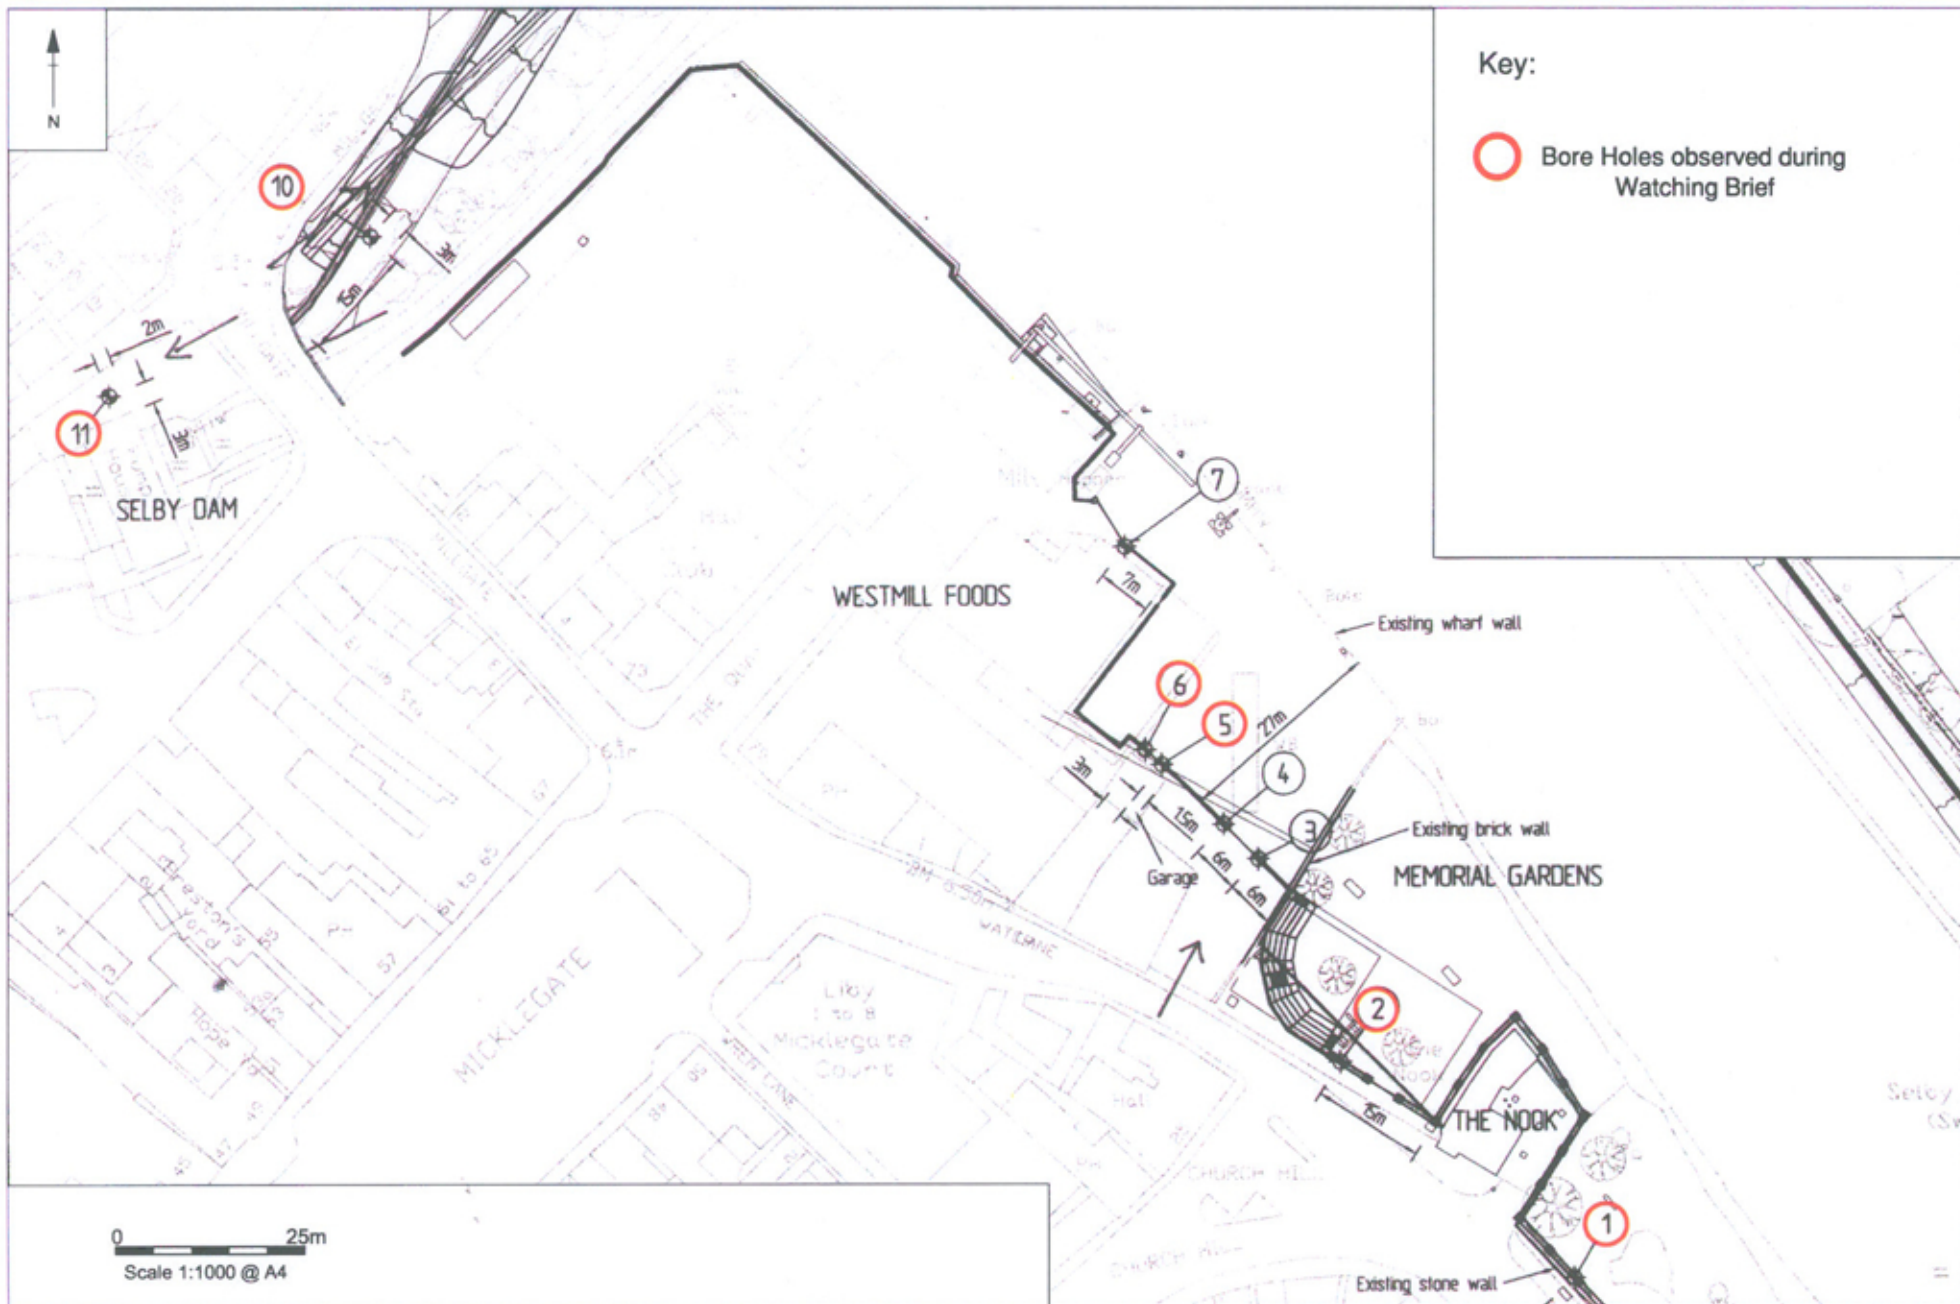
Figure 2: Borehole location plan

- 3.1.1 The site (centred on SE 61 6325) occupies a location on the south-west bank of the River Ouse (Fig 1). Two boreholes were drilled in the Memorial Gardens to the west of Barlby Lane Toll Bridge, either side of a building known as “The Nook” (BH 1 and BH 2). Two boreholes were drilled on the quayside of Westmill Foods in front of a brick-built garage fronting the river (BH 5 and BH 6). The two boreholes on the quay of Westmill Foods are located on the downriver side of a partially upstanding masonry listed building incorporated into a later brick-built warehouse. Two boreholes were drilled along the north-western side of the tributary of the River Ouse, Selby Dam (BH 10 and BH 11). See Figure 2 for the positions of the boreholes.

- 4.1.1 In total, six percussion boreholes were monitored during the watching brief. The results are shown in Table 1 and the core positions on Figure 2.
