HOTBANK FARM, Northumberland

Archaeological Watching Brief Report

September 2005

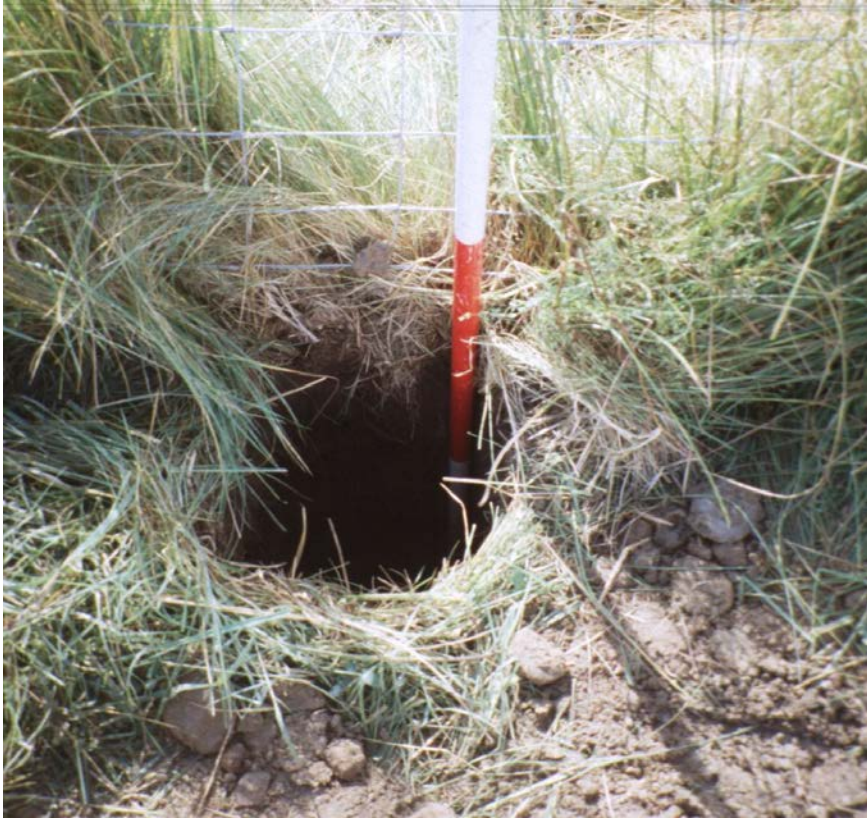
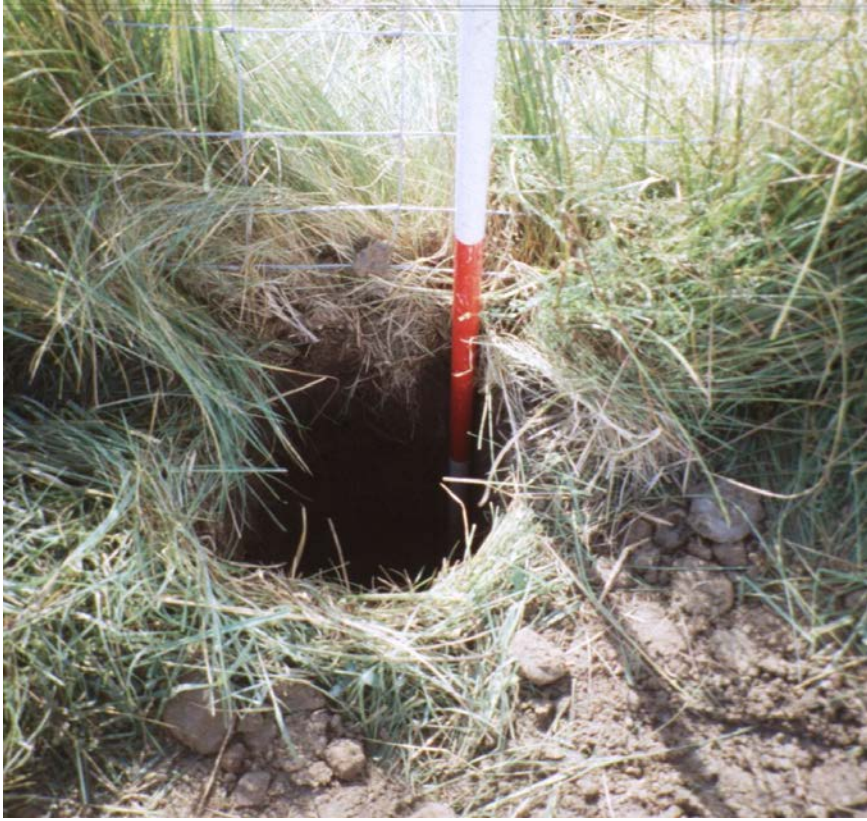
3.2.1 **Gate 1:** the insertion of the easternmost gate into the current dry stone wall involved the excavation of four postholes, each measuring 0.35m square and 0.85m deep (Plate 1), in pairs approximately 2m apart. This involved the removal of a mid-brown loose sandy clay, with less than 2% angular stone inclusions. No finds or deposits of archaeological significance were noted during the excavations.

Plate 1: Posthole for Wicket Gate 1

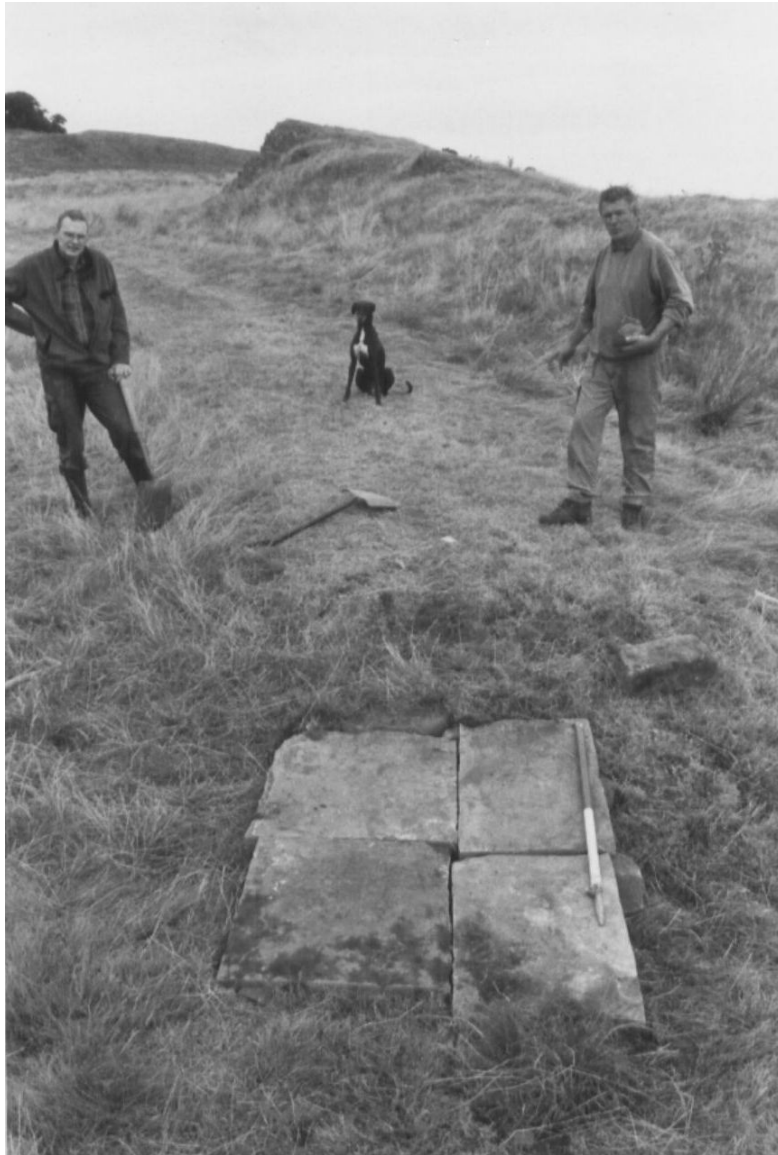
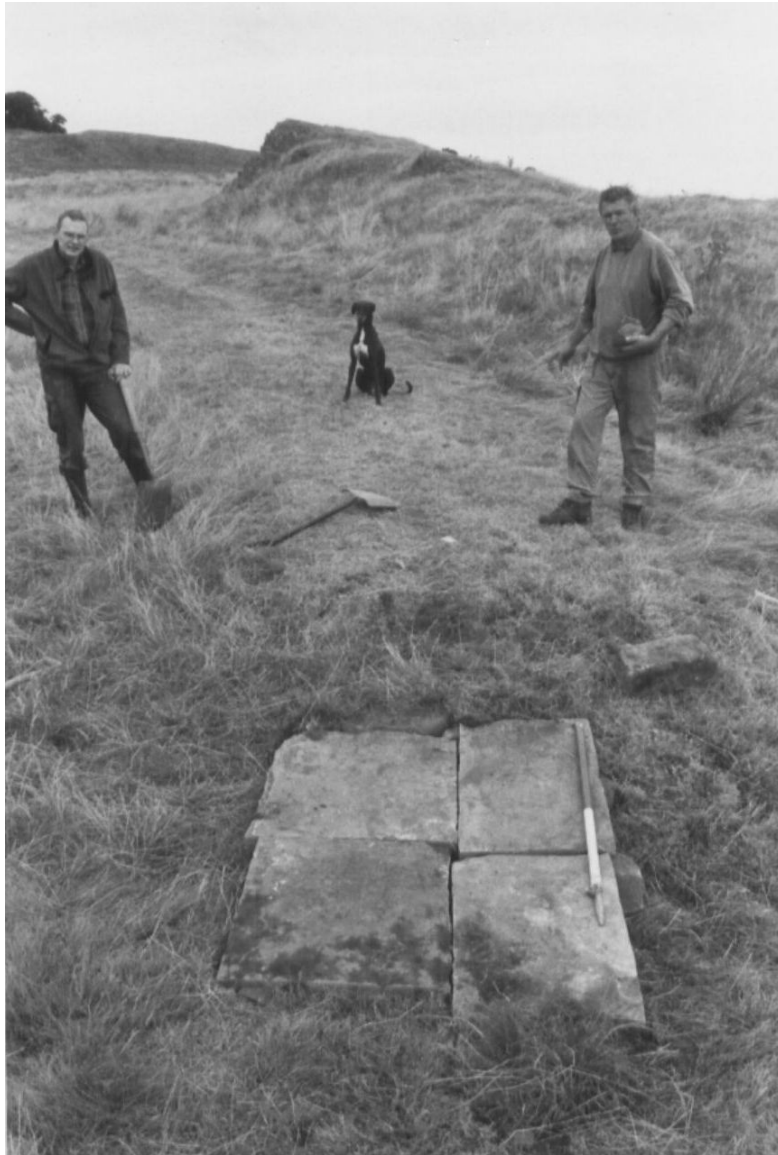
3.2.4 **Flags 2:** the second section of flags was placed on the Military Way, in an area which has evidently been either previously affected by water erosion, or deliberately excavated for drainage, creating a U-shaped profile in this section of the road. Very little disturbance of the soil horizon was required to lay the four flags, which effectively bridged the ditch, forming a small clapper bridge, allowing water free drainage beneath them. The flags covered an area 1.4m by 1.04m on an east/west alignment, the western end of which was deturfed to a depth of 0.10m across the width of the paving slabs for 0.3m along their length. The eastern end was built up with stone and turf to allow the paving slabs to form a level surface. One stone was removed at the eastern end, measuring 0.7m by 0.4m by 0.3m, creating a hole 0.5m by 0.4m by 0.3m, from the south-eastern corner of the area to be covered by flags. This was a fragment of dolomite, originating from the Whin Sill, and was not considered to have formed any element of the Military Way.

Plate 2: Flag 2, across the line of the Military Way, looking west

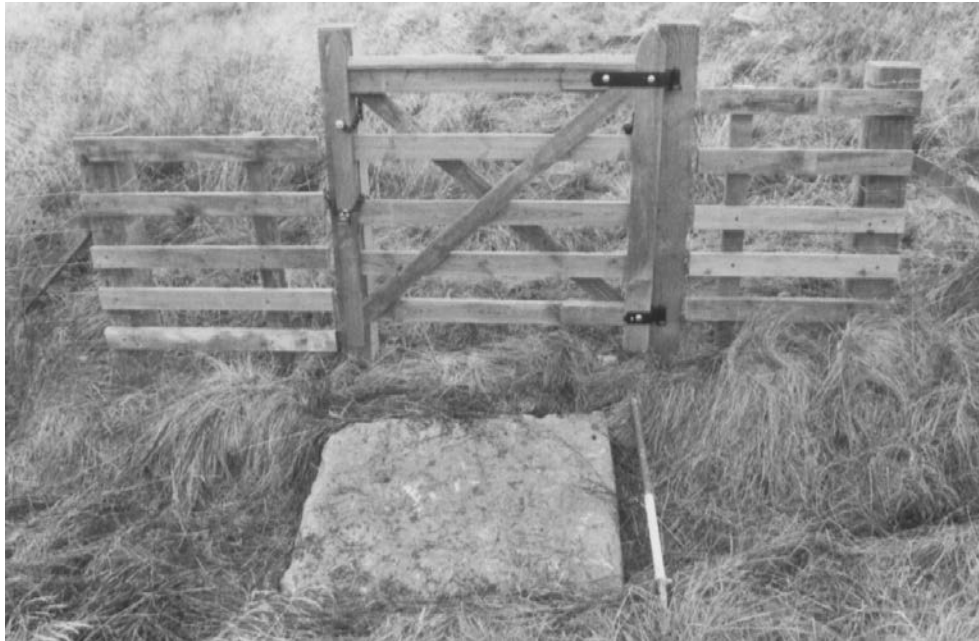
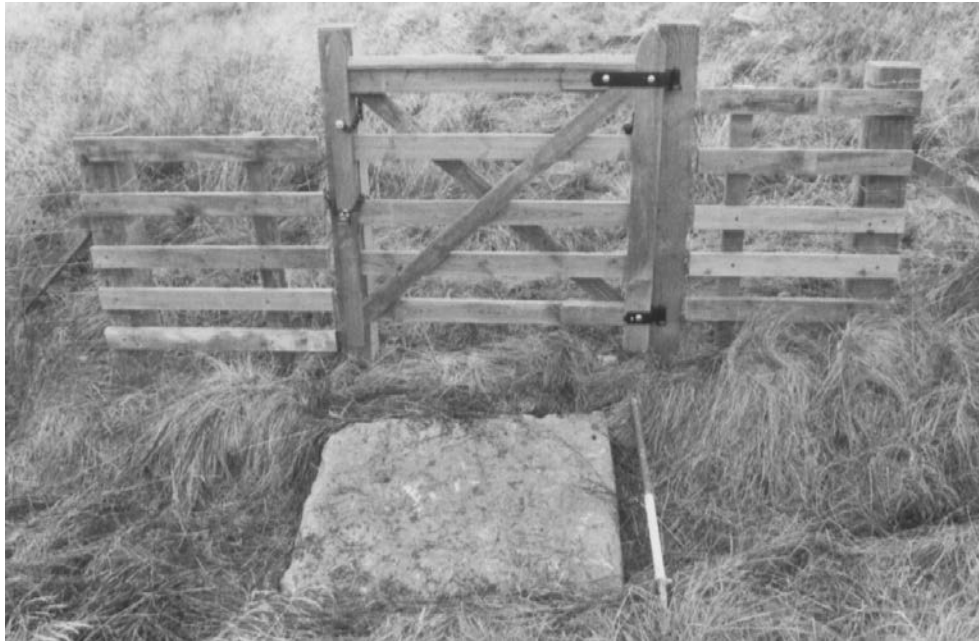
3.2.2 **Gate 2:** the insertion of the westernmost gate into a modern wire fence involved the excavation of four postholes, each measuring 0.40m by 0.35m and 0.85m deep, some 1.20m apart. The turf was removed to a depth of 0.10m, followed by a further 0.75m of a firm bluish grey sandy clay with occasional stone inclusions. No finds or deposits of archaeological significance were noted during the watching brief.

3.2.5 **Flag 3:** the westernmost flag was placed to the south of Gate 2. A single flag, measuring 1.10m square, was laid to bridge the drainage ditch to the south of the field boundary. At each end a small amount of turf was removed across the

width of the flag, 0.10m deep, and 0.3m along the length of the flag. The drainage ditch, therefore, remained undisturbed below the flag.

Plate 3: Flag 3, and Wicket Gate 2, looking north

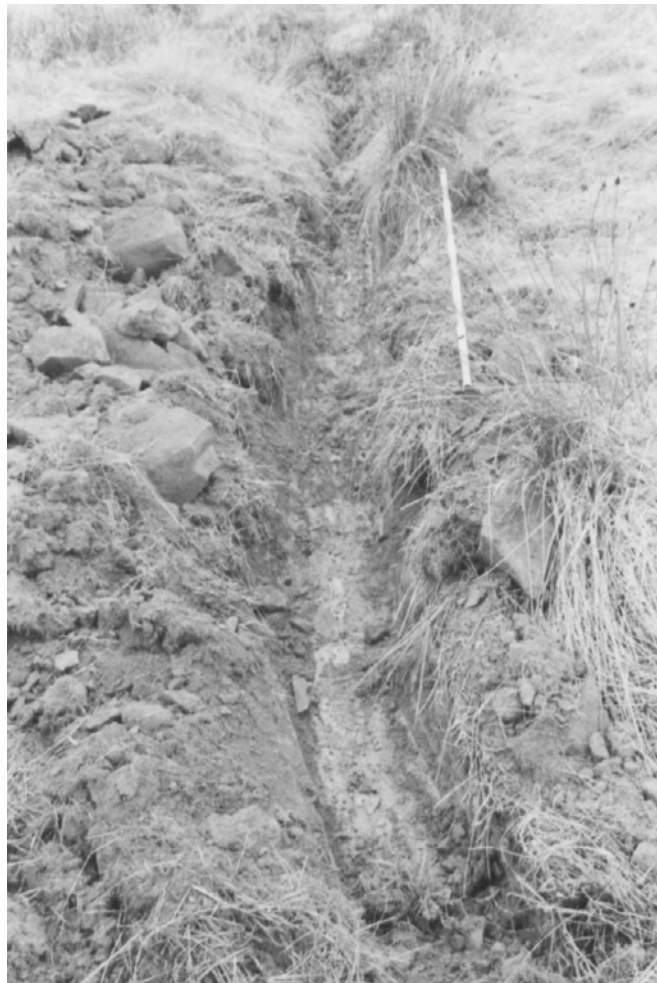
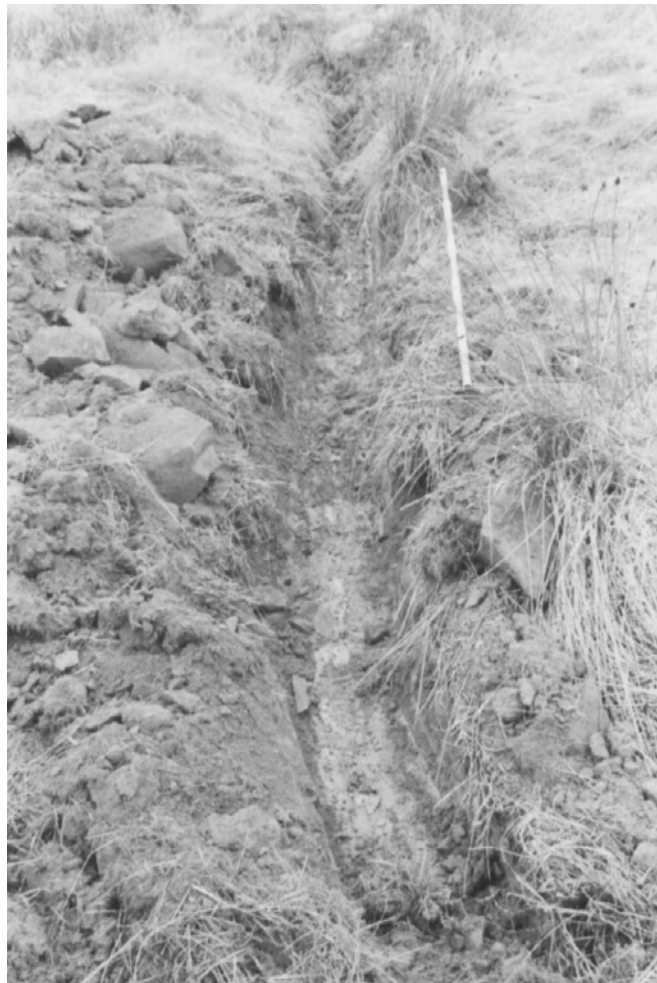
- 3.2.6 ***Insertion of the pipe into a drainage ditch:*** some 80m west of Gate 1, a pipe was inserted into a drainage ditch to prevent pinchpoint erosion on the line of the Military Way. This required the removal of the fill of the drainage ditch to a depth of 0.50m, 0.45m wide (east/west), for a length of 5.7m (north/south). The uppermost deposits comprised a dark grey medium sandy clay soil, 0.40m thick, with 30-40% angular and sub-angular stone inclusions of a maximum size of 0.50m by 0.36m by 0.25m. Below this was a mid-orangy grey clay, a glacial till, excavated for a further 0.10m depth. The very stony soil within the ditch was considered possibly a deliberate backfill in this section of the ditch. The drainage ditch in this location crosses the Military Way, visible as an earthwork, and this stone backfill may have allowed the Military Way subsequently to be used as a farm track. Nothing of the original fabric of the Military Way was visible in section, as the area excavated did not extend beyond the limits of the original drainage ditch.

Plate 4: Excavation for insertion of pipe into drainage ditch, looking south
