Abbey Close Car Park
Abbey Grounds
Restoration
Abingdon
Oxfordshire

**Archaeological
Watching Brief Report**

Document Title: Abbey Grounds Restoration, Abbey Close Car Park,
Abingdon, Oxfordshire

Document Type: Watching Brief

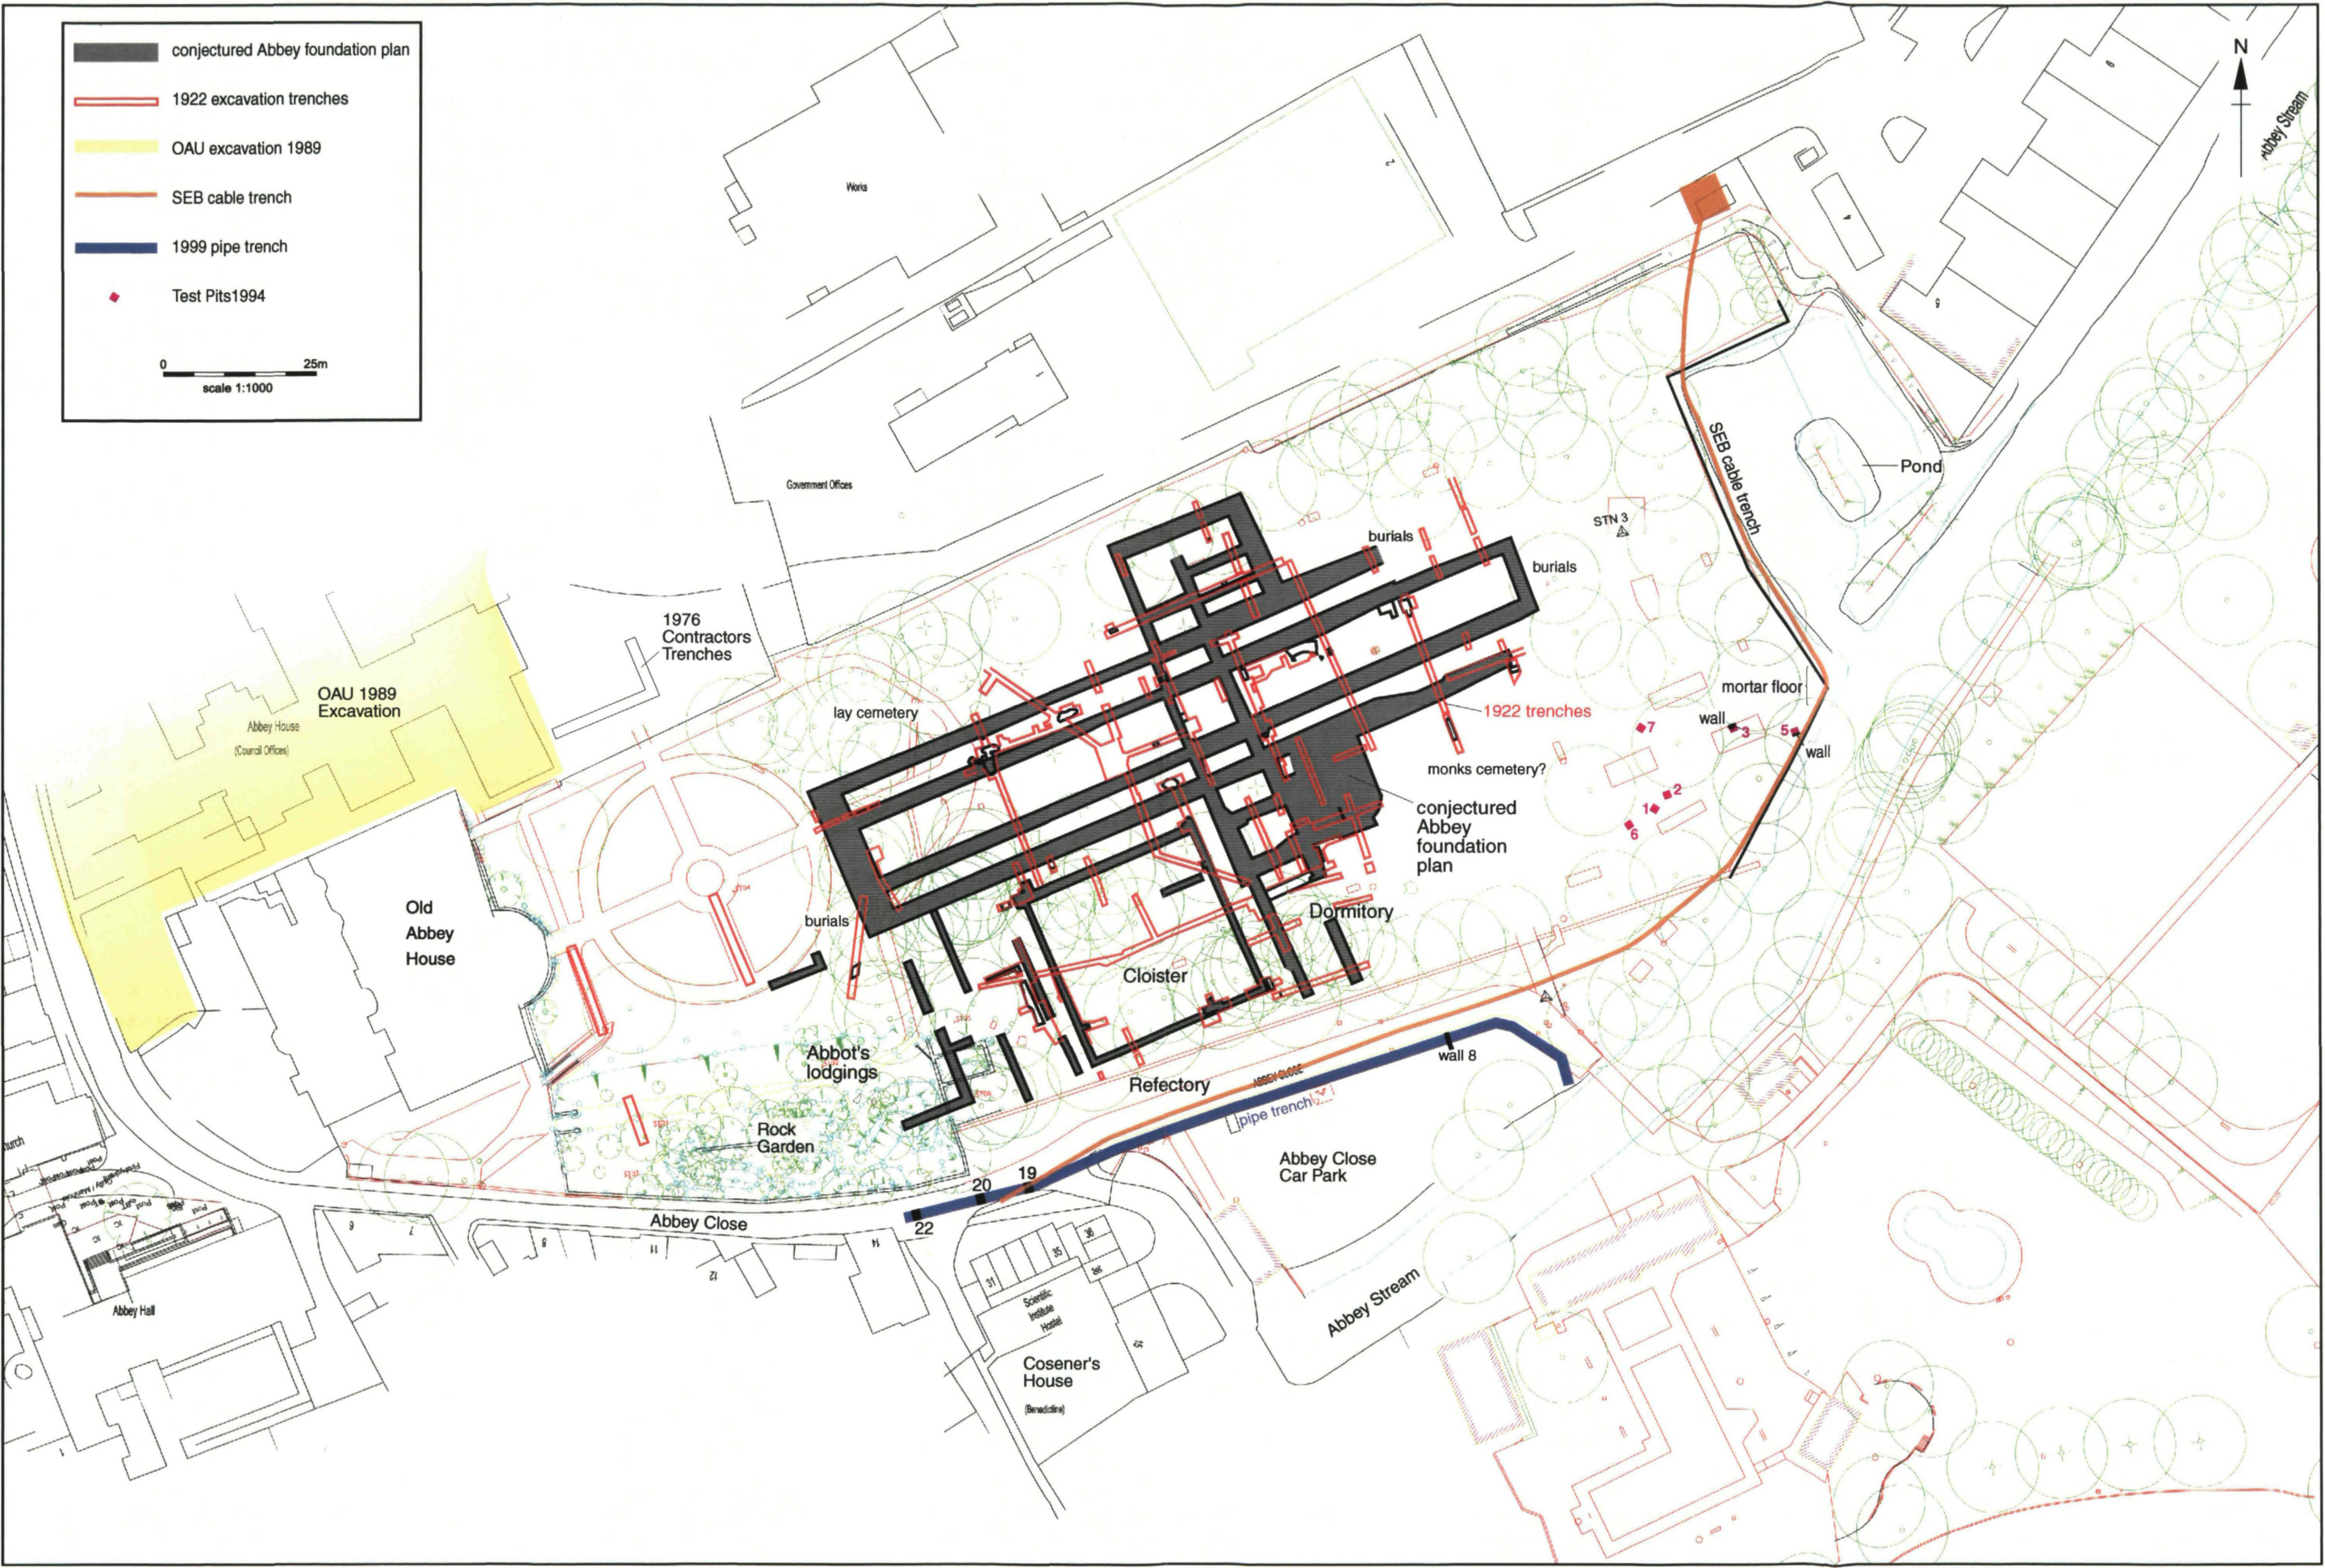
Figure 2: Abbey Gardens and Abbey Close Car Park showing previous archaeological observations.

conjectured Abbey foundation plan
 1922 excavation trenches
 OAU excavation 1989
 SEB cable trench
 1999 pipe trench
 Test Pits 1994

1.3.1 The archaeological background to the watching brief was prepared for the WSI for the project (OA 2002) and is reproduced below. A plan of the Park showing previous below-ground investigations is shown in Figure 2.

- 1.3.3 Problems with two systems for numbering the trenches, and the absence of a contemporary comprehensive plan showing all of the excavated trenches, mean that even the published plan represents only a best fit, and omits some of the trenches dug west of the abbey church. The more recent geophysical survey (Bartlett 2001) has however in general confirmed the accuracy of the plan as established by Biddle (see below and Figure 2).

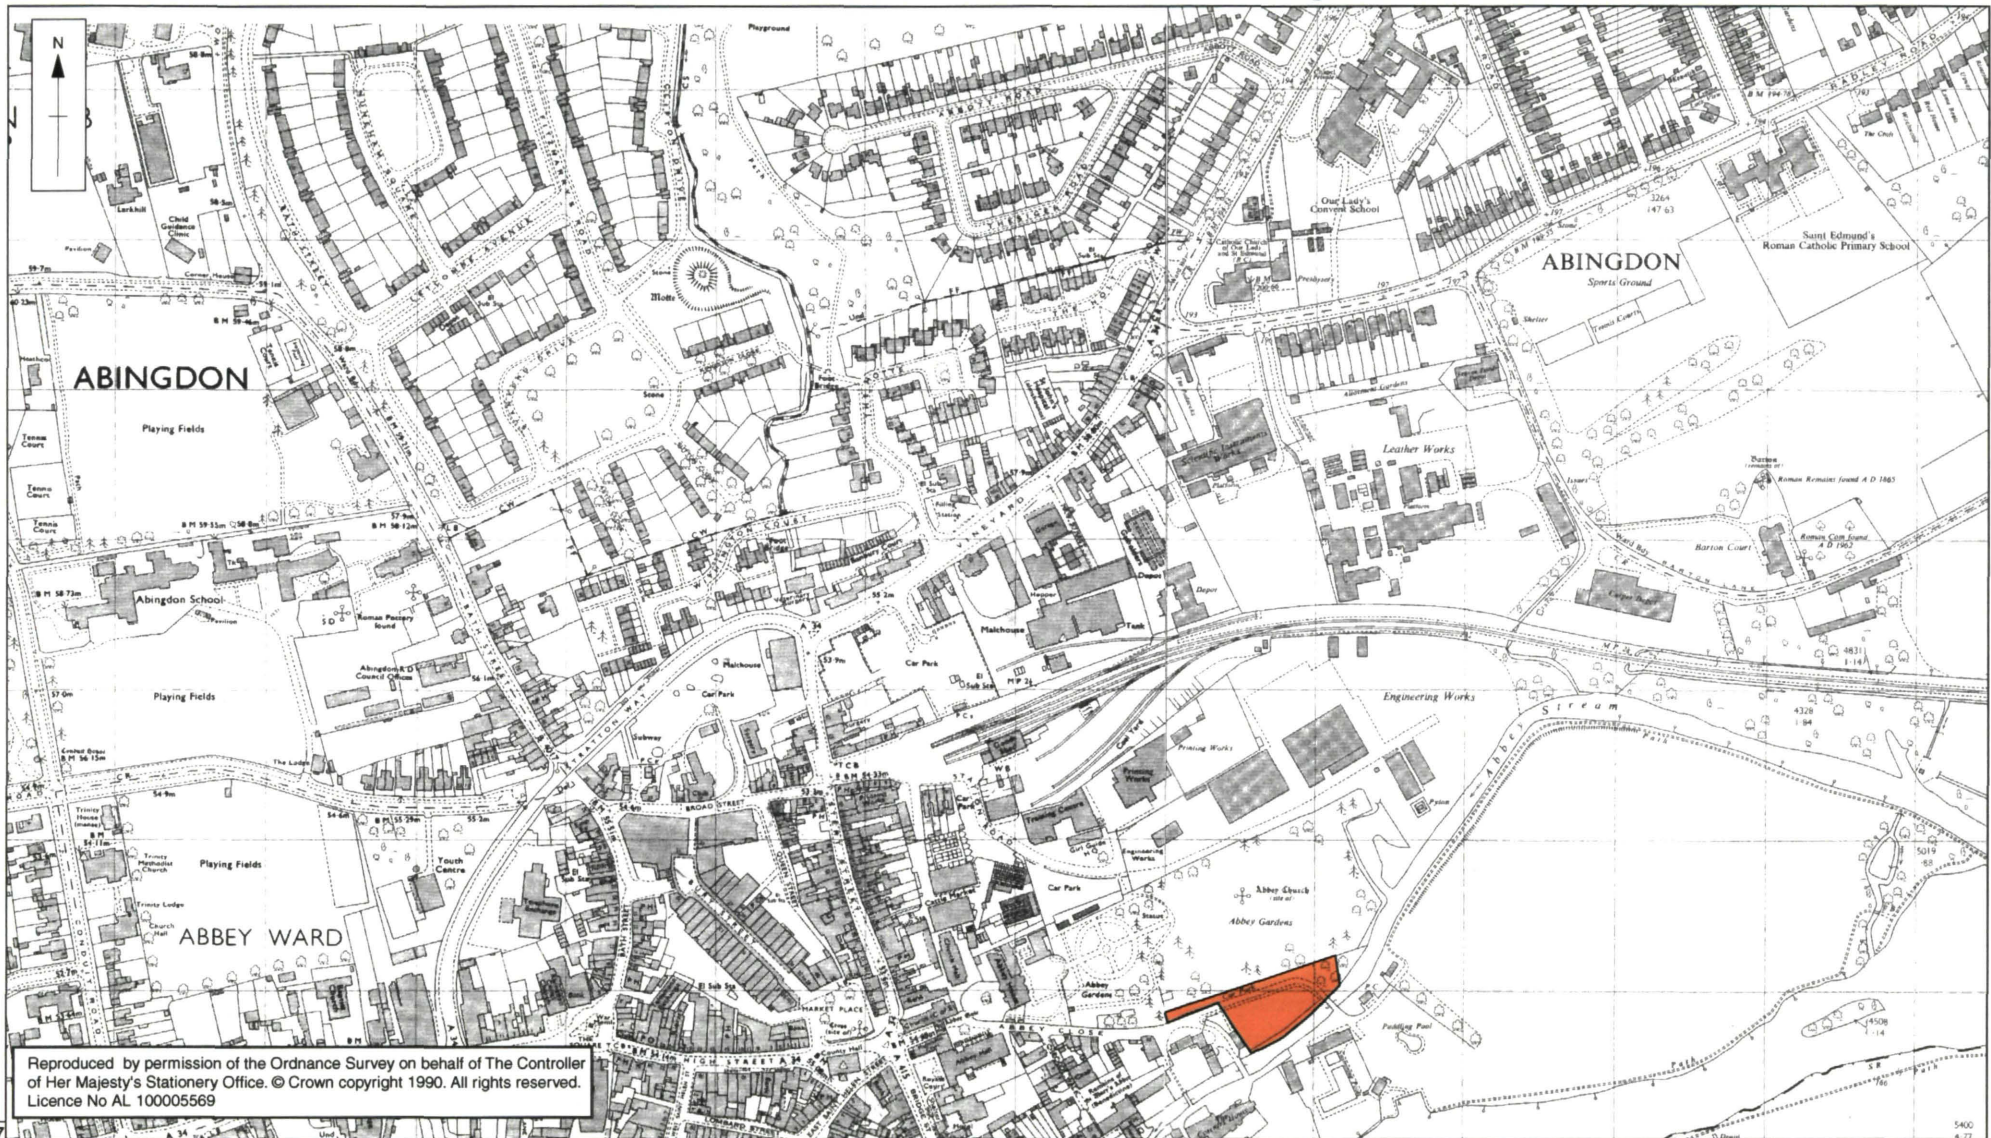
Figure 3: Plan showing area of watching brief

Area of watching brief

- 2.2.1 The modern car park surface (Fig. 3) was stripped by a 360° machine with a 1.8 m ditching bucket. The trenches for the new drainage were then excavated with a 0.6 m wide toothed bucket to a maximum depth of 2 m. In addition trenches were excavated for new lighting, and the interceptor tank outflow into the Abbey Mill stream. After the new car park was installed, excavations took place for two foundation pads for the new footbridge over the Abbey Mill stream.
- 2.2.2 All archaeological features were planned at a scale of 1:100 and where excavated their sections drawn at scales of 1:20. All excavated features were photographed using colour slide and black and white print film. A general photographic record of the work was made. Recording followed procedures detailed in the *OAU Fieldwork Manual* (ed D Wilkinson, 1992).
