**MILECASTLE 38
HOTBANK
HADRIAN'S WALL
Northumberland**

Archaeological Earthwork Survey

Oxford Archaeology North

October 2002

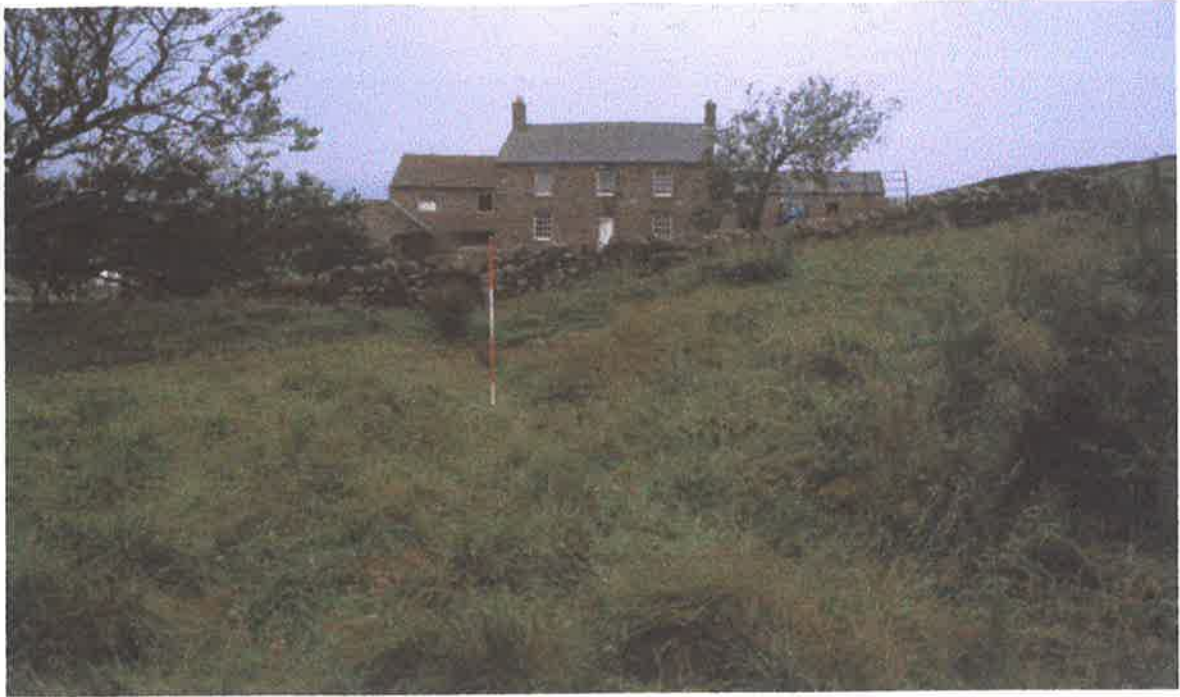
Plate 1: Ditch North of Milecastle 38, Looking North-West

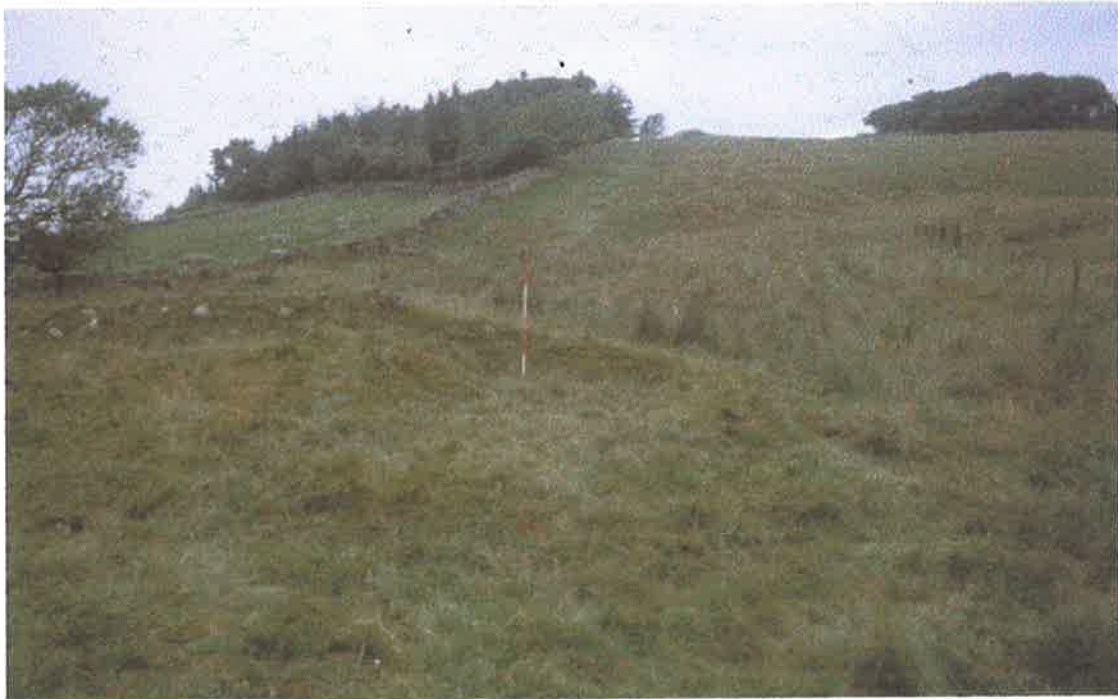
- 3.1.1 The majority of the earthworks fit the general form of the outline of the milecastle, which measured 18.58m north/south, by 20.75m east/west. The narrow entrance on the south side, which was seen to be 3.35m wide, is clearly visible, although the wall to either side is expanded and apparently spread, being up to 6.36m wide; there was some slight indication of structures beneath this. The east and west walls were seen to be 2.33m and 2.48m wide, respectively. The east side survives to a greater height, up to 0.30m higher, than the west and is made up of considerably more material, with what is probably a wide area of tumble on its interior side. The north side, formed by Hadrian's Wall, is partially obscured by the present field boundary, which essentially revets the side of the milecastle, leaving only traces of the wall beneath. Within this, however, there was an apparent gap, some 12.75m wide, which may correspond to the approximate position of the north gate, although this was identified, but not excavated, in 1935 (Simpson *et al*, 1936, 265).

Plate 2: Remains of South Gate in foreground, Looking North-East

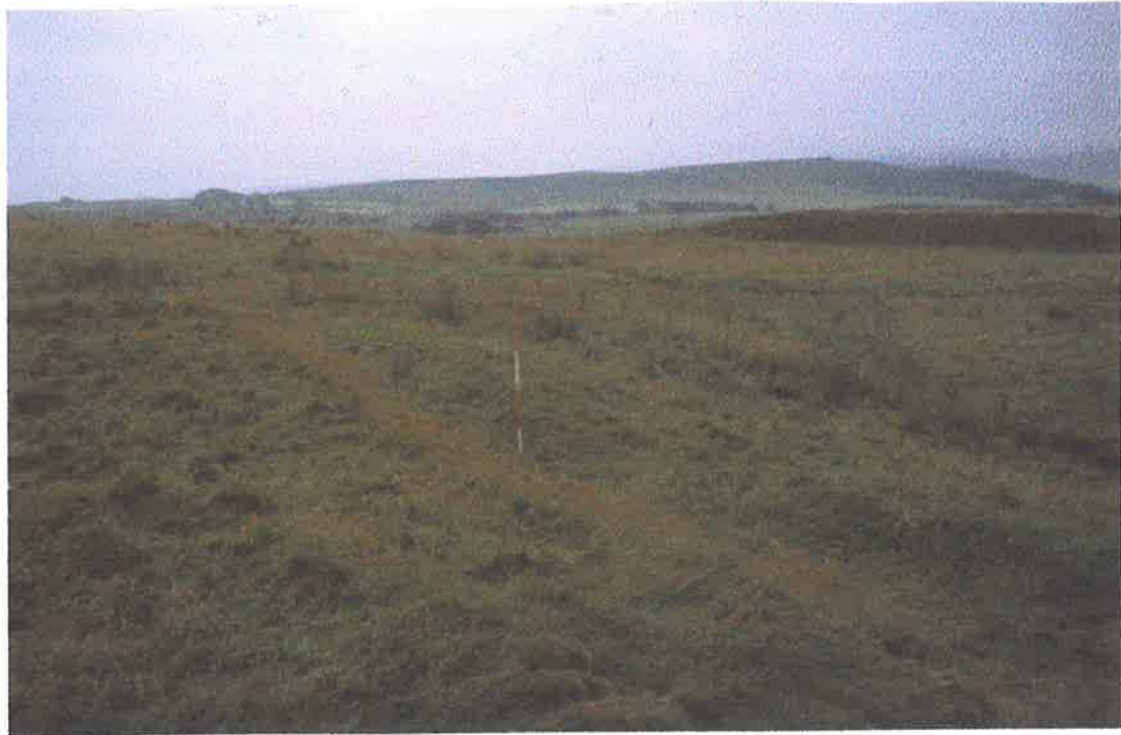
- 3.1.4 Large banks are visible to the west of milecastle, some 2.6-4m wide. These also clearly post-date the Roman structure and would best be interpreted as the spoil from the excavations of 1935.

Plate 3: Possible Spoil Heaps to South-West, Looking South-West

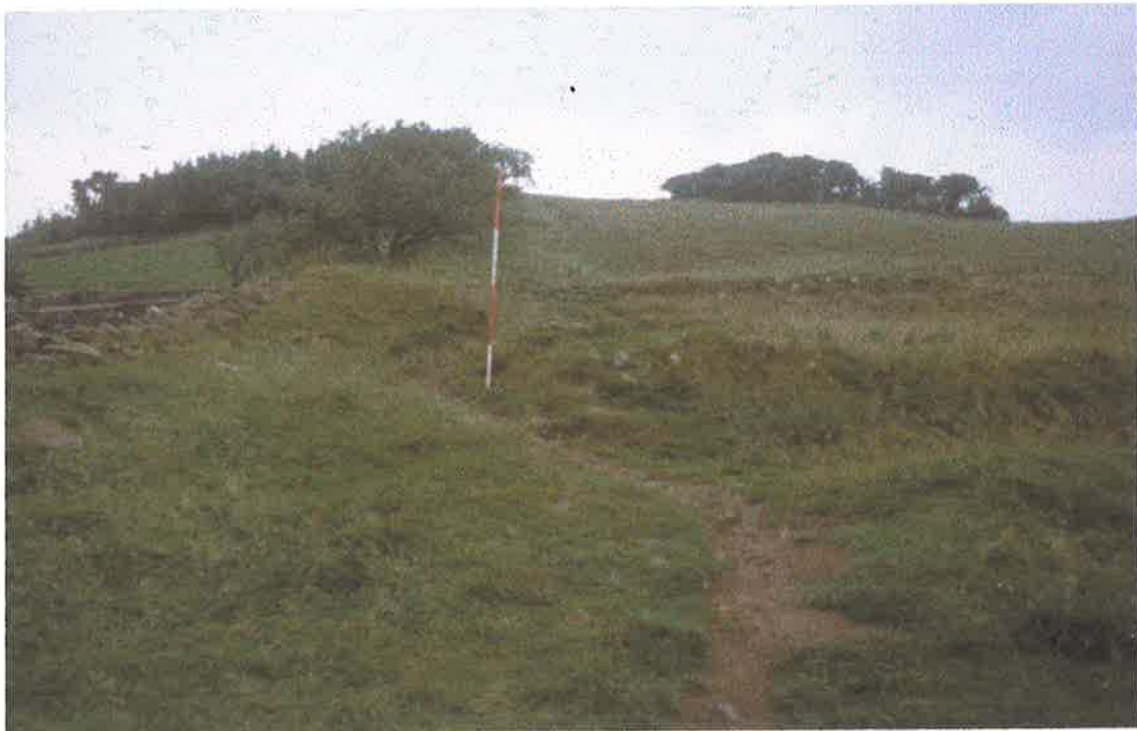
- 3.1.5 The walked route through the milecastle is causing wear on both the east and west walls of the structure, forming a clear corridor down the slope, at its

worst through the west wall. Within the decayed walls, patches of bare earth are now visible, within trays formed by the passage of walkers. Within the interior of the milecastle, the condition of the route is better, although the greensward is distressed, but the later structure in the north-west corner is also being affected by the erosion, and this is perhaps more fragile and susceptible to wear than the milecastle itself.

Plate 4: South-West Bank of the Milecastle Showing line of Erosion, Looking North-East
