SALVIN'S FACTORY AND NEW ISLINGTON MILL, ANCOATS, MANCHESTER

Post-Excavation Assessment

Oxford Archaeology North

December 2005

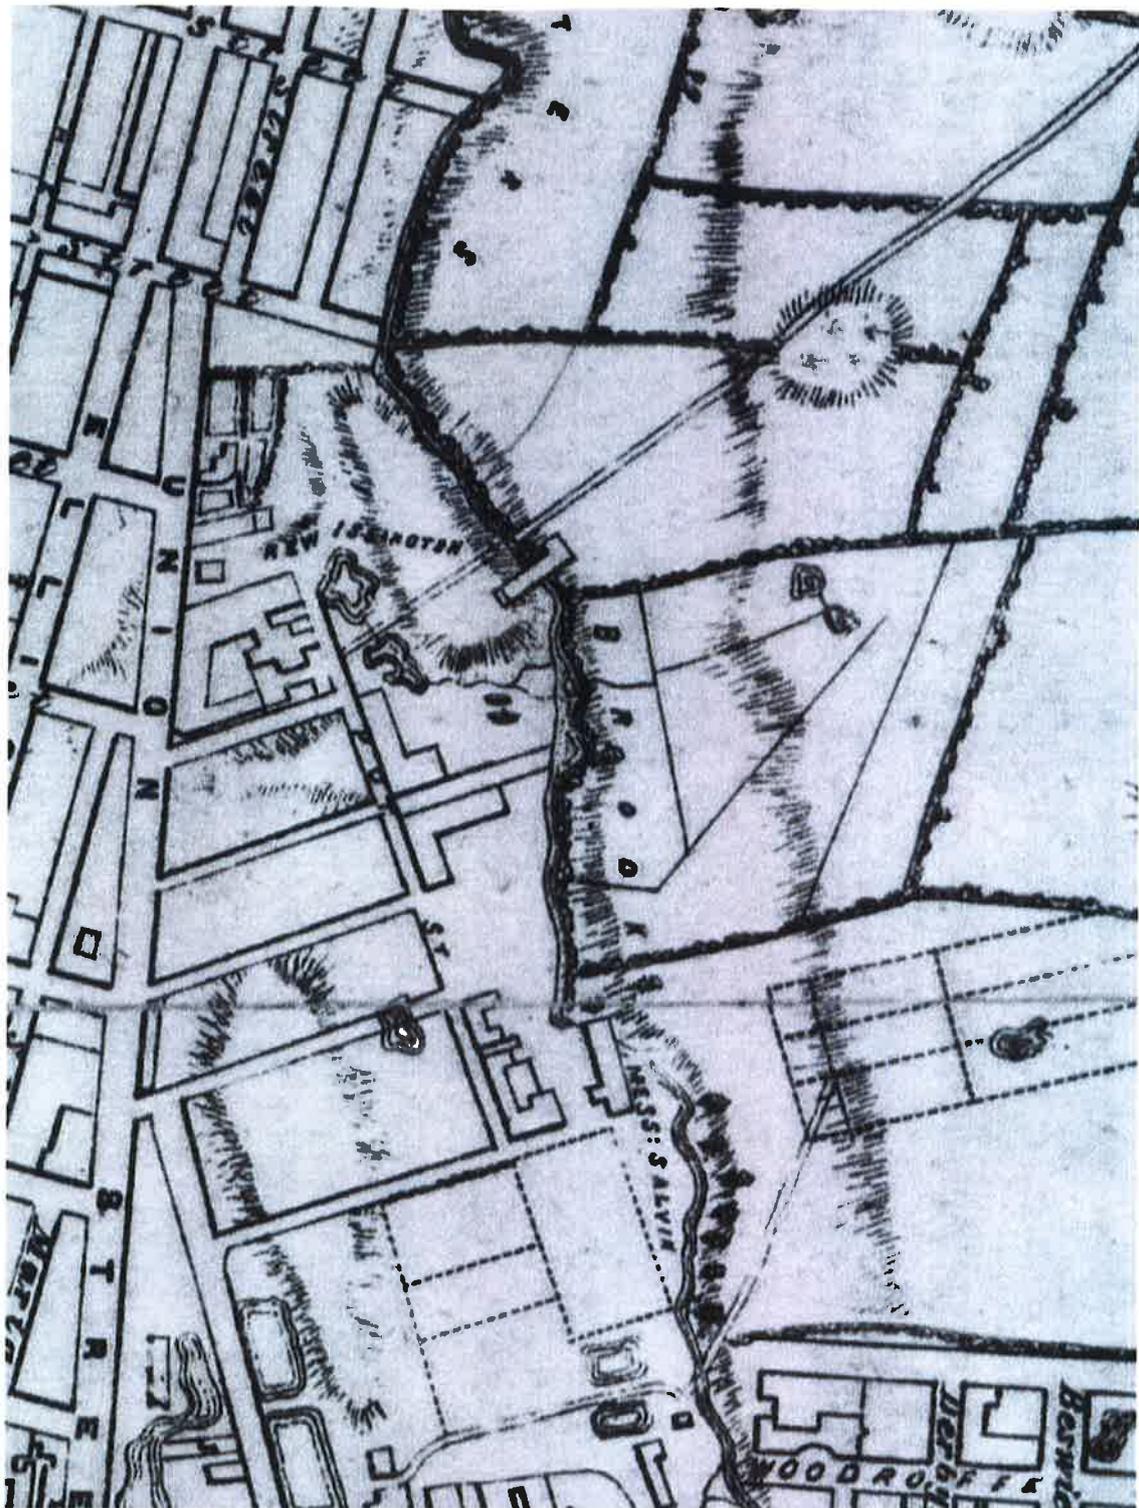
Figure 3: Extract from Lewis' *Map of Manchester*, published in 1788. A building in the position of New Islington Mill is shown straddling Shooter's Brook, with Salvin's Factory shown a short distance downstream, similarly straddling the brook.

3.5.2 The earliest map of the site is that produced by Lewis in 1788. This shows a narrow rectangular building with a short projection at its eastern end forming a L-shaped structure, with the main body of the building straddling Shooter's Brook. It is situated in the position of New Islington Mill, and whilst it is not labelled as to its function, its dimensions are consistent with those of a late 18th century textile mill, and particularly those of an Arkwright-type factory. These typically measured 60m by 9m, and represented the emergence of large, multi-storey purpose-built spinning mills, and the first diffusion of the factory system in the cotton industry (Chapman 1981).

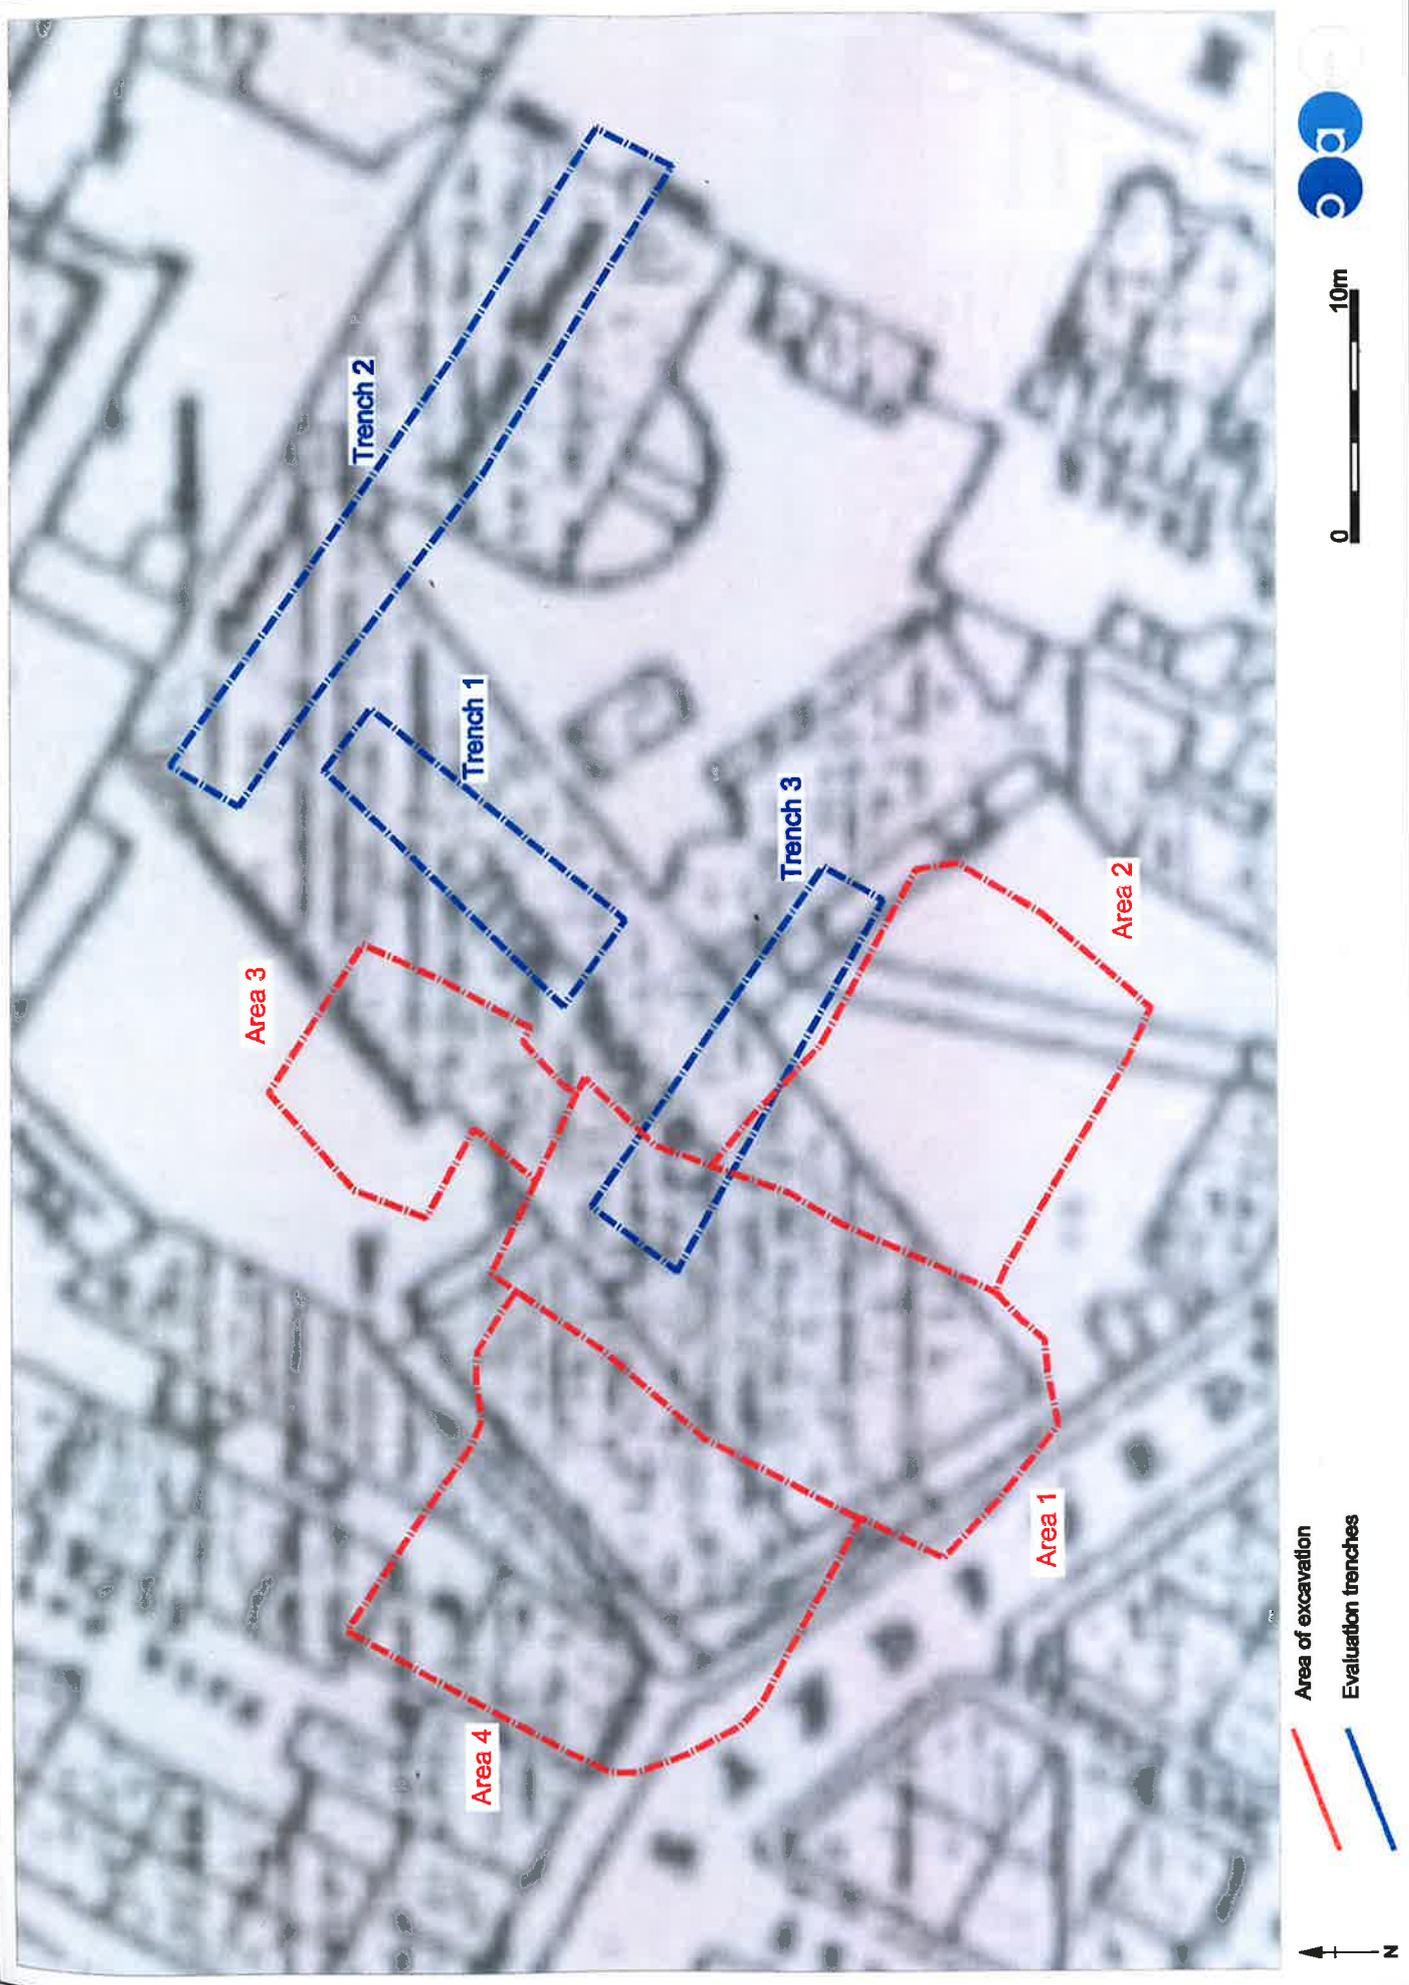
Figure 4: Location of the archaeological investigations superimposed on the Ordnance Survey 60": 1 mile map, published in 1851

- 4.4.16 During the evaluation a complex arrangement of flues (**21**, Plate 10), that bore resemblance to flue **I30**, were observed within the central area of Trench 2 (OA North 2004a). Two narrow flue channels, each 0.25m wide, were exposed within the central part of the trench. The channels were linked by a smaller channel composed of refractory bricks that formed a single channel 0.7m wide. All of the component bricks were heavily sooted, confirming the use of this structure as a flue. The structure was situated within the mill's north-eastern range, and in the vicinity of a boiler house as depicted on the Ordnance Survey Map of 1851 (Fig 4).

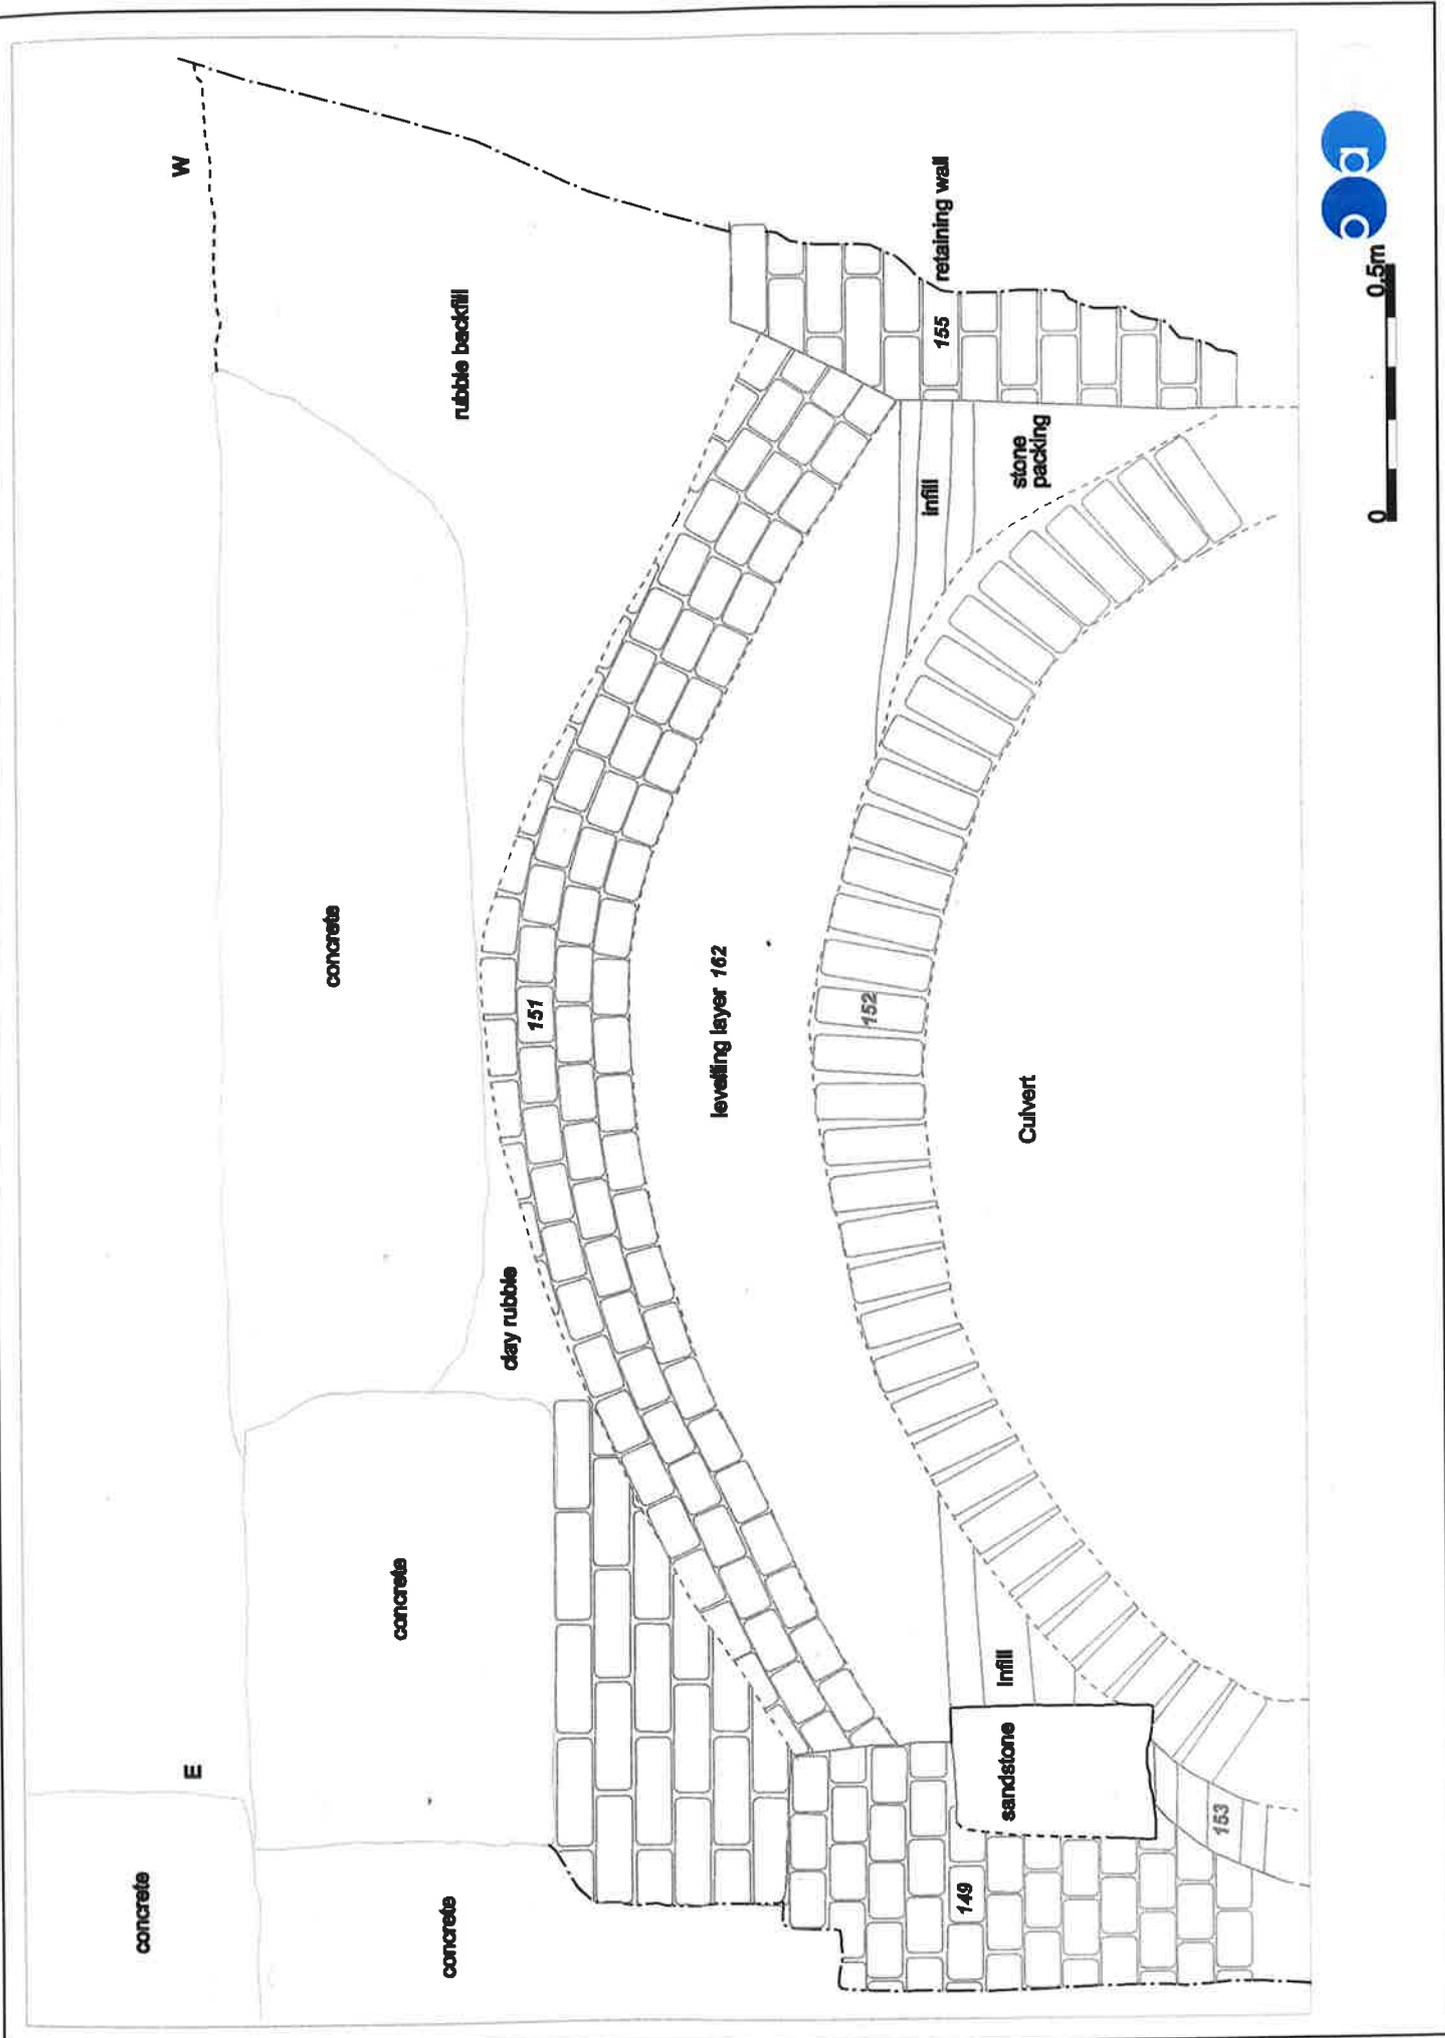
Figure 6: Salvin's Factory: North-facing section through culvert 145

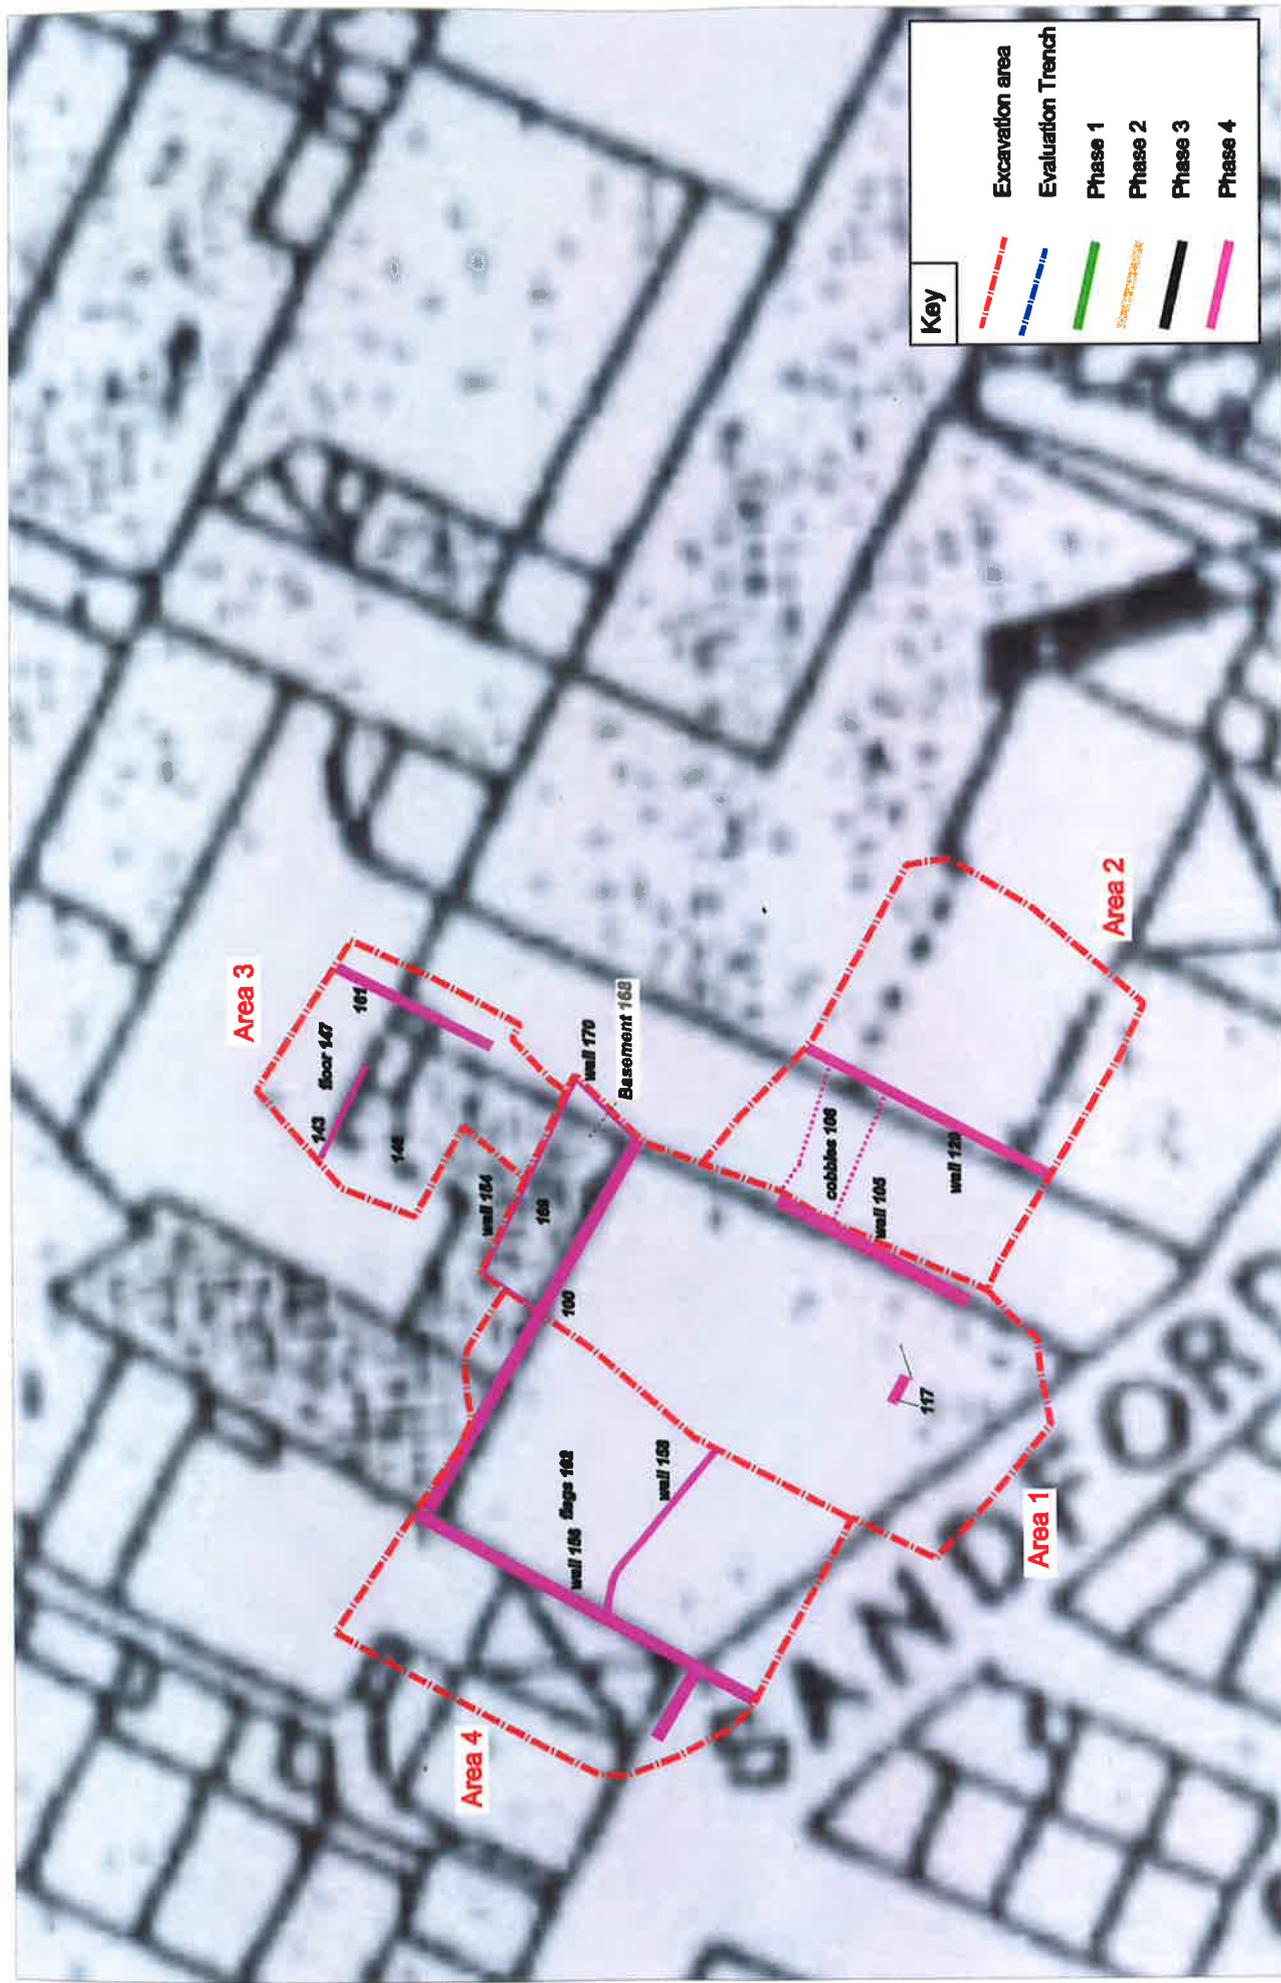
Figure 8: Salvin's Factory: Plan showing Phase 4 structures, superimposed on extract from Ordnance Survey Map, 1891

- 4.5.1 The Ordnance Survey maps published in 1891 shows a building on the site of Salvin's Factory (Fig 8), which may be identified from entries within contemporary trades' directories as an engineering and carriage-maker's works (Slater 1895). The excavated remains from this period include deposits of clay used for levelling, a cobbled yard, concrete floor foundations and external walls.

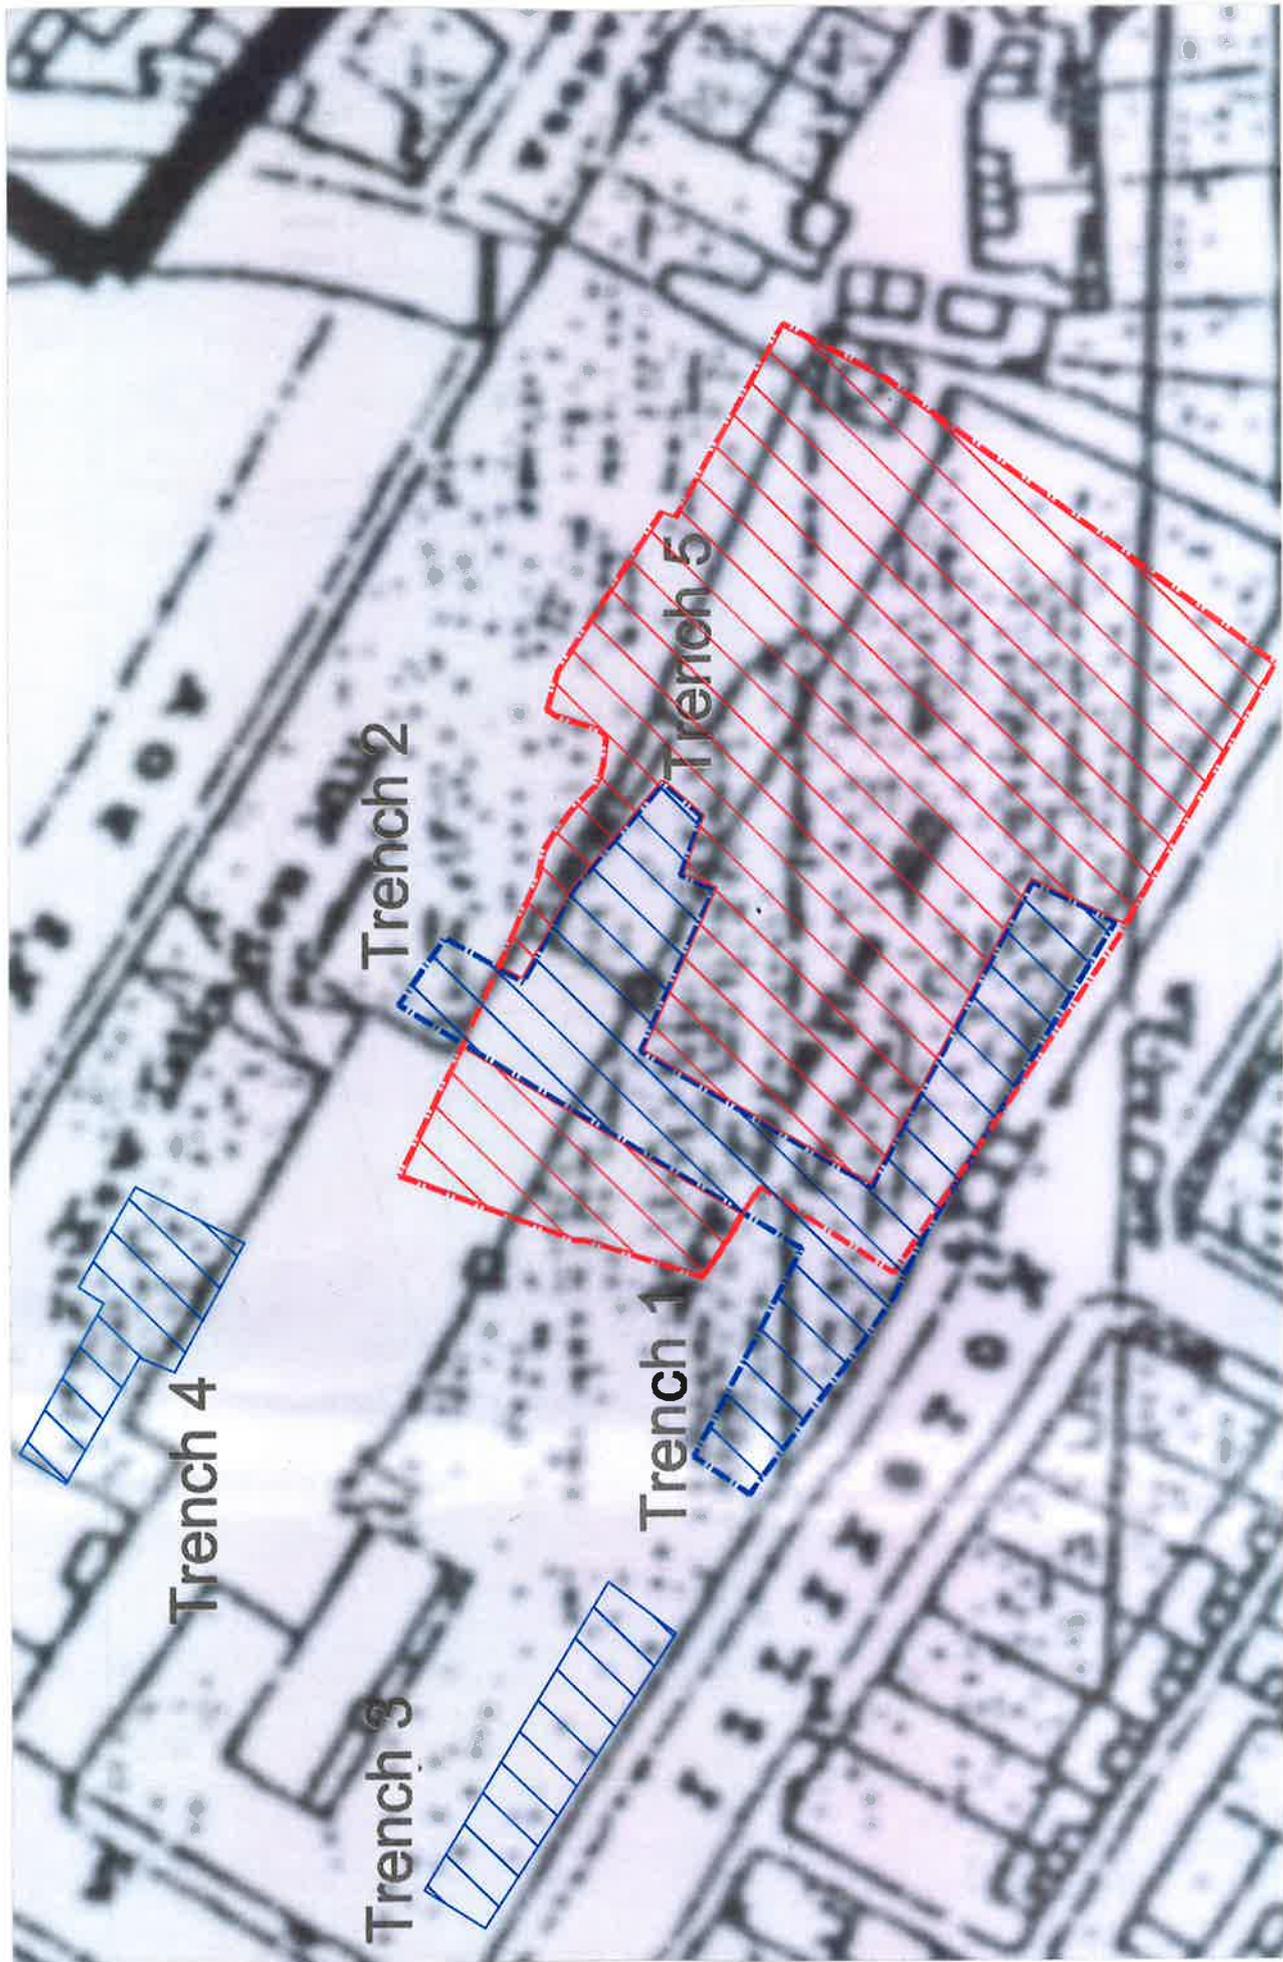
Figure 9: Position of evaluation and excavation trenches at New Islington Mill superimposed on the Ordnance Survey Map published in 1851

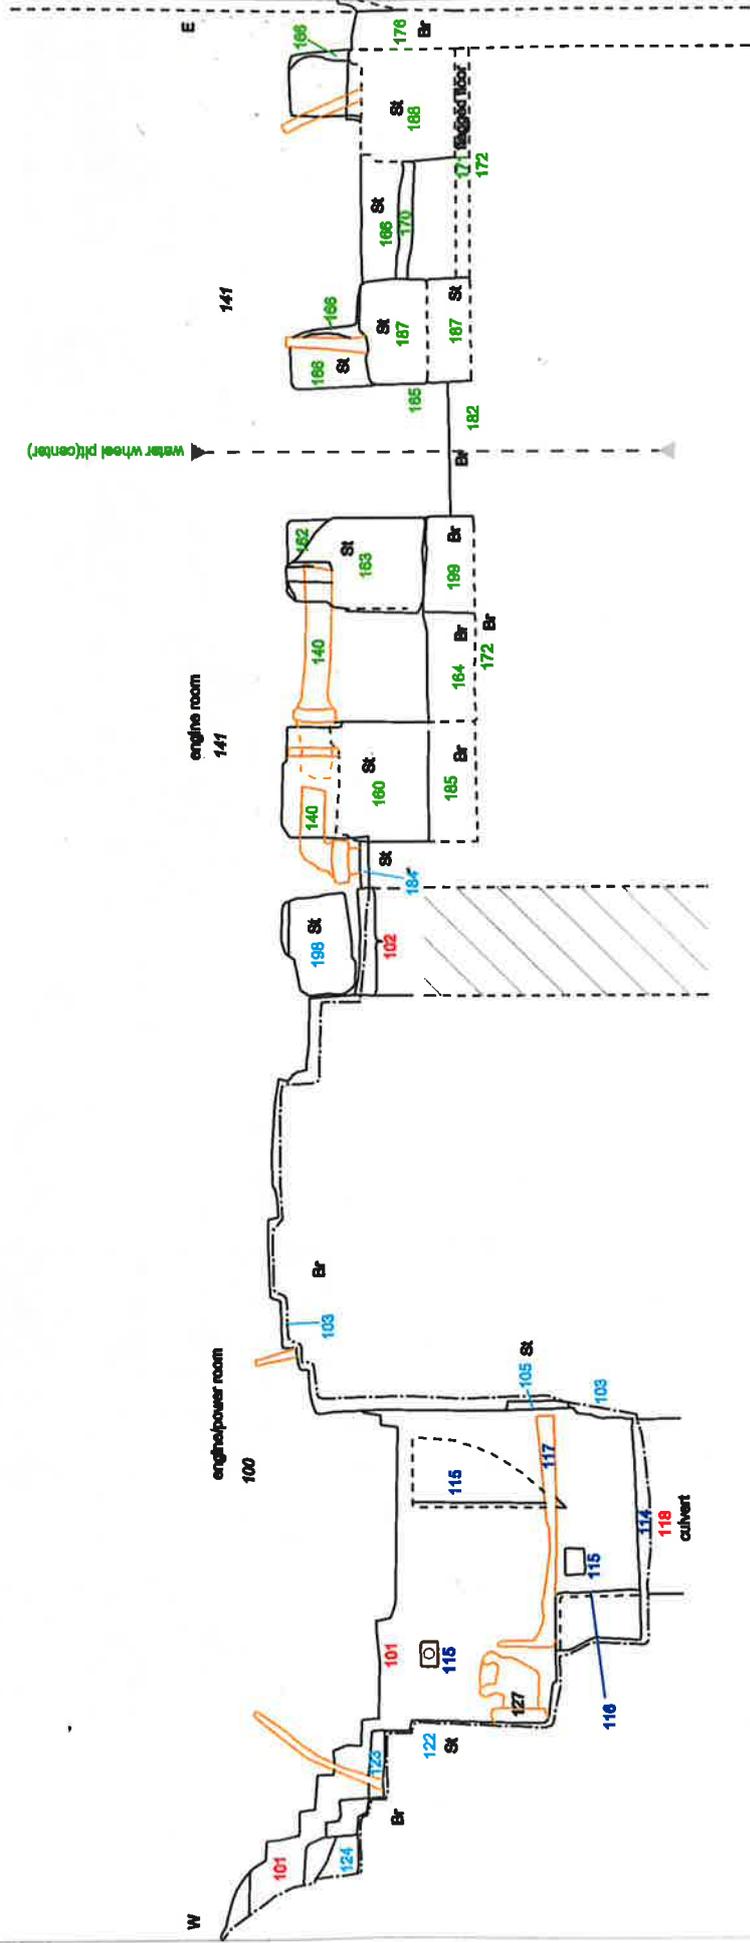
Figure 11: New Islington Mill: South-facing section through Engine Rooms 100 and 141

- 5.3.2 The early steam engine was almost certainly housed within 'engine/power room' **100**. The physical evidence for the engine was provided by several features (Fig 11), including machine scars (**115**), a small condenser pit (**108**), a large iron plate (**117**), and foundation beds (**109** and **126**).

- 5.3.5 Overlying floor **116** was a heavily-corroded cast iron collared pipe (**127**) that entered the southern part of the room (Fig 11) through a brick foundation (**121**). The pipe was recumbent along a north/south alignment for 0.35m, and returned vertical next to pit **114**. The pipe had a maximum diameter of 0.29m and an internal diameter of 0.16m, secured to the north by a 0.33m-wide high-pressure flange joint.

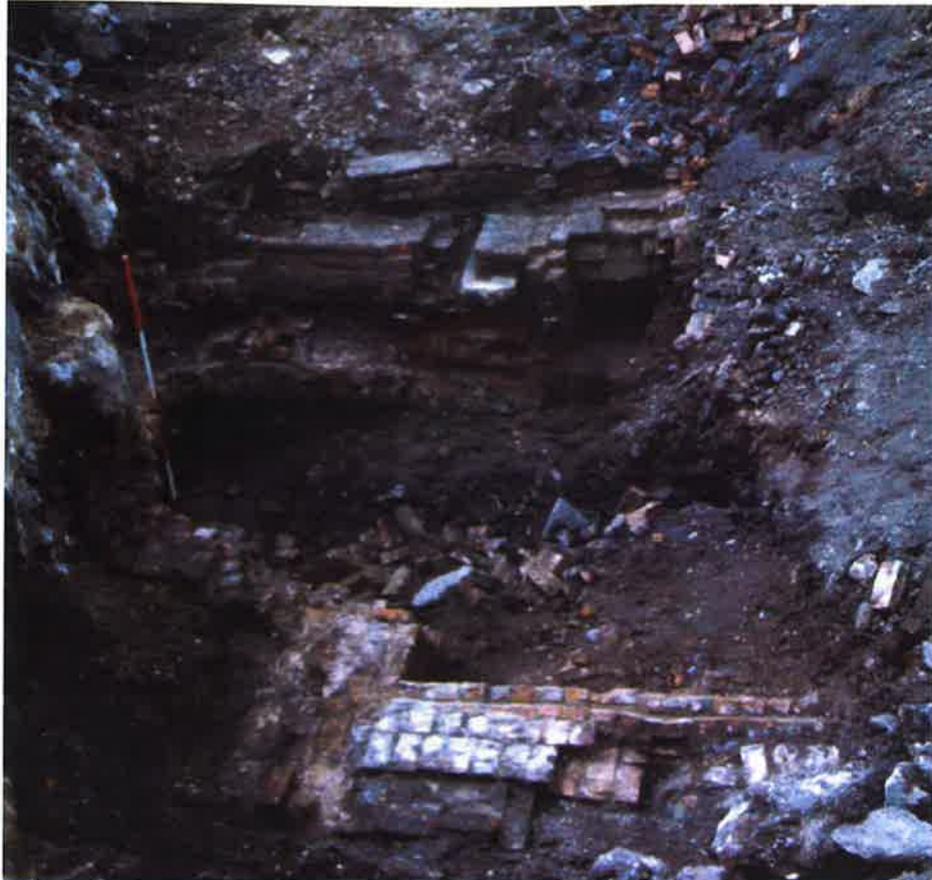
Plate 3: View of the widened section of culvert *145*, looking south-west

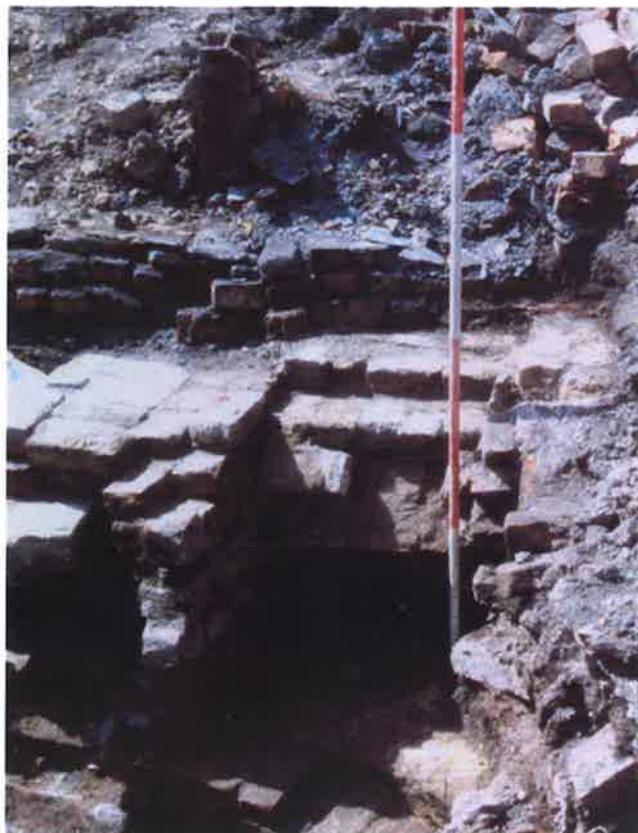
Plate 4: View of overflow/by-wash through the west wall of culvert *145*, looking south-west

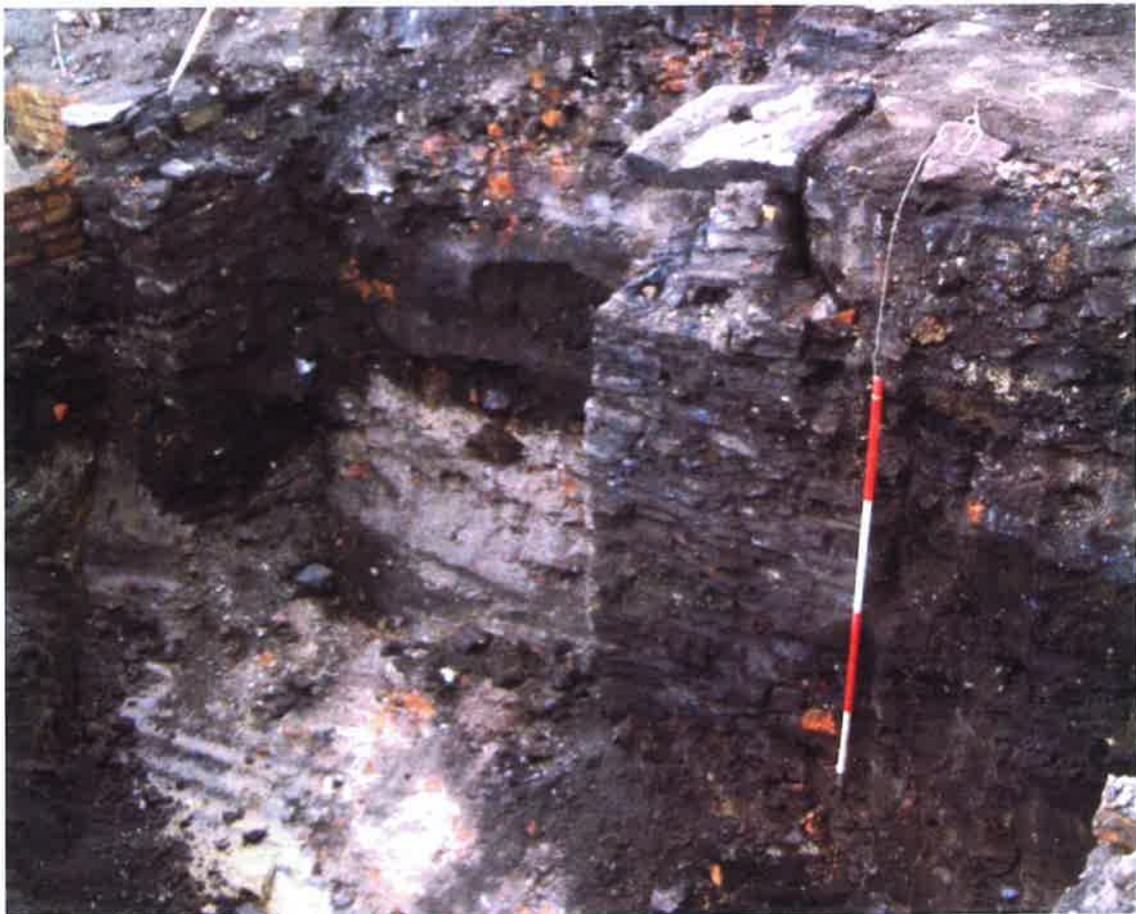
Plate 6: View of two stone columns (*104*) associated with the original boiler house of Salvin's Factory

- 4.4.7 An east/west aligned culvert (**157**) was observed within Area 4 during the watching brief phase of work. It was placed across the north-western edge of stone columns **104** (Fig 7). The culvert was exposed over a distance of 6.5m, and was recorded at a depth of 3.5m below the modern ground surface, cut into natural clay. The eastern edge of the culvert seemed to continue beyond the edge of the excavation in the direction of Shooter's Brook, implying that a water passage was connected to the brook across the northern edge of the site, with the intention of carrying water to the engine and boiler rooms.

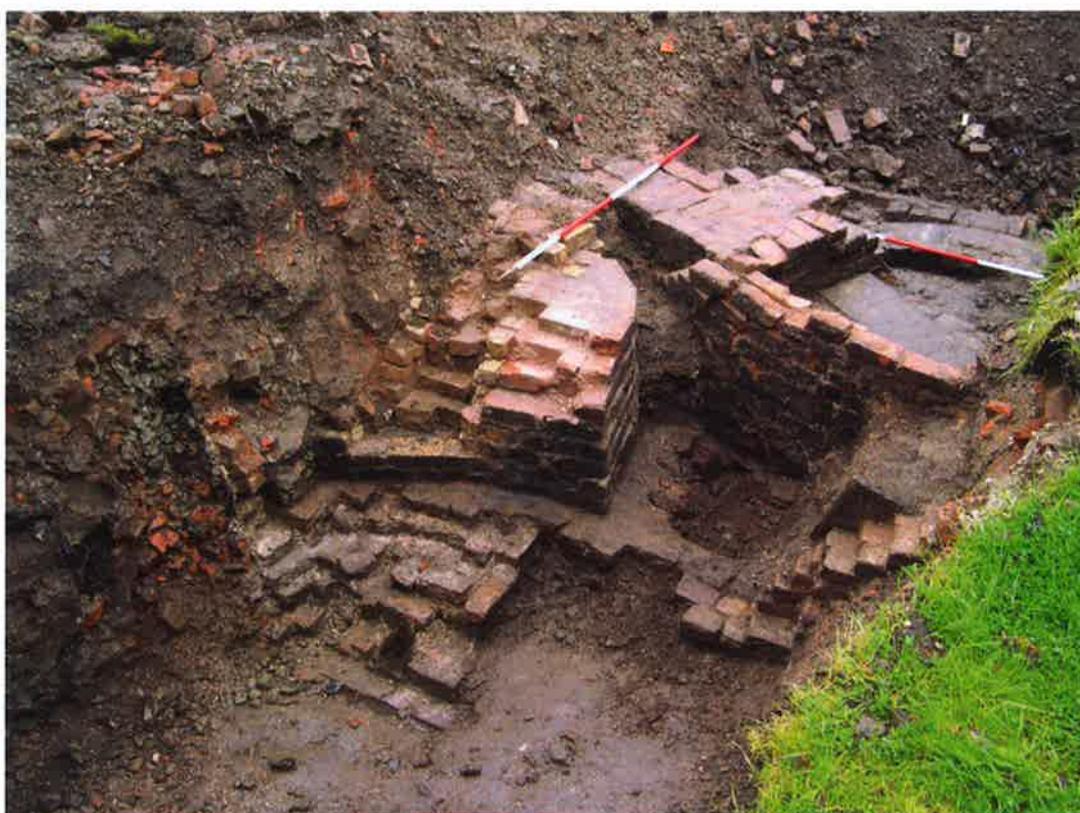
Plate 10: General view of flues *21* within evaluation Trench 2 across Salvin's Factory

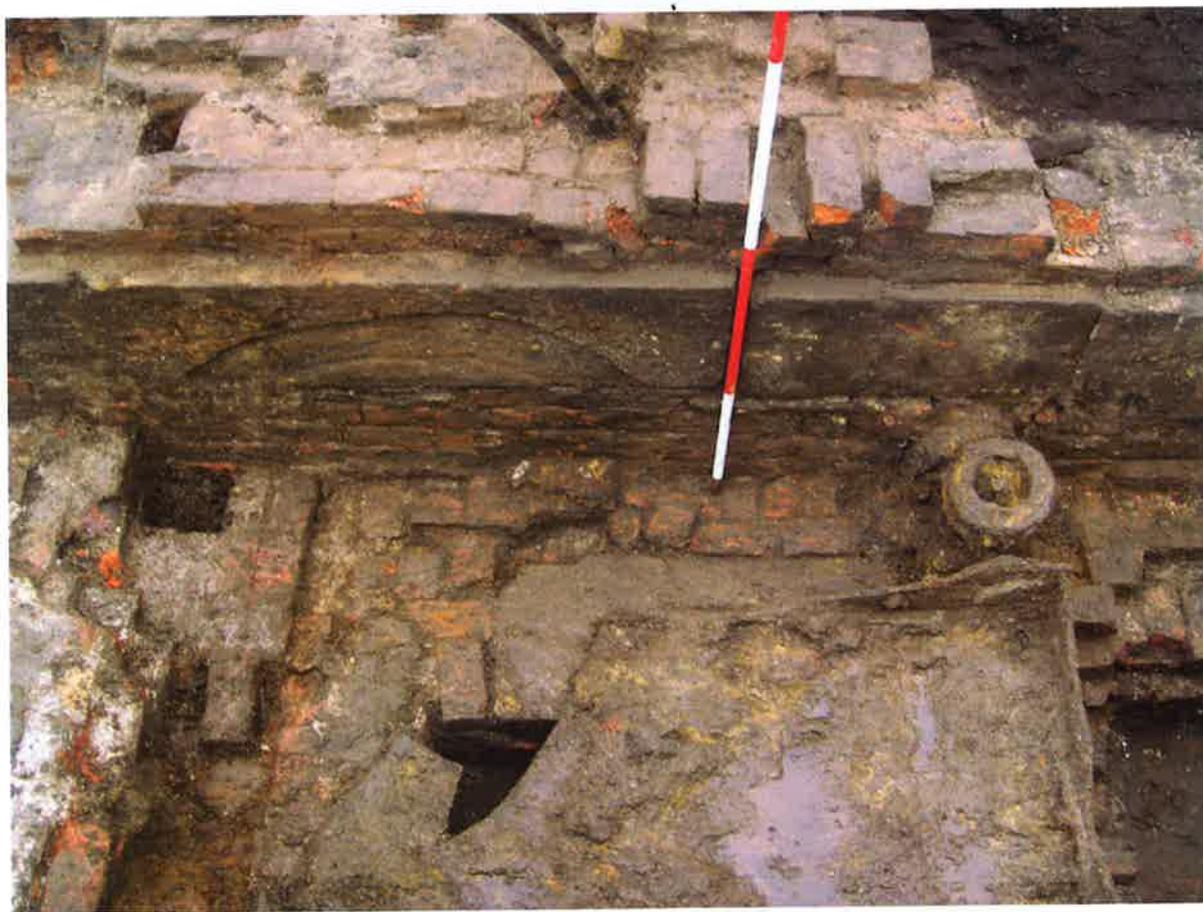
Plate 12: 'Power room' 100, showing re-used stone block with wheel scar in east-facing elevation. Culvert 118 lies beneath the metal plate

surviving walls. In particular, a large worked stone block, built into the east-facing elevation of the room, retained clear evidence of a wheel scar (Plate 12). The projected circumference of this scar would not fit within the layout of room **100** as excavated, suggesting that the room had been remodelled, or the block had been re-used. However, the earliest phase was not fully exposed as a decision was made to preserve the foundations *in-situ*, and they were not therefore excavated.

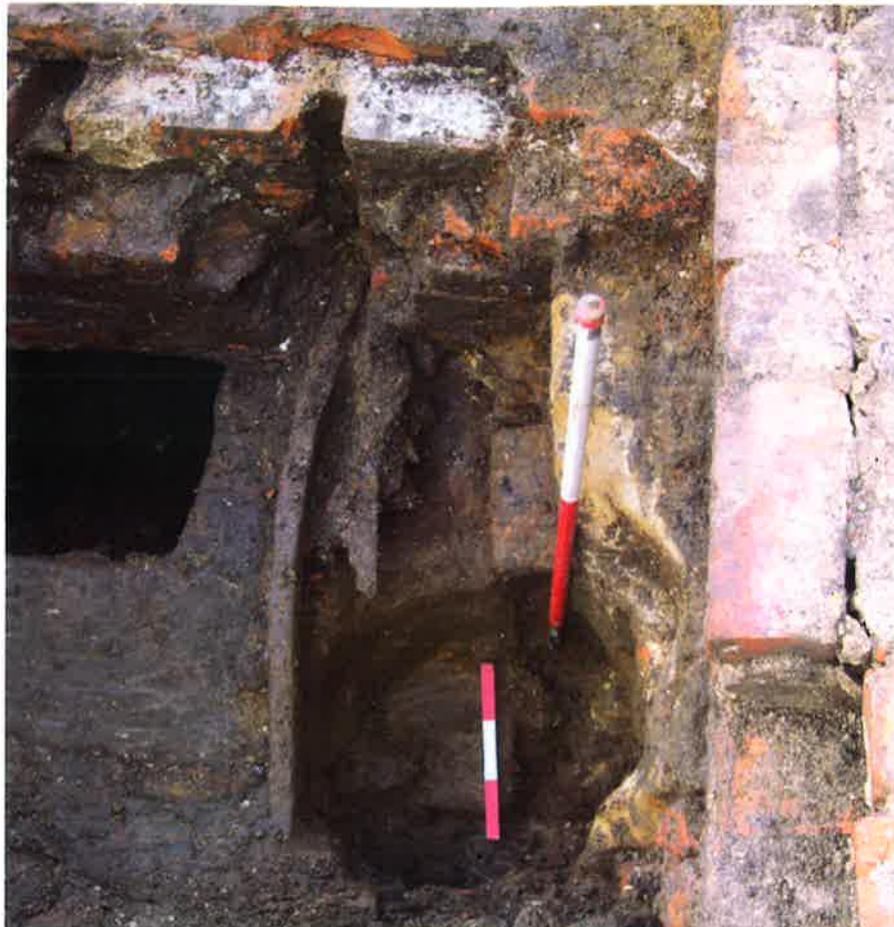
Plate 15: Pit *108* and culvert *118* within engine room *100*

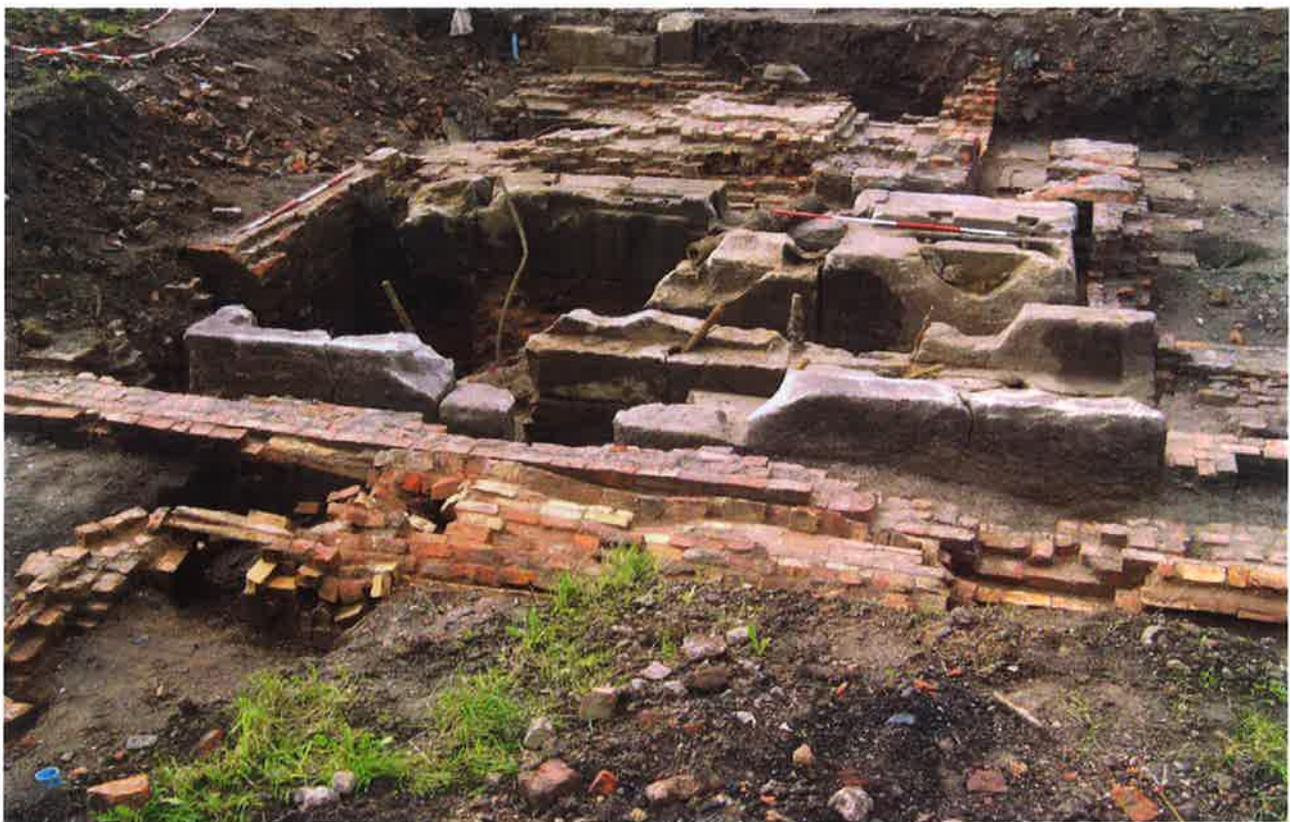
Plate 16: General view across engine room *141*, looking south-west, with flue in the foreground

- 5.4.4 **Engine Room 141:** the room was located along the eastern edge of the excavation, with three contiguous walls (**102**, **159** and **176**) exposed below varied depths of modern demolition debris (Plate 16). The walls comprised mould-thrown bricks set in lime-based mortar. The south wall (**159**) survived to a maximum height of 2.03m and comprised 24 courses laid in an English Garden bond (Brunskill 1997). The east wall (**176**) was observed for a distance of 7.5m. The room was rectangular in plan, with dimensions of 6.90m by 5.5m. Several internal features suggested that it had been used originally to house a small water-wheel that had been assisted by a steam-powered pumping engine. Large circular-sectioned restraining rods on the floor demonstrated the position of machinery within the room.

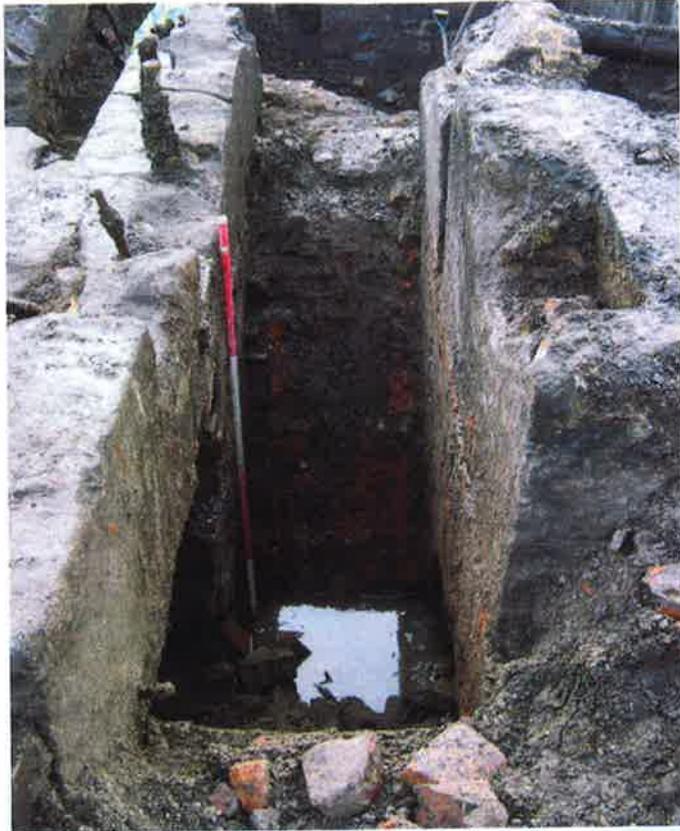
Plate 17: Water wheel pit 165

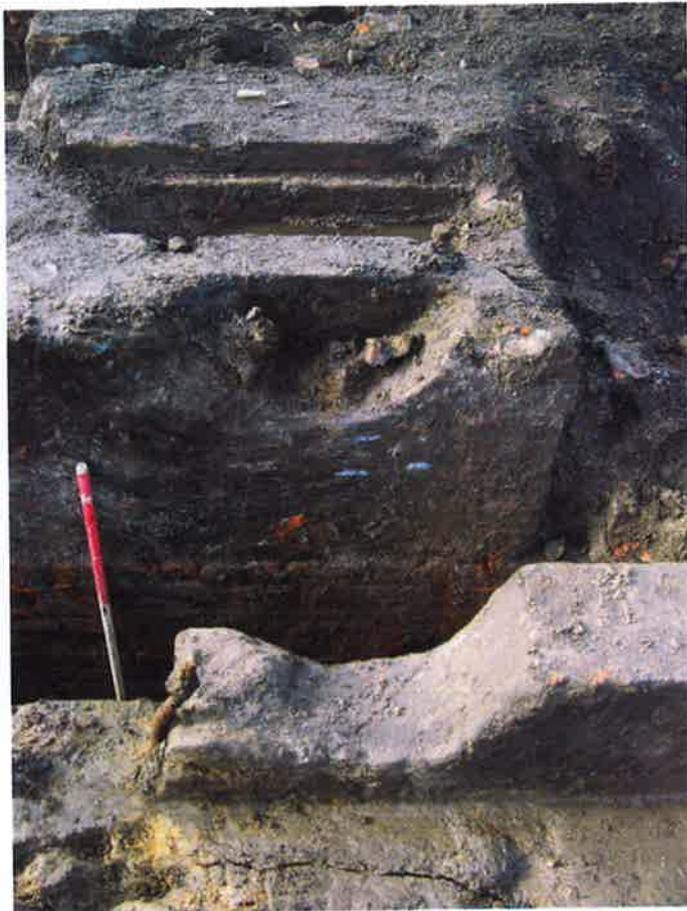
Plate 18: Housings for the water wheel axle bearings
