SALVIN'S FACTORY AND NEW ISLINGTON MILL, ANCOATS, MANCHESTER

Post-Excavation Assessment

Oxford Archaeology North

December 2005

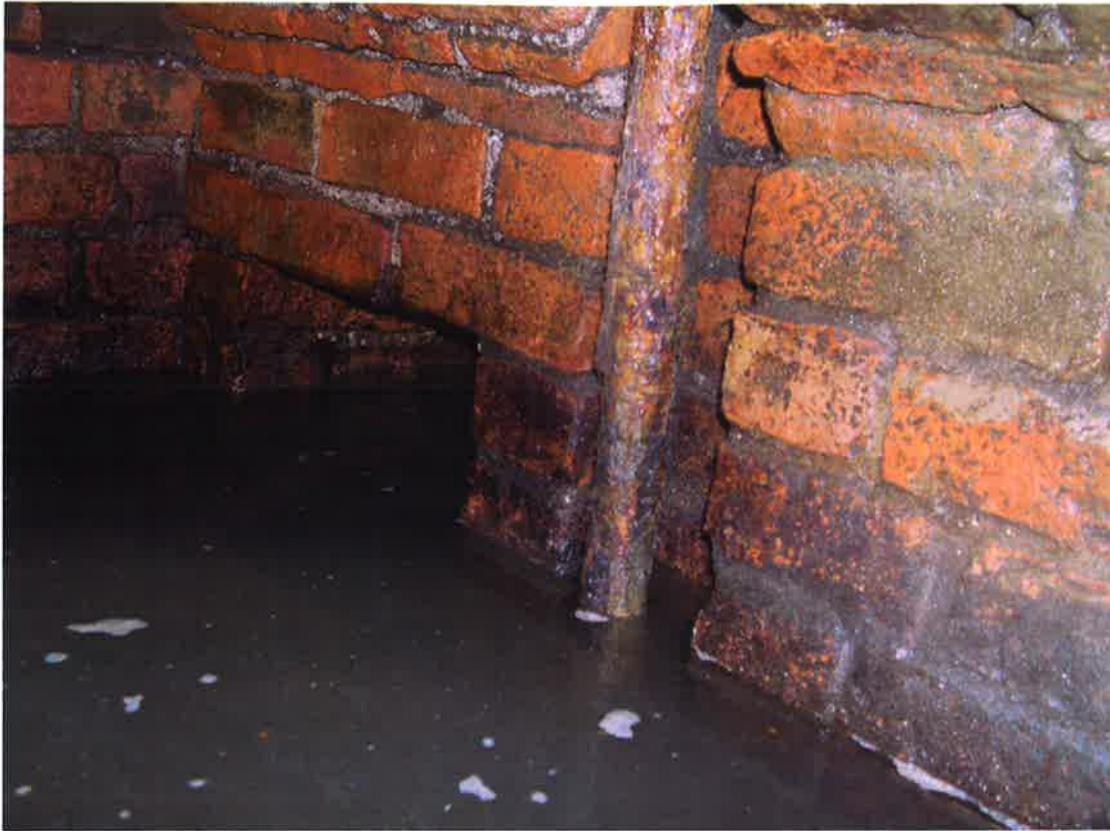
Plate 19: Pipe within culvert 178

- 5.4.7 Culvert **178** was aligned east/west through the wheel pit, and provided a constant source of water into it. The eastern wall of the culvert had a vertical pipe positioned (Plate 19) inside the entrance of the west-facing roof arch that extended from the water level and continued through the inner skin of the wheel pit wall, terminating above ashlar block **166**. Culvert **179** was observed running north from **178** in the centre of the wheel pit, seemingly acting as a tail-race. The roof of the culvert was capped with stone lintel **183**, which was exposed at a depth of 1.41m below the top of the wheel pit walls.

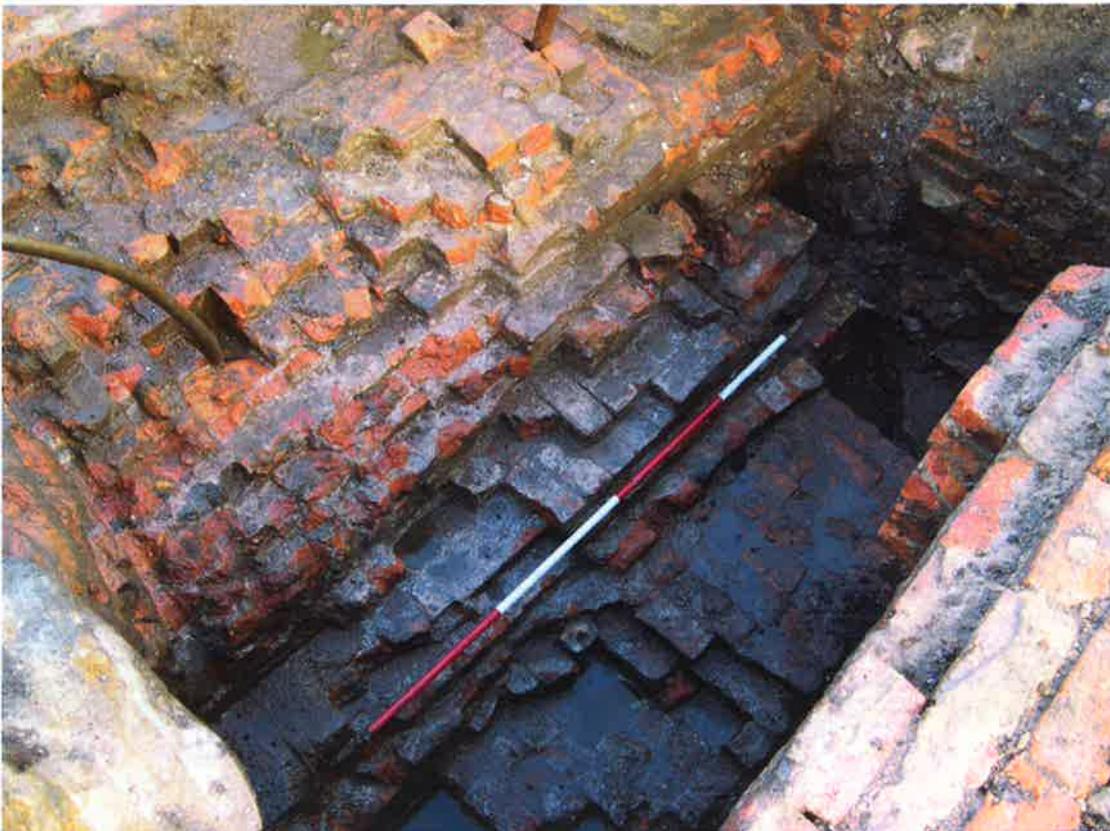
Plate 20: Platform 173 across the south edge of the pumping engine room (141)

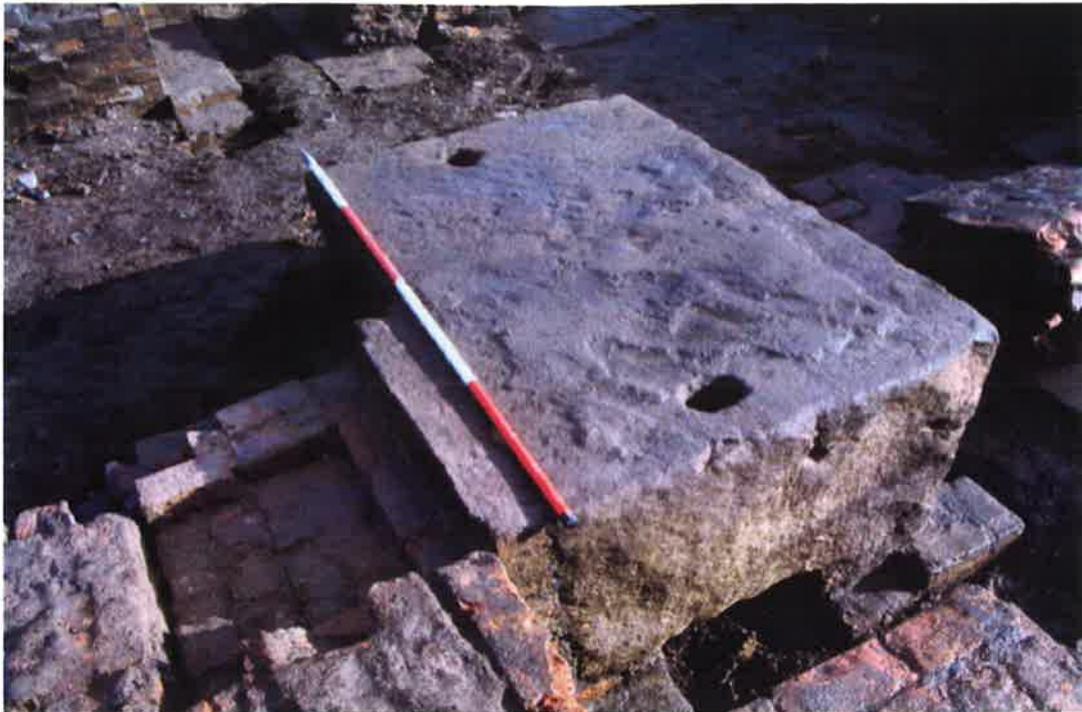
Plate 23: Ashlar foundation bed *136* within boiler house

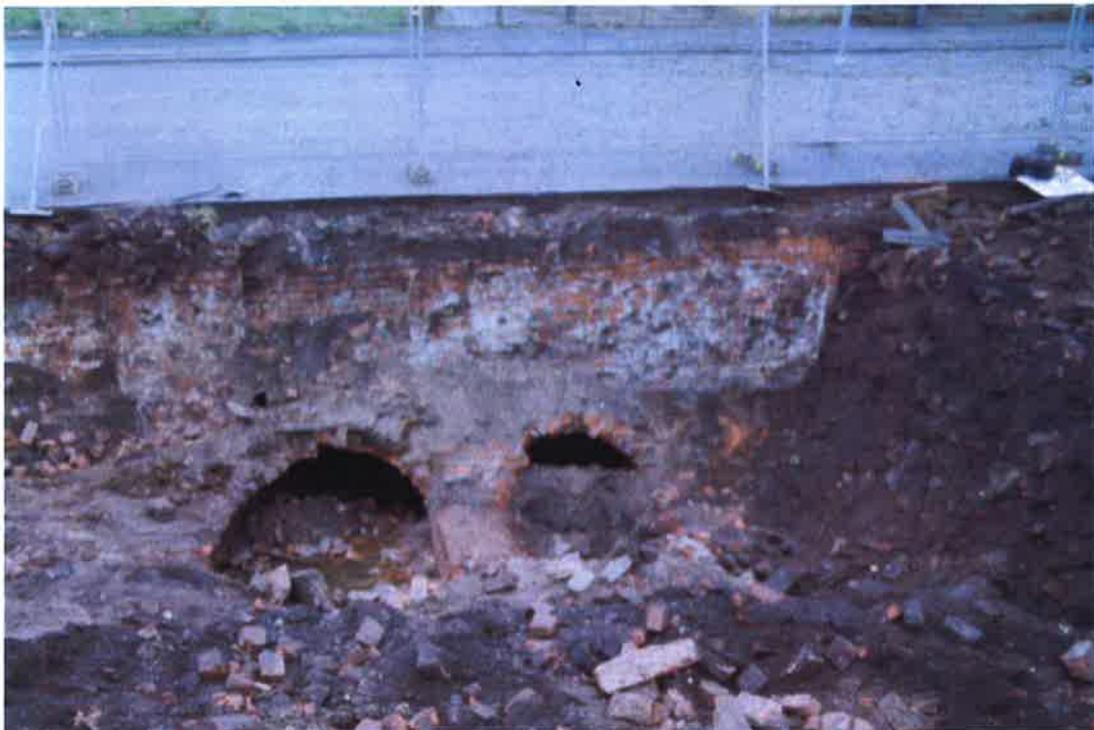
Plate 24: Culverts running beneath New Islington Road via the mill's west external wall (*196*).

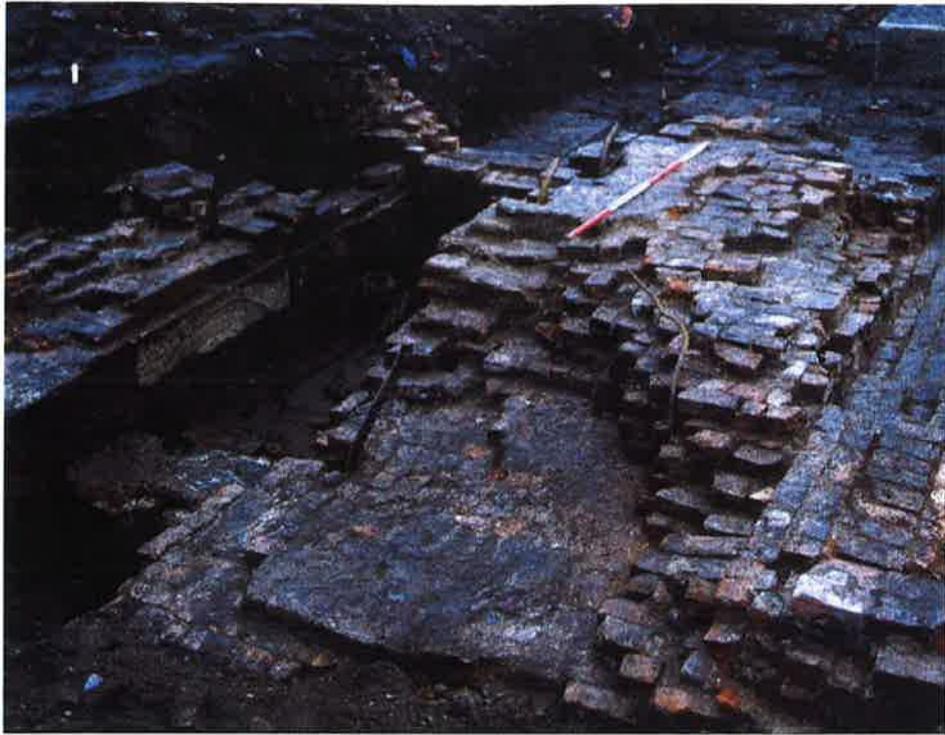
Plate 25: View of machine restraining rods within brick platform *103*

surviving brick course. Each block contained square and round threaded iron restraining rods protruding vertically to a height of 0.35m through the upper brick courses, positioned 0.5m apart (Plate 25). At the south-eastern corner of structure **103** was a repaired section (**107**, Plate 26), which measured 1.10m by 0.43m and comprised a single course of brick headers that overlaid the north block in row **105**, with further brick infilled along its southern edge. The repair was probably created to allow for the insertion of a larger stone block (**109**) that sealed the earlier brick foundation base across the width of the room.

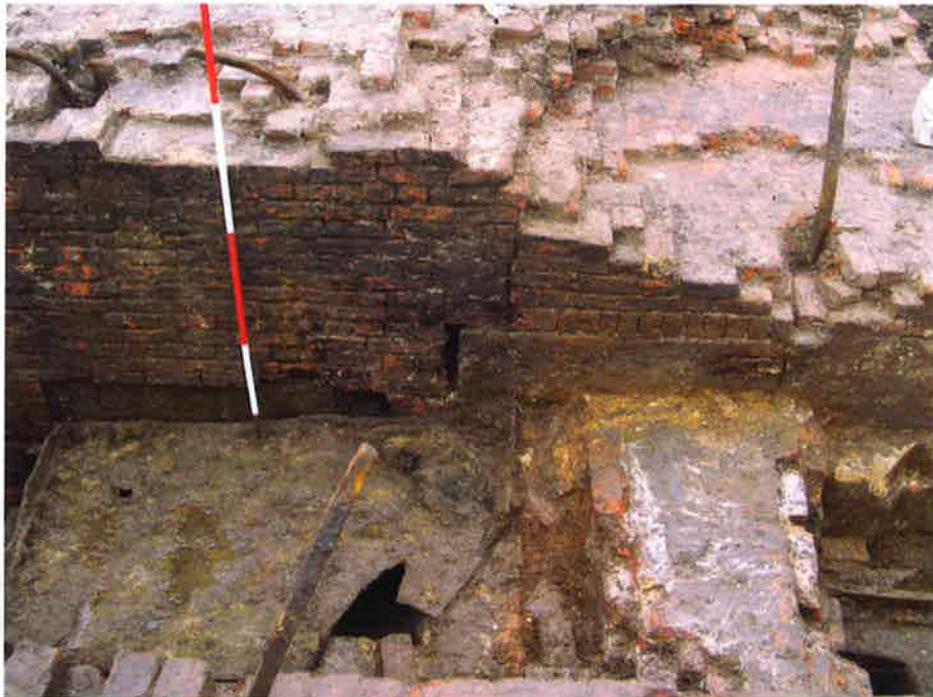
Plate 26: Section of repair (*107*) within the west face of platform *103*

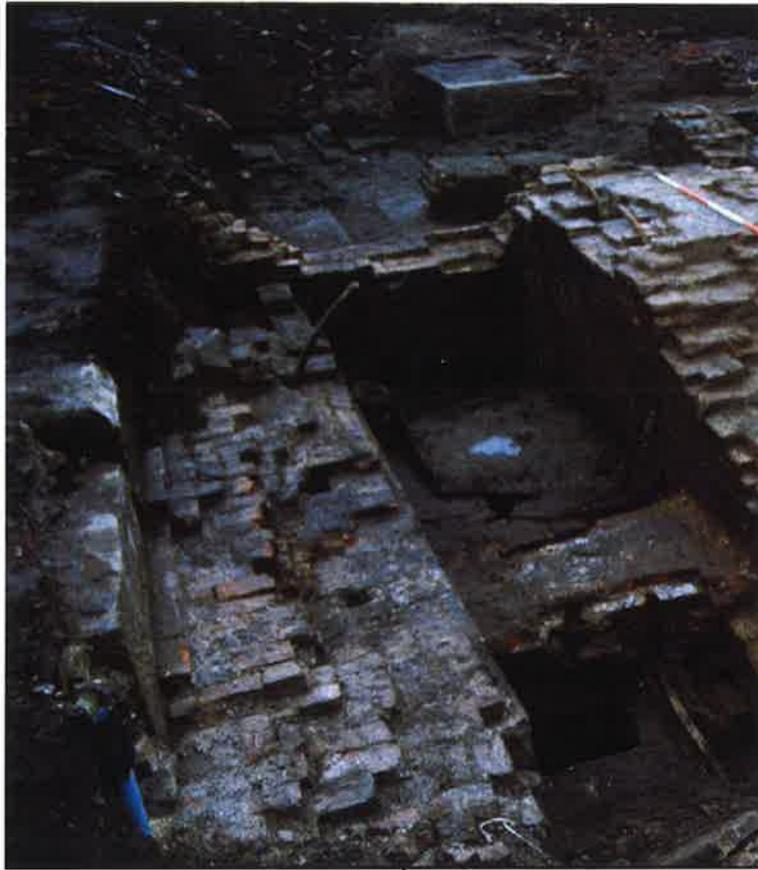
Plate 27: Brick platform *123* along the west edge of engine room *100*

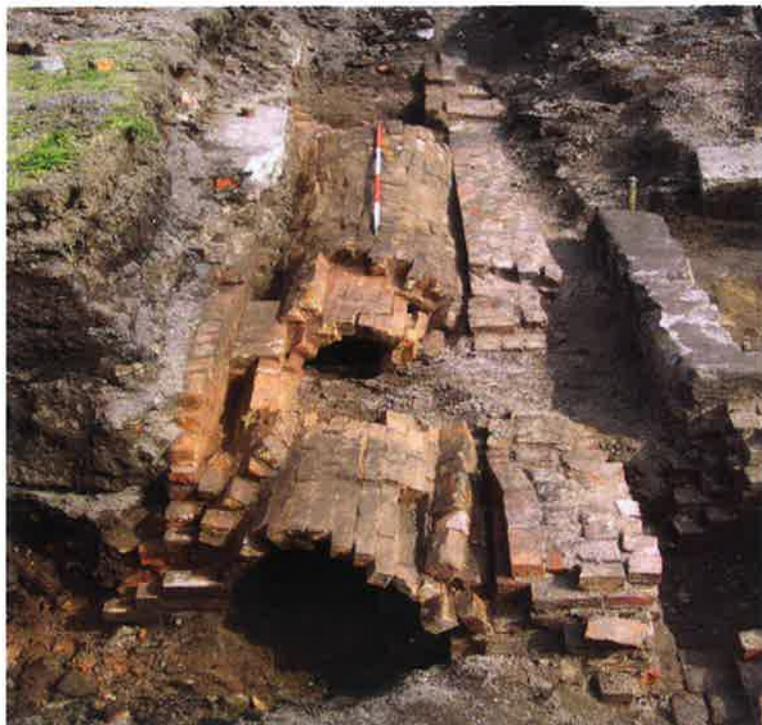
Plate 28: Flue *143* along the east edge of engine room *141*
