# Archaeological Evaluation and Photographic Building Survey at Norwich School

October 2018

Client: Lanpro Services on behalf of Norwich School

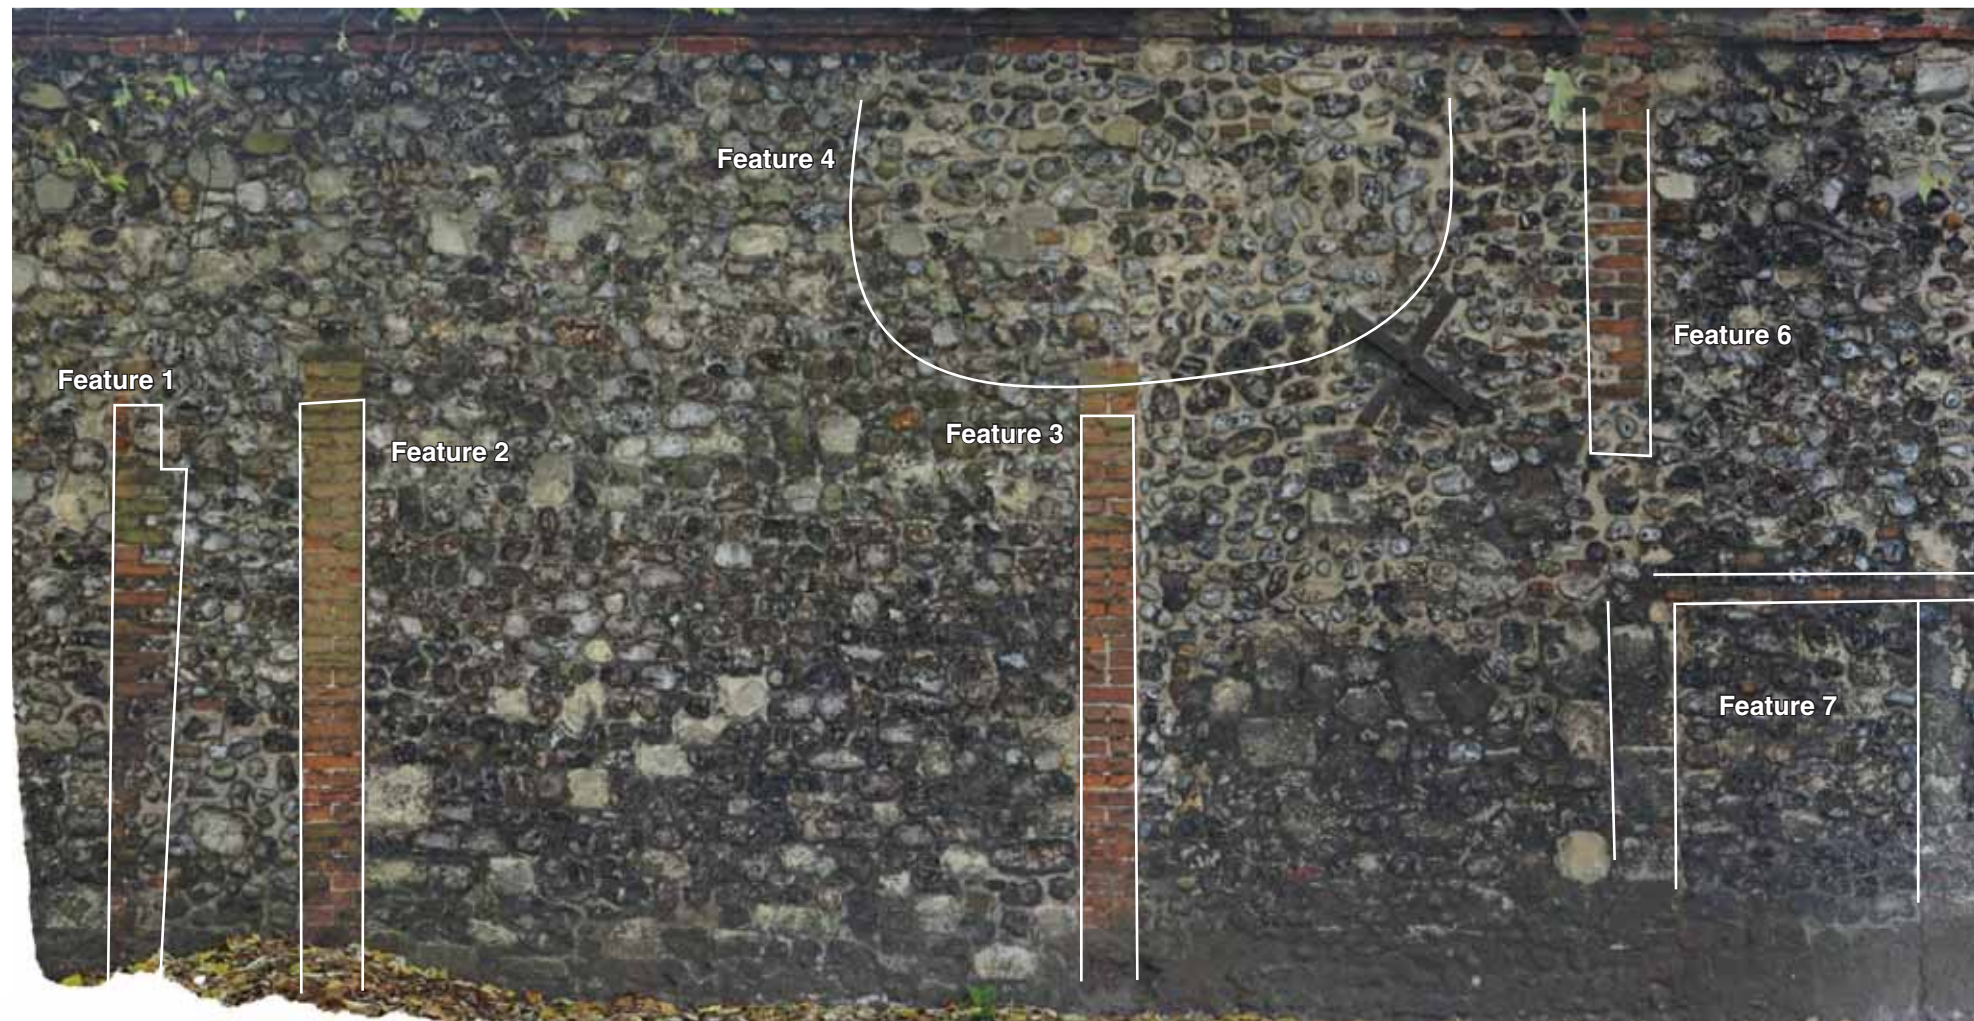
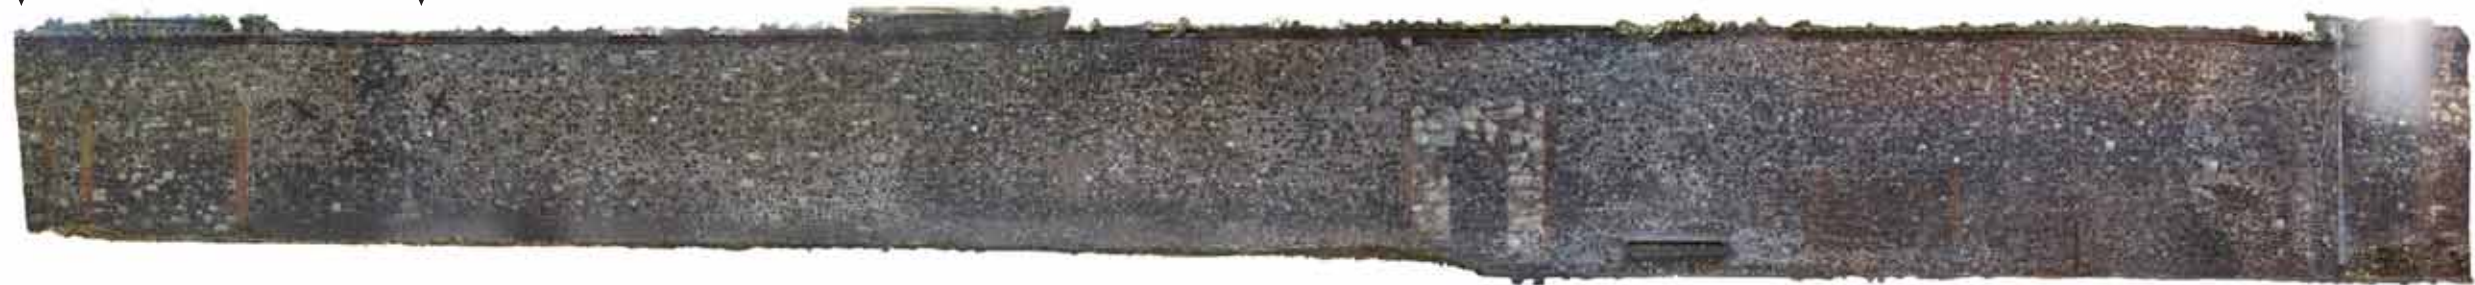
Figure 14: Wall Elevation 1

- 3.6.10 The other two piers (Features 1 and 6) were constructed from a slightly smaller brick (21cm x 6cm x 10cm) and likely date to the 18<sup>th</sup> century. As with Features 2 and 3, Features 1 and 6 were one stretcher wide, but alternating with a single header (in the manner of a corner bond). Feature 1 was built up from the ground for approximately 30 courses, although the lower courses are somewhat worn and missing in places. Feature 6 comprised 13 courses beginning approximately half way up the wall, it then continued intermittently interspersed with blocks of flint before meeting the top of the wall. Features 1, 2 and 3 all terminate at the same height.

- 3.6.11 Within this section an iron cross wall-tie was noted. This was located at 2.68m above ground level. It was constructed with two bands of iron forming a cross. The bands were 0.50m in length. Another of identical design was located 2.5 metres to the west (Elevation 2; Feature 8). These ties would have been used to pull the wall in to another structure which suggests a building had been set into the wall at some time, although no evidence of any building remains.

- 3.6.12 A brick lacing course was also recorded on Elevation 1 (Feature 7). This was located at 1.72m above ground level and consisted of a single course of headers laid to a length of 1.50m. This sat on top of a reused building stone that had been used as repair material.

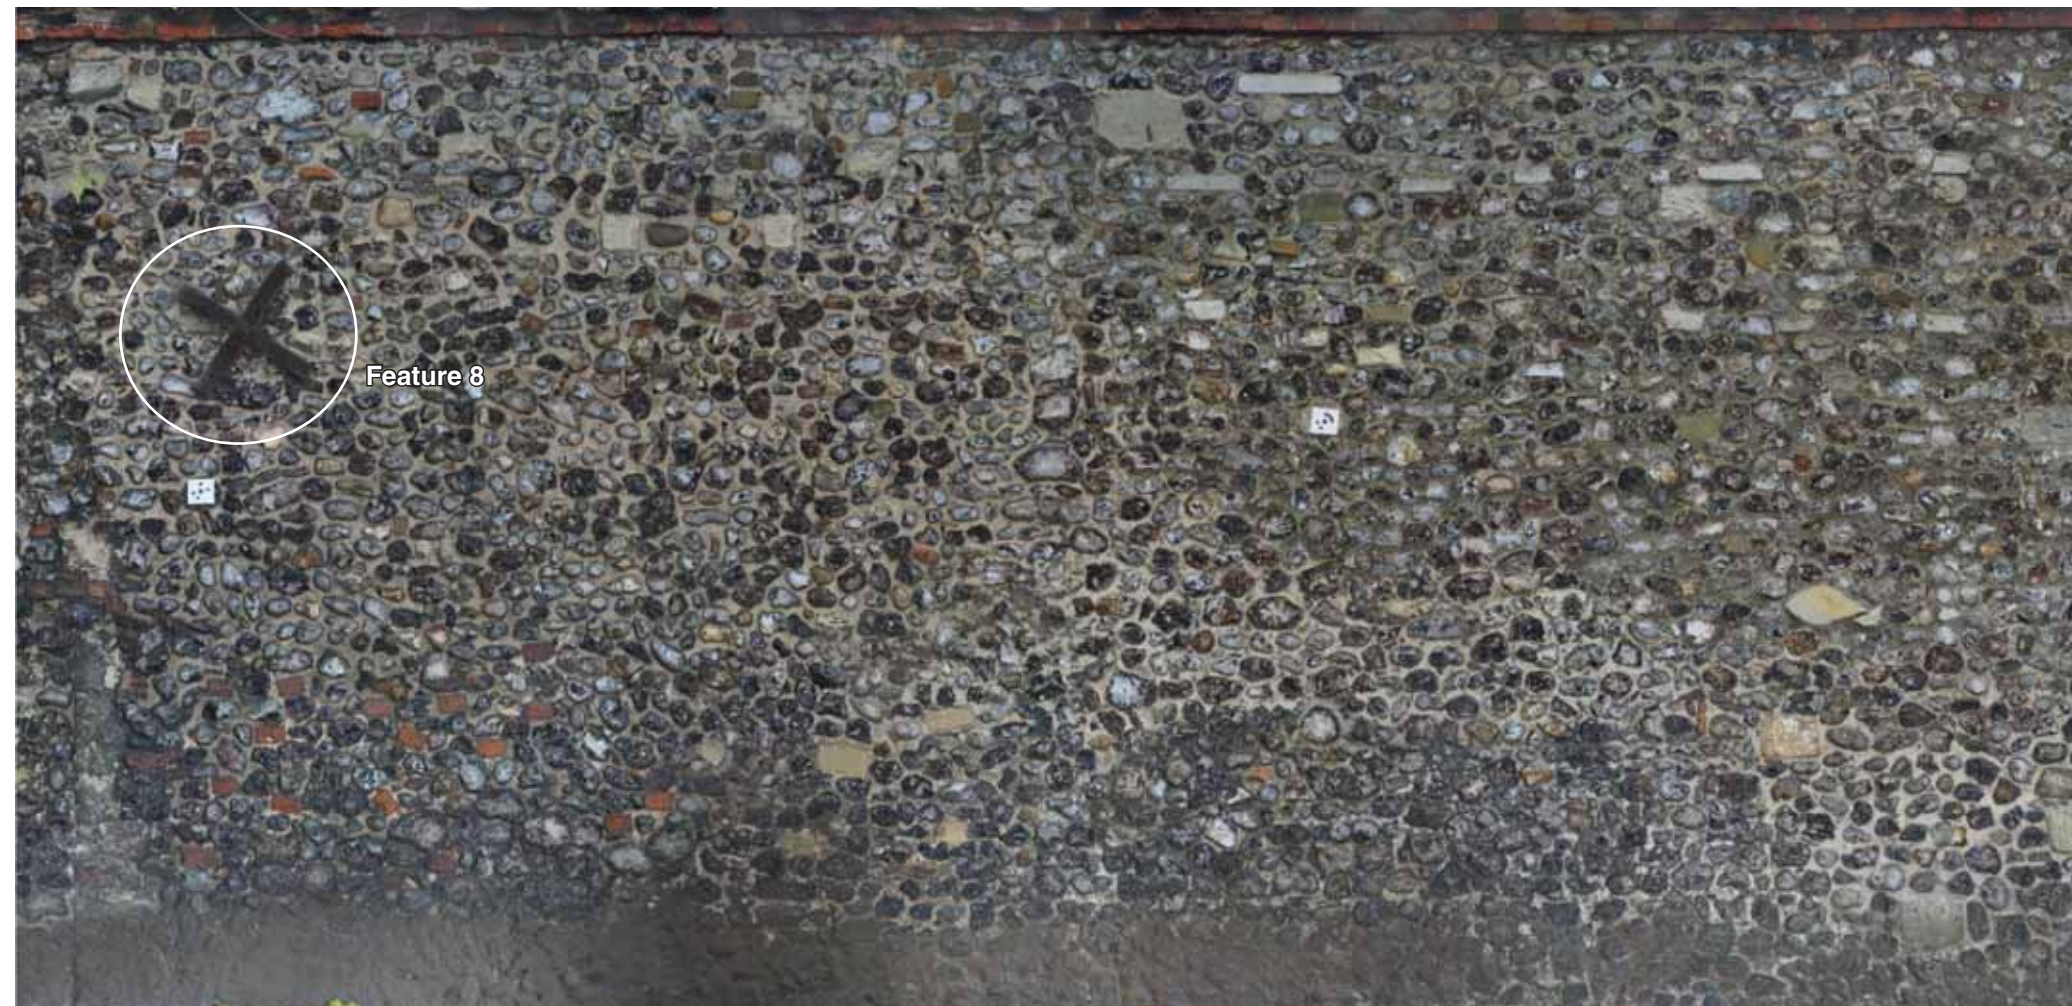
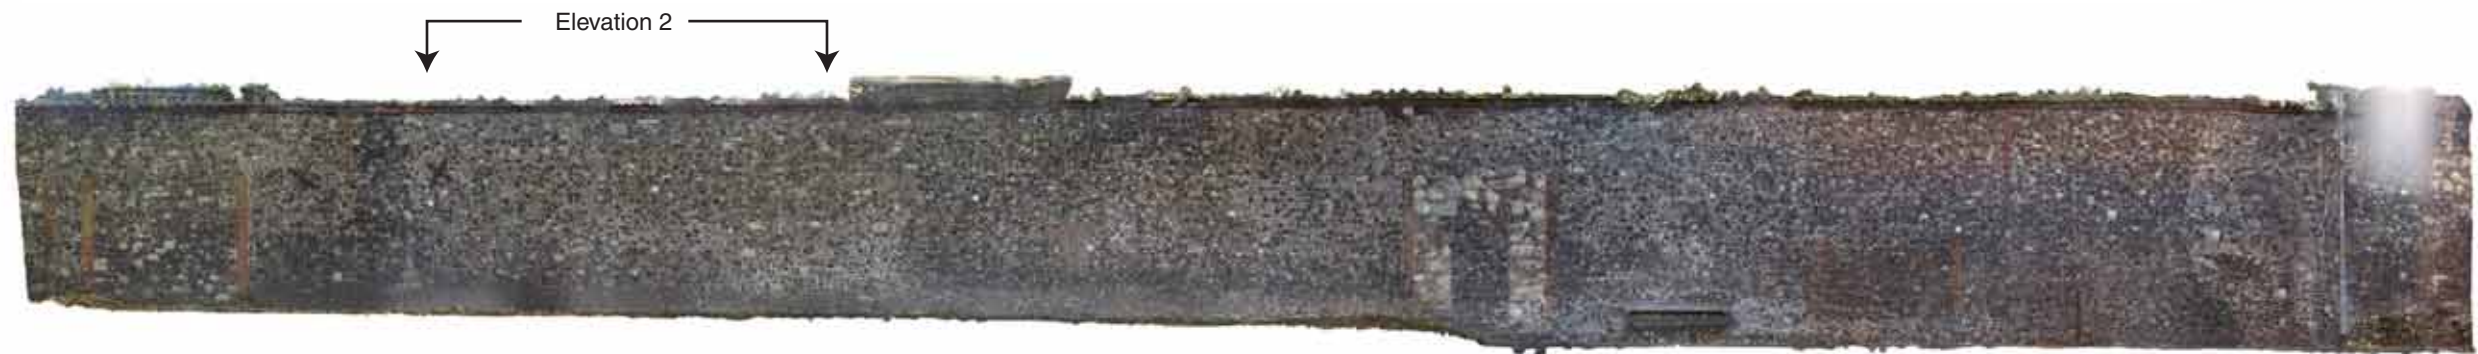
Figure 15: Wall Elevation 2

The only noticeable feature located within this section of the wall is Feature 8, an iron cross beam wall tie that has been previously described. The wall in common with all other sections was made up of repair and rebuild. The materials contained pieces of re-use worked stone but somewhat less brick than seen in other parts of the wall.

Stone and flint repair

Brick and flint repair

Division of repair

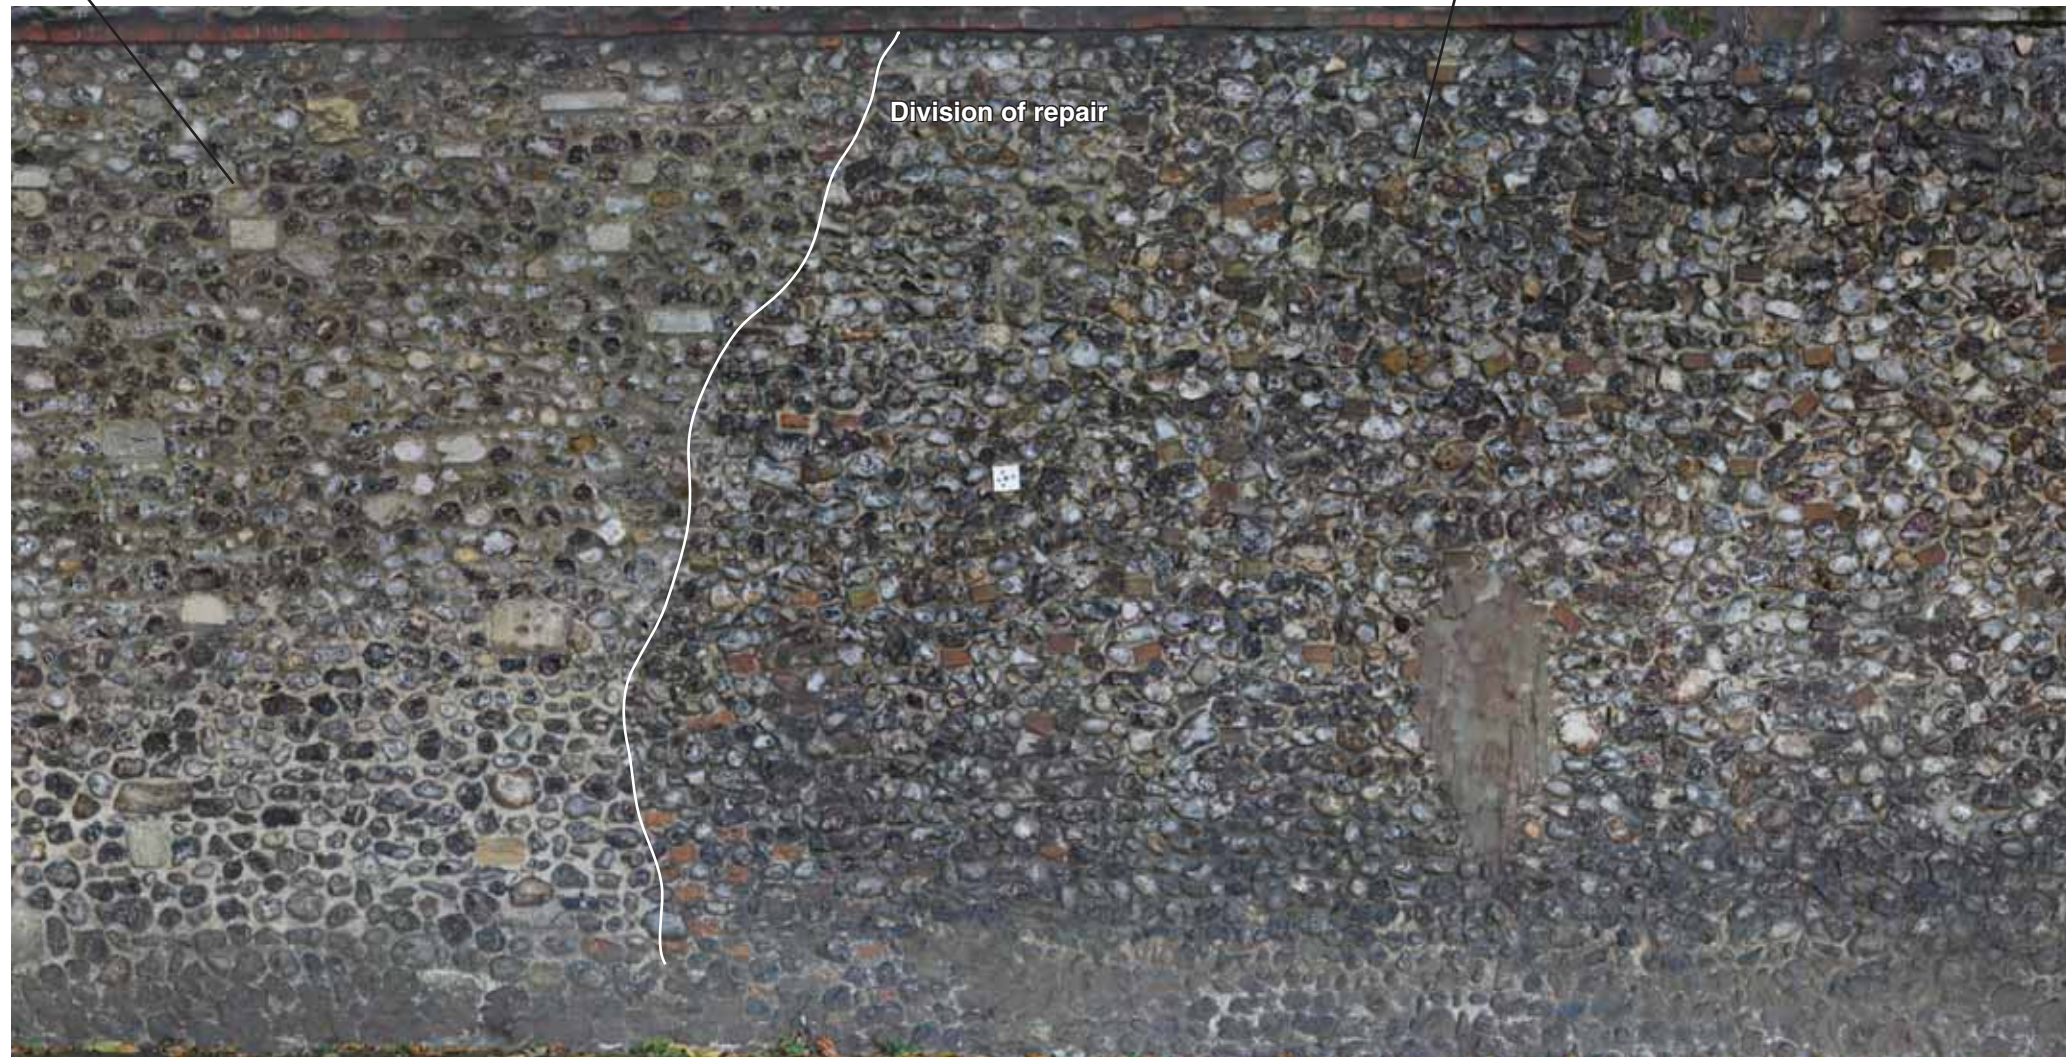
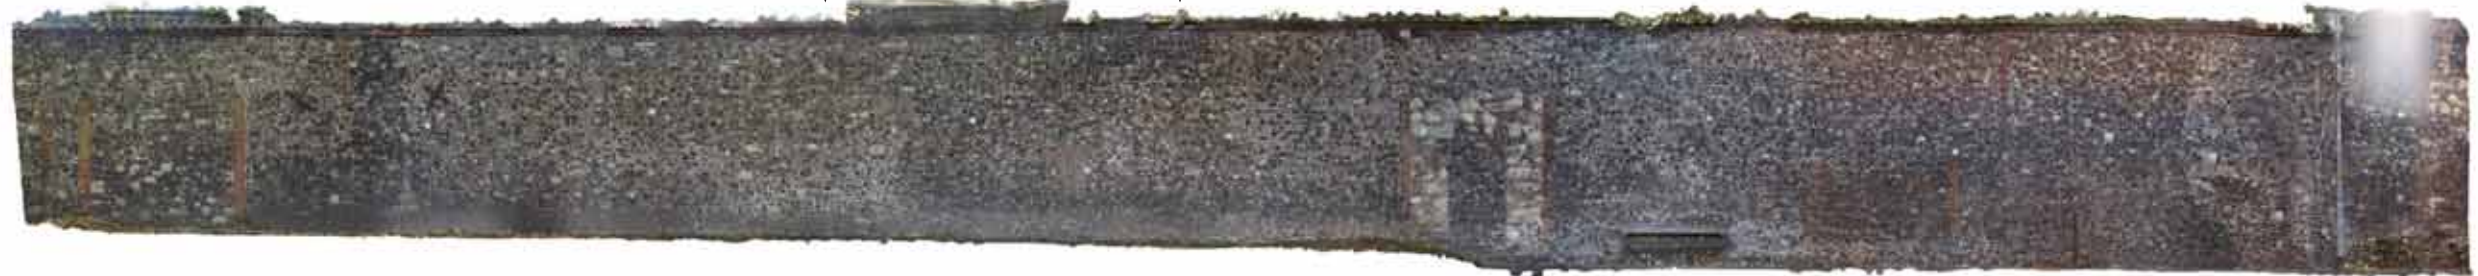
Figure 16: Norwich Cathedral Wall Elevation 3

- 3.6.14 This section of the wall had a length of 8.12m and a height of 4.2m. It was capped with two courses of red brick and pantiles.
- 3.6.15 Rudimentary repair had been carried out to a section to the east of the elevation. This area of repair had utilised large amounts of re-used building stone but hardly any red brick. To the west of this the repairs had mainly used flint with the addition of brick. The repairs were crudely done and little attention had been given to relaying the flint and brick in any visible course.

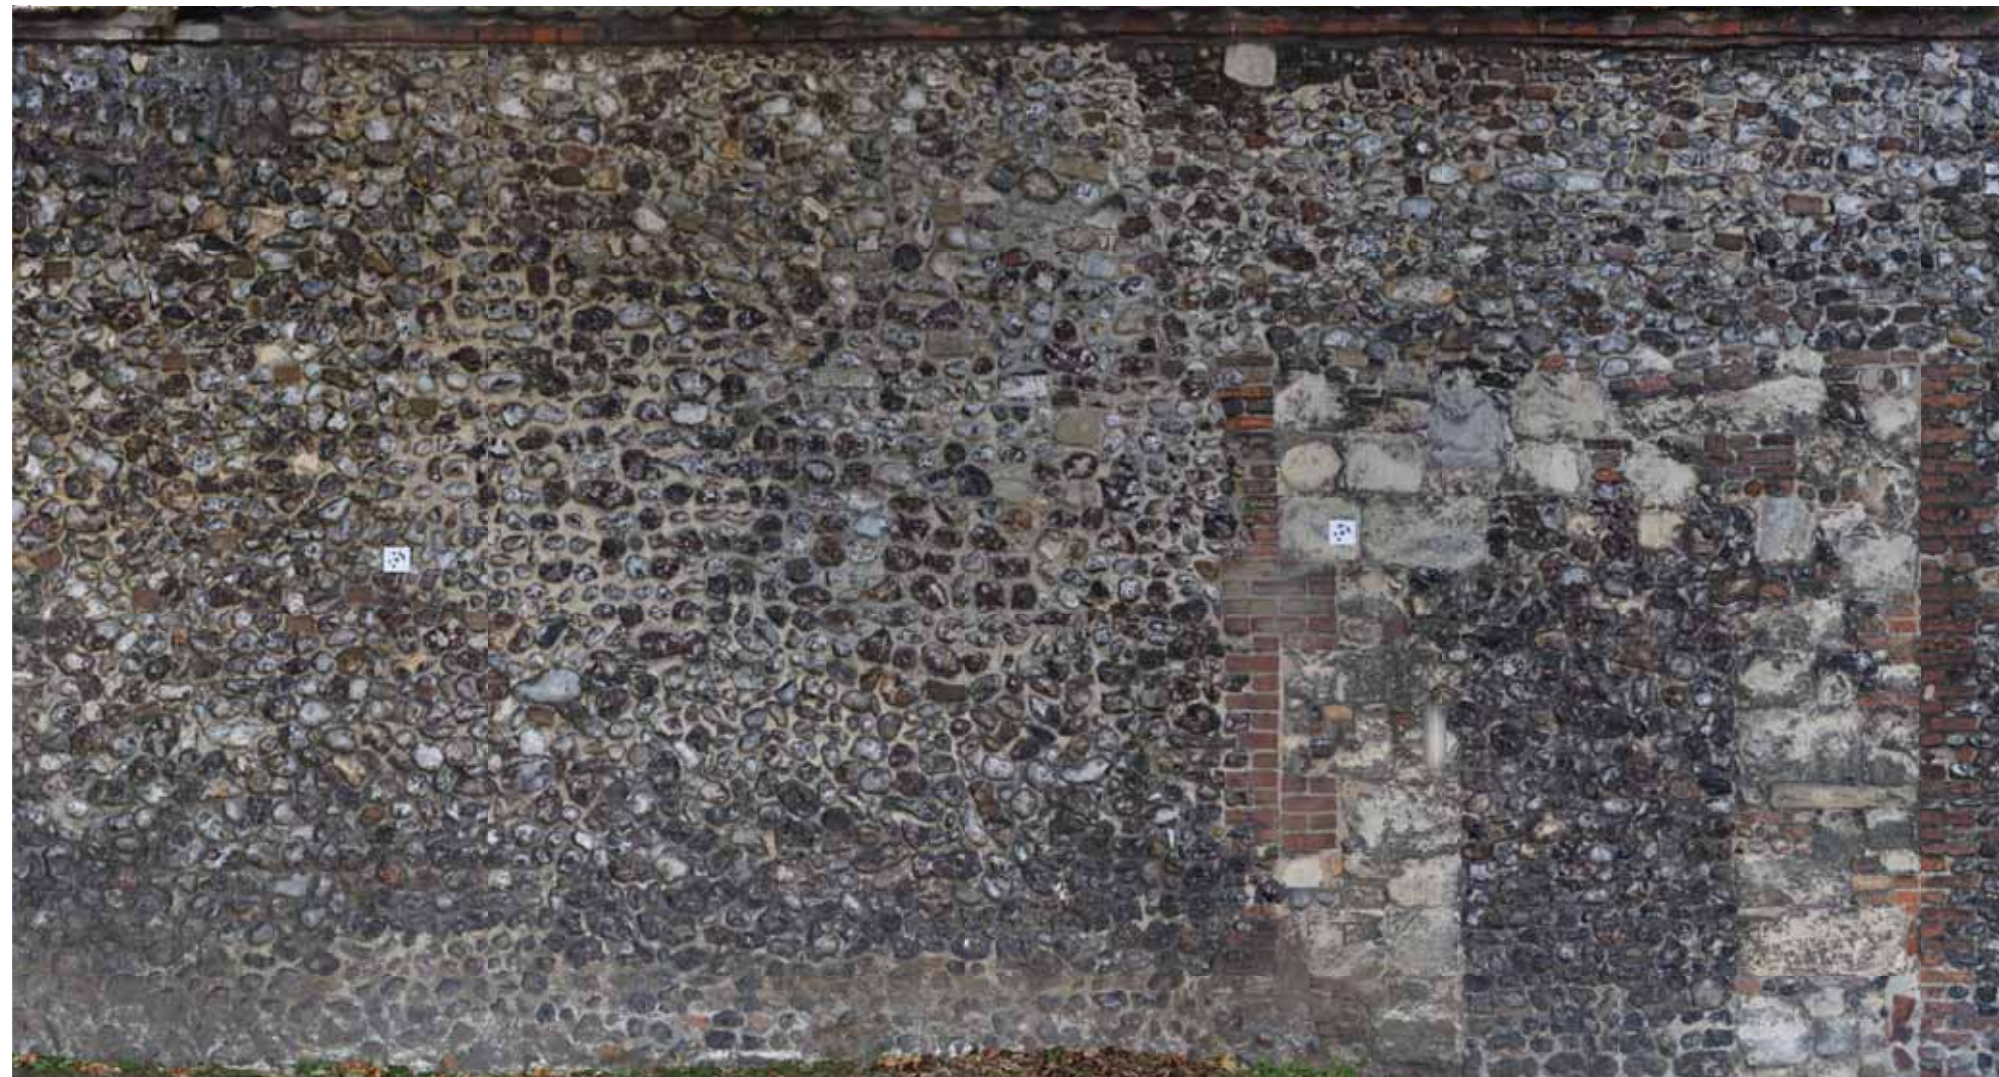
Figure 17: Wall Elevation 4

- 3.6.16 Elevation 4 measured 7.64m in length and had a height to the pantiles of 4.12m and as in common with the previously described sections of wall this has undergone various phases of repair and rebuild and once again the most common repair material

3.6.19 Bricks have been used to bolster the stone blocks and also to repair the existing structure. The dimensions of the bricks suggest 18<sup>th</sup> and 19<sup>th</sup> century phases of repair.

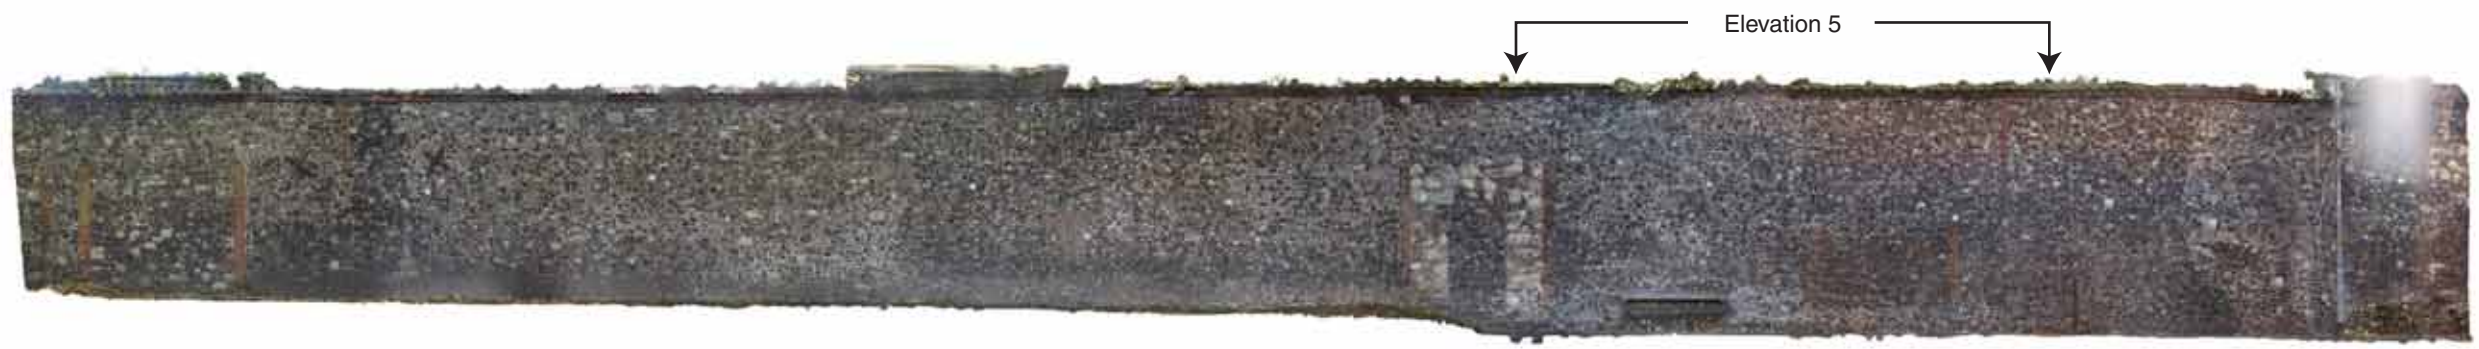
Figure 18: Wall Elevation 5

3.6.21 This section of wall showed large areas of repair mainly using flint as the repair material. Areas had also been re-pointed using a pale concrete mortar.

3.6.23 To the west of this pier the wall had been repaired in the upper half using flint interlaced with brick. This reflected the design of the wall below. This is one of the few examples of a repair trying to match an earlier phase of building. This flint interlaced with brick repair continued in to Elevation 6.

Good care taken to match existing wall

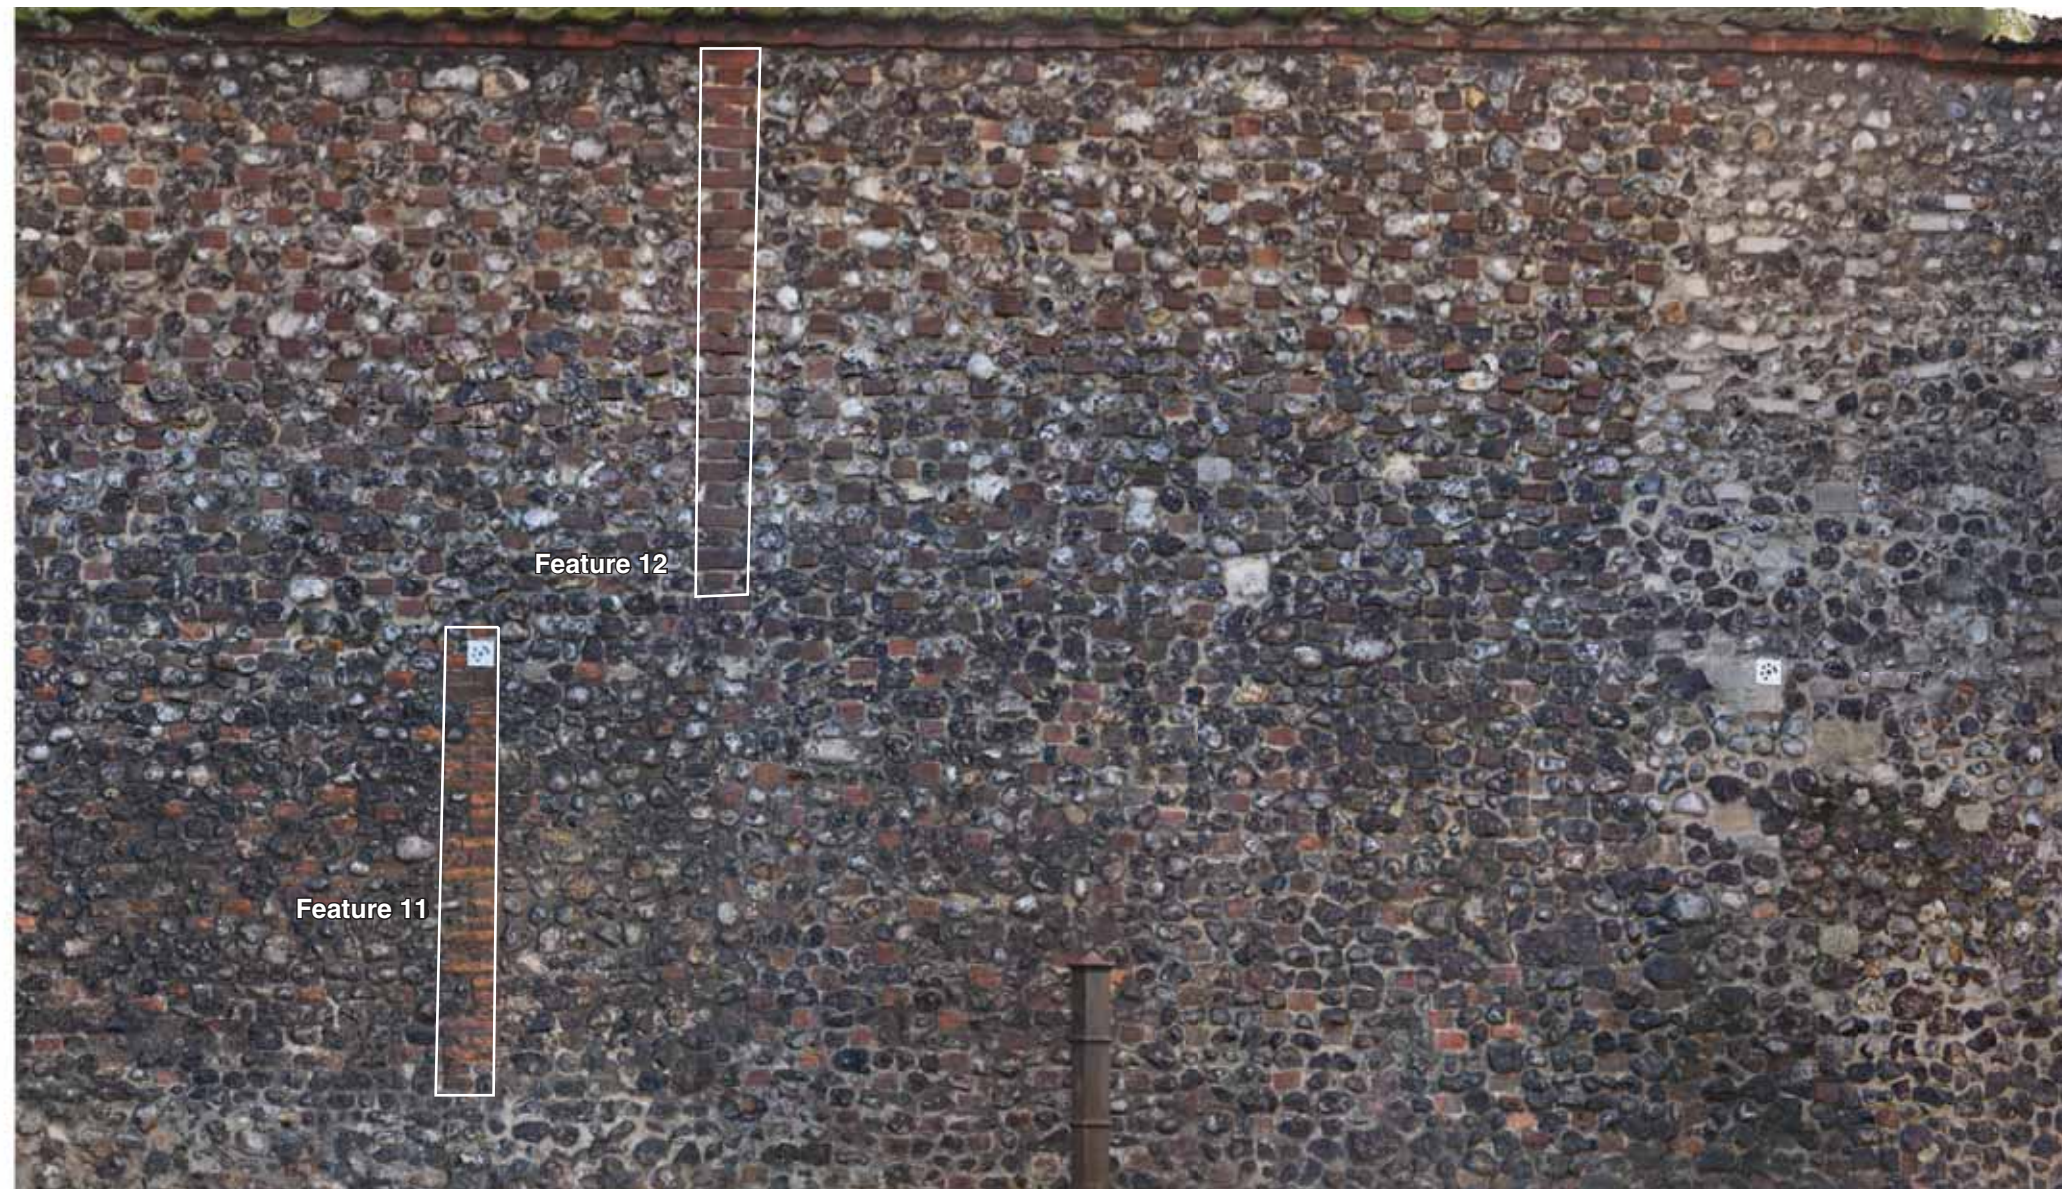
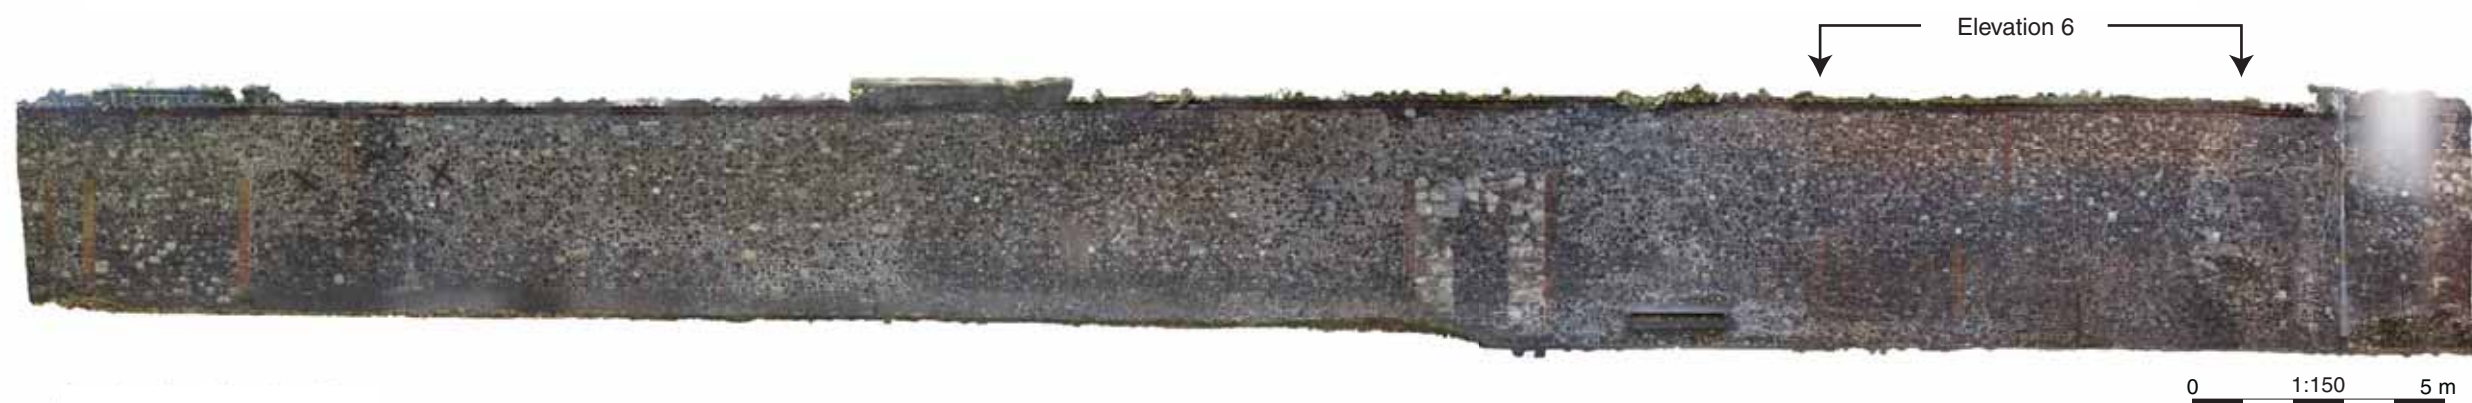
Figure 19: Wall Elevation 6

3.6.24 Elevation 6 measured 6m in length and had a height of 4.2m to the pantiles. A corresponding pier (Feature 11) to that described in Elevation 5 was noted. A further 19<sup>th</sup> Century brick pier (Feature 12) sprang from the top of the wall for a length of 2.25m. This was constructed by using a stretcher overlying a header. A continuation of flint and brick courses was also noted.

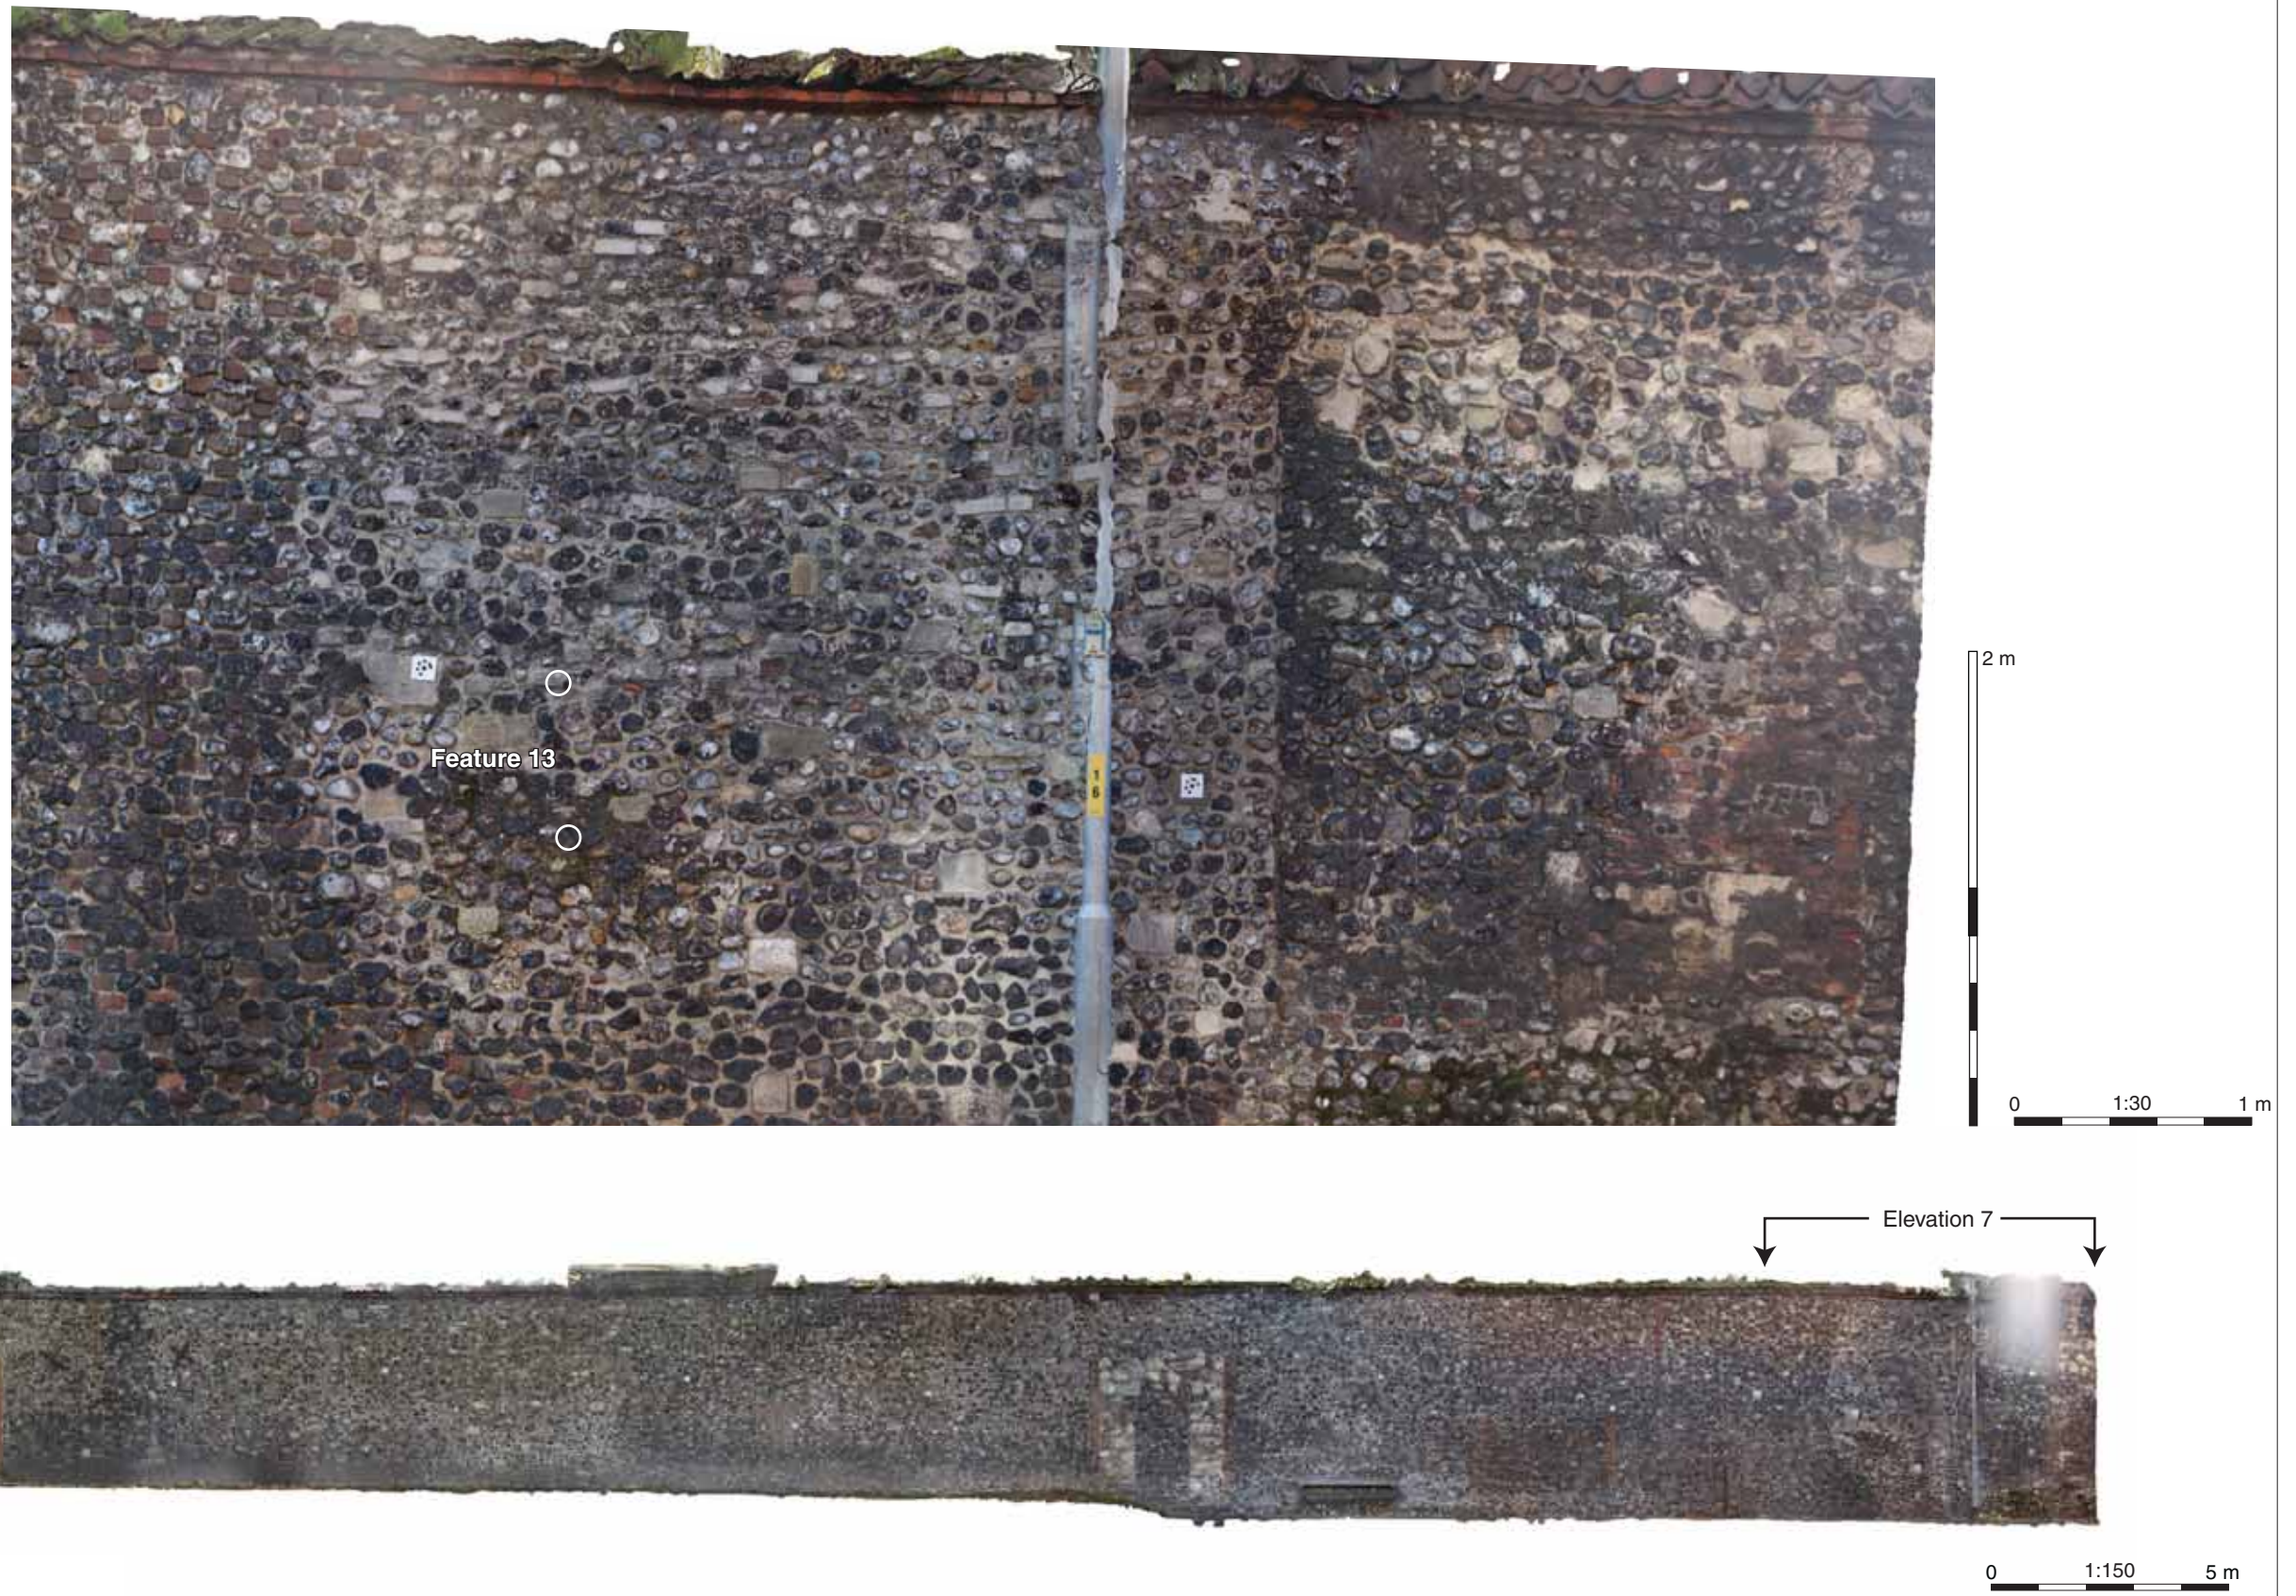
Figure 20: Wall Elevation 7

3.6.25 Elevation 7 measured 6.3m in length and had a height of 4.6m. The wall continued to a half tower abutting Palace Street. This section of wall has been heavily repaired and at a height of 2.2m four small metal spurs were noted protruding from the stone work which suggests there is a suggestion that a small window or shutter may have once existed here (Feature 13).

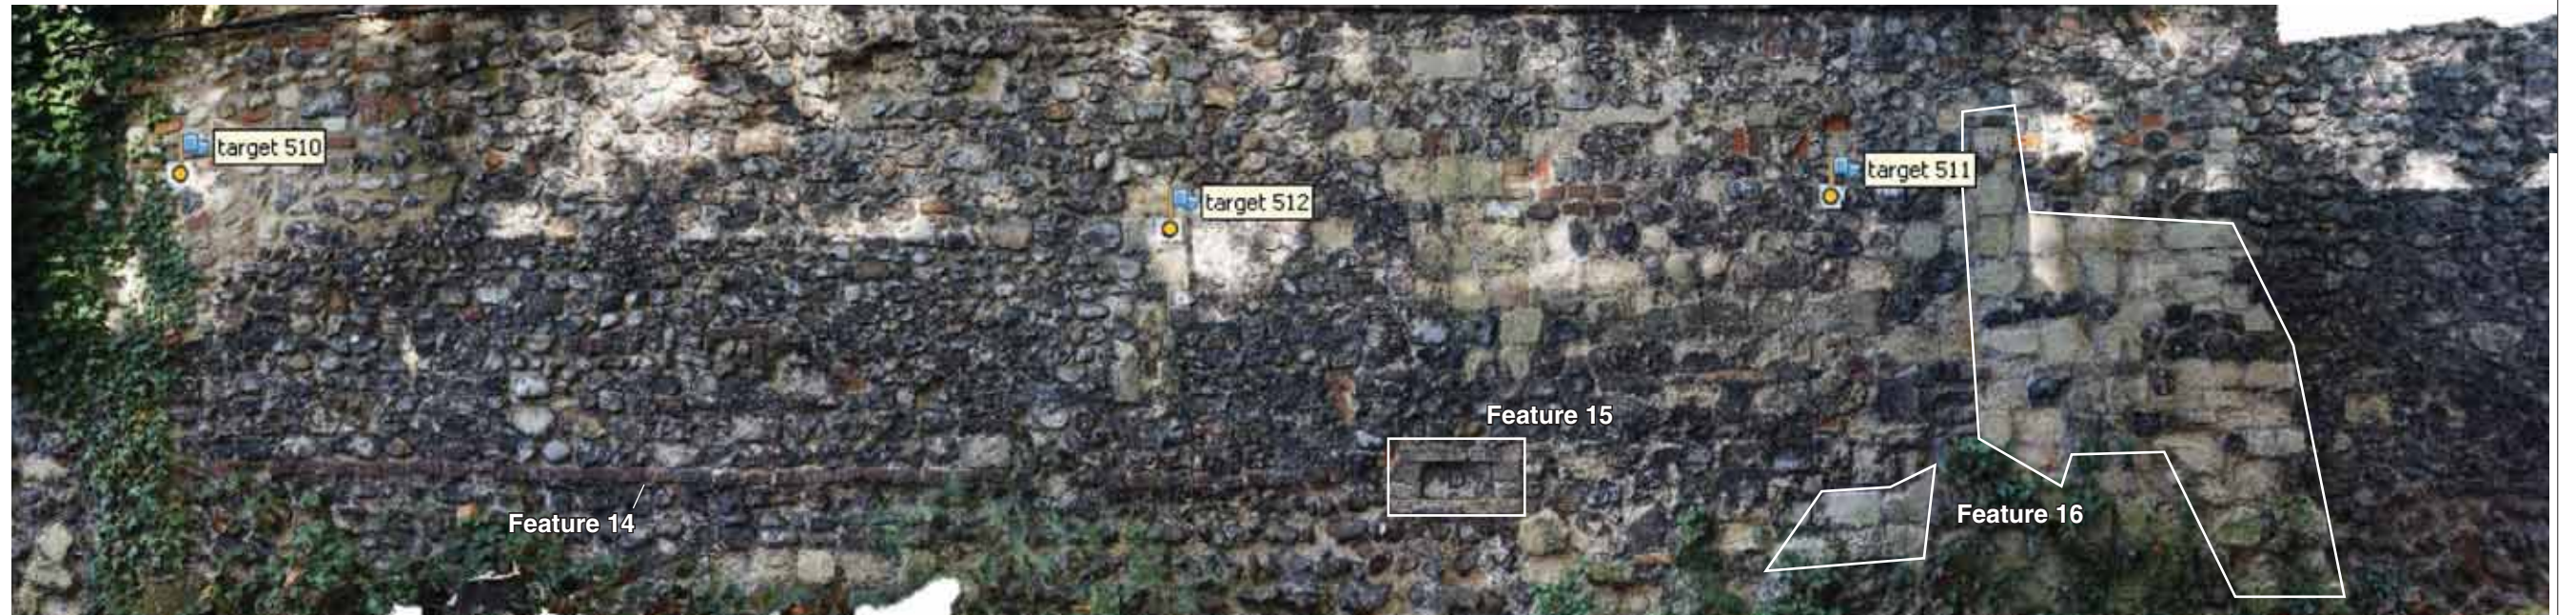
Figure 21: Interior Wall Elevation 8

- 3.6.28 Internally the wall differed little from the external view. A large amount of repair and rebuild had occurred and noticeably a lacing course had been inserted towards the base of the wall (Feature 14). Buff coloured bricks (Feature 15) with a recessed “D” have also been inserted into the wall (Plate 14), this marks the point at which drainage from the Bishops Palace exits the garden. This can be seen on a plan of services dated 1859 (Fig. 7).

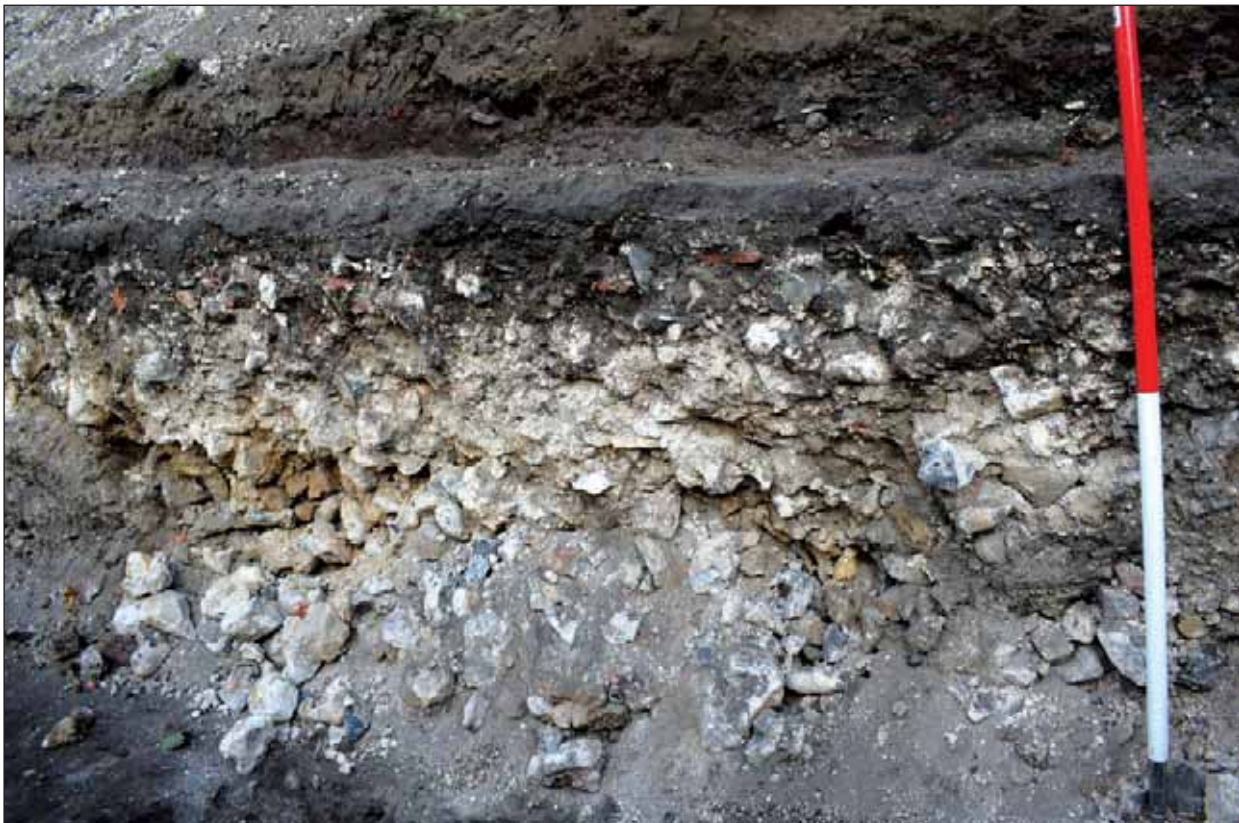
3.4.7 Fill 109 lay against the western edge of pit **111**. It consisted of a moderately loose mid to light grey sandy silt which was 0.32m thick and 0.60m deep. This material contained small stones but no finds. A similar deposit (108) was present on the eastern side of the pit.

3.4.8 The bulk of the pit was filled with a mix of flint rubble, building stone and some crushed ceramic building material (110). A piece of a decorative moulding constructed from Caen stone was found within the backfill.

3.4.9 The limited size of the evaluation trench did not reveal whether the backfill of the pit related to a building or wall that could have been located close to the trench or just a spread of material that had been brought into the area. It is known that a tree existed on the spot from at least the mid-19<sup>th</sup> century (Plate 1) and did not fall until 2004. No roots were found on the spot during the evaluation and it is possibly that the pit may relate to the removal of the tree stump and roots.

Plate 4: Pit 111, viewed from the west.
