# Archaeological Evaluation and Photographic Building Survey at Norwich School

October 2018

Client: Lanpro Services on behalf of Norwich School

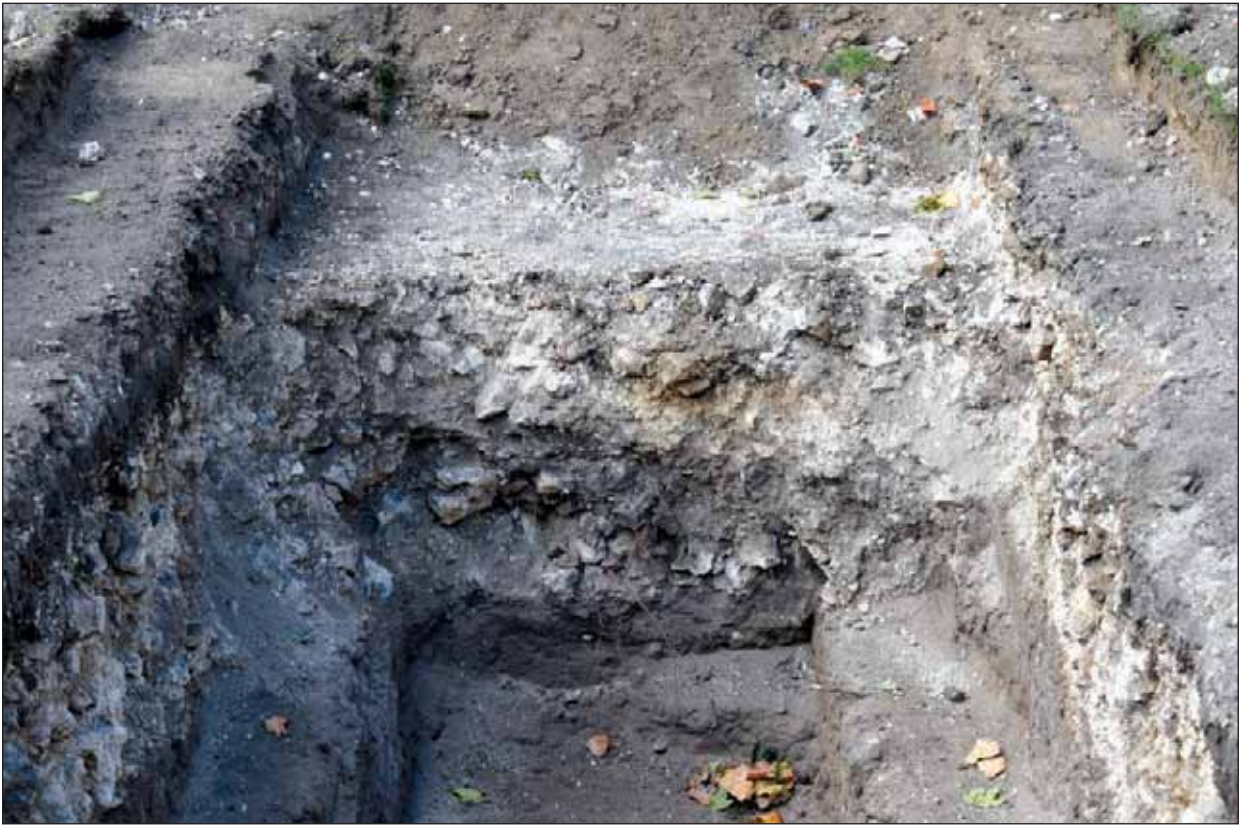
- 3.4.11 Layer 104 consisted of a compacted silty chalk and stone. It had a width of 1.2m and a maximum depth of 0.2m. It contained small to medium sized stones. Although no gravel or metaling was noted, the material was compacted and likely to have been deliberately placed, perhaps to form a base for a surface.

Plate 5: Layer 104 viewed from the south-east.

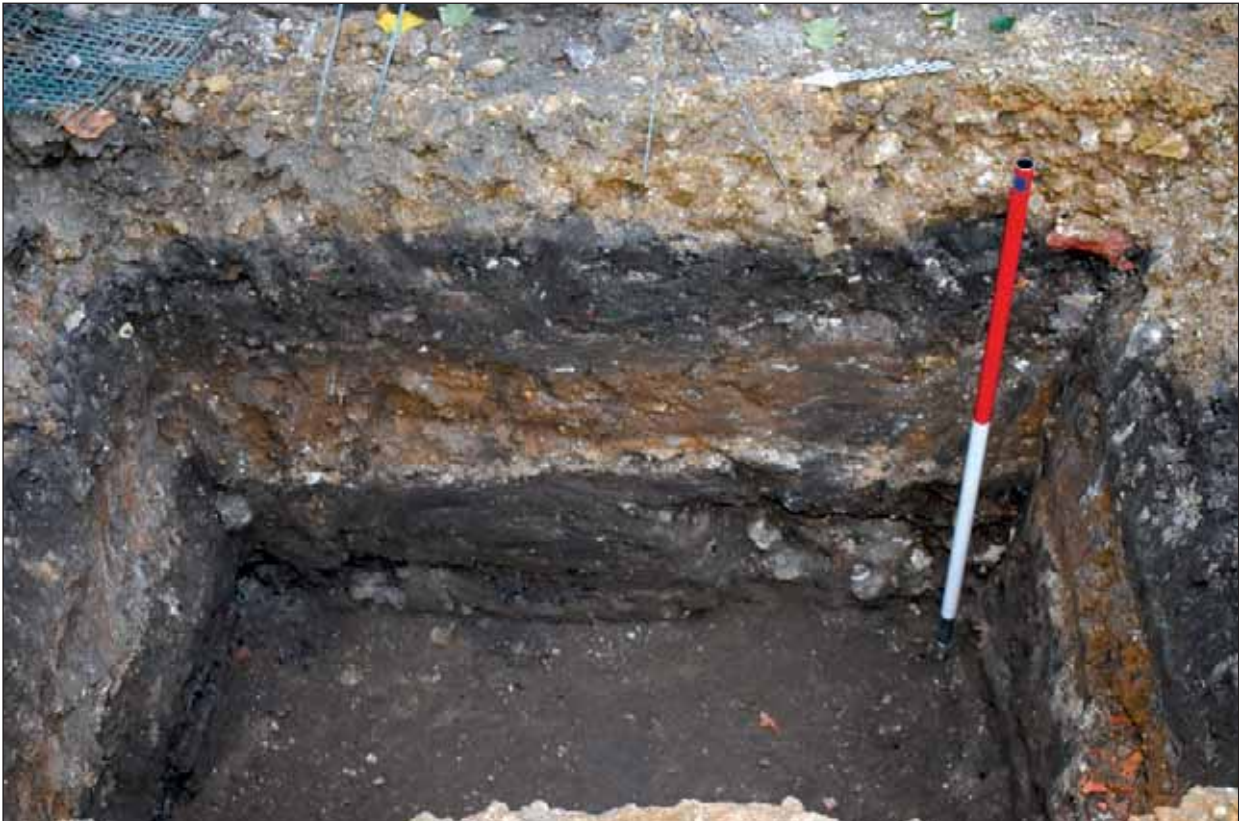
3.5.7 Within the upper levels of layer 210 a group of flints were noted. (Plate 10). It is possible that these flints may have been the those identified as a wall during the geophysical survey. Although extremely loose, they may have lost their bonding and so may represent the remnant of a flint wall.

Plate 10: Layers 202-210

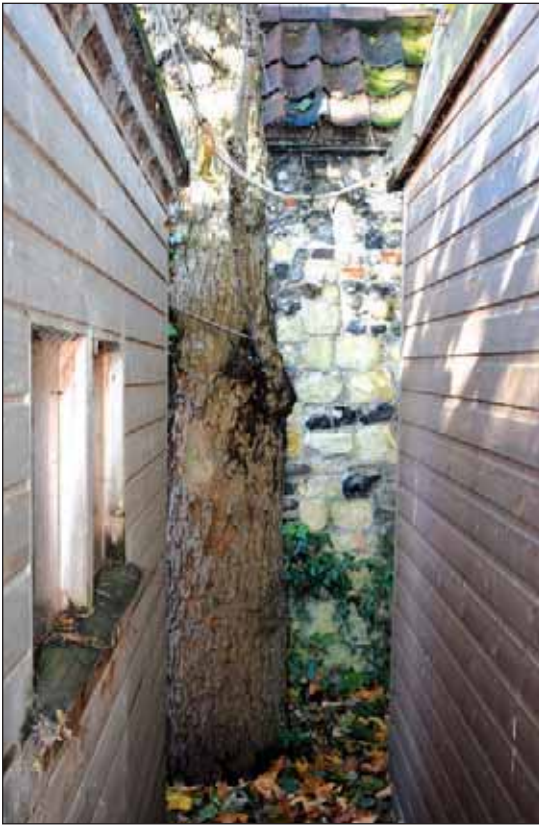
4.3.13 Internally the wall showed much of the same repair and rebuilding as the exterior. A small marker stone was noted towards the base of the wall (Plate 13). This marker indicates the point at which a foul water pipe enters the Bishops Palace garden. This stone dates to 1859 and can be seen on the service map of that date (Fig.7).

Plate 13: Plate of wall and building
