All Saints Church, Elton

Archaeological Monitoring and Recording

July 2018

OAE Report No: 2231

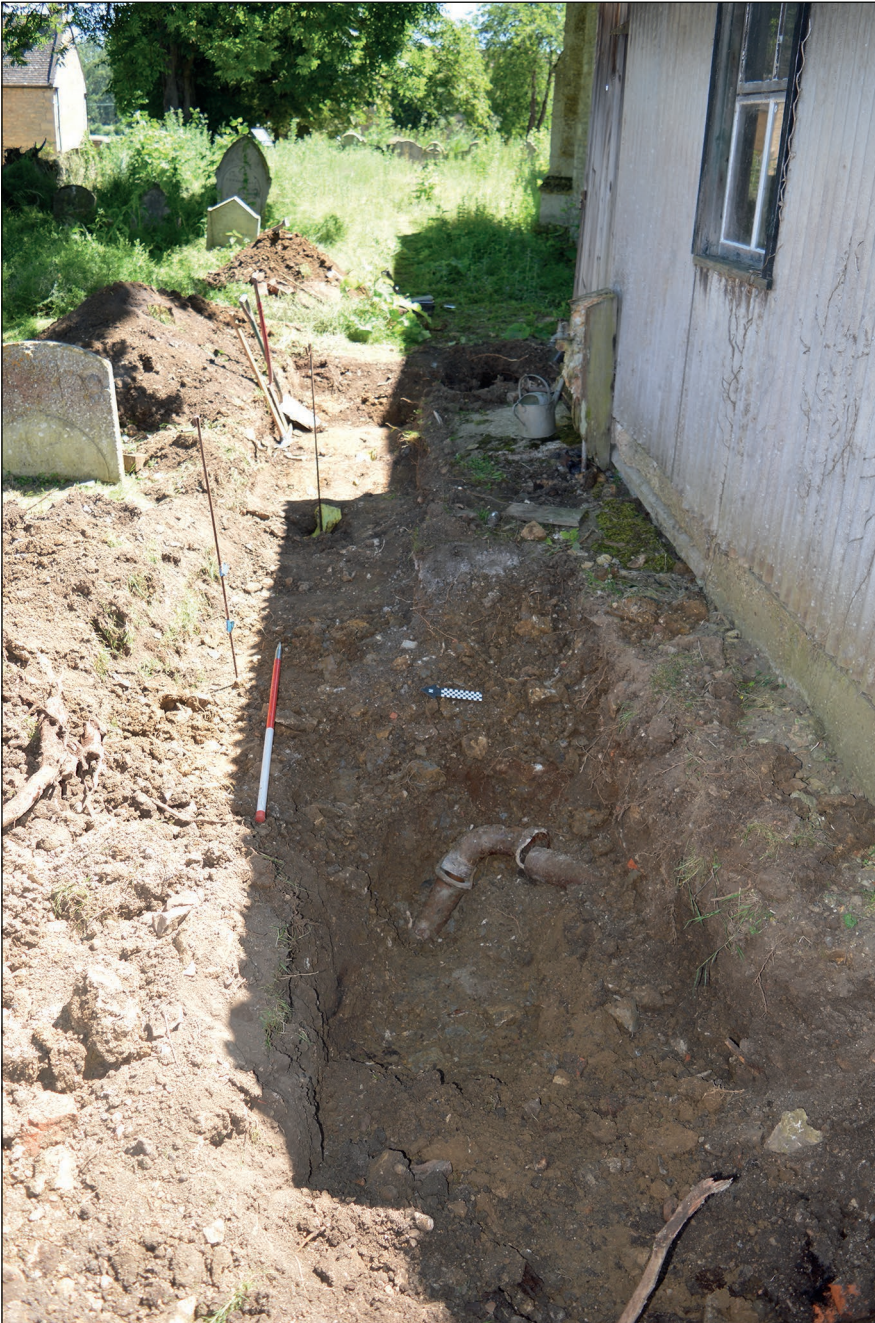
Plate 1: Trench looking east

- 2.1.1 A single cut foundation trench (Plate 1) in an 'H' shape configuration was excavated following the course of the footprint of the standing boiler house (Figure. 2) on the northern side of the church. The trench was aligned on an E/W axis.
- 2.1.2 The trench measured approximately between 15m to 18m long and 1m wide. The depth was recorded at between 0.6m and 1m along the whole of the trench.
- 2.1.3 The excavation was undertaken by a 6-ton tracked mini-digger fitted with a 1m wide toothless bucket. All machining was monitored by the author.
- 2.1.4 Where necessary, hand excavation was undertaken around standing masonry and possible archaeological horizons. The spoil was stored alongside the trench and was subjected to a metal detector survey. Numerous ferrous metal objects were present in the fill, but were not retained due to their early modern date.

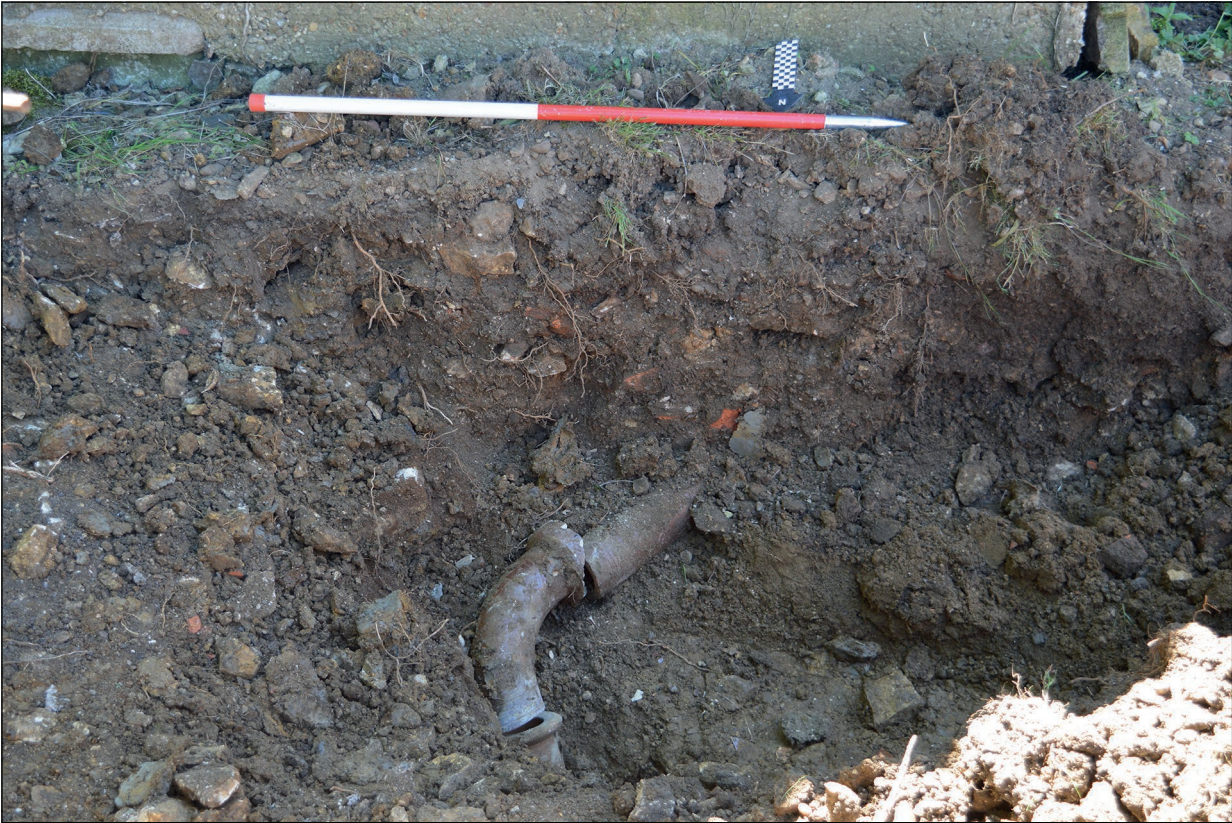
Plate 2: Made ground deposits looking south

- 3.1.1 The soil sequence observed in the trench was a uniformed mixture, comprising of backfilled subsoil and made ground deposits. The homogenised made ground deposit comprised of brick work and associated debris, ceramic pipe, ferrous metal and glass, with the backfilled soil being represented by a sandy silt, measuring between 0.6 and 1m thick (Plate 2). This was overlain by turf measuring 0.10m thick. The natural geology was not observed.
- 3.1.2 Ground conditions throughout the monitoring were good, and the trench remained dry throughout. The results are deemed to have a good level of reliability.
