# Royal Arsenal, Building 10 (Southern Blocks)

## Archaeological Observation and Recording Report

March 2020

**Client: Berkeley Homes Ltd**

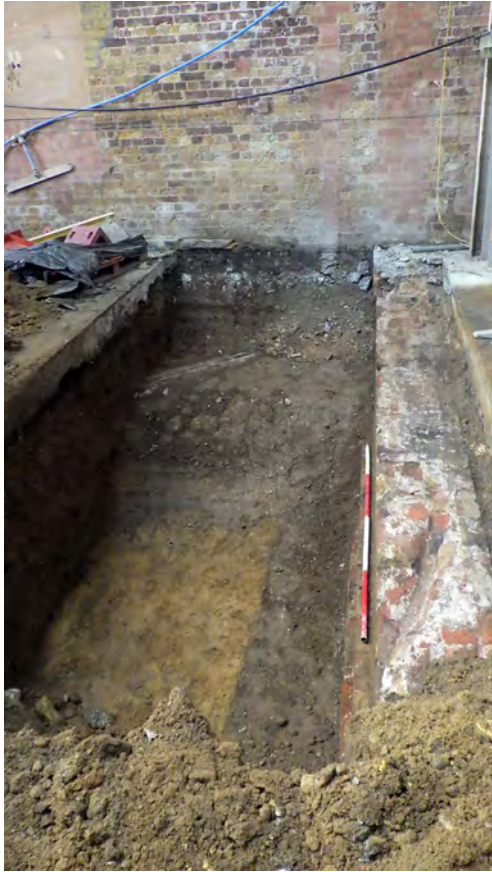
Plate 1: Wall 20169, view to S

3.3.1 Two NE-SW aligned brick walls (20160=20169 and 20183) ran at right-angles to the north and south walls of the existing building. Both walls originally formed part of the original 19th-century building, as repairs were visible on the internal wall of the existing building at the point where both walls joined them (Plate 1). The walls were both constructed with red and yellow frogged bricks bonded with light yellowish mortar, similar to the walls of the existing building. A narrow culvert (20161, Plate 2) was built into and ran alongside the western side of wall 20160.

- 4.1.2 Within Block 2, a number of brick walls and culverts were revealed. These are likely to have been contemporary with the extant building that was constructed in 1802-5 as part of Building B, which contained Royal Carriage Factory. Walls 20183, 20160/20169 and 20175 each correspond to internal dividing walls depicted on a plan of 1866 drawn by Colonel Sir H James. This depicts an 'Iron Store', as well as two smaller storage rooms, including an 'Oil Store', at the far east end of the building. Several intercepting culverts within this part of the building are likely to have been used to supply water, although a black deposit observed filling Structure 20157 that crossed the oil store could suggest other uses. It is likely that the internal layout of Block 2 was modified after its remodelling in c 1890 or perhaps at some part after, resulting in the demolition of the internal divisions at the east end of the building (OA 2008, 28-33).

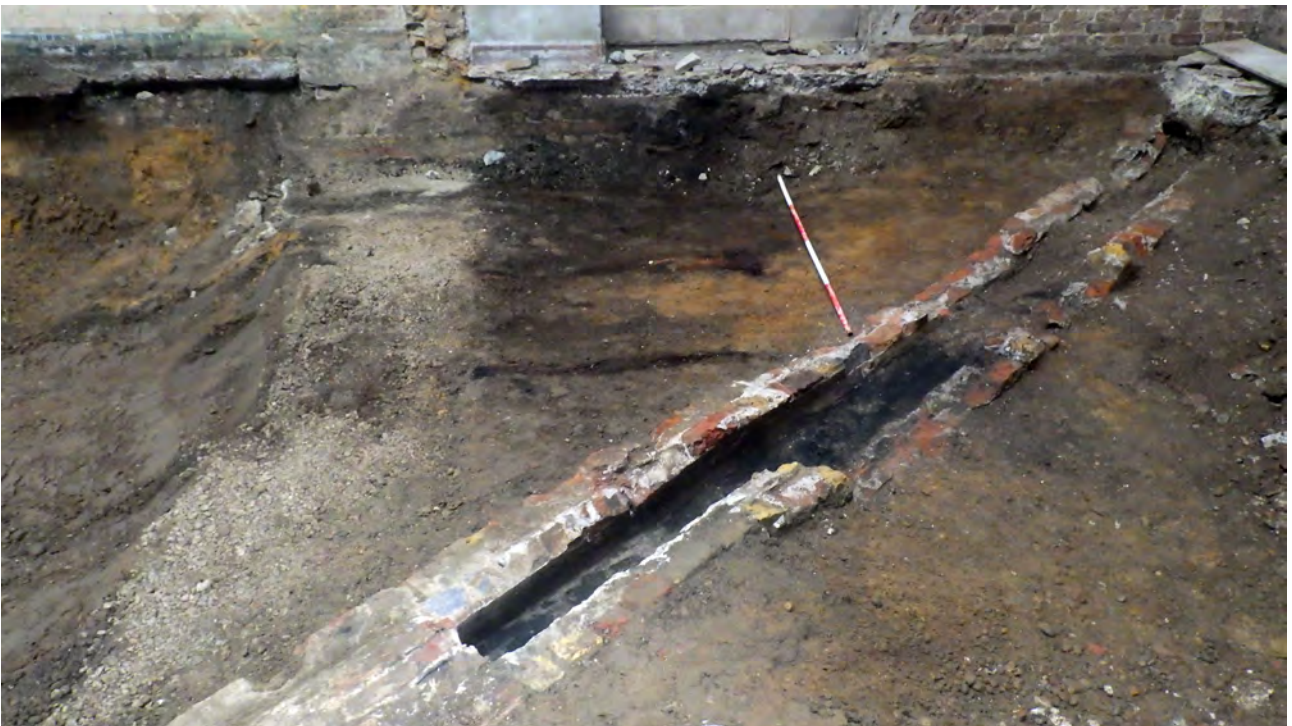
Plate 3: Timber sleeper remains 20158 and culvert 20157, view to N

3.3.4 The decayed remains of three equally spaced timbers (Structure 20158), set parallel and aligned with the north wall of the building, pre-dated structure 20157 (Plate 3). They were formed with rectangular cut timbers measuring 0.13m wide and up to 1.6m

in length. They possibly represented the remains of sleepers for a north-south aligned narrow gauge railway, of 19th century date. Their relationship with the extant building is unknown.

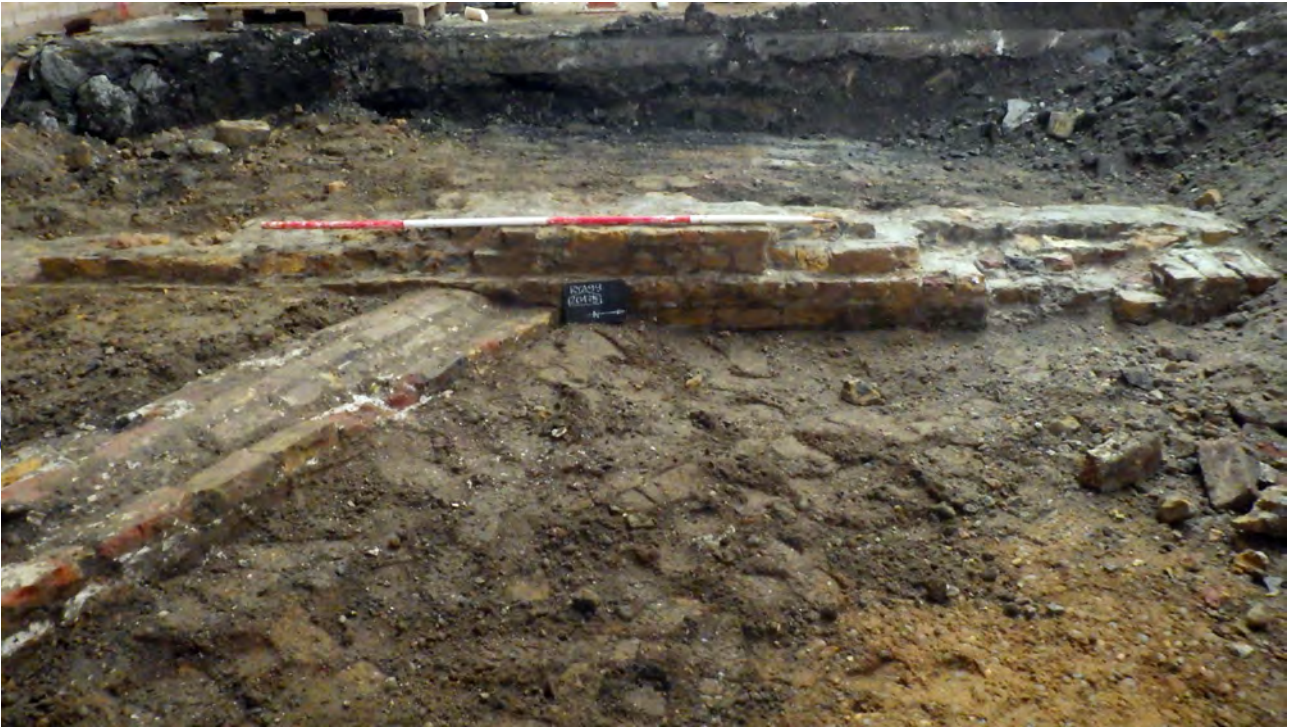
Plate 4: Wall 20175 overlying culvert 20174, view to N

3.3.3 A north-south wall (20175) arched over structure 20174 suggesting the culvert/flue was in use when the wall was constructed (Plate 4). The wall was of similar build to the other walls described above.

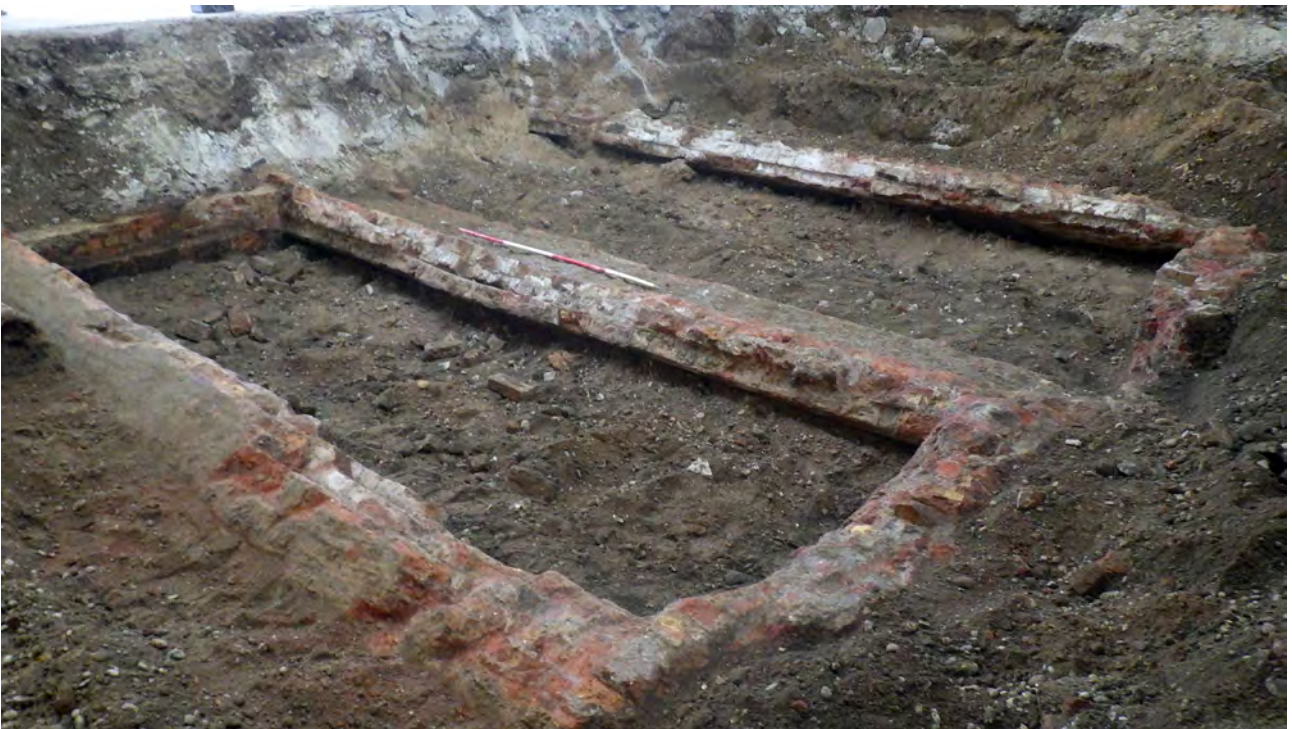
Plate 5: Cellars 20153 and 20154, view to SE

- 3.4.1 A pair of vaulted cellars (20153-55), which were delimited by and abutted a NE-SW aligned wall to their west (20050), were revealed. The cellars were both barrel-vaulted, the base of their springing vault arches surviving on top of the remains of the walls (Plate 5). The internal area of the north cellar measured 5.5m x 1.7m (18 x 5½ feet). The southern cellar was slightly wider at 2.2m (7 feet) but probably of the same length and both were at least 1.0m in depth. Wall 20150 probably delimited the eastern extent of a cellared building that had largely been destroyed. It survived to a height of at least 1.4m and had evidence for an internal division (Plate 6). All the walls were of a similar construction, 19th century frogged red brick, English bond course, bonded by light greyish mortar.

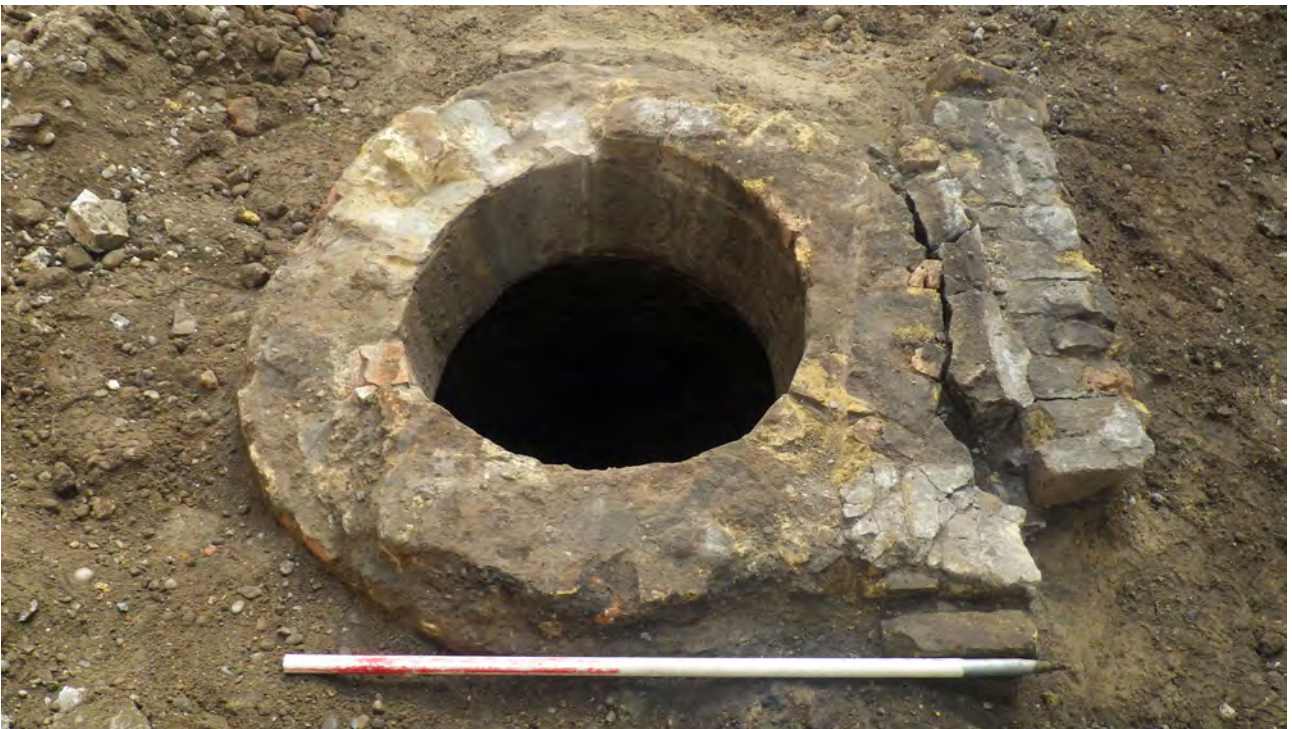
Plate 7: Well/soakaway 20156, view to E

- 3.4.2 To the west was a small circular brick-built soakaway or well (20156) that remained open for depth of c 6.0m (Plate 7). To the west were two brick-built soakaways (20185 and 20186), connected by a drain/culvert, possibly modern in date.

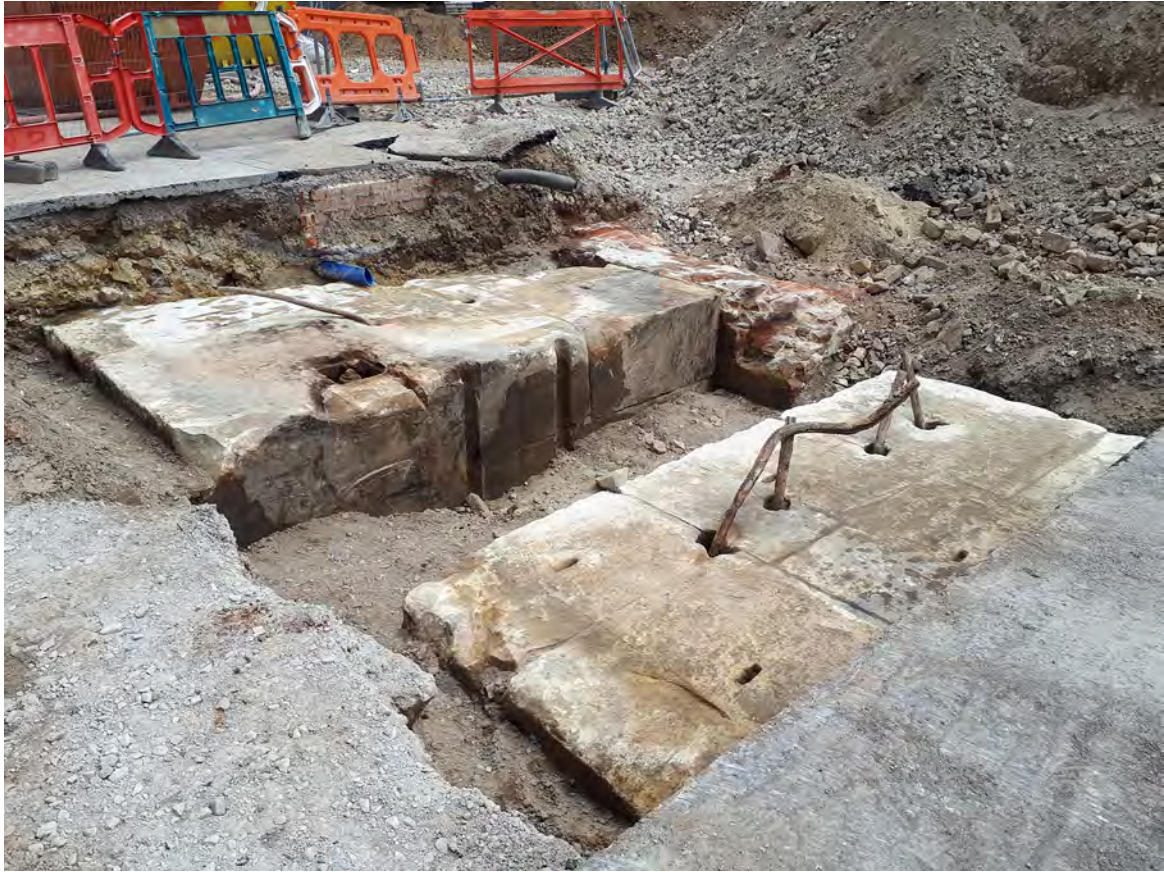
Plate 8: Stone structures 20187 and 20189, brick wall 20190, view to SW

- 3.5.1 A contractor excavation with Block 1L revealed a pair of massive rectangular stone-built structures (20187 and 20189), likely to represent machine bases (Plates 8 and 9). They were spaced 1.50m apart. The full dimensions of the western structure (20187) were partially exposed by the investigation, which revealed the structure to be 5.77m long and 3.17m wide. The eastern structure was of a similar width and was at least 2.10m in length. Both were constructed with large well-finished ashlar-like sandstone blocks (56¼ x 48 x 24 inches) bonded by creamy lime flecked mortar with grey Portland cement repairs. The gap between the two structures was emptied to a depth of 2.44m which revealed that both structures had a stepped foundation. There were a number of small regularly spaced rectangular slots on the surface of both structures, together with a pair of deep, parallel grooves running vertically down the west face of Structure 20189. In addition, there was a row of four larger holes on the surface of 20187, each attached to a length of iron rod. Structure 20189 also had two small cast-iron fittings inserted into its surface, which along with the above probably were associated with the fitting of machinery which the blocks once supported.

- 3.5.2 The possible machine bases appear to have been contained within a brick-built structure defined by wall 20191 to the west and wall 20190 to the south. Both were quite substantial, measuring 0.70m-0.75m in width and constructed with 19th century red and yellow frogged bricks bonded by light greyish lime mortar.

- 4.1.4 The large stone structure within Block 1L is likely to form the base or plinth that supported a substantial piece of machinery that was utilised for the carriage works. As such its position corresponds with the location of an 'Engine Room' depicted on the 1866 plan which shows that it formed part of a 'Boiler House'. The stone work abutted brick walls to the south and west that correspond closely with the outline of the boiler room. These were additions to Block 1L that formed part of the southern side of the original primary quadrangle that was constructed in 1802-5. This engine room was probably added in the Crimean period expansion at the Arsenal during the 1850s (*ibid.*, 25 and fig. 12).
