# SCR Lift Installation, SCR Lift Installation, Merton College, Oxford Historic Building Recording

February 2018

Document Type: Historic Building Recording

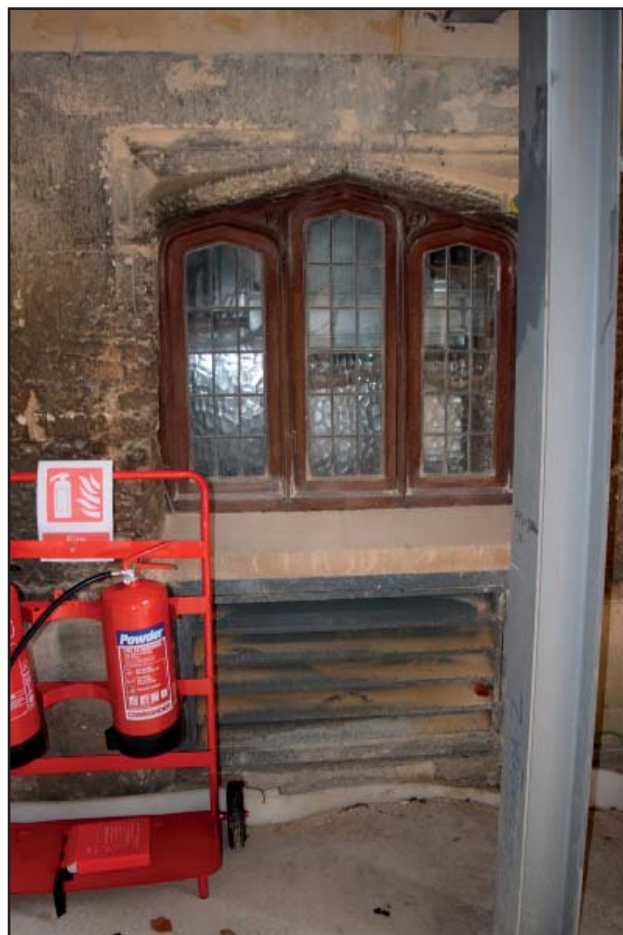
Plate 2: View of ground floor window inserted into former corridor opening to Mob Quad in 1960

3.2.3 The window to the south is located within a former arched entrance which provided access to a passageway leading to Fellows Quad and was blocked up during works to Patey's Quad in the 1960s. The window inserted has three lights with leaded glazing and the frame is timber with moulded detail and the date of the window construction on the spandrels '1960'. Beneath the window is a large ventilation louvre. Aside from the inserted sill for the window the stonework appears original.

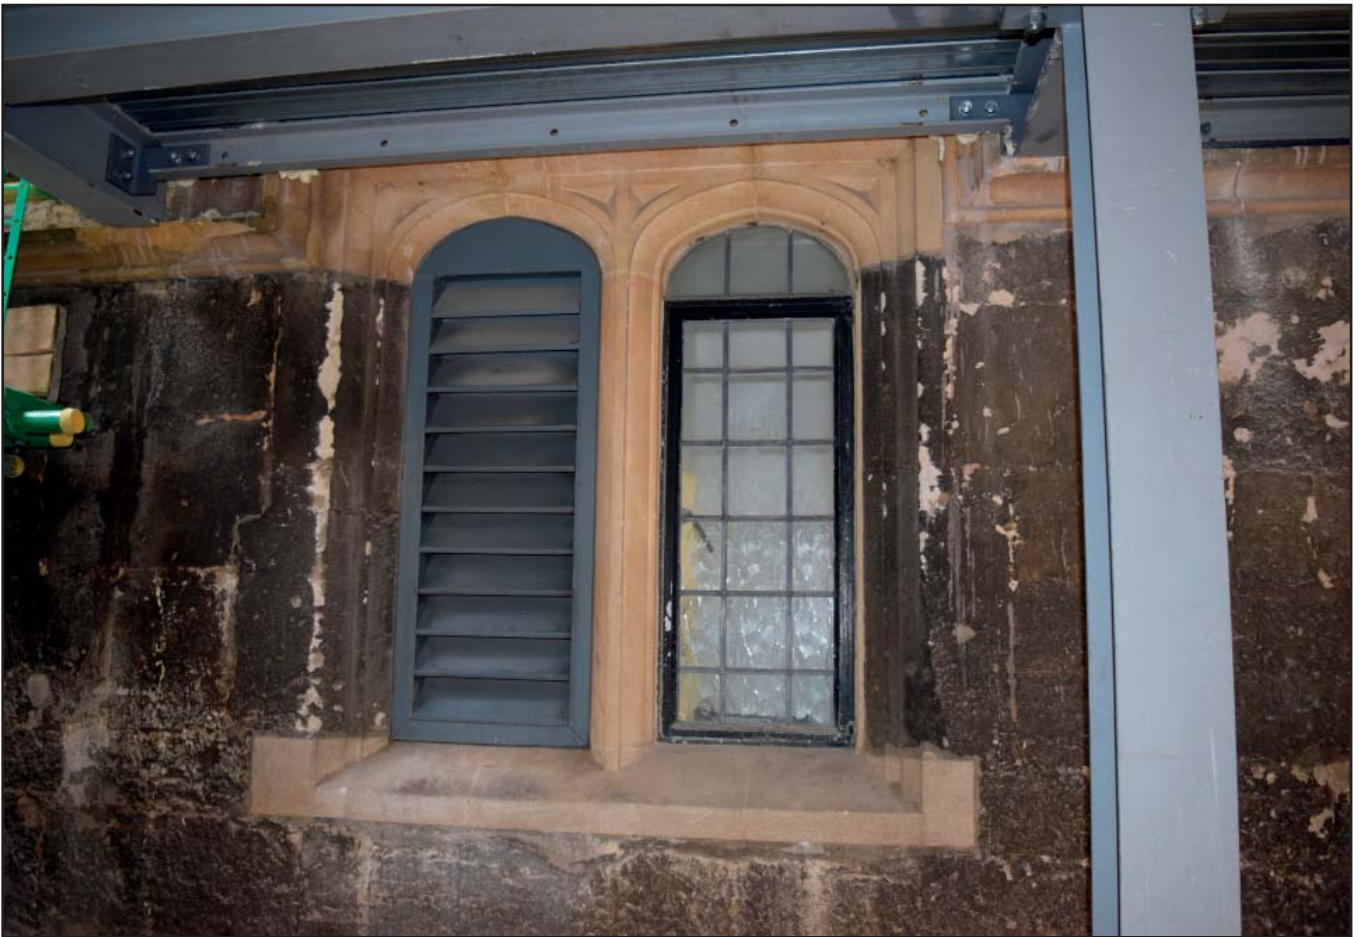
Plate 3: View of northern ground floor window

3.2.1 No invasive works were carried out on the ground floor, which is currently configured as a potwash for the kitchen above, however the new extension housing the lift structure enclosed two ground floor windows. The northernmost window is a stone window with central mullion and two 4-centered arch openings. The northern opening has been replaced with wood louvre ventilation shuttering and the southern opening contains a rectangular multi-light leaded casement with fixed 3-light window above.

3.2.2 The mullion, sill and much of the lintel stonework has been replaced in the mid to late 20<sup>th</sup> century. Beneath this window is a decorative plinth of a slightly greyer coloured limestone with moulded coping.

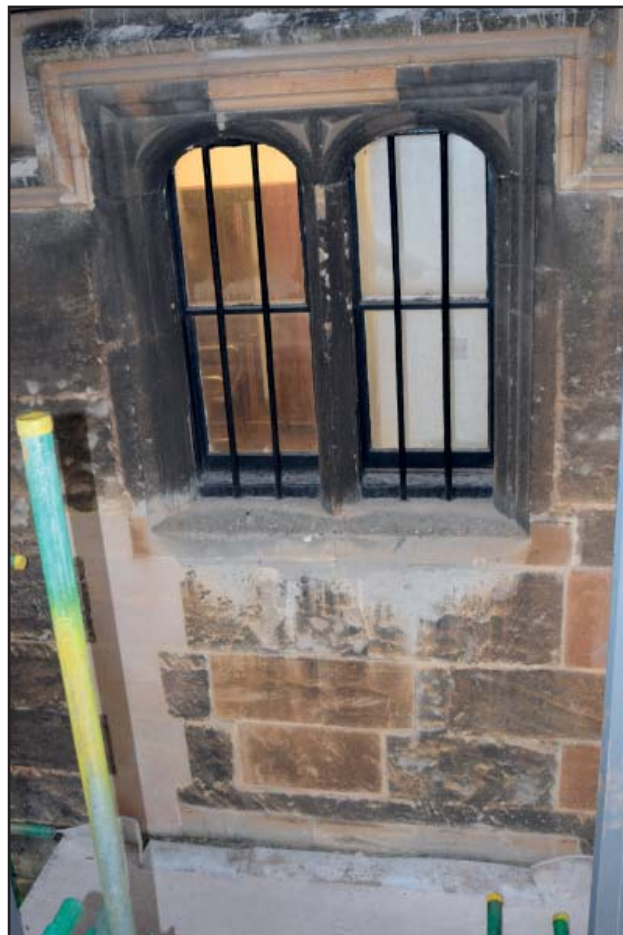
Plate 4: View of first floor window

3.3.2 The window within this area is a 17<sup>th</sup> century stone window which is barred from the outside with vertical bars. The window has two lights with four centered arches over and moulded detail around the openings. The stonework is entirely hidden behind a wood frame containing two 2-light sash windows of early 20<sup>th</sup> century date. The reveal for the window is not symmetrical reflecting the awkward position of the opening in the present kitchen configuration and internal space adjacent to this window is covered with plastic sheeting which covers the wall beneath and obscures any features. Externally the window has moulded jambs, a square hood mould over and is surrounded by dressed stone walling, some of which dates to the 1960s refacing works. A small masons mark could be seen on an external ashlar stone (Plate 23).

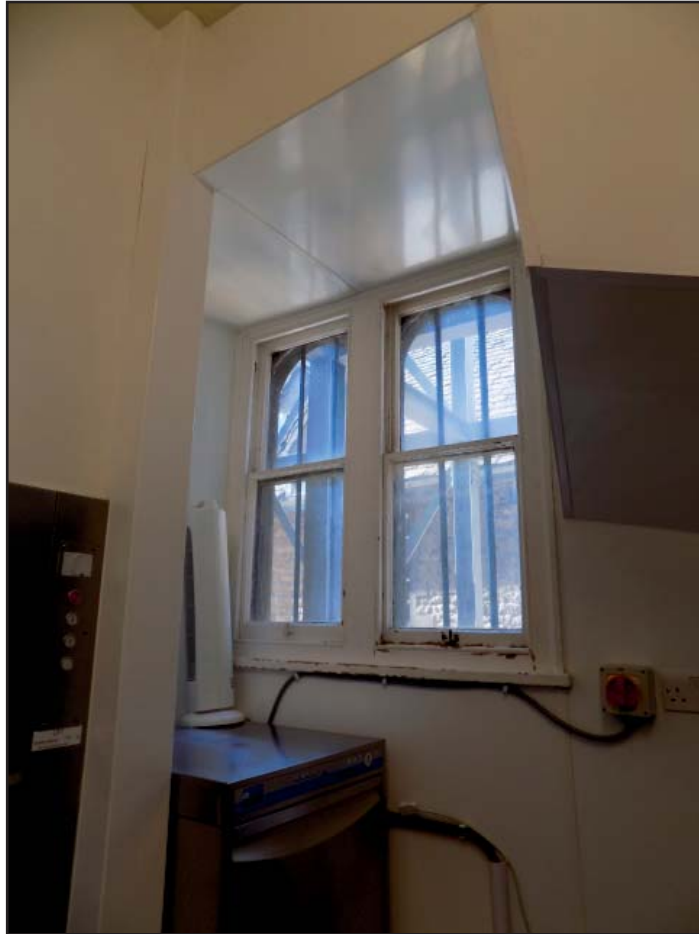
Plate 7: Internal view of first floor window

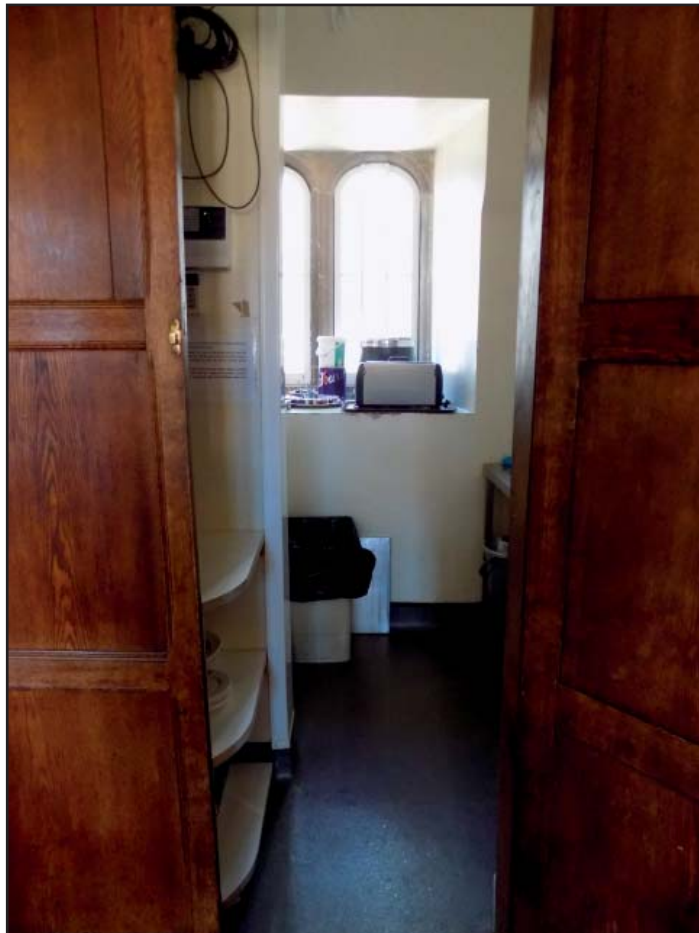
Plate 8: Internal view of second floor window

3.4.4 Behind the wooden screen doors is a small pantry with modern fixtures including a hoist. The main feature of this room is the 17<sup>th</sup> century stone window which is barred from the inside with vertical bars.

3.4.5 The window has two lights with four centered arches over and, apart from the simple rounded moulded detail around the openings, the stonework is unadorned. Each opening has a wooden frame with two lights which are non-opening. The reveal for the window is not symmetrical reflecting the awkward position of the opening which is probably part of the 20<sup>th</sup> century reconfiguration of the kitchens. Externally the window has moulded jambs (Figure 9), a square hood mould over (Figure 10) and is surrounded by dress stone walling.

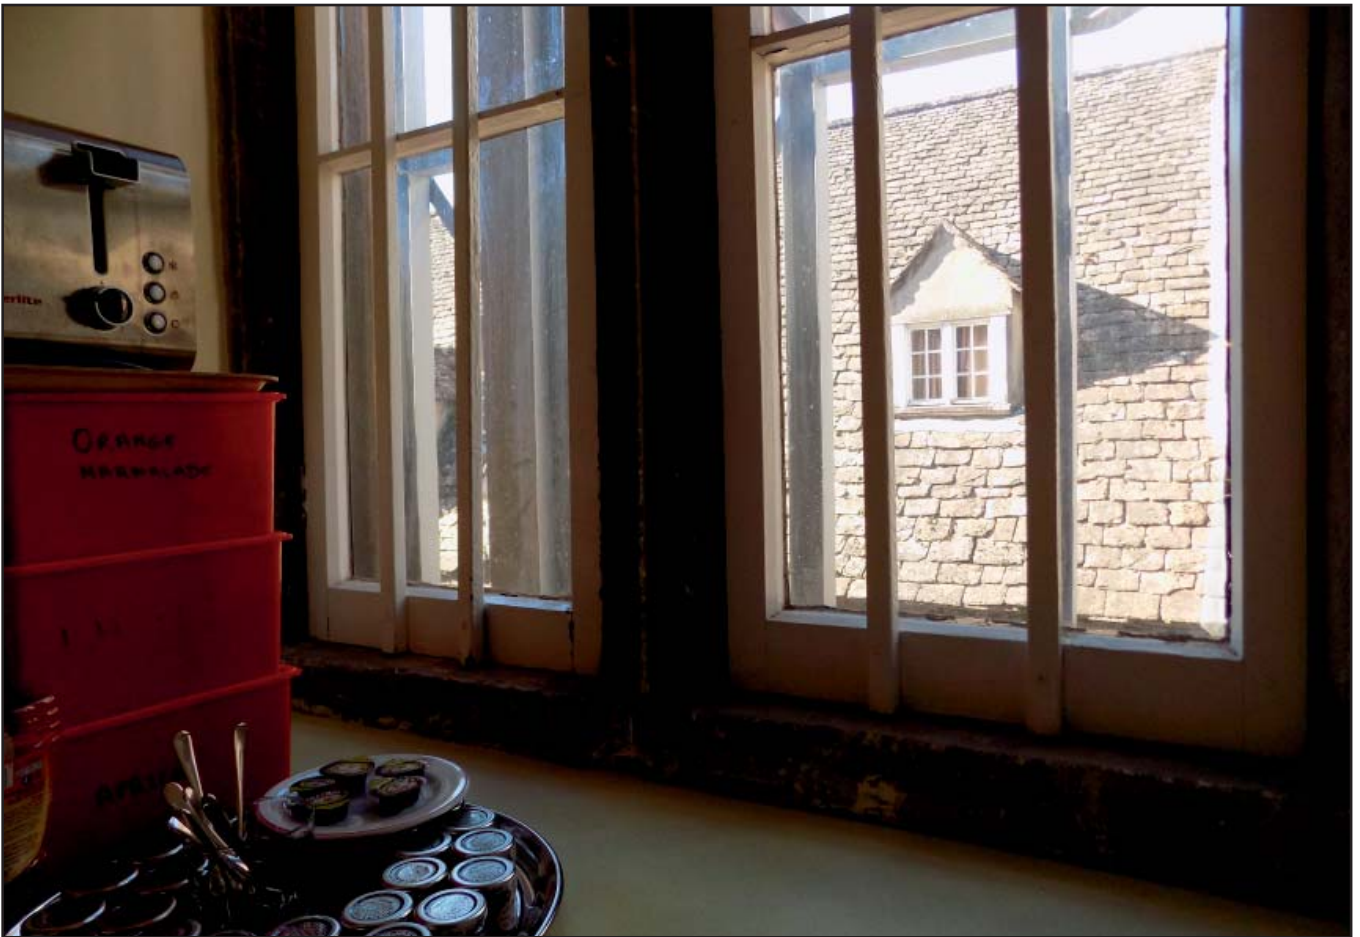
Plate 9: Detail of first floor window moulding and bars

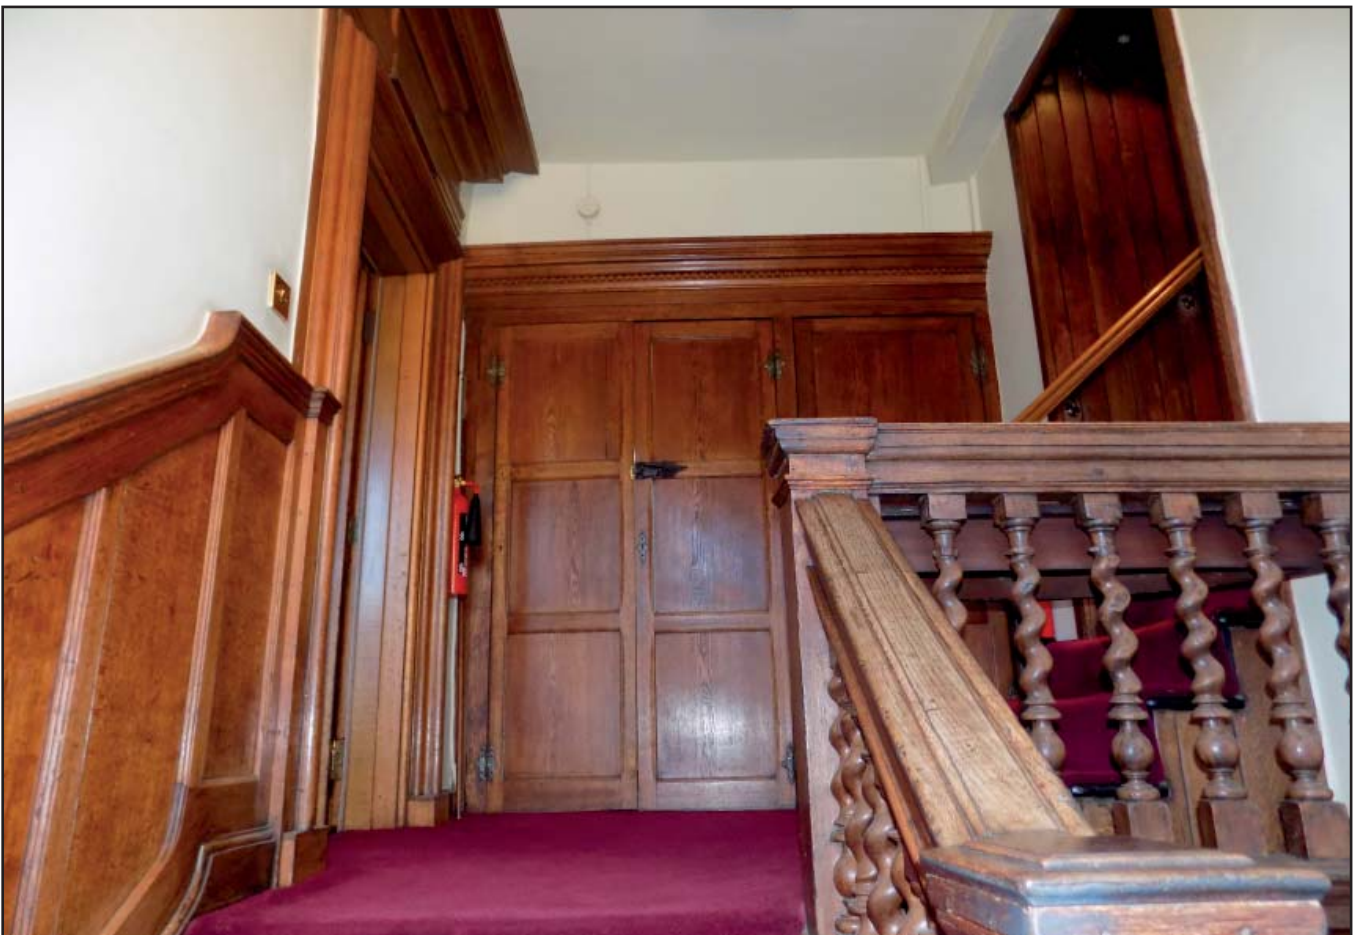
Plate 10: View of second floor joinery screen

3.4.2 The screen is formed of three sections of recessed panelled doors with moulded cornice detail over. The doors date to the late 19<sup>th</sup> or early 20<sup>th</sup> century, however the corncicing and timber frame behind the doors are mid 20<sup>th</sup> century indicating the screen was inserted here during the 1960s works. The entrance to the pantry is via the two smaller width doors and the remaining door is wider and opens to reveal the rear of the horizontally boarded wall within the pantry. The space within the frame behind the door is used for storing small cleaning items.

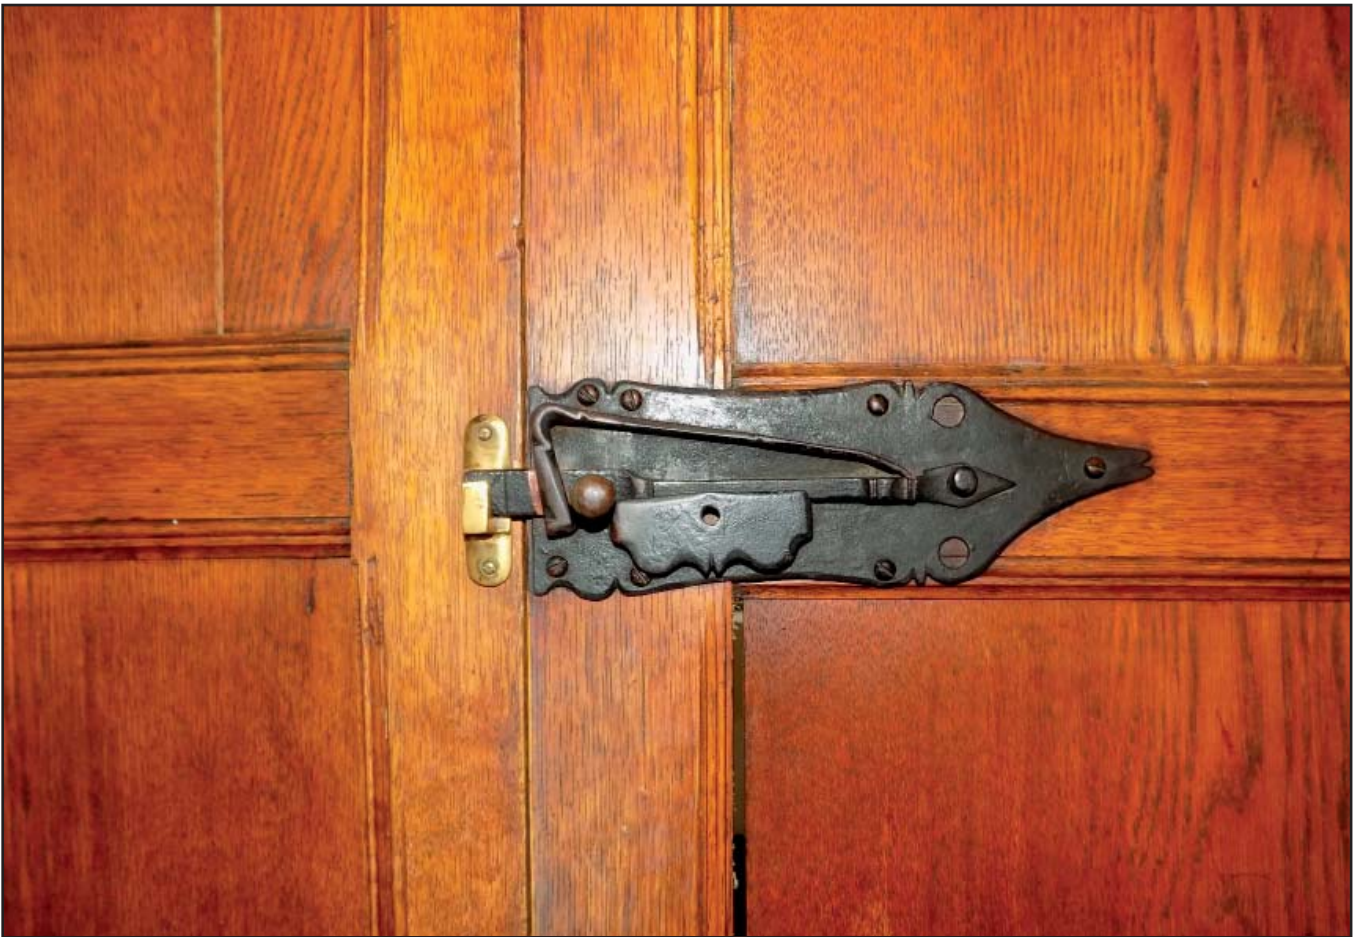
Plate 11: Detail of second floor joinery screen latch

3.4.3 The doors have an elaborate metal spring latch and the hinges are H-hinges with keyplates in a similar style. The doors have been reused from elsewhere in the college or reset as on the southern door there is evidence of former hinge location on the edges of the shutting stiles and there is a keyhole in the same side as the hinges. This keyhole is without a keyplate, although nearby nail holes suggest one was formerly in situ. There is an extant keyplate on the central door and on the wider door to the north, the height and placing of which closely match the missing one from the former keyhole. These doors will be reused as part of the works.

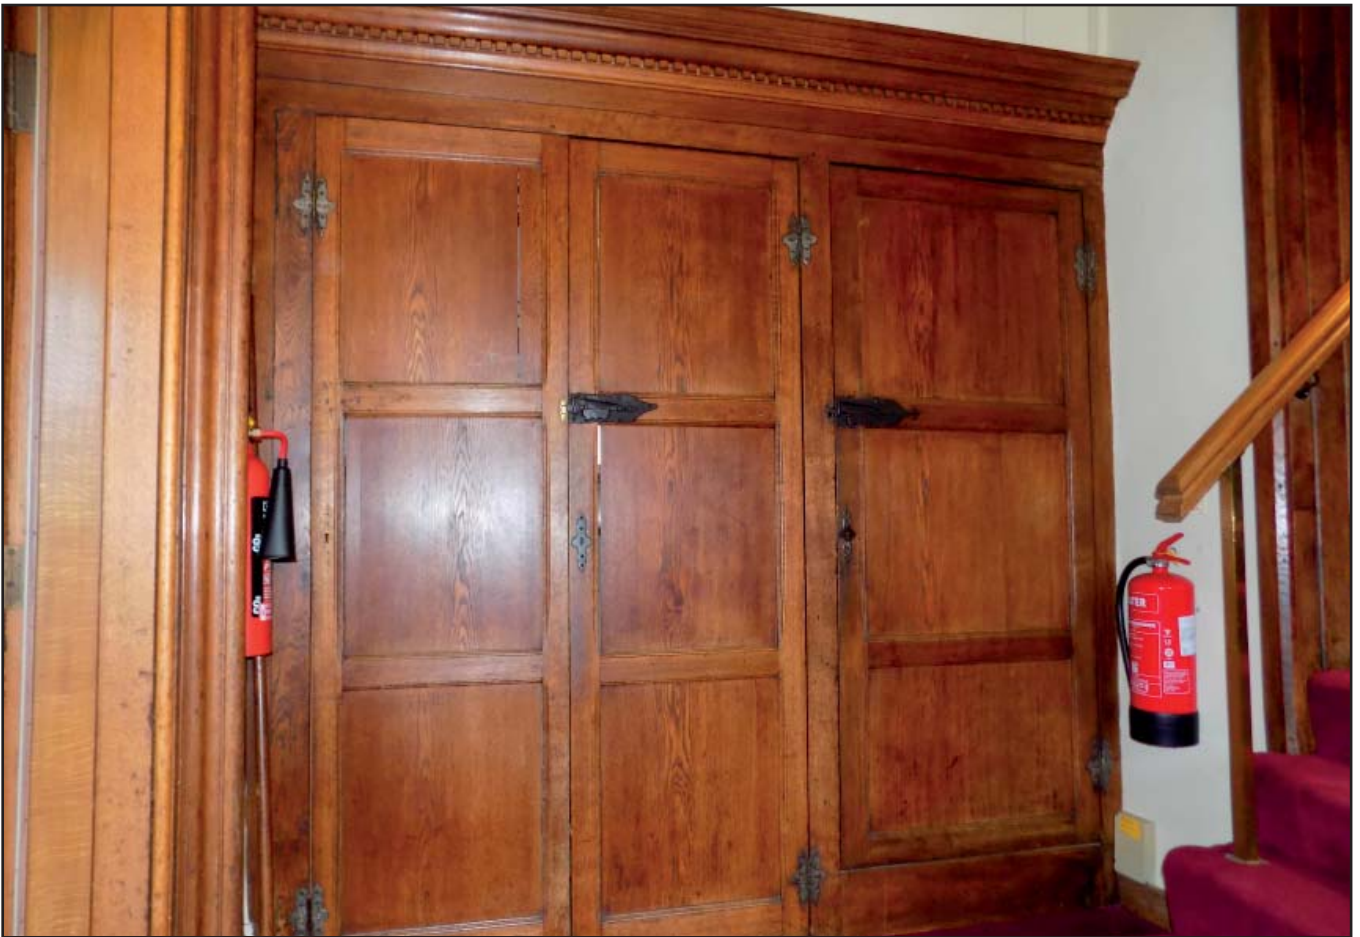
Plate 13: View of second floor joinery screen

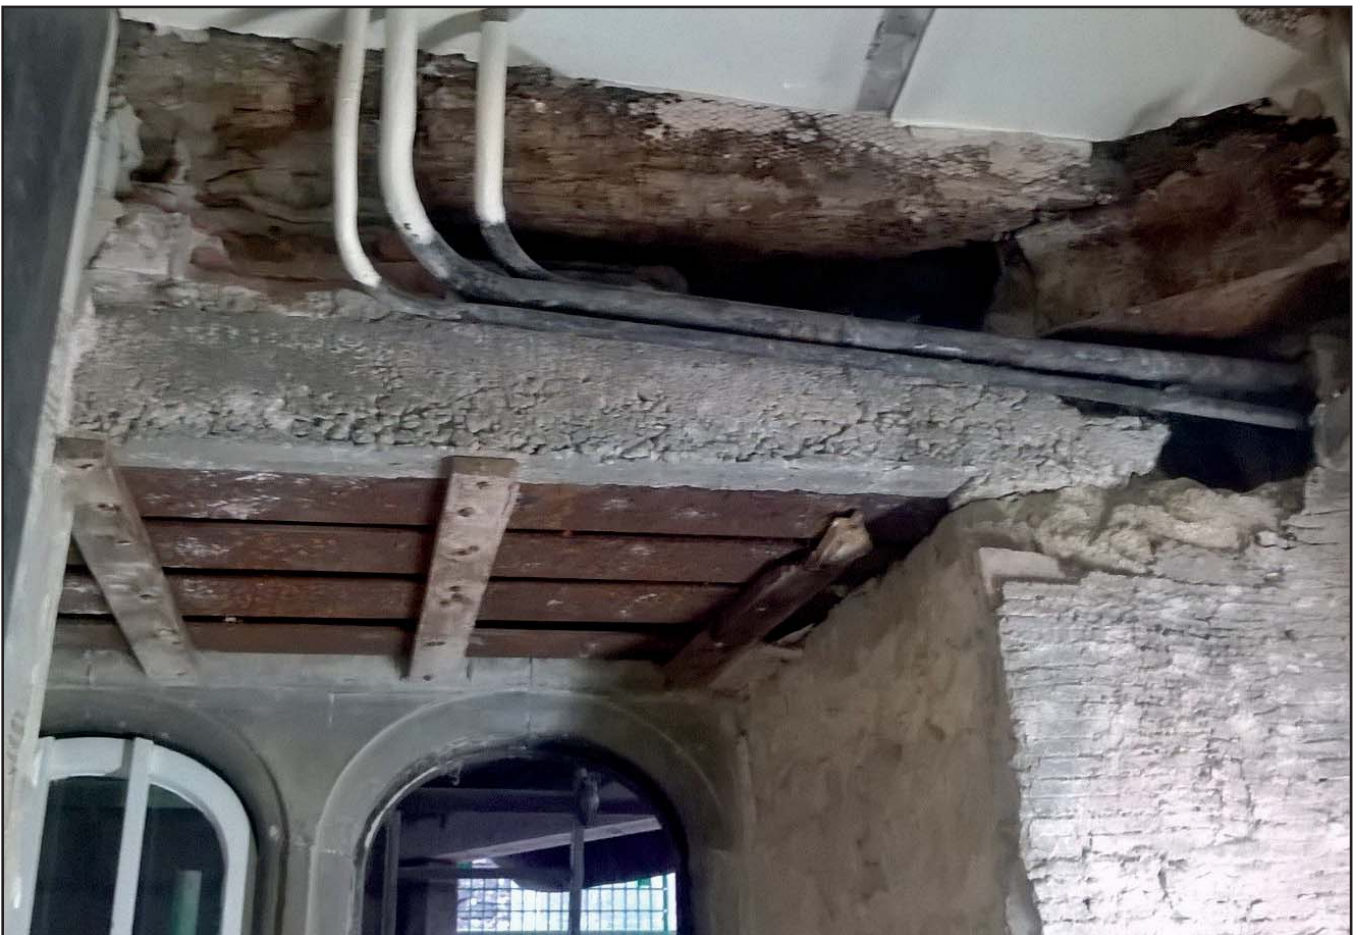
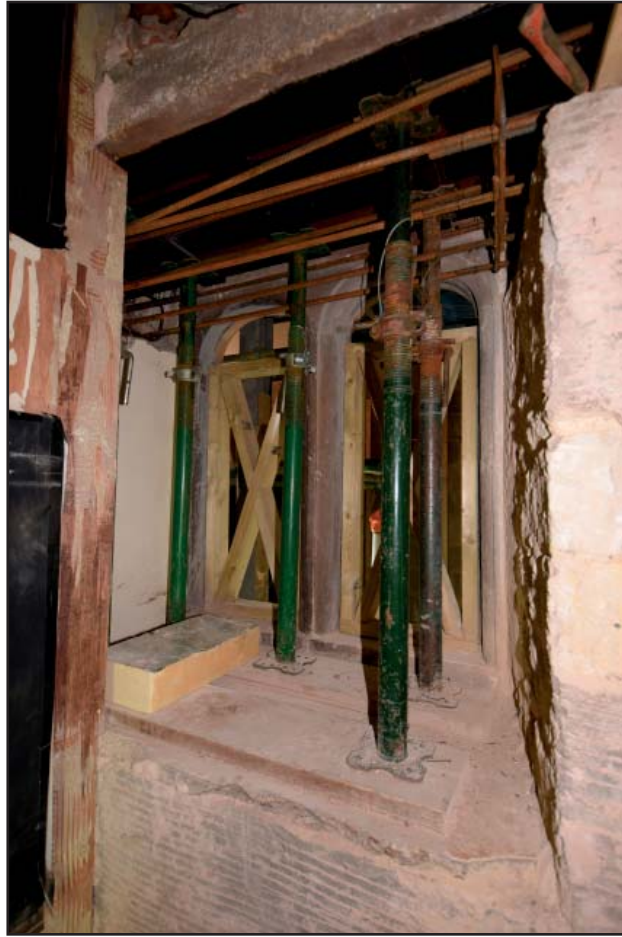
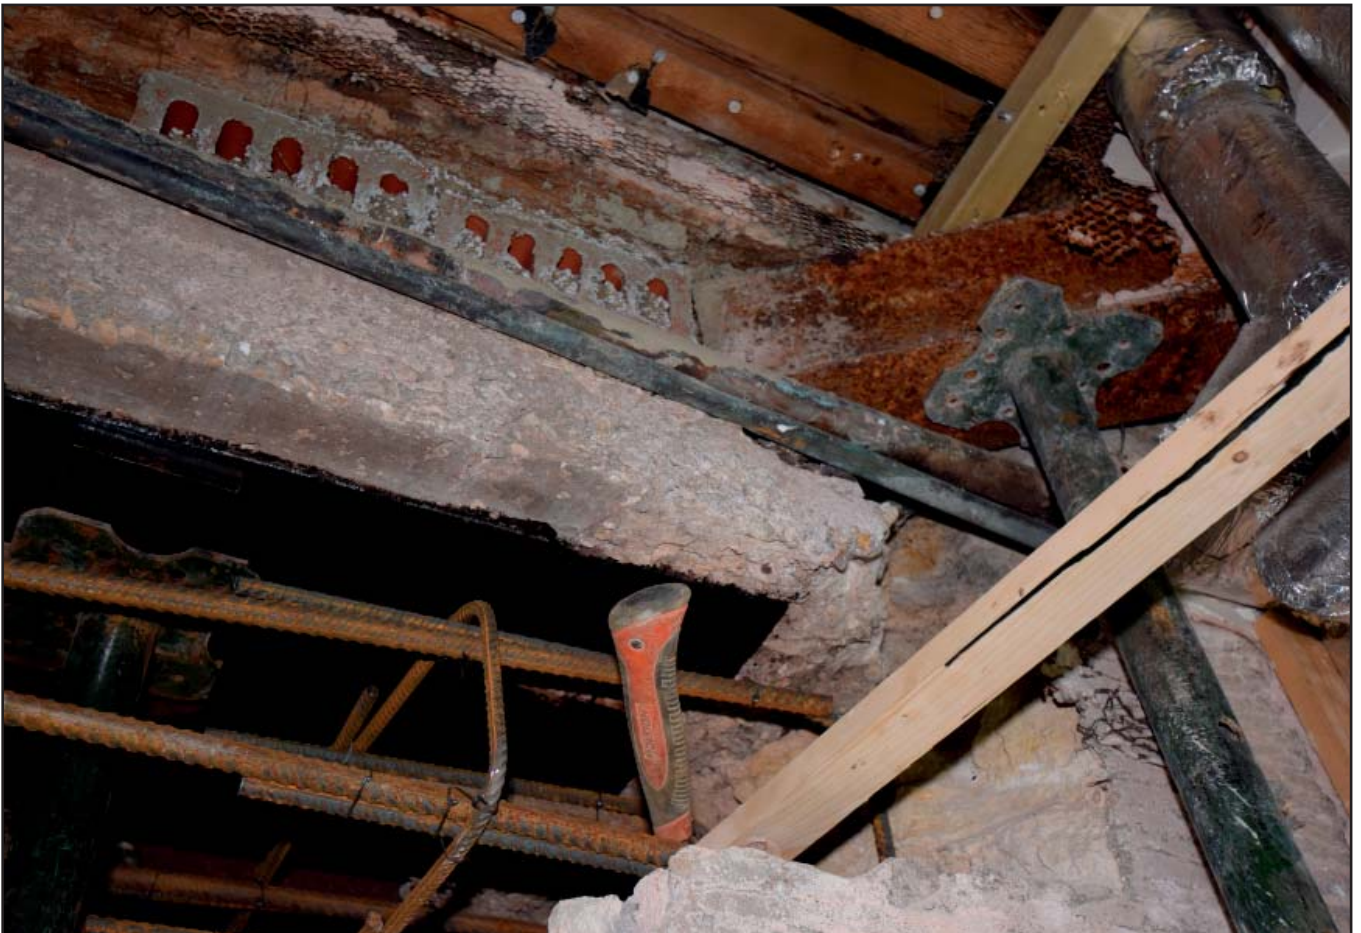
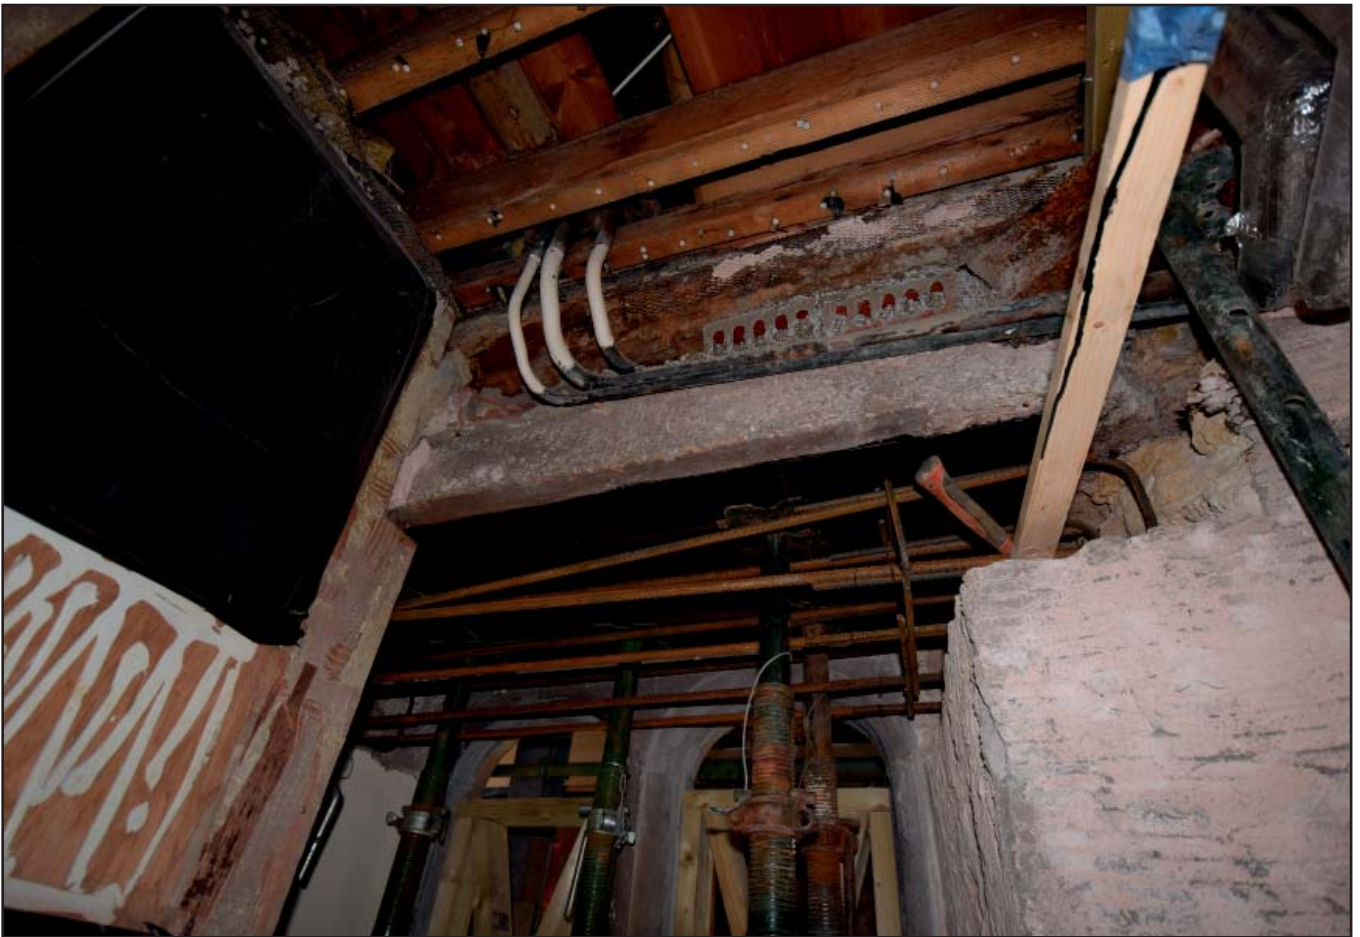
Plate 14: Second floor window following removal of modern material

Plate 15: Second floor window following removal of modern material

Plate 16: Second floor window following removal of modern material

Plate 17: Second floor window following removal of modern material

3.4.6 The window was removed during the works to allow access from the lift to the second floor. The works revealed the stone facing to be unusually shallow at an average of 10cm depth with a rubble core behind which included some fairly large, irregular stones (10-45cm x 3-10cm). The mortar seen was a very pale cream friable lime

mortar with occasional inclusions. The internal face of the stonework was mostly covered in a hard grey/white coloured render and larger blocks of dress stone were seen at the edge of the reveal. The lintel of the reveal was seen during the works and was of timber with frassed ends.

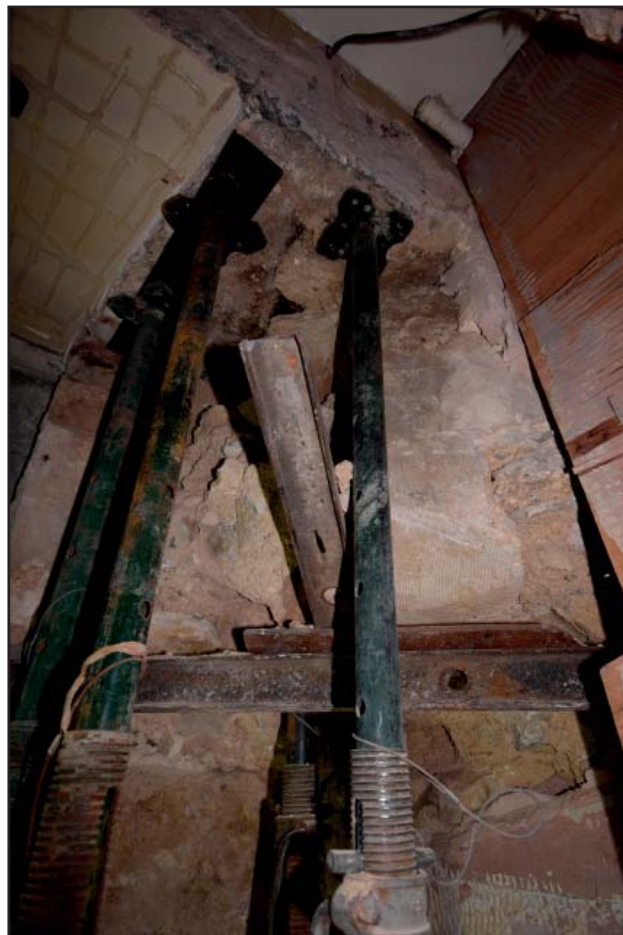
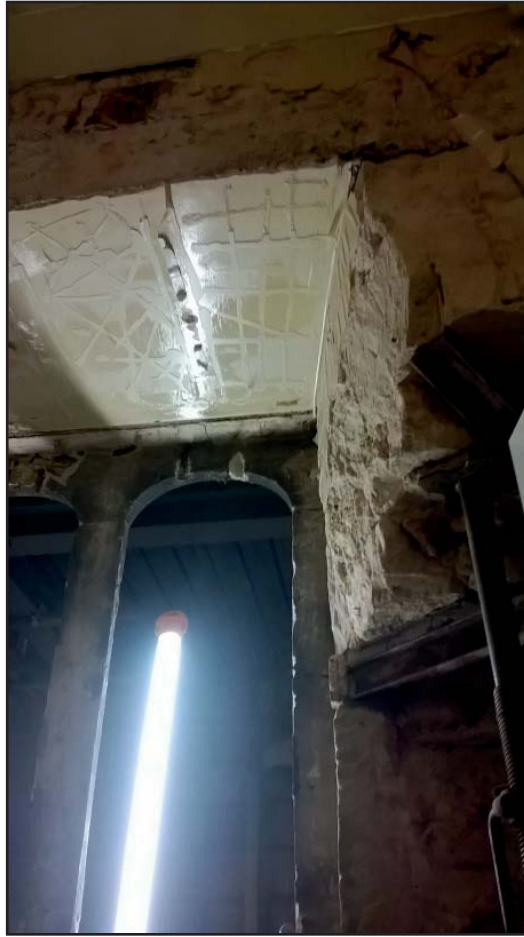
Plate 18: First floor window following removal of modern material

Plate 19 : First floor window following removal of modern material

3.3.4 The window was removed during the works to allow access from the lift to the second floor. The works revealed the stone facing in the reveal and under the window to be between 15cm and 57.5cm depth with a rubble core behind which included some fairly large, irregular stones. The stone around this window was unusually friable at the edges. The mortar seen was a very pale cream friable lime mortar with occasional inclusions. The internal face of the stonework was mostly covered in a hard grey/white coloured render and larger blocks of dress stone were seen at the edge of the reveal. The lintel of the reveal was seen during the works and was of concrete with a large amount of mixed stone inclusions, metal supports were seen within the stonework further indicating the reveal had been rebuilt at some point probably during the 1960s works.

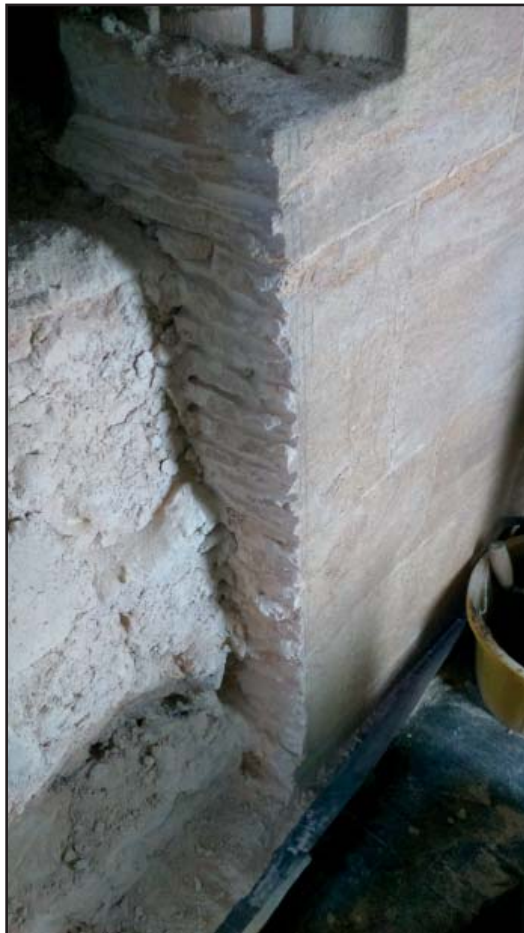
Plate 20: Detail of first floor window showing depth of worked stone and rubble core

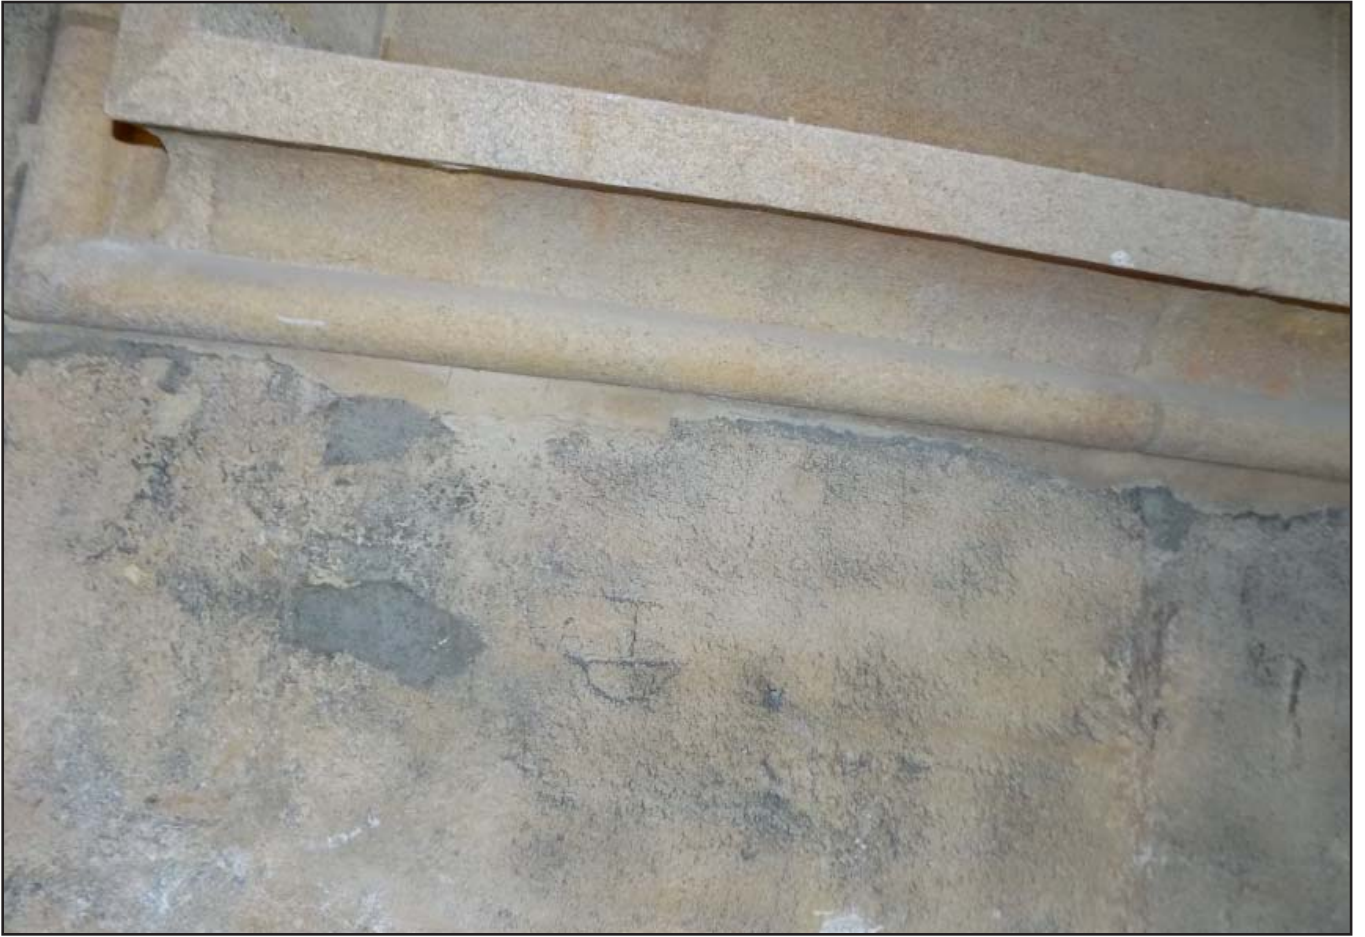
Plate 23: Detail of masons mark on 2nd floor of external elevation
