St. Cross College
West Quad
Oxford

**Watching Brief and
Building Recording**

March 2015

Client: Oxford University Estates

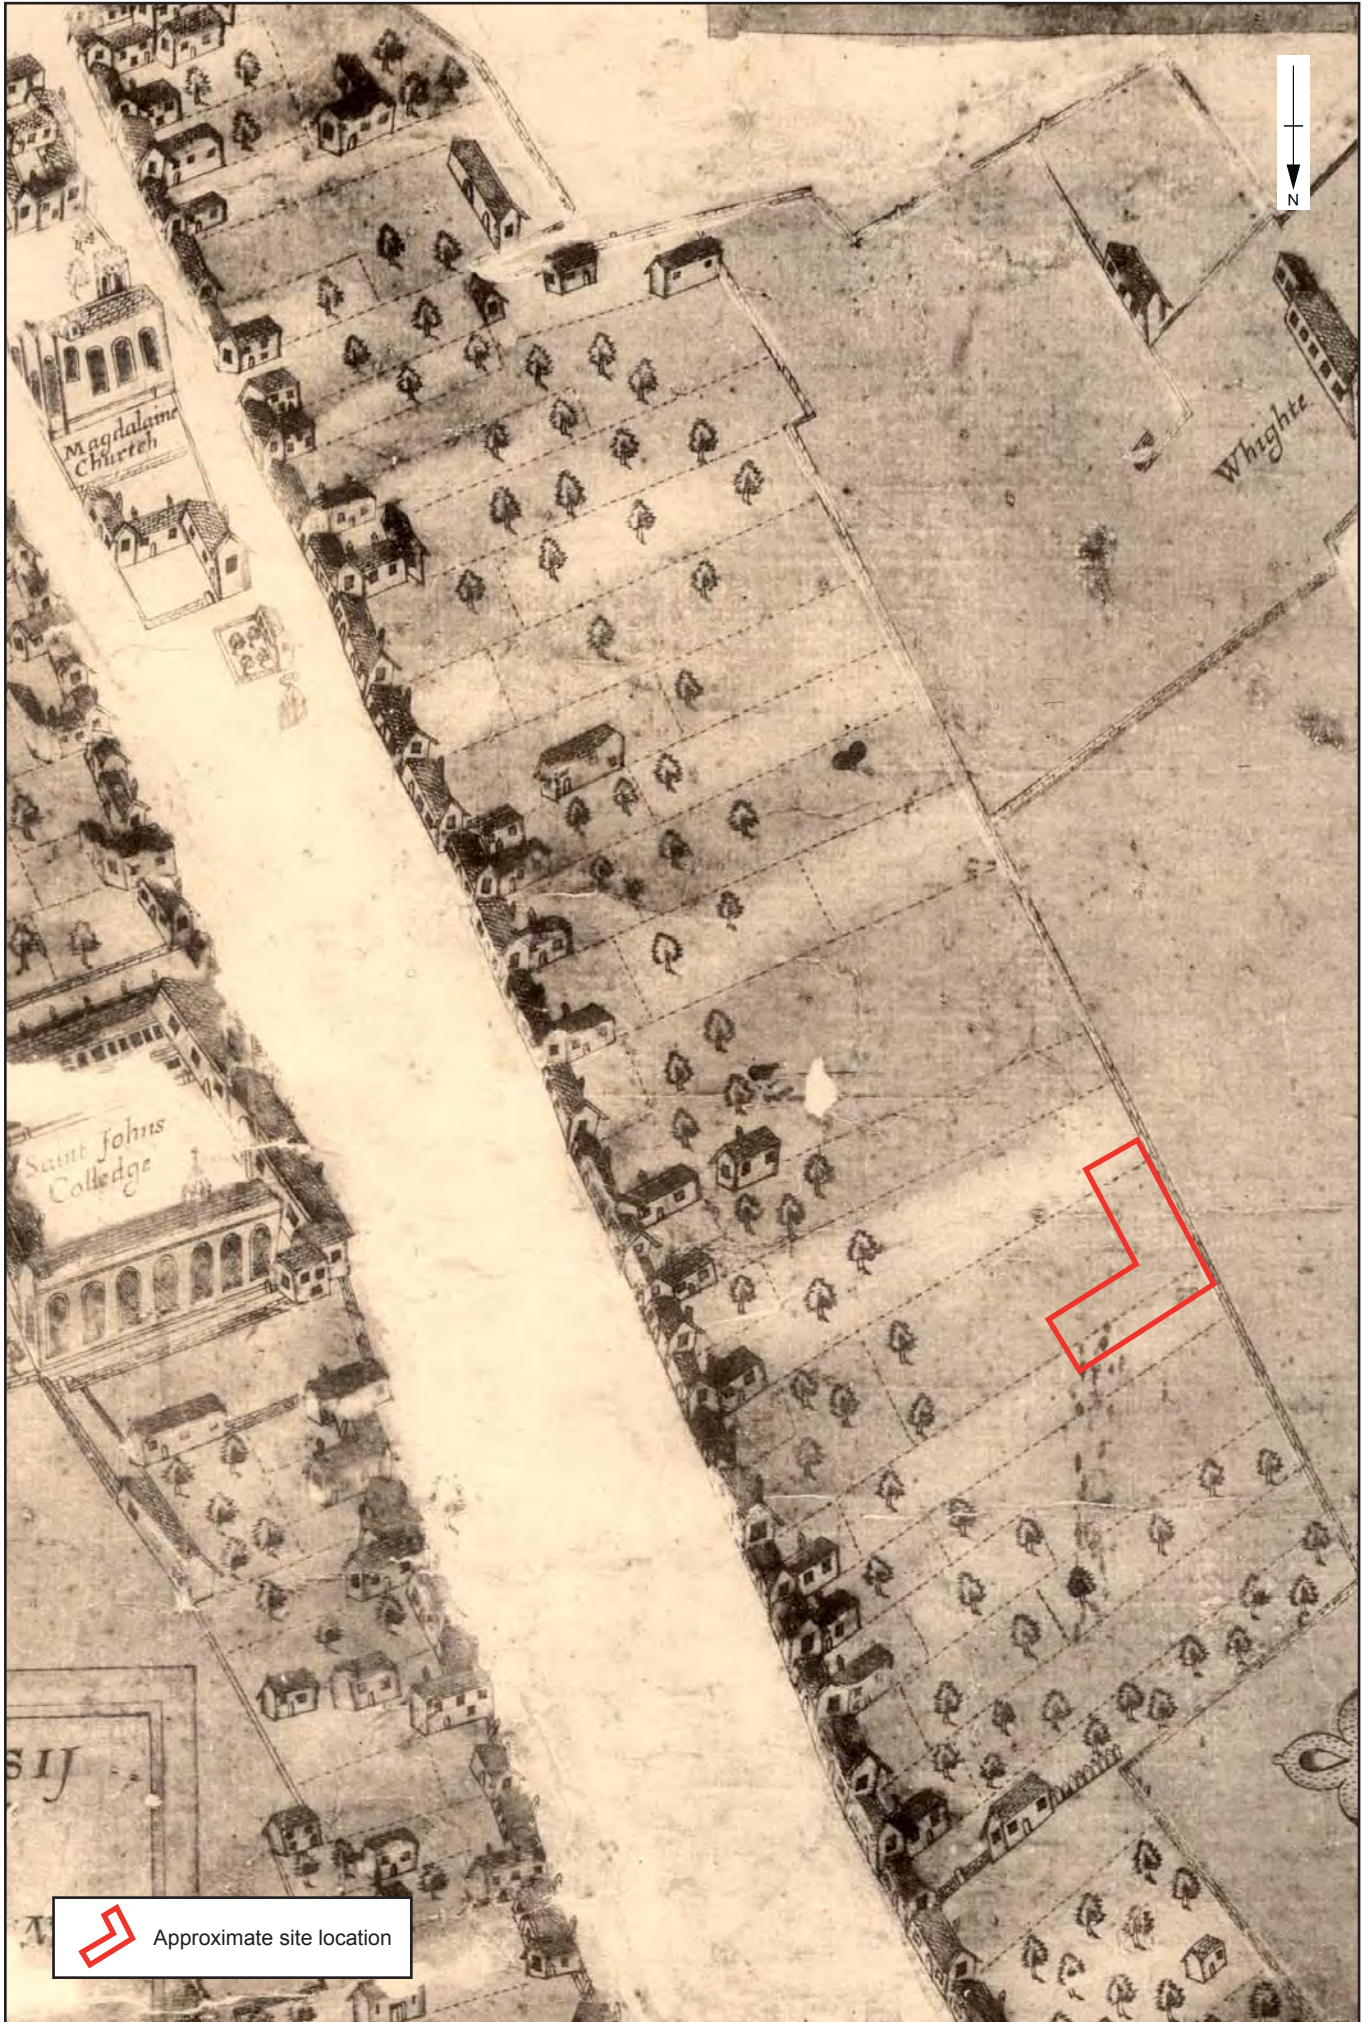
Figure 3: Agas' Map of Oxford 1578

2.2.1 (**OA 94a**) appears as a boundary on Agas' Map of Oxford, 1578 (Figure 3), and as a wall on Loggan's Map of 1675 (Figure 4), and Hoggar's Map, 1850 (Figure 6), running into the buildings that faced onto St. Giles at the time. It is shown to follow the line of the parish boundary from Hoggar's 1850 map onwards.

2.2.3 The Grade II Listed wall that runs north to south along Pusey Lane (**OA 14**) is on the same alignment as the late medieval boundary wall of the Beaumont Estate and some fabric may date to this period. This boundary on Agas' Map of Oxford, 1578 (Figure 3), and as a discernible boundary on all subsequent maps of the area.

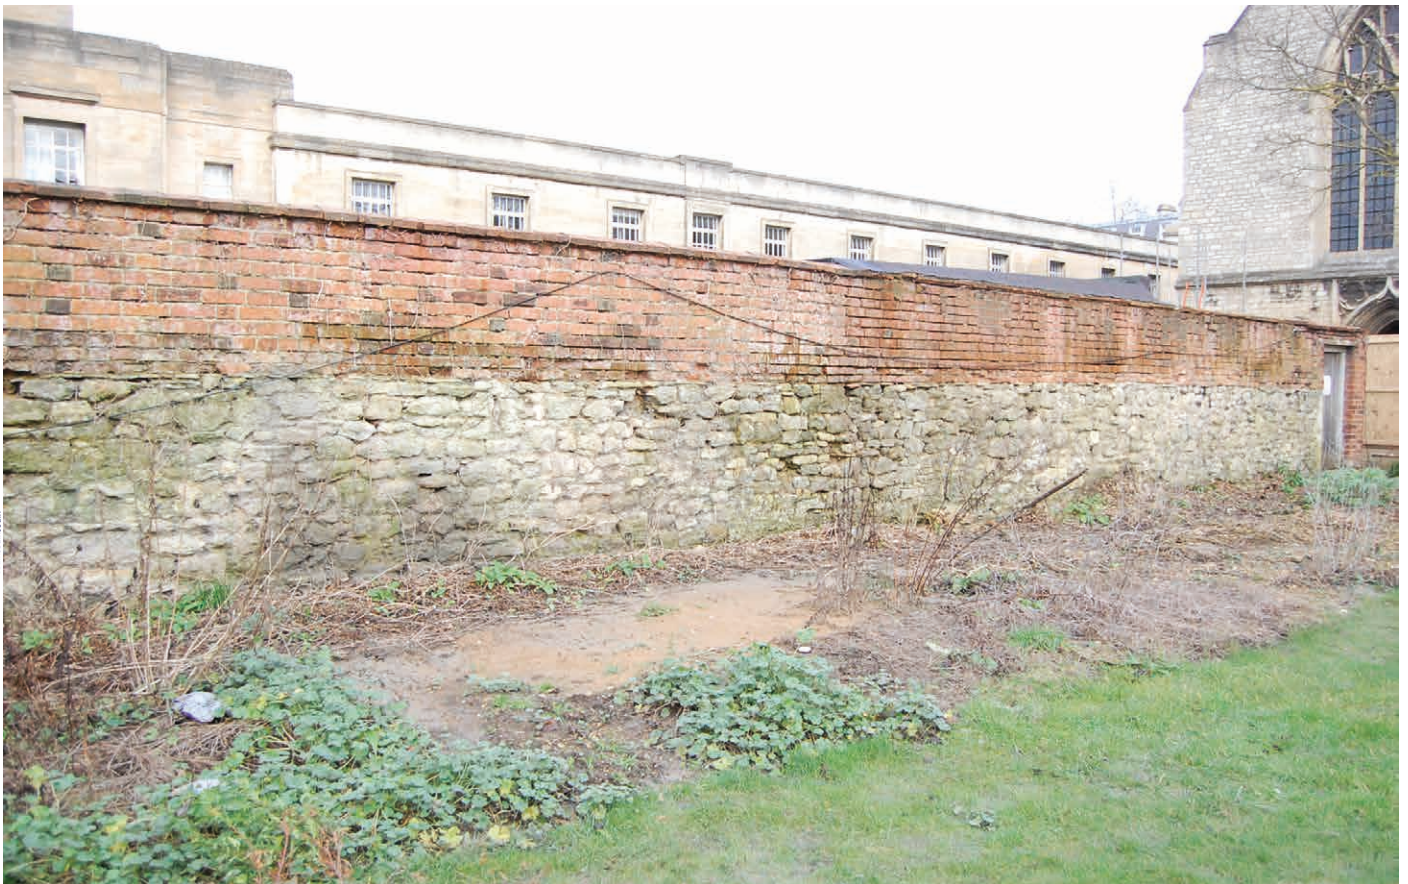
3.1.1 **OA 94a** (*Figure 11*) The boundary wall that runs east to west inside the Site (**OA 94a**), parallel with the wall along Pusey Street (**OA 103**), may represent the oldest wall, as exists above ground, on the site (Plate 1). It abuts the wall running north to south along Pusey Lane at its east end. It has large irregular stones with irregular coursing and has 12 courses of 19th century red bricks with curved coping built on top of it. This appears to be a Victorian stock brick, built with a course yellowish lime mortar with pebble and lime inclusions. Modern 20th century garages have been built between this and the wall running along Pusey Street (**OA 103**) and there is a modern doorway at the extreme east end of the south face. The mortar in the wall is a loose friable, earthy brown lime mortar. The coursing of brickwork, built in a simple stretcher bond, features a more compact, yellowish white lime mortar. On the east end, the wall returns to meet **OA 103**. This section of wall is built entirely with red brick, which is sewn into the red brick at the east end of **OA 94a** on the east side of the modern doorway. The north south running section of wall appears clearly for the first time on the OS map of 1921.

Plate 1: Parish boundary wall running east to west within Western Quad, OA 94a, looking north east

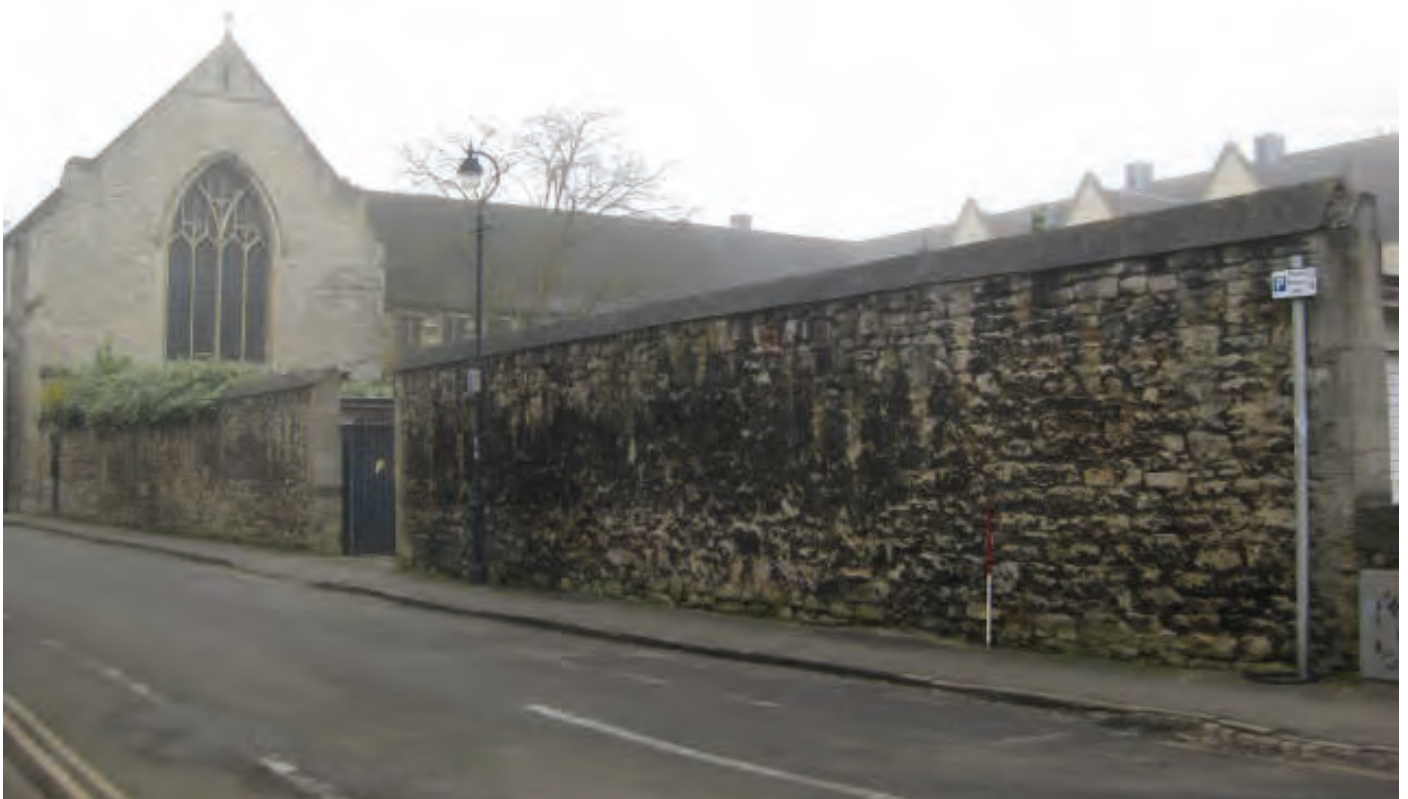
3.1.3 **OA 103** (*Figure 12*) The wall that runs east west along Pusey Street (**OA 103**) abuts St Cross College chapel at its west end and it is likely that this wall was built when Alfred Street was constructed in 1828 (Plate 2). The coursing is irregular and built with large squared stones of irregular sizes. A Tudor style arched doorway with large quoining is

Plate 2: St Cross College boundary wall running along Pusey Street, OA 103, looking south west

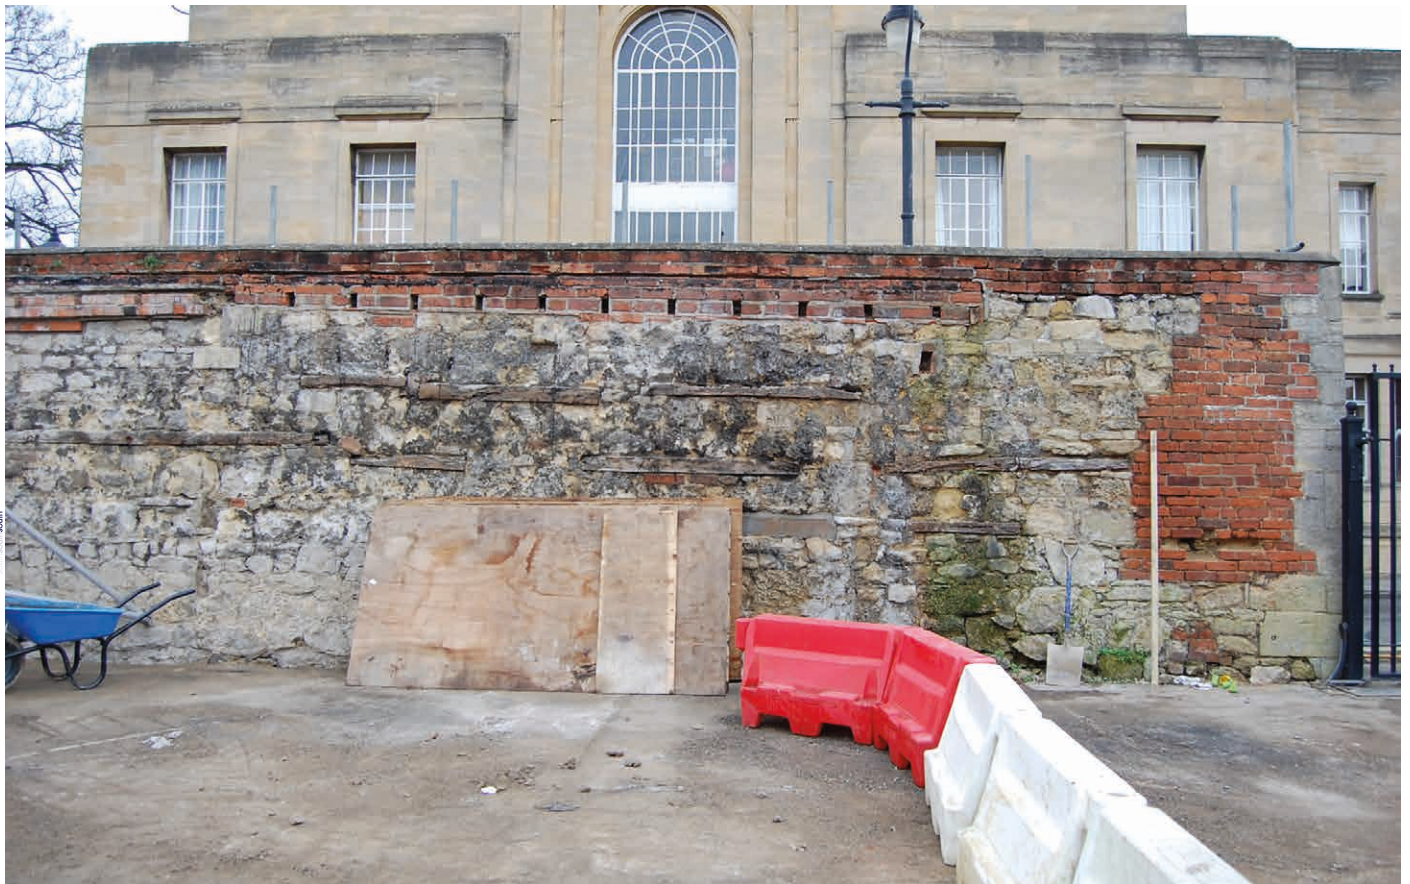
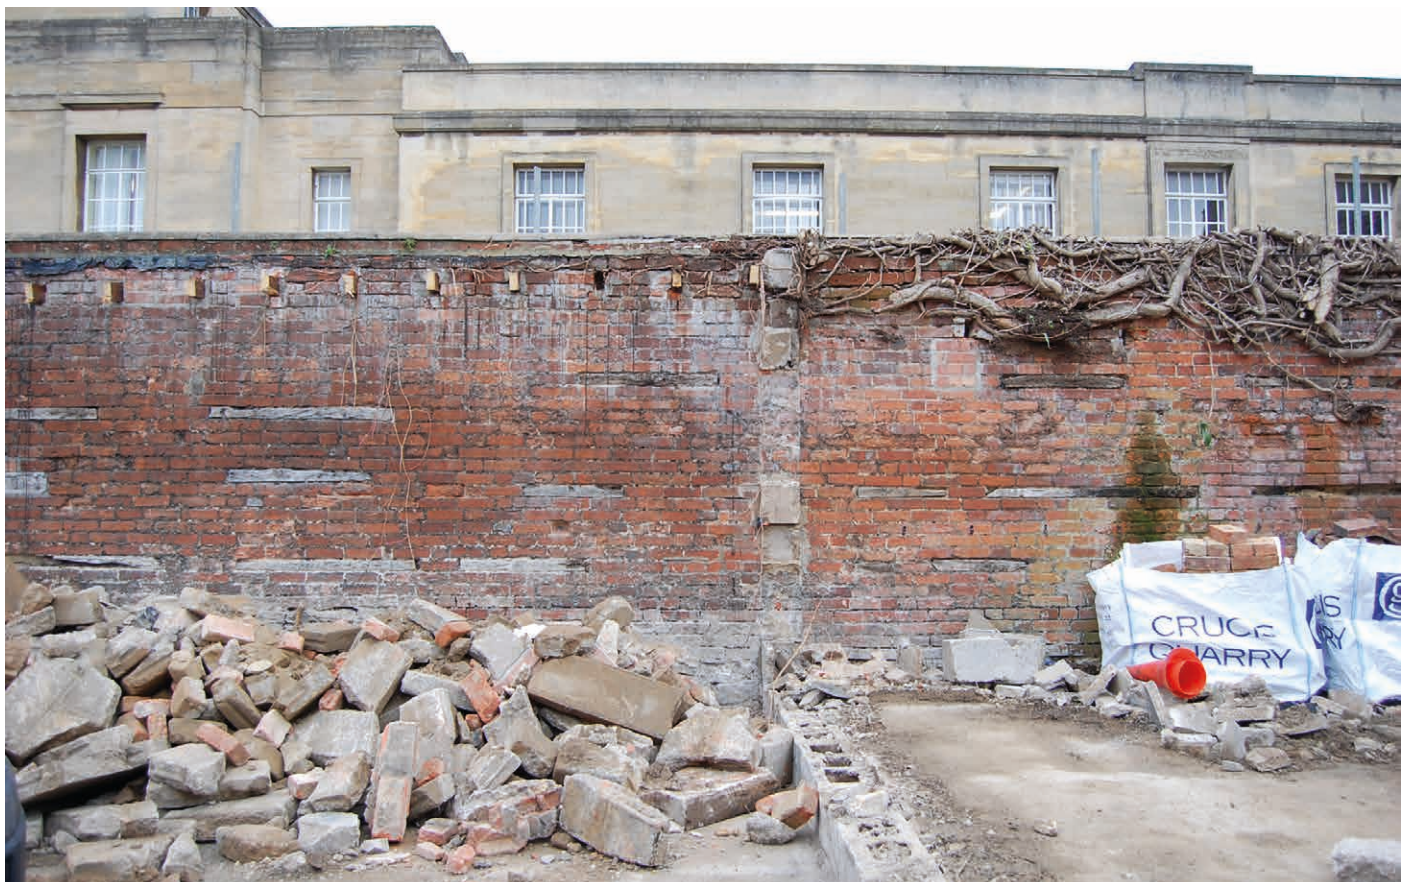
- 3.1.4 This leaf of red brick appears irregularly across the north face of OA 103. It appears to be a Victorian stock brick, built with a course yellowish lime mortar with pebble and lime inclusions. The coursing is irregular but mainly features stretchers. In the section to the west of the garage gateway, it appears in large patches at the east and west ends of the walls with two courses running along the top under the coping. Below these two courses, where the flat roofs of the modern garages met the wall, are three to four courses of modern bricks with cement mortar. In the section between the garage gateway and the red brick return of OA 94a, the south face of OA 103 is almost entirely faced with red brick, with the exception of approximately five courses of stone above the ground in the eastern half of this stretch. In both the red brick areas and the stone areas of the enclosed south stretch of OA 14 are lengths of timber built into the coursing (Plates 3 & 4).

Plate 3: St Cross College boundary wall running along Pusey Street, OA 103, looking north

Plate 4: St Cross College boundary wall running along Pusey Street, OA 103, looking north:

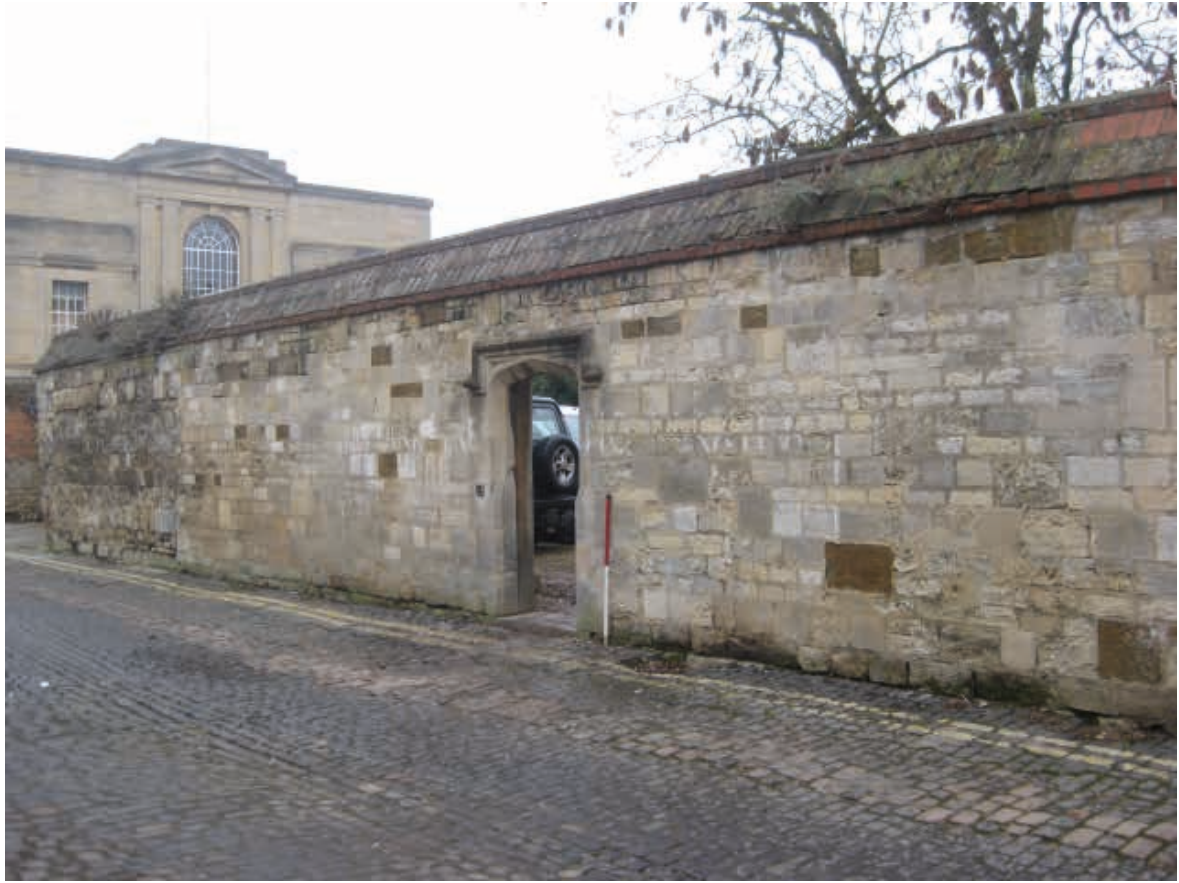
- 3.1.5 **OA 14** (*Figure 12*) Towards the south end of OA 14 is a 19th century Tudor style arched doorway and on top of the wall is 20th century cement and red brick coping, like that of OA 103 (Plate 5). Like OA 103, it appears to have two phases, but these are much more discernible. The southern end of the wall appears older and more weathered with smaller less regular coursing (Plate 6). The doorway is likely to be a later insertion. The northern end of the wall appears more modern and the masonry is larger and more regular, and almost ashlar like. The northernmost section of the wall has been removed for the insertion of the garages into this western façade and the southernmost part replaced with a wooden gate as part of the St Cross College 20th century development. Here we see a short section of 20th wall returning west to east, creating an entrance way. This has larger cobbled masonry on its north face and more regular squared masonry on its south face. It is built with a cementitious mortar.

Plate 5: St Cross College boundary wall running along Pusey Lane, OA 14, looking north east

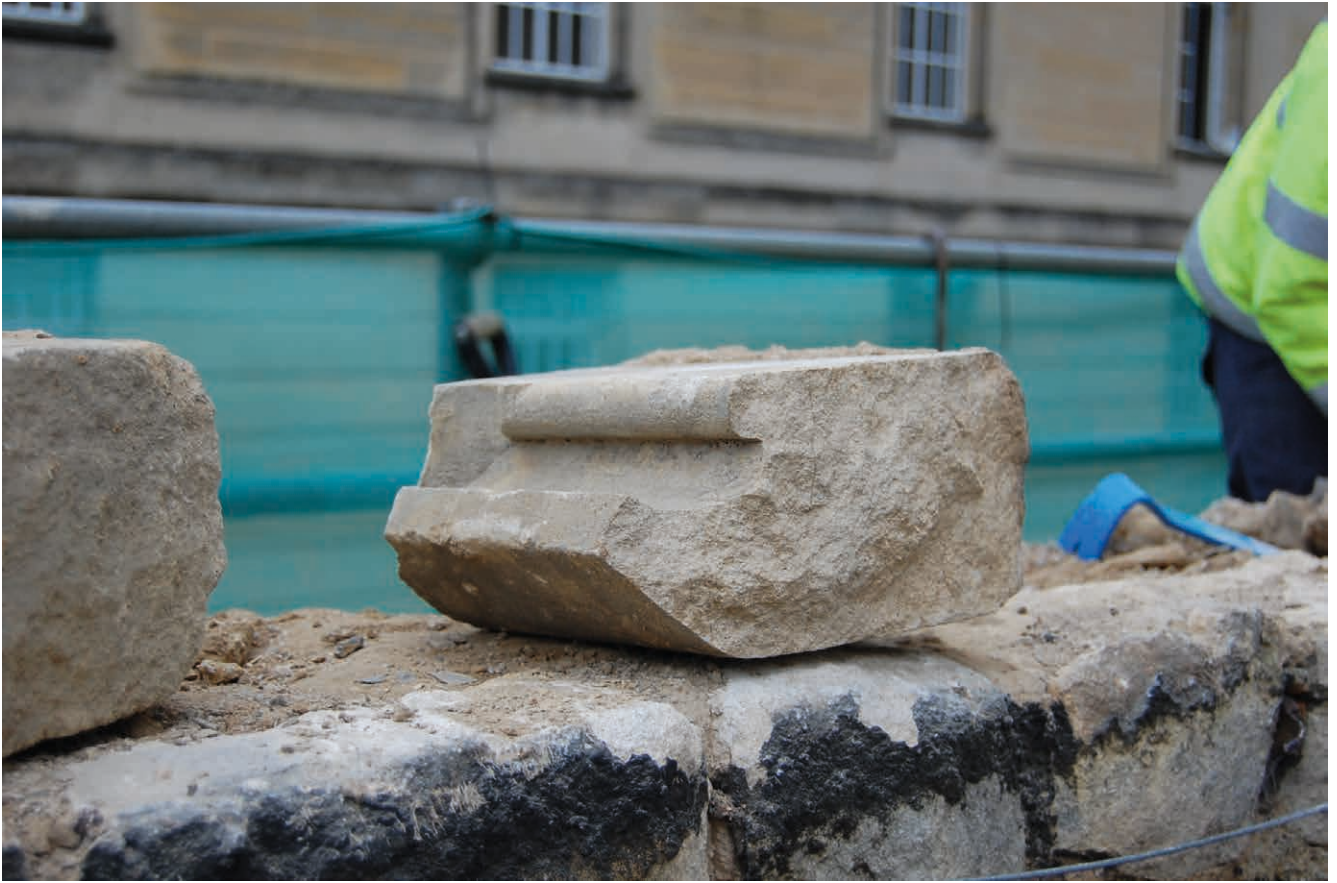
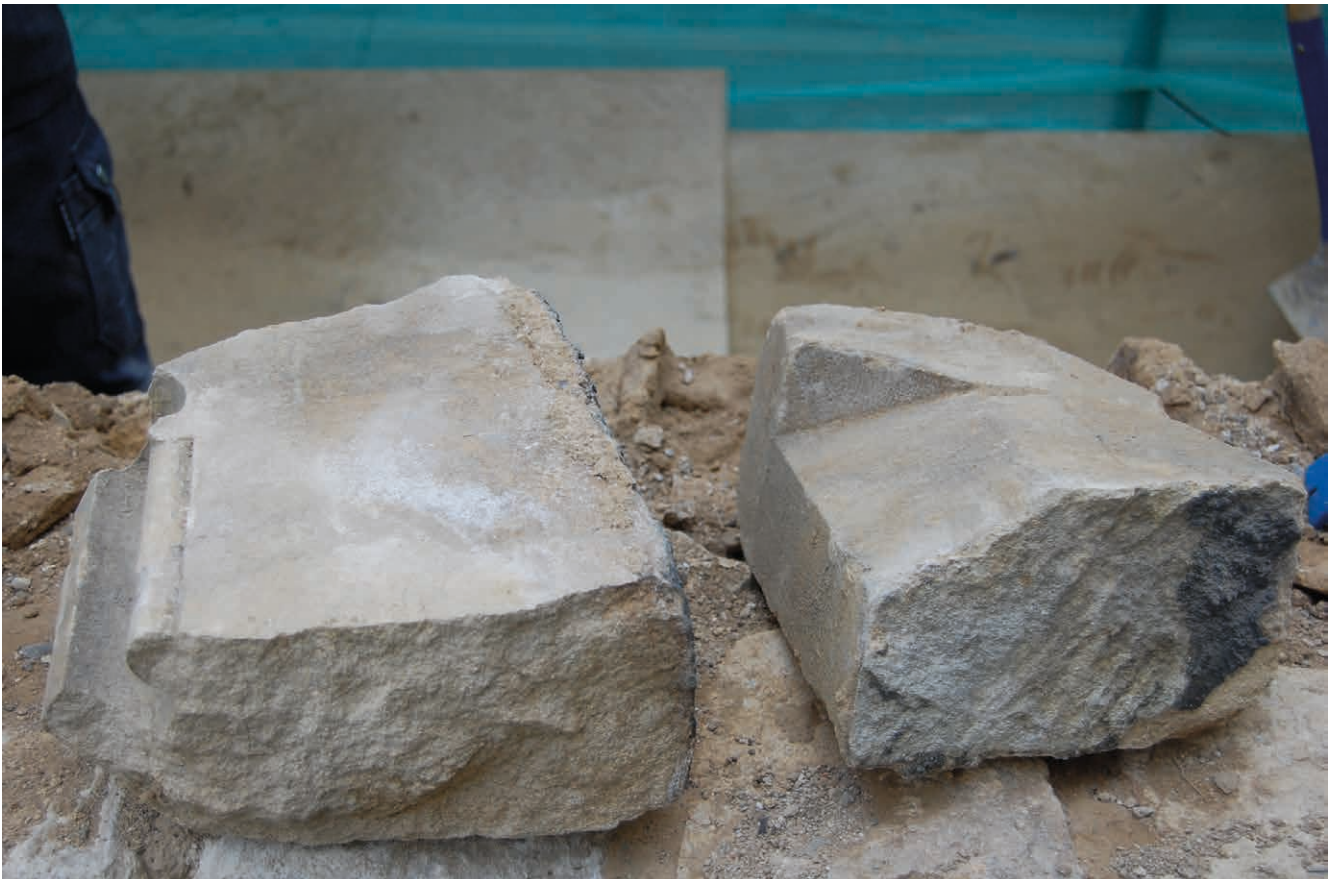
- 4.1.2 The modern concrete coping was removed and the stones were removed course by course with hammer and chisel. Occasional moulded stones were removed from the walls (Plate 7 & 8) and invariably, their moulded faces were facing inwards, so as to create a flat external wall face. These pieces of masonry included mullions, jambs and possibly pieces if lintels. All appeared to be crisp and similar to moulded stones in Victorian rebuilds throughout Oxford, suggesting they may be broken debris from nearby buildings sites dating to the 19th century.

Plate 7: Moulded stone removed from OA 103

Plate 8: Moulded stone removed from OA 103

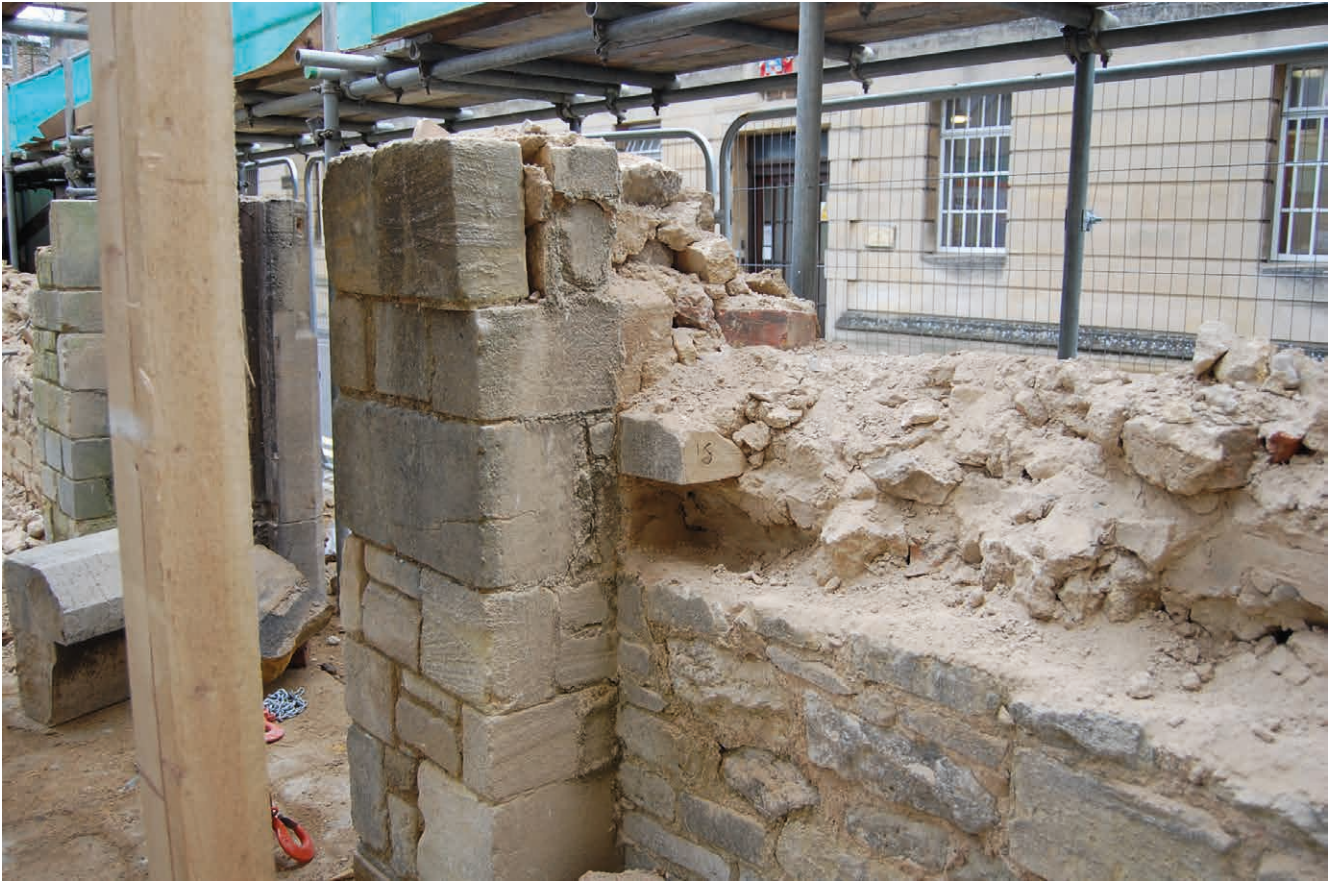
- 4.1.3 On the south side were stone buttresses at either side of the doorway that appeared later than the wall and were not sewn in, suggesting that the doorway is a later insertion (Plate 9). The mortar throughout the wall is a pinky brown earthy mix that lenses to a more

Plate 9: Inserted 19th century doorway in OA 103, looking north west

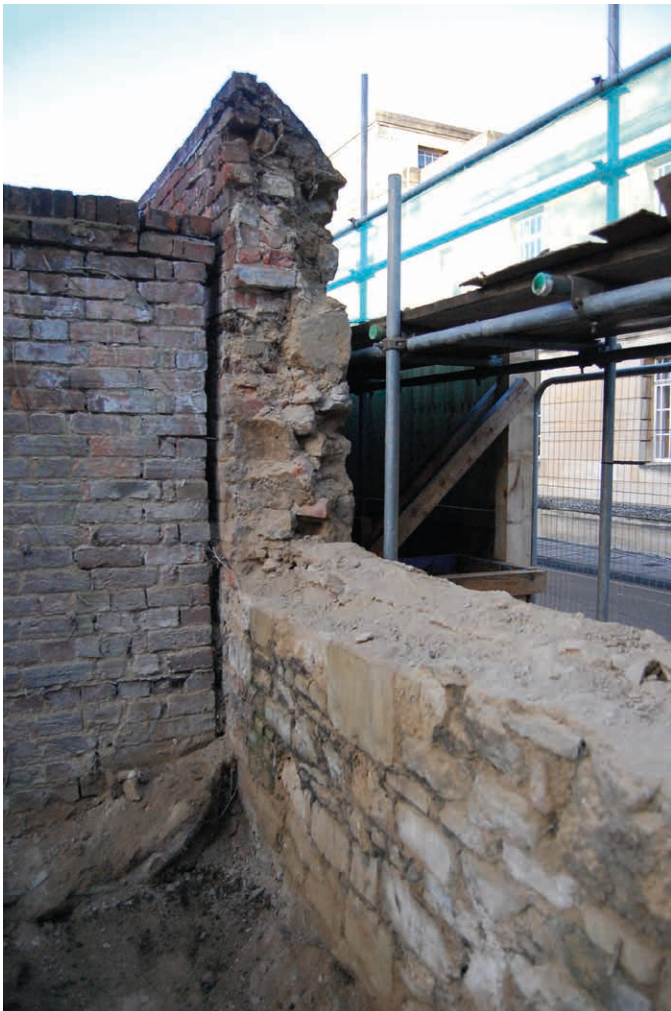
- 4.1.4 The dismantling of this section of wall exposed the red brick leaf in the enclosed length of wall in section, revealing that it appears to be one build rather than a refacing of the wall (Plate 10).

Plate 10: OA 103 in section, looking north west

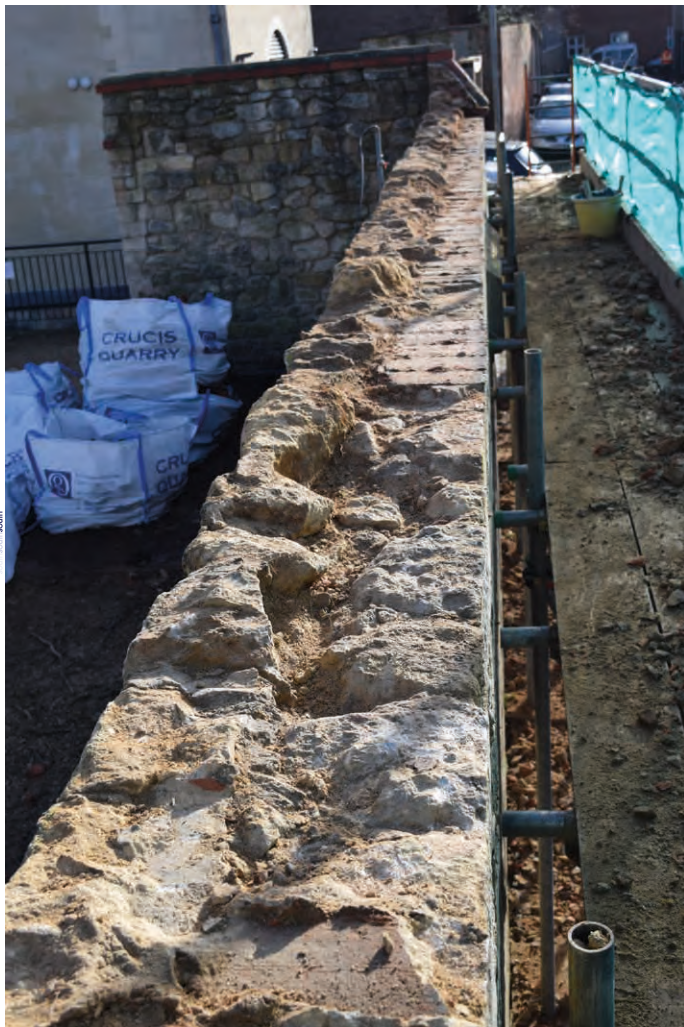
- 4.1.5 A watching brief was partially maintained during the dismantling of OA 14 along Pusey Lane also. As masonry was removed, it was revealed that what we believed to be the older length of wall was later than expected as cementitious mortar was used throughout. This was similar to the cementitious mortar used in the later northern section of wall and may indicate that it was taken down and rebuilt at the time of the later build. Here, like OA 103, the doorway is a later insertion and not sewn into the masonry of the wall. Like the wall, it has a cementitious mortar and may have been added in the late 19th or early 20th centuries. The northern length of the wall is probably of a similar date.

Plate 11: OA 14 with reduced coursing, revealing cementitious mortar, looking south

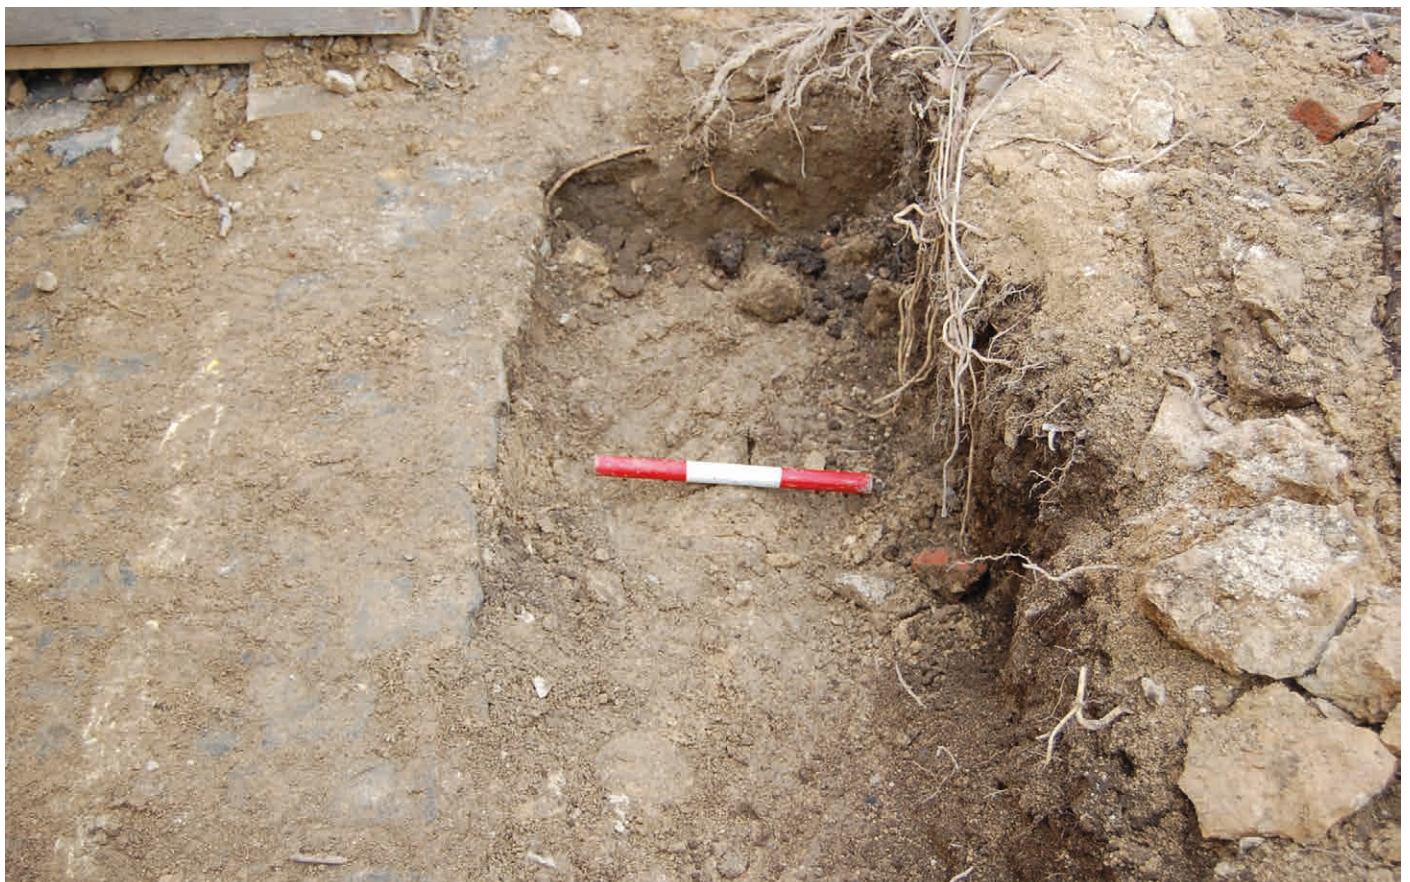
- 4.1.6 The short length of wall making up the entrance appears to be 20th century and features a rough grey cementitious mortar throughout. Both this and the northern length of wall have very shallow foundations, sitting no more than 100m under the level of the road surface (Plate 12).

Plate 12: Foundations of OA 14, looking north

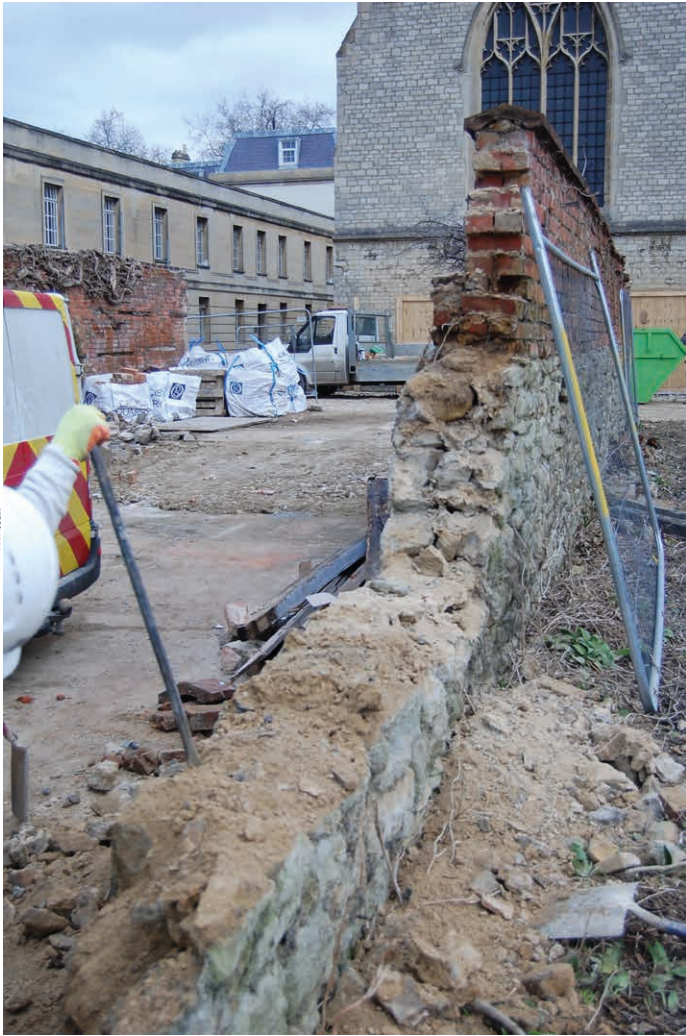
- 4.1.7 Like OA 14, on inspection during the watching brief, OA 94a was discovered to be later than expected, although is likely to be the oldest wall on the site above ground. The red brick upper section was removed west to east and stones underneath removed in quick succession, presenting the wall in section along its length (Plate 13). The mortar in the lower masonry construction was a pinkish brown earthy mortar that was organic rich and very friable. Within this was found pieces of broken red brick and some broken tiles with sandy yellow striations, which were common in Oxford in the late 16th and 17th centuries. Some pieces of moulded stone were also removed from the wall (Plate 14). The foundations of this wall were very shallow, reaching no more than 200m below the ground level of the garages.

Plate 13: OA 94a in section, looking east

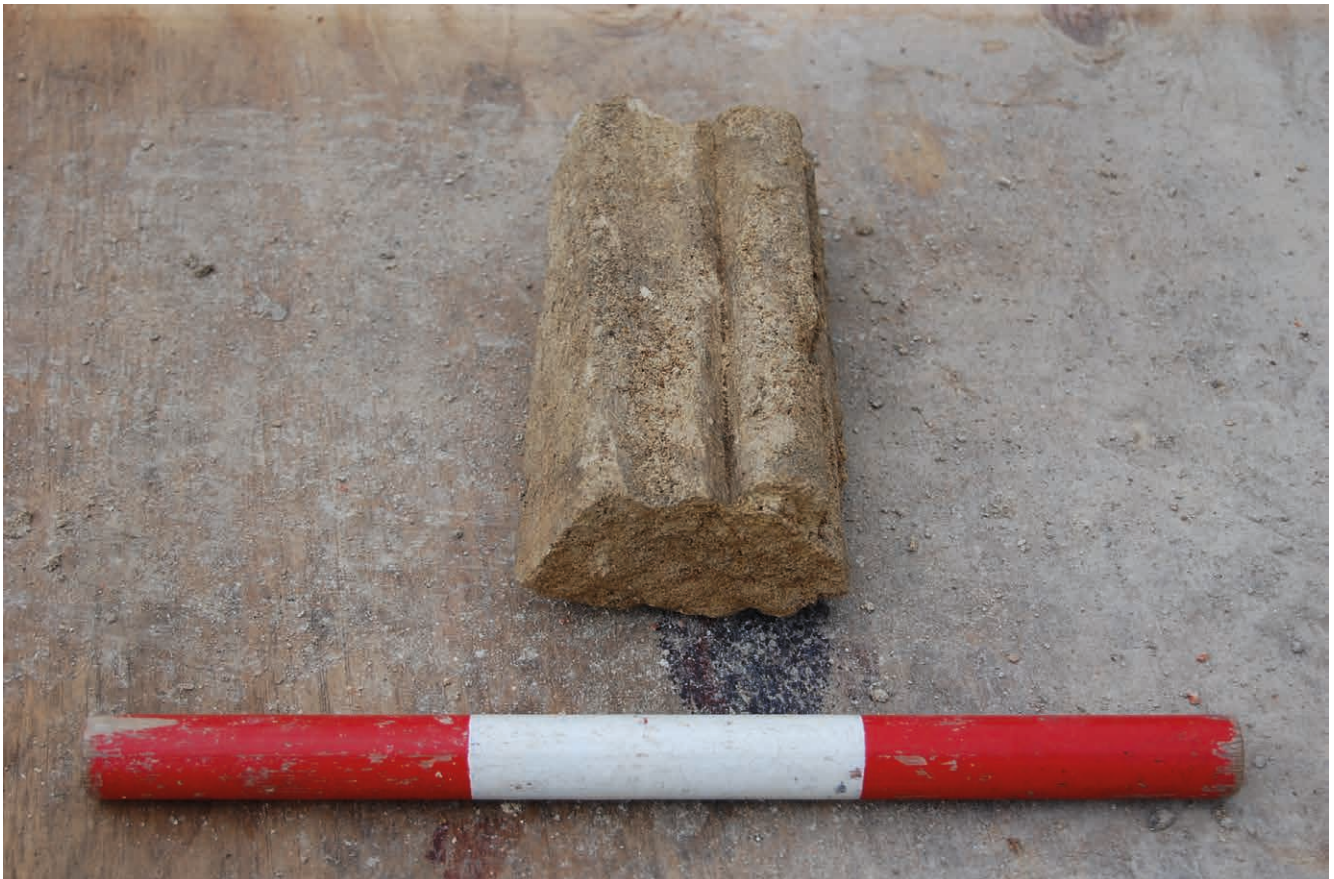
Plate 14: Moulded stone removed from OA 94a
