# Archaeological Monitoring and Recording of Geotechnical Test pits, Watford, Hertfordshire

## Archaeological Watching Brief Report

**Archaeological Monitoring and Recording of Geotechnical Test pits, Watford,  
Hertfordshire**

*Site Code: XHT CAR 13*

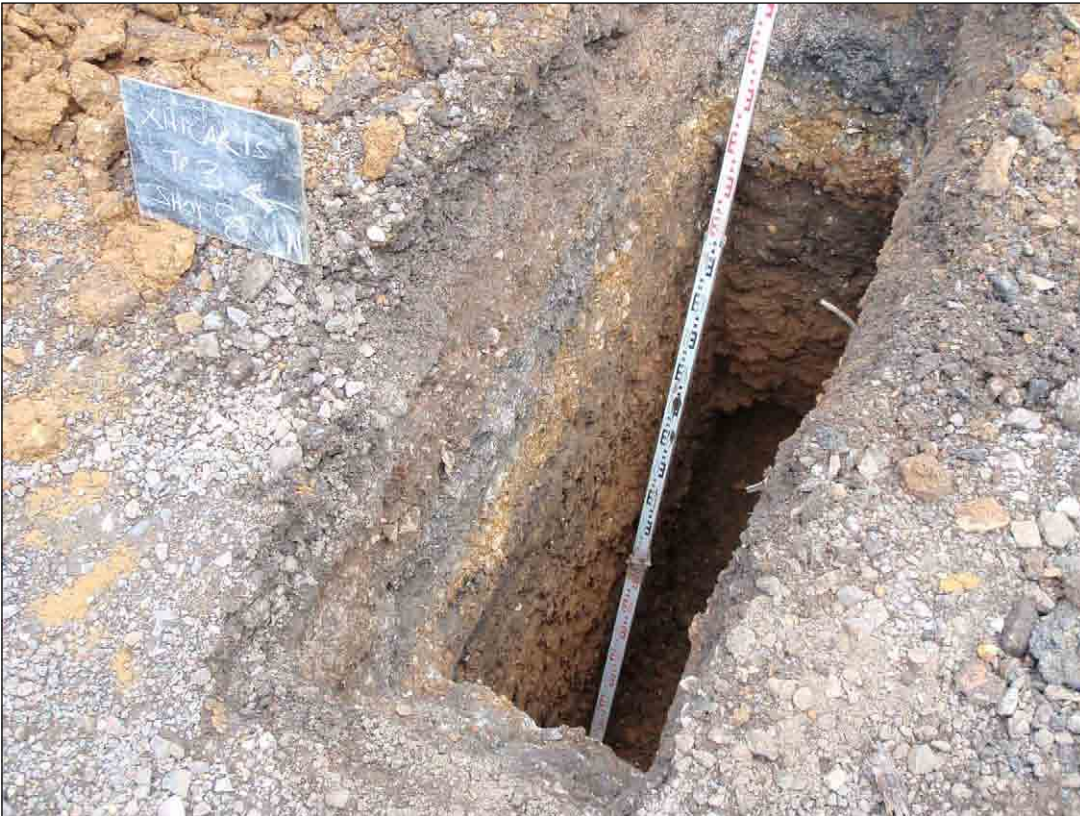
Plate 1: Buried soil in Test Pit 3

- 4.1.6 Test Pit 3, located north of Cardiff Road contained a sealed garden soil which had been partially truncated by the modern layers associated with the current yard surface. (Plate 1).

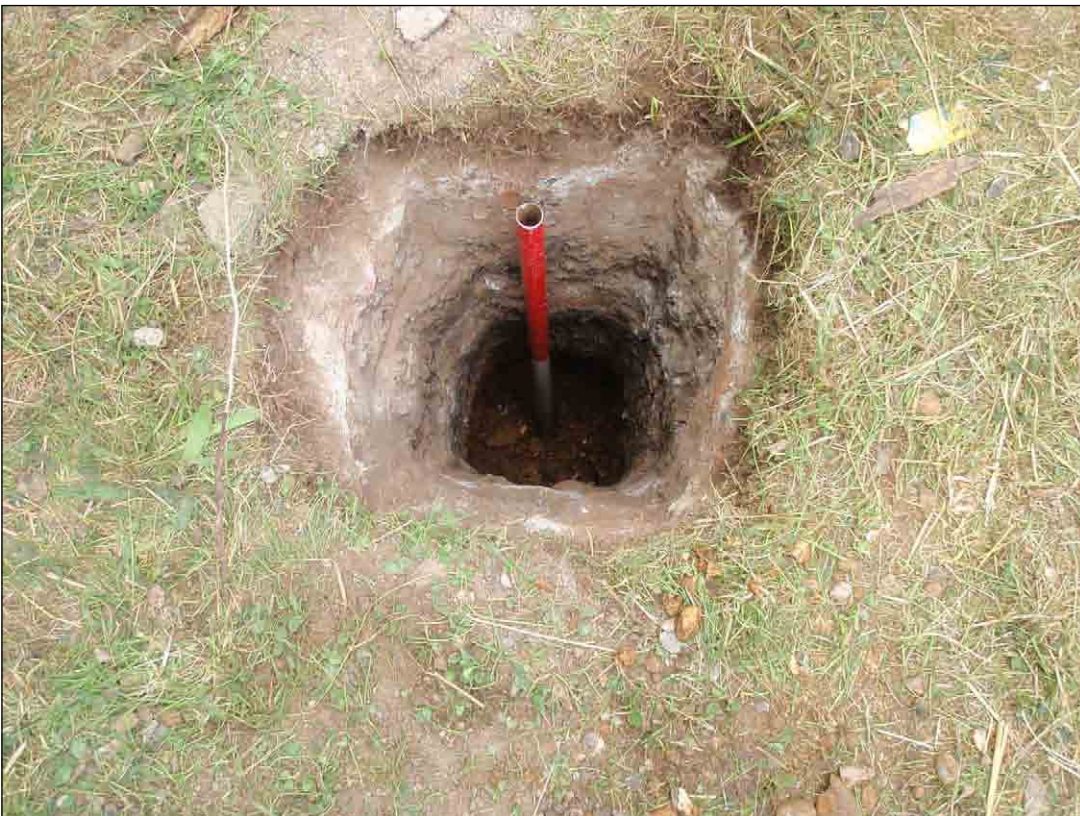
Plate 2: Upper terrace river gravels Test Pit 5

- 4.1.3 A total of ten test pits (figure 3) exposed natural river gravels, test pits 5 (Plate 2), 29, 30 and 31, located on higher ground, to the north of Cardiff Road, showed evidence of upper terrace gravels, test pits 2, 3, 4, 7, 10, and 11, located on the lower ground, each side of the river Colne, exposed the lower terrace gravels.

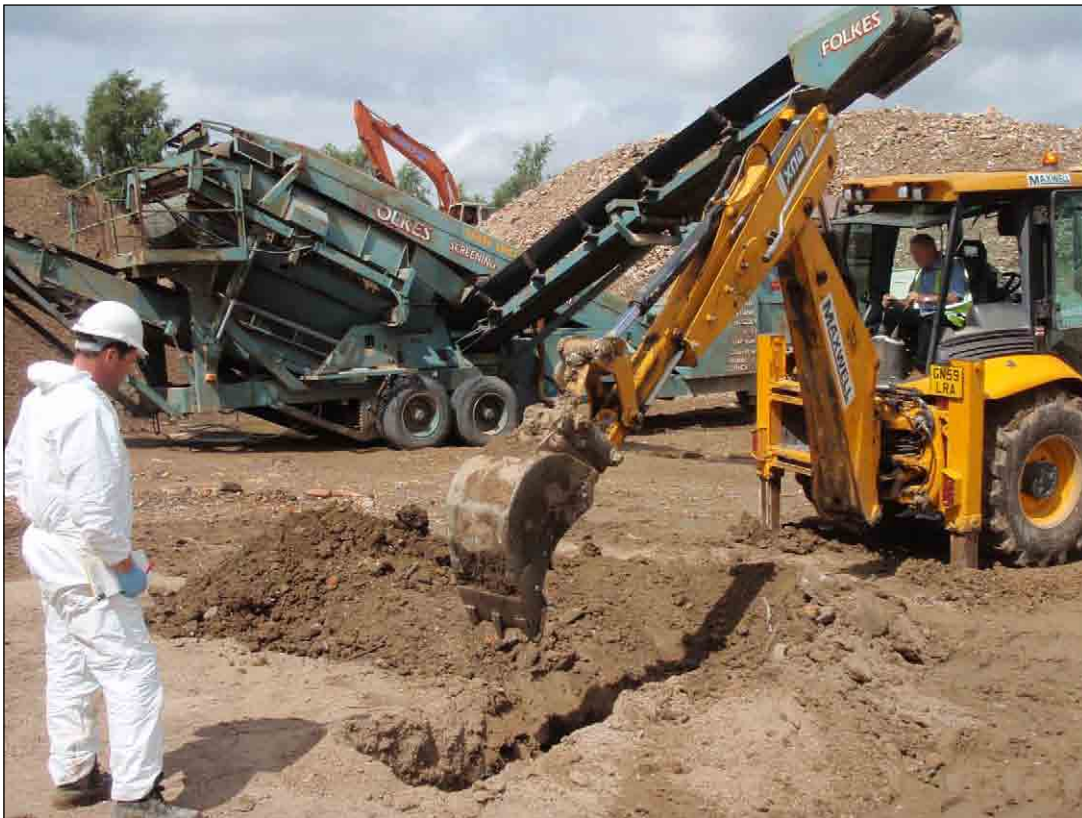
Plate 3: Machining of Test Pit 20

- 4.1.2 Thirteen test pits were machine excavated (using a JCB wheeled digger, plate 3), up to a depth of 3m, a width of 0.7m and a length of between 2 and 3m, a further 12 test pits were hand dug. The descriptions for each test pit are recorded in appendix A. Where individual test pits vary from the standard they are described in more detail below. A total of five test pits (15, 18, 25, 27 and 28) were not excavated test pit 8 did not require archaeological monitoring.

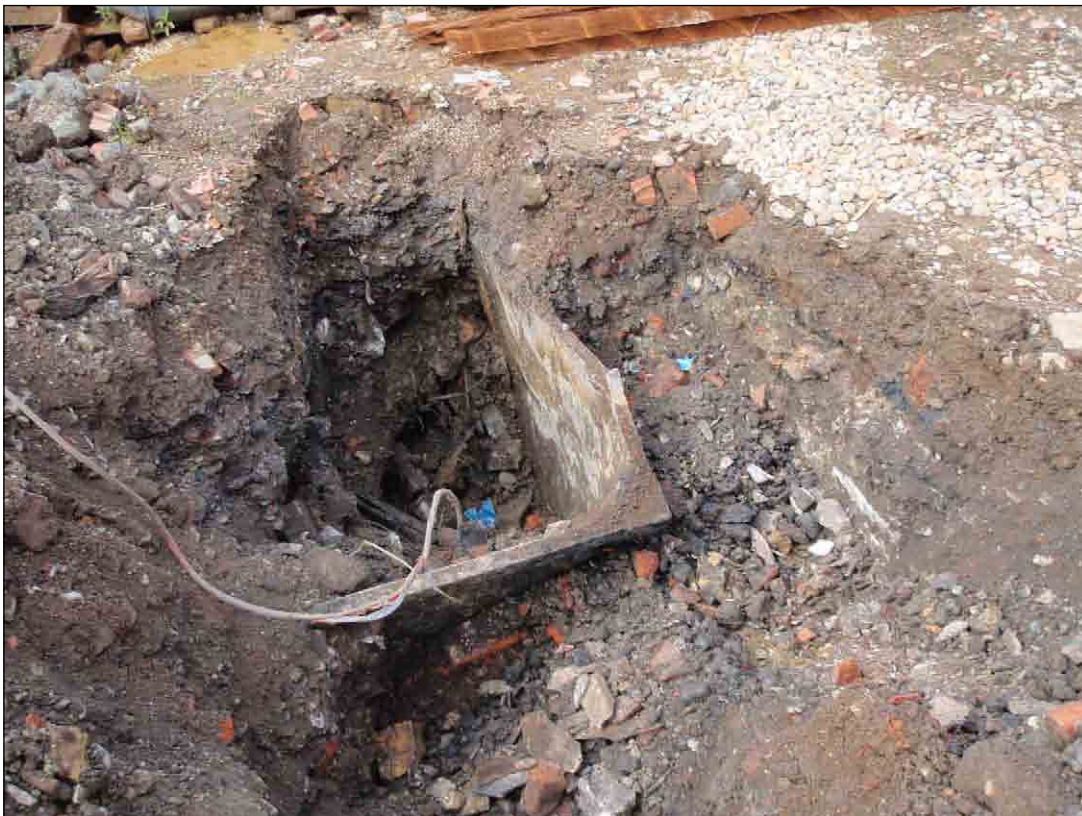
Plate 4: Buried skip in Test Pit 13

- 4.1.4 A single test pit (26), exposed the natural chalk (Plate 8), test pit 13 exposed the remains of a buried skip (Plate 4).
- 4.1.5 Test pits 10 and 11, located close to and on the south side of the river contained evidence of palaeochannel or flood deposits which sealed natural river gravels. (Plates 9 and 10).

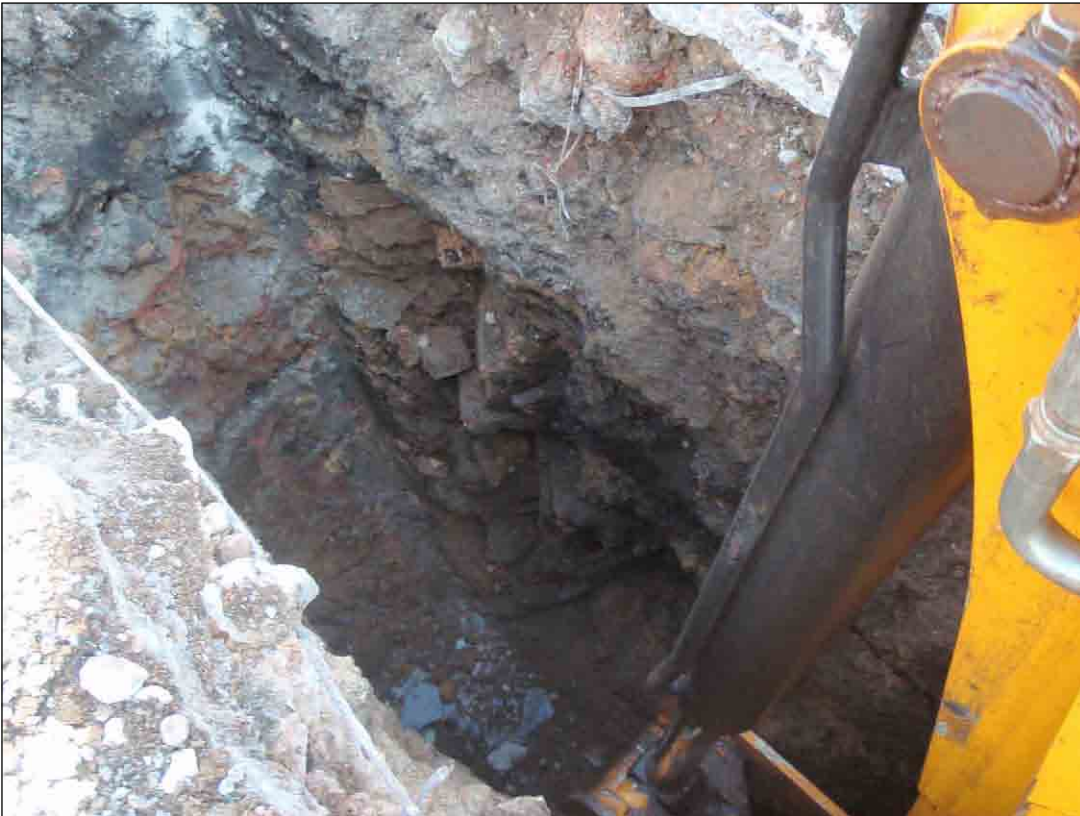
Plate 5: Wall in Test Pit 19

- 4.2.2 Because of the unstable sides of the test pit access was not possible, therefore all recording took place from the top edge of the test pit.
- 4.2.3 Wall 19.7 was aligned SE-NW, at 0.30m wide and 1.70m high, the top of the wall was exposed at 0.48m below current ground level and constructed of brick and mortar. (Plate 5)

- 4.2.4 Wall 19.8, was more difficult to interpret, it appeared to be N-S aligned across the west end of the test pit. The machine excavator had cut through the brick work and exposed a large void against the east side of the wall, this is interpreted as being the remains of a subterranean cellar.

- 4.2.5 The building, possibly of early 20th century date, is likely to have been associated with a power station complex, known to have existed on the site.

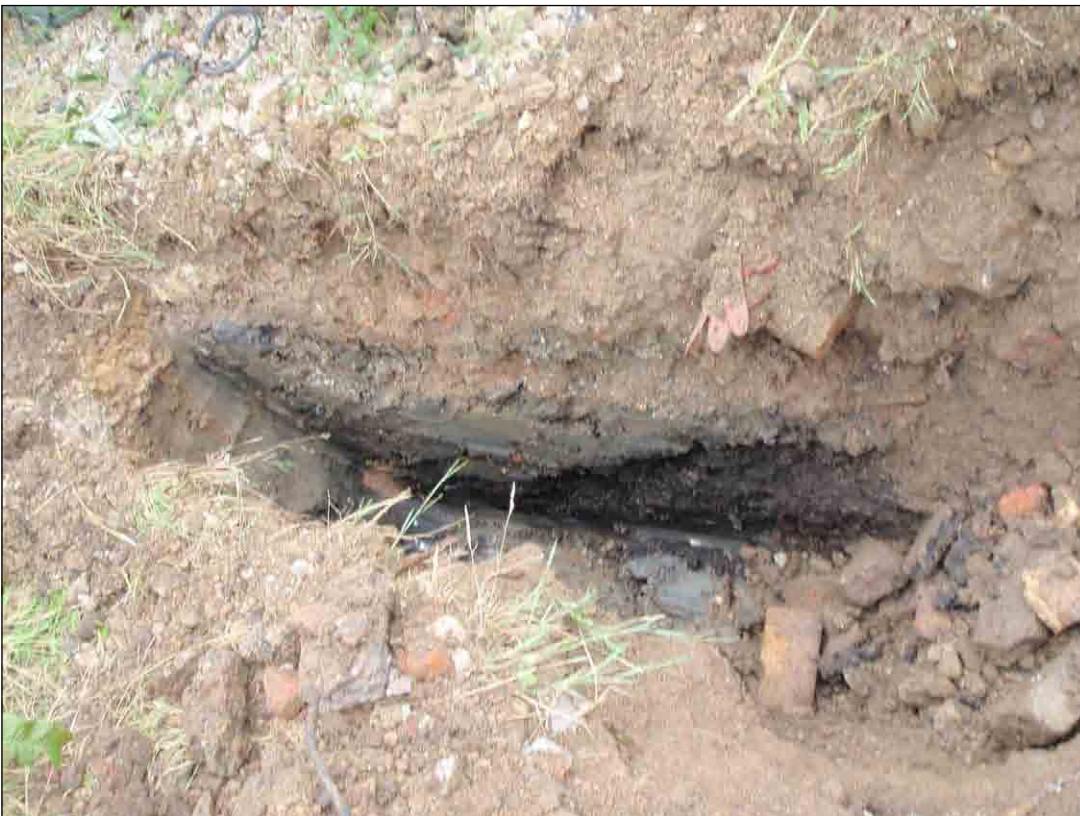
Plate 6: Pit in Test Pit 23

- 4.3.1 This test pit was located towards the east part of the site, on the opposite side of the road to the Irish Centre. The test pit was excavated to a depth of 3m cutting through a modern hardcore surface (23.1) at 0.50m thick, which had truncated the upper parts of a pit 23.4.
- 4.3.2 The pit was only partially exposed, 0.70m deep with a very steep edge, containing two fills, a grey blue clay (23.2), sealing (23.3) a charcoal rich and clay, silt, gravel deposit (Plate 6).
- 4.3.3 The pit was cut into a blue orange clay (23.4) which was up to 2.50m thick and was dated to the mid 19th century

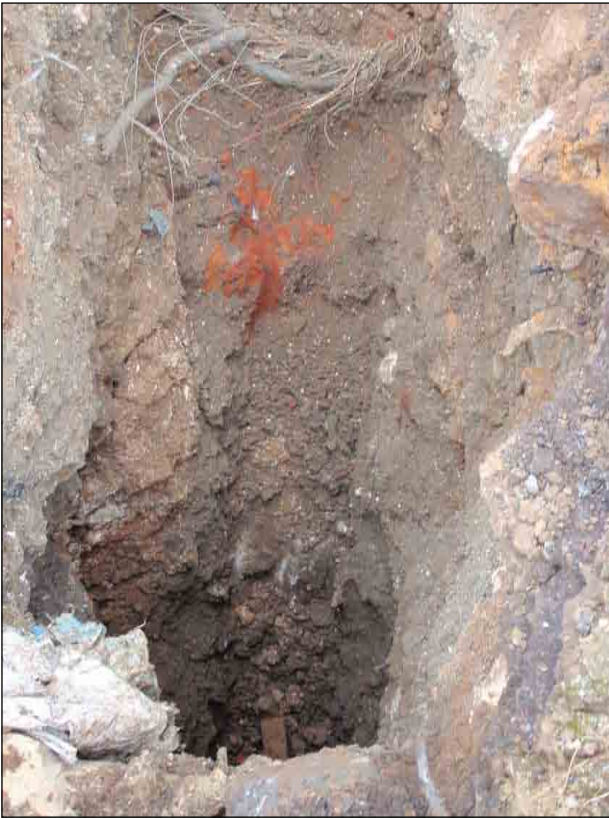
Plate 7: Wall in test Pit 24

- 4.4.1 This test pit was located close to test pit 23, on the opposite side of the road to the Irish Centre. The test pit was excavated to a depth of 3m cutting through a tarmac surface (24.1) and a modern make up deposit (24.2) over a concrete slab (24.4), exposed in the base of the test pit.
- 4.4.2 A brick wall (24.3. Plate 7) was exposed in the side of the test pit at 1.50m below ground level. This modern structure possibly forms part of a subterranean chamber or cellar.

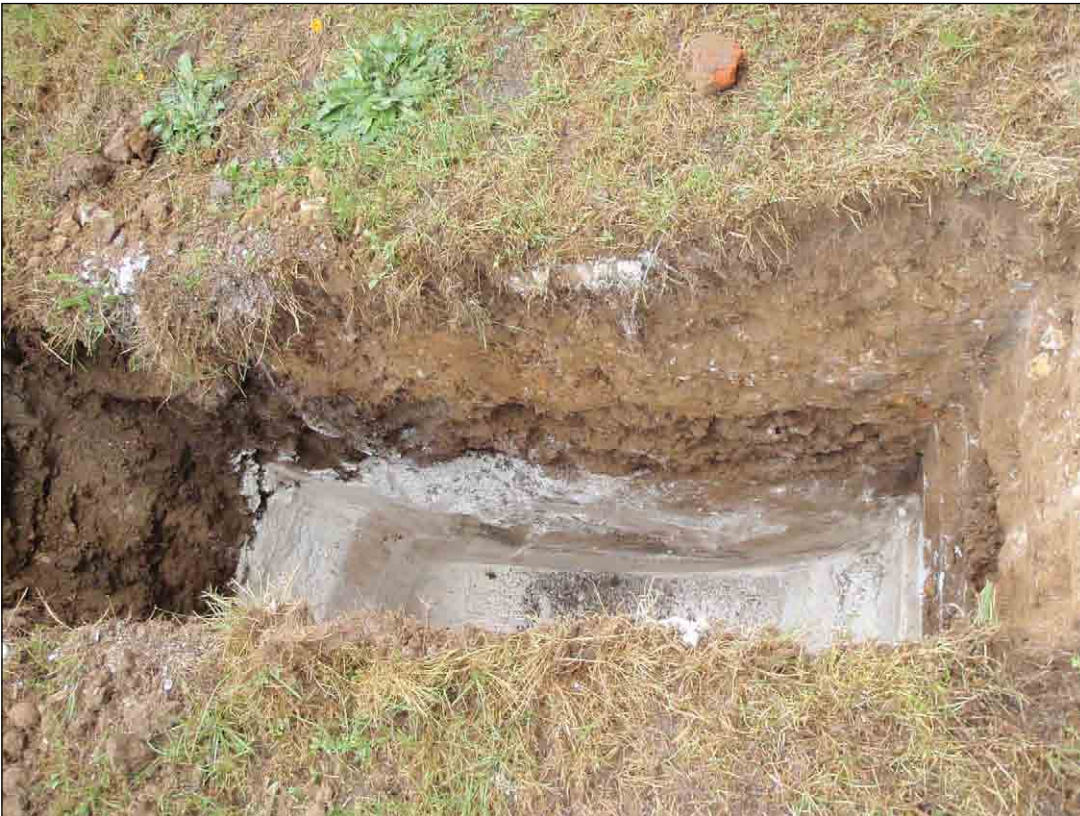
Plate 8: Chalk natural base of Test Pit 26

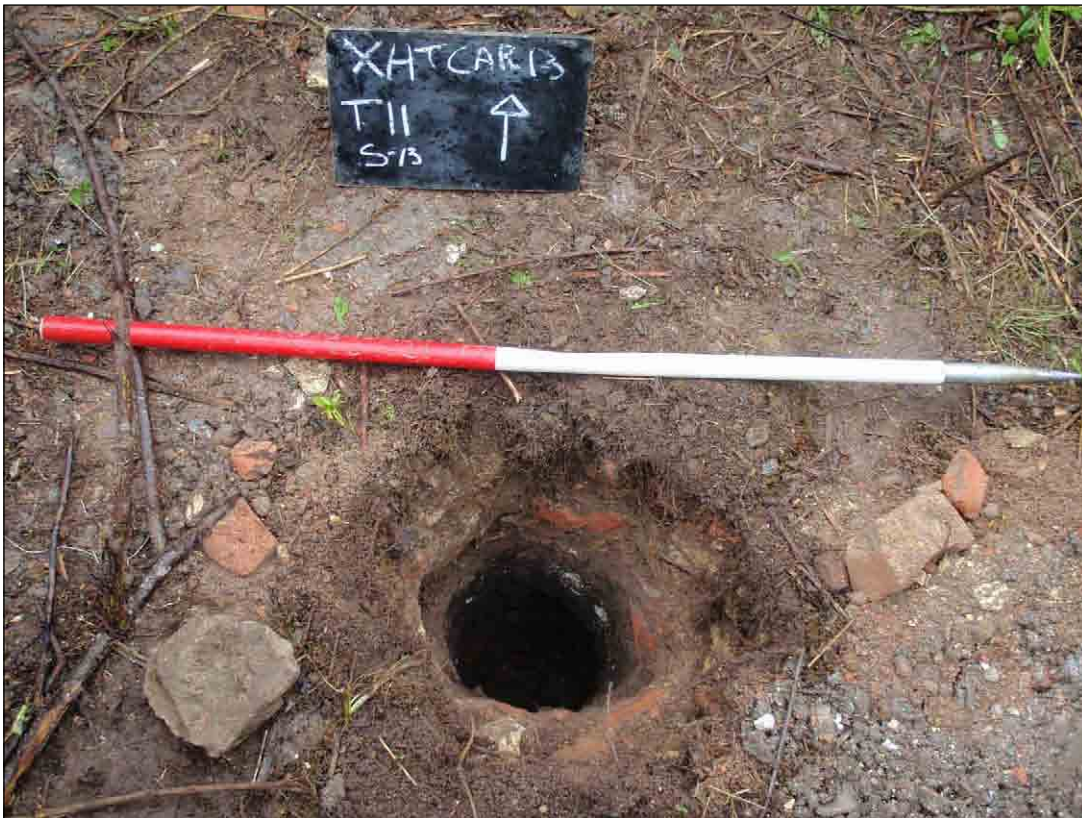
Plate 9: Palaeo channel Test Pit 11

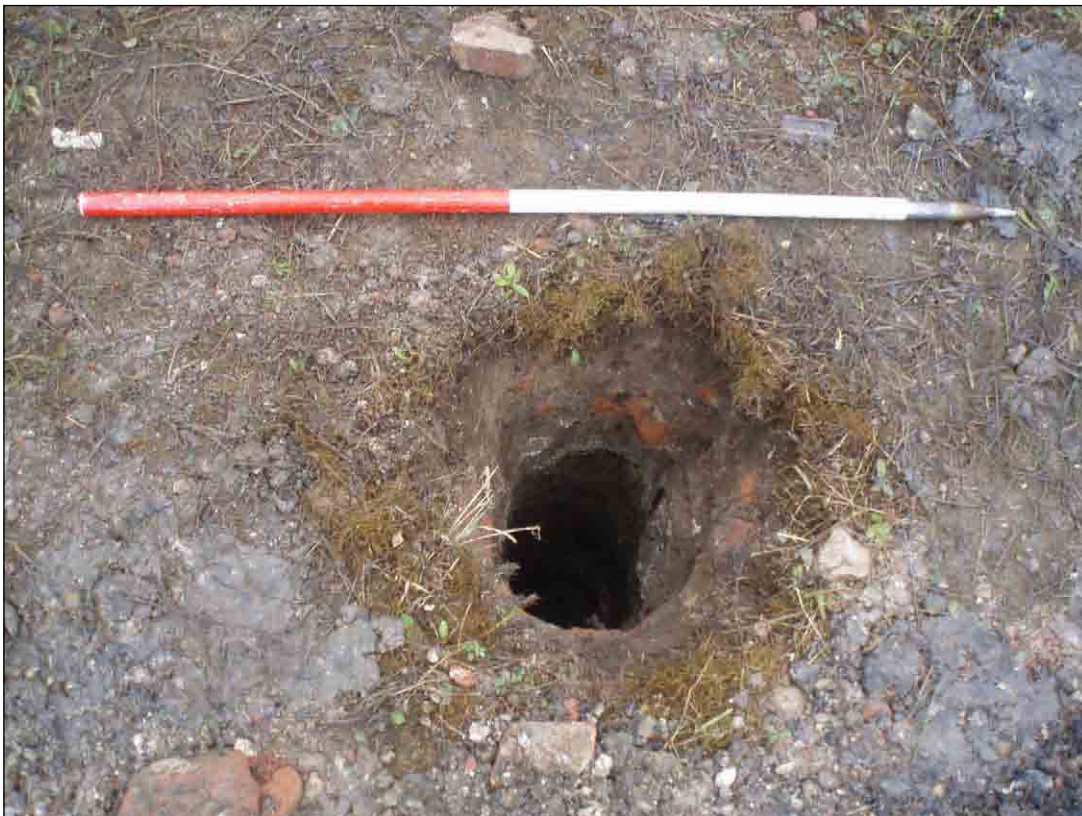
Plate 10: Palaeo channel Test Pit 10
