## **Specialist Report 4**

### **Ceramic Building Material**

This is one of 16 specialist reports  
within a digital volume that supports the findings  
presented in  
*London Gateway:*  
*Settlement, farming and industry from prehistory to the present*  
*in the Thames Estuary*  
(ISBN 978-0-904220-81-0)

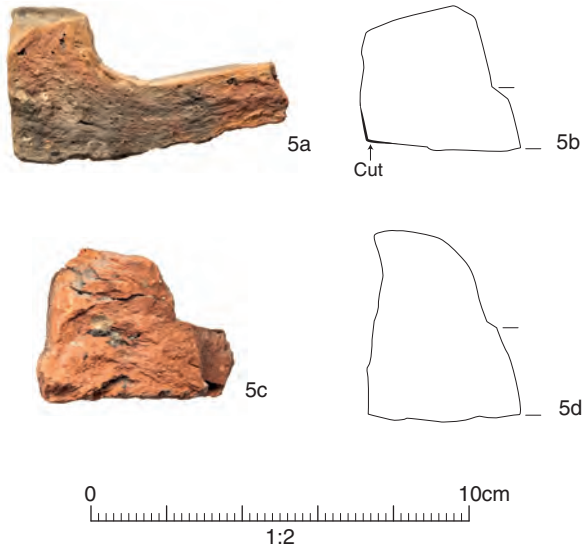
Figure 2: Tegulae, no. 5

Fig. 2, no. 5. Tegula flange profiles: 5a. Type A (2629, Id.32), 5b. Type A3 (2629, Id.28), 5c. Type A5 (3301, Id.55), 5d. Type B (2629, Id.29)

4). One tegula had a complete length of 390mm and a surviving incomplete width of 195mm (Fig. 1, no. 1). Most of the tiles making up tile surface 2630 appear to be deflanged tegulae; dimensions of 410mm long, 330mm wide and 30mm thick was recorded on site. Most of the surviving tegula flanges (Fig. 2, no. 5a-d) are rectangular in form, with either vertical (type A) or angled inner edges (type B), though two had a curved profile (type E and F). Three tegulae had cutaways, one both upper and lower (Table 4.2). The upper cutaway was of standard rectangular form measuring 50mm long. Its lower counterpart was 60-65mm long and was identified as Warry's (2006) type D. Two other lower cutaways were present: a second example of type D and one of type C5. According to Warry, these are both later types. The type C group broadly dates from mid-2nd to mid-3rd century AD and the type D from mid-3rd to 4th century. The relatively short complete length is also consistent with a later date. Tiles with visible flanges and cutaways that remained *in situ* appear to be of type A flanges and type D cutaways. One plain fragment had a large peg or nail hole 16mm in diameter, centred 40mm from the tile edge, and is certainly a tegula fragment. This is rather large, as most nail holes in tegulae measure 7-9mm in diameter. Nail holes are rare features and become more common in the later Roman period.

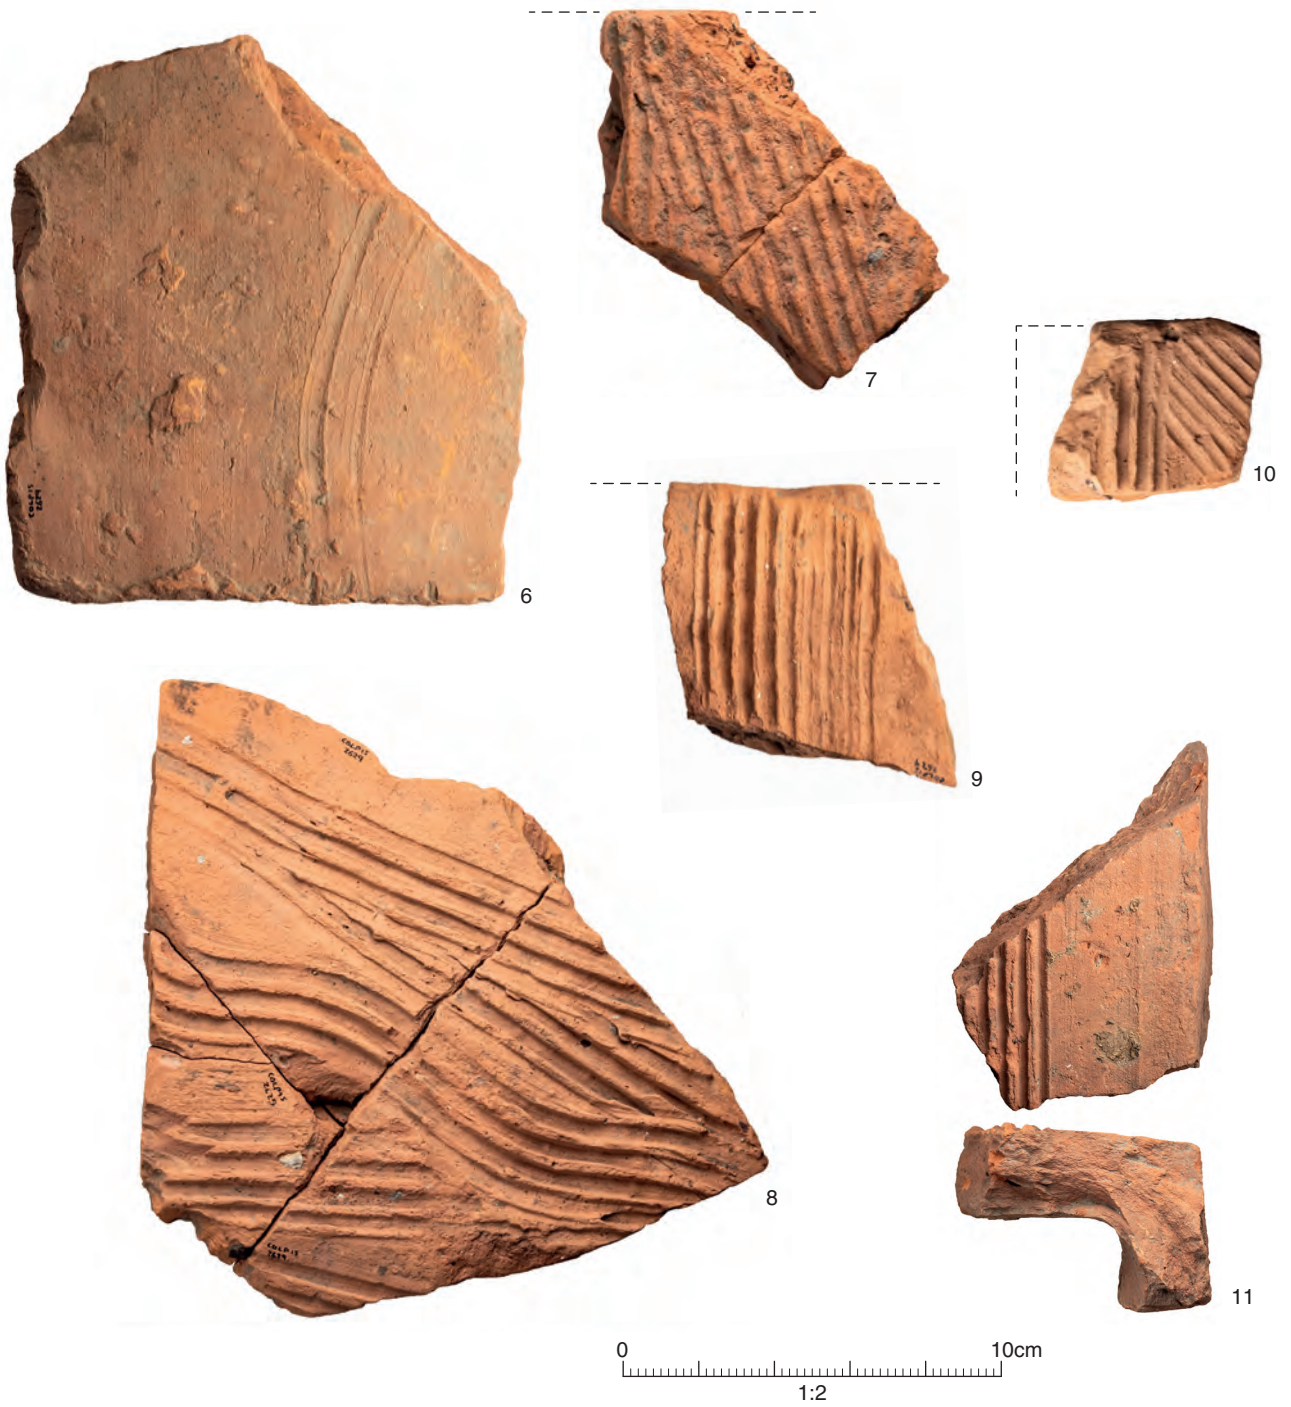
Figure 3: Brick and tubuli (box flue) with combed keying patterns

Fig. 3, no. 6. Brick: fragment with signature type 2.2. Ctxt: 2650, Id.59

Fig. 3, no. 7. Tubulus: fragment with zigzag combed keying. Ctxt: 2615, Id.6

Fig. 3, no. 8. Tubulus: fragment with zigzag and wavy combed keying. Ctxt: 2629, Id.22

Fig. 3, no. 9. Tubulus: fragment with straight perpendicular and diagonal bands of combed keying. Ctxt: 2629, Id.23

Fig. 3, no. 10. Tubulus: fragment with straight perpendicular and diagonal bands of combed keying. Ctxt: 2629, Id.24

Fig. 3, no. 11. Tubulus: fragment with straight linear band of combed keying and rectangular vent. Ctxt: 2629, Id.46

#### *Brick* (Fig. 3, no. 6)

#### *Flue tile* (Fig. 3, nos 7-11)

A surprisingly large proportion of the assemblage was formed by flue tile (10% by fragment count, 4.5% by weight). By contrast, at Stanford Wharf, only 1% of the tile assemblage was flue tile (Shaffrey 2012, 153). The flue tile was all of standard box flue or *tubuli* type with combed keying on the surface. They measured from 19mm to 25mm thick and the largest surviving piece measured over 200mm long and over 150mm wide. Nearly all were made in the finest fabric D, which contained very little fine or no sand and had a neat, even finish with smooth or knife-trimmed edges. One had a rectangular vent, 63mm long, cut in the plain face. The combed keying was generally made with medium combs 42-47mm wide, with between six and nine teeth or more. A narrower comb of 28mm width had only four teeth creating a very coarse combing. The bands of keying were most often vertical or parallel to the edges, though diagonal and zigzag or criss-cross bands (Fig. 3, nos 7 and 8) were also present, which is the pattern visible on the flue tile fragment incorporated in tile surface 2630 (Fig. 4). The thickness of the flue tile suggests that the tile is likely to be mid-late Roman in date.

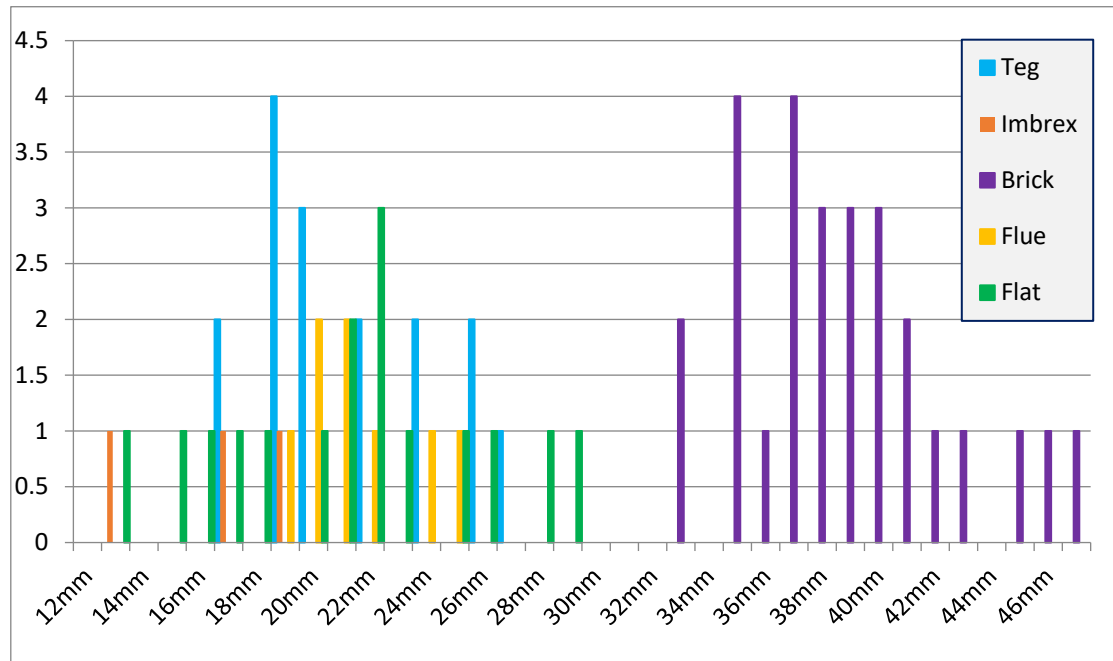
**FIG. 4: ROMAN TILE THICKNESS IN RELATION TO DIFFERENT TILE FORMS (WHERE TILES HAD A THICKNESS RANGE THE THICKEST MEASUREMENT WAS USED)**

The tegulae generally have a regular finish with knife-trimmed edges, smooth upper surfaces frequently finely striated from smoothing, and fairly regular rough sanded bases, though rough pitted bases occurred on two tiles. Thicknesses ranged from 14mm to 26mm; several exhibited a range of thicknesses from the tile edge to the centre (Fig.

Brick formed a large proportion of the assemblage, amounting to over 50% by weight and 25% by fragment count). The brick had a rougher finish than the roof tile, often having uneven, lumpy or striated upper surfaces and a rough base and rarely with evidence of knife-trimming. Edges had a variable finish, both rough and smoothed, and a few were knife-trimmed. The brick ranged in thickness from 35mm to 45mm, but unusually for Roman tile, several examples thinned to the edges, rather than the more typical pattern of thickened edges and a slightly concave top surface (Fig. 4). The single
