# Canon Green Court, Salford, Greater Manchester Archaeological Evaluation, Strip, Map and Record, and Watching Brief Report

August 2019

**Client: Willmott Dixon Construction Ltd**

Issue No: 2019-20/2010

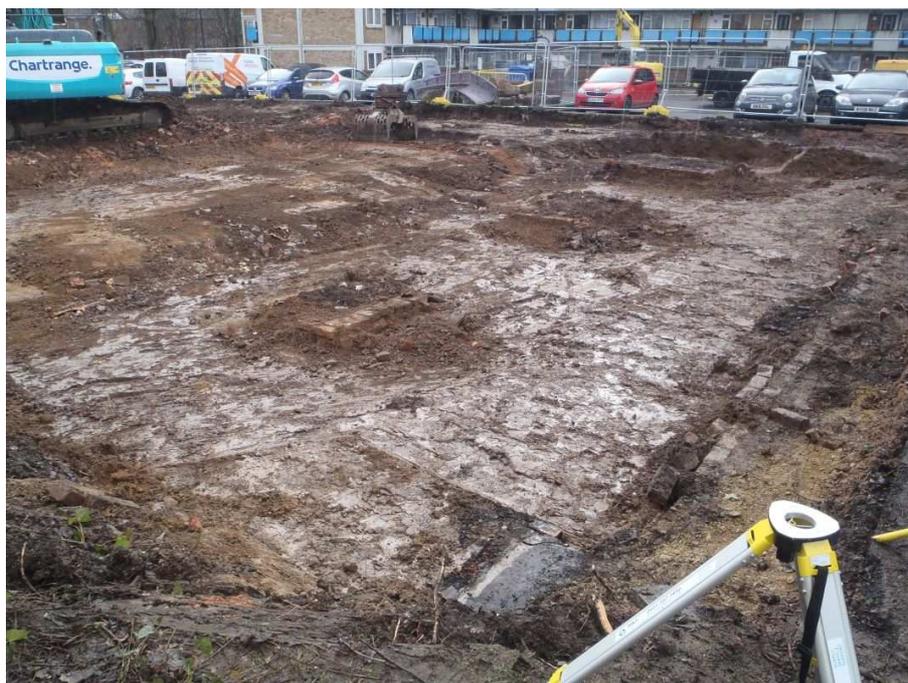
*Plate 1: Watching brief area. Looking south-east*

3.4.1 Several structures built of handmade brick were recorded where exposed by the shallow groundworks for the compound in the western part of the development site (Plate 1; Fig 3). All shared the same alignment, and would appear to relate to a terrace of houses that fronted onto Broughton Street, with their rear yards bounded by Ravald Court (Bancks and Co 1831). North-north-east-aligned wall **1006** traversed the full 17m length of the western part of the watching brief area, and was likely to represent the base of the rear wall of the main block of the terrace. Towards the centre of the wall, a 4m-long section extended from it at a right-angle, before returning to the north-east, just before the corresponding limit of excavation. The latter would appear to represent an internal division within the terrace

3.4.2 Some 1.5m to the south east of wall **1006** was a row of three rectangular structures (**1002-1004**) that were evenly spaced, c 3m apart. They measuring approximately 1m x 1.45m, with up to four course of brickwork visible. The short walls were composed of a single row of stretchers, whilst the longer walls each comprised two skins of headers, none of which seemed to be bonded with mortar. At their western edges, and partially extending into their enclosed area, the structures were each connected to a drain that was itself connected to a north/south 'header' drain, 2m to the east. The features were filled with a dark organic deposit which, due to the likelihood that these represented the bases of sanitation features, was not closely examined.

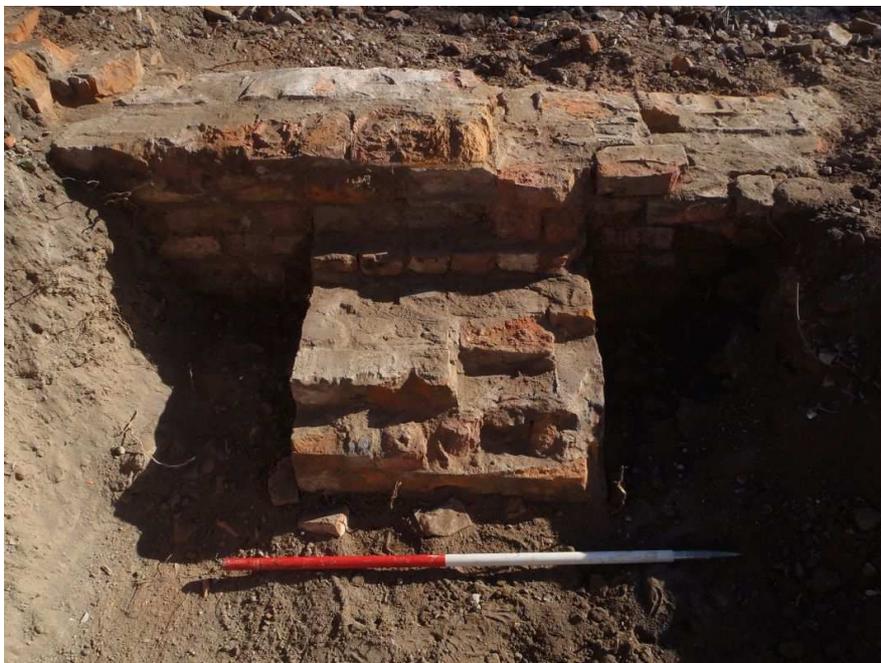
*Plate 4: Trench 2, Wall 201. Looking east with a 1m scale*

3.5.2 **Trench 2** revealed brick wall **201**, which was c 0.7m in width, with a single brick buttress projecting from its western face (Fig 4; Plate 4). The wall followed a slightly oblique north/south alignment and comprised four courses of hand-made brick, with an additional two courses of machine-made frogged brick bonded to the eastern face with cement mortar.

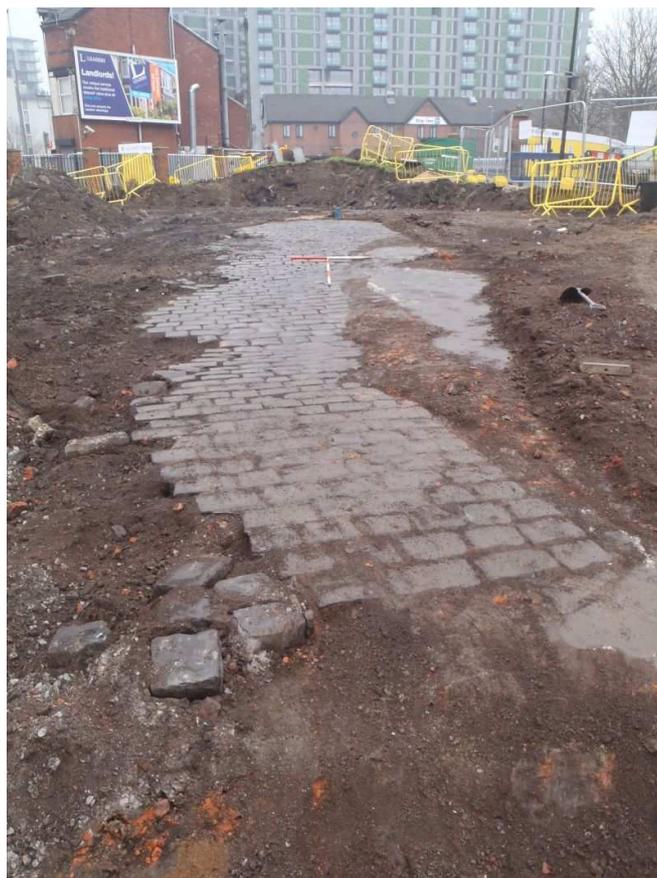
Plate 5: Trench 5, Surface 501. Looking east with 2x2m scales

3.5.3 **Trench 5** was largely dominated by an extensive surface (**501**) of granite setts (Fig 4; Plate 5). This surface, which was exposed for a length of 12.5m and survived to a width of 2m, seemed to extend from the south-west before turning slightly and continuing approximately east/west, although that curvature may have been an artefact of preservation. The western side was partially sealed by a deposit of crushed brick rubble, which also sealed the natural clay in the local area. Both rubble and clay had been cut for the foundation trench for the eastern corner of a wall (**502**). The surviving footing, which was three stretchers wide, comprised several courses of wire-cut bricks with a very dark, soily bonding material. Lapping against the wall and sealing the rubble deposits was a layer of concrete.

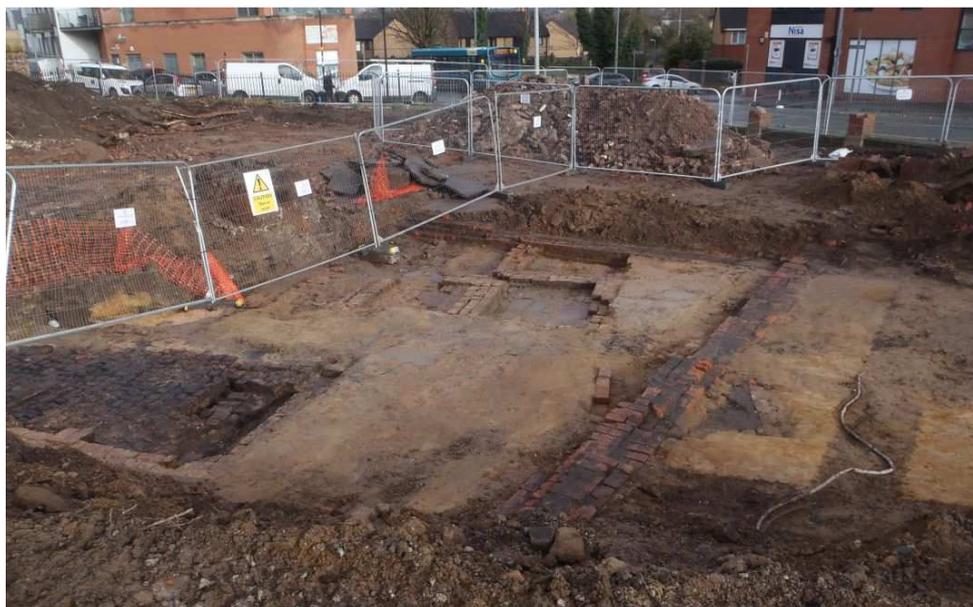
Plate 7: Area A. Looking North

- 3.6.1 **Area A:** this open area revealed a variety of structures, including early nineteenth-century brick walls, brick surfaces, and late nineteenth/early twentieth-century walls. The character and fabric of the physical remains supported the cartographic evidence, highlighting two distinct phases of construction.

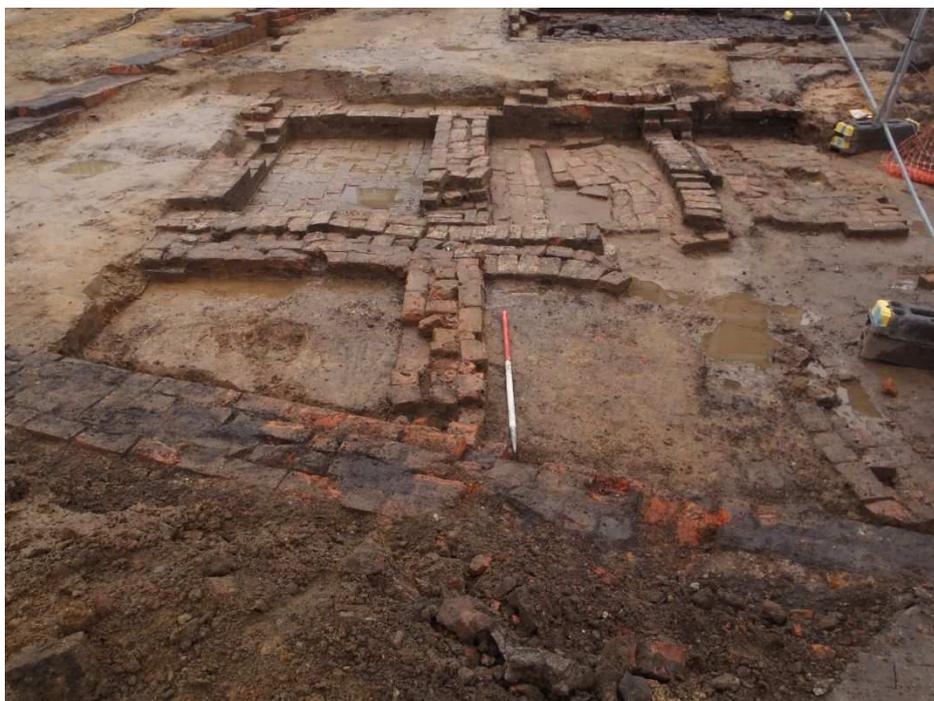
*Plate 8: Area A, northern structure. Looking South with a 1m scale*

- 3.6.4 The row of three cells to the north of wall **427** were less well-preserved, having been disturbed by later construction. They contained no floors or other internal features, although the walls between the cells survived, one of which, **417**, was bonded into wall **427**.

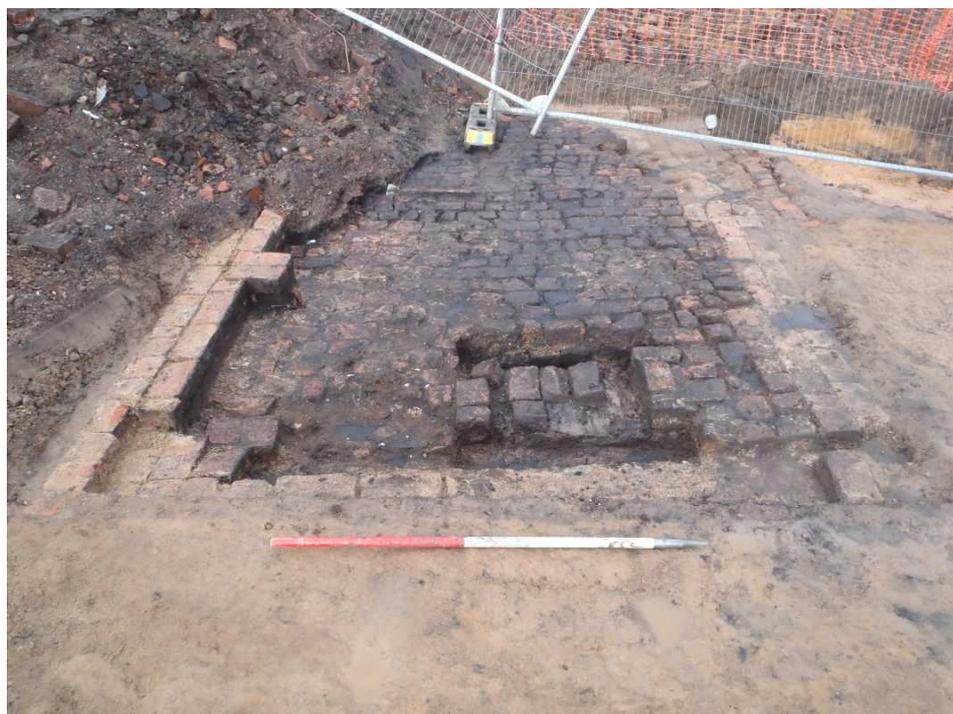
*Plate 9: Area A, southern structure. Looking west with a 1m scale*

- 3.6.5 A second rectangular structure, of handmade brick bonded with a lime-based mortar, was partially exposed within the south-western corner of Area A. It measured 4.2m east/west by 2.8m, continuing beyond the south-western limit of excavation. It was defined by wall **403=413**, which survived to two courses of bricks. These had generally been laid as two skins of staggered stretchers, but at roughly 1m intervals pairs of stretchers had been set at right-angles to project slightly into the interior of the structure, presumably as the base of some sort of support for internal fixtures. Within the building were two phases of brick flooring (Fig 5; Plate 9). The earlier, **402**, comprised handmade bricks set as east/west rows of stretchers. This was overlain by

floor **401**, largely composed of half bricks and with the occasional north/south-aligned stretcher. It was covered by a thick, black silty deposit, indicative of standing water.

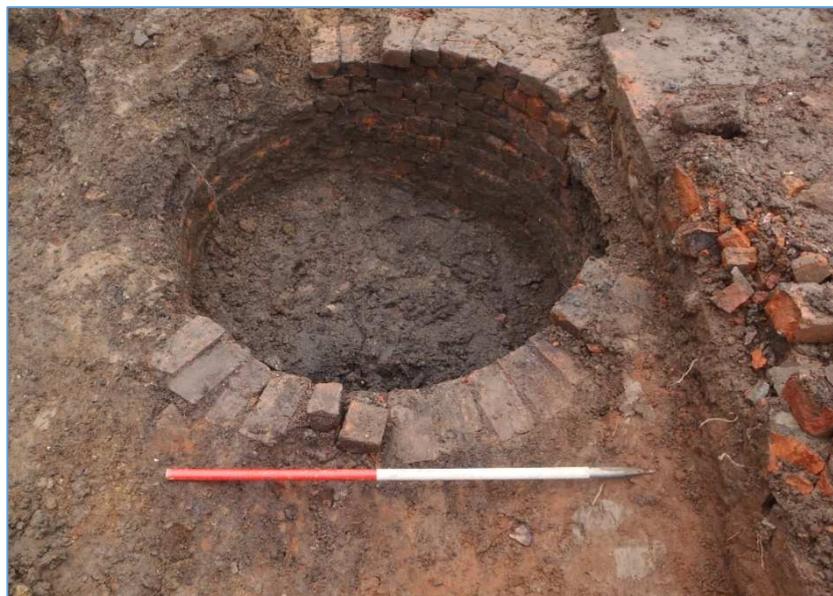
*Plate 10: Brick Well in Area B. Looking south with a 1m scale*

- 3.6.9 *Early nineteenth century*: this phase is essentially represented by brick-built well **603**, observed in the south-eastern part Area B (Fig 6; Plate 10). The well was approximately 1.6m in diameter and constructed using hand-made bricks. The internal space was

backfilled with a mixed deposit and the western extent had been partially dismantled and overlain by walls associated with the later bathhouse.

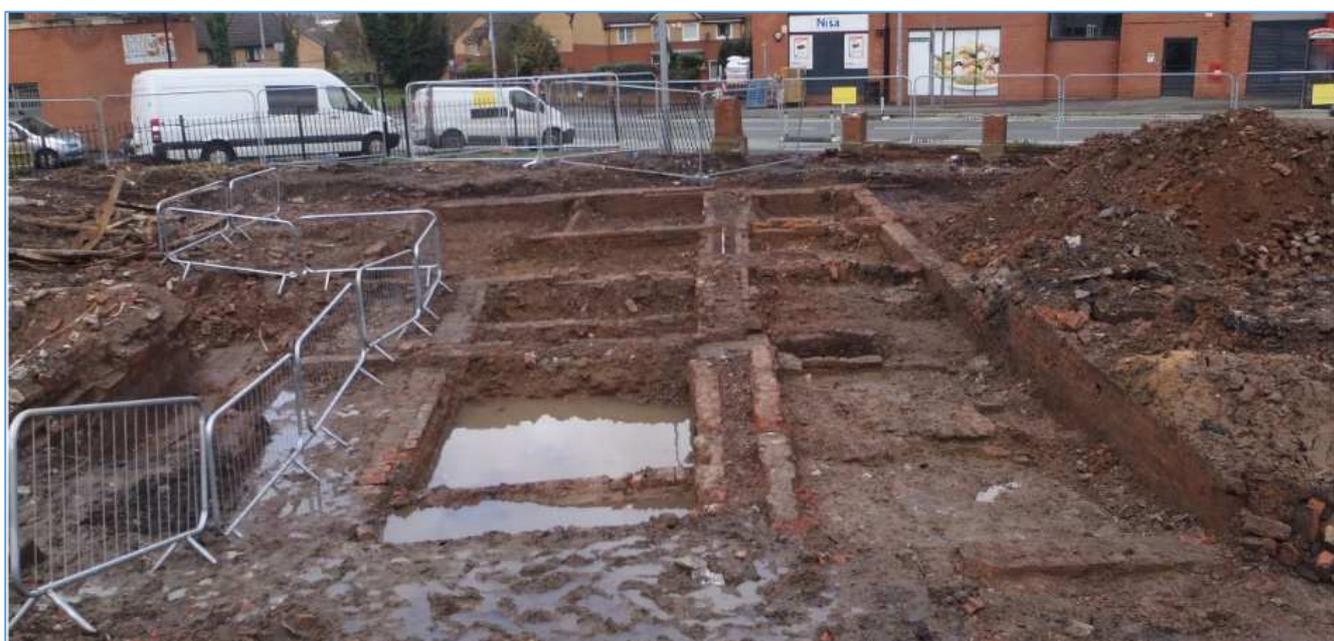
*Plate 11: Area B Bathhouse structures. Looking north.*

3.6.10 *Late nineteenth century*: The majority of structures identified within Area B were thought to relate to the later nineteenth-century bathhouse. Unfortunately, due to poor weather conditions and the presence of asbestos-containing materials, the structures within this area could only be partially cleaned prior to recording. This has subsequently impacted upon further interpretation regarding the function of those structures where additional details may have provided further insight or additional phasing information.

3.6.11 The remains of the bathhouse lay on a slightly oblique north/south alignment and comprised a mixture of (possibly reused) handmade bricks and machine-made bricks, bonded by cement-based mortar (Fig 6; Plate 11). In places, the structural remains were substantial, surviving to heights of up to a dozen courses, with the lowest resting on a wider footing seated directly into cuts into the natural geology. The northern, exterior wall was particularly robust and well made, with a thickness of five skins of stretchers. Internally, the walls were generally of three skins of stretchers, laid in English garden wall bond. Together with several fixtures and fittings, these largely formed the footings for what appeared to be a series of small rooms arranged in two north/south-aligned rows (**605-612**).

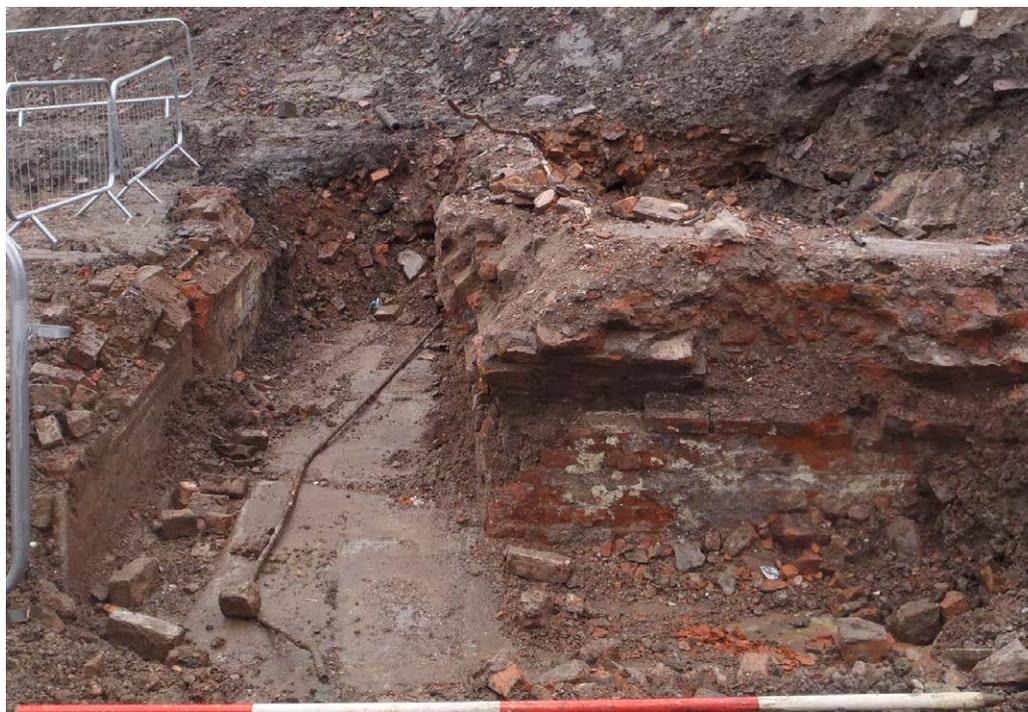
*Plate 12: The remains of a large vaulted-roofed duct at the southern end of Area B. 2m scale*

3.6.12 Only a very small part of what might have been a pool (**604**) was exposed at the south-western limit of excavation (beyond which site topography and safety considerations precluded any further expansion). The area was substantially masked by overburden, but it was possible to discern that at least one of the walls that defined the area had been faced with white glazed tiles. To its east lay the remains of what appeared to have been a large duct that contained metal pipes (**601**; Plate 12). It was some 1.2m wide, with a base of stone slabs. The roof of the duct was incomplete, but there was sufficient surviving brickwork in the side walls to suggest that it may have been some 0.6m tall, and would have had a vaulted roof. Evidence for the duct was visible for some 10m from the southern limit of excavation, at which point it formed a junction, one part passing west beyond the corresponding limit of investigation, the other, **602** (some 0.5m in diameter) entering room **610**, to the east.

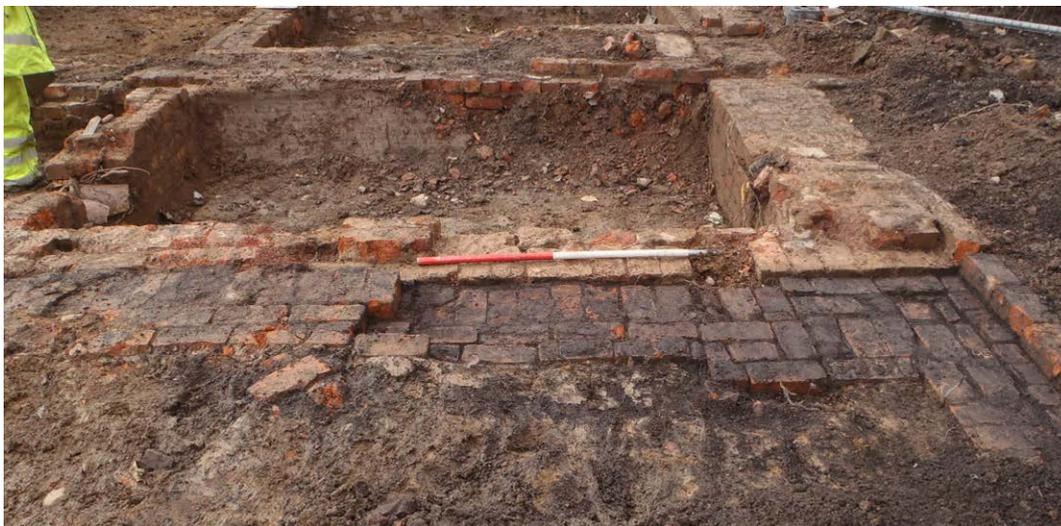
*Plate 13: The remains of a brick floor (foreground), with the substantial remains of the bathhouse's northern wall in the background*

and a c 0.4m-gap between. A narrow wall, comprising a single skin of stretchers, and a vestigial brick surface, were identified abutting the exterior face of the bathhouse's western wall and corresponding end of the northern wall (Plate 13). These had been built on the surface of the natural geology, and were thus raised somewhat above the base of the footings for the bathhouse in their deep foundation cuts.

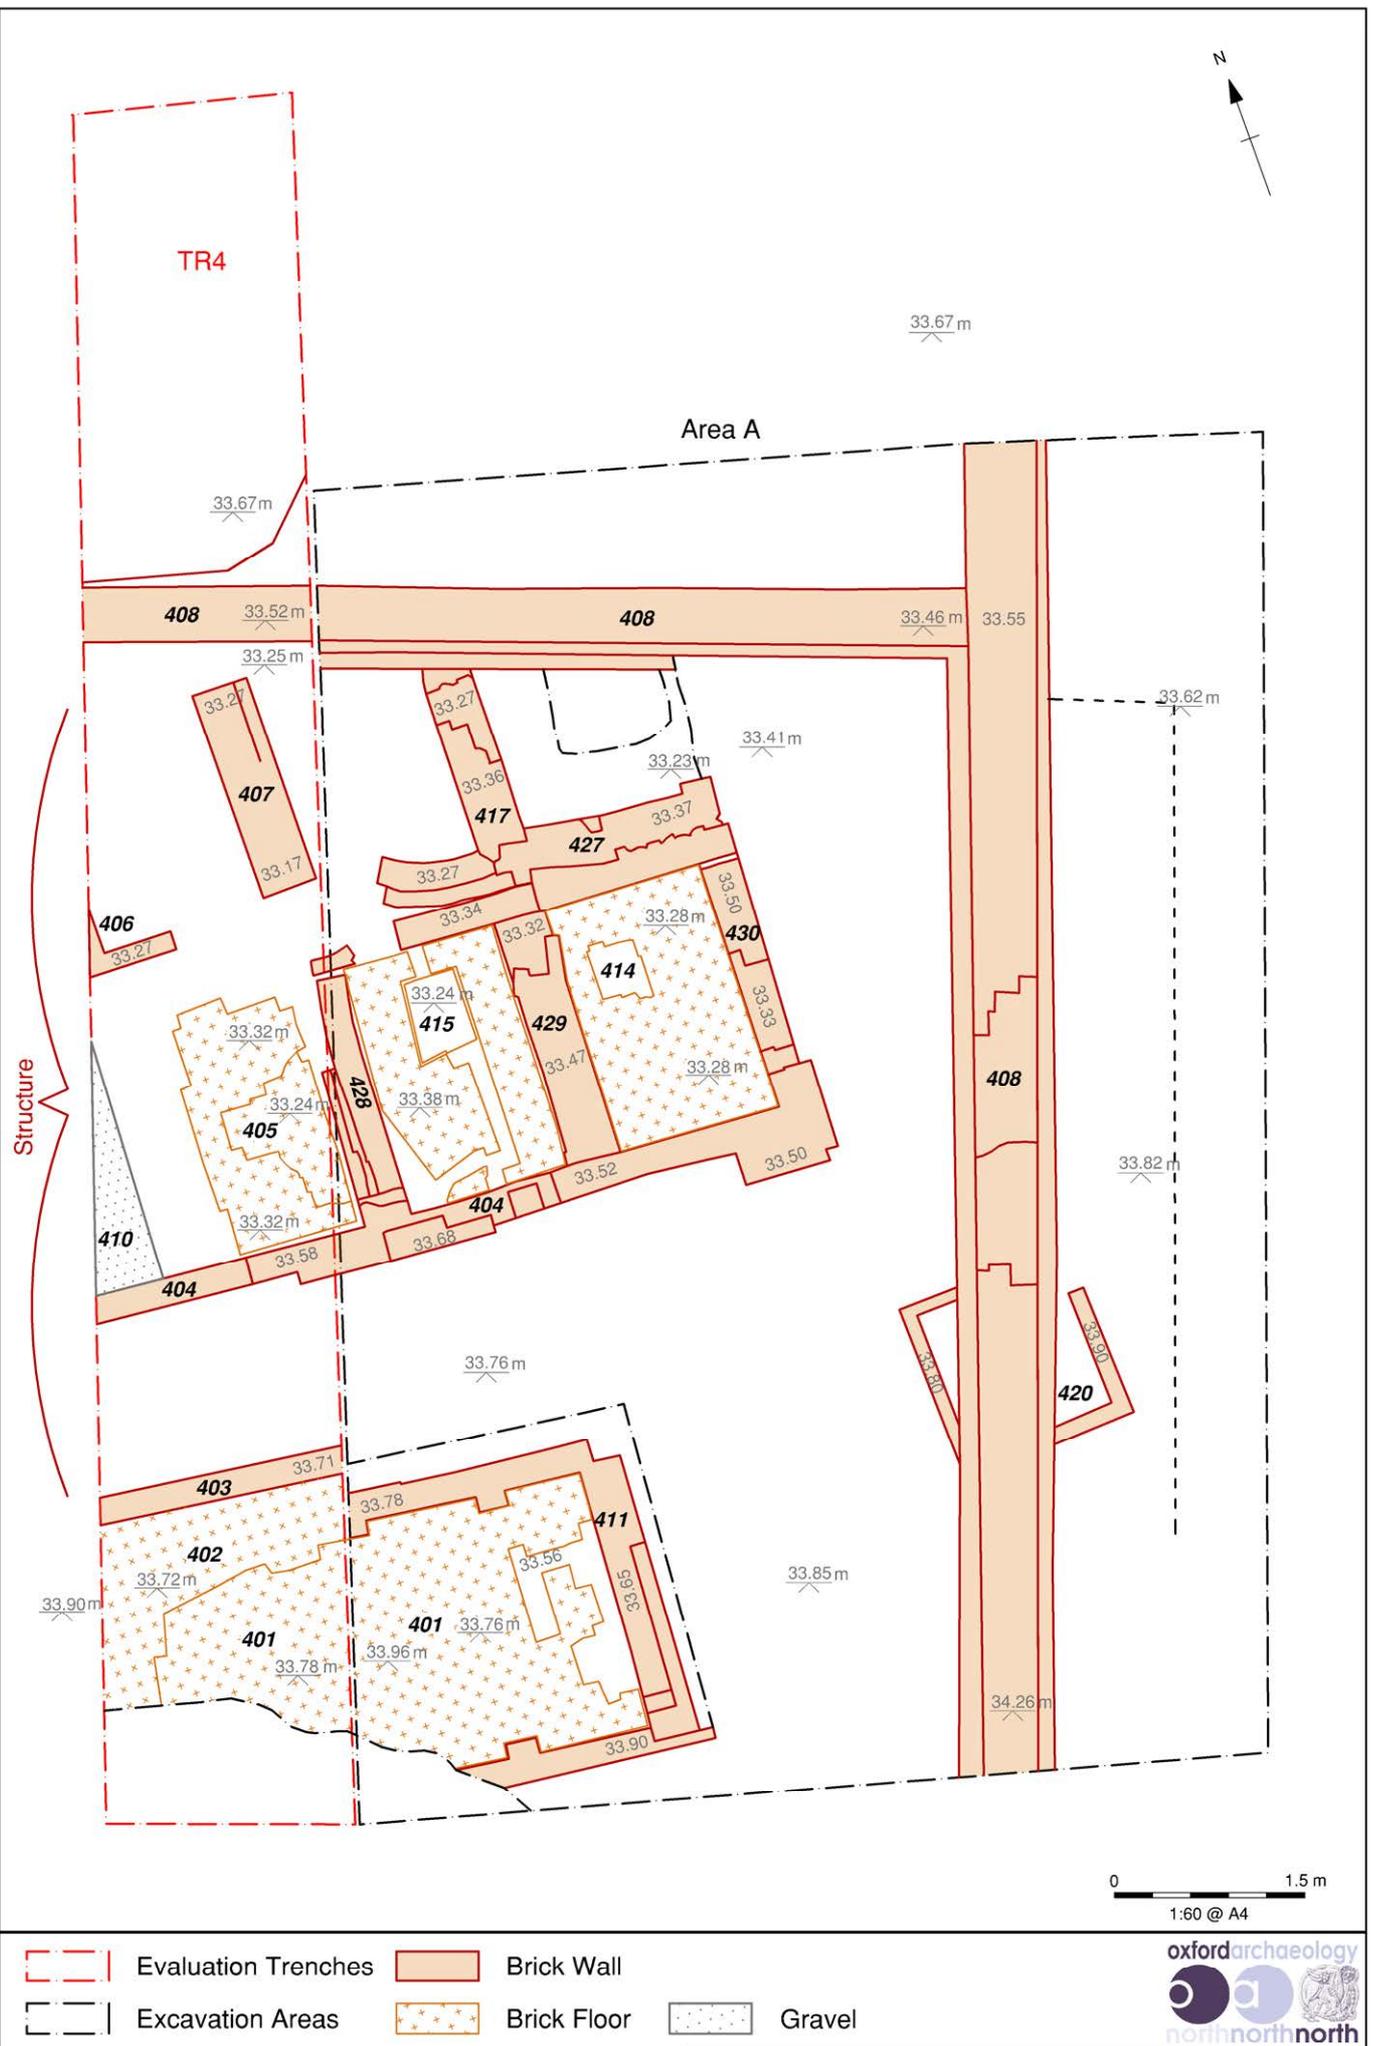
Figure 5: Plan of Area A and Trench 4

- 3.6.6 A third structure, **420**, was located along the eastern extent of the excavation (Fig 5) and comprised a small, 0.90m-square arrangement of hand-made brick walls, bonded with lime-based mortar. The internal space was occupied by dark grey soil **425** and the whole structure was cut across by later activity.

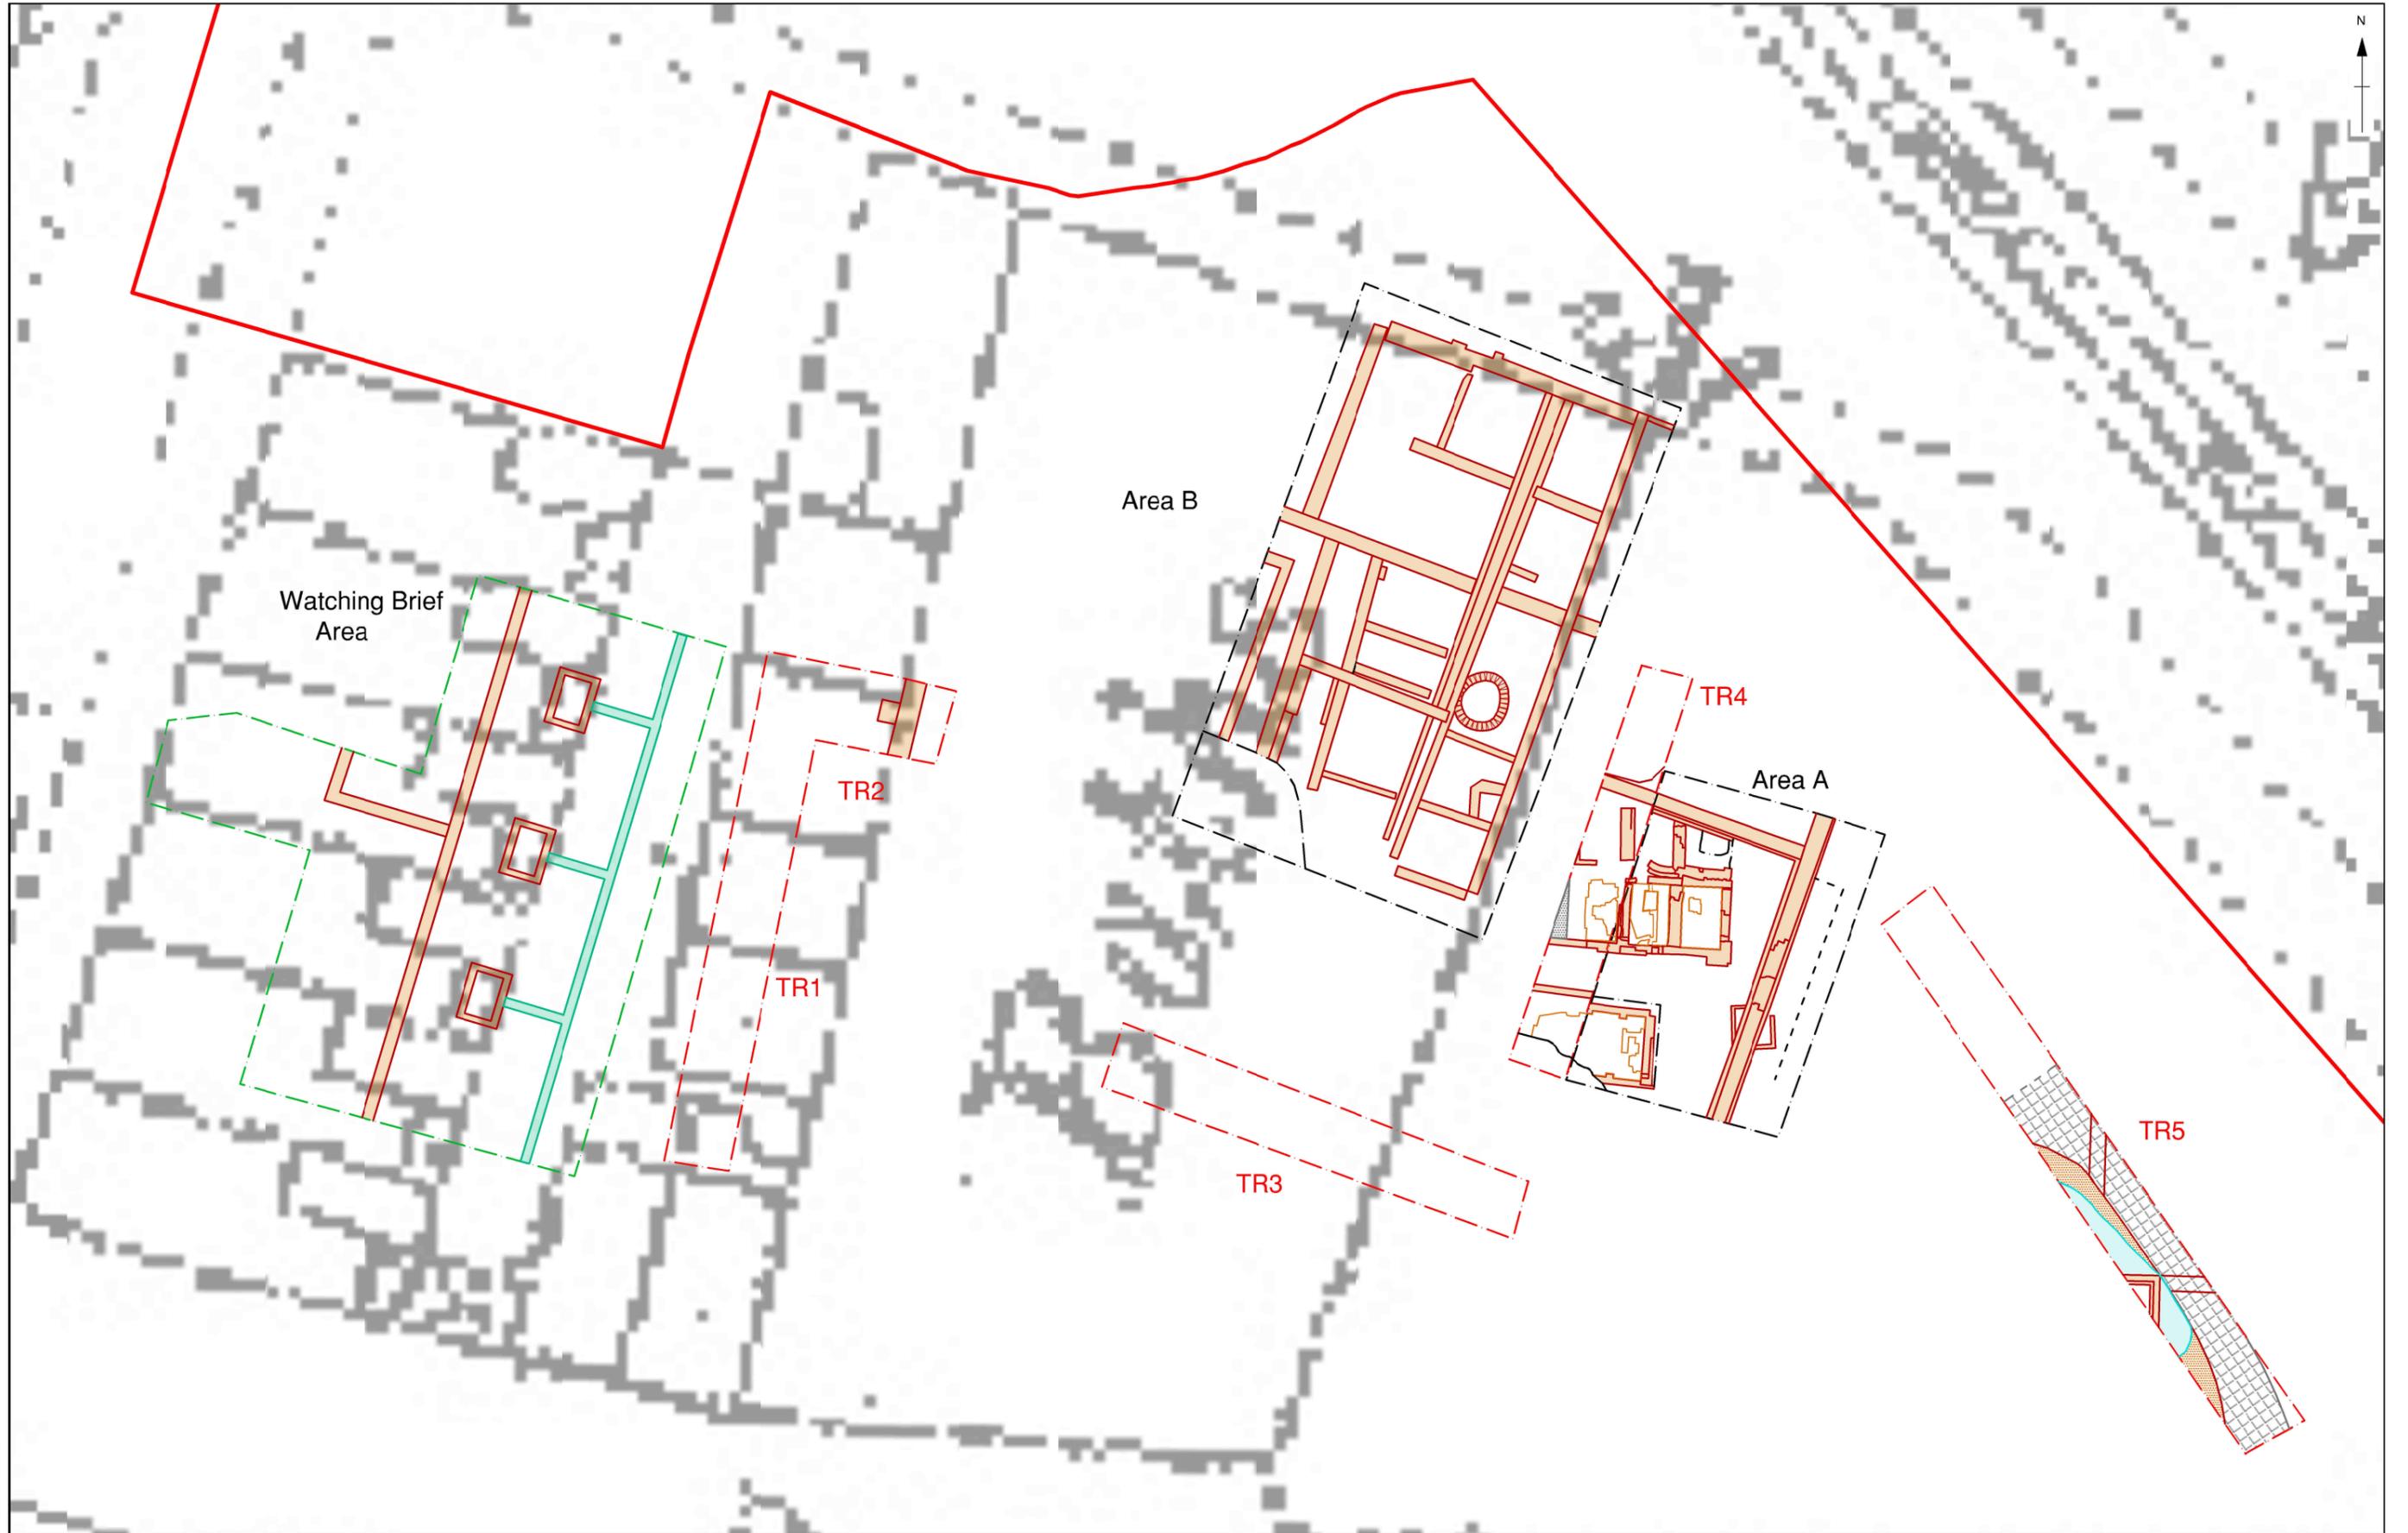
Figure 9: Archaeological remains superimposed on the Ordnance Survey 1:2500 map, 1894

- 4.3.7 **Phase 2: the late nineteenth-century public baths:** extensive remains of the brick foundations of the late nineteenth-century public baths, opened in 1880 and depicted on historic mapping from 1891 onwards (OA North 2018a; Fig 9), were found in Area B and Trench 2. Of the original fabric, the most readily identifiable feature was what appeared to be the remains of a large duct that may well have been associated with the distribution of hot water, and possibly hot air, to various parts of the complex. The 1891 OS 1:500 town plan shows that the bathhouse was equipped with a chimney at its southern end, and it is probable that this was associated with a boiler, to which duct **601** could have been connected.
