# The Malthouse and Malthouse Cottage, Boxley, Kent

HISTORIC BUILDING RECORDING  
AND ARCHAEOLOGICAL WATCHING BRIEF

OXFORD ARCHAEOLOGICAL UNIT  
JANUARY 1999

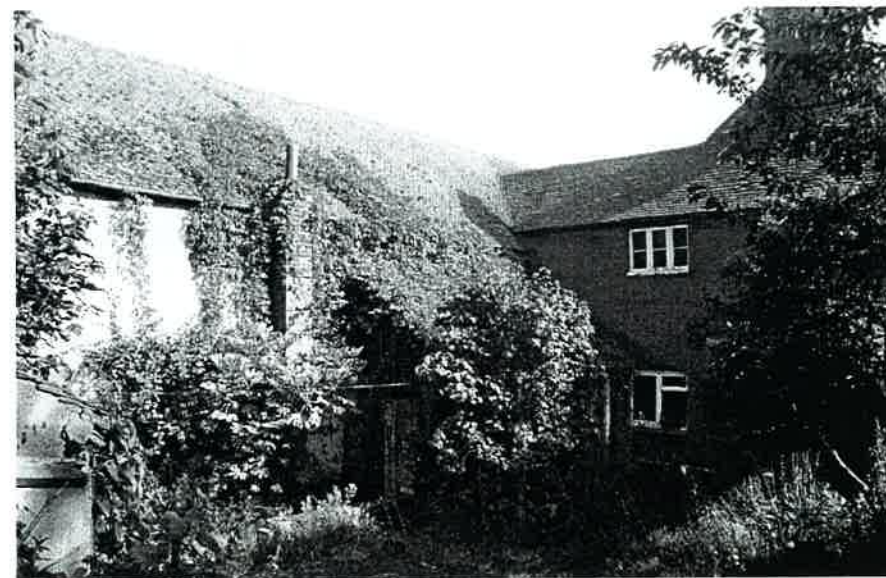
Plate 2: West façade of malthouse (to left) adjacent to north wall of cottage  
Plate 4: Upper growing floor viewed from north-east

- 5.7.4 Although this chimney has been truncated at the lean-to roof there is another similar shaft against the west wall of the malthouse which extends vertically above the eaves of the main building (Plate 2). This shaft, which is similarly dimensioned to the first, is located c 1.2 m to the north of the lean-to and is 30 cm to the south of a low brick base. The base is c 45 cm high and is in the shape of a rectangle (1.15 m x 40 cm) with a chamfered north-west corner. It is clear from various pieces of evidence that the existing lean-to extended substantially to the north, probably for the full length of the malthouse, enclosing both of these features. The first piece of evidence is that the west wall of the lean-to continues slightly beyond the existing structure, as a low garden retaining wall. There is also a clear trace of roof flashing against the existing chimney shaft, consistent with a lean to roof, and there are small joist holes within the chalk wall, extending to the north end of the building, at the height of the lean-to roof ridge.

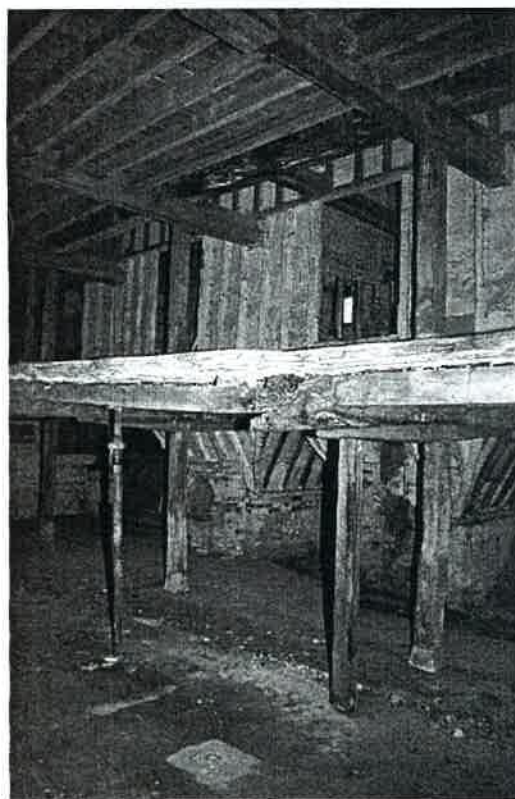
Plate 7: View towards Kilns 3 and 4 from within area of collapsed first floor

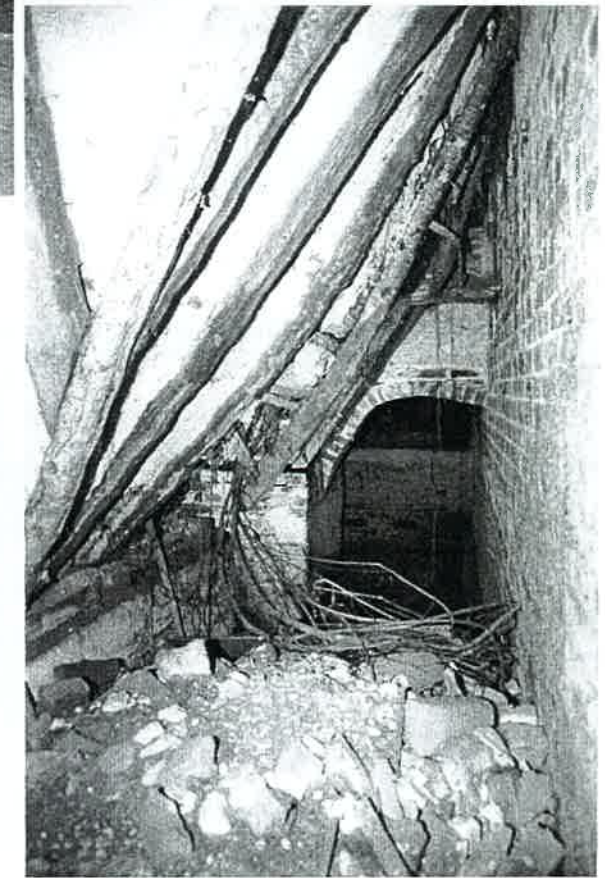
Plate 12: Curved flue to rear of Kiln 2

- 5.6.13 An important additional piece of evidence, also suggesting such a distinction, exists to the rear of Kiln 2. The feature is hinted at by the fact that while the side walls of the other 4 small kilns are entirely of chalk, the uppermost 21 cm (3 courses) of the side walls of Kiln 2 are of brick (Plate 12). This is explained to the rear where an arched brick flue enters the kiln through the three upper brick courses. The flue extends through the outer wall of the malthouse and into a later lean-to structure where it adjoins a shared chimney shaft (Plate 2, see below for more detail). The flue is clearly shown to be secondary by the later brick vertical extension to each of the walls of the kiln base, being at the same level and of the same date as the flue. The flue exits the kiln at the base where the fuel would be placed and the conclusion may be that it was added to draw air through the kiln to generate a greater heat. Another possibility may be that it was used to draw off some of the heat if the kiln generated too much or possibly it was an attempt to allow the use of a different, cheaper type of fuel by drawing off most of the smoke up the chimney. Charcoal was the standard fuel for hop drying up to the 1930s. (Filmer R, 1982)

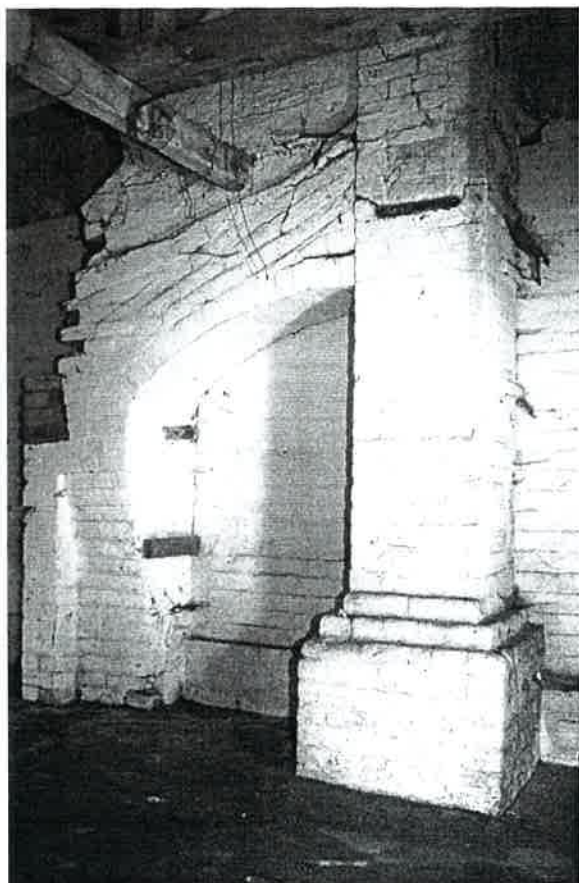
Plate 17: Chimney stack within lean-to to rear of Kiln 2
