Bowring Park, Merseyside

Archaeological Watching Brief Report

July 2020

WSP and Knowsley
Metropolitan
Borough Council

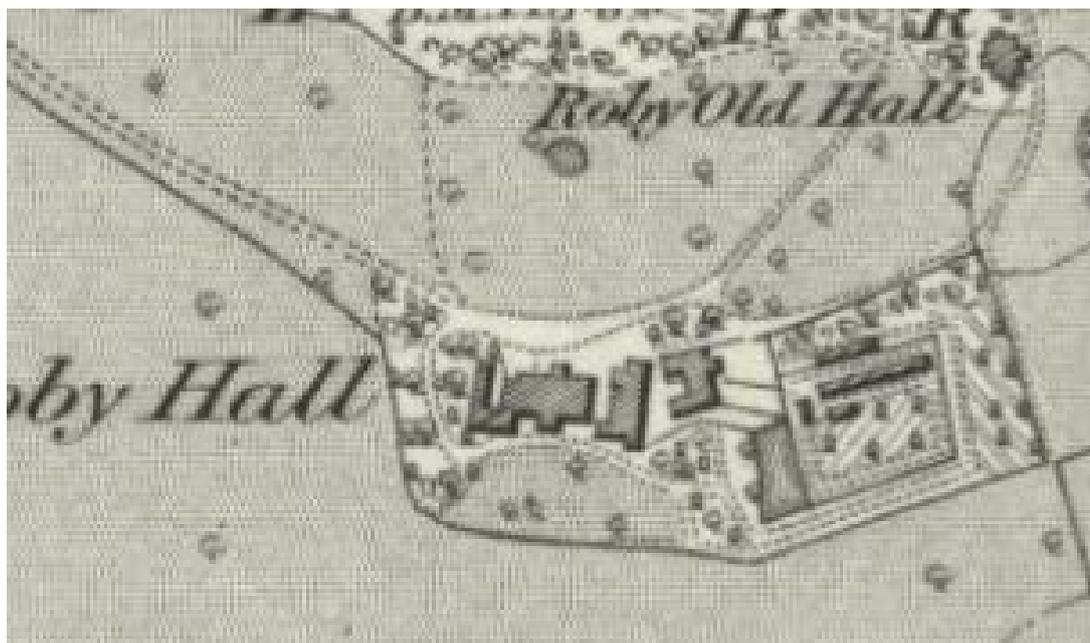
Plate 2: Excerpt from Ordnance Survey map of 1850 showing Roby Hall central to the Stables (left), Coach House buildings (right), and the walled garden and Ha-ha

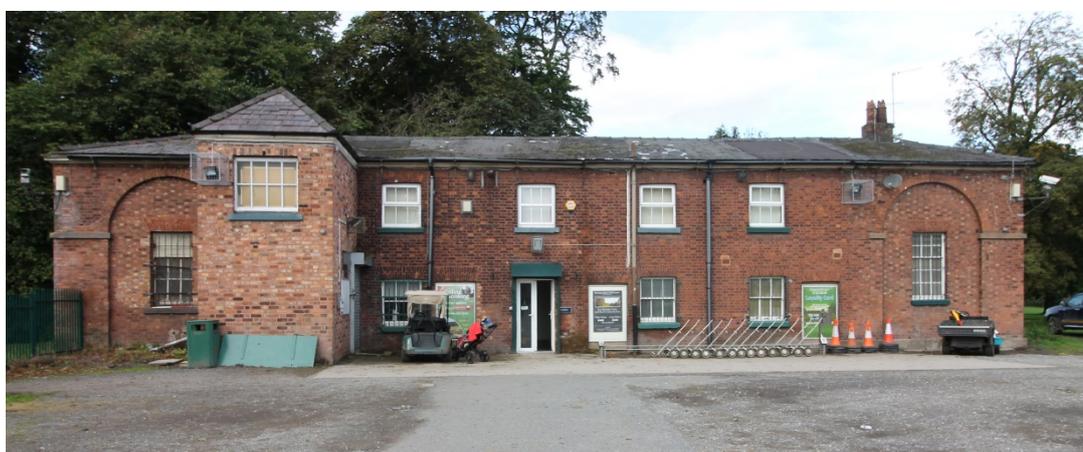
Plate 4: The eastern elevation of the former Stable Block

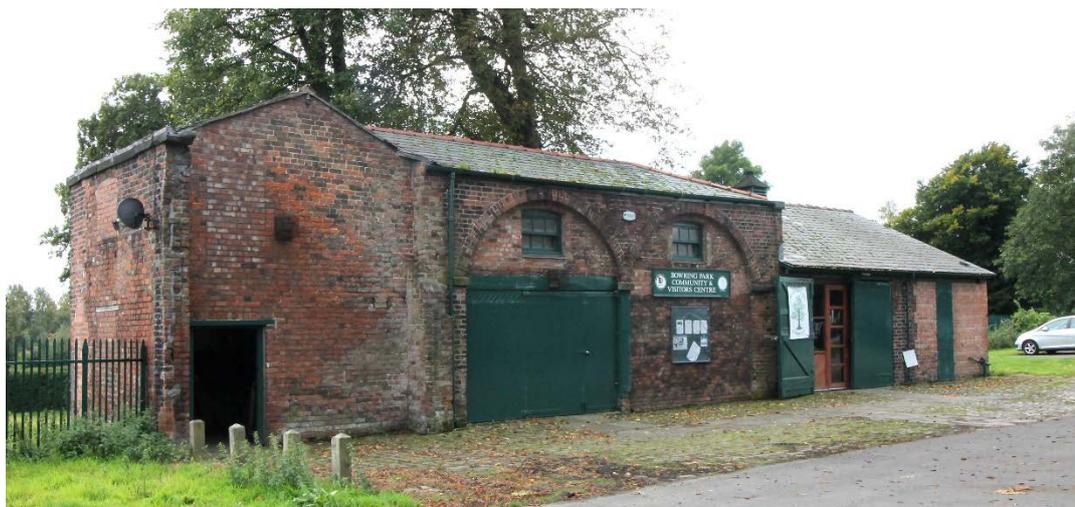
Plate 5: Northern elevation of the Coach House

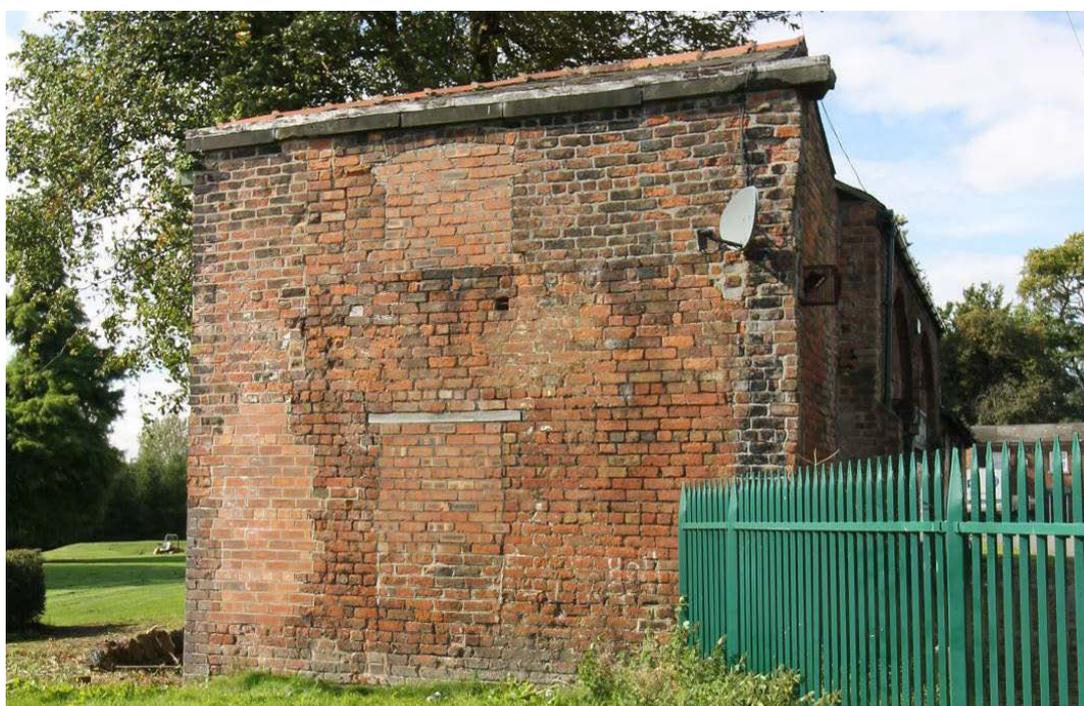
Plate 6: Eastern elevation of the Coach House (Building B)

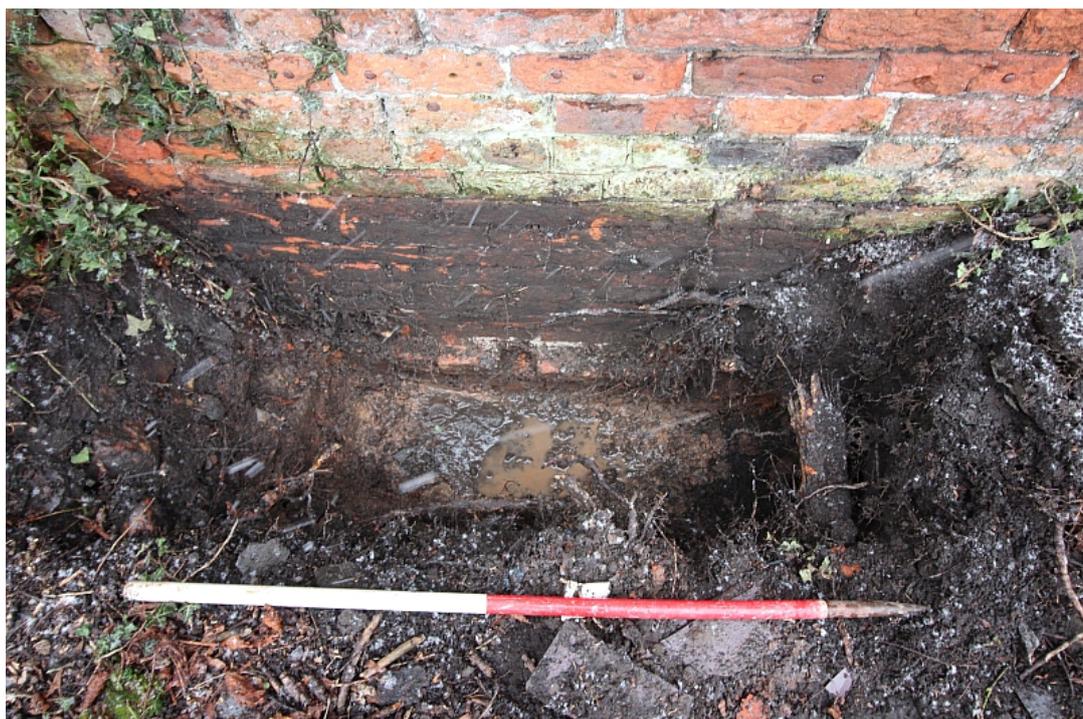
3.2.2 **External Test Pits:** there were 17 test pits at intervals around the external walls. Most of the external test pits (**TP 30, 31, 33, 35, 36, 37**) exposed only the brick foundations of the extant Coach House walls (Plate 7). Although none of the external test pits were excavated below foundation depth, a maximum of six courses of brickwork were identified below the present ground surface. Where the basal course was identified, this was slightly wider than the main wall.

Plate 7: Example of brick footings: **TP35**, southern elevation of the Coach House, 1m scale

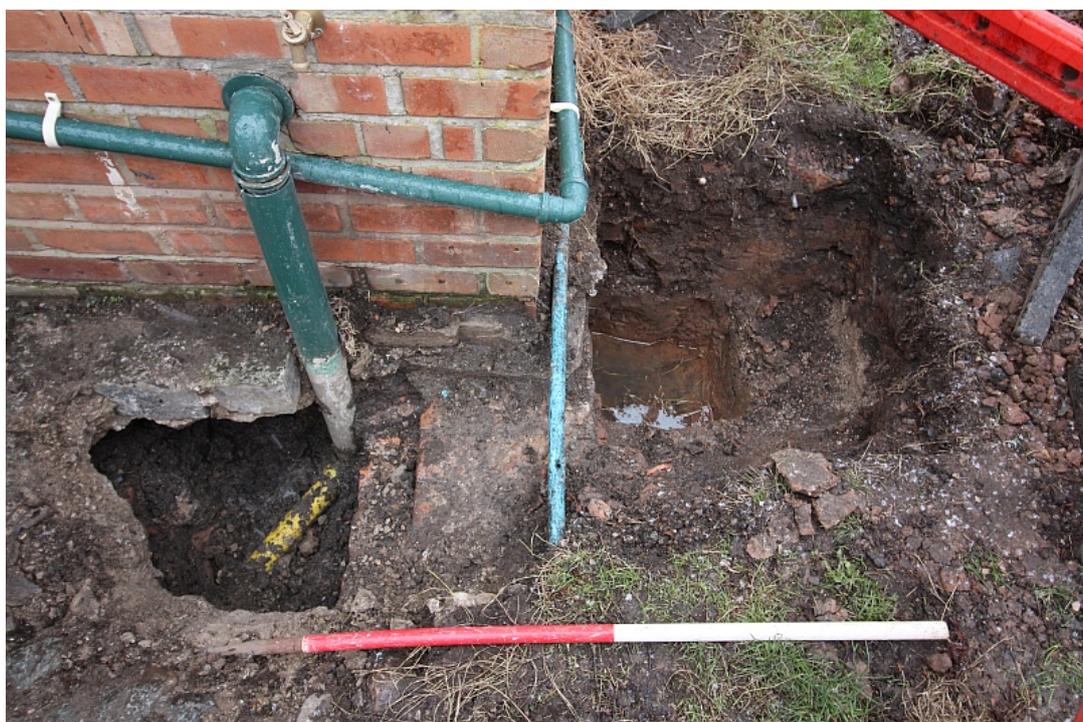
3.2.3 Several of the test pits exposed the remains of sub-surface features. In **TP29**, at the north-western corner of Building A, the brick foundations of a previous wall on a north/south alignment were identified below a modern brick wall forming an extension to the north-west of the present building (Plate 8). This indicates that the modern wall was constructed on pre-existing foundations. Photographs and historic mapping from 1891 and 1894 (eg Plates 1 and 3) show a north/south-oriented building to the north of the present Coach House.

Plate 8: **TP29** against the north-western corner of the coach house, 1m scale

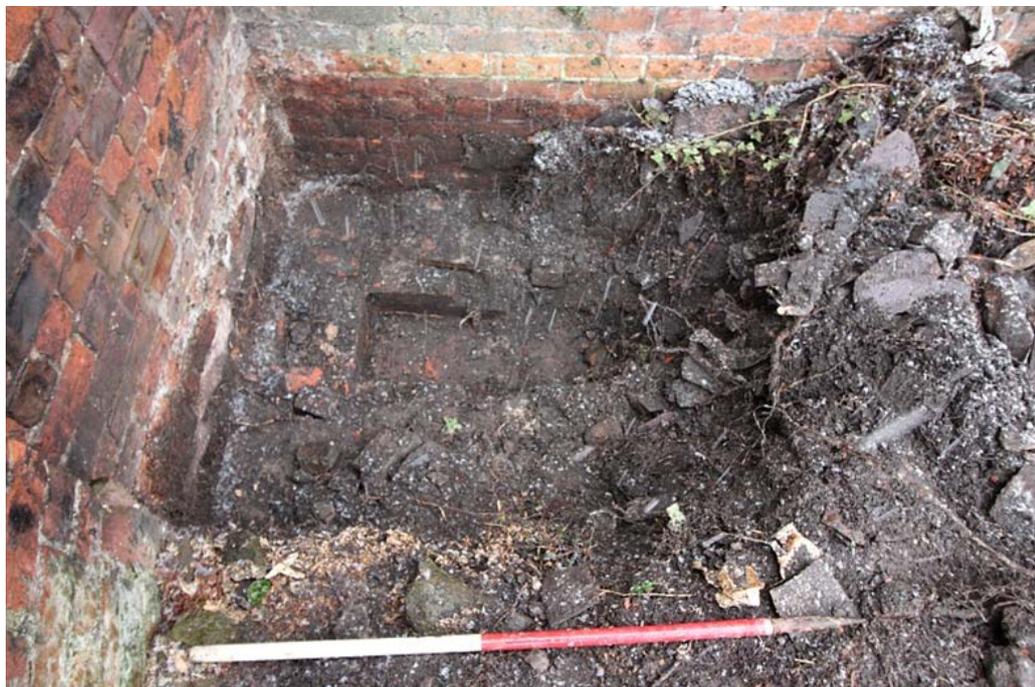
- 3.2.4 **TP38**, situated against the south wall of Building B, in a corner formed between it and the former café (Building A) to its west, revealed a brickwork floor (Plate 9), which was six brick courses below the present external ground level. This probably relates to the floor surface of an earlier building which projected southwards from the present layout.

Plate 9: TP38 showing brick floor, 1m scale

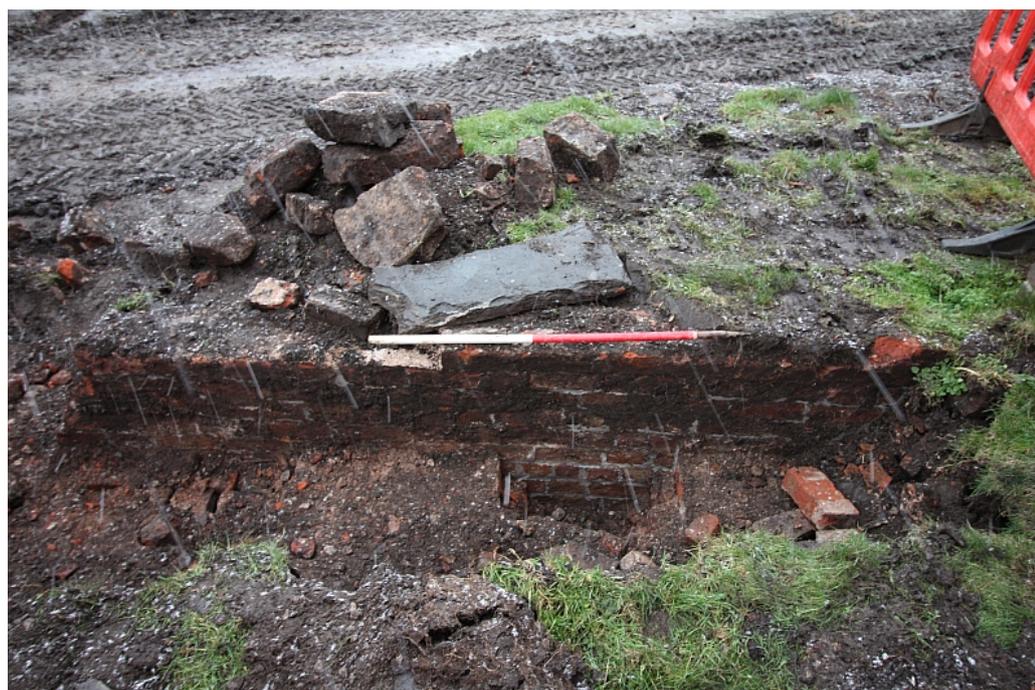
- 3.2.5 At the south-eastern corner Building B, **TP34** exposed the remains of the footings of a brick wall extending east from the presently extant east elevation (Plate 10). Excavation of the test pit revealed the presence of demolition rubble, presumably used as infill for the void. This material included brick rubble, faced sandstone blocks and what appeared to be a stone step or threshold.

Plate 10: TP34, wall and footings, 1m scale

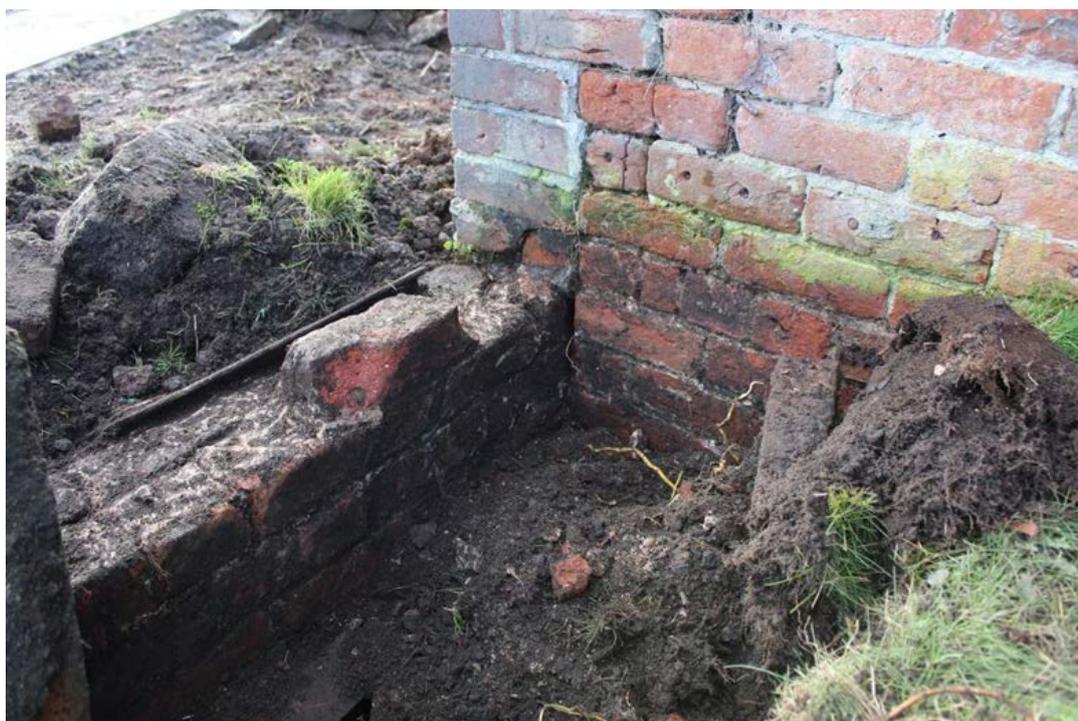
3.2.6 The wall exposed by **TP 34** was exposed further during later ground reduction works (also recorded as wall **B5**; Fig 3; Plates 11 and 12). Although eight courses had been identified within **TP 34**, when it was exposed for a second time, its visible extents amounted to five stretcher courses of a double-skinned wall bonded with lime mortar. It ran on an east/west alignment for *c* 3m before turning 90 degrees to the north. The footings abutted those of the presently extant south-eastern corner of the building, but pre-dated the modern, twentieth-century addition or repair of the southern elevation. This wall (**B5**) appears to relate to a former extension to the eastern end of the building identified on historic mapping (OA North 2018) and demolished in the 1970s. Appended to the south-eastern corner of the brick wall was a curved stone garden wall which carries on along the southern elevation of the Coach House and remains extant further to the west.

*Plate 11: Close-up of south-east corner of uncovered brick wall, **B5** demonstrating relationship with Building B, south-west-facing*

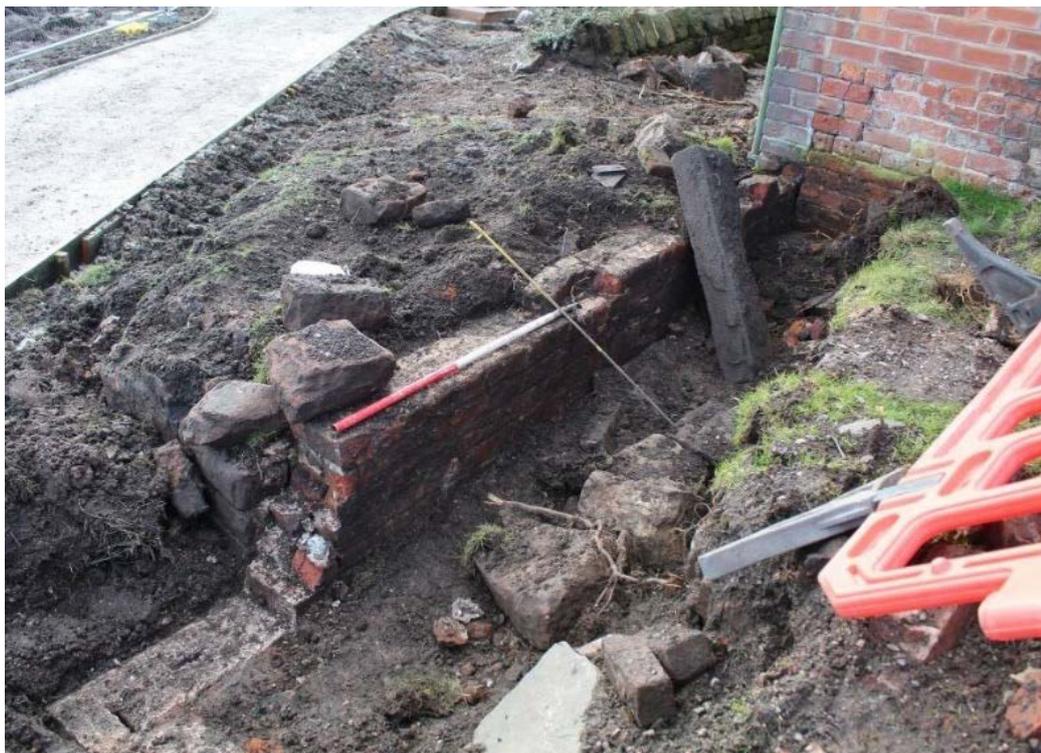
Plate 12: Brick wall, B5, on south-east end of Building B, south-west-facing with 1m scale

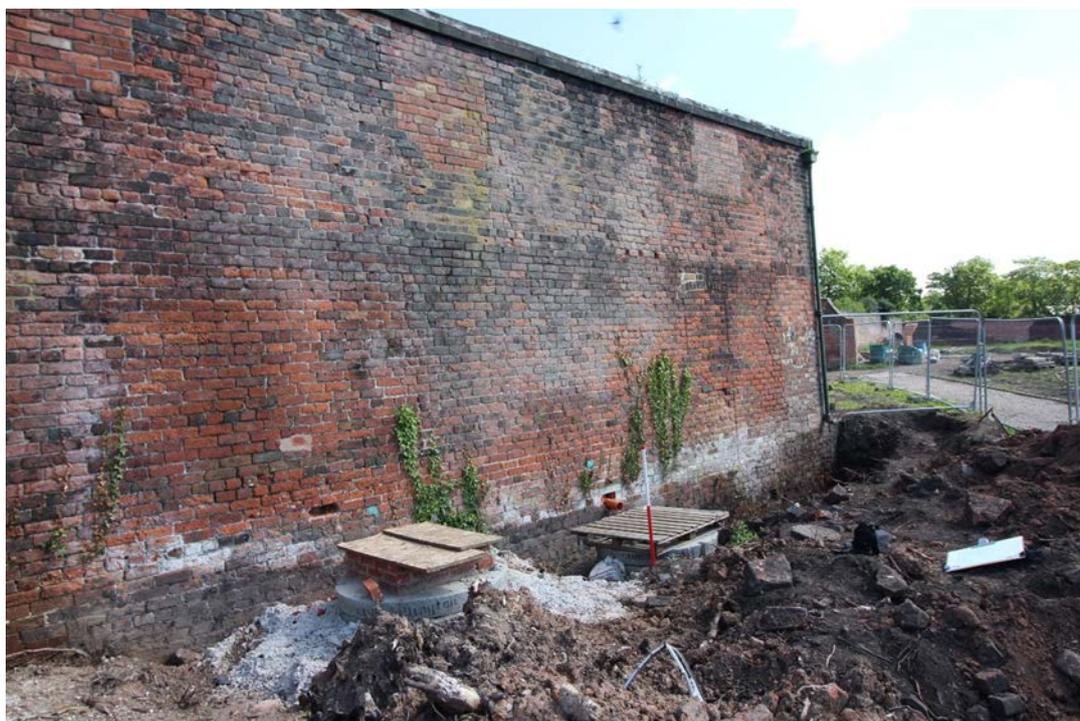
3.2.7 Groundworks undertaken in May 2019 to the rear of the Coach House illustrated more detail of the southern elevation (Plate 13). The remainder of the stone-built garden wall had been demolished and the ground cleared around the base of the Building B to a depth of c 0.7m below the former ground level. This was in the location of earlier test pits (23, 24, 35, 36 and 37) which had revealed only topsoil and brick foundations.

Plate 13: Southern elevation of the Coach House Building B

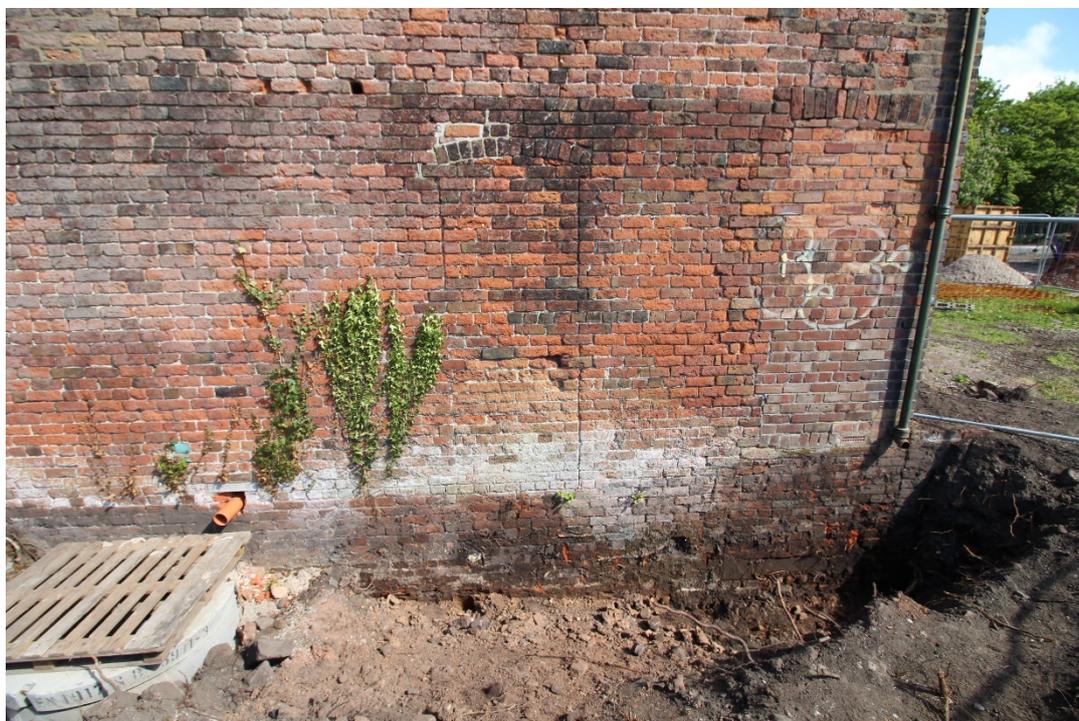
- 3.2.9 As described by the building survey (OA North 2018, *Section 4.5*) there are two blocked apertures in the southern elevation of Building B, one close to the south-eastern corner of the building, blocked with modern brickwork, and another, *c* 2m to the west, that was originally a door, then half-blocked to make into a window, with the window also subsequently blocked (Plate 14). Also, there was a soldier course in the south-east corner, probably over another door; this again had relatively modern blocking, suggesting that it had, at some point, formed a window before the aperture was completely blocked. The basal part of the blocked aperture contains a modern air brick. There is a slight change in levels between the two former apertures, with the more modern aperture (to the east) being slightly higher, probably reflecting different contemporary ground levels inside the building (Plate 13).

Plate 14: Detail of southern elevation of the Coach House Building B

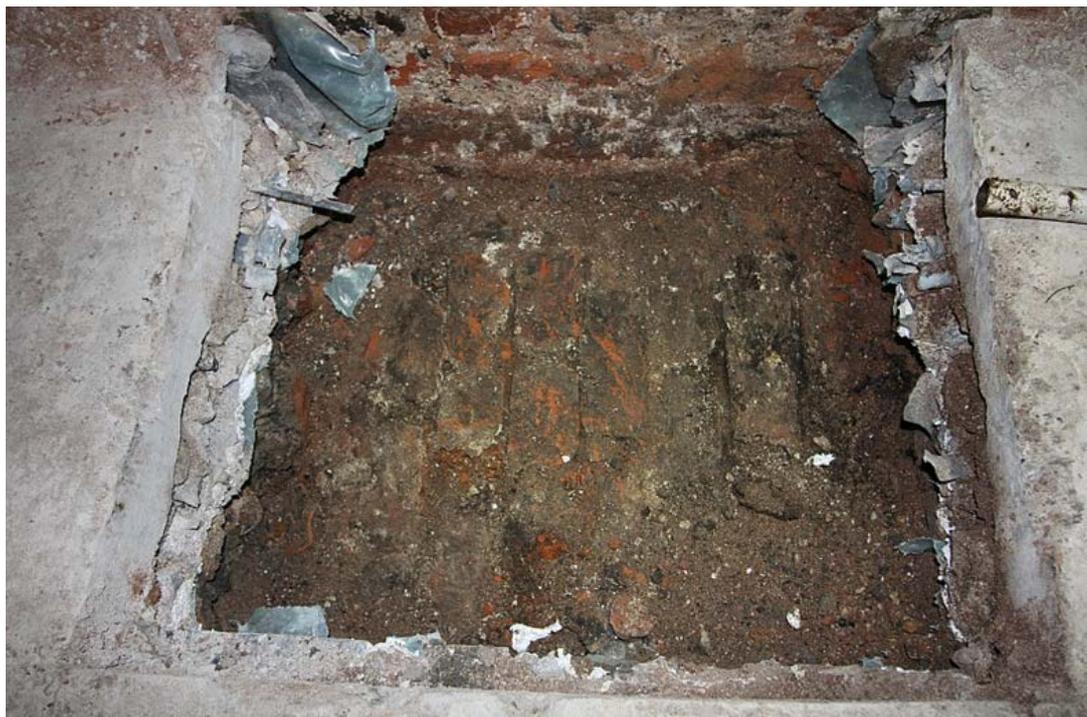
- 3.2.10 **Internal Test Pits:** six test pits were excavated by hand inside the Coach House (**TPs 39, 40, 41, 42, 43** and **44**). Situated against the southern wall of the western bay of Building B, **TP 40** contained a brick floor surface, at a depth of *c* 0.2m below the present internal ground surface (Plate 15). Although it did appear to be constructed within the walls of the building, this surface may have been relatively localised as no surfaces were recorded within **TP 39**, located *c* 2m to the west, or **TPs 41** and **42**, further to the north-east. It is possible that floor levels may have been removed or truncated by modern activity; the remainder of the test pits, although illustrating the presence of wall footings, contained mixed demolition material seemingly of twentieth-century date, below the modern concrete floor and damp proof membrane upon which this had been laid.

Plate 15: TP40 with brick floor, located against the south-facing elevation of the Coach House

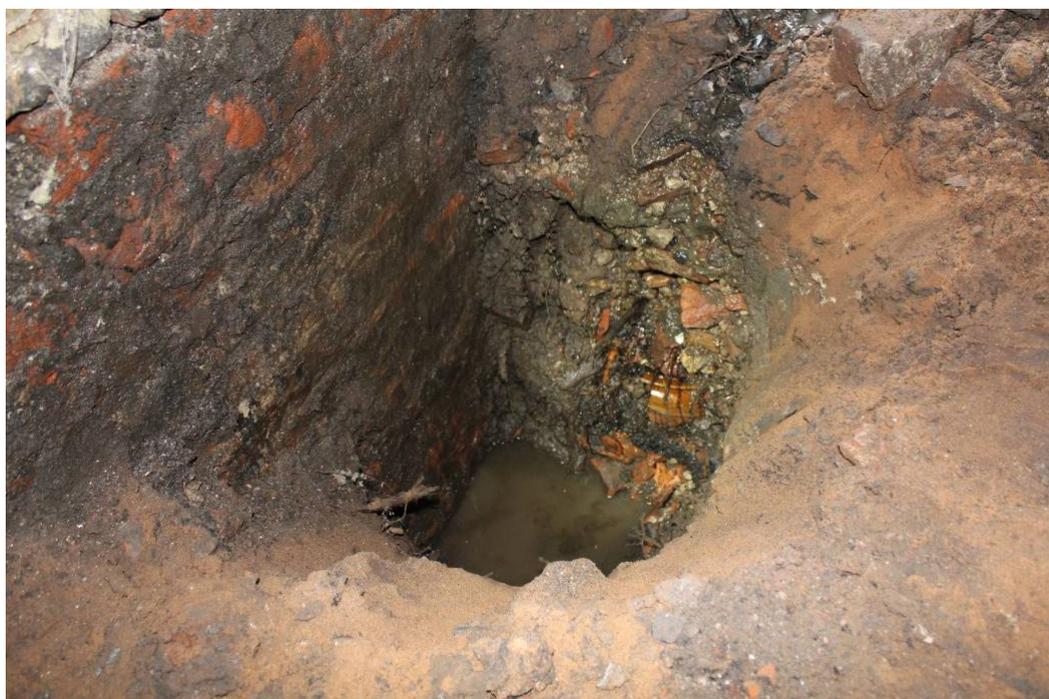
- 3.2.11 **TP44**, against the northern wall of the eastern end of Building B, demonstrated that the wall foundations were nine courses of brickwork below the present floor surface (Plate 16). Below this, the material making up the present floor level comprised refuse and demolition material, including nineteenth-century glazed stoneware and building rubble, to a visible depth of c 0.75m. Below this level, the test pit was inundated with ground water.

Plate 16: TP 44, against the northern exterior wall of the eastern bay of Building B

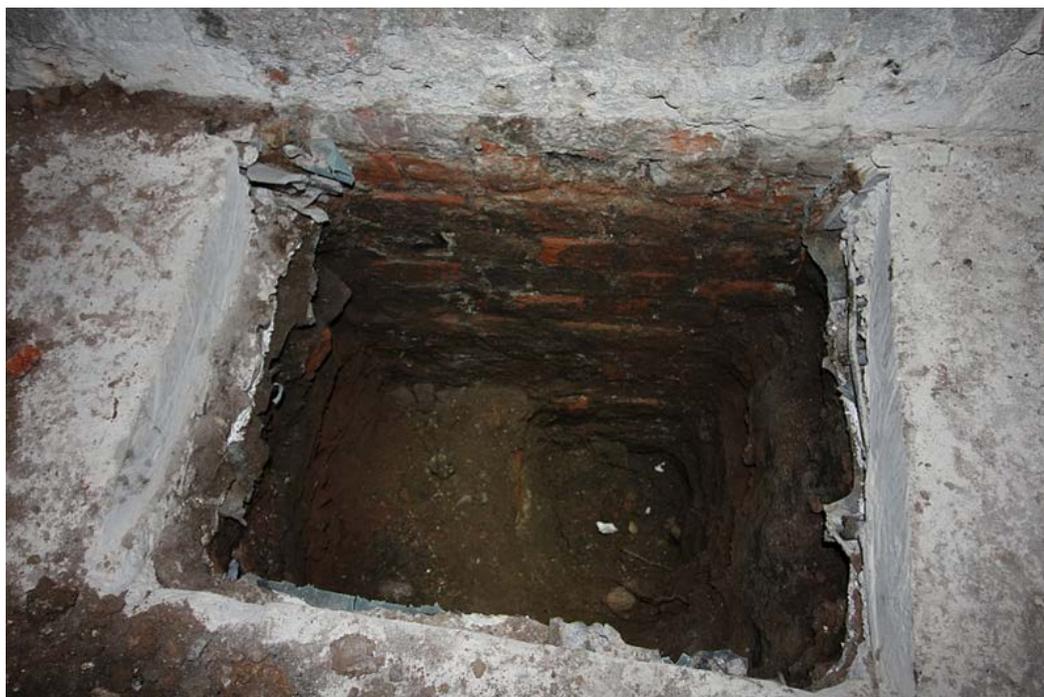
3.2.12 Whilst the contents of most of the internal test pits contained little structural evidence, the walls against which they were placed had footings of different depths. Like that in **TP44** (against the northern wall of the eastern element of Building B), **TP41**, against the western wall, also had footings of at least nine courses below the present surface (Plate 17). These two walls belong to the easternmost north-to-south-oriented bay of the coach house, which is part of the Phase 1 former L-shaped range (1849-91). To its west, **TP42** illustrated that the internal dividing wall between the two western bays of Building B was of five stretcher courses, with a basal header course seemingly acting as a foundation (Plate 18).

Plate 17: **TP 41** located to the west of an internal dividing wall within the Coach House

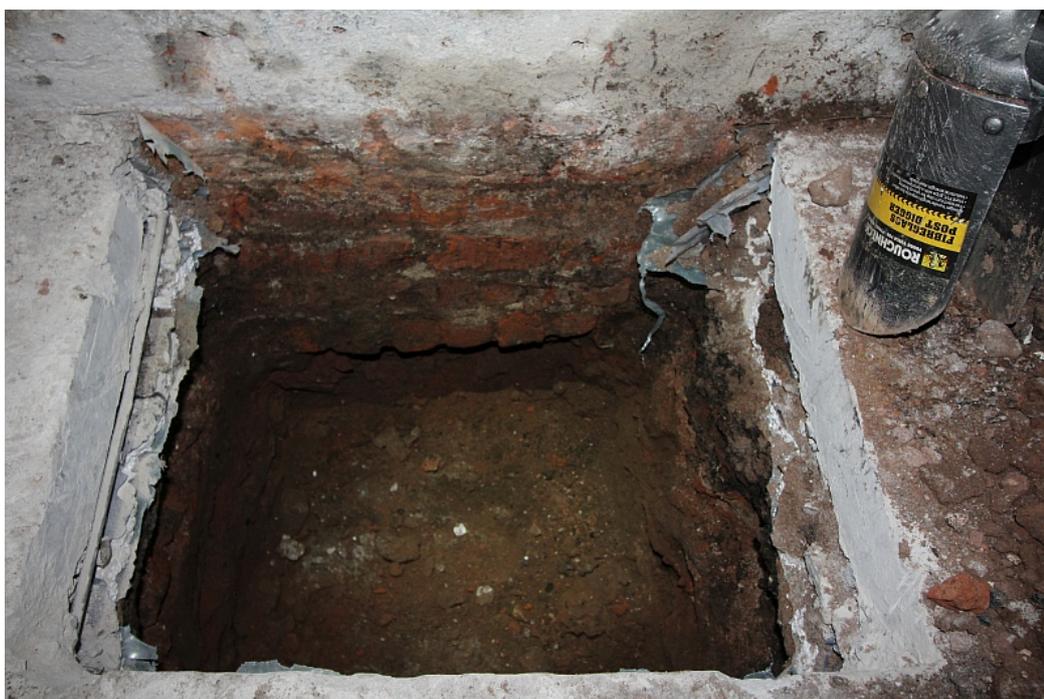
Plate 18: **TP 42** located to the east of an internal partition within the Coach House

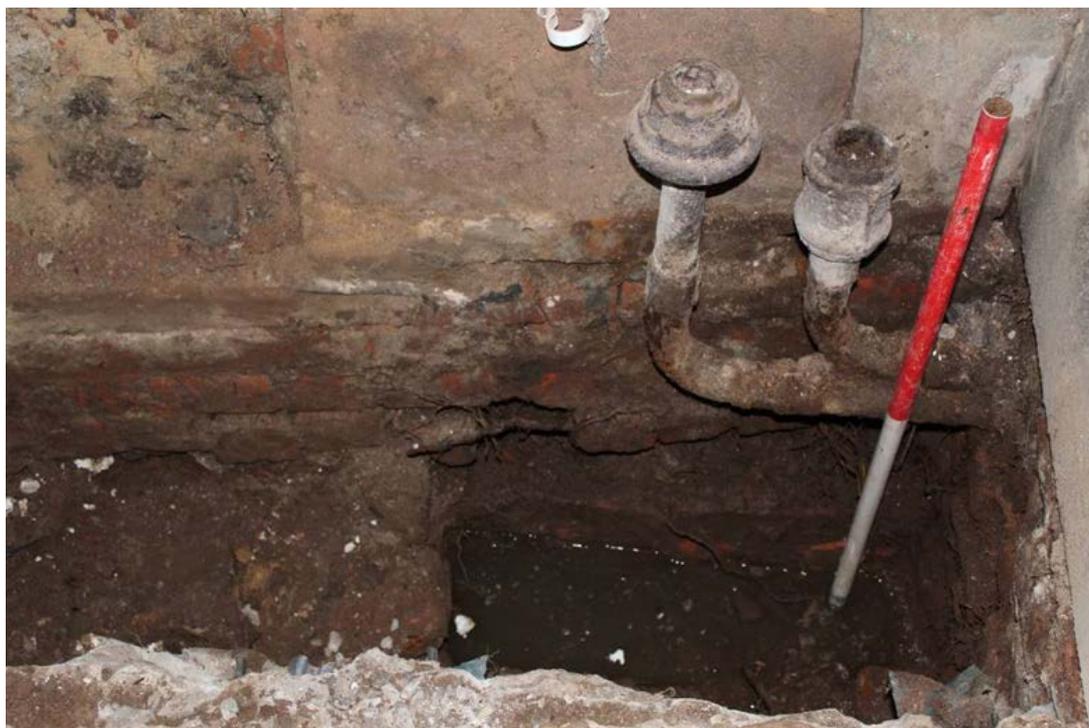
3.2.13 **TP 43**, located within the interior of the south-western end of the Coach House (Building A) had two phases of brick foundations (Plate 19). There were three courses beneath the present surface, with a header row acting as a foundation akin to that visible in **TP42**. Below this was more brickwork, for a minimum depth of 0.4m. This was set on a slightly different alignment, but this was difficult to characterise due to high groundwater levels. In the wall above the test pit was a large block of sandstone, which may relate to the row of sandstone blocks visible externally (OA North 2018, plate 30); which also illustrates the complexity of the construction sequence in the south-western corner of the building.

Plate 19: Two phases of brick foundations within TP43

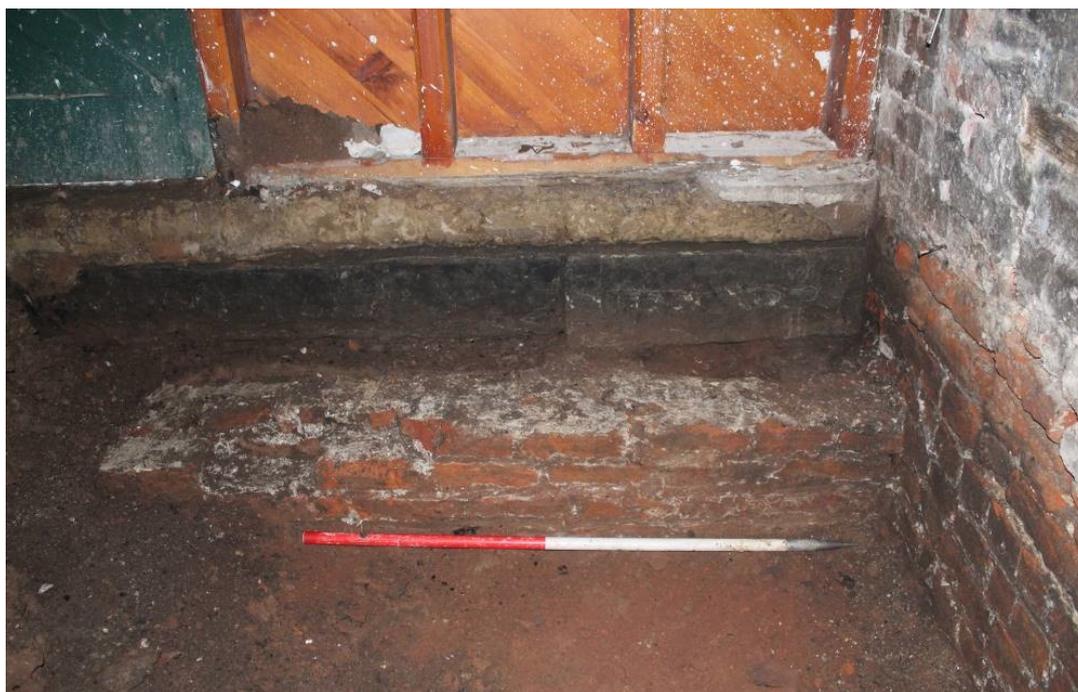
3.2.14 **The Wagon Doors:** in February 2019, the floor surface within the north-east corner of the central bay of Building B (OA North 2018) was reduced below the present wagon door, which exposed features associated with previous openings. An east/west- aligned wall foundation was exposed (**B1**) beneath the present wagon door (Plate 20). The wall comprised four stretcher courses of red handmade bricks, three bricks wide, bonded with lime mortar. The western extent of the wall was obscured by spoil forming a ramp for machine access (Plate 21); its observed extent was 1.70m long by 0.26m high and 0.36m wide. Its eastern extent butted up to the foundations of the north/south-aligned internal wall of the eastern bay of Building B.

*Plate 20: Wall foundation, **B1**, within north-east corner of Building B, 1m scale*

- 3.2.15 Partially overlying wall foundation **B1** was a makeup layer of grey-brown clay, 0.05m thick, above which was a makeup layer of a similar depth, containing small fragments of brick, charcoal, and lime. Sat upon the makeup layer was a stone threshold 0.25m high. It was made up of three visible lengths, one of which was fully exposed and was *c* 0.5m long; the remainder were obscured by a modern access ramp (Plate 20). The threshold was also identified externally, within **TP32**. Sitting on top of the stone threshold was a concrete slab associated with the extant wagon door and at the same height as the modern external surfacing.

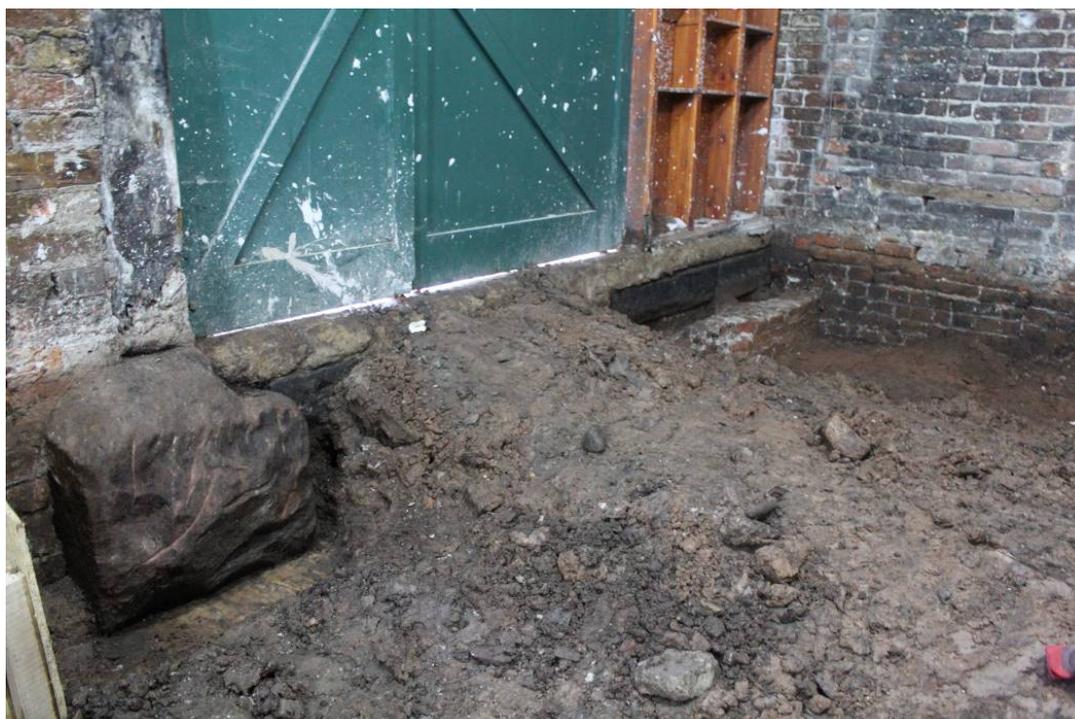
- 3.2.16 Directly to the west of **B1** and the rubblestone ramp was a large block of worked sandstone which was 0.70m by 0.70m by 0.20m (Plate 21). It had chisel marks on its east and west faces. Its curved top appears to have been purposely shaped and a section within its top west corner had been cut out, to allow for the concrete surround associated with present wooden door. The stone block, situated close to what would have been the column separating the two external archways, was placed on top of the natural clay, and butted up to the brickwork foundations of the north external wall (**B1**). These foundations were of a different style and colour of brickwork compared with the presently extant wall which infills the former arched openings (Plate 22). This suggests that the sandstone formed a plinth for an earlier wagon door associated with the arched openings visible externally.

Plate 21: Sandstone plinth, thresholds and wall footings associated with a former wagon door entrance

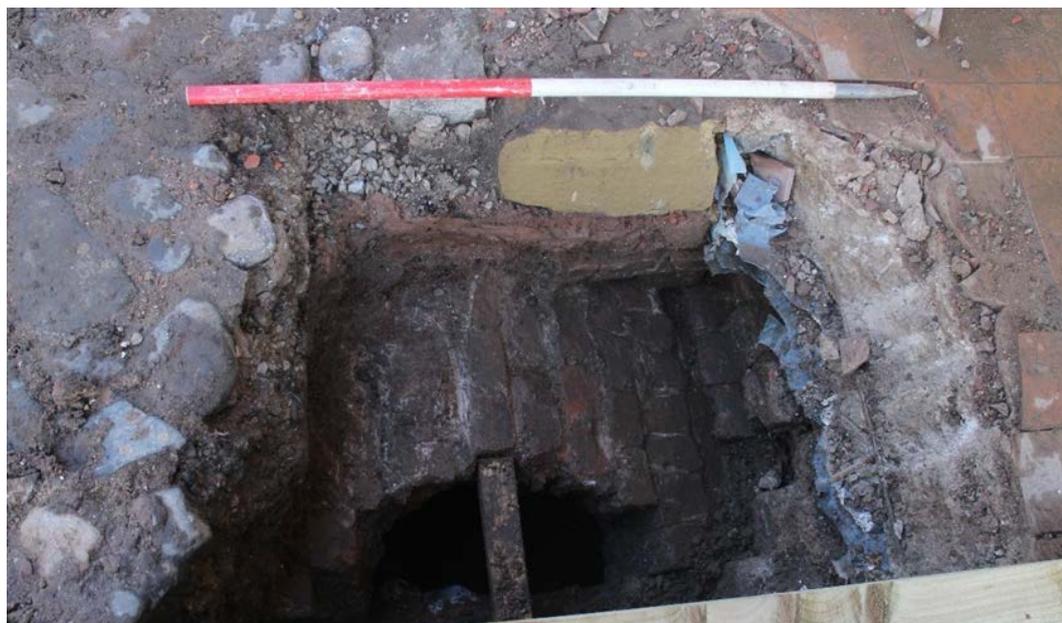
Plate 23: Brick-arched roof of cistern and levelling layers, facing east, 1m scale

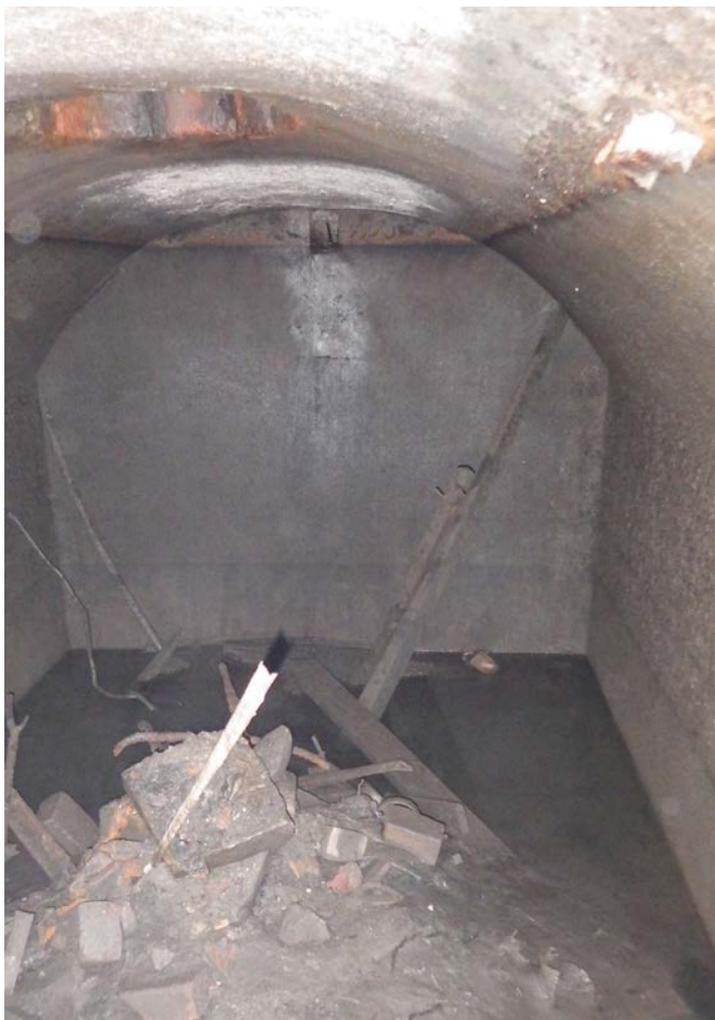
building contractors indicated that the feature was a large underground cistern, opening from an extant manhole located above the eastern extent of the cistern (Plates 24 and 25). The manhole, covered by a surface-visible iron cover, comprised four courses of what appeared to have been salt-glazed bricks, in a cylindrical formation, creating an opening to the void below. Two modern plastic drainage pipes were visible within the eastern side of the manhole, feeding into the cistern (Plate 24), and modern brickwork had been used to form a surface for the manhole cover flush with the present (modern) cobbled surface. The cistern was also fed by a downpipe extending from the northern elevation of the Coach House Building A.

Plate 24: The interior of the cistern showing the location of the manhole, photo provided by WSP

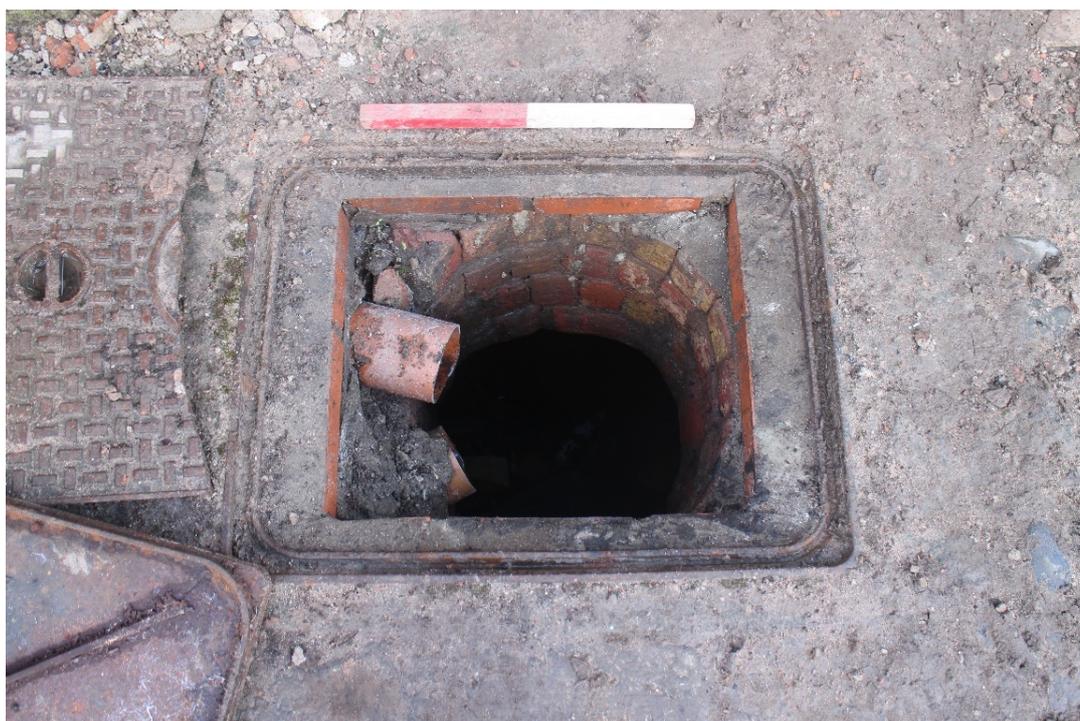
Plate 25: Manhole into the roof of the cistern

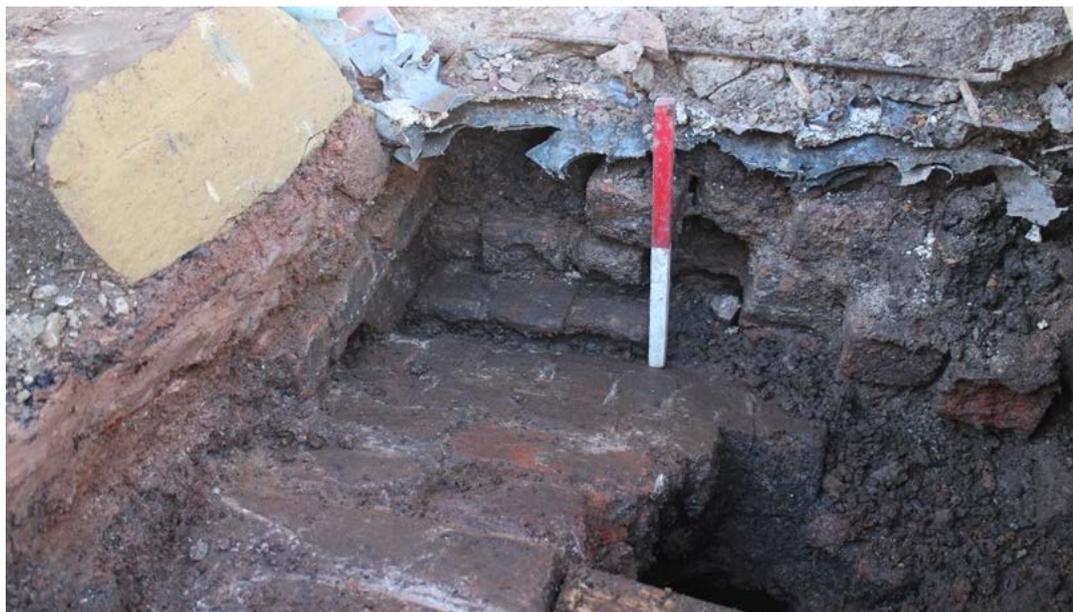
3.2.18 The exposed arched cistern was constructed of handmade red bricks which appeared contemporary with those of the earliest phase of Building A. The visible arch consisted of a two-course layer of brick stretchers forming the curve, with rows of headers visible on the south side butting up against the arch (Plate 26). The exposed extent of the arch was *c* 1m wide and 0.75m long. Where not damaged, they butted up to a north/south-aligned brick wall which suggested its western extent. Above the cistern roof were levelling layers; three layers of red bricks, the lowest layer shaped to fit the curve of the arch, covered by a makeup layer of light pink compacted clay approximately 0.1m deep. Above this, the present-day cobbled yard surface had been laid.

Plate 26: The roof of the cistern, with 0.40m scale, and brickwork defining its western extent

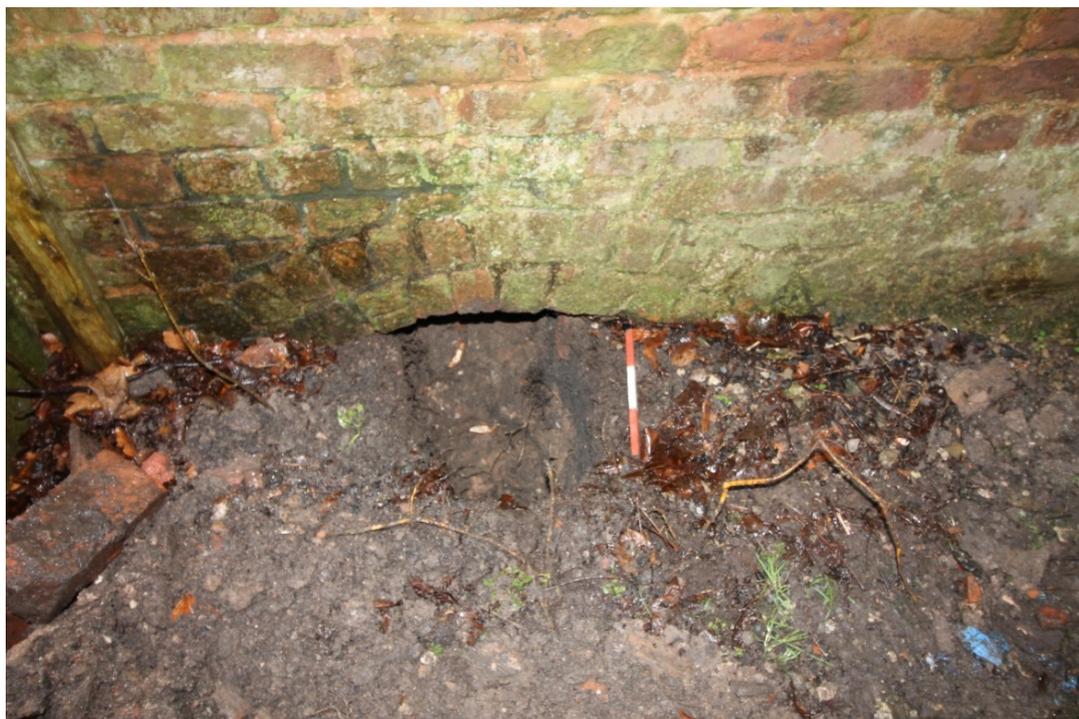
- 3.3.2 **Test Pits 20 and 21:** two test pits were excavated adjacent to the rear of an ancillary building appended to the west wall of the Stables. These were close to an apparently sub-surface arched feature in the western elevation of the ancillary building. Both test pits revealed 0.1m of topsoil, overlying a deposit of loose dark-blackish-brown gritty silty material (0.12m). Below this was a deposit, 0.20m deep, of mid-yellow brown mixed silty clay, which contained brick fragments. Within **TP20**, these deposits appeared to continue beneath the visible arch (Plate 27). What appeared to be natural clay was reached at a depth of 0.5m below the present surface. The function of the arch is unknown, and the ancillary building was not accessed during the building survey (OA North 2018).

Plate 27: TP 8 excavated in the vicinity of an apparent sub-surface arched opening beneath an ancillary building west of the Stables

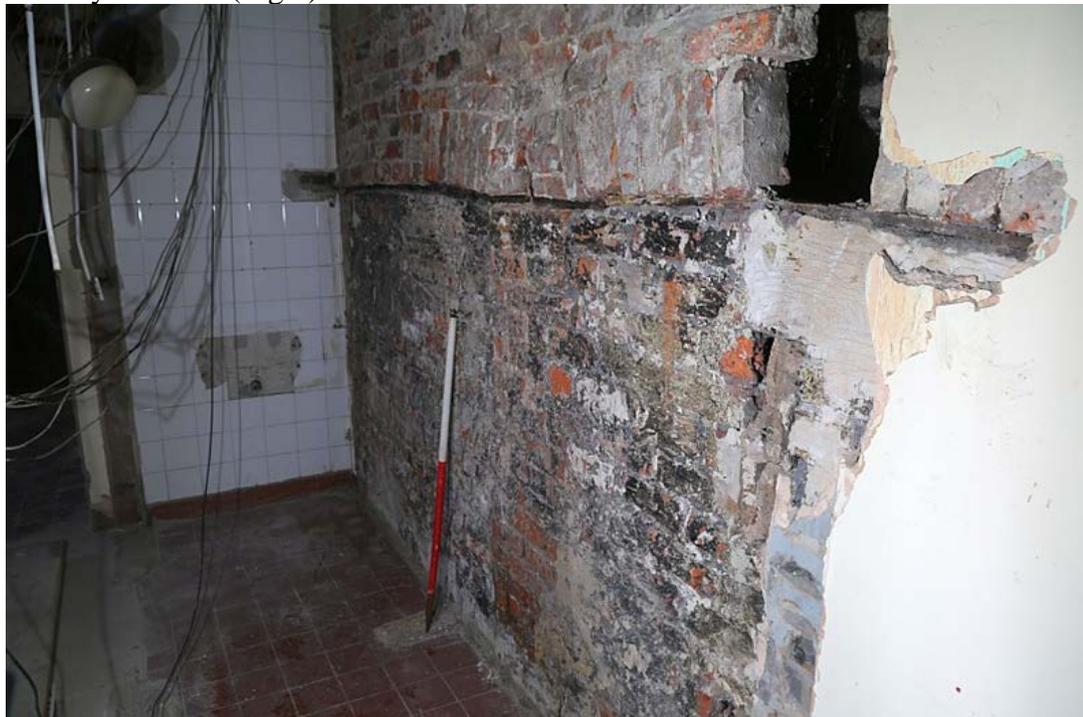
internal side of the south-western elevation of the building, where the building survey had identified a large chimney stack partly blocking a window pocket which was part of the original eighteenth-century build (Plate 30). The thickness of the wall on either side of the original wall line suggests the presence of a void and indicates that the arches were part of an inner wall backing on to the line of the original wall line, with a cavity between (Fig 4).

Plate 28: Bricked-up fireplaces with the southern element of the Stables, showing the void behind, 1m scale

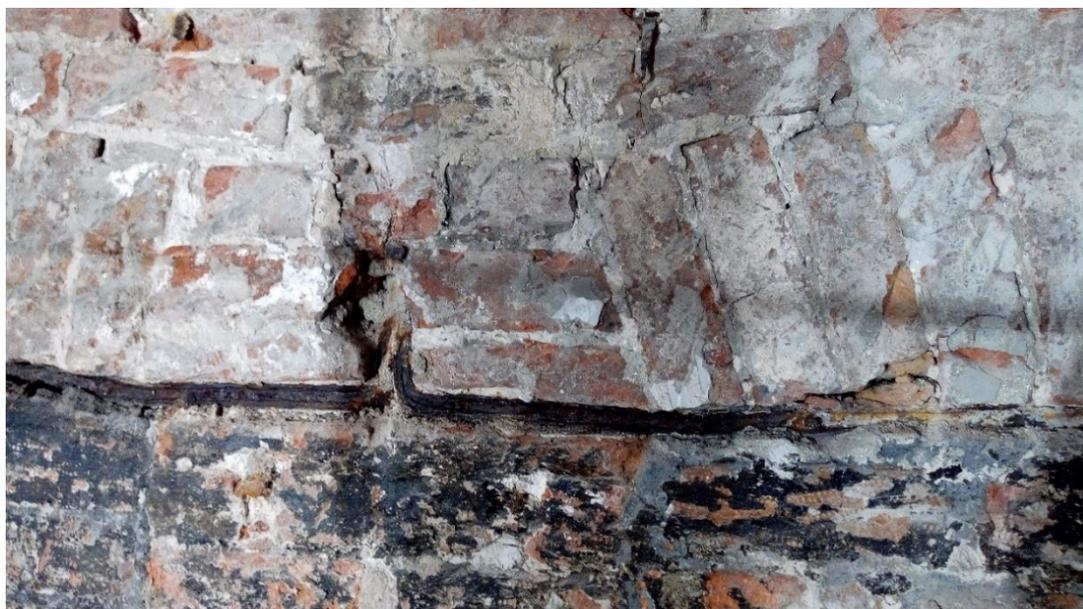
Plate 29: Iron straps supporting the brickwork arches
