Bowring Park, Merseyside

Archaeological Watching Brief Report

July 2020

WSP and Knowsley
Metropolitan
Borough Council

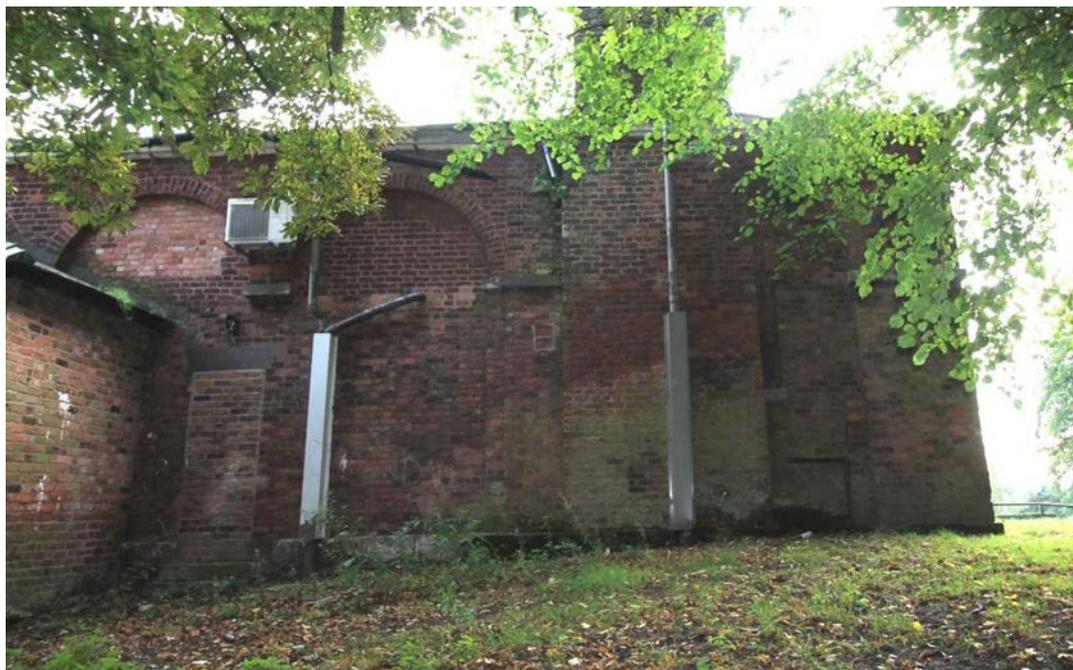
internal side of the south-western elevation of the building, where the building survey had identified a large chimney stack partly blocking a window pocket which was part of the original eighteenth-century build (Plate 30). The thickness of the wall on either side of the original wall line suggests the presence of a void and indicates that the arches were part of an inner wall backing on to the line of the original wall line, with a cavity between (Fig 4).

Plate 30: South-western external wall showing chimney stack, blocking window and southern arcade

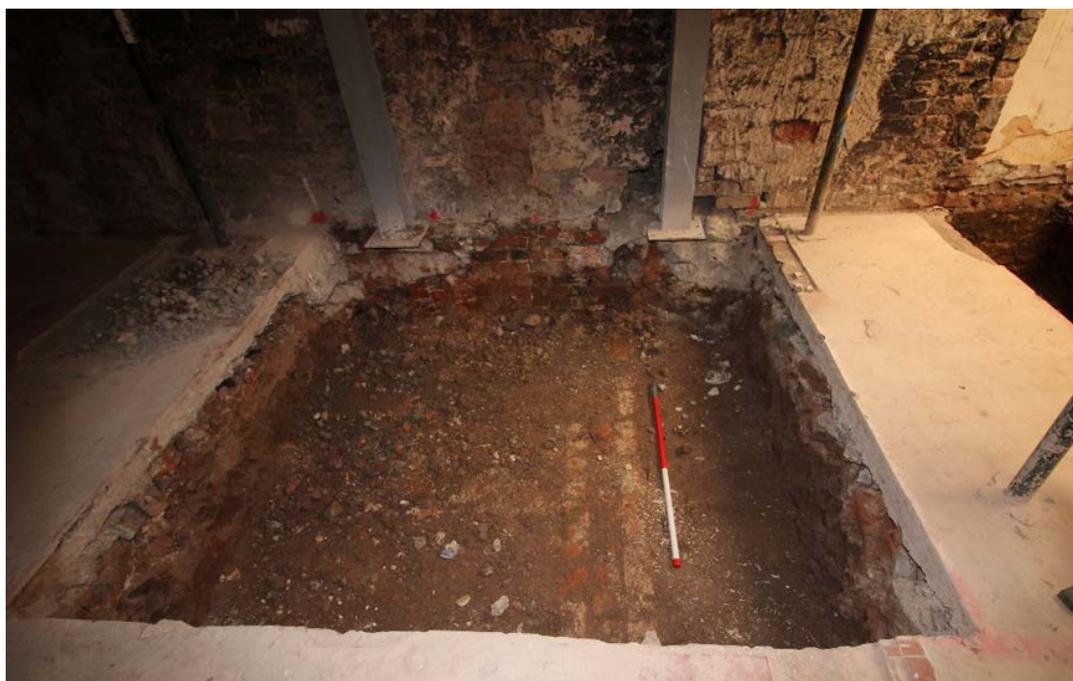
- 3.3.5 In May 2019, archaeological monitoring took place on a previously excavated lift shaft in the same room as the fireplaces had been identified. The trench was located, in its entirety, up against the inner skin of the infilled arched wall; the inner skin is of uncertain date but likely to be of nineteenth century date. The trench had been excavated by contractors, and included the remains of a demolished brick wall, which the section illustrated had stood to just below the concrete raft which formed the modern floor (Plate 31). Steelwork for the lift shaft had also been installed, which partly obscured the relationship between the wall and the arched openings.

Plate 31: West/east-aligned wall exposed within lift shaft trench

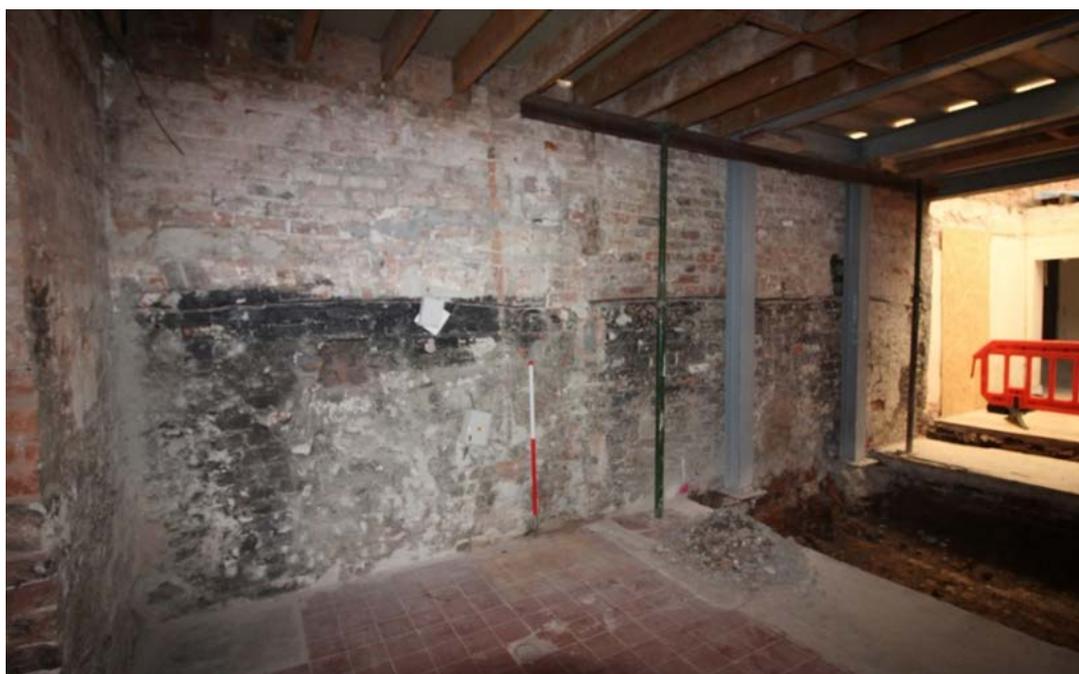
- 3.3.8 Demolition of the cross wall (exposed in the lift-shaft trench) revealed no evidence for any association with the fireplace wall (in the form of scarring), which it abutted in its extant form as recorded during the 2018 building survey. Although a slight difference in the character of the brickwork was visible, this seemed to be related to surface treatments above and below floor level, rather than illustrating anything of the cross wall (Plates 31 and 32).

Plate 32: Western wall of the southern element of the Stables, showing the series of arched fireplaces and lift shaft trench

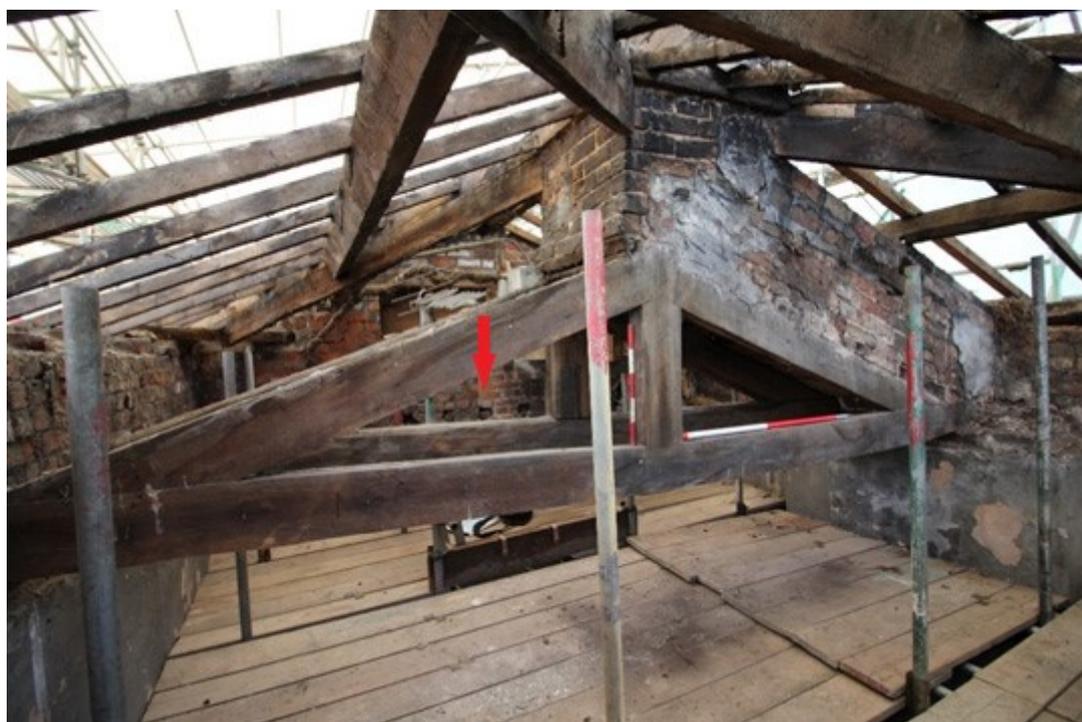
- 3.3.11 The brick-built chimney stack had been constructed in two parts; the vertical element visible above the roofline and a lateral element, supported by a pair of kingpost trusses, separated by *c* 0.9m (3ft), set below the extant hipped roofline (Plate 33; Fig 5). The lateral element was formed of eight courses of brickwork, following the angle of the trusses, and supported by timber planks set between them (Plate 34). The planks were *c* 0.36m wide (*c* 1 ft) and *c* 0.63m long (*c* 2 ft) and *c* 50mm thick (*c* 2in) and had circular pegs on their undersides indicating how they had been attached to the trusses. The first course of bricks was headers and the remainder were stretchers. The western end of the trusses were supported by a brick plinth formed by the flue rising from the ground floor and their eastern ends were built into the eastern elevation, approximately at the same level as the top of the arcade and the window headers visible externally (Plate 4).

Plate 33: The central chimney, set upon a pair of kingpost trusses, facing south (nb the scaffolding boards do not reflect a former floor level)

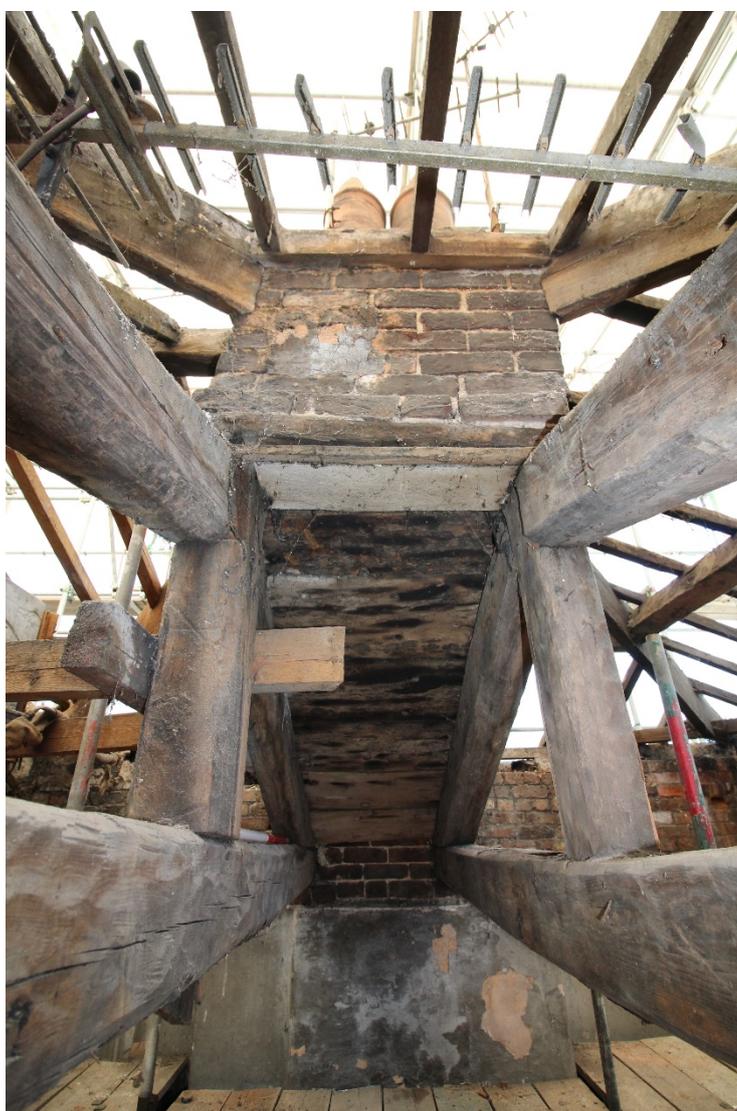
- 3.3.13 The mid/late twentieth-century grey cement-based render visible below the trusses (Plate 34) indicates the top of the plaster height in the room below; brick pockets in the wall at the southern end of the bay (Plate 33 (annotated with an arrow)) indicate the ceiling joists. This indicates that the trusses' tie beams were, at some point in the mid/late twentieth century, used to support the ceiling of a first-floor room below.

Plate 34: View from the underside of the trusses supporting the lateral stack

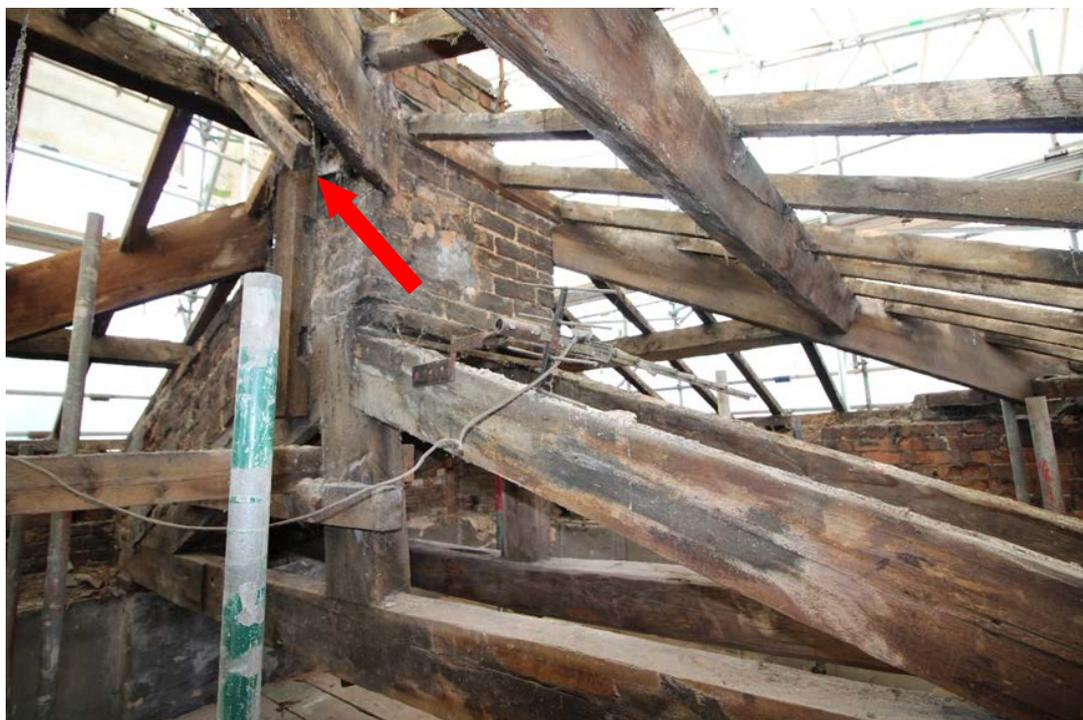
central element of a symmetrical roofline. The hip rafters are wedged up against the chimney and support a purlin, which itself supports the common rafters; these oversail the brick wall at the same approximate height of the apex of the brick arcade and window headers externally. The roofline to the south of the chimney has been subsequently reconfigured; a new ridge beam has been added, its northern end butting the chimney stack, with short braces leaning on the former hips and a plate attached to the stack (Plate 35).

Plate 35: On the south side of the chimney a ridge (marked by an arrow) has been added, superseding the hipped roof structure

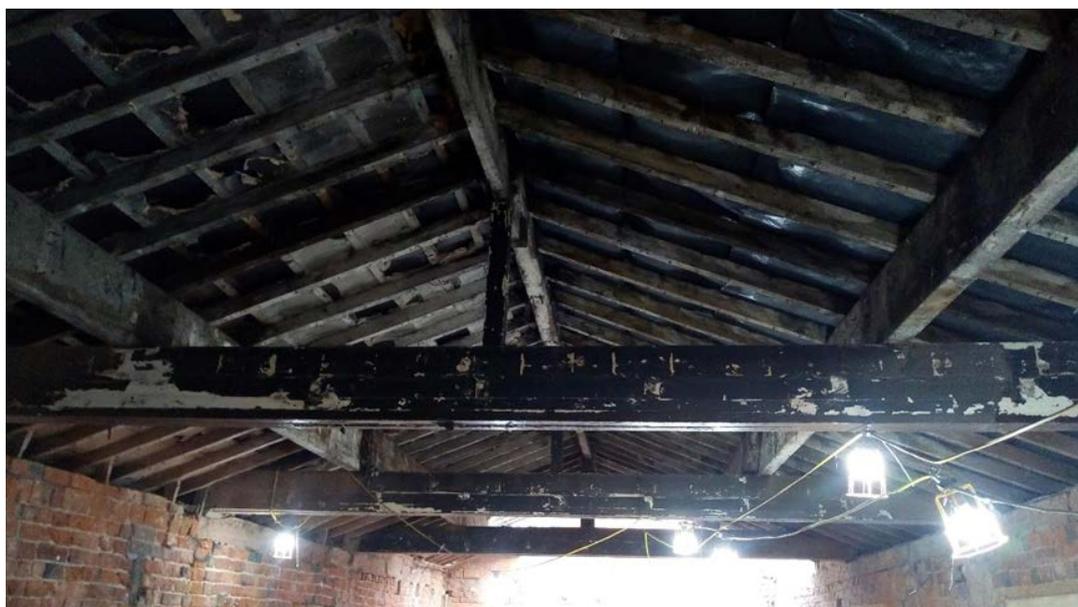
Plate 37: Detail of the roof within the central element of the Stables

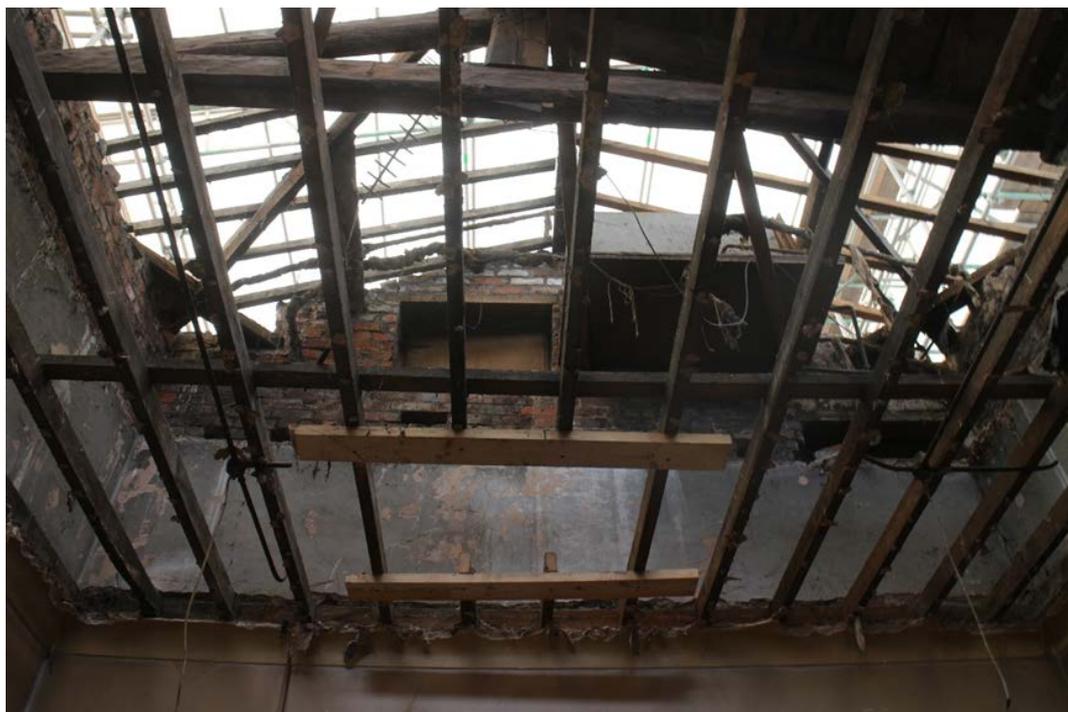
- 3.3.18 During the 2018 building survey, the first-floor room in the northern bay was not accessible; a blocked doorway was noted within the lounge bar but no access was found into the space above the ground floor office (OA North 2018). Subsequent demolition of the ceiling structure in that room, however, indicated the presence of a former floor level and a continuation of the grey, twentieth-century plasterwork visible within the roof structure directly below the trusses supporting the lateral chimney stack (Plates 34 and 38). This plasterwork partially sealed the bricked-up doorway identified at the north end of the former lounge bar (Plate 36).

Plate 38: The wall between the northern and central bays of the Stables, facing south, with the southern truss, blocked doorway and the crawl-through visible

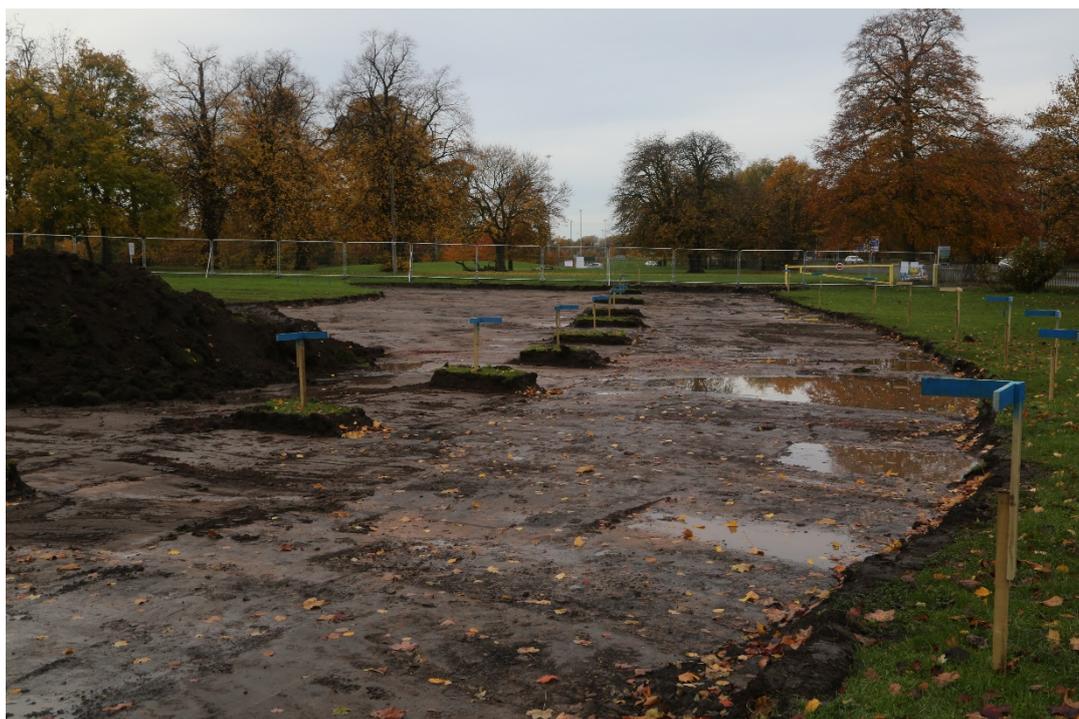
- 3.4.1 **Northern lawn:** in November 2018, an archaeological watching brief took place during topsoil stripping of an area of lawn immediately south of the site entrance and the A5080 Roby Road, in the location of a planned pond and secondary access road (Fig 2; Plate 39). This monitoring revealed no features of archaeological significance.

Plate 39: Archaeological watching brief of proposed pond and access road area

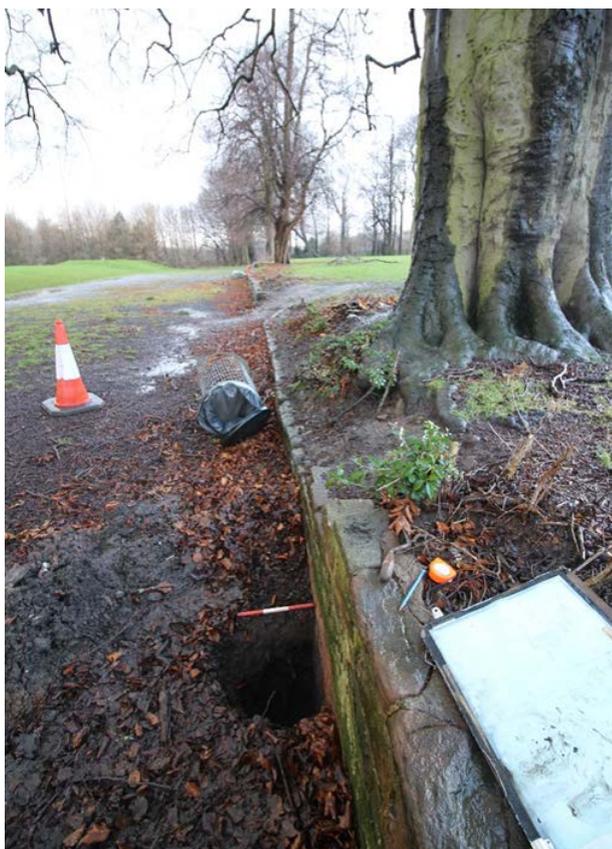
Plate 40: Sandstone element of the Ha-ha wall, west of the Walled Garden (TP13)

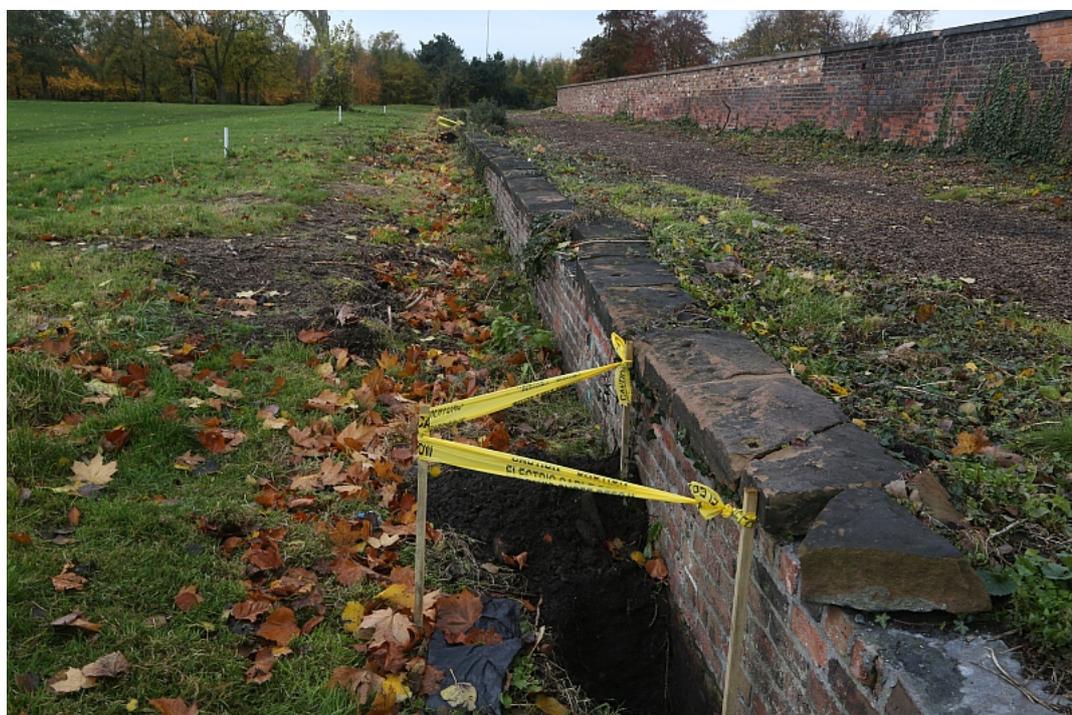
Plate 41: Red brick Ha-ha wall, view west from (TP 6)

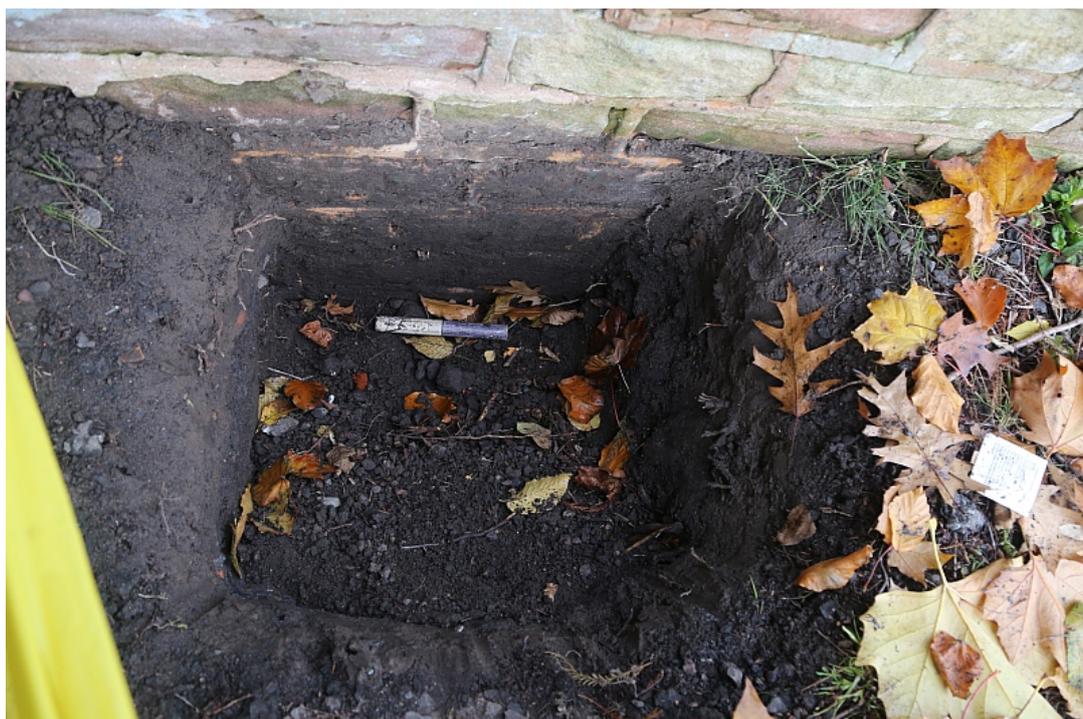
- 3.4.4 The sandstone elements of the wall were strap-pointed in a pinkish twentieth-century cementitious mortar, which in most cases continued beneath the present ground surface (Plate 42). The brickwork was pointed (and bonded) with a hard, dark-grey lime-based mortar (Plate 43), the dark-grey colouring indicating the presence of charcoal/ash within the mix and suggestive of a Victorian date.

Plate 42: Representative illustration of test pits through the sandstone-built western part of the Ha-ha (TP2, 0.2m scale)

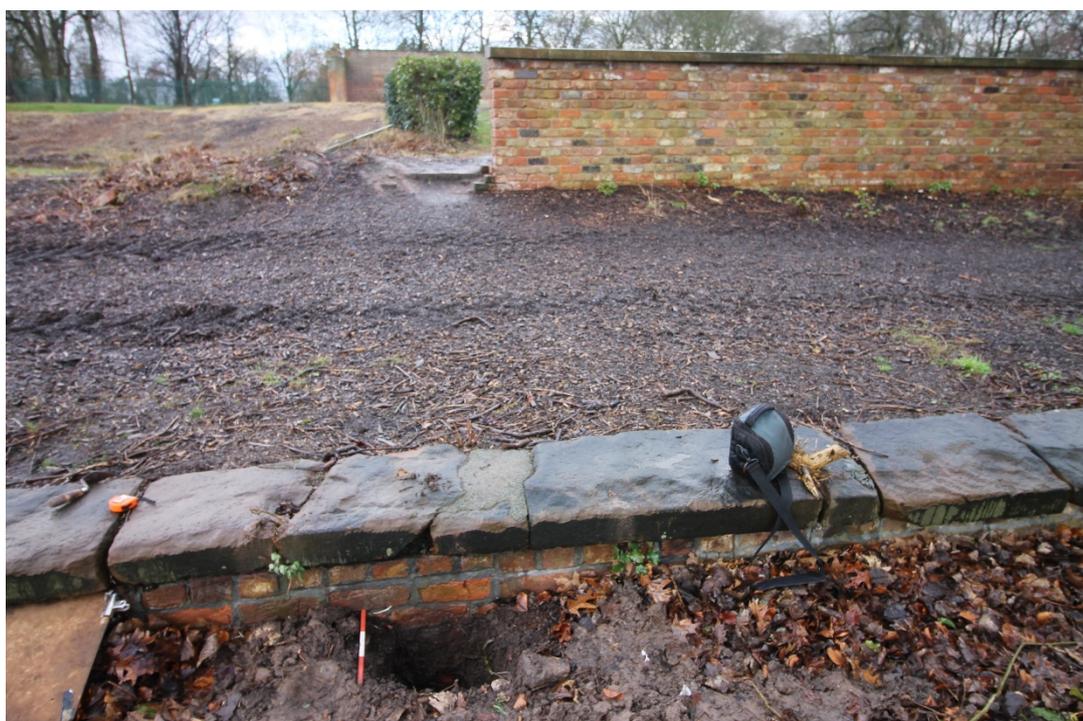
Plate 43: Brickwork Ha-ha wall, south of the Walled Garden (TP15)

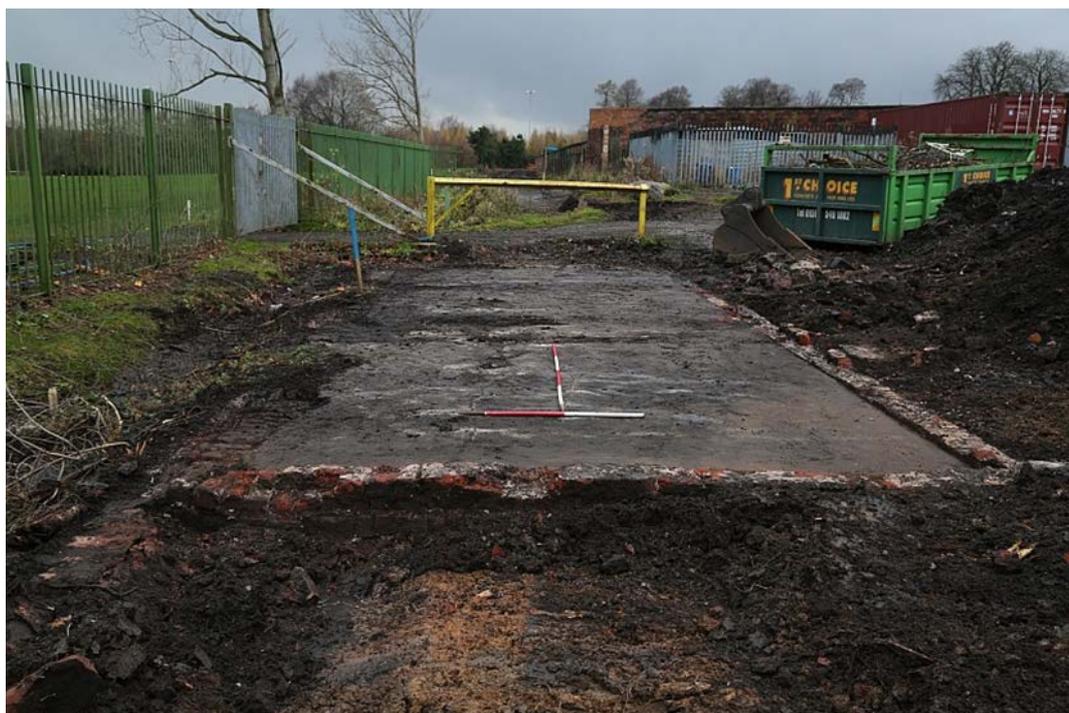
Plate 44: Structure revealed in the Storage Area, 1m and 2m scale

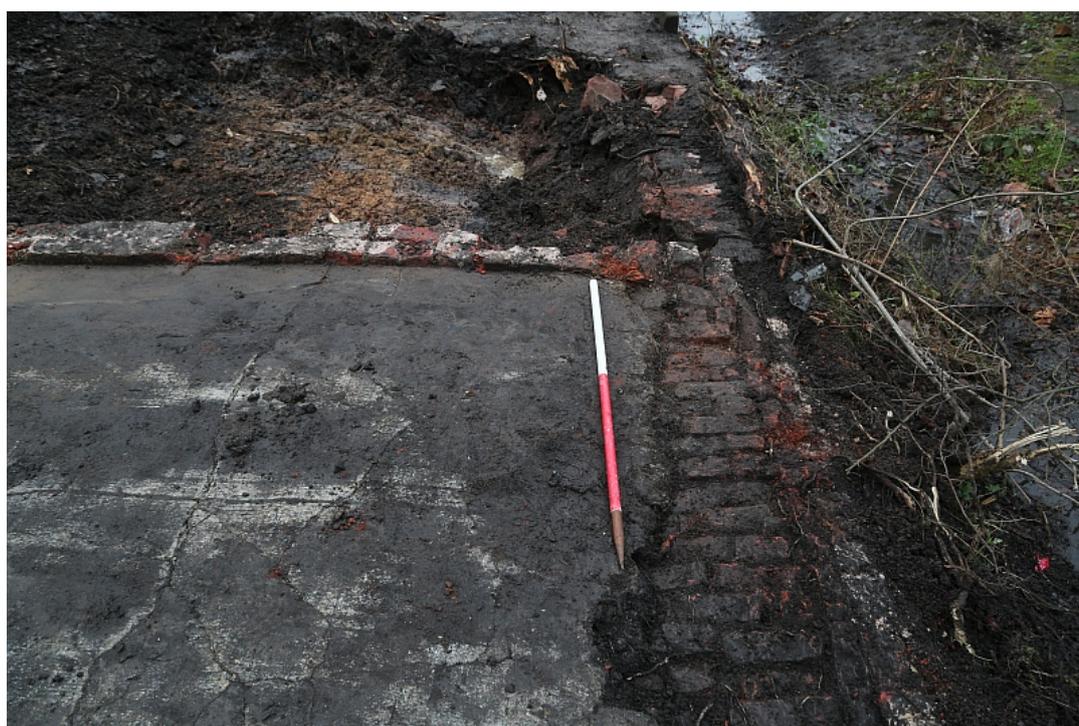
Plate 45: Floor of the former structure, abutting to the Ha-ha wall, 1m scale

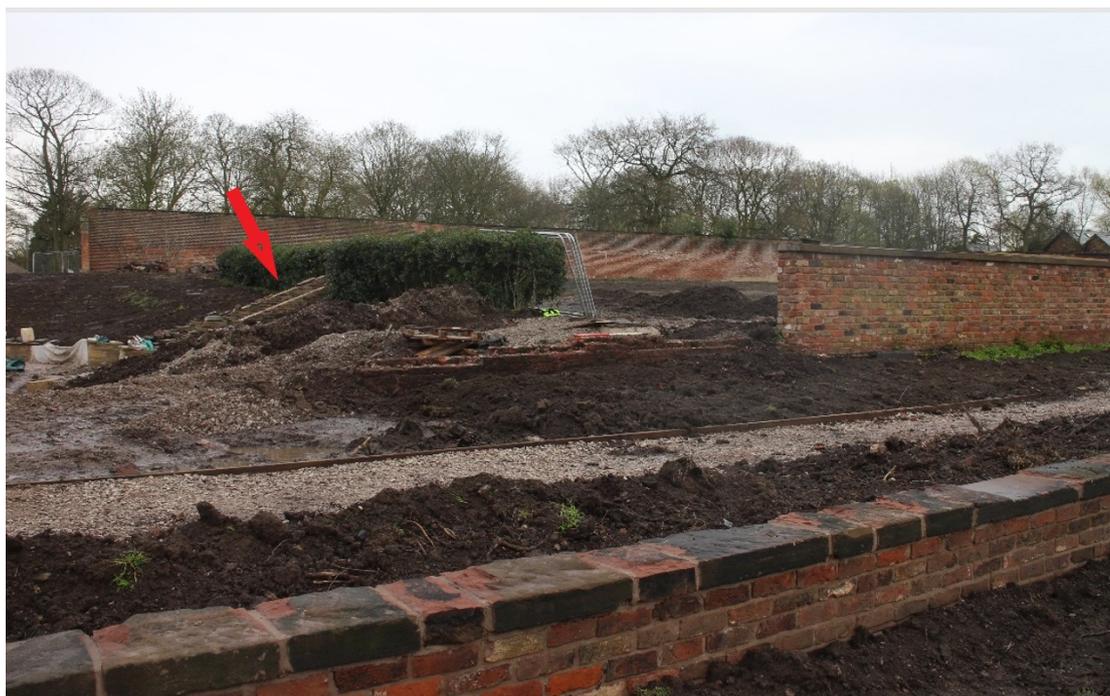
Plate 46: remains of brick wall, between the Ha-ha and the Sunken Garden, west of the Walled Garden's south wall (facing north-east). The arrow shows the sunken garden steps.

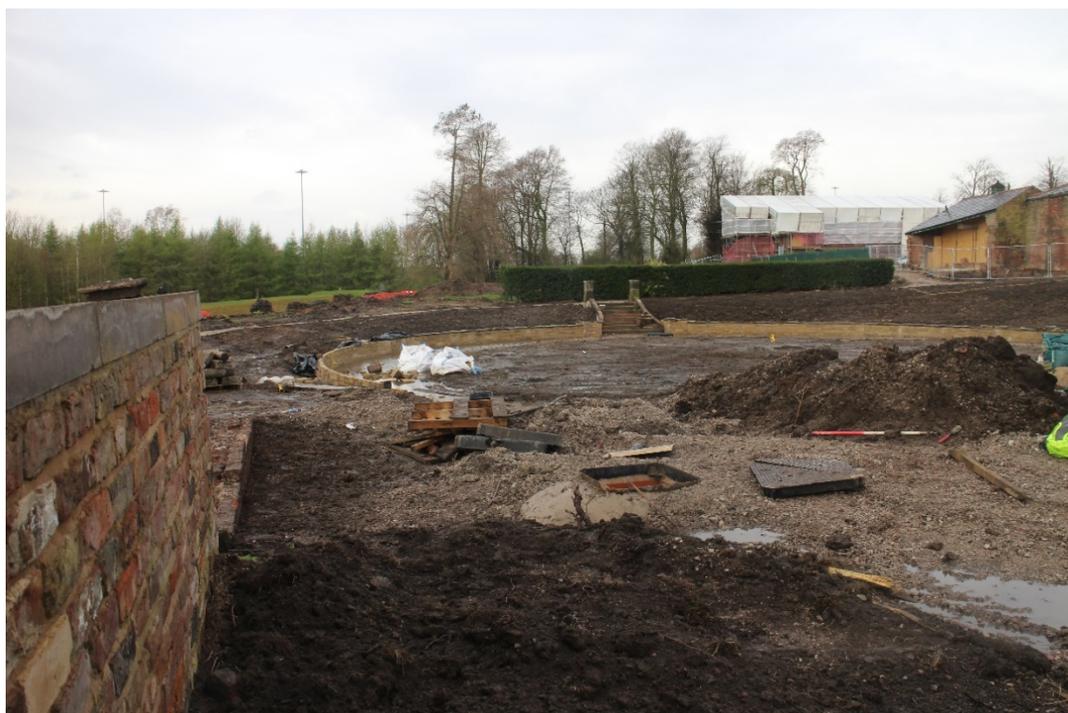
- 3.4.8 A sunken brick-built tank was also uncovered *c* 2m north of the wall; for safety reasons this had been covered prior to archaeological monitoring, but a manhole was still exposed (Plate 47; Fig 6). The tank was constructed of red brick, and nine visible stretcher courses created a rectangular tank/chamber. The depth of the tank was not ascertained, as the bottom contained standing water (Plate 48).

Plate 47: Modern manhole with brick tank, and Sunken Garden in the background (facing west)

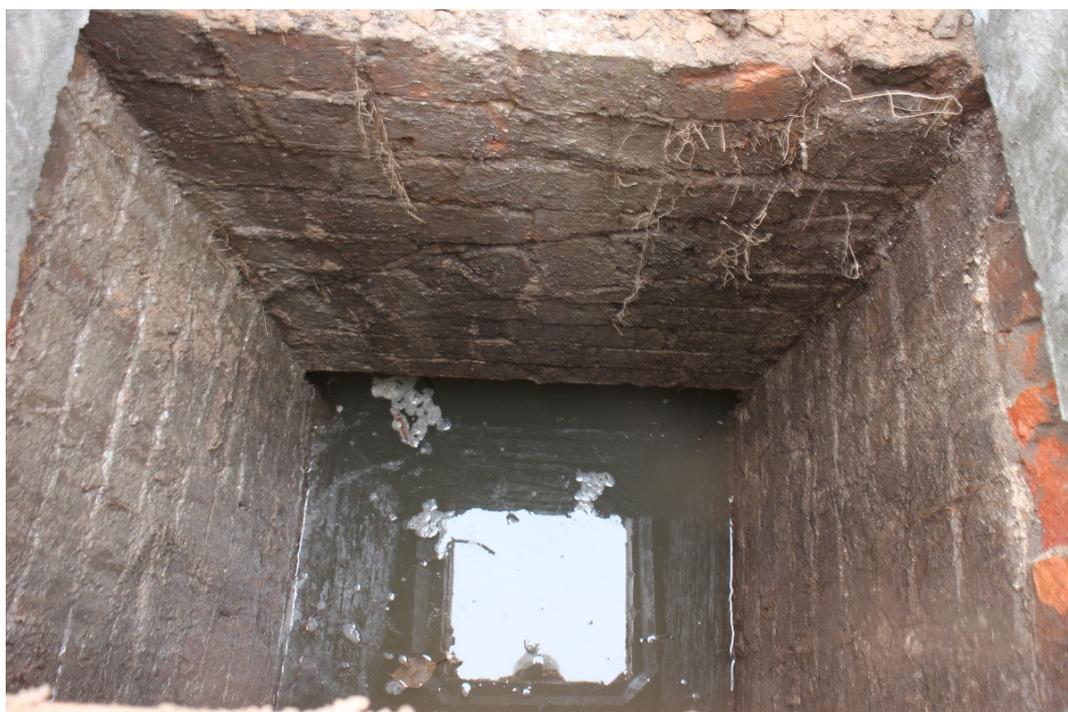
Plate 48: detail of brick-built water tank between the Sunken Garden and south-western extent of the Walled Garden

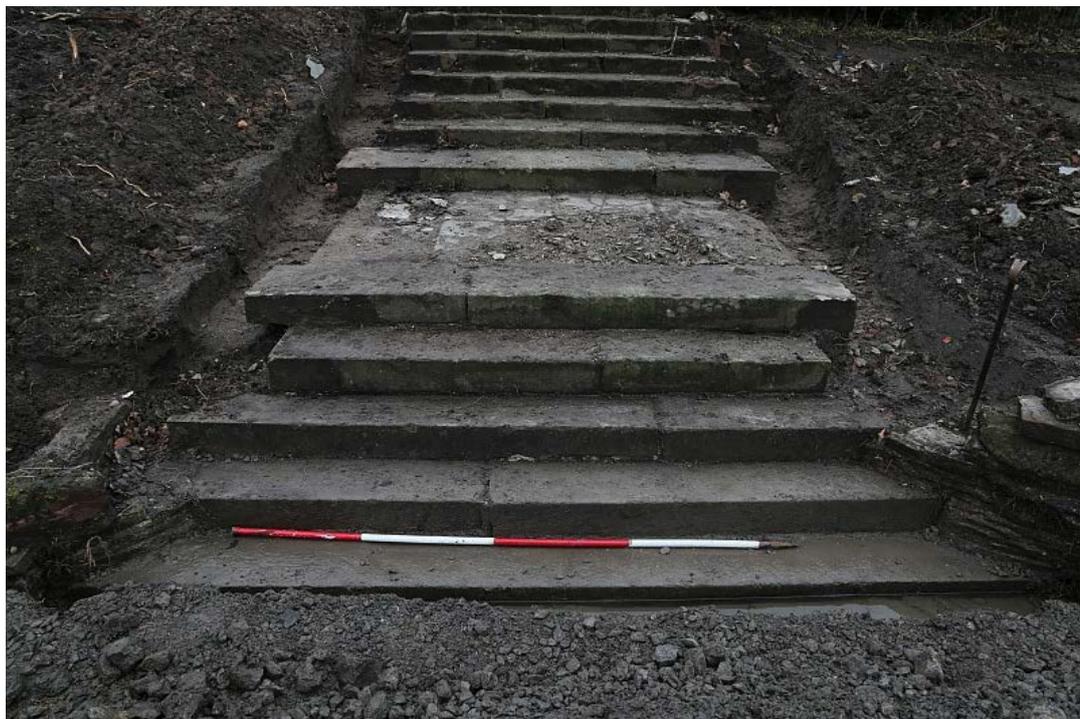
long, 0.3m wide and 0.9m deep and comprised three stone slabs, 0.9m, 1.9m and 0.70m long (Plate 49). The lower step on the western flight was a single stone slab, 3.7m long, 0.3m wide and 0.16m deep (Plate 50).

Plate 49: Lower steps on the eastern flight to the Sunken Garden, 2m scale

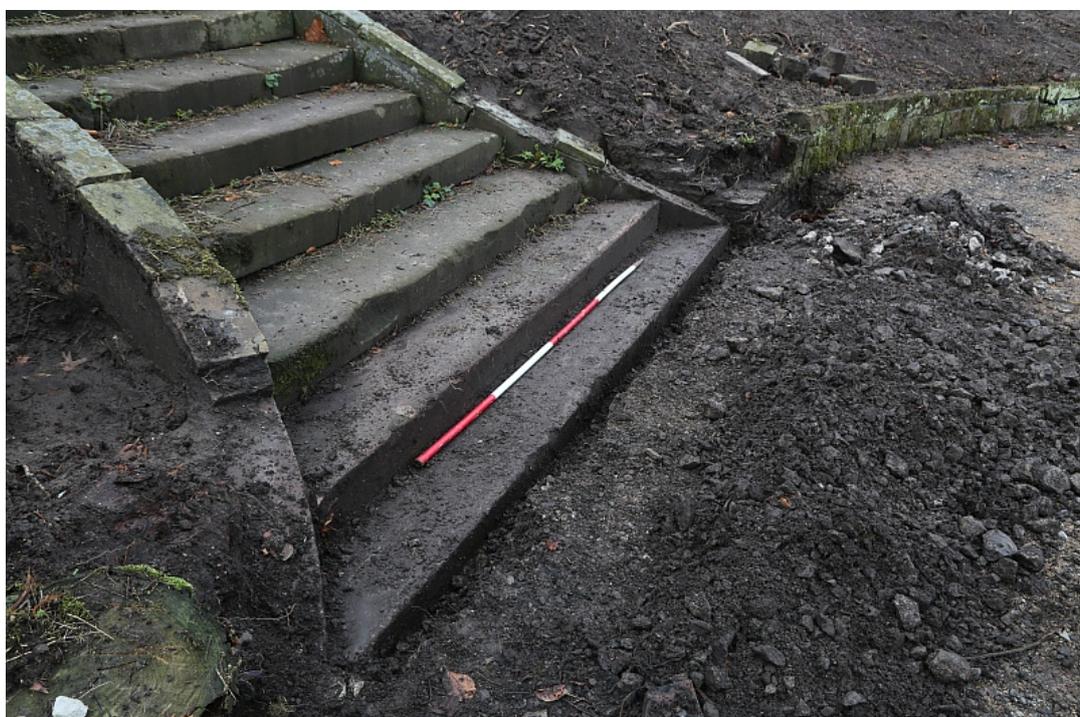
Plate 50: Lower steps on the western flight into the sunken garden, 2m scale

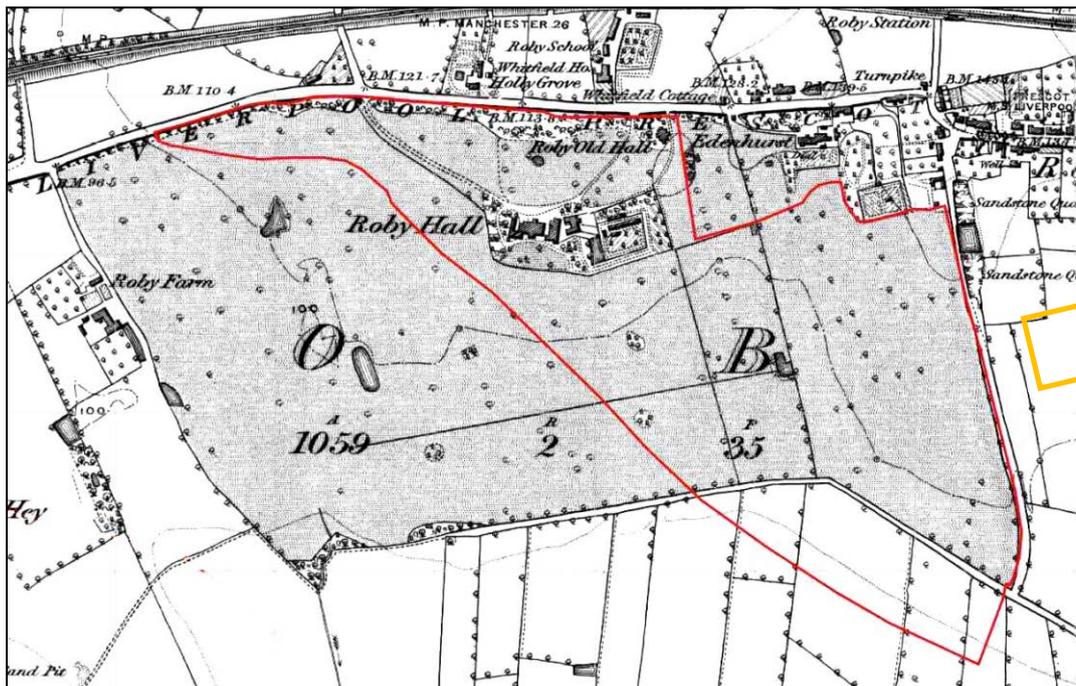
Figure 2: Extract from 1851 Ordnance Survey Map showing absence of building to the east of the walled garden and indicating location of the current storage area
