Plot 2, Pond Farm, High Street, Witcham, High Street, Witcham

Archaeological Evaluation Report

September 2020

Issue No:	2
OAE Report No:	2437
NGR:	TL 46650 80075
Planning app. No:	16/01567/FUL

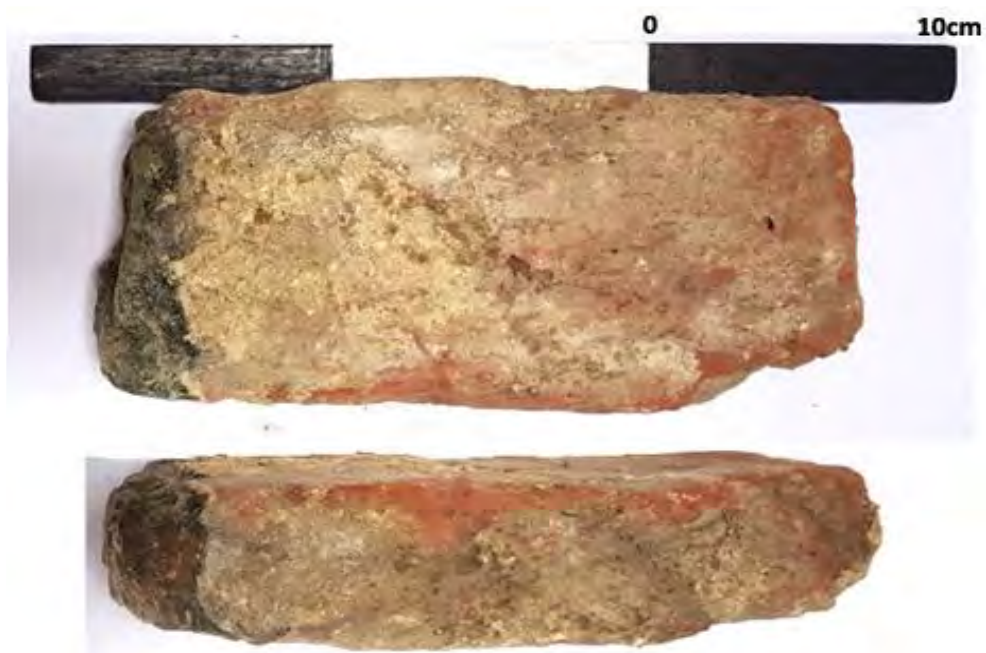
Plate B.1.1: First Brick from Wall **301** (bed and stretcher face)

- B.1.4 The first brick (1.682kg), is slightly damaged, with one corner missing and more recent chipping (App. Plate B.1.1). However, much of the damage appears to be relatively old and may indicate reuse, or that the brick was damaged during firing. The first brick was used in the wall with the header exposed, the second having its stretcher face exposed, both forming part of what the excavator described as an (English) garden wall bond (three courses of stretchers alternating with one course of headers).

- B.1.5 The first brick is slightly sub-rectangular due to the missing corner and part of the header is also damaged, its dimensions are 230 x 105 x 50mm. Drag marks can be seen on the upper bed, while the lower bed is obscured by soft off-white mortar. There is a diagonal skintling mark on the more complete stretcher face and the upper bed is in part covered by thicker mortar (2.5Y 8/2 pale yellow), which is very probably lime mortar.

- B.1.7 The exposed header on the first brick and the stretcher face on the second are both weathered and the header on the first brick is somewhat green from possible algae

that also extends across the edges of the beds. The exposed brick was in a damp area of the wall, possibly just above or at ground level or just in a dark damp area. The weathered face on the second brick is not only partly green but also slightly sooted or blackened, which extends clearly onto the beds of the brick, suggesting that the wall's pointing/jointing was very probably raked or recessed rather than flush, or that the wall has suffered considerable loss of mortar due to weathering.

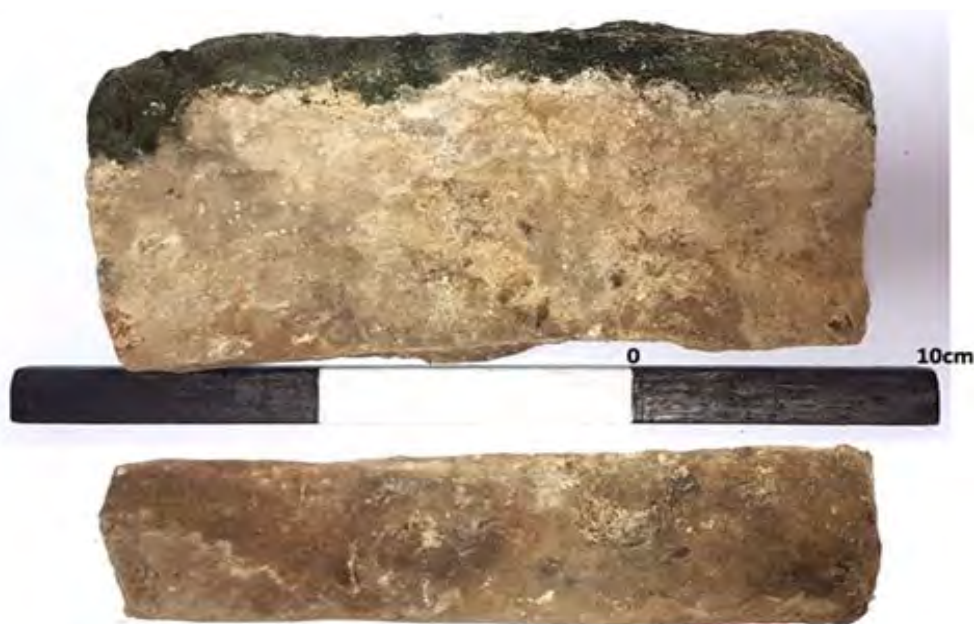
Plate B.1.2: Second Brick from Wall **301** (bed and stretcher face)

- B.1.6 The second brick (1.928kg) is distinctly bloated on each stretcher face and bloated and sintered on one header face. The beds are only slightly affected by the overfiring. There is a diagonal skintling mark on the exposed and weathered stretcher face. The brick's dimensions are 230 x 105 x 50-55mm (due to bloat distortion). The upper and lower beds, headers and small areas of the rear stretcher all bear traces of powdery mortar lumps (2.5Y 8/2 pale yellow) as with the first brick, of very probably lime mortar.

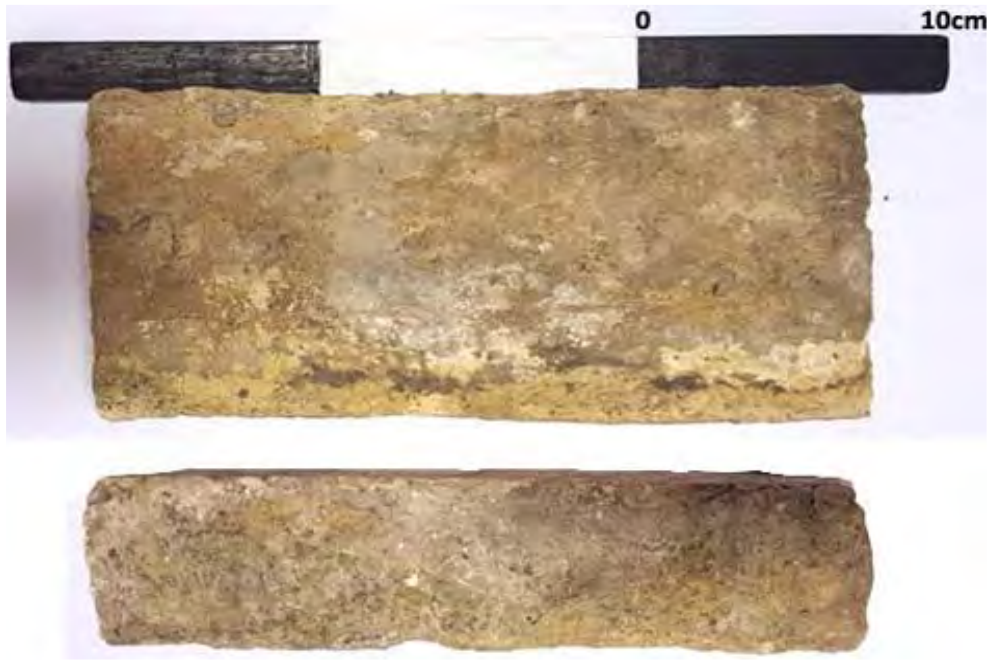
Plate B.1.3: Brick from Wall repair **303** (bed and stretcher face)

- B.1.8 A single brick (2.159kg) was recovered from wall **303**, which was constructed on top of the remains of wall **301** (App. Plate B.1.3). If this is a representative sample of wall **303**, then it was constructed of handmade, slightly uneven, unfrogged, Suffolk white/Burwell type bricks (230 x 105 x 55mm). This particular example is 2.5Y 8/4 pale yellow, on a fresh break. The exposed stretcher face has weathered to a more yellow colour, 2.5Y 7/4. Part of the exposed stretcher face has become somewhat smoothed in part, suggesting wear, perhaps caused by something rubbing against the wall, although it is possible that this is a reused brick and the wear is not related to its use in the wall. A diagonal skintling mark is visible on the unweathered stretcher and drag marks are visible on the upper bed. Traces of off-white mortar survive on all but the exposed stretcher. The brick is very probably 19th century.

- B.1.9 All the bricks are similar in size. The Suffolk white/Burwell type from wall **303** is very probably 19th century, when white bricks were common, and the red bricks are probably 19th century, although perhaps much earlier in the century than the brick from wall **303**.

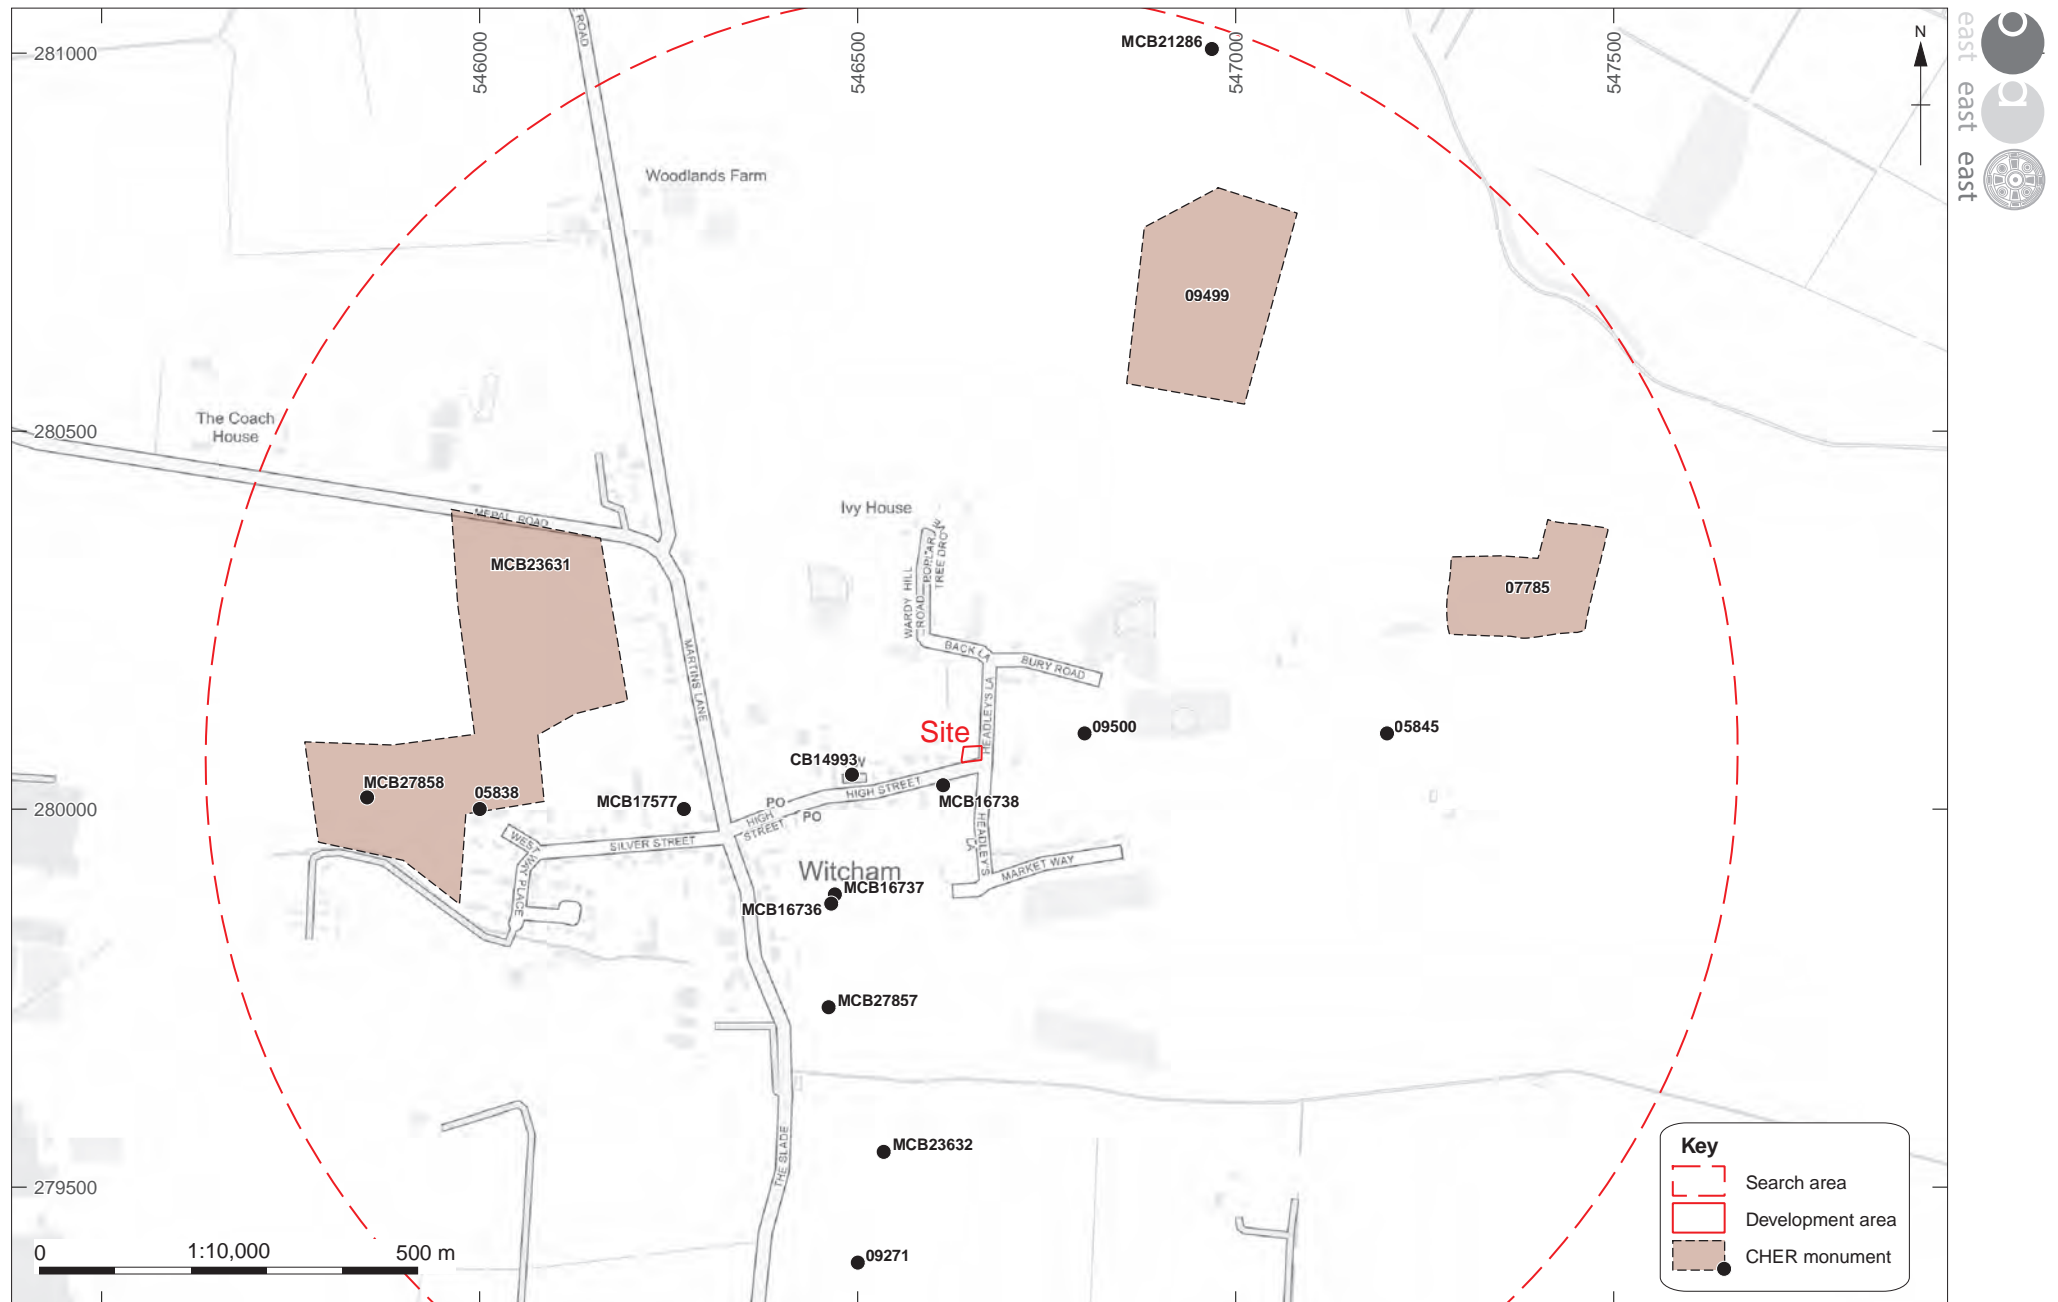
Figure 3: CHER entries mentioned in the text

- 1.3.2 A full search of the Cambridgeshire Historic Environment Record (CHER) of a 1km radius centred on the evaluation site was commissioned from CHET (under licence number 19-4196). The following is a summary, with pertinent records shown on Figure 3.

2.2.1 Two evaluation trenches (Fig.3) were excavated, totalling 20m in length. The trenches were 10m long by 1.5m wide and positioned to address the aims given in Section 2.1.

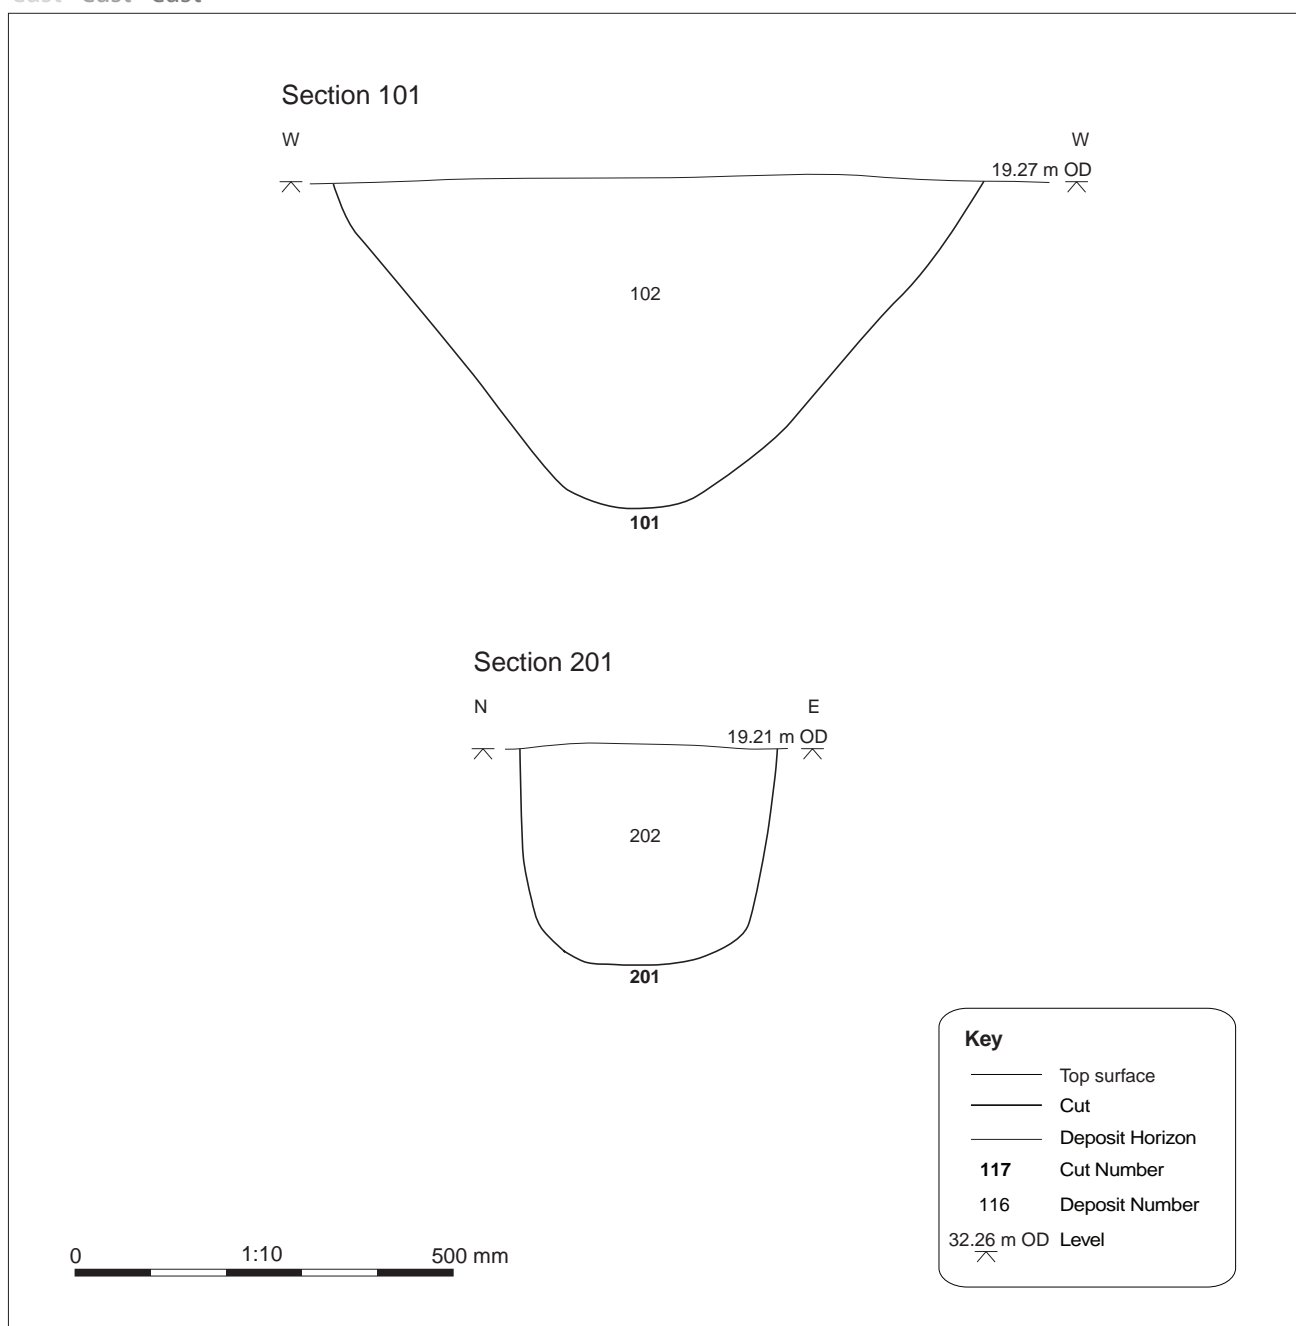
Figure 5: Sections

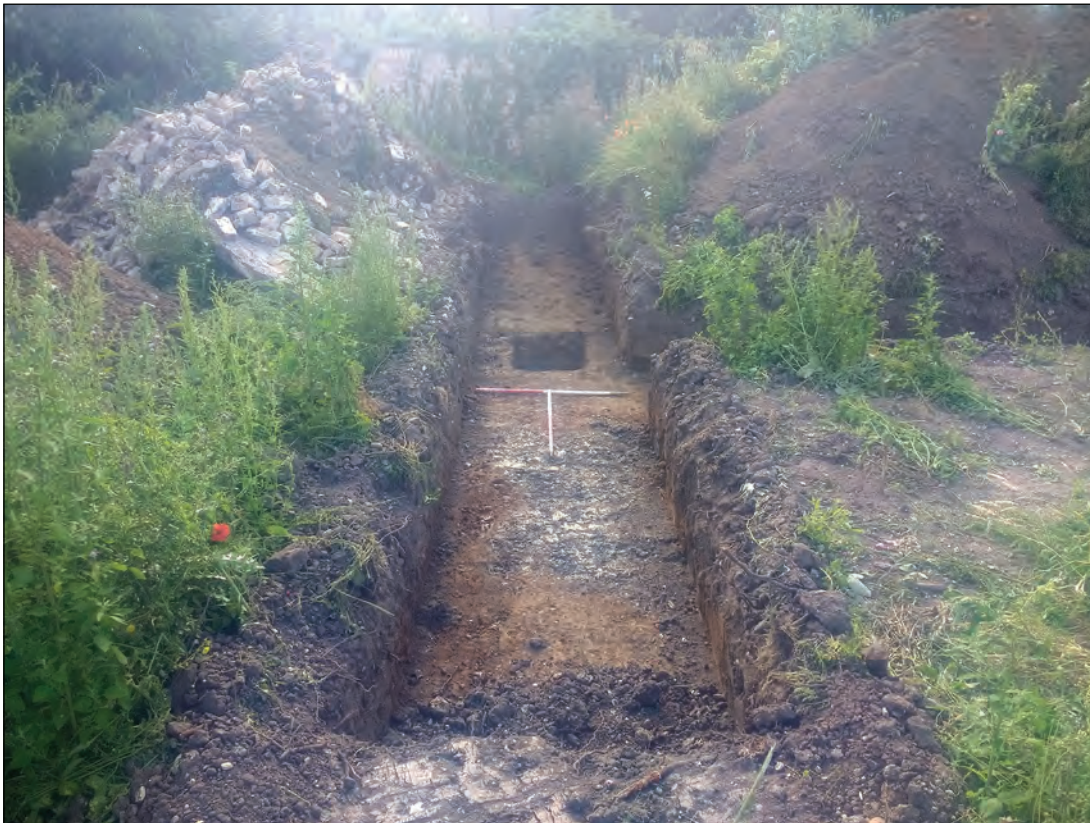
- 3.4.1 Trench 1 was orientated east to west. The natural geology was encountered at an average depth of 0.65m. A single ditch was uncovered towards the eastern end of the trench.
- 3.4.2 Ditch **101** was orientated north to south (Fig. 4; Fig. 5, Section 101; Plates 1-2). It measured 0.91m wide and 0.43m deep with steep sloping sides that led down to a concave base. It was filled with a deposit (102) of firm dark greenish grey silty clay. No finds were recovered from its fill. However, the environmental bulk sample taken from it producing small quantities of charred grain, legumes, charcoal and shrub/tree macrofossils (see Appendix C).

Plate 1: Trench 1, looking east

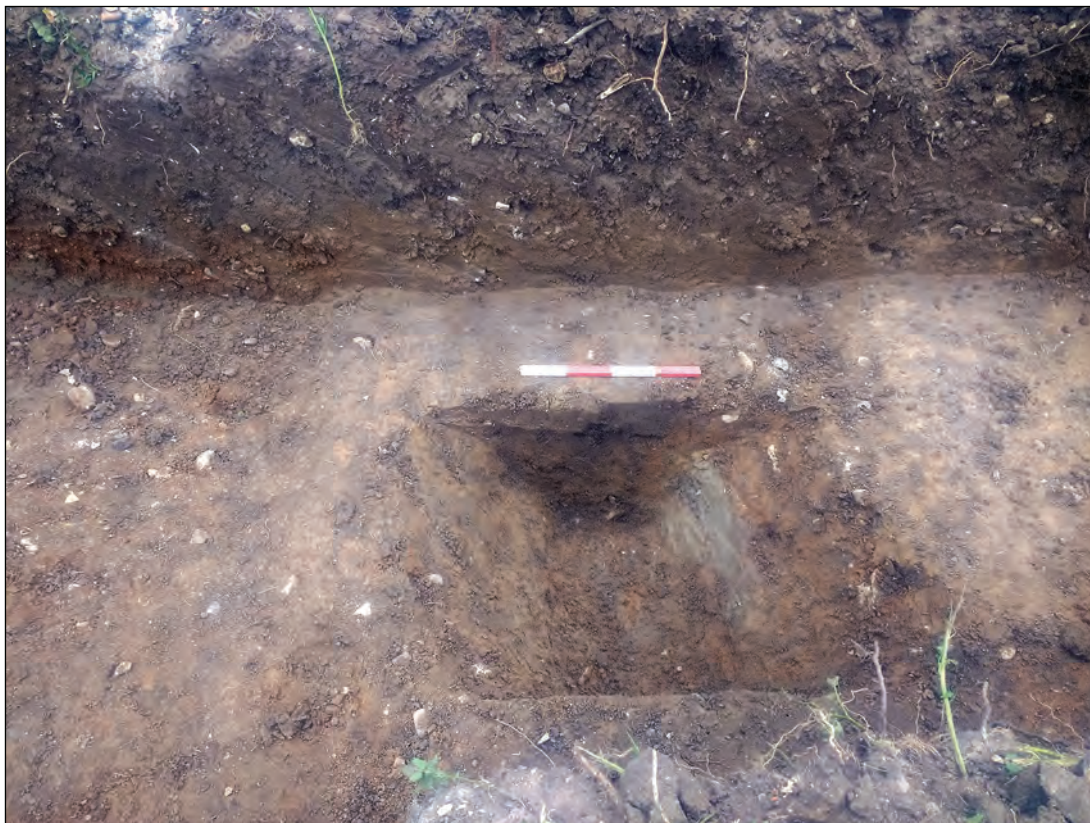
C.1.8 Sample 1, fill 102 of ditch **101** (Trench 1), contains a small quantity of charred barley (*Hordeum vulgare*), wheat (*Triticum sp.*) and cereal grains that were too highly abraded to identify. The sample also contains a single charred legume (*Pisum/Lathyrus/Vicia sp.*) and a few untransformed bramble seeds (*Rubus sp.*) and elderberry seeds (*Sambucus nigra*). A moderate quantity of charcoal (20ml) was recovered from this sample.

Plate 2: Ditch **101**, south facing section

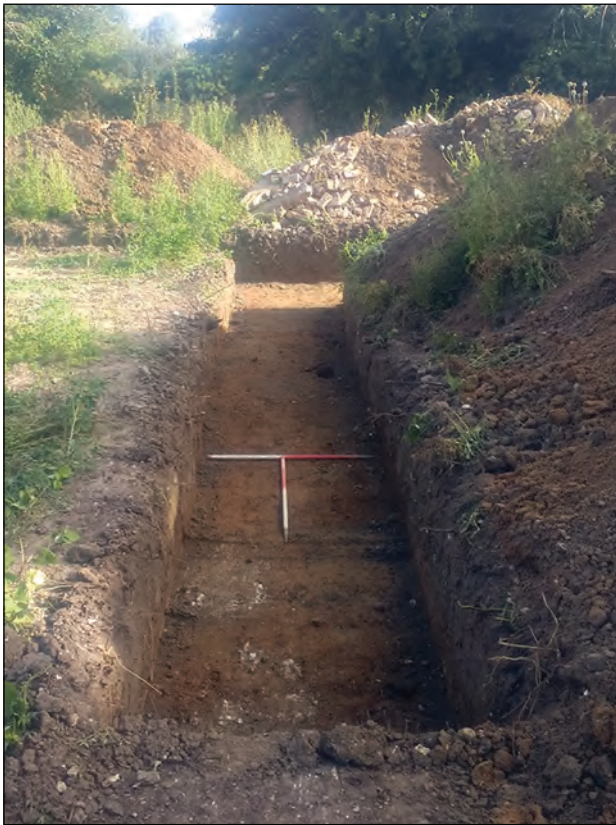
- 3.5.1 Trench 2 was orientated north to south. The natural geology was encountered at an average depth of 0.65m. A single post hole was uncovered towards the northern end of the trench.
- 3.5.2 Post hole **201** measured 0.35m in diameter and 0.29m in depth (Fig. 4; Fig. 5, Section 201; Plates 3-4). It was circular in plan and had steep, near vertical sides that led down to a concave base. No finds were recovered from its fill.

Plate 3: Trench 2, looking north

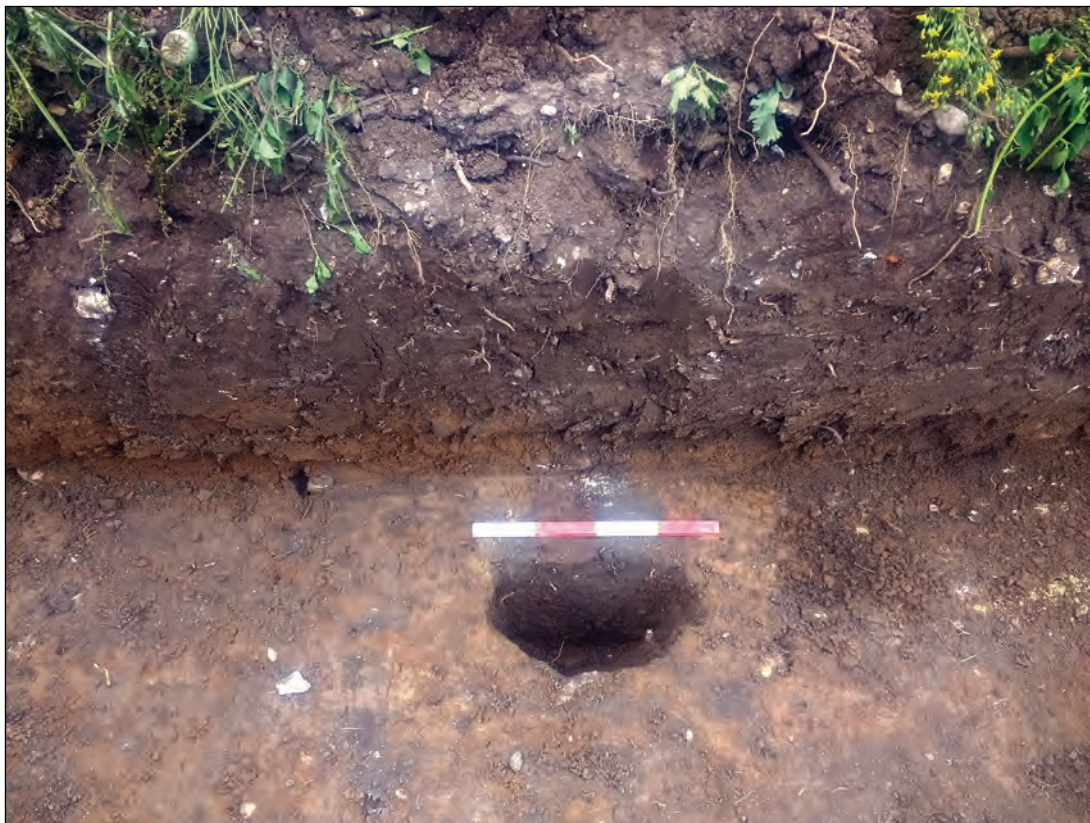
- 4.3.1 Neither of the two features uncovered on the site produced any artefacts to help determine their age or function. Examination of Ordnance Survey (OS) maps as far back as the 1870s shows no sign of any associated ditch or structure in that part of the site, which suggests they may be of earlier origin. Both features were sealed by subsoil, which supports this suggestion. The north-south alignment of the ditch lay parallel with the eastern perimeter wall of the site and may conceivably represent an earlier plot boundary. However, its width and depth is perhaps more suggestive of a drainage cut, as opposed to demarcating a property. The small quantity of plant remains found in the ditch fill were probably blown or washed into the open feature. The purpose of the discrete feature **(201)** remains inconclusive since it was a standalone feature, although its vertical sides and large diameter suggest it may have been structural in origin and possibly held a substantial post.

Plate 4: Post hole **201**, west facing section

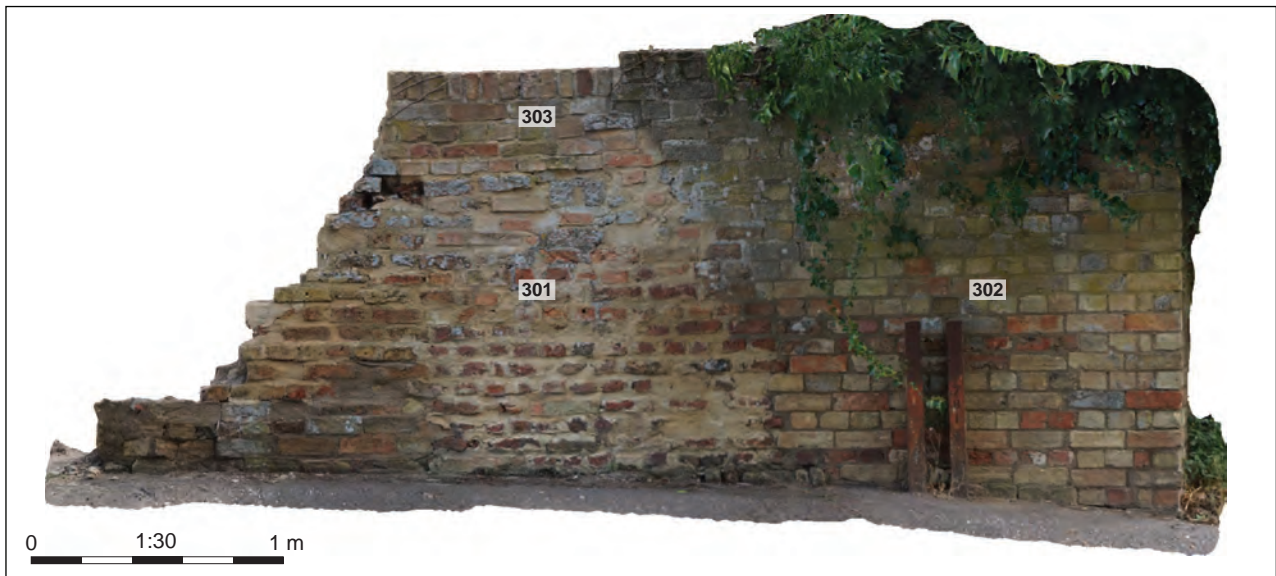
works, this wall had previously extended along the site's entire southern side. The oldest wall element was exposed along the upper part of its central section, with up to nine courses of modern brickwork appended to the front-base facing High Street (Plate 7). This later brickwork was presumably added to prevent collapse and reconsolidate the original structure. The surviving wall remnant was recorded using photogrammetry (Plates 5 and 6).

- 3.6.2 The oldest part of the wall (**301**) faced the site's interior, its external side facing High Street having later been clad with later brickwork. This part measured 2.81m long and 1.03m high and had a thickness of 0.28m. It was constructed with dark red flat unfrogged brick, typically measuring 230 x 100 x 60mm. Fourteen regular courses of this brick were arranged in an English garden wall bond. These bricks were bonded with a friable loose sandy beige mortar. Its northern face had been partially stained black. It was this brickwork that was evident in the Google Earth images (Plate 7) and it is clear that it had extended to the full height of the existing modern additions of this wall prior to its demolition. Bricks recovered from this wall were dated to the earlier 19th century (see Appendix B.1).

- 3.6.3 On the side of the wall facing High Street, a much more recent renovation had been made on the wall with yellow sandy mortar and in places modern brickwork (**302**). This brickwork represented the majority of the pre-existing wall visible on Google Earth images as well as on the remaining recorded section. It measured 1.72m high and was constructed from beige yellow brick bonded by a hard, white yellow mortar. The bricks measured 220 x 110 x 70mm and were constructed in 21 regular courses from street level, arranged in a stretcher bond apart from the topmost course which formed a header bond.

- 3.6.4 A later section of wall (**303**) was observed to both overlie wall **301** and abut wall **302** (Plates 5 and 6). It was apparently constructed to raise the height of wall (**301**) to that of the newly refurbished section (**302**), where there had evidently been a previous collapse at their juncture. This section measured 0.92m long and was 0.41m high and was created from four courses of brick in an English cross bond with the topmost course in a header bond. The bricks were bonded with a loose yellow white mortar. Examination of the bricks recovered from this wall determined them to be a Suffolk white/Burwell-type dating from the 19th century, although somewhat later than those found in wall **301**.

Plate 5: Wall **301**, **302** and **303** external facade

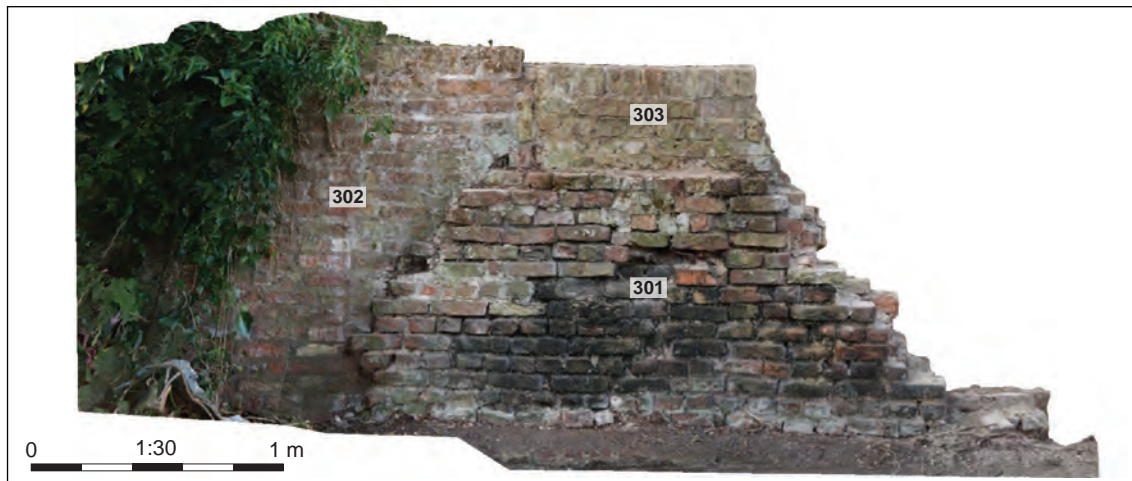
Plate 6: Wall **301**, **302** and **303**, internal facade

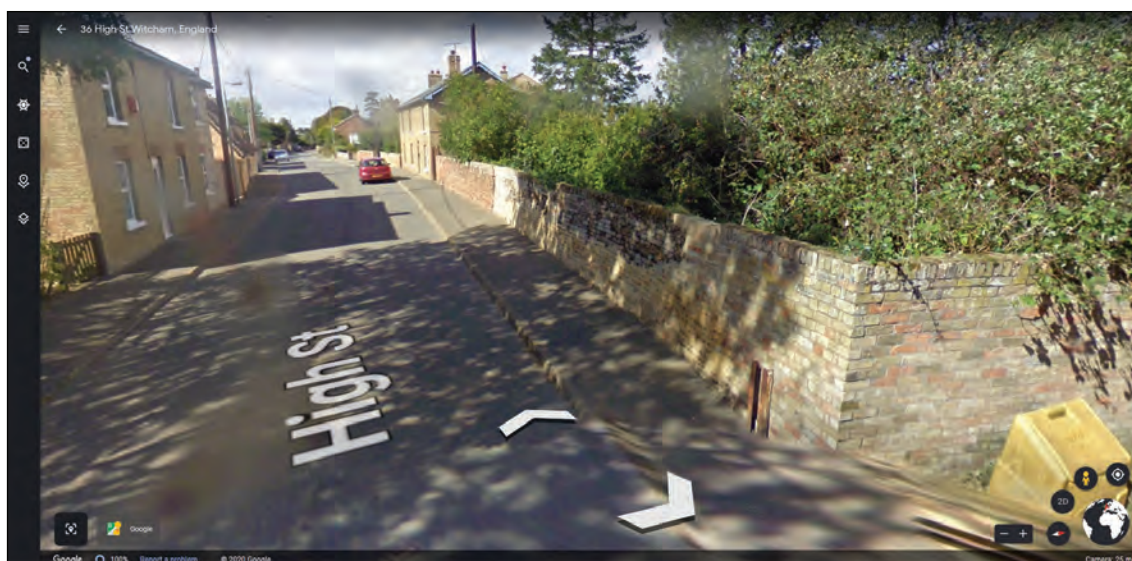
- 3.6.1 The only surviving part of the mostly demolished perimeter wall (which had previously faced High Street) was a short, east to west aligned section located at the site's south-eastern corner. Google Earth images of High Street show that prior to the development

- 4.3.2 Google Earth images clearly shows the site's former southern perimeter wall extending along High Street prior to its recent demolition. Photogrammetry recording of the remaining small section of this wall located at the site's south-eastern corner and examination of bricks recovered from its earliest fabric **(301)** has determined it to have probably been an early 19th century construction that was subject to much more recent refurbishment **(302)** and repair with reused brick **(303)**. The 19th century brickwork is notably similar with that of the perimeter wall surrounding Witcham House (present on the 1887 OS map), directly east of the site across Headley's Lane.

Plate 7: Google Earth image of wall (facing south) prior to demolition
