## Chapter 5: Road Excavations

*by Andrew Mudd and Simon Mortimer*

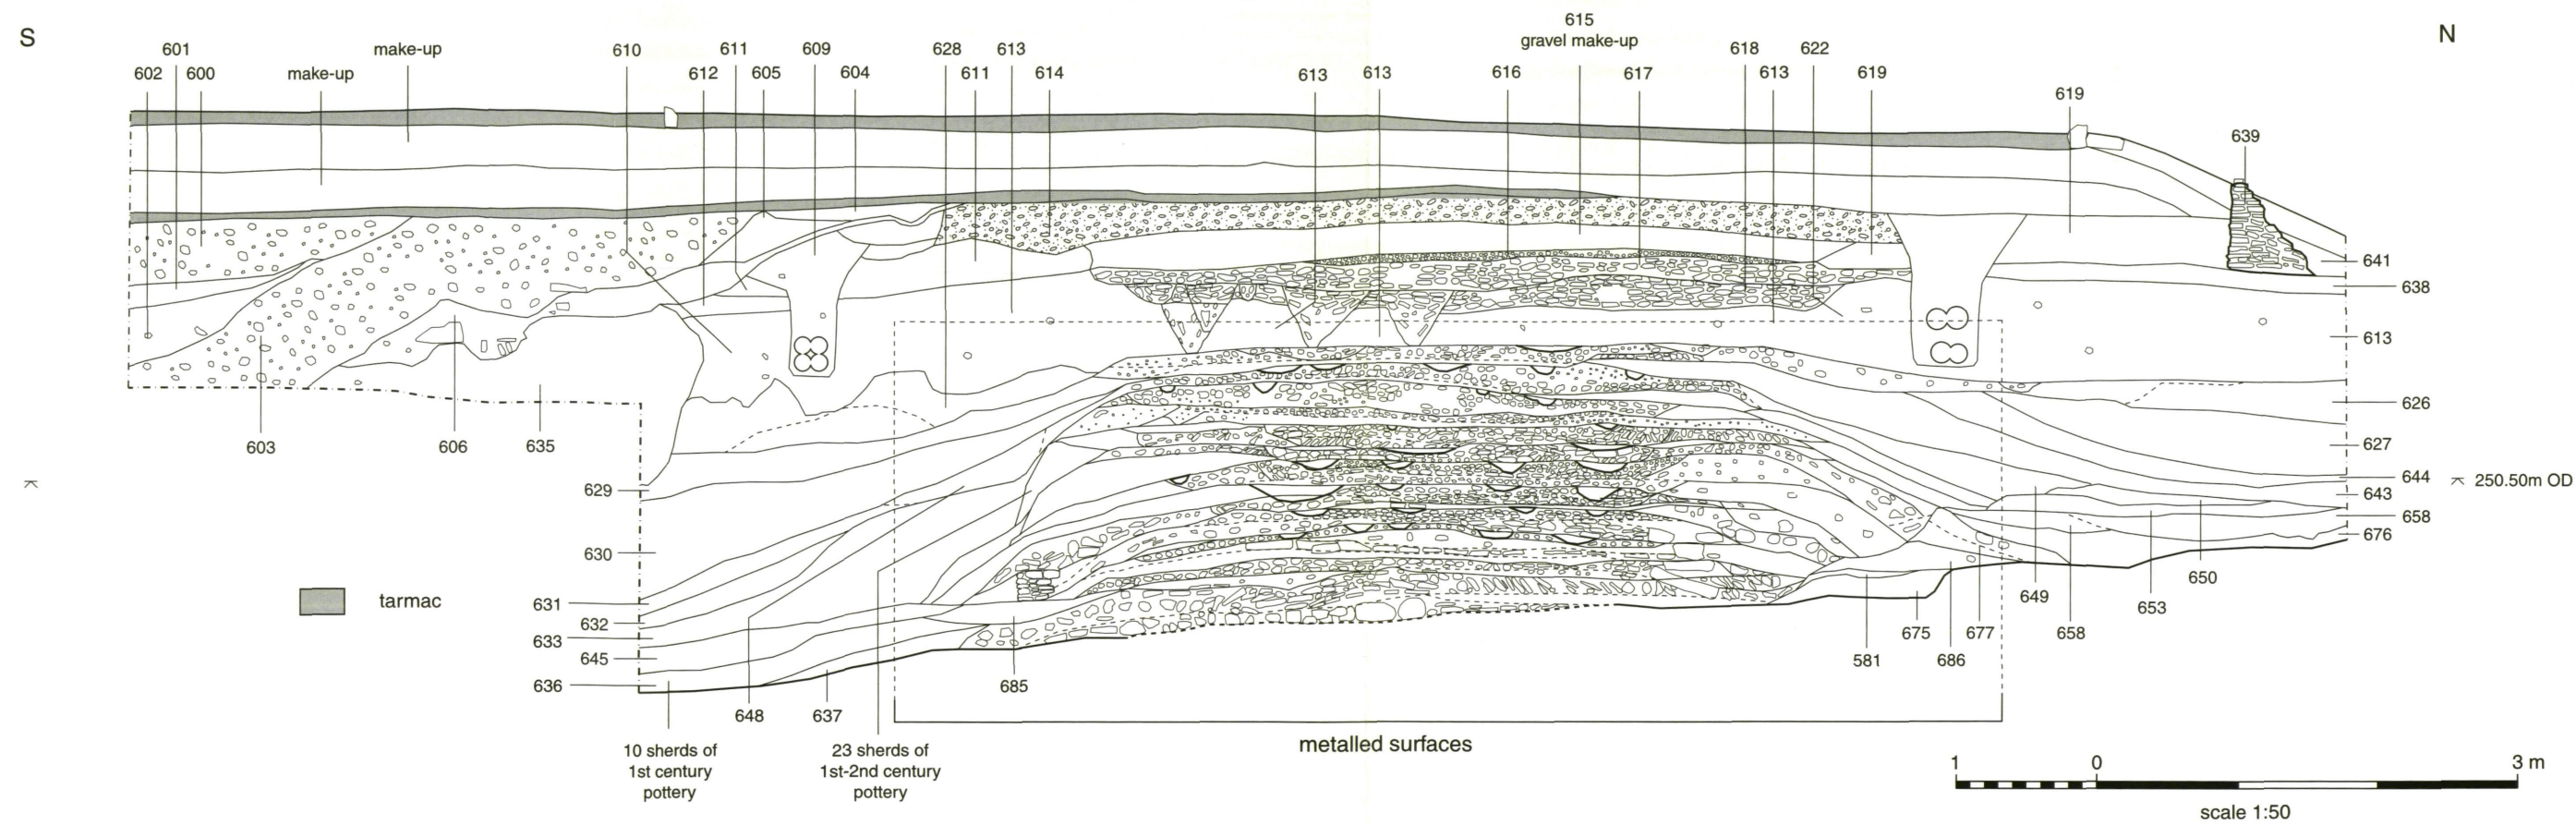
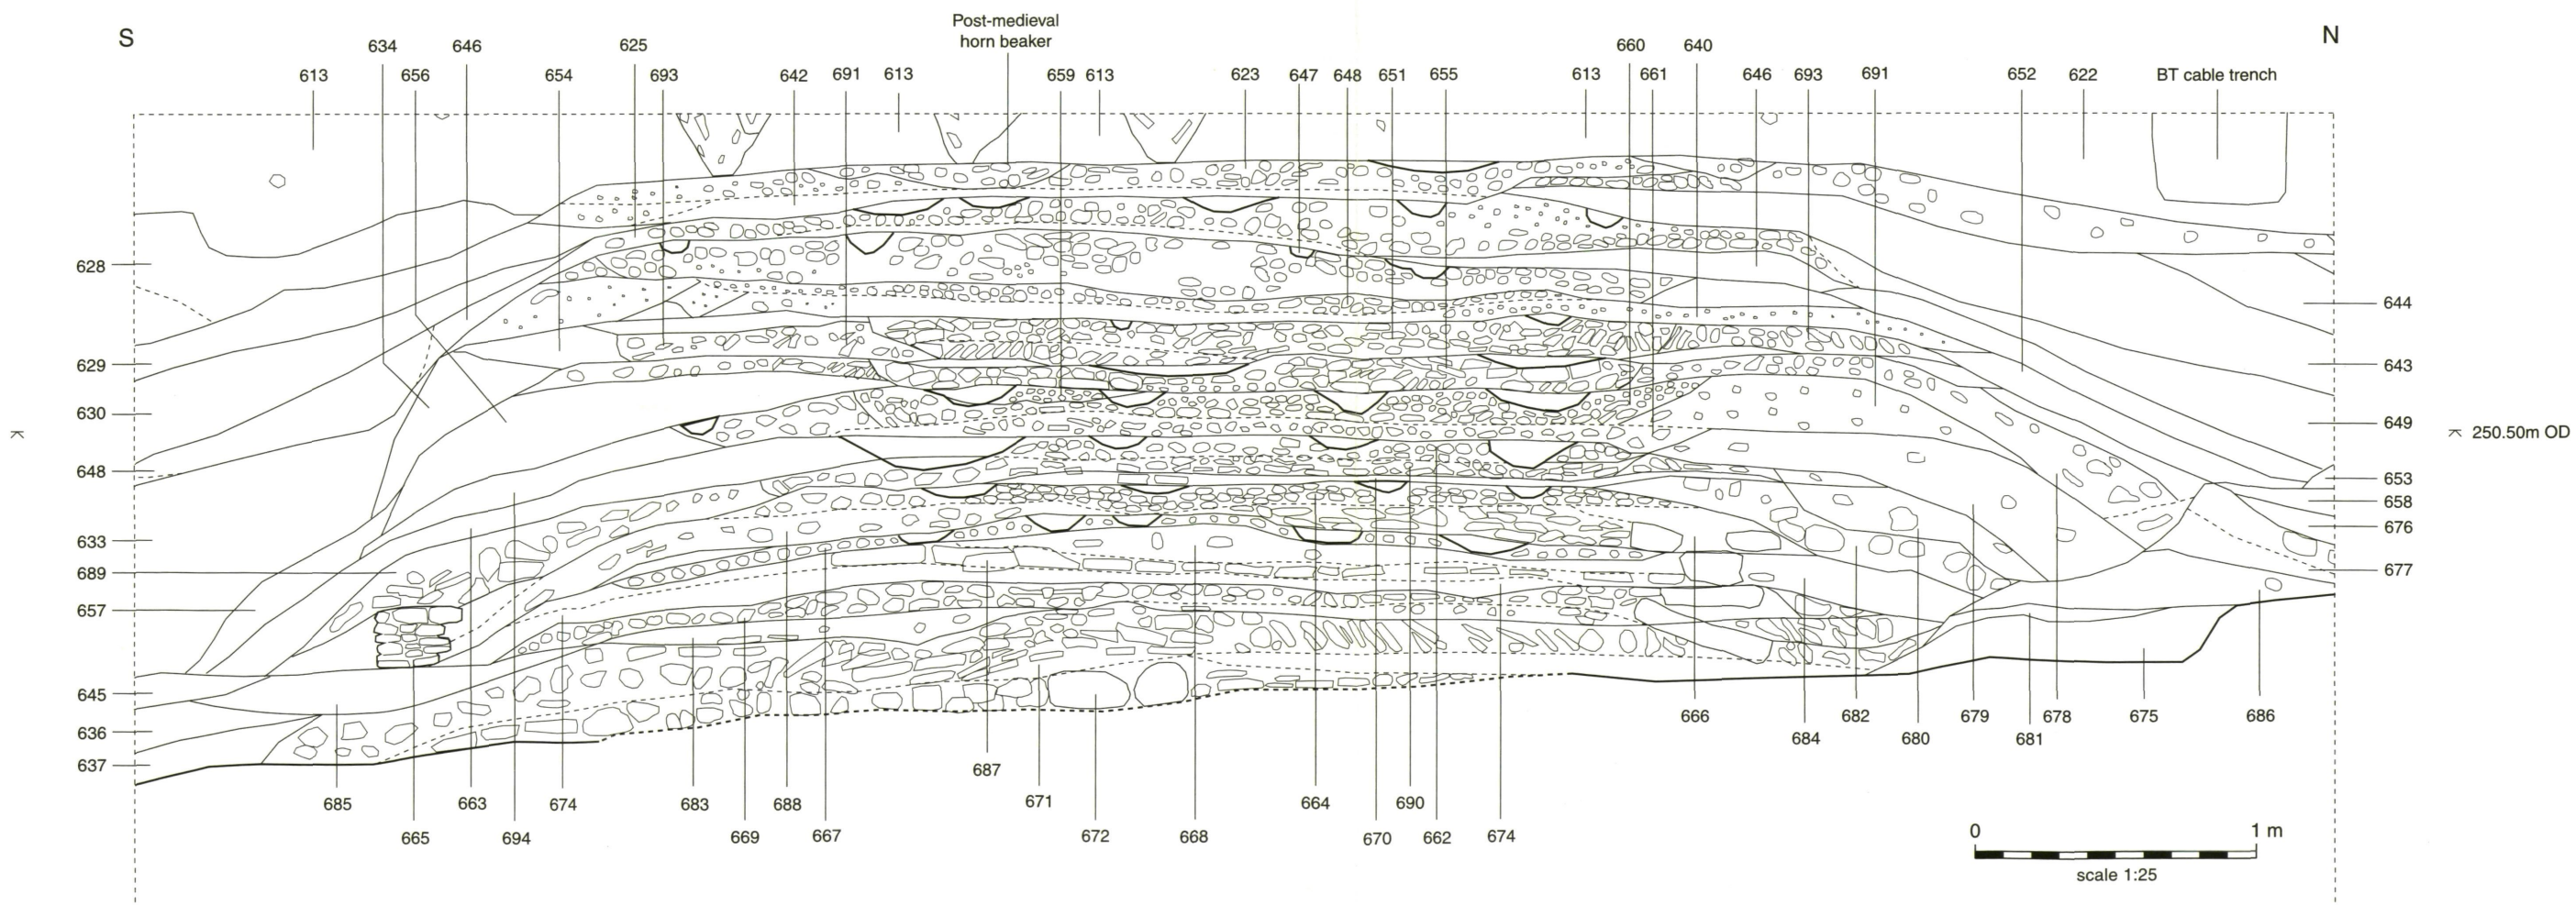
Figure 5.3 Cowley Underbridge, Trench 6, section

The deepest sequence of road surfaces was found at Cowley Underbridge, where Ermin Street crossed the narrow valley 200 m south-east of Birdlip Quarry. The slightly oblique angle of the crossing meant that the road was constructed on a slope from north to south (Fig. 5.3). The ground within the valley was damp and the soil under the road (673) was found to contain waterlogged plant remains (see Pelling, Chapter 8). These indicated a predominantly open grassland environment, although with an arable and

ruderal element to the flora. The preservation of these plants would suggest that the levelling of the ground for road building did not involve comprehensive de-turfing, and it is possible that the turf was removed from the top of the slope and used to raise the ground further down. Flecks of charcoal in the top of 673 may indicate that some of the vegetation in the road corridor was cleared by burning although this would not have been likely, or necessary, within the valley itself. It appears that the Roman road builders terraced the slope to the north in preparation for the construction. Deposits 675 and 686, interpreted as colluvium, appear to have been cut through and may have been deposited as a bank (deposits 650, 653) on the northern edge of the road to stop water running across its surface. There were no roadside ditches associated with this phase of construction. The first road make-up layer, 672, consisted of mixed limestone rubble in an orange-brown silty clay. This was capped by 671 which was composed of larger limestone slabs, many pitched at an angle, set in a light bluish grey clay. Slabs protruding from the surface of layer 671 were clearly incorporated into surface 669, which may have been a second phase of surfacing rather than the

original one. This layer formed a central corridor, 3.6 m wide, of small rounded limestone 'cobbles' flanked by rather larger flat slabs. The Roman road was thus almost exactly 6 m wide at its base and up to 0.38 m deep. Wheel ruts in the surface of 669 were relatively broad and shallow.

The silt deposits 636, 637, 645 and 685, to the south of the road were mixtures of redeposited natural silt with some stone rubble and appear to have been deposited to consolidate the edge of the road and to prevent the road base from spreading laterally under the pressure of traffic. A total of ten sherds (76 g) from a single early Severn Valley Ware vessel dating to the later 1st century AD derived from deposit 636. This deposit was stratigraphically earlier than road surface 669, and provides the most conclusive evidence from any of the excavations for the presence of the original Ermin Street. The care taken over the construction of the road and the distinction between the road foundation and surface, appear to be typical of the early Roman road. In this instance it is clear that there were two make up layers resulting in an extremely solid graded stone *agger*, with a camber such that the centre of the road was c. 0.1 m higher than the edges.

The difficulty with understanding the Cowley Underbridge section lies in deciding where the highest Roman surface lies. The section shows a sequence of ten road surfaces directly above 669 before a layer of silt, 613, appears to indicate that the road in this location went out of use. The sequence of roads shows similarities of construction technique, although there are also some distinctive individual characteristics. In general, each road surface was composed of small limestone 'cobbles' on a base of larger stones, which in turn were bedded into a levelling layer of clayey silt laid on the earlier surface. Surface 664 was associated with a drystone retaining wall, 665, on the south side. On the north side the terrace cut into the colluvium acted to prevent the road spreading in this direction. Higher up, surface 655 was observed to have kerbs of larger stones, although it is possible that this was a fortuitous exposure of the larger foundation stones by erosion, rather than a deliberate technique (as with surface 667, Figure 5.4). A road wash deposit (634) associated with this surface yielded a number of sherds (40 g) of early Severn Valley Ware of the 1st to 2nd centuries. This is suggestive of a relatively early date for this surface, particularly as the sherds may have come from a single thin-walled vessel broken in antiquity and are, perhaps, unlikely to have been redeposited. However, this dating evidence cannot be regarded as conclusive.

The subsequent road surface (651) was again well-constructed and had a distinctive edging of pitched stone and smaller rubble (693). This had the effect of widening the road to about 4.5 m, although only the central 3.0 m over the more solid base was rutted. The road was also distinctive in having a relatively large quantity of burnt stone in the make-up. A Roman cart linch pin came from surface 651. The southern edge of the road may also have been reinforced at this time with a dump of brown clay (633), although this

At Cowley Underbridge (Fig. 5.3), surface 648 (conceivably but not demonstrably 4th-century in date) was a poor quality cobbled surface, but it did not widen the road. The Gloucester Beeches section further south (Fig. 5.5) is difficult to interpret. There was a widening of the road with surface 771 and this was directly overlain by a thick deposit of silt 739, so the surface may have been late Roman. The trench at The Highwayman (Fig. 5.7) gave little clue as to the date of any of the road surfaces above the earliest one, although layer 505 appears to represent a widening of the road, albeit on the other (south-west) side. The Dartley Bottom trench provides the most intriguing evidence for late road widening in the form of cobbled surface 838, but the medieval dating evidence from 841, while contestable, could identify this as a post-medieval surface rather than a 4th-century one (Fig. 5.2). The other road sections, including the Burcombe Lane trench, just 120 m south-east of Field's Farm, yielded no useful evidence on this question, probably due to truncation. The main road sections therefore give no reliable support to the suggestion of a general road widening in the 4th century although the question still remains open. It may be argued that these sections, the points where the road crossed dry valleys, should be viewed as special cases where road widening would have been less practicable and therefore less likely even if it had been undertaken on the flatter ground. The question as to why widening the road should be considered necessary at all is a further enigma. It may have been an alternative to

If the implications of a turnpike road lying directly on a Roman road surface extended to the section at Cowley Underbridge (Fig. 5.3), similar difficulties of interpretation are introduced. Here, the turnpike road

construction equivalent to 847 is likely to be 647. This is different from the underlying roads in that it consisted of a relatively thick layer of rubble with a smoothed and rutted surface, but without evidence of metalling. It also appears to have been associated with a consolidation of the southern road margin in the form of a dump of clay 633. It is similar to layer 530 at The Highwayman, although they are not necessarily equivalent and neither contained dating evidence. The later surface, 623, was almost certainly used in the post-medieval period, but if it were a turnpike repair rather than the surviving Roman surface, the layer of silt (613) before the presumably 19th-century reconstruction (618) again needs to be explained.

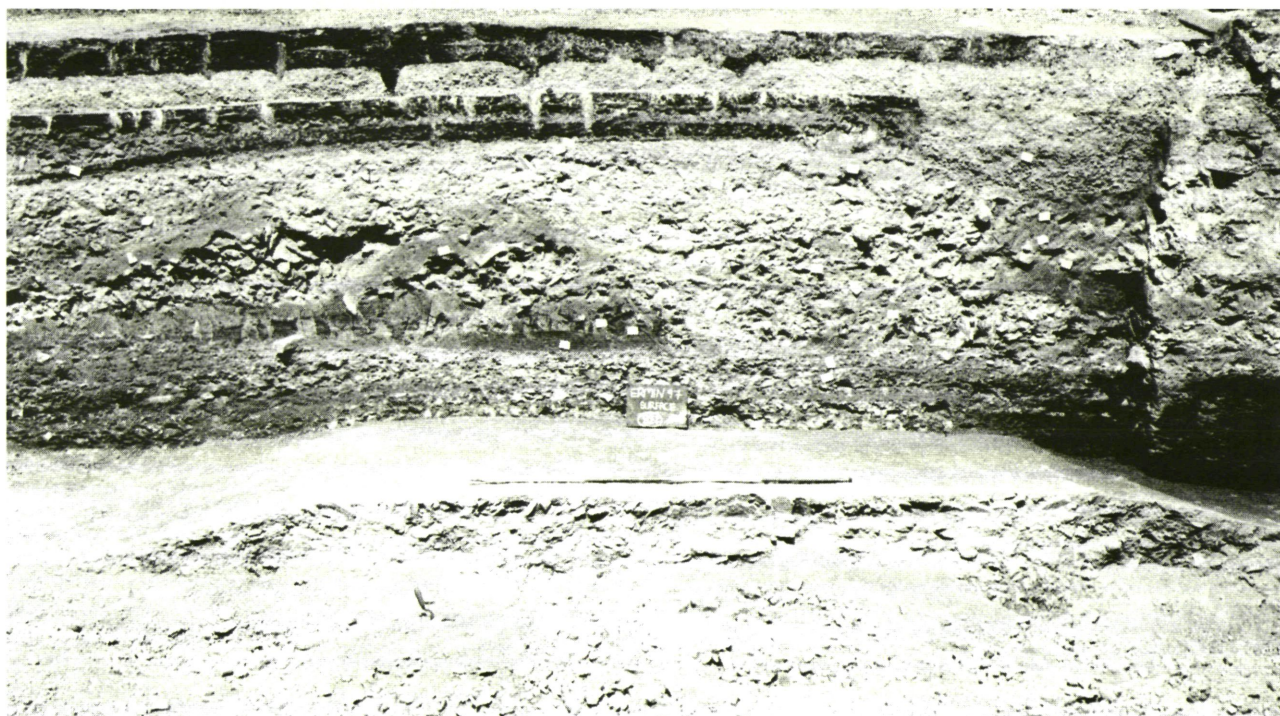
Plate 5.1 Dartley Bottom, Trench 8. Roman road surface 871.

The subsequent road was the most solidly constructed, with a base formed of tightly packed pitched stone, 874, capped with 'cobbled' surface 871. The two later surfaces, 851 and 842, were similar but laid on thin make-up layers, 866 and 865, which had the effect, intentional or otherwise, of increasing the camber of the road and narrowing its width.

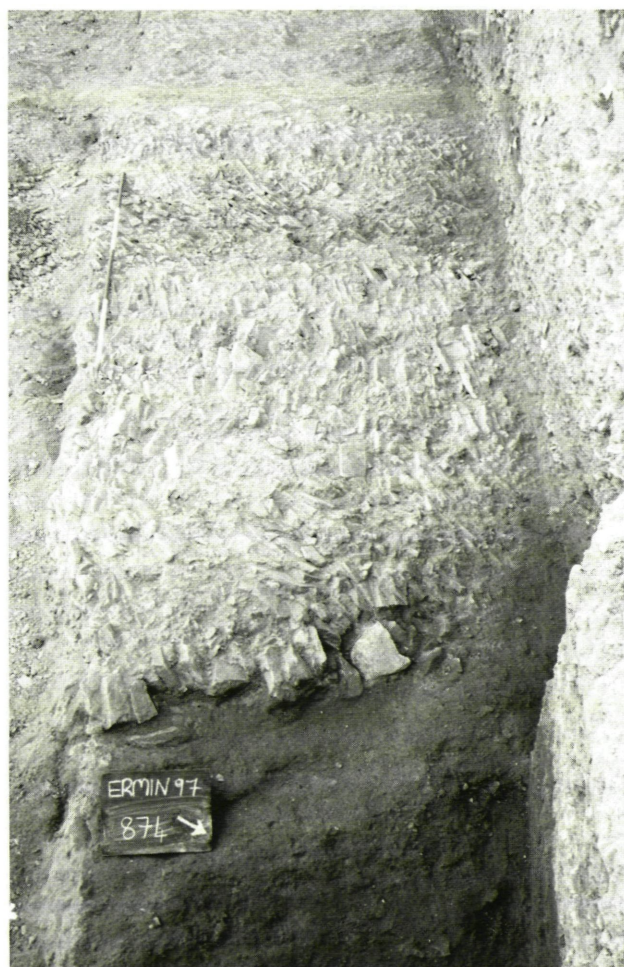
Plate 5.2 Dartley Bottom, Trench 8. Pitched stone foundation (874) for road surface 871.

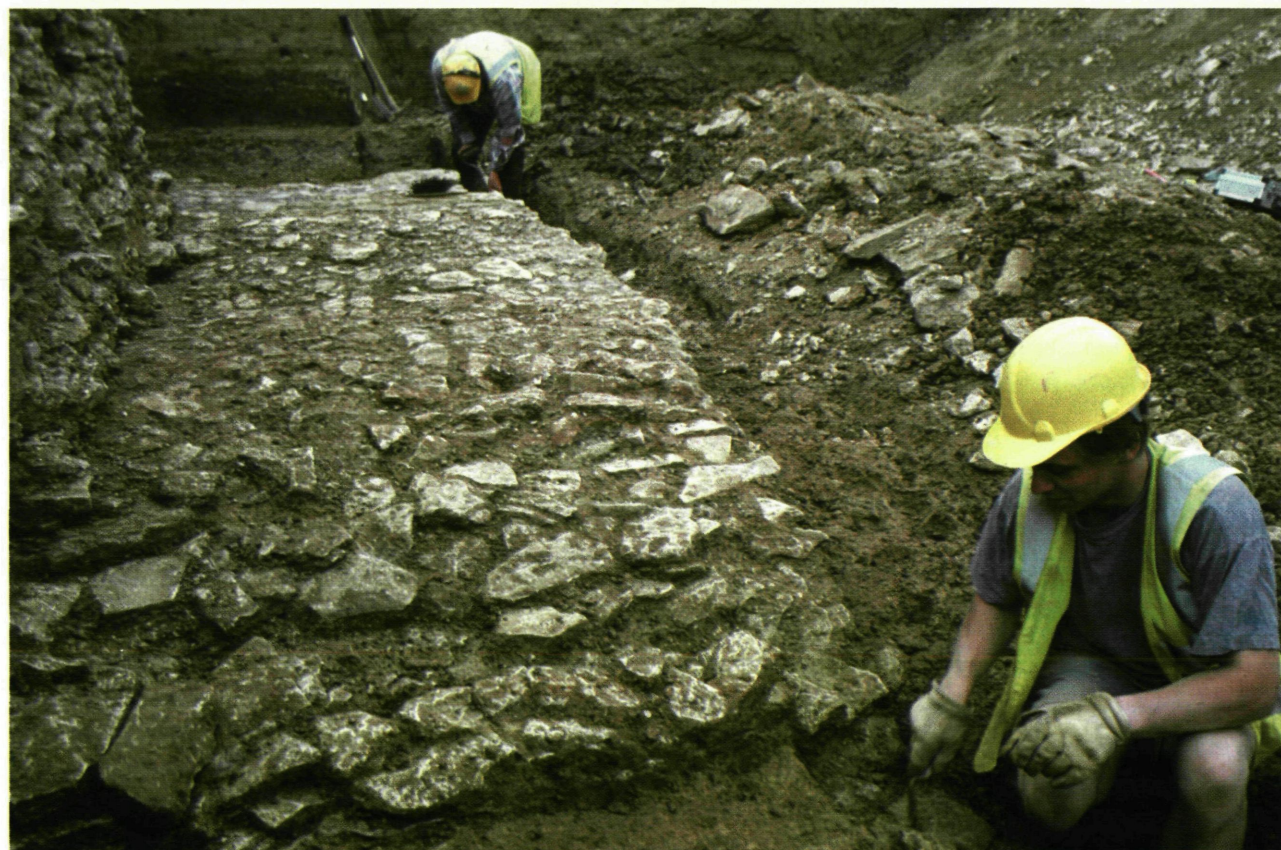
Plate 5.3 Roman road surface 669 at Cowley Underbridge (Trench 6).

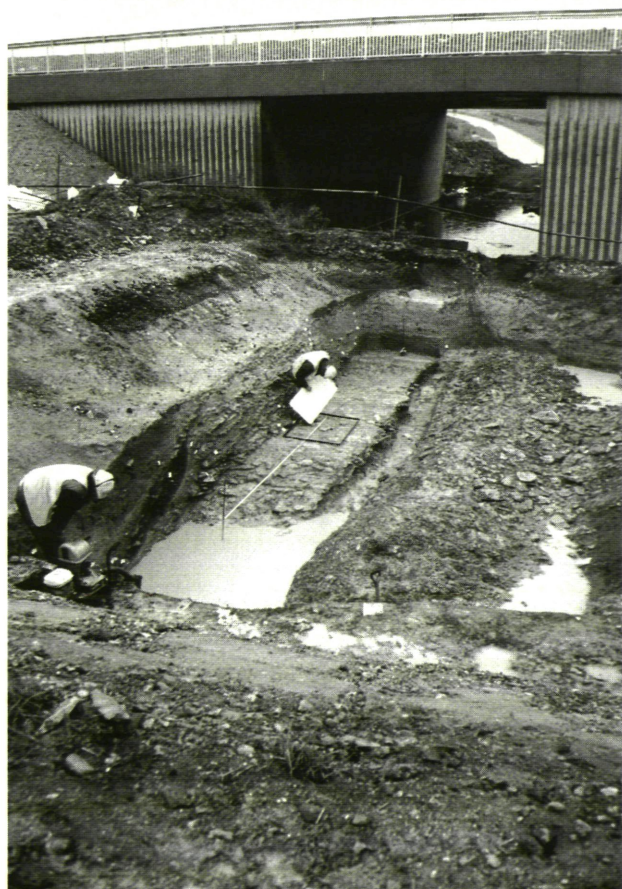
Plate 5.4 The earliest Roman road surface (669) beneath Cowley Underbridge (Trench 6).

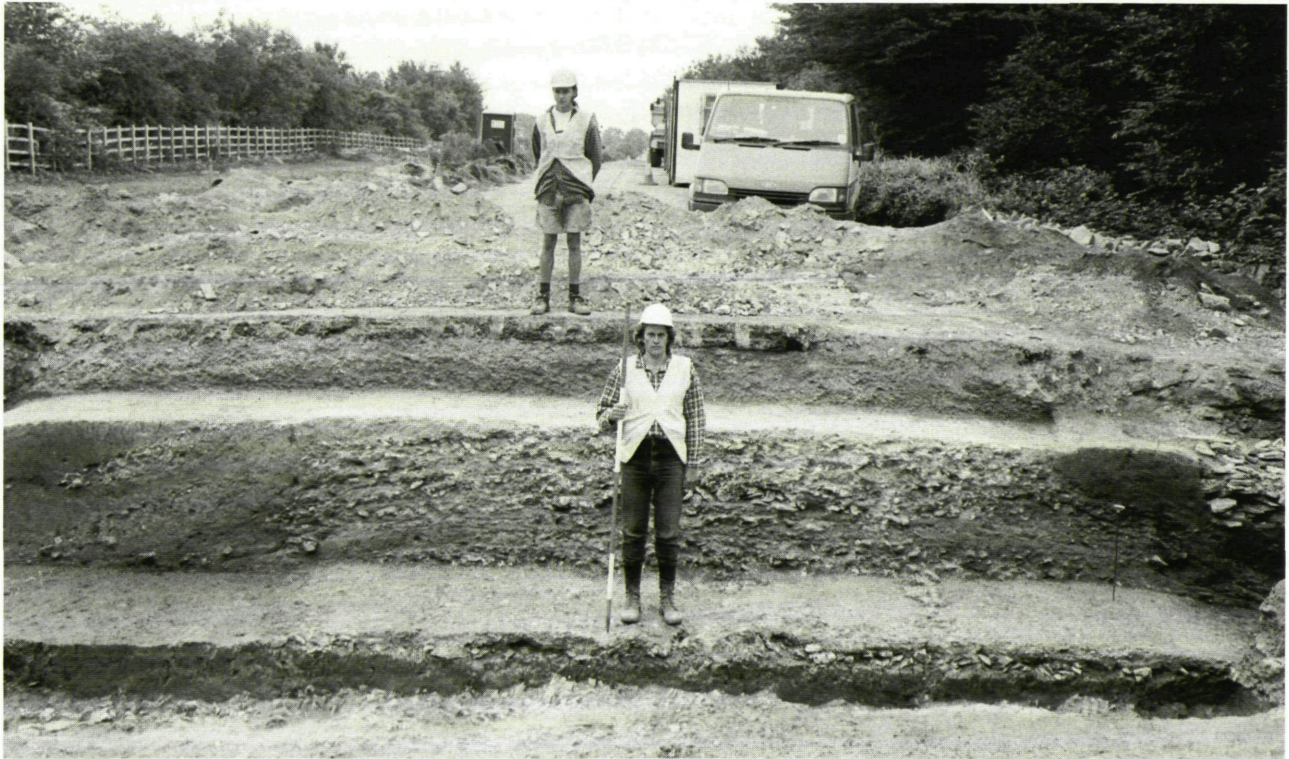
Plate 5.5 The earliest Roman road surface (1066/1067) in Trench 10 at Italy Underpass.

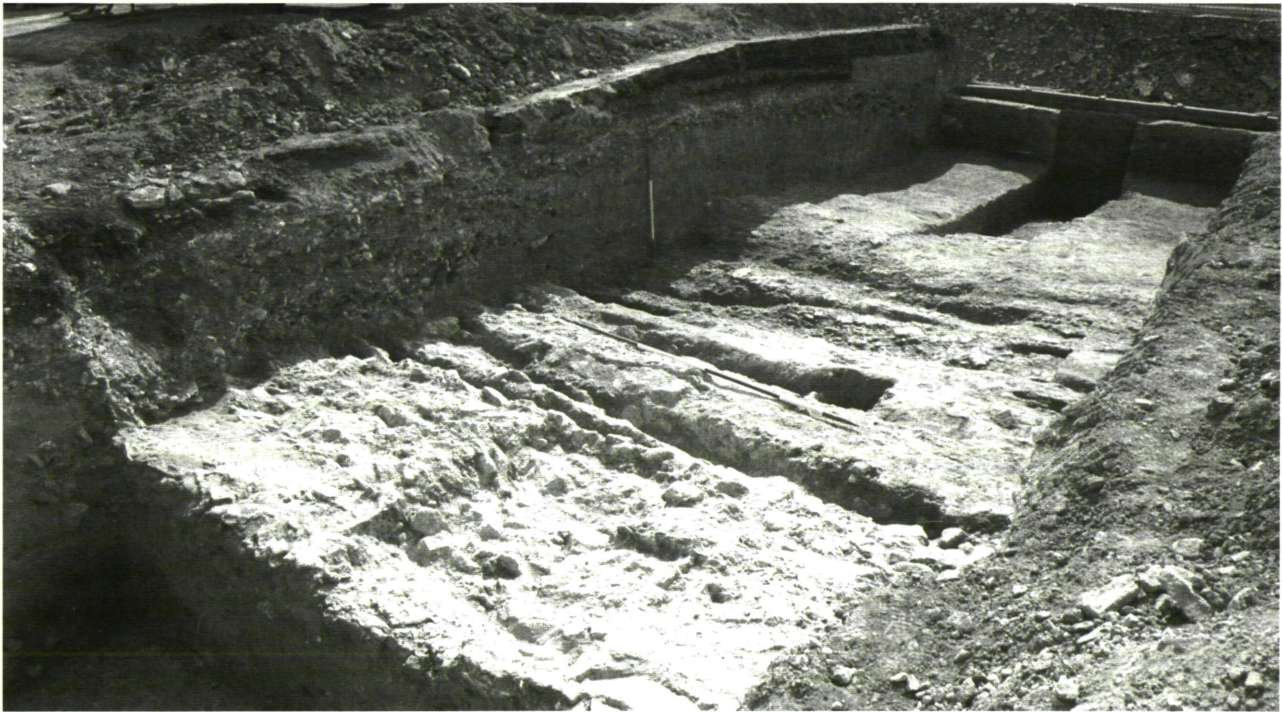
Plate 5.7 Heavily rutted road surface (553) under the modern Burford Road (Trench 5 looking south-east).

A similar sequence of road surfaces and associated deposits were encountered in both trenches. In Trench 1/3/5 the earliest definable road construction, 553, overlay silts 529 and 573 (Plate 5.7). This was heavily rutted, the ruts from this surface probably causing the apparent rutting in silt layer 529 which, however, is less likely to have been used as a road surface. It is unclear how well this road was originally constructed. The only evidence for road foundation was on the southern edge where surface 575 was laid on a base of small rubble and silt. It is possible that this was a better preserved remnant of 553 which had been intensively churned elsewhere. To the north, a thin layer of stones, 317, over 325 appears to have been at least partly contemporary with 553 but perhaps a later extension. It was possibly as much as 6 m wide. There were no finds from the road layers themselves but the overlying greyish silts 535 and 320 contained a fragment of bottle glass, two clay pipe stems and a horseshoe fragment. In Trench 2/6/4 the equivalent road construction, 661 and perhaps 673, were limited to the area overlying surface 410/663. The later road appears to have been laid after cutting into accumulated silts 409 and 620. The surviving evidence indicates that this road was only about 3 m wide, although it is possible that its extent to the south was removed when the make-up to the subsequent road, 621, was prepared. Two farthings of Charles II (1660–85) came from 620 (cat. 223–224). This is important dating evidence since the coins were found close together and are likely to have been associated, ruling out any question of residuality. At face value, this gives a quite precise *terminus post quem* for road surface 661.

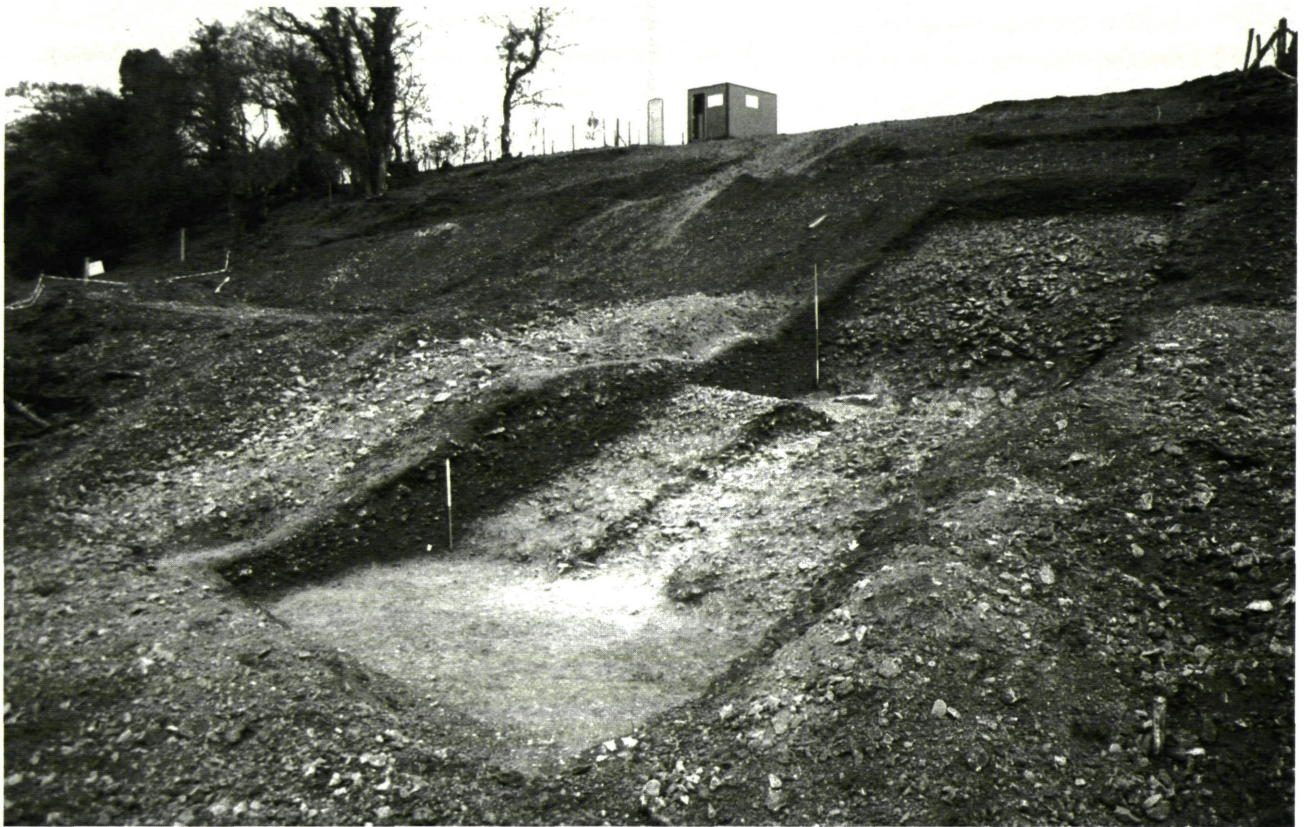
*Plate 5.8 Trench excavated through The Lynches Trackway on the side of the Churn Valley. looking north-east.*

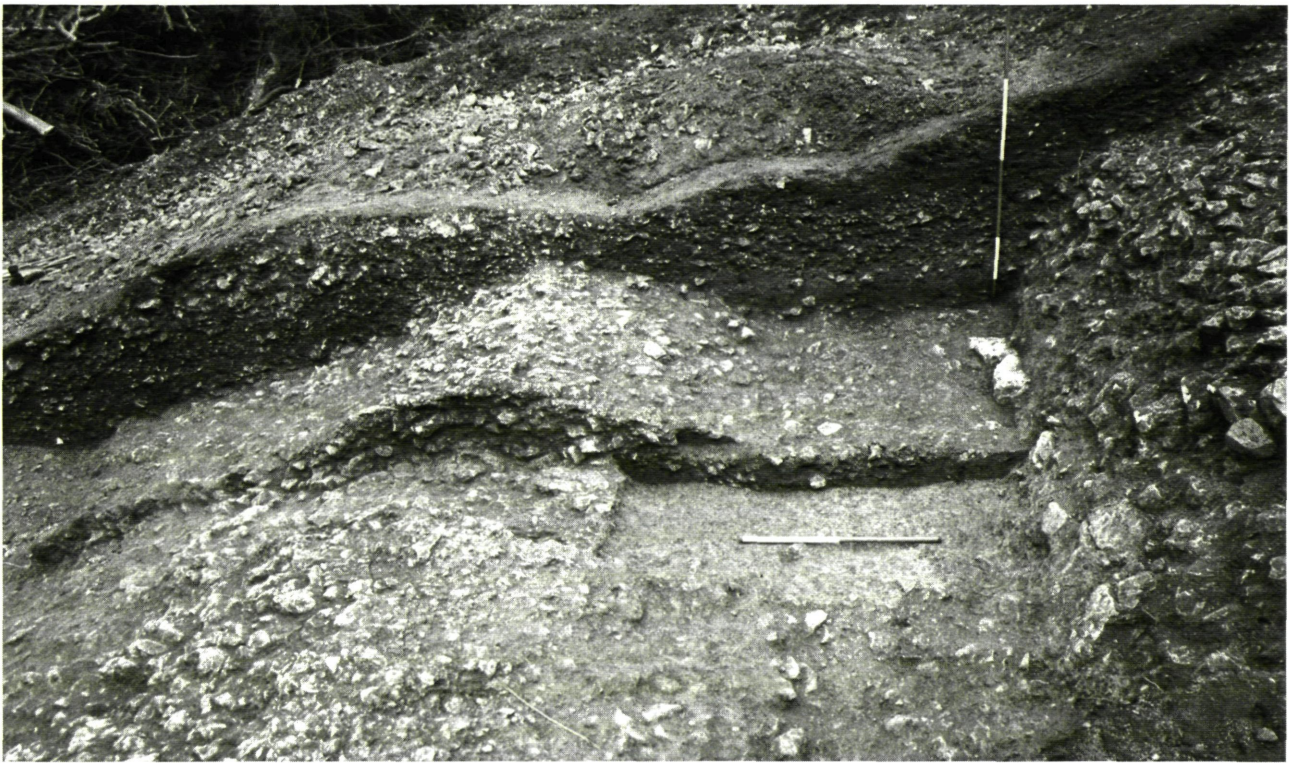
Plate 5.9 The Lynches Trackway showing Roman surface (22) and stony bank to left. The central slot has been excavated to bedrock.

The excavation revealed that the earliest trackway had been cut into the valley slope forming a c. 2.2 m wide hollow up to 1 m deep in the hillside with a c. 1.4 m wide, 0.4 m high, bank on the downslope side (Fig. 5.11). This natural bank appeared to have been enhanced by the addition of stony material (14) excavated from the hollow. Though no trace of wheel ruts were discovered on the cut natural surface, the limestone did show traces of wear.
