Archaeological Evaluation of Land at Manor Farm Pertenhall, Bedfordshire

Archaeological Evaluation Report

January 2015

OA East Report No: 1720

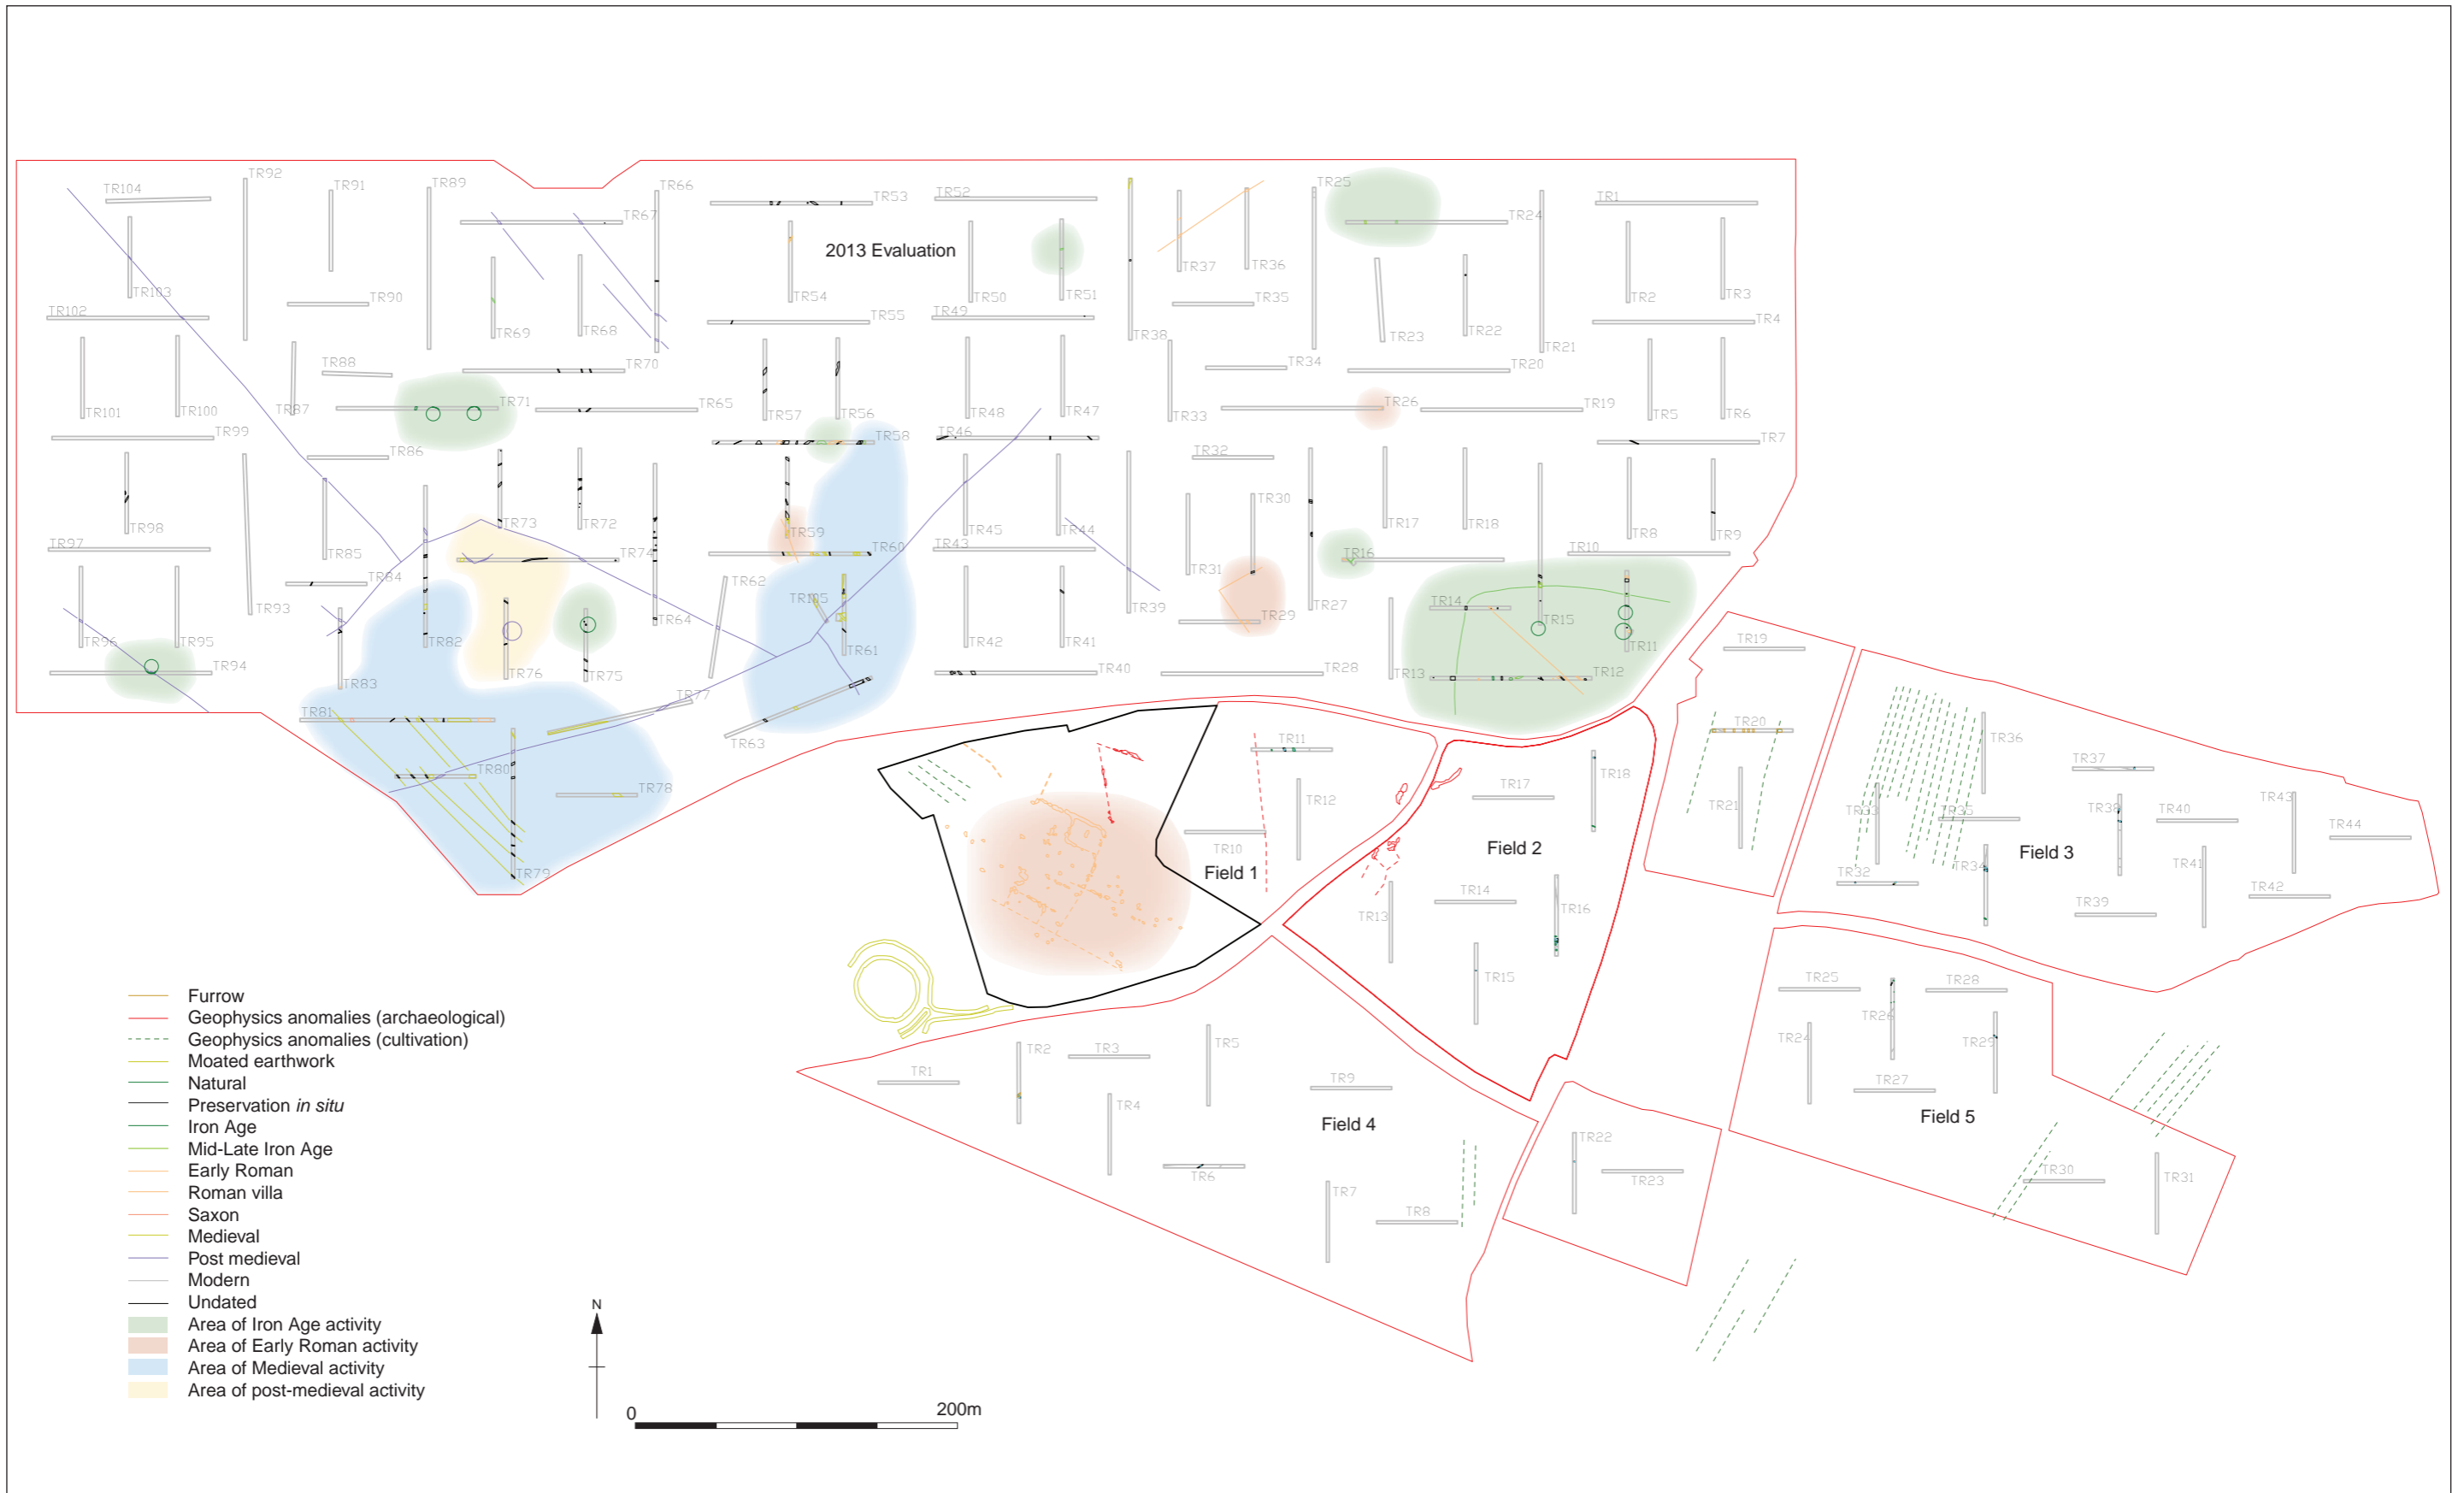
Figure 8: Phased plan of the evaluations in 2013 and 2014

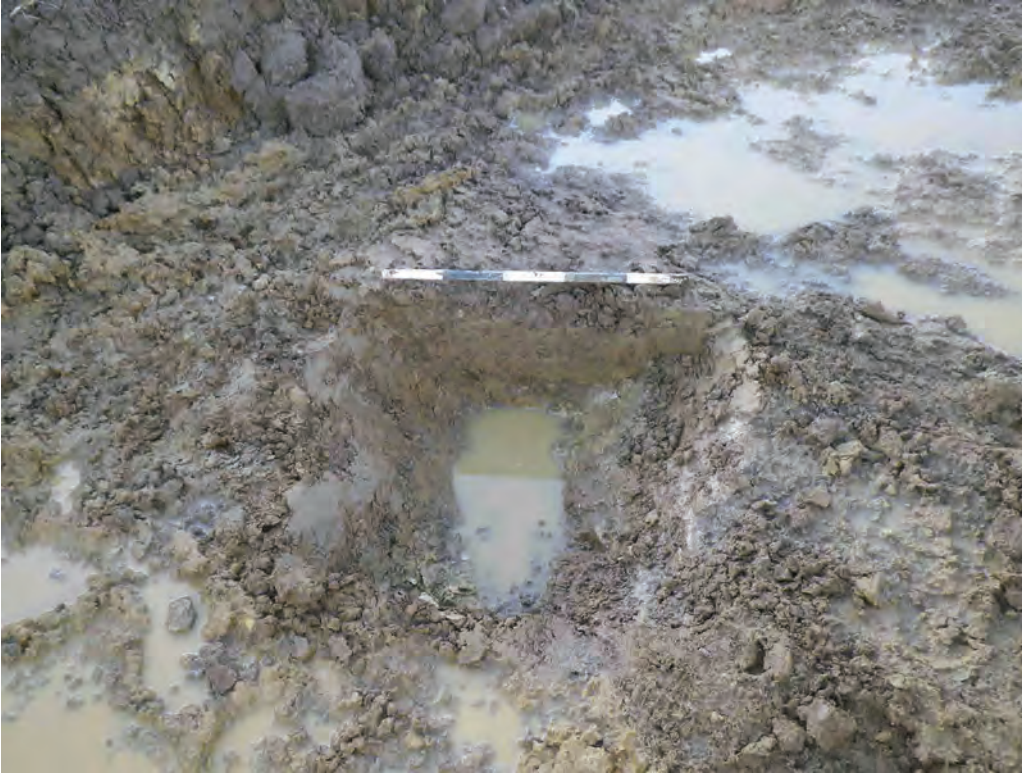
3.2.6 Trench 6, at 46mOD, contained a shallow ditch (**44**, plate 1) with a concave base and steep sides that was aligned north-east to south-west across the middle of the trench. It was filled by a plastic mid brownish grey silty clay (**45**). No finds were recovered from the feature.

Plate 1: Ditch terminus **44**, Trench 6. Photograph taken from the north-east.

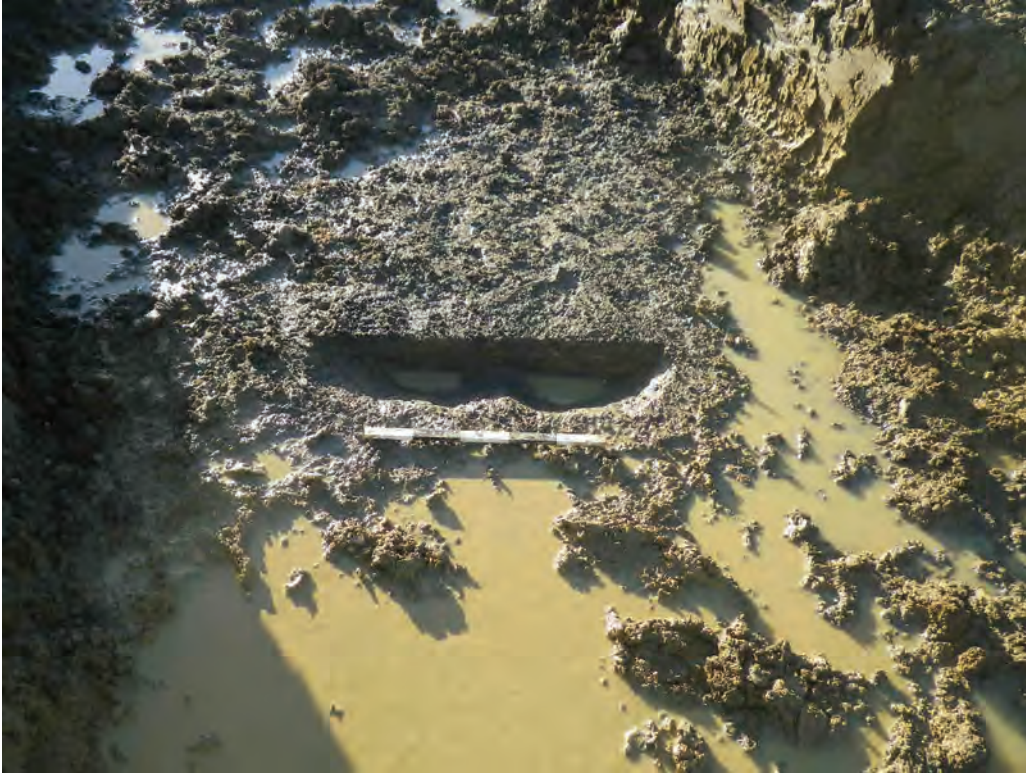
3.2.13 This trench, in Field 2, contained two small, shallow, possible pits (**32** and **34**, plate 3). Pit **34** cut the north-west edge of pit **32**, and was circular with a concave base, gentle sides and was filled by a soft light blueish grey silty clay (33). Pit **34** was circular with a concave base and gentle sides, and was filled by a soft mid blueish grey silty clay (35). Both were undated, containing no finds.

Plate 3: Pit 34 cutting pit 32, Trench 15. Photograph taken from the south

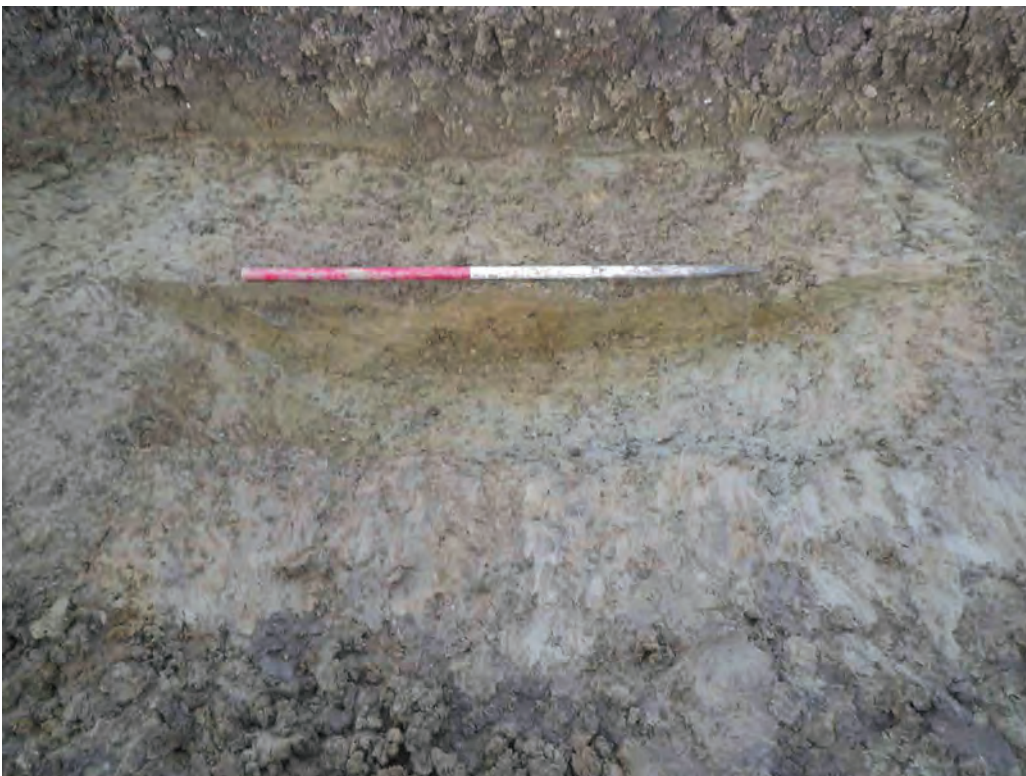
3.2.18 This trench, at the west end of Field 3 at 42mOD, contained remnant ridge and furrow. Furrow **17** (plate 4) had a concave base with gentle sides and was filled by a loose mid orange-brown silty clay (18). Furrow **19** also had a concave base with gentle sides, and was filled by a loose mid orange-brown silty clay (20). These two furrows were at each end of the trench, with a further five furrows regularly spaced between. An abraded fragment of 19th century ceramic was recovered from the topsoil of this trench.

Plate 4: Furrow 17, Trench 20. Photograph taken from the south

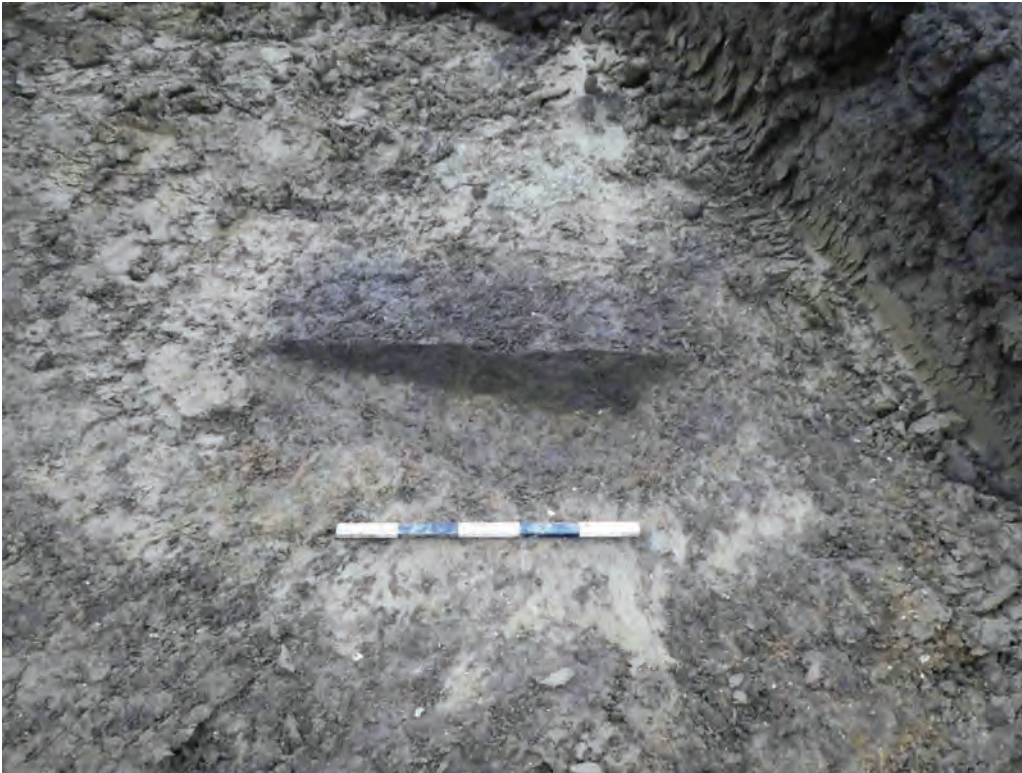
3.2.20 Trench 22, in Field 5, contained a single circular undated possible pit (**43**, plate 5) with a concave base and gentle slope on its south-east side and steep slope on its north-west side. It was filled by a soft mid grey clayey silt (43). No finds were recovered from the feature.

Plate 5: Pit 42, Trench 22. Photograph taken from the south-west

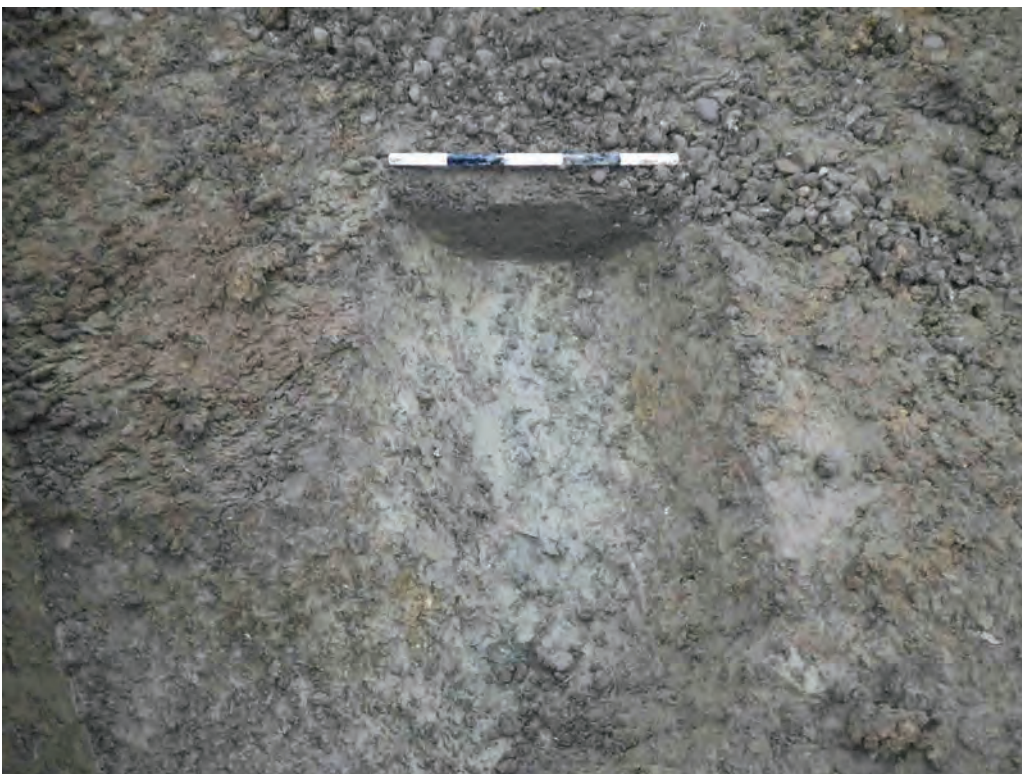
- 3.2.22 Trench 26 was located in Field 5 at 41mOD. The north end of trench 26 contained a ditch terminus (**39**, plate 6) with root disturbance at the terminal end. It ran north-east to south-west, had a concave base with steep sides, and was filled by a plastic dark brownish grey silty clay (38) that contained a fragment of post-medieval brick. This ditch was probably part of the same field drainage system as ditch **37** in trench 29.

Plate 6: Ditch 39, Trench 26. Photograph taken from the north-east

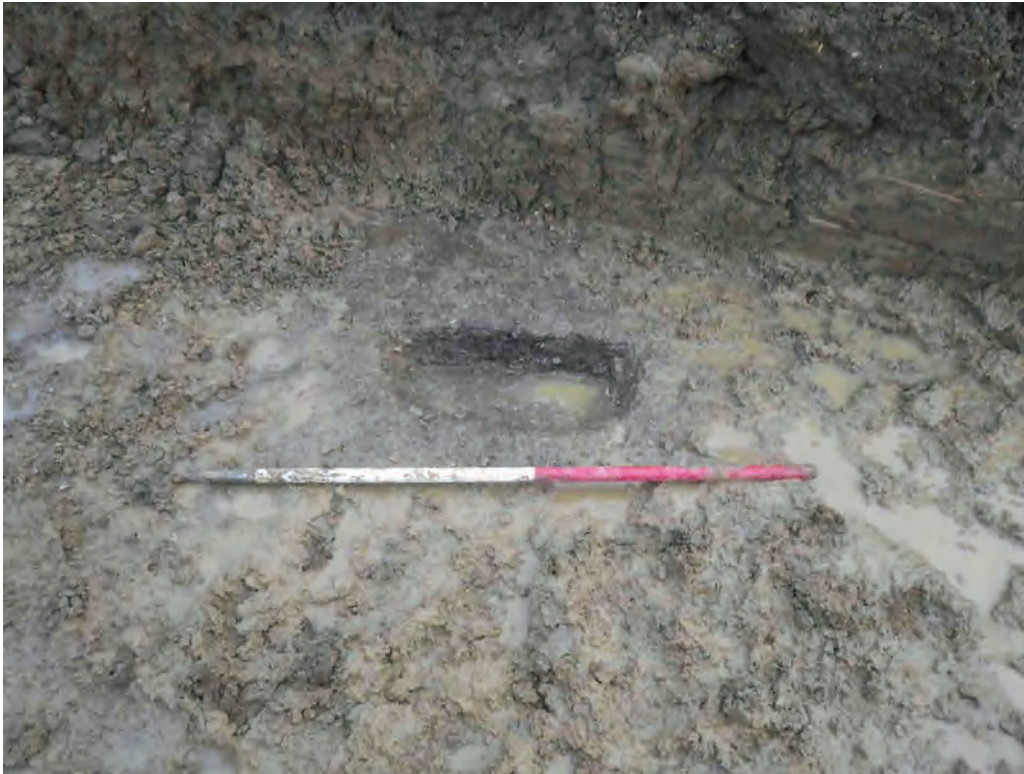
- 3.2.26 This trench in Field 3 contained a small possible pit (**21**) with a concave base and steep sides that was filled by a firm mid blueish grey clayey silt (22) that contrasted with the fills of other features. This trench also contained a curvilinear gully (**23**, plate 7) with a concave base and sharp sides. This was filled by a plastic light grey silty clay (24) and an overlying soft dark blueish grey clayey silt (25). The lower fill was a silting deposit, whilst the upper fill appeared deliberately deposited.

Plate 7: Pit 21, Trench 32. Photograph taken from the north-east

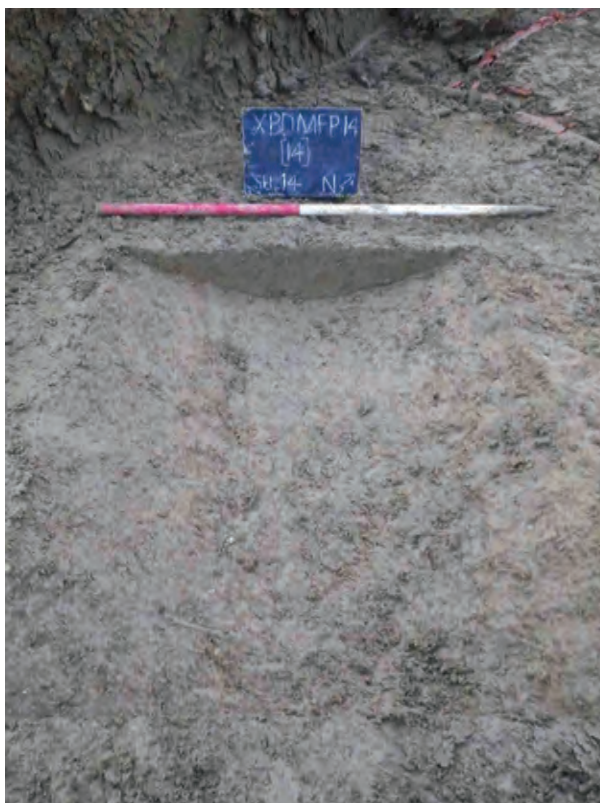
- 3.2.28 This trench in Field 3 contained a shallow ditch (**14**, plate 8) with gentle sides and rounded base that was filled by a compact light orange-grey clay silt (13), and a concave based ditch (**16**, plate 9) with steep sides that was filled by a compact light orange-grey clay silt (15). Both of these ditches were filled by natural silting once they had gone into disuse. These two ditches, with comparable profiles and fills, were close together and at about 45 degrees to each other, although they did not intersect within the trench, and may represent slight alterations in the prevailing drainage of the field.

Plate 8: Ditch 14, Trench 34. Photograph taken from the south-east

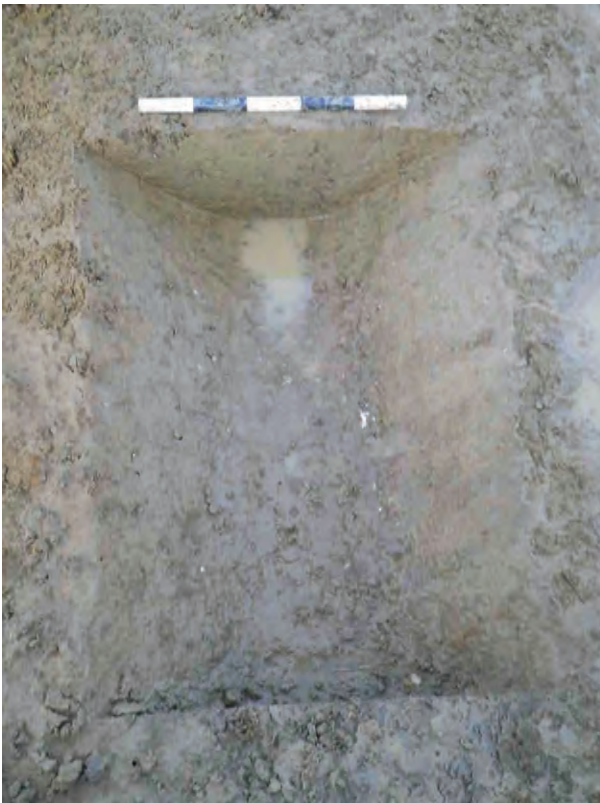
Plate 9: Ditch **16**, Trench 34. Photograph taken from the east-south-east

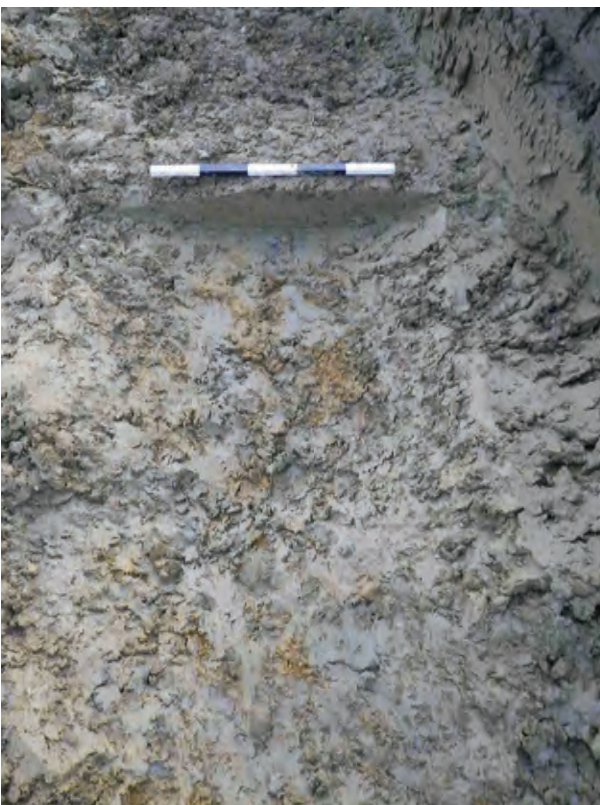
- 3.2.31 This trench was located in the middle of Field 3. It contained a ditch terminus (**04**, plate 10) with gentle sides and a concave base, and was filled by a firm light greyish brown

Plate 10: Ditch terminus **04**, Trench 38. Photograph taken from the north-east.

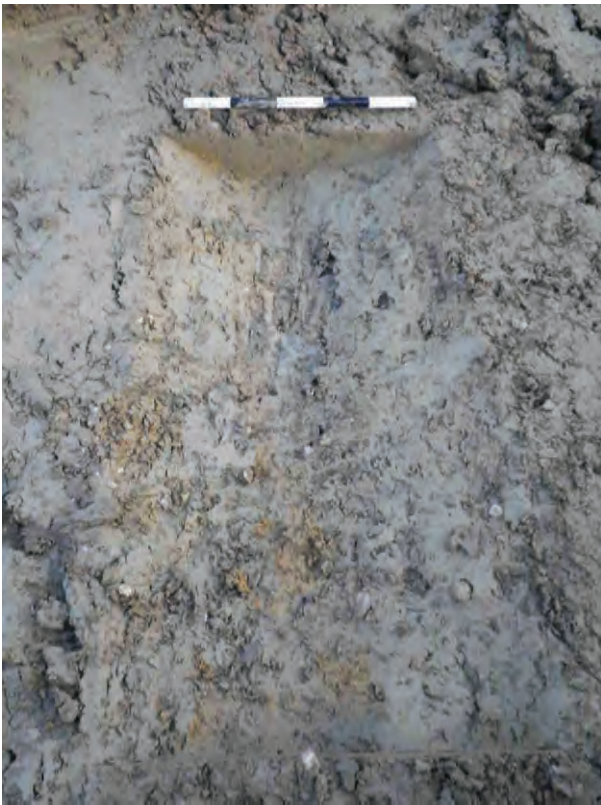
silty clay (03). This was perpendicular to, and about 1m from, ditch **06** (plate 11) which had a flat base and gentle sides, and was filled by a firm light greyish brown silty clay (05). Ditch **04** contained a fragment of abraded Roman pottery (R. Mortimer pers. comm.), and ditch **06** a fragment of ceramic building material, probably post-medieval.

Plate 11: Ditch **06**, Trench 38. Photograph taken from the north-west.

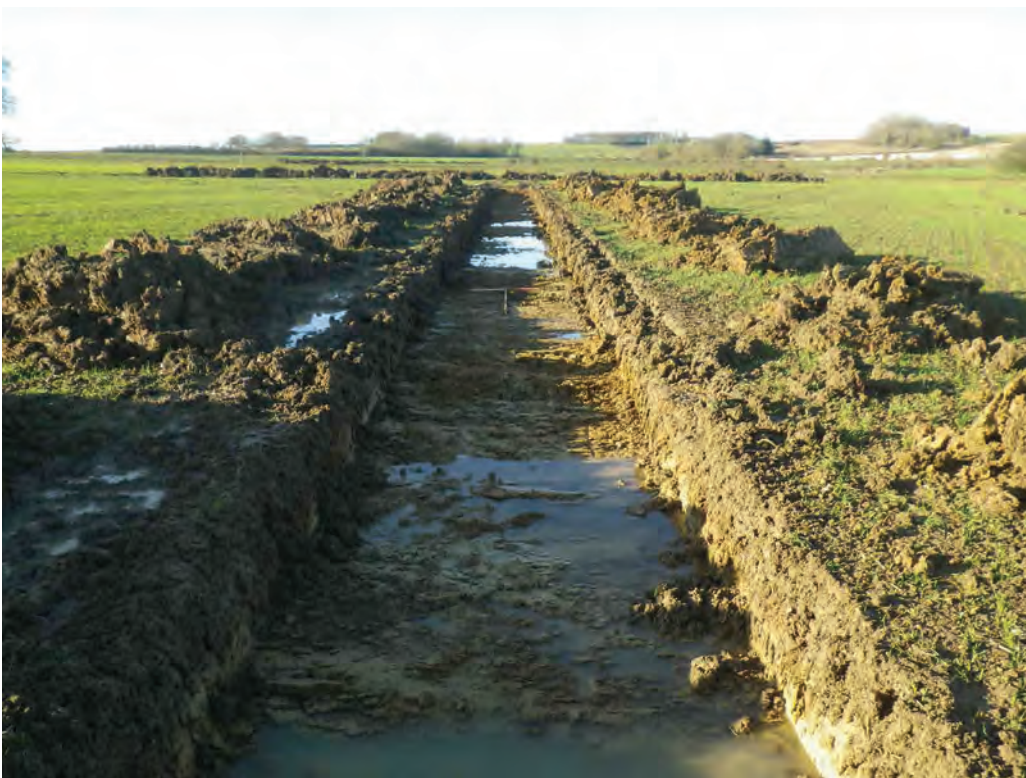
Plate 12: Photograph of Trench 23, showing the pooling of water on the surface and the poor drainage of the land, especially the field in the top right corner. Photograph taken from the west
